# Worldwide Pollution Control Association

FirstEnergy ESP Seminar  
November 27<sup>th</sup> – 28<sup>th</sup>, 2007

# Precipitator Maintenance and Operations

By Scott Williams

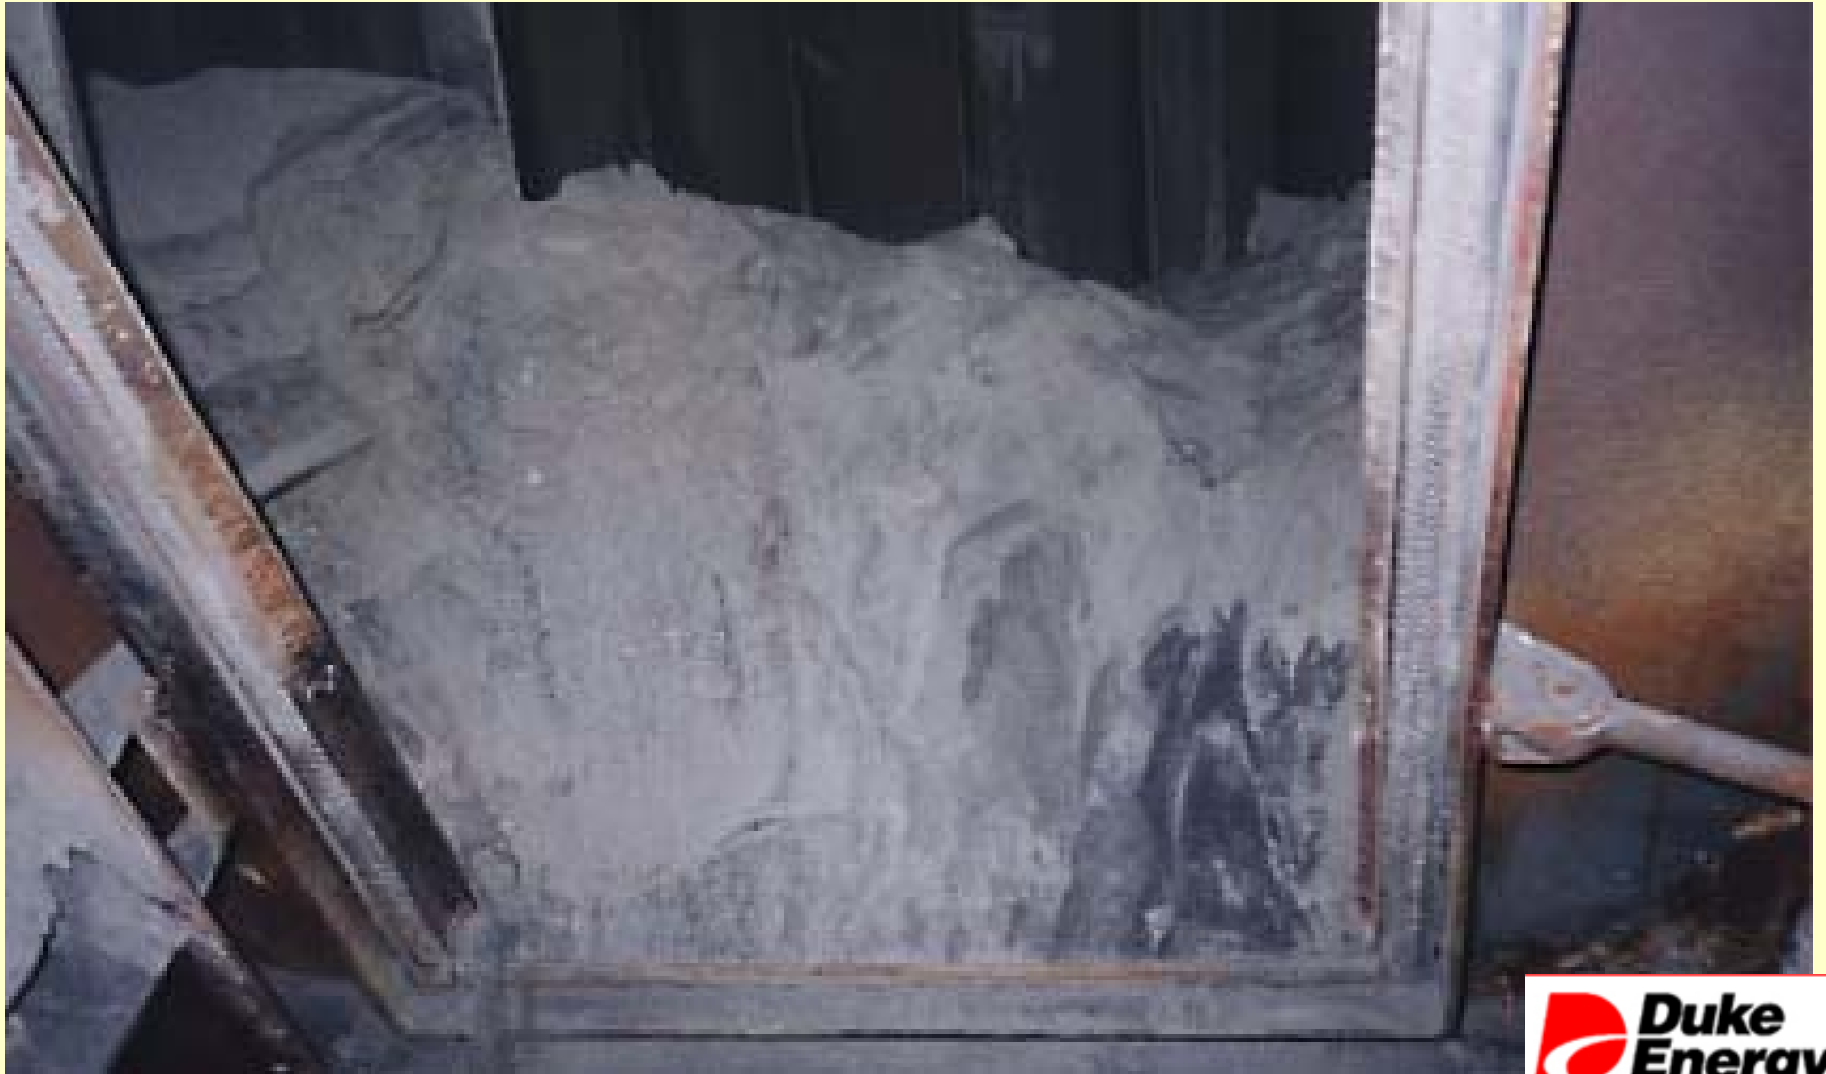
## Carbon Loss on Ignition Decreases Collection Capability

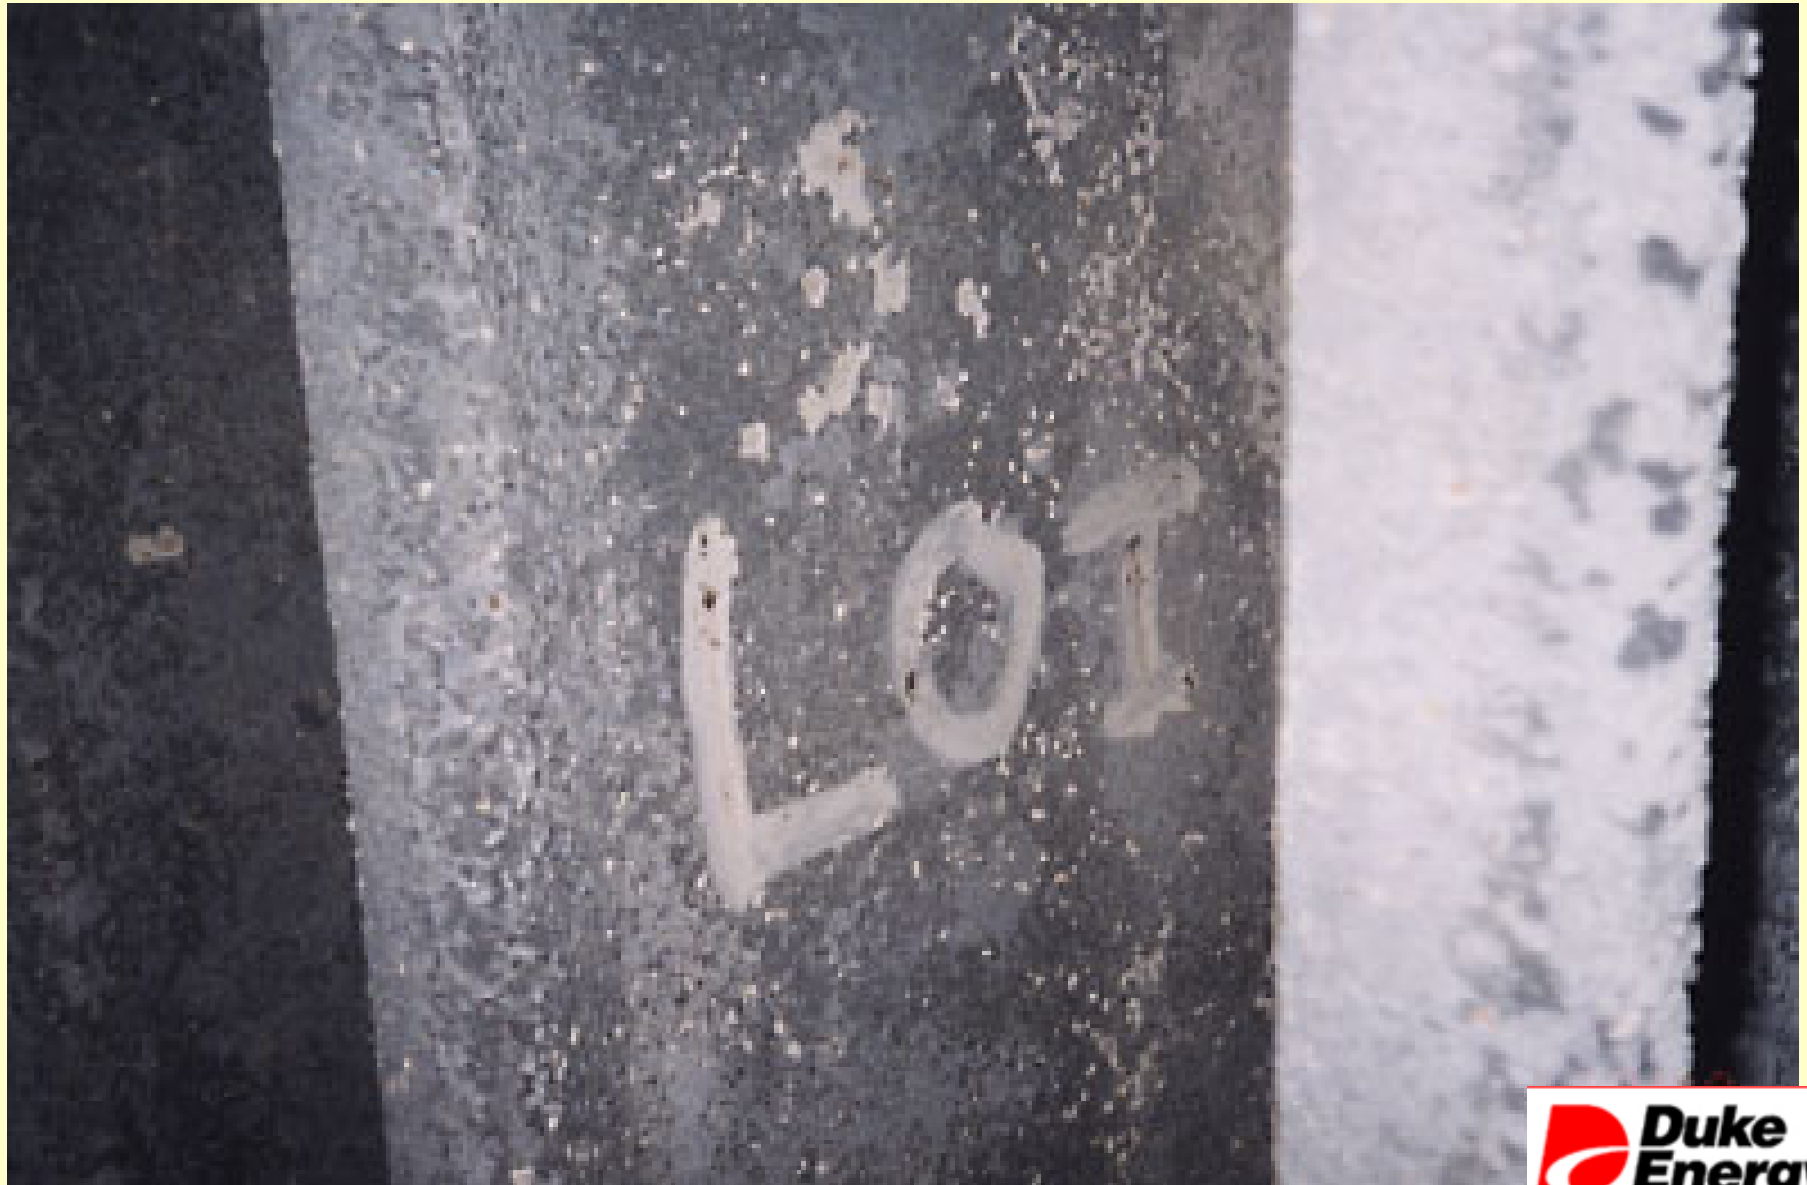
## Carbon Loss on Ignition Increases Emissions and Opacity

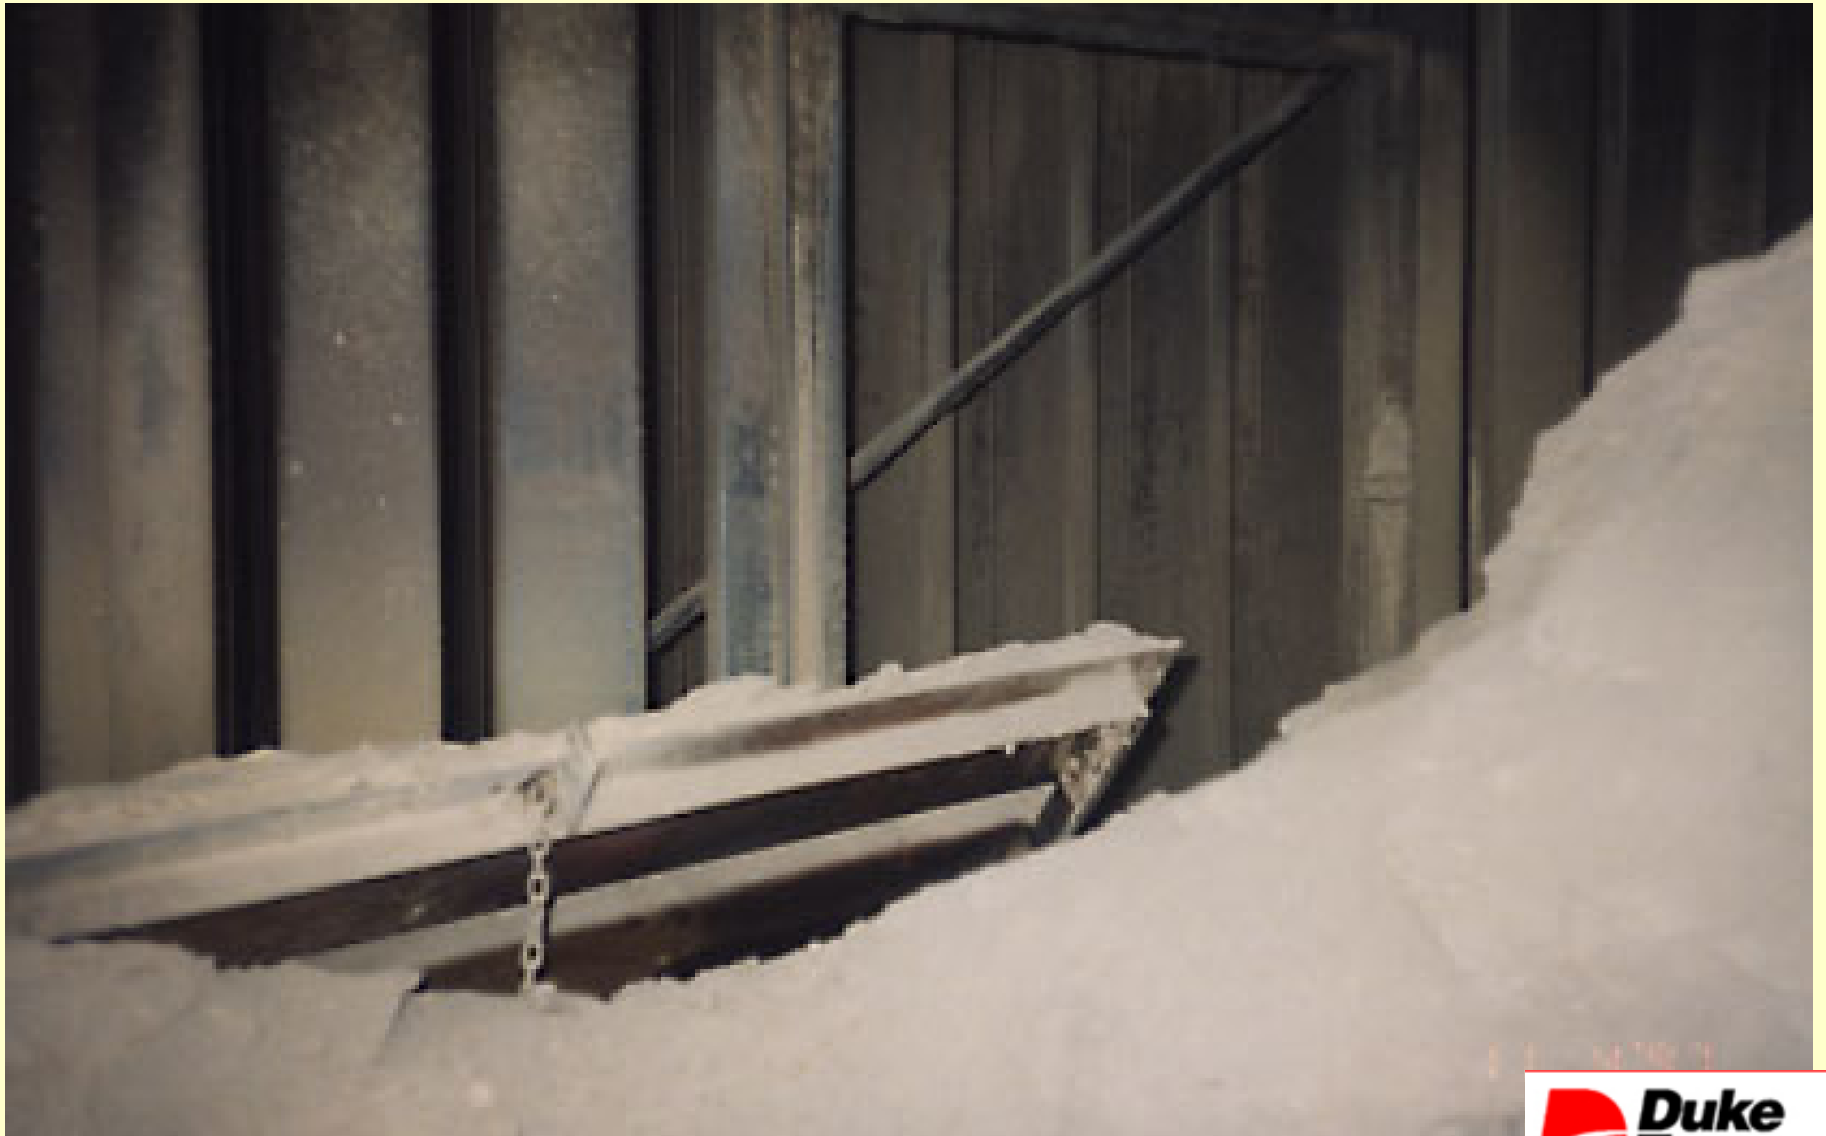
## Ash Build-up at Precipitator Inlet

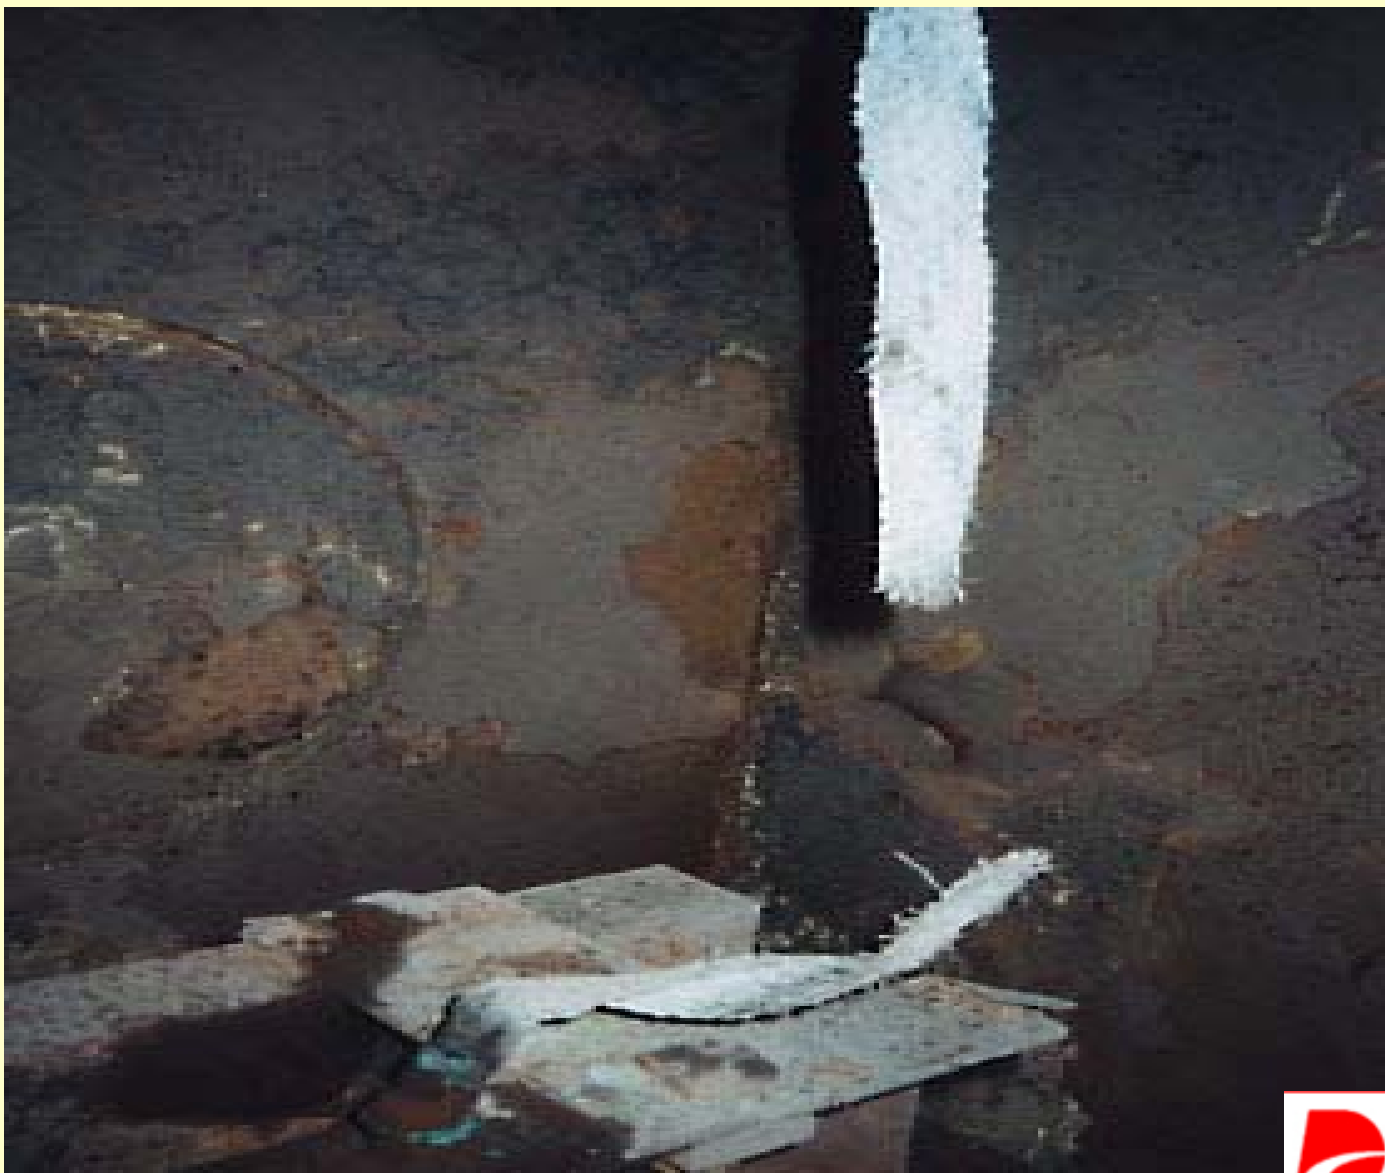
## Power Path High Voltage Failure

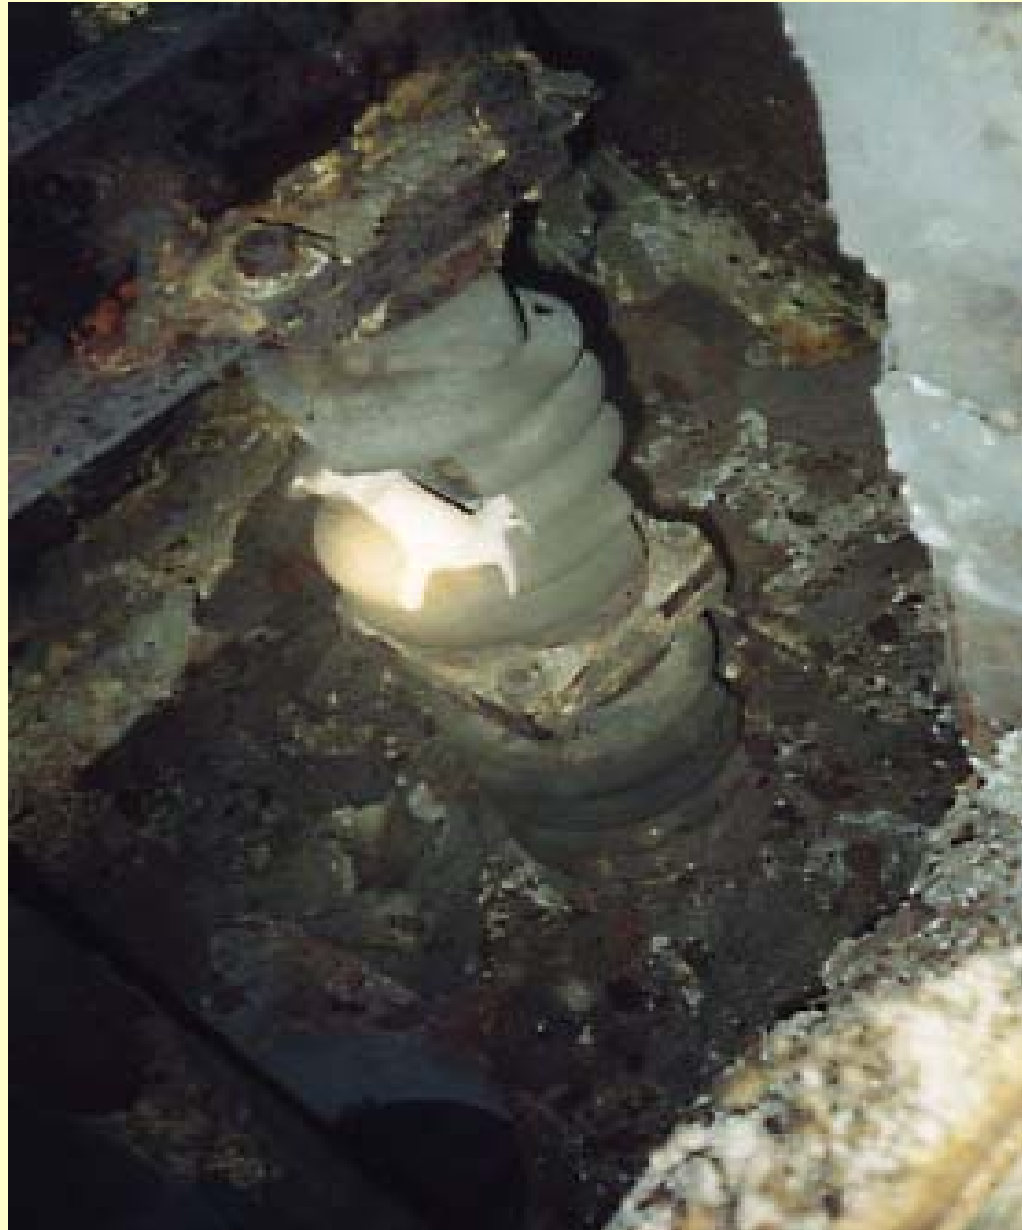
## Broken High Voltage Insulator

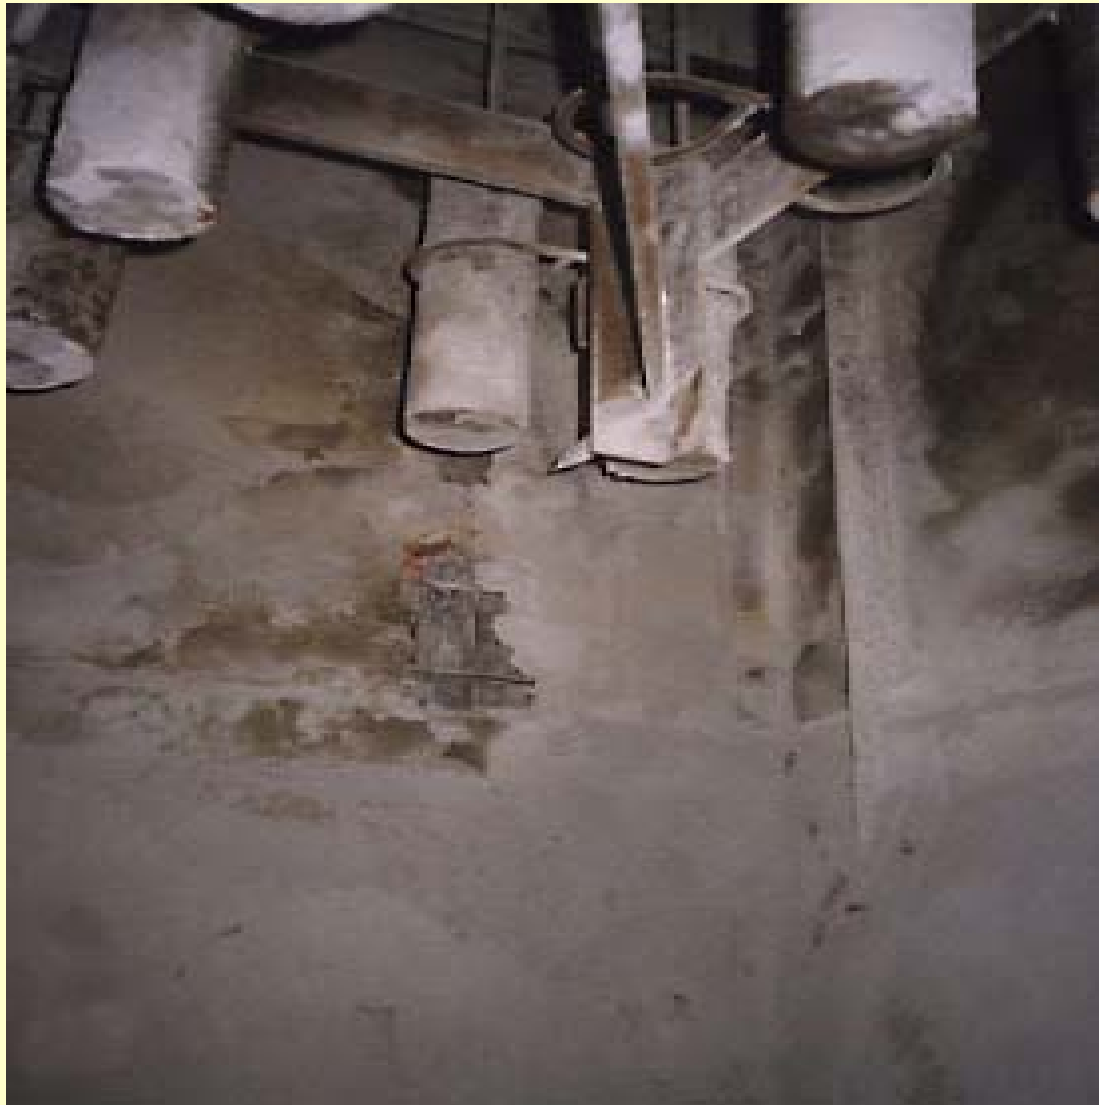
## Holes in the Side of the Precipitator Due to Corrosion

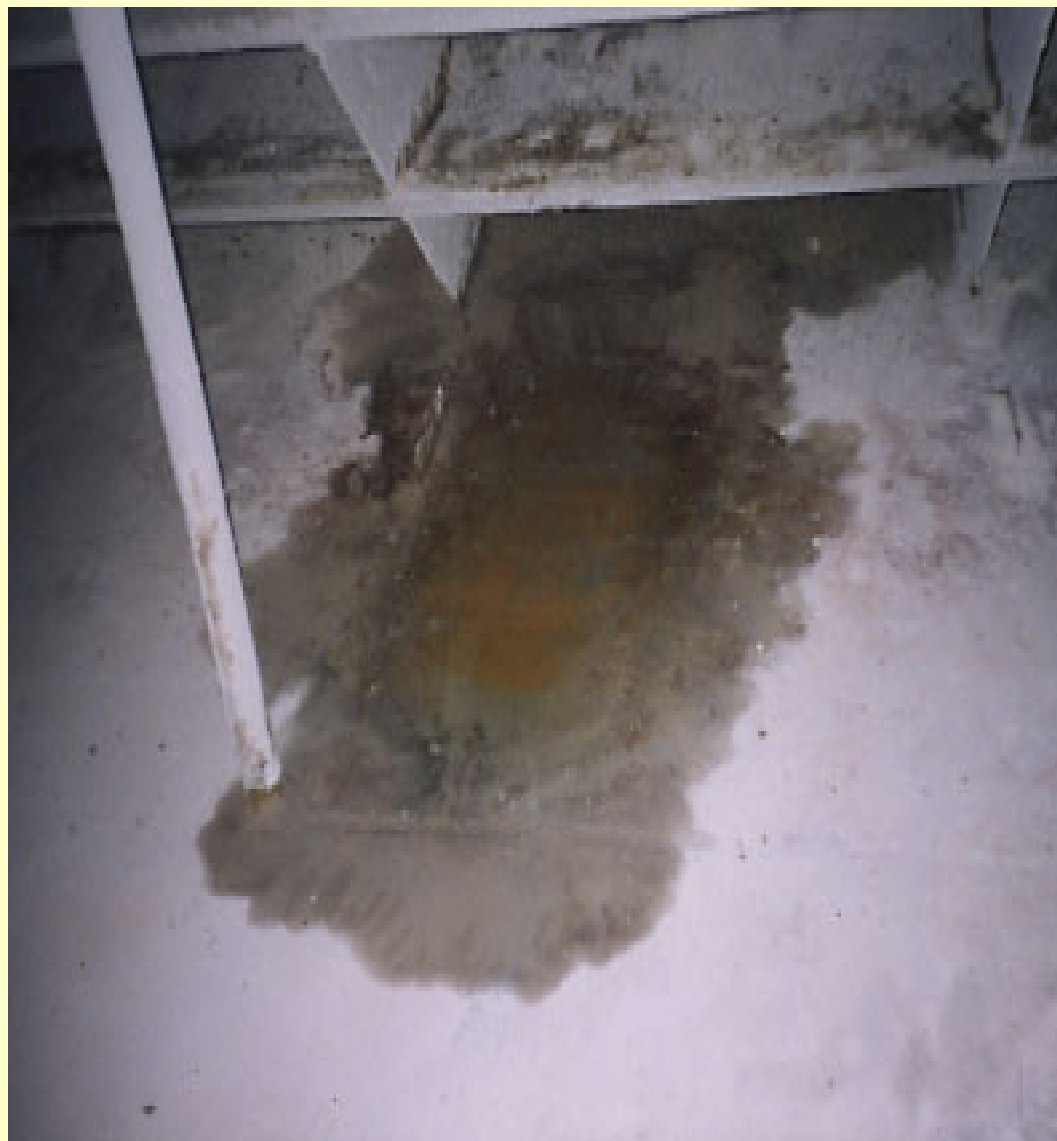
## Water Leaks From Ductwork

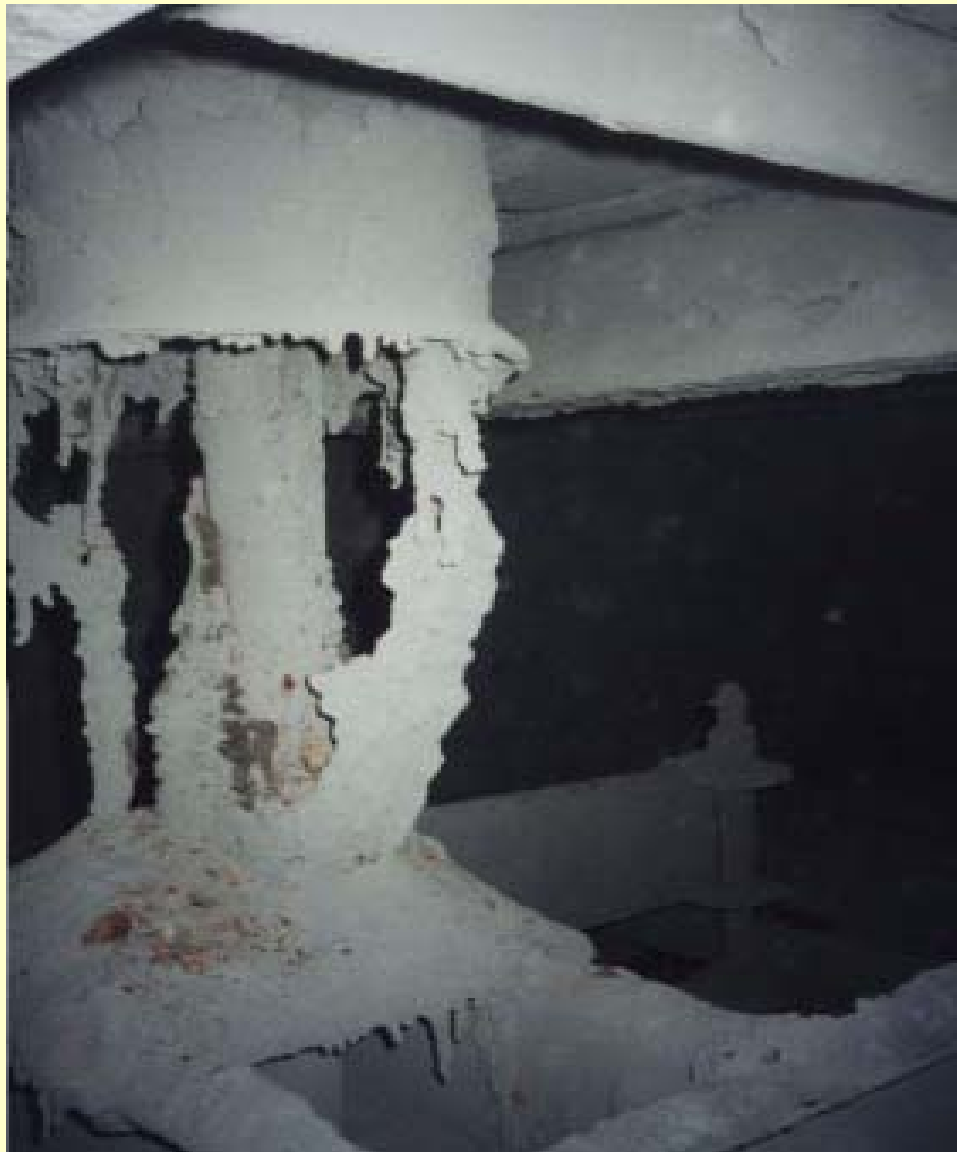
## High Voltage Guard Air Leakage

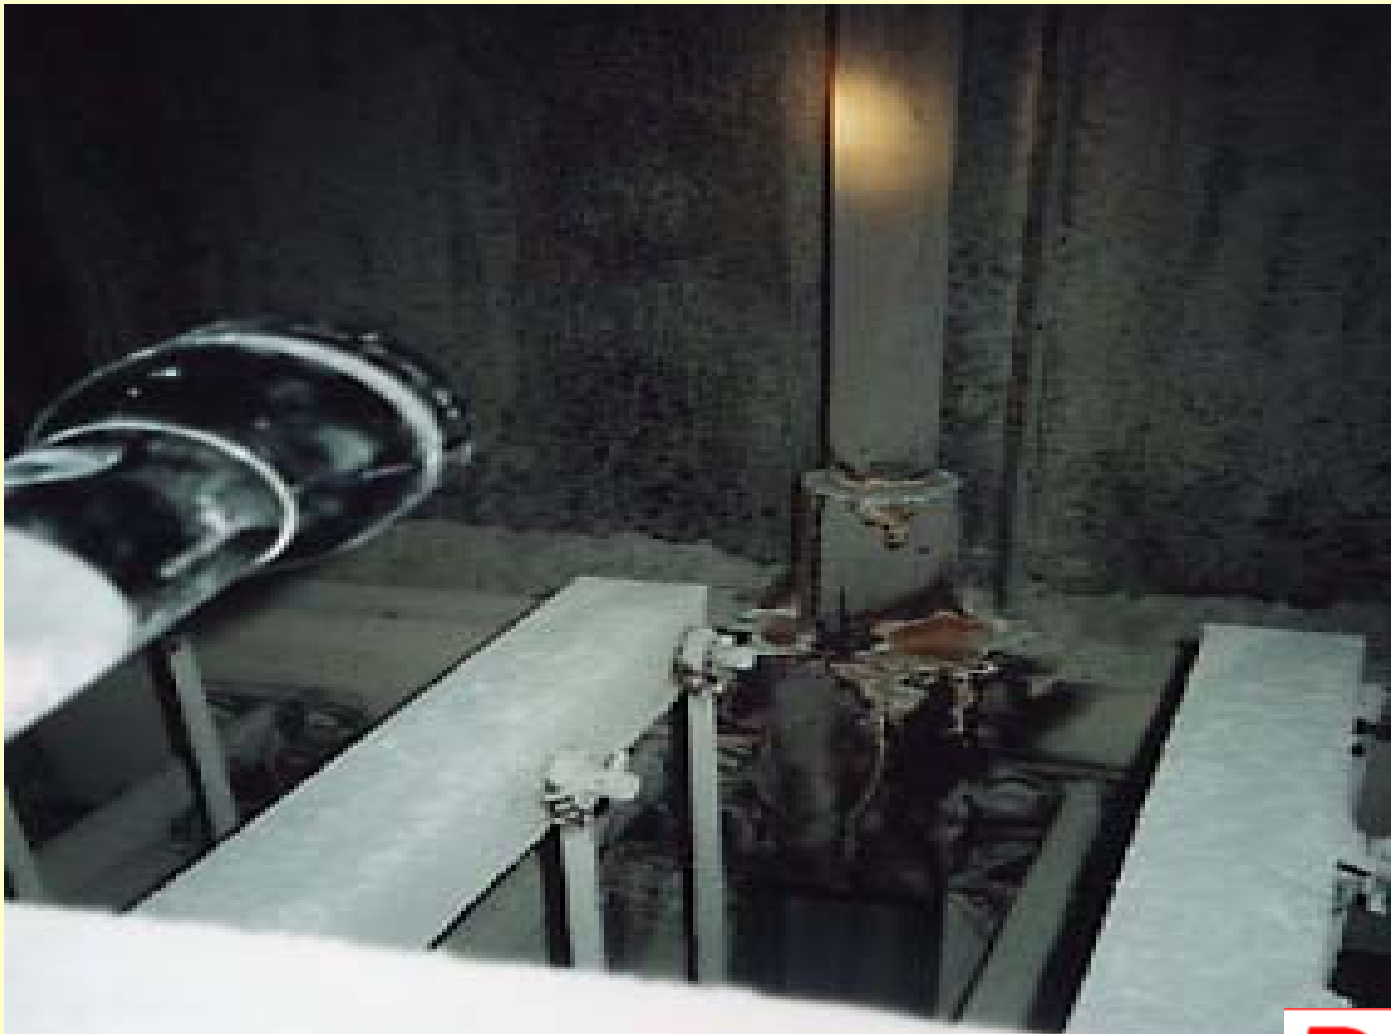
## Water Leakage Around Rapper Boot Seal

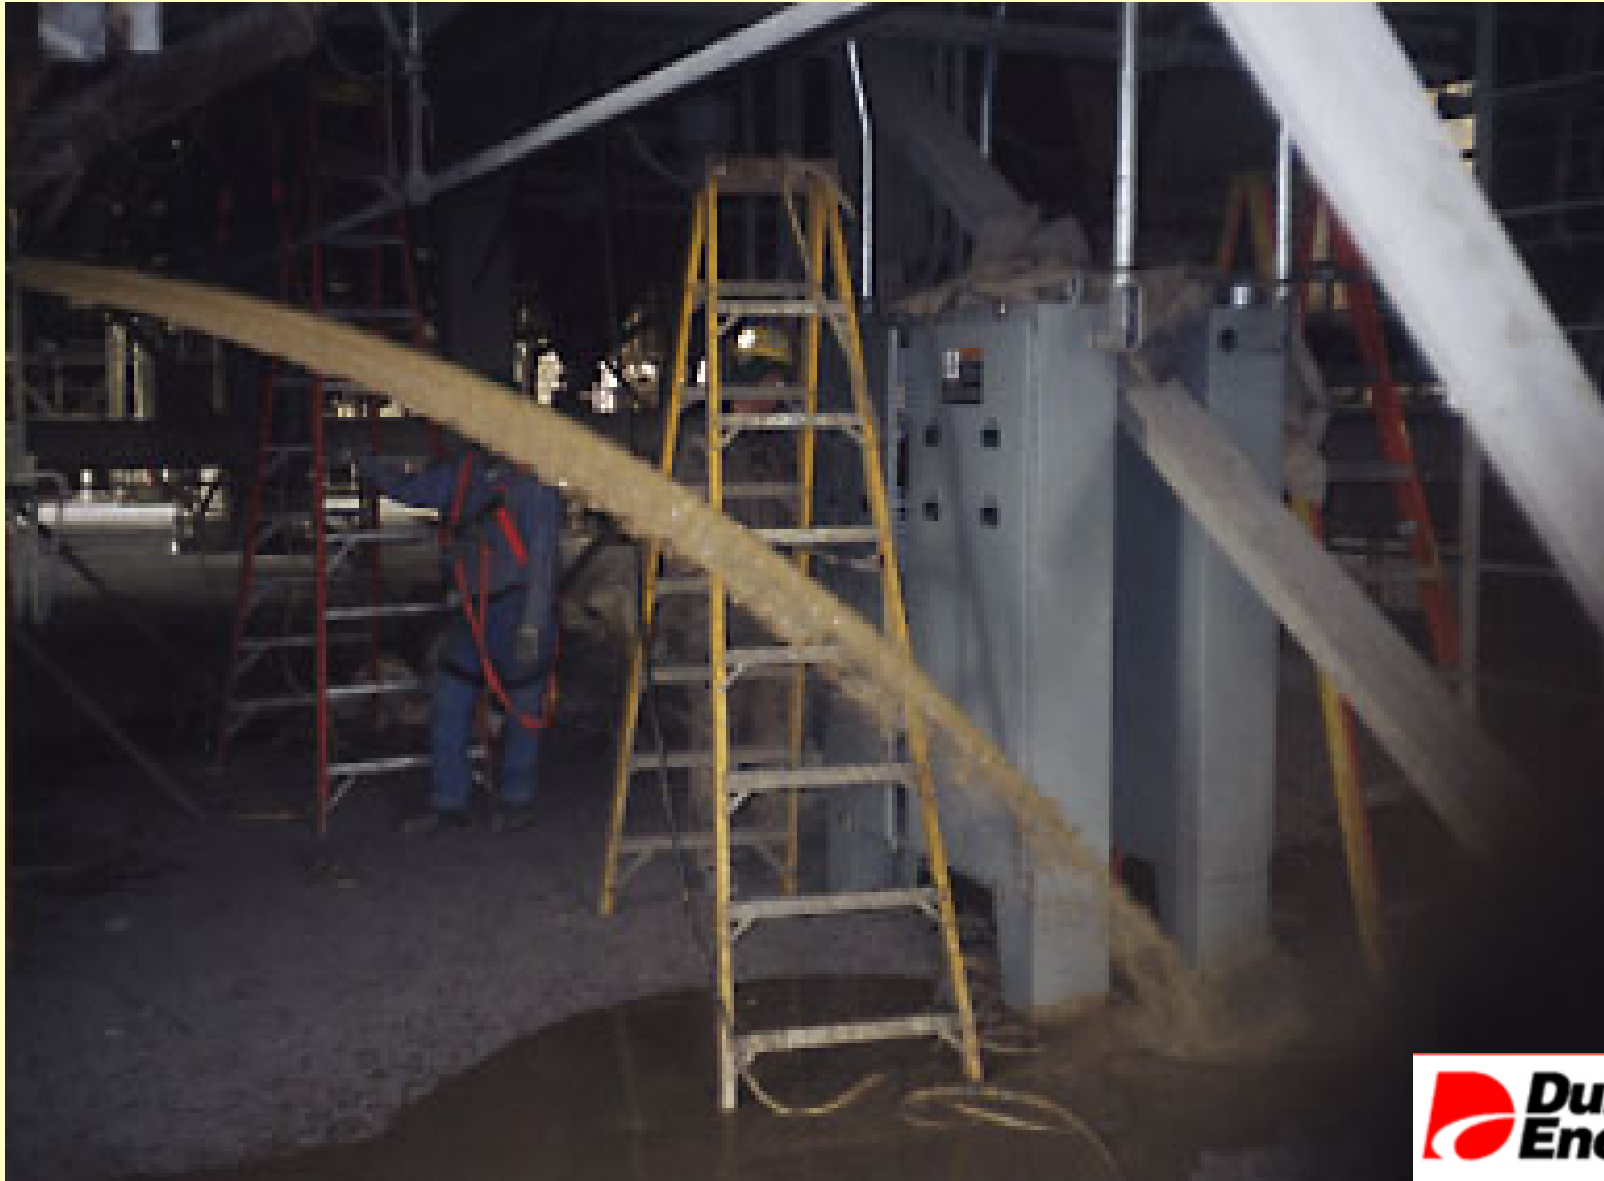
## Water Pouring From Precipitator Hopper

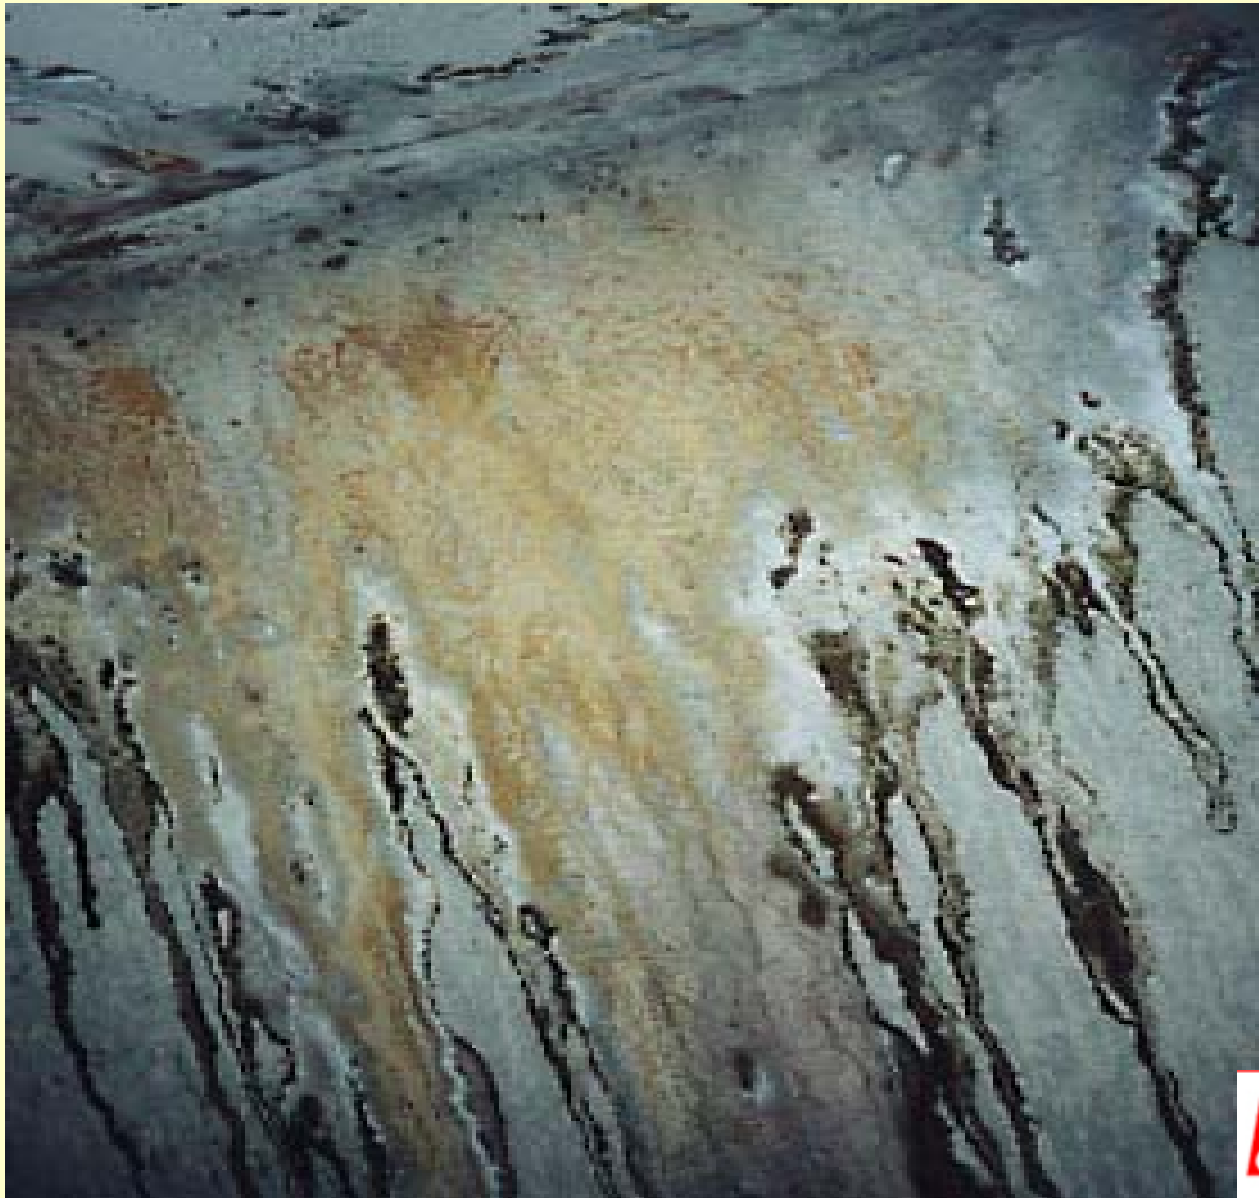
## Water Leakage Through the Precipitator Roof

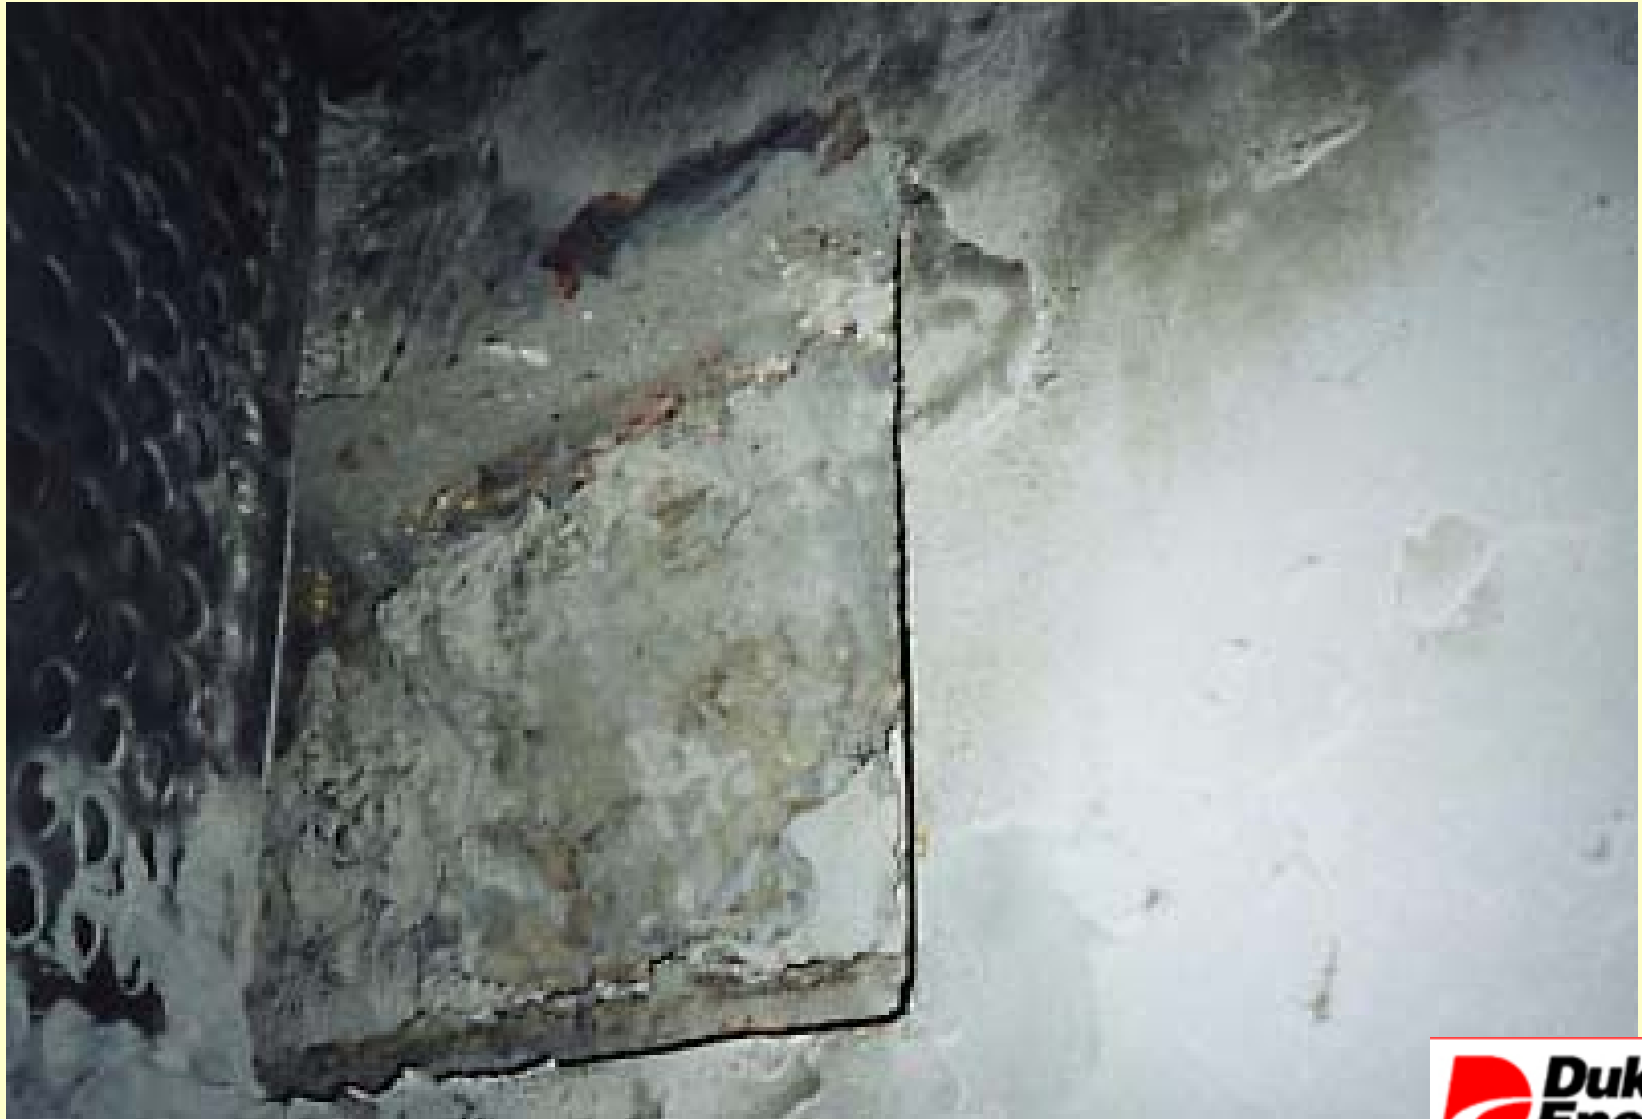
## Center Wall Cracking

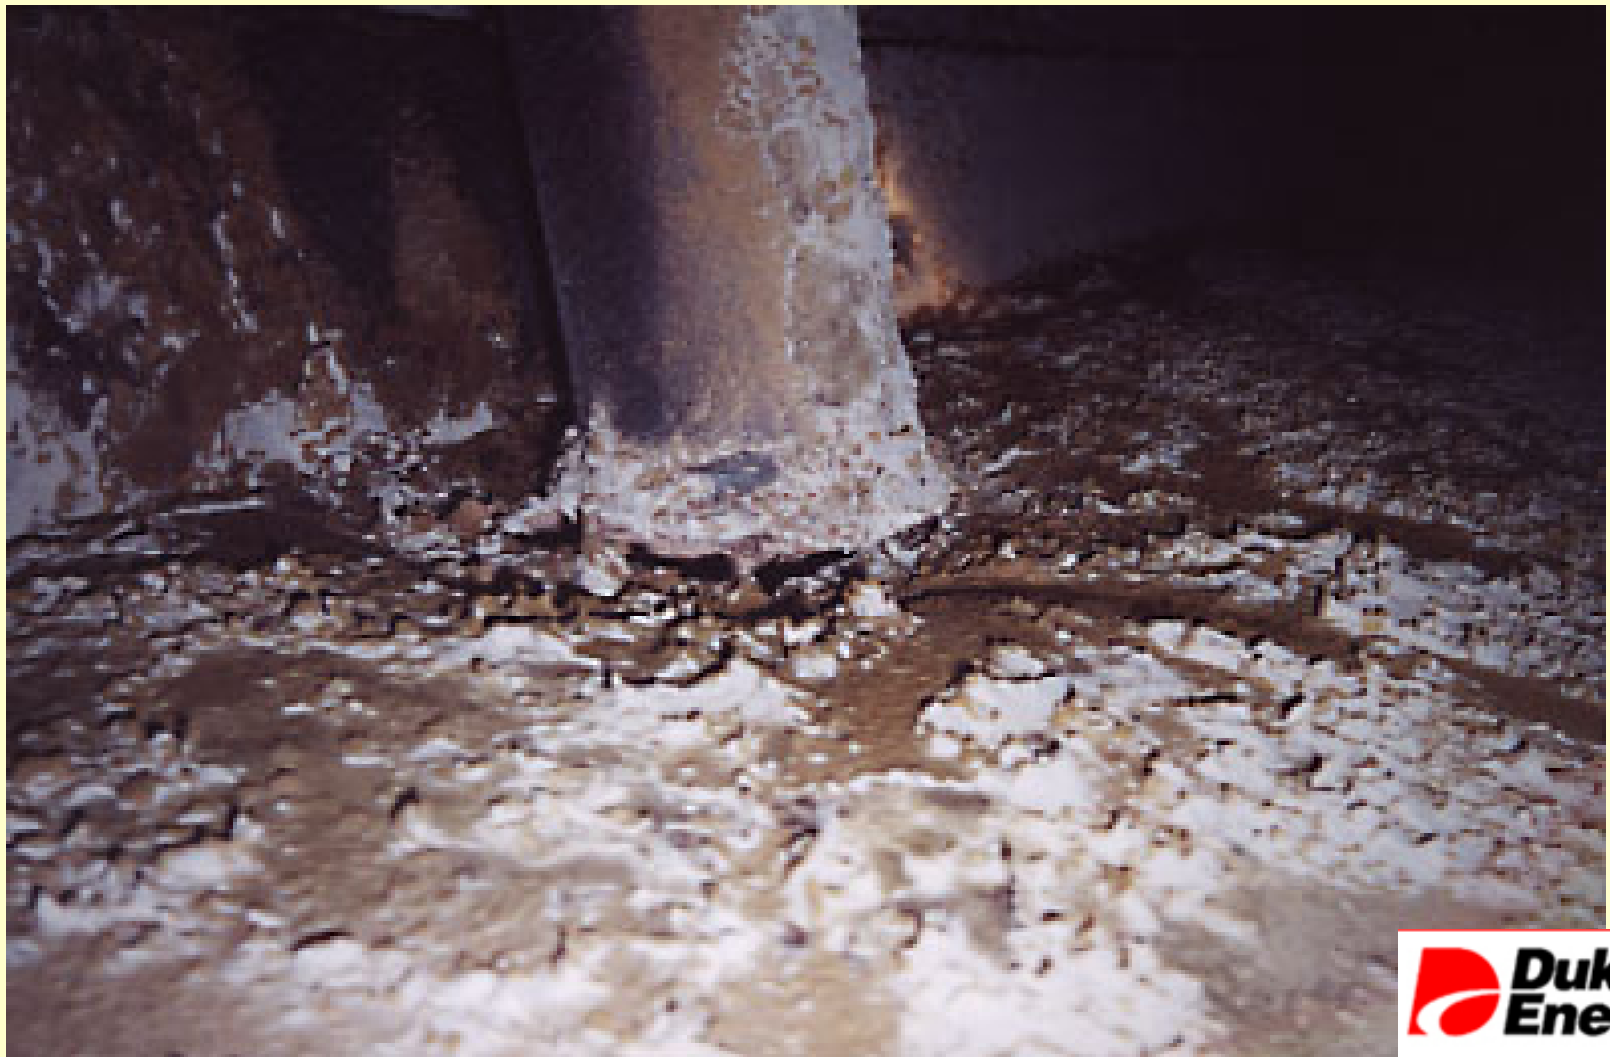
## Thermal Fatigue Cracking At Turning Vane Support

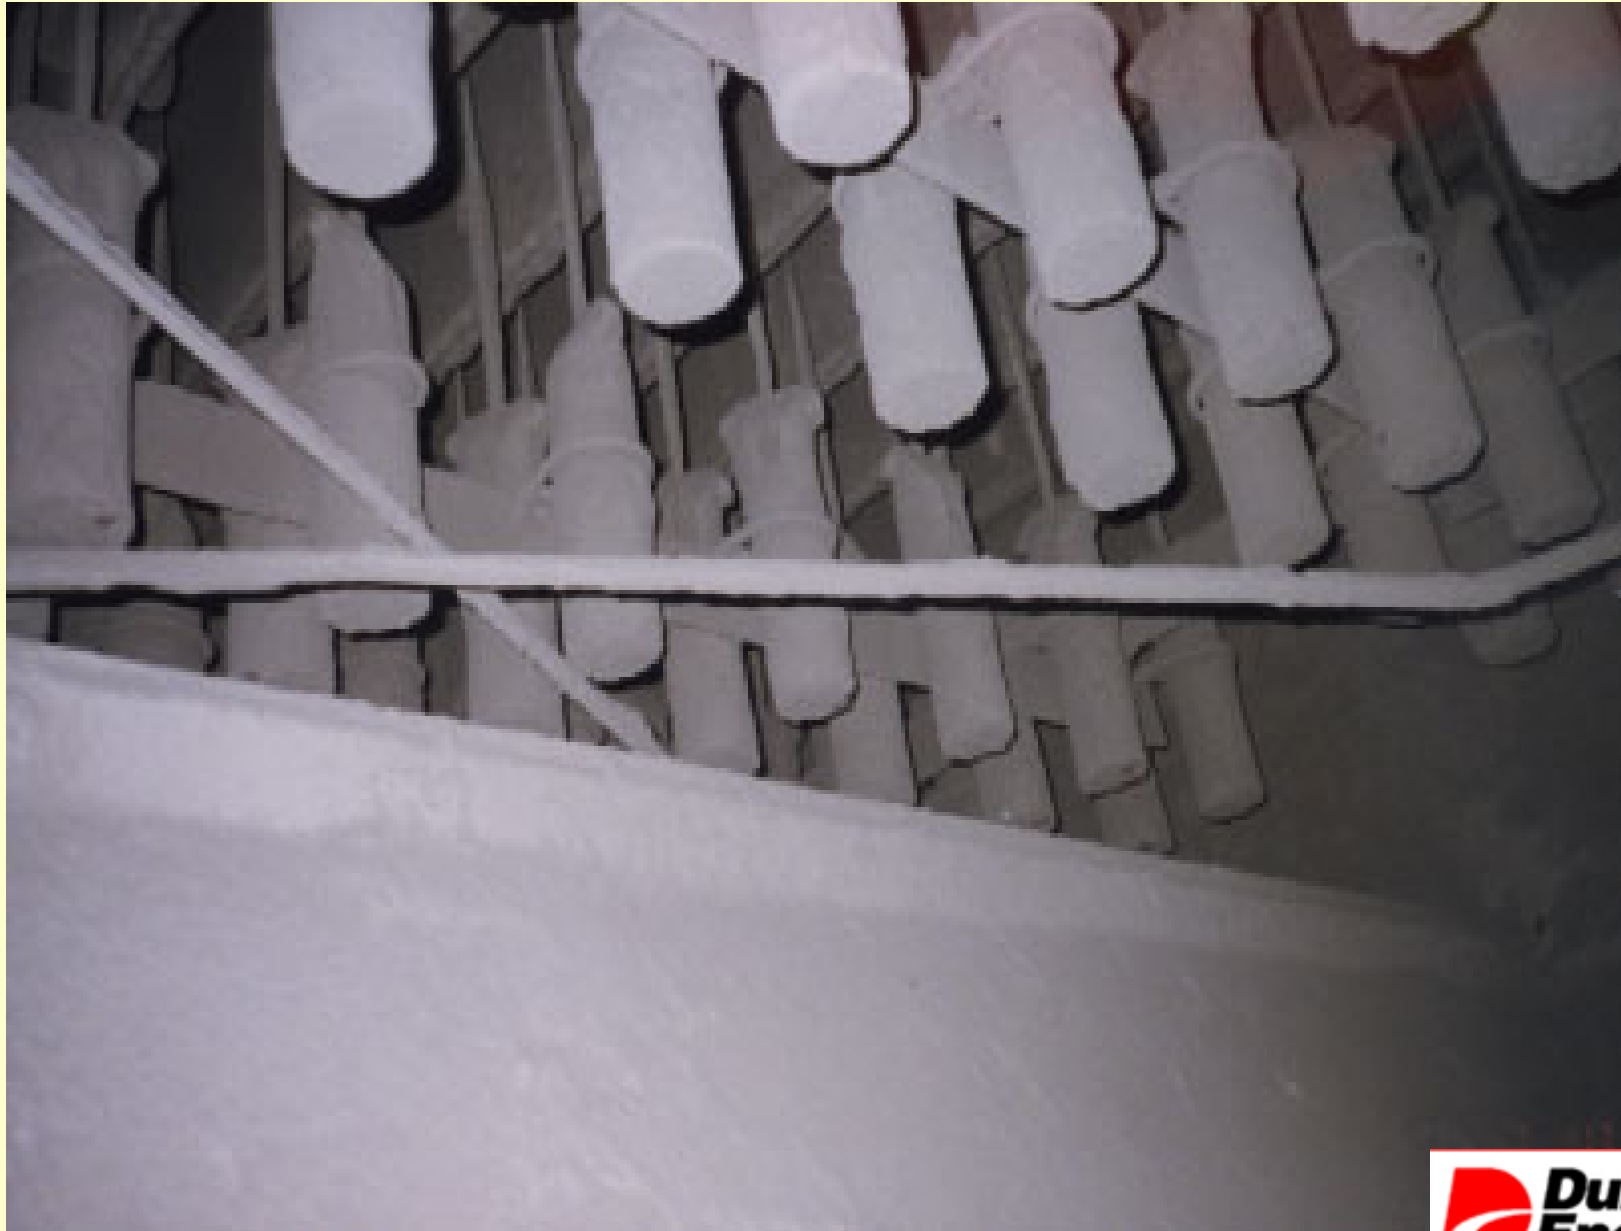
## Bent Structural Cross Bracing
