# Worldwide Pollution Control Association

FirstEnergy ESP Seminar  
November 27<sup>th</sup> – 28<sup>th</sup>, 2007

# Precipitator Maintenance and Operations

By Scott Williams

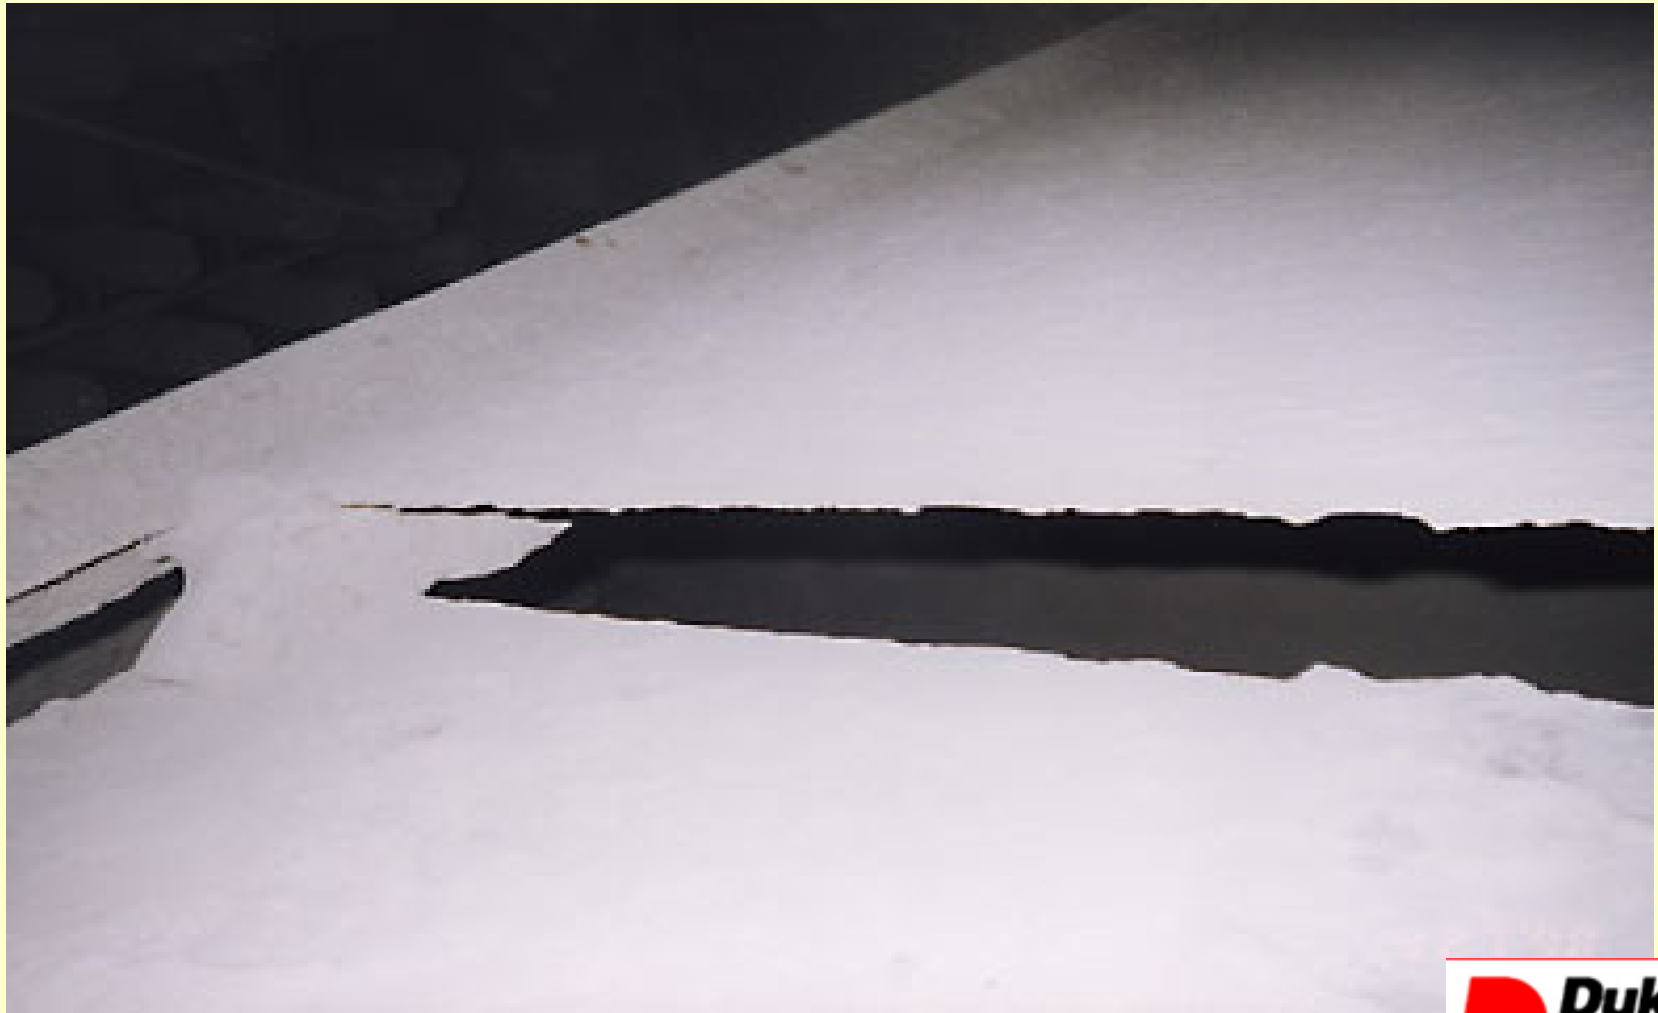
Baffle Component Failure- Gas will bypass the baffle

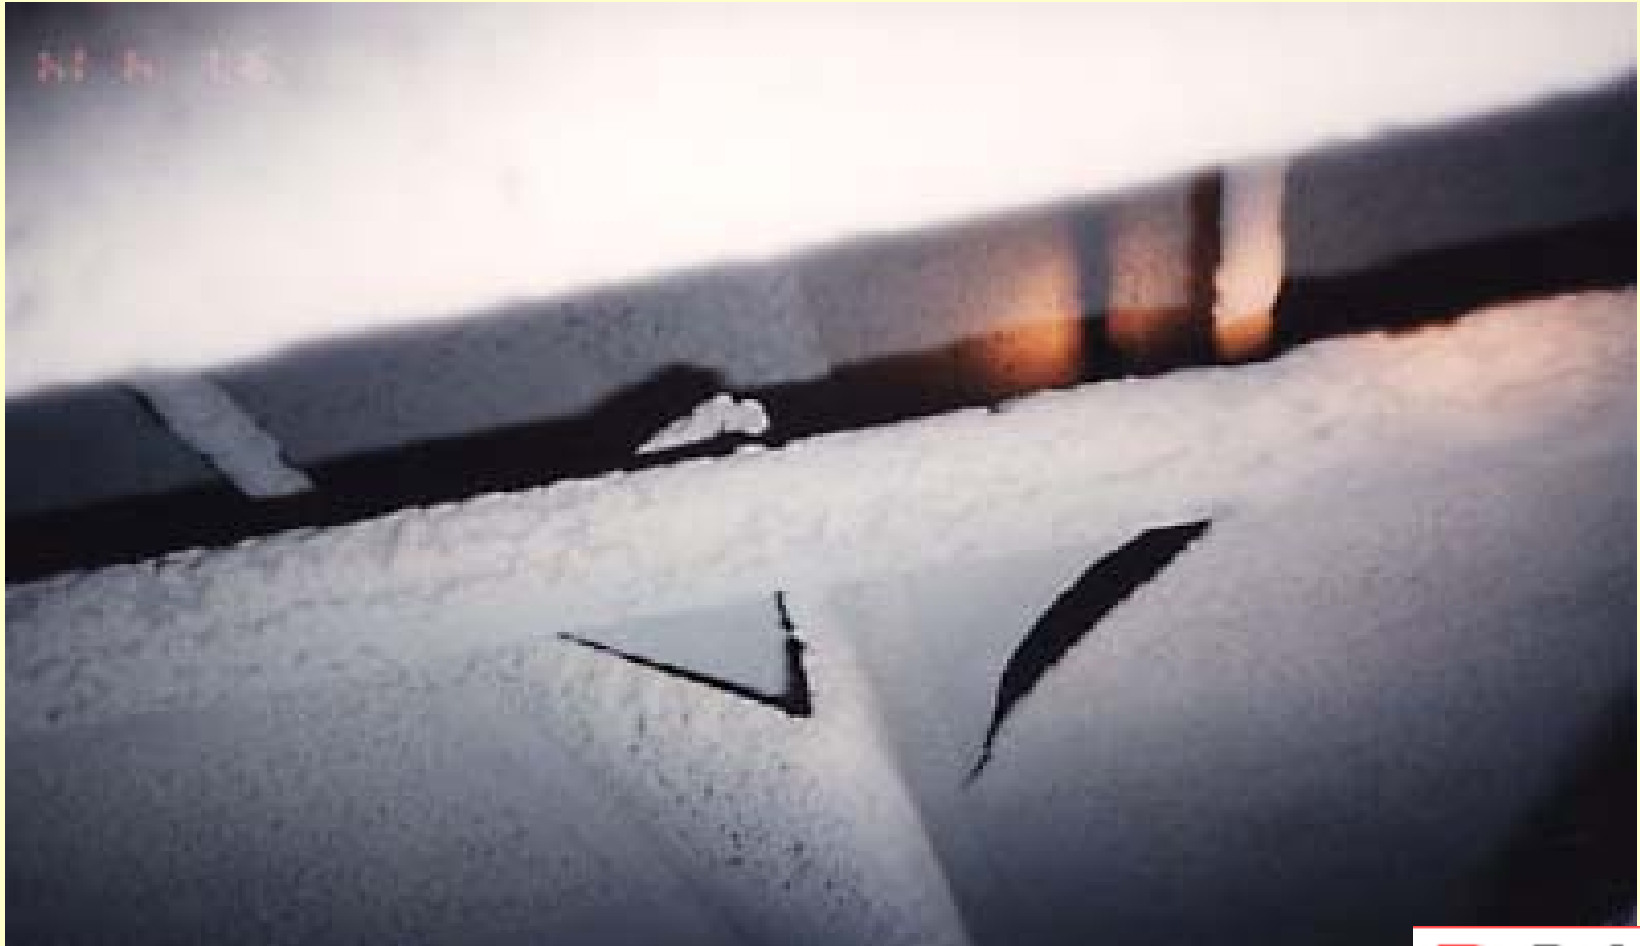
## Crack Plate

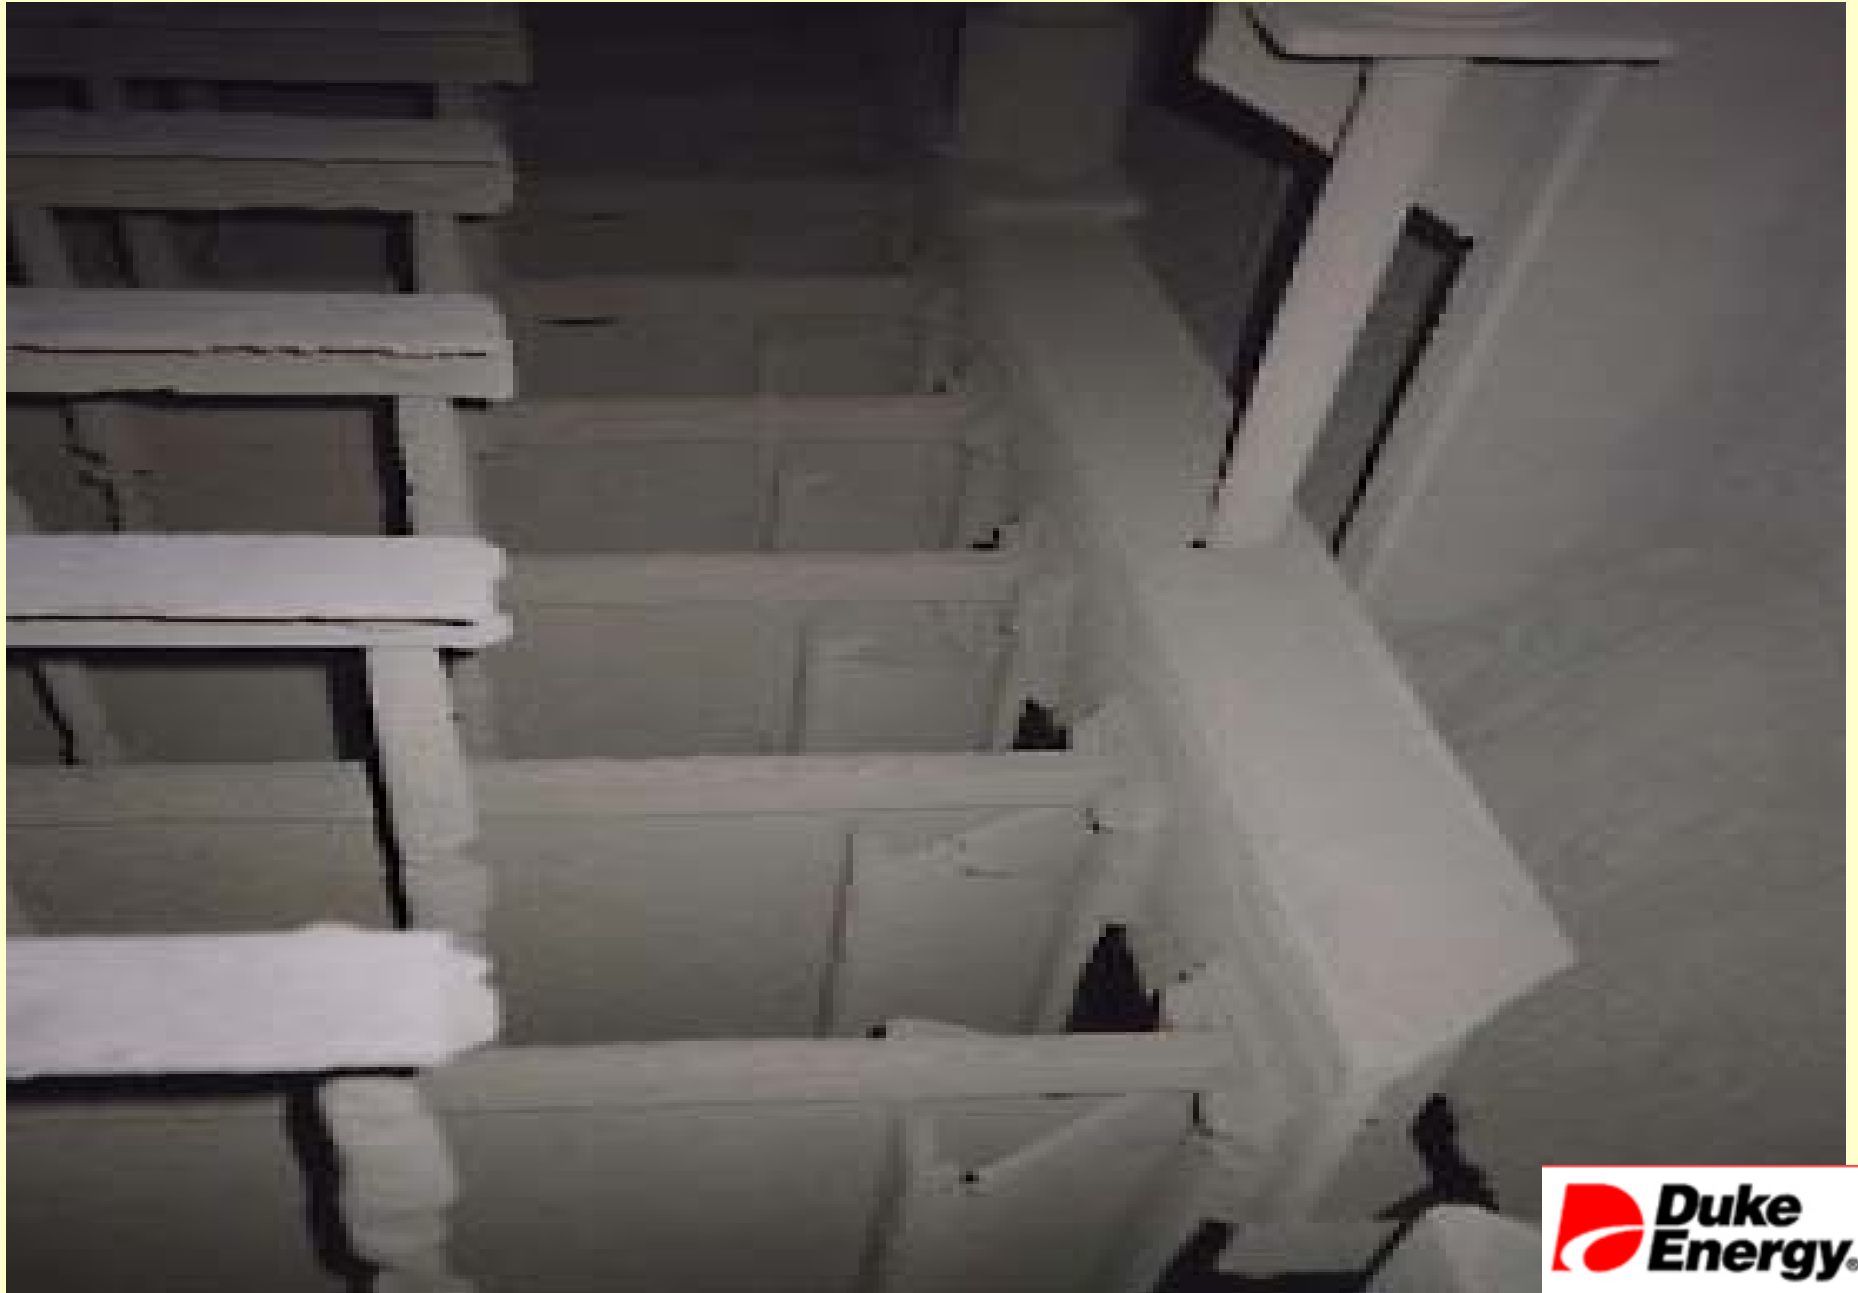
## Crack Plate Swords

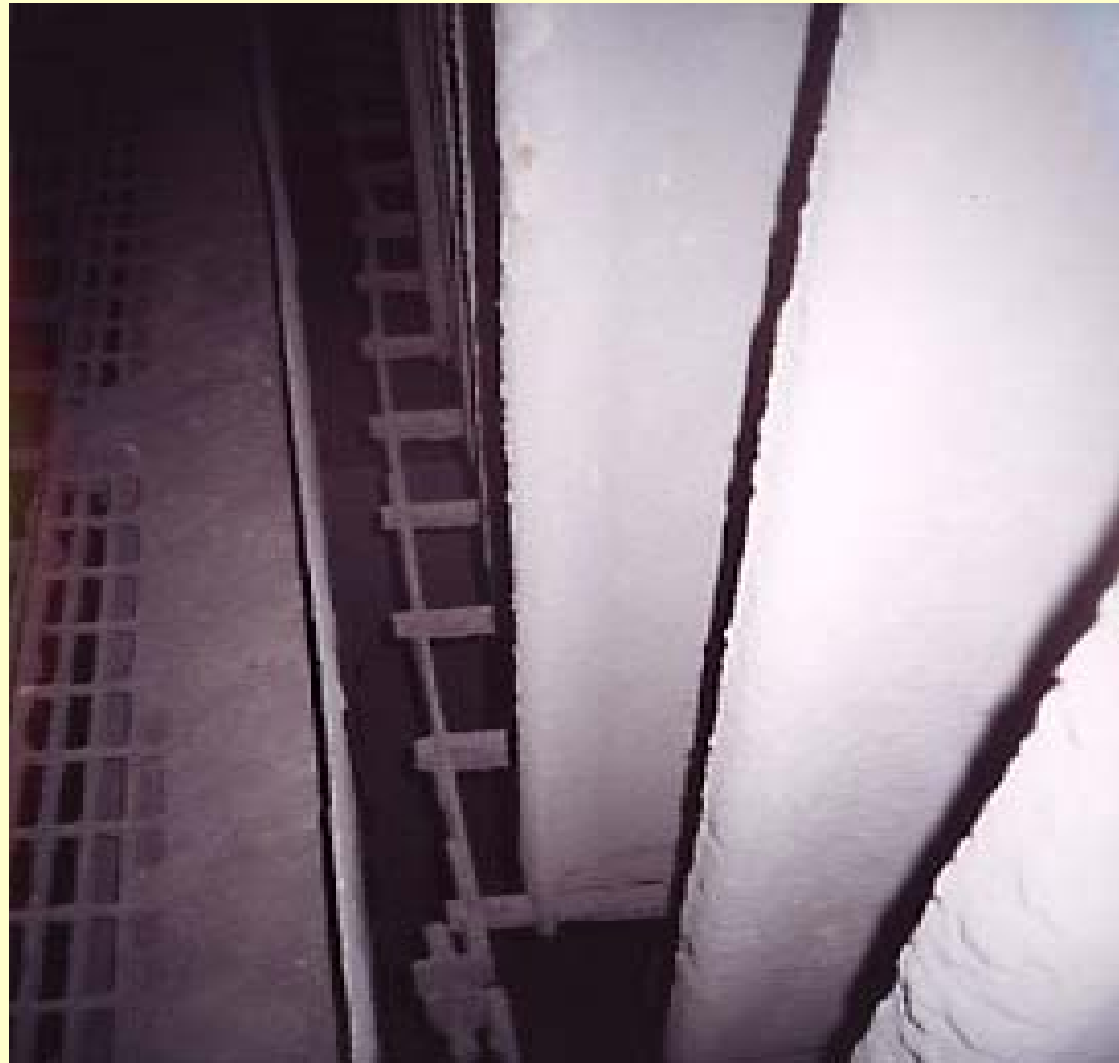
## Weld Failure At Top of Plate

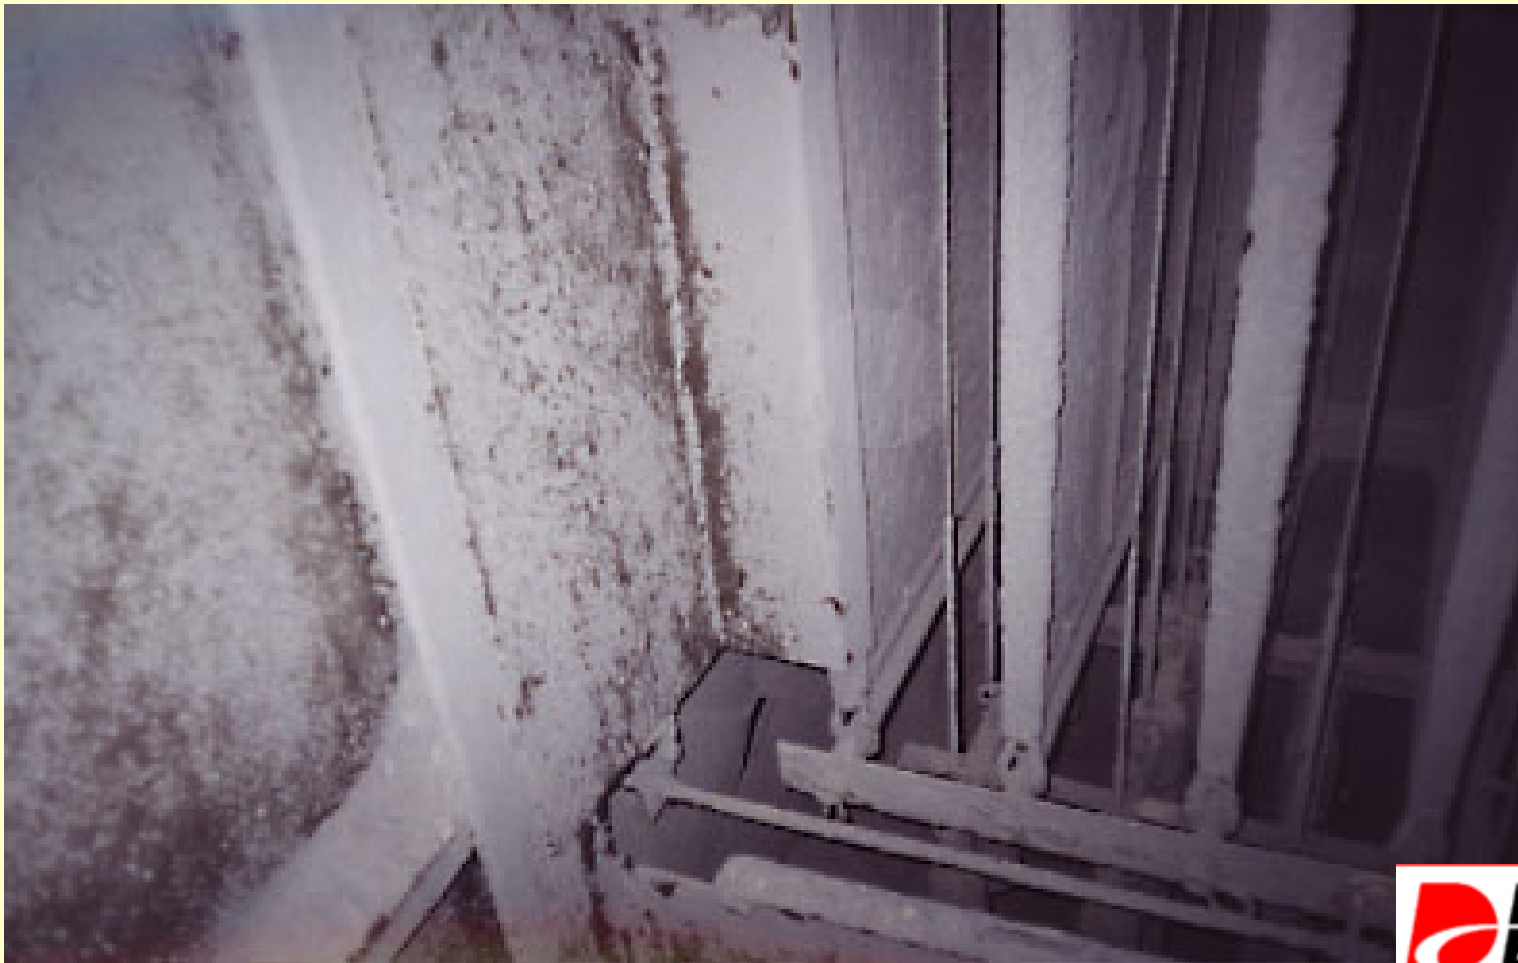
The Wire/Electrode Carries the Charge  
The Plate Collects the Ash  
Plate to Wire Clearance is Critical

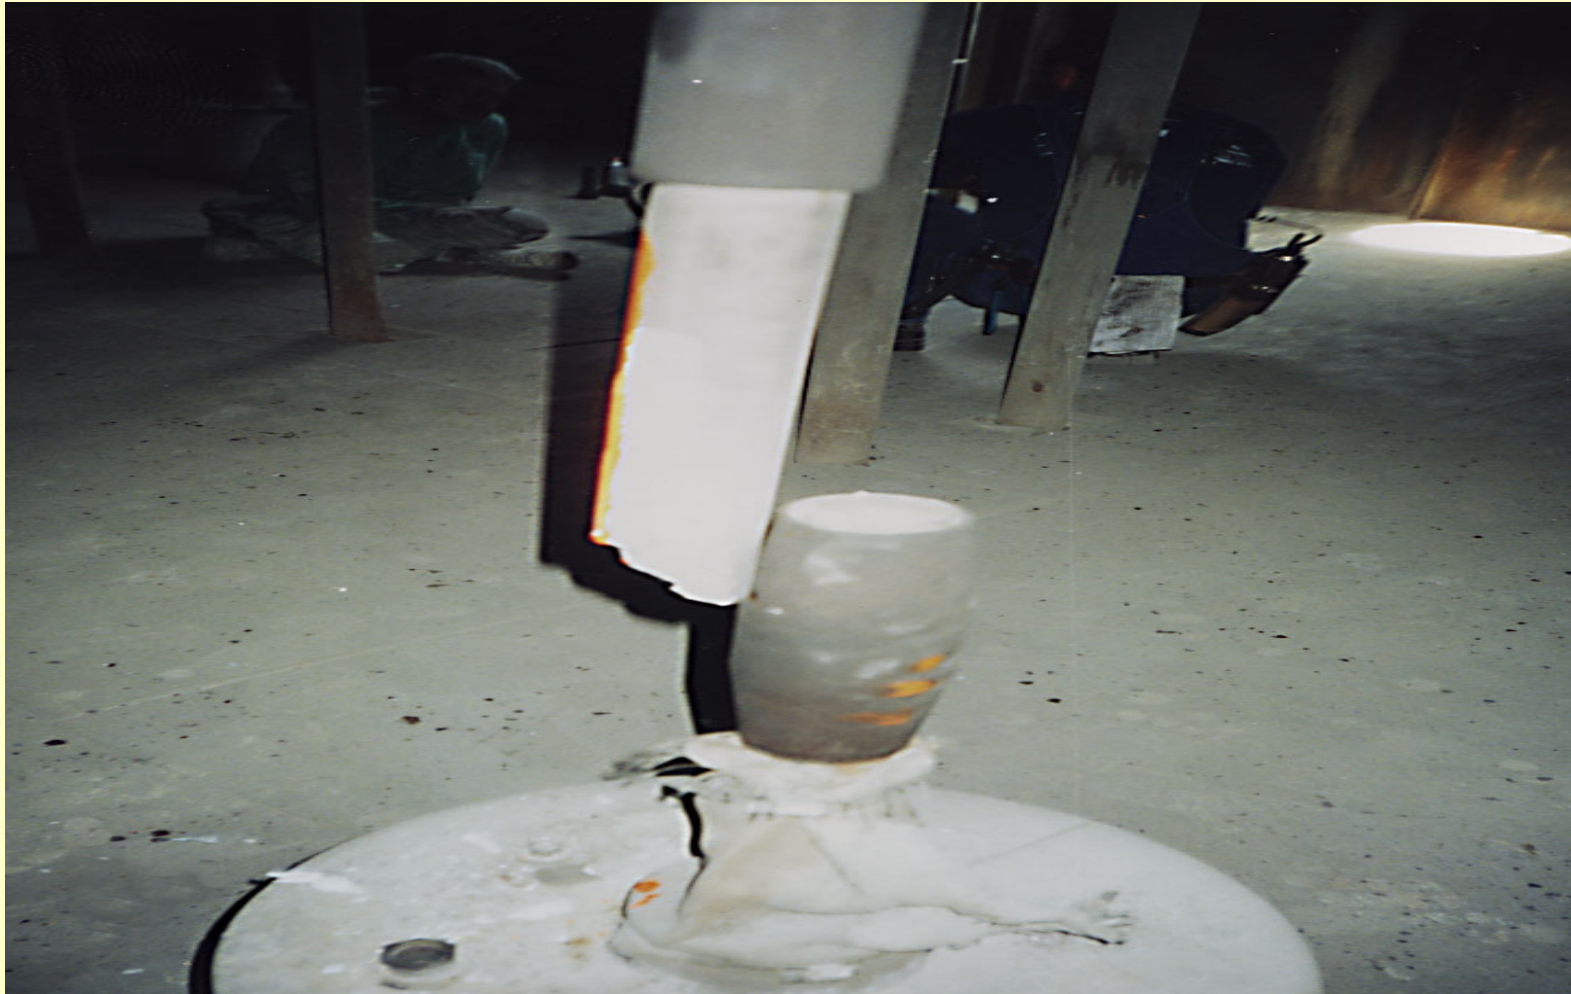
## Broken Rapper Shaft- In the Penthouse

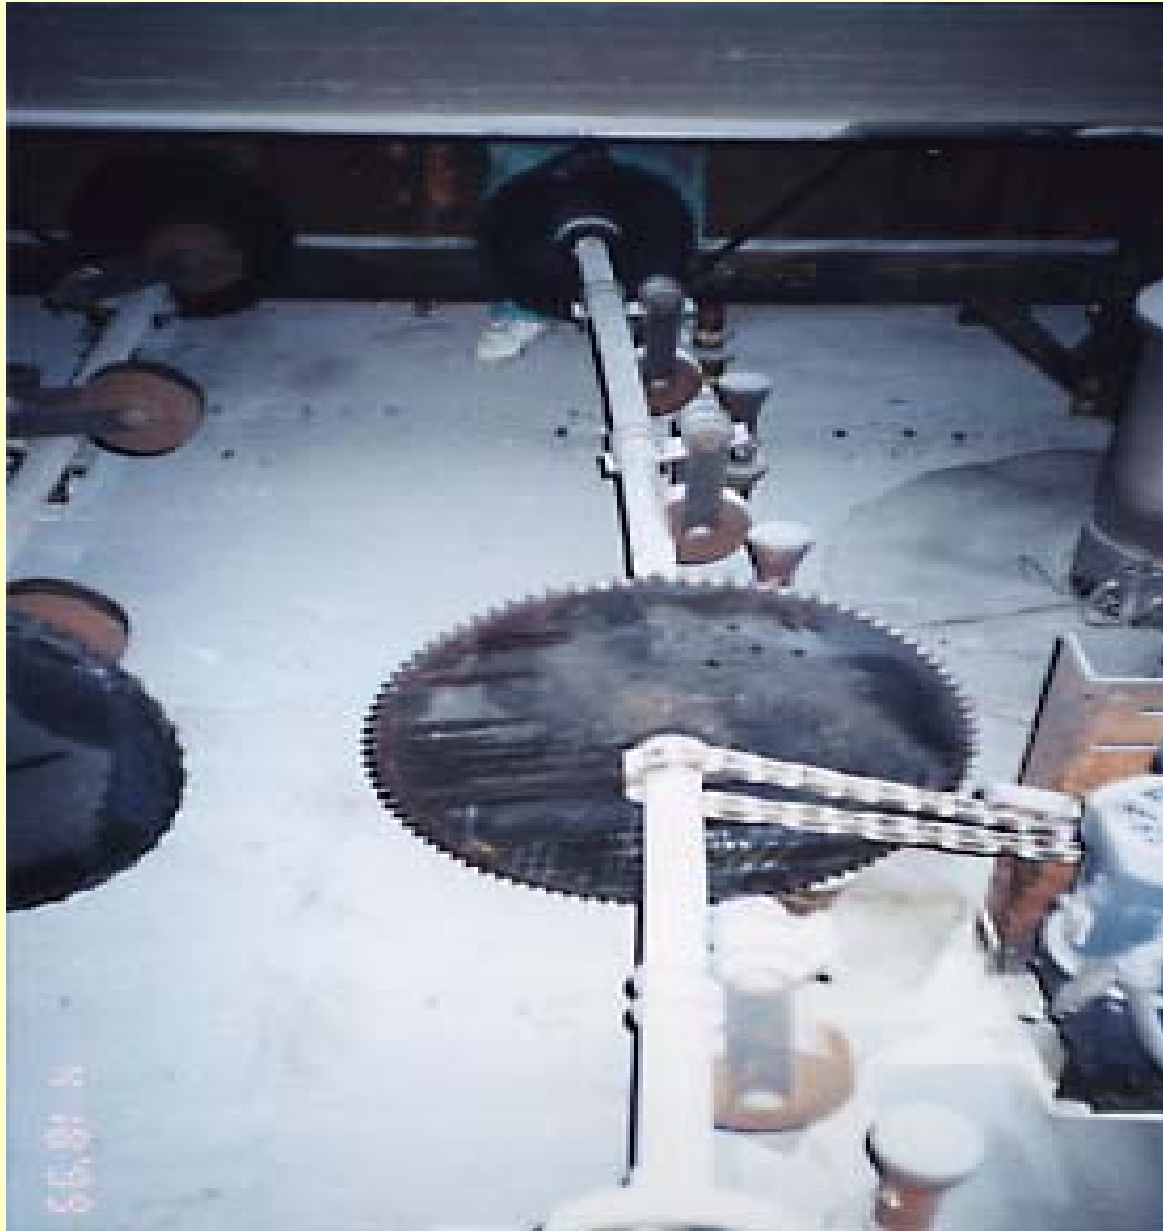
## Chain of Tumbling Hammer Sprocket

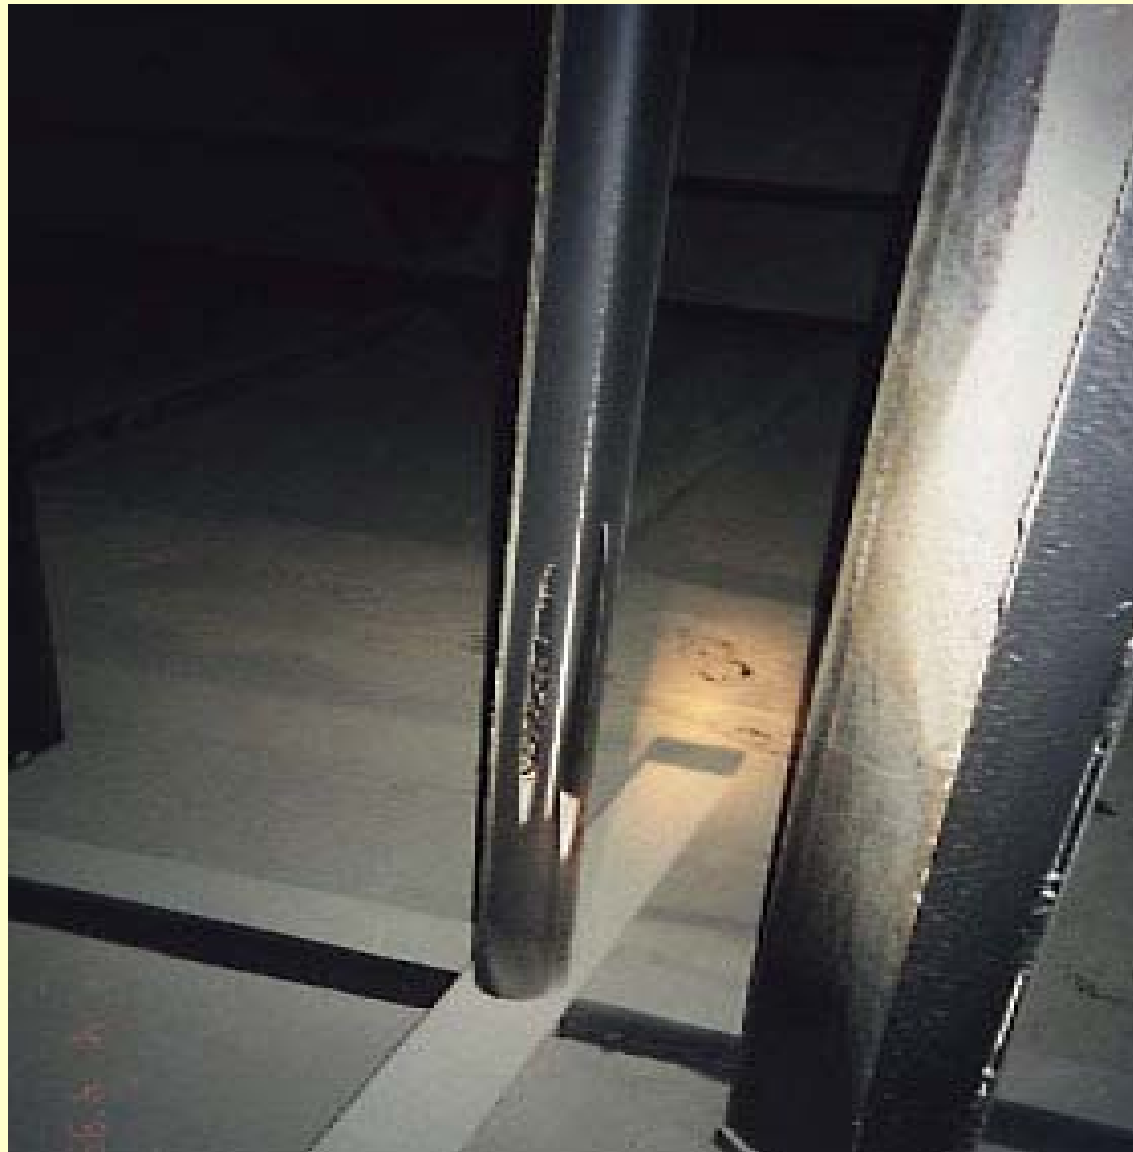
## Erosion Due to Ash if Flue Gas on Structural Support

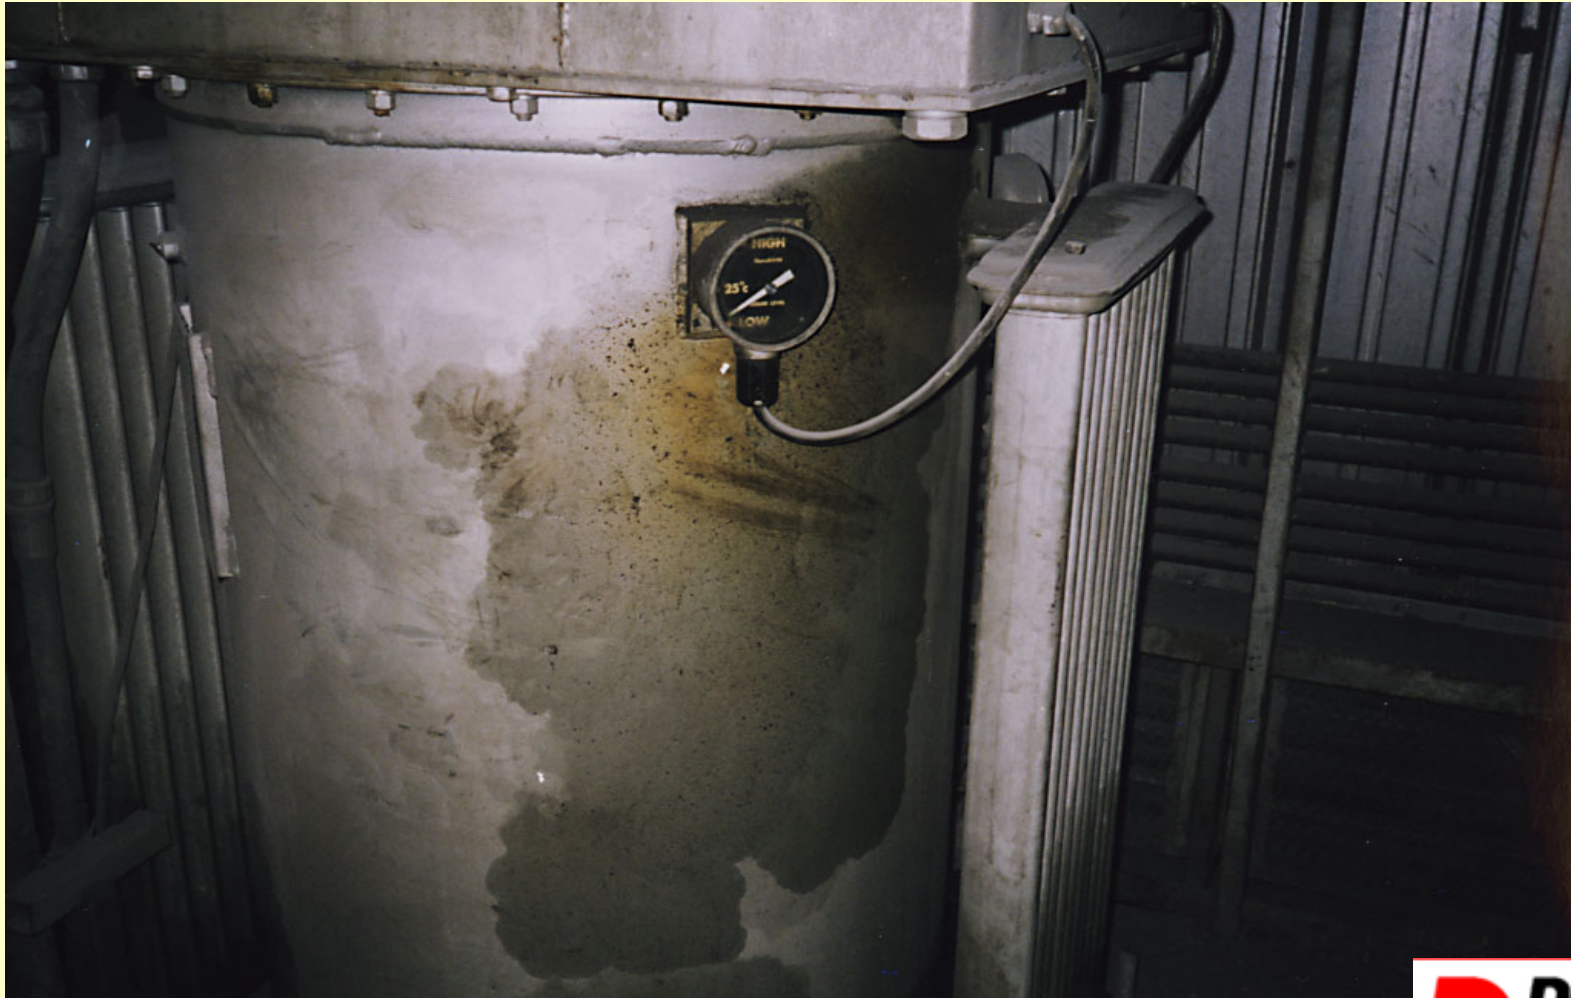
## T/R Set Oil Leakage
