# Worldwide Pollution Control Association

**Ameren Seminar**  
**August 19–20, 2008**  
**Effingham, IL**

# Precipitator Maintenance and Operations

By Scott Williams

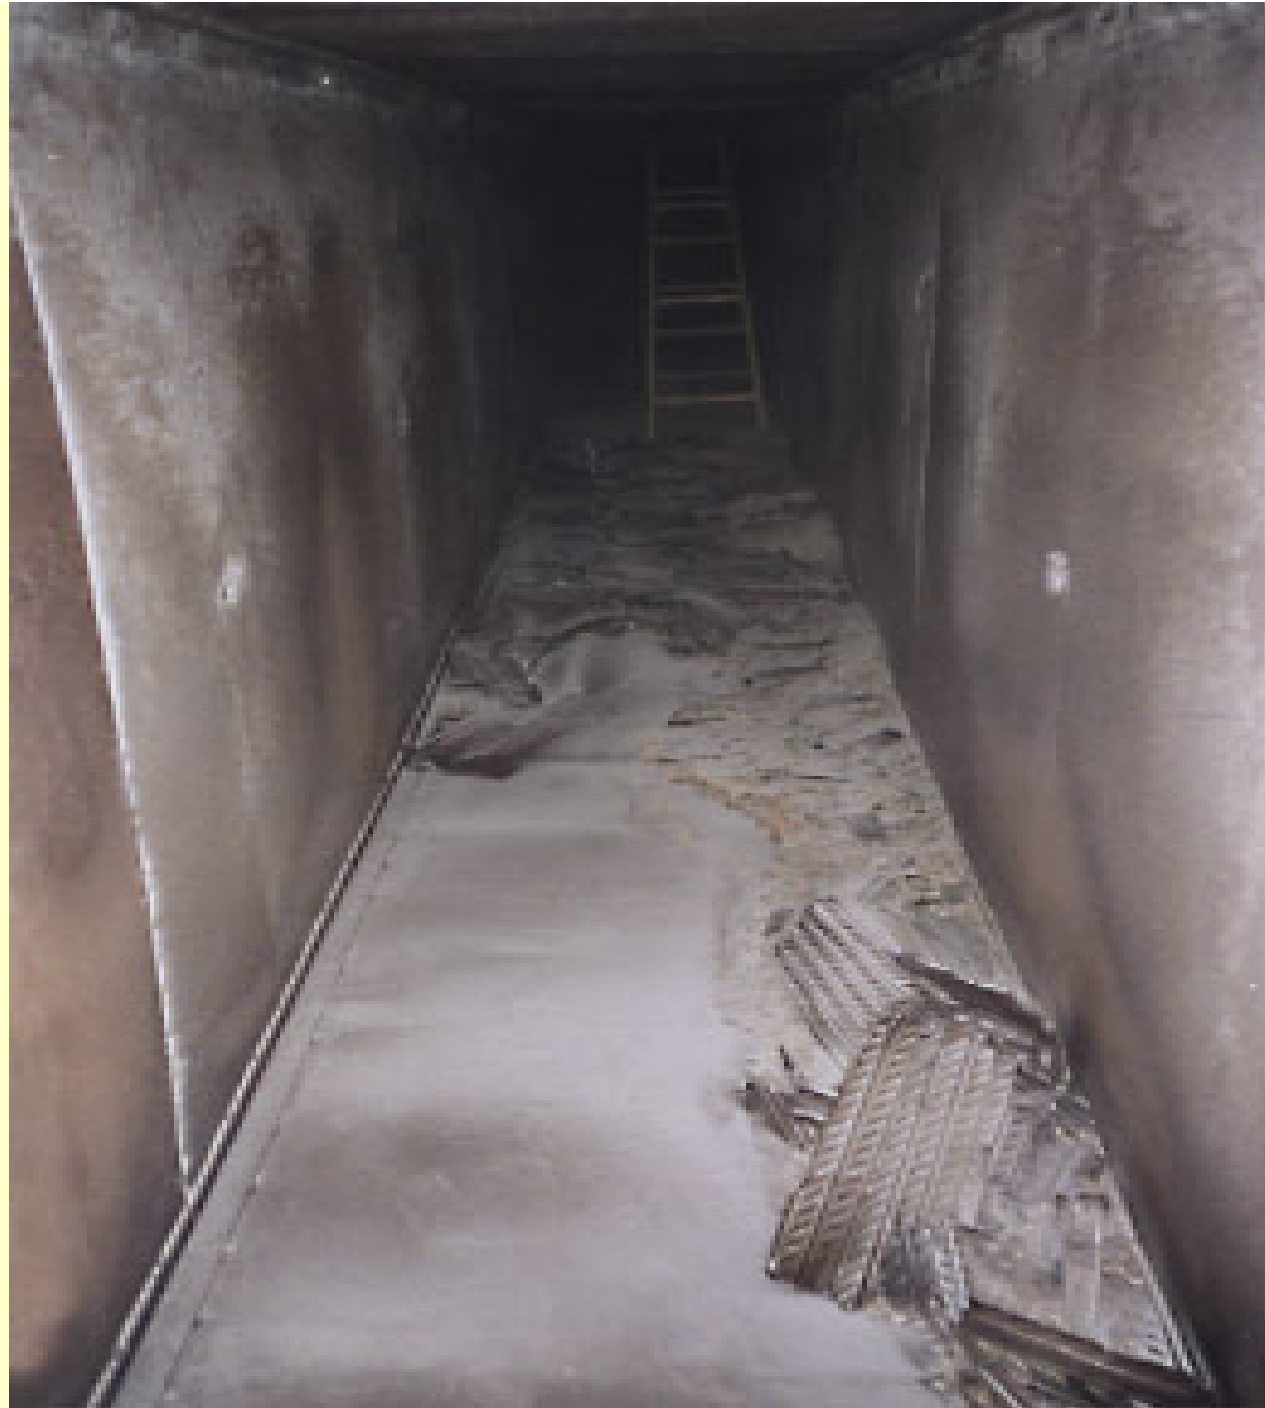
Preheater Basket  
Material Can  
Ground Out  
Precipitators

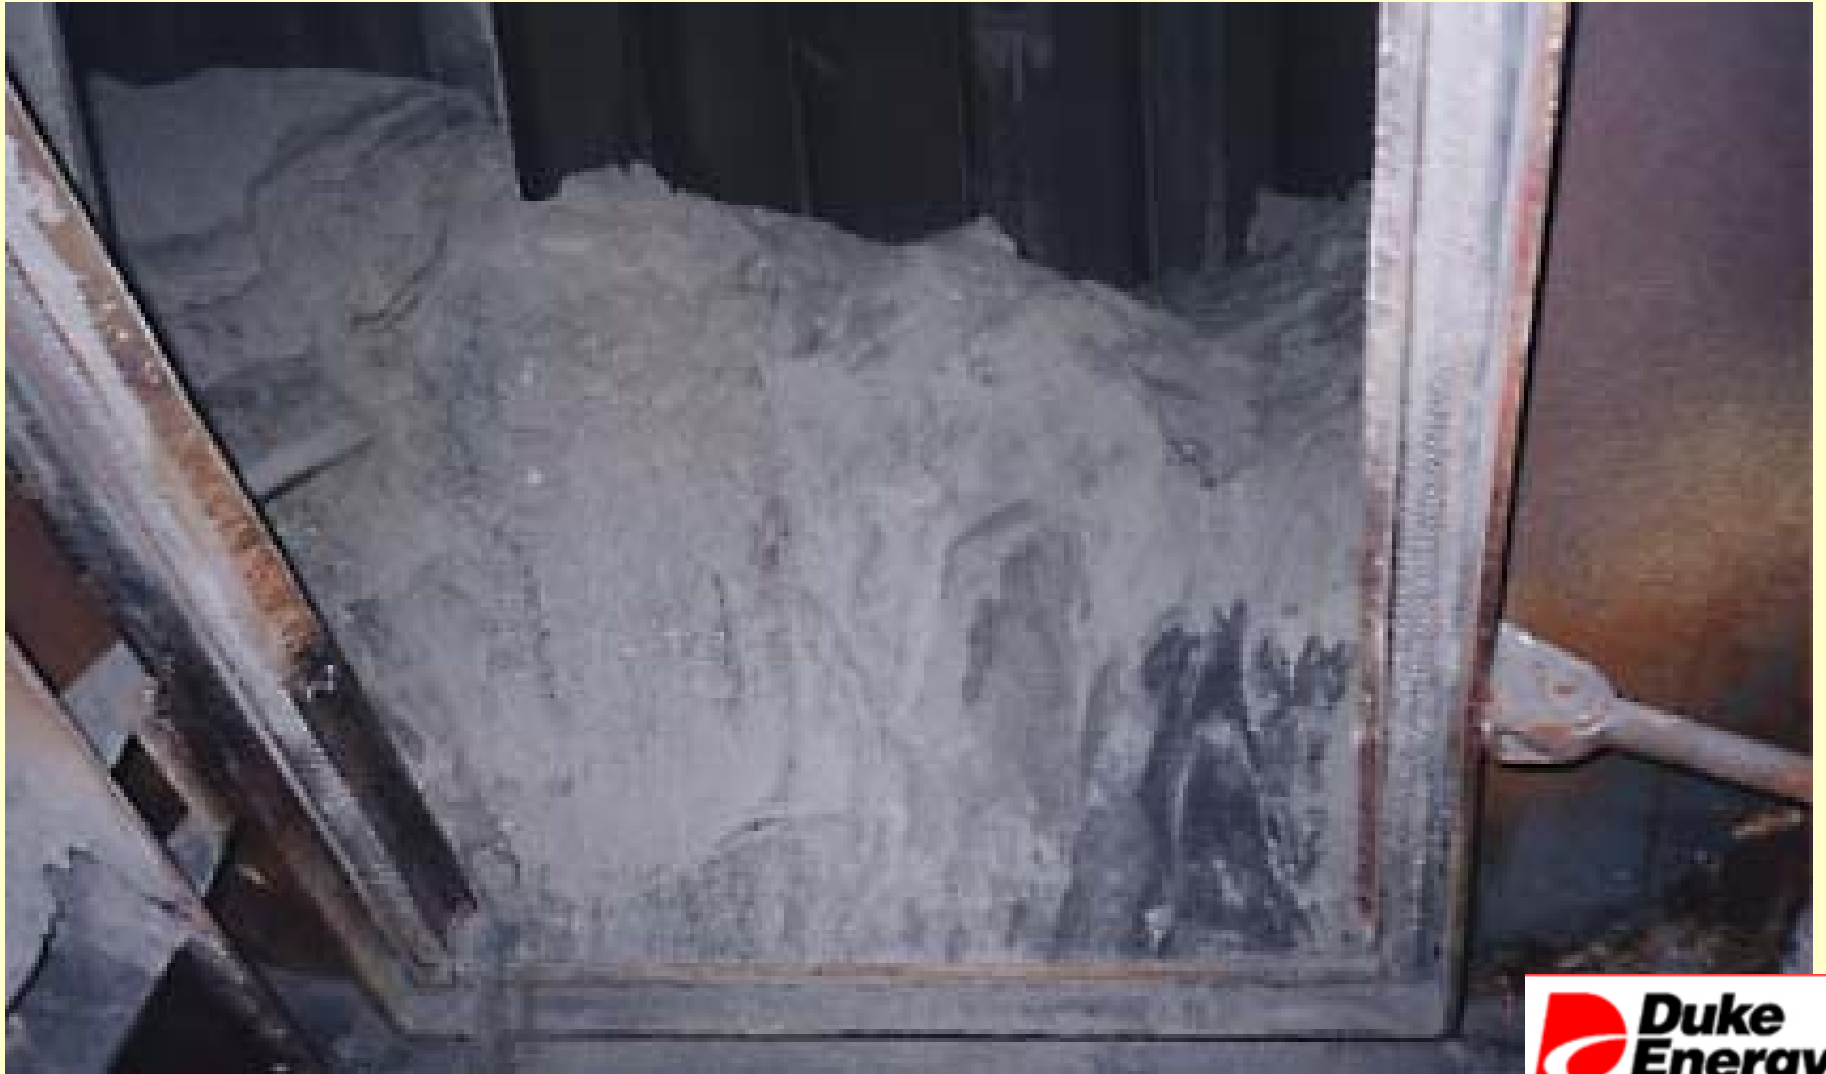
## Carbon Loss on Ignition Decreases Collection Capability

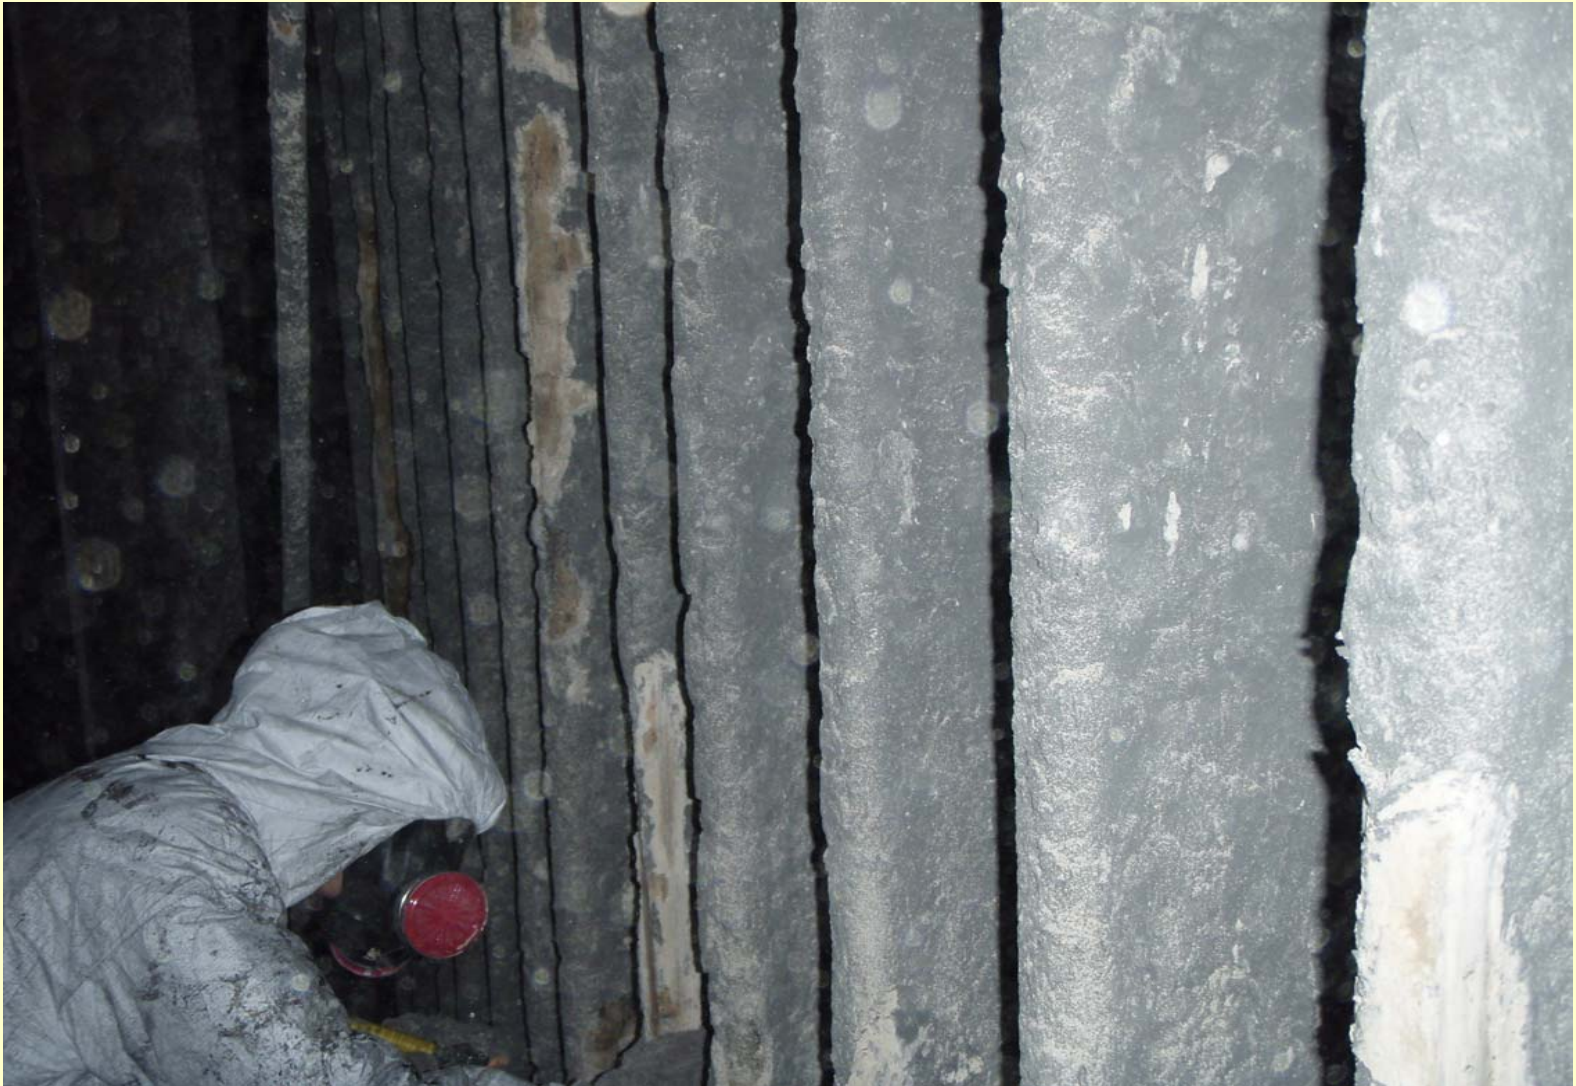
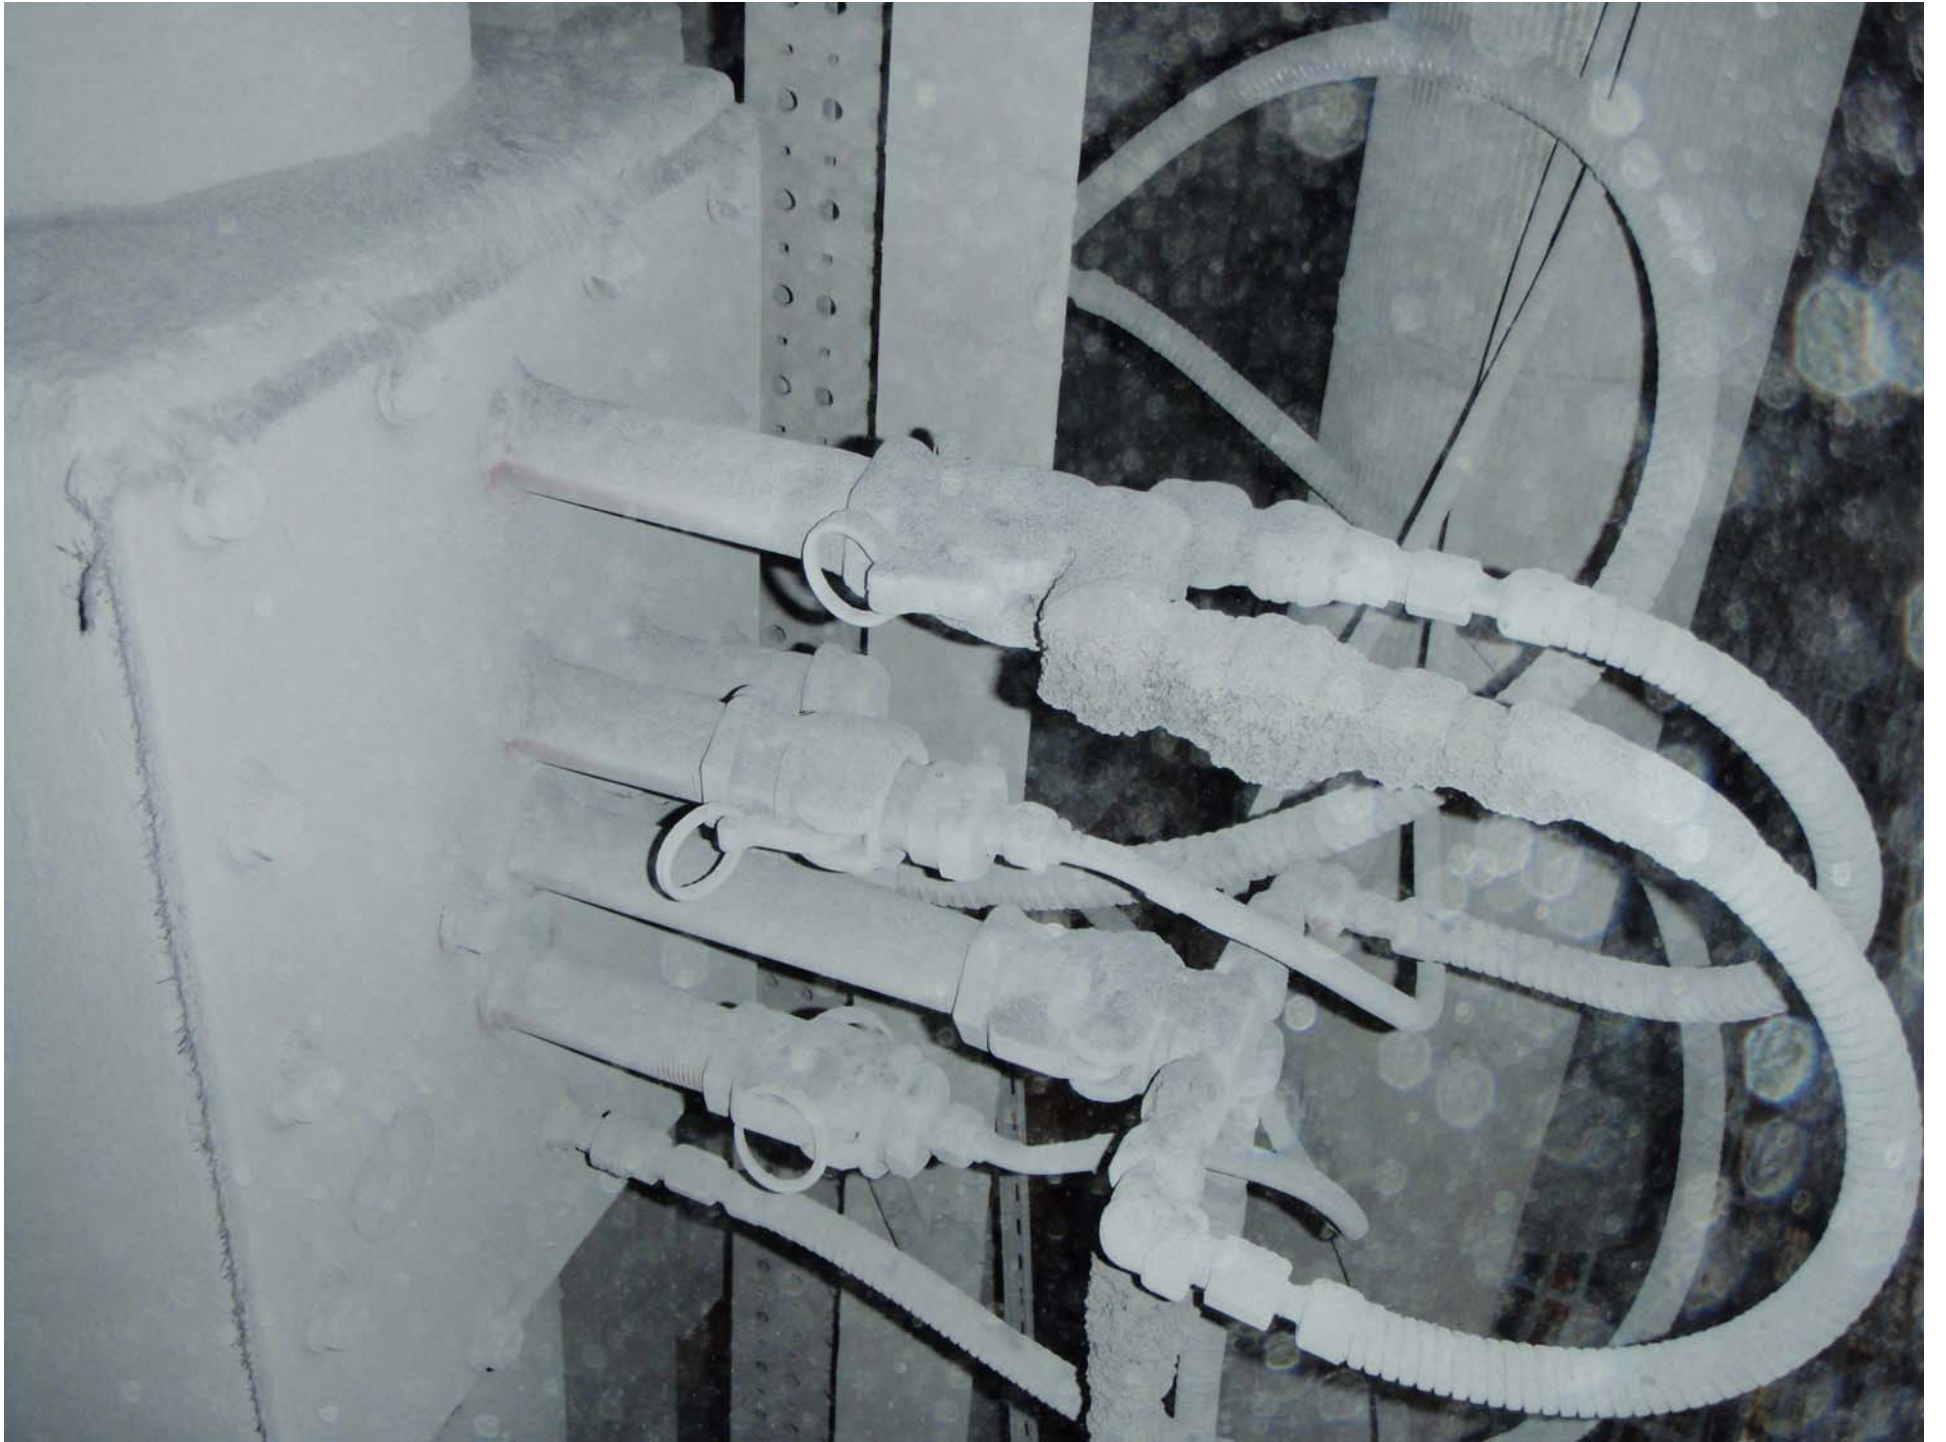
# Oil on the Plates

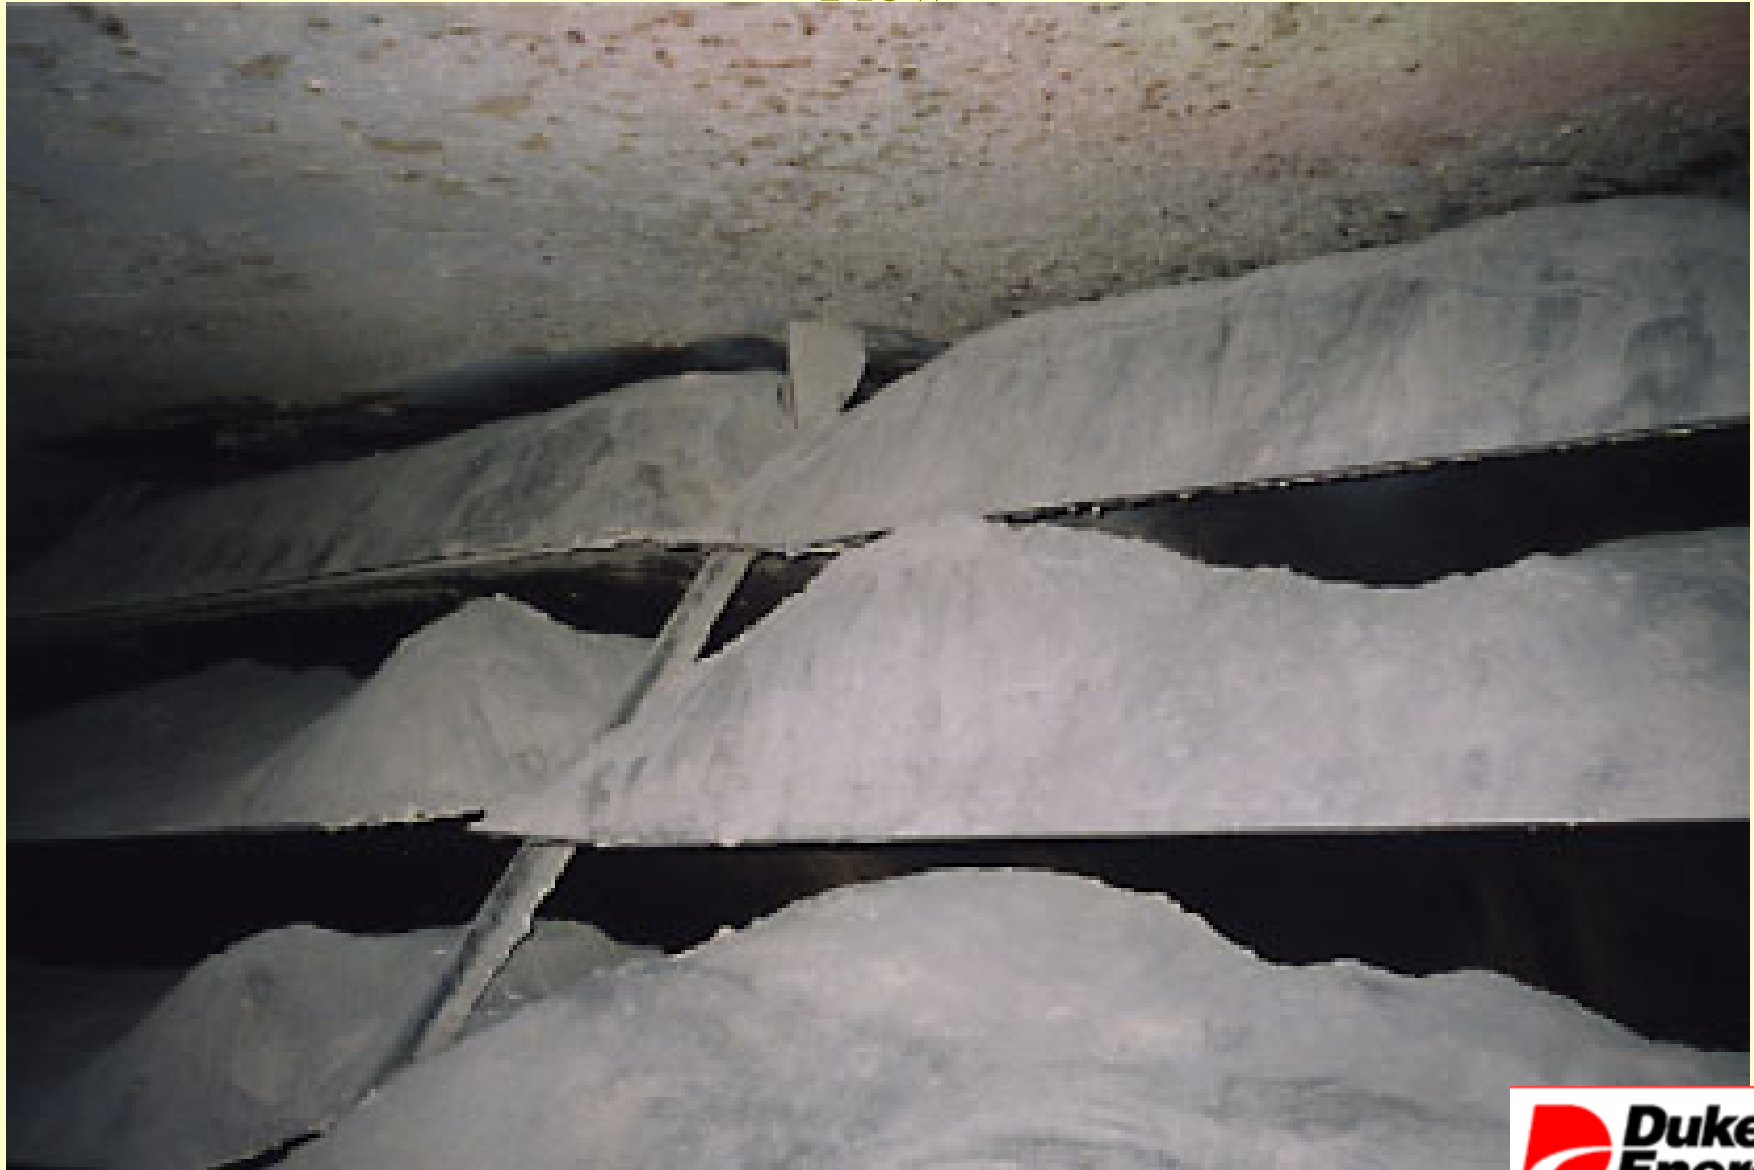
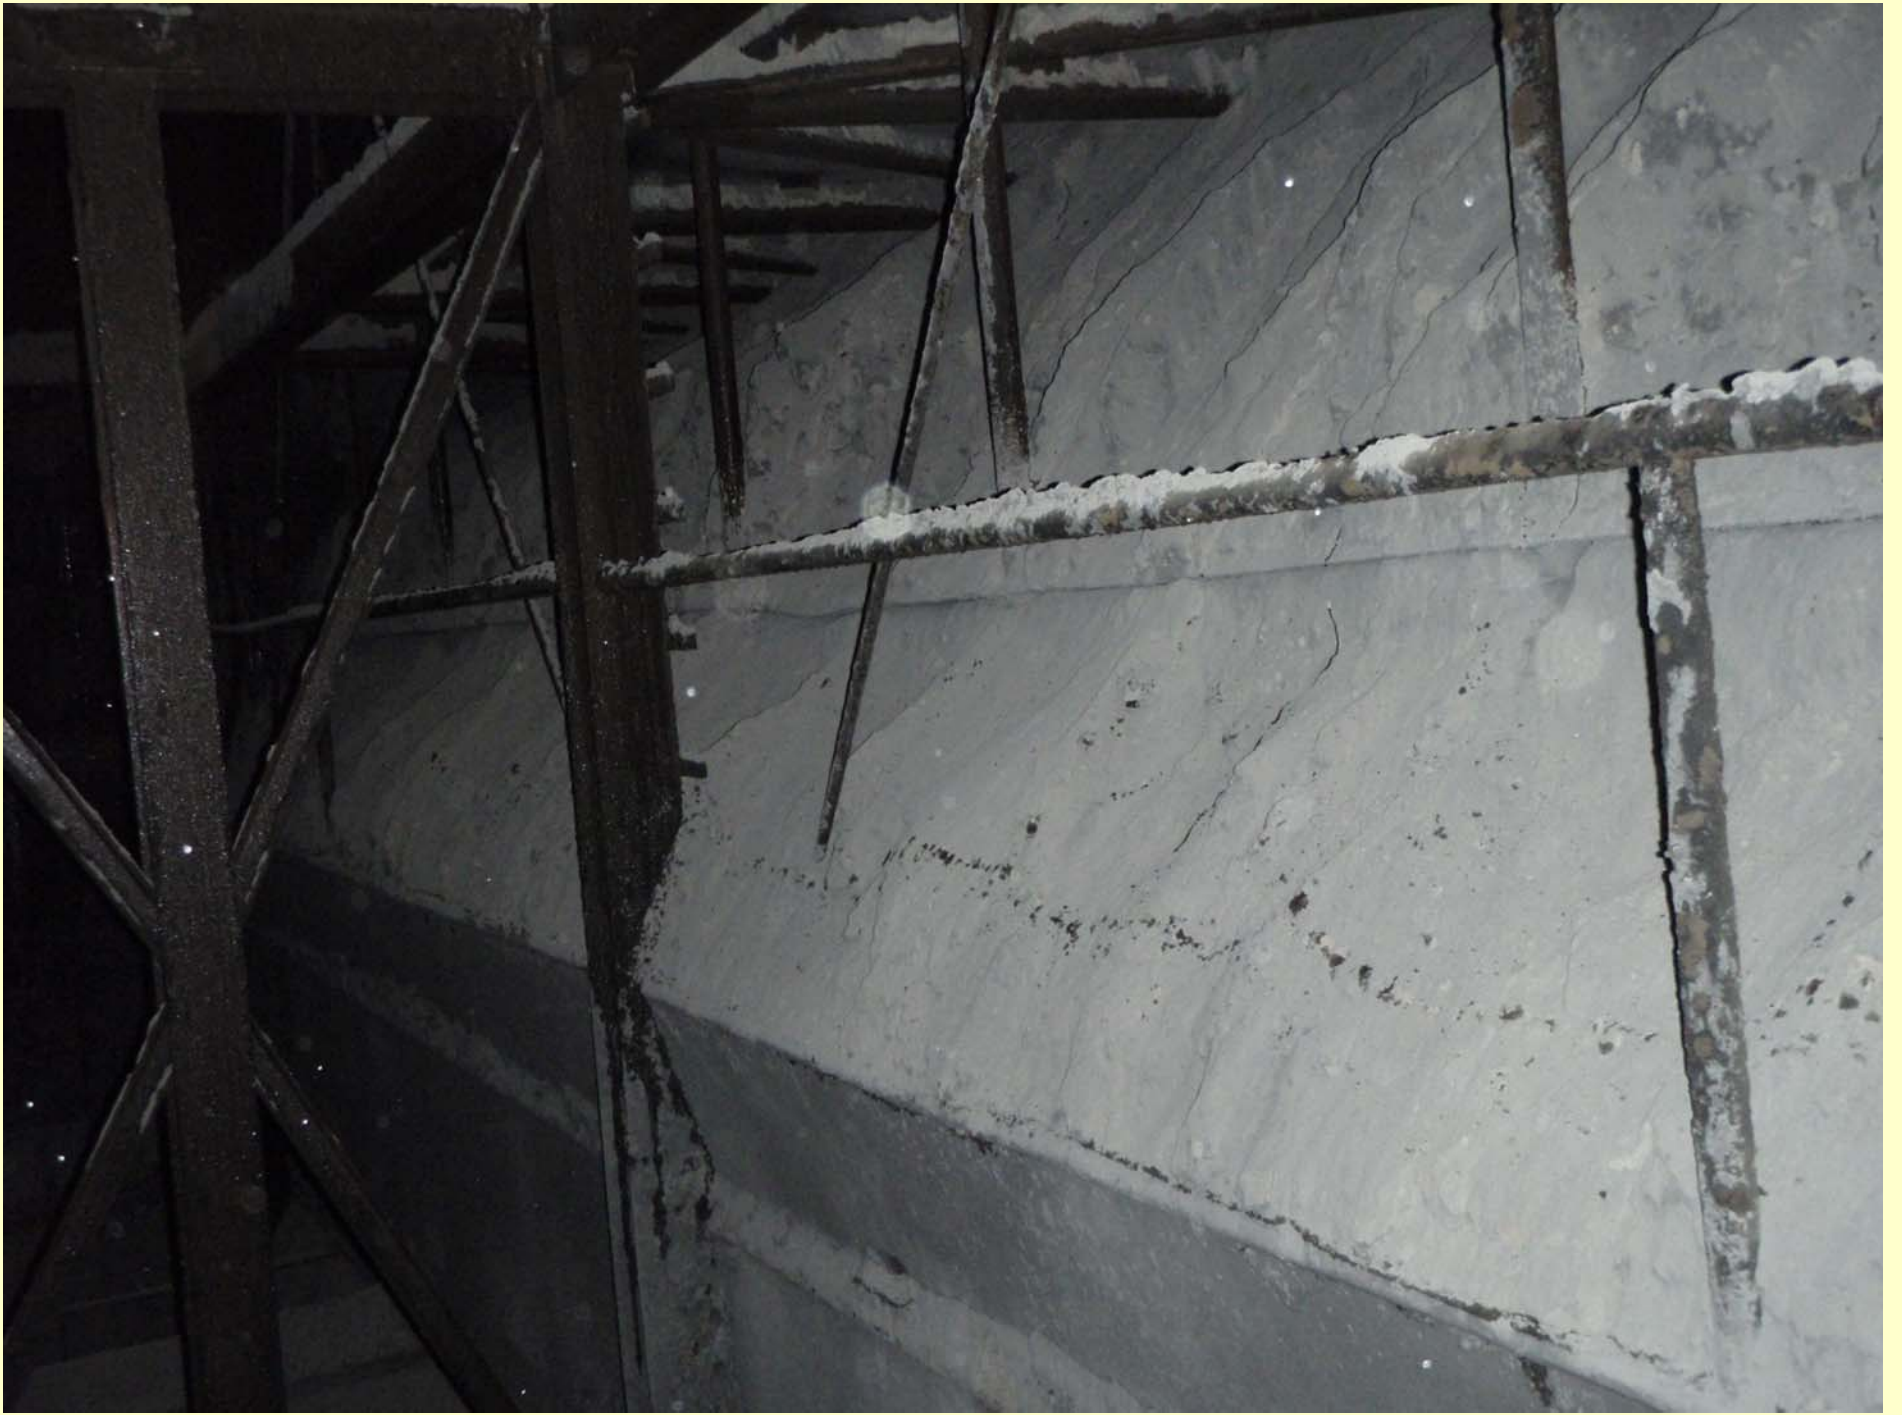
## Ash Build-up on Turning Vanes in the Duct Causes Poor Gas Flow

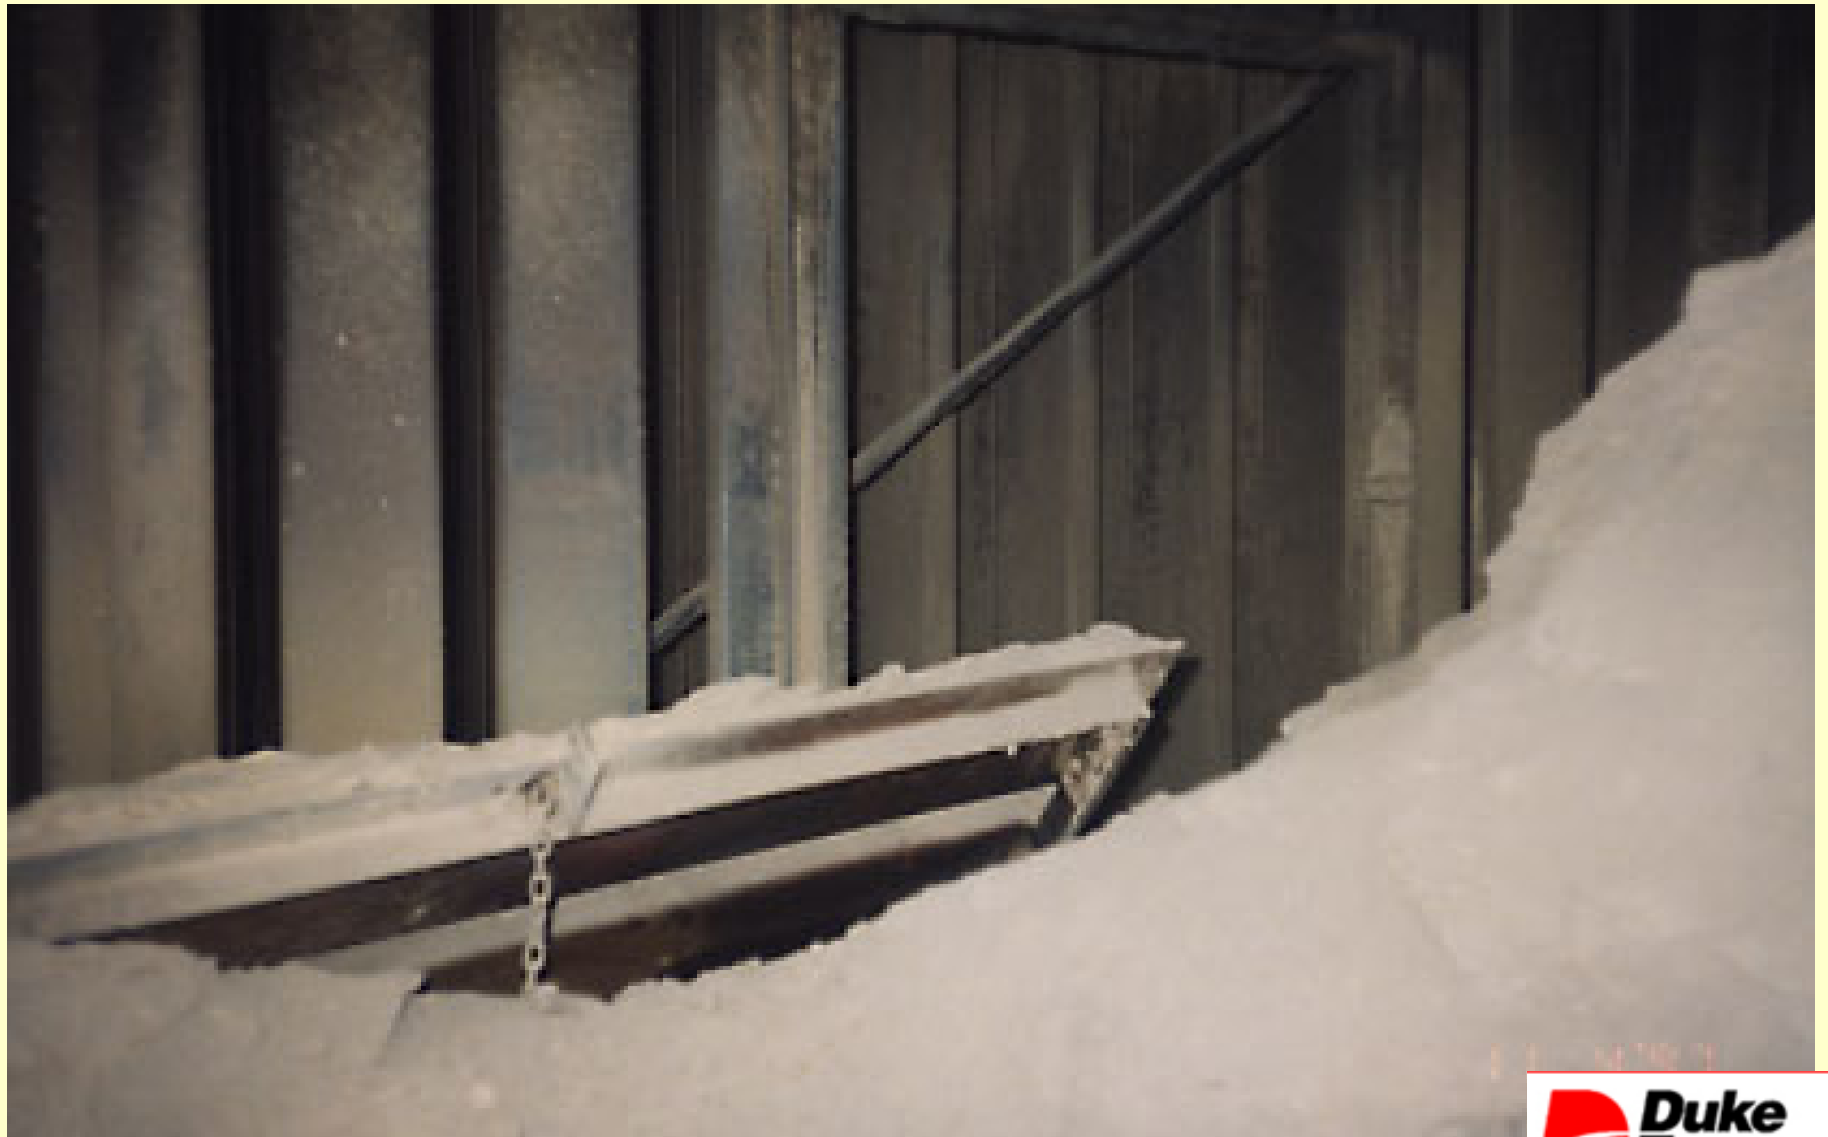
## Ash Build-up at Precipitator Inlet

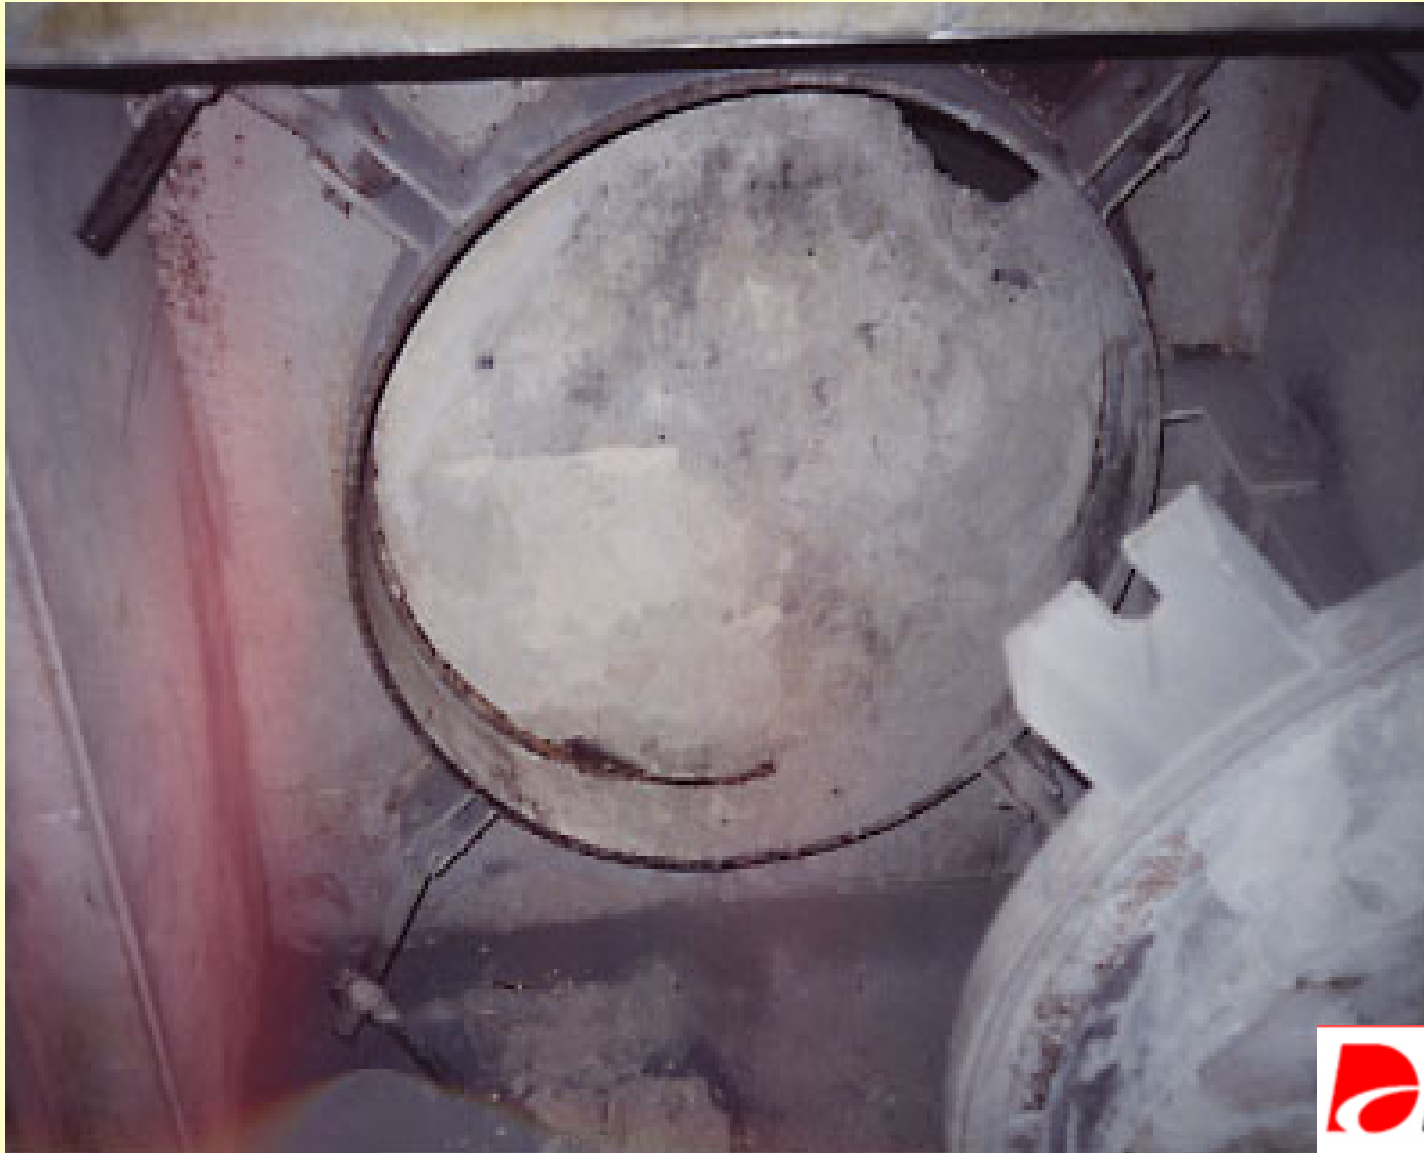
## Ash Buildup at Access Door

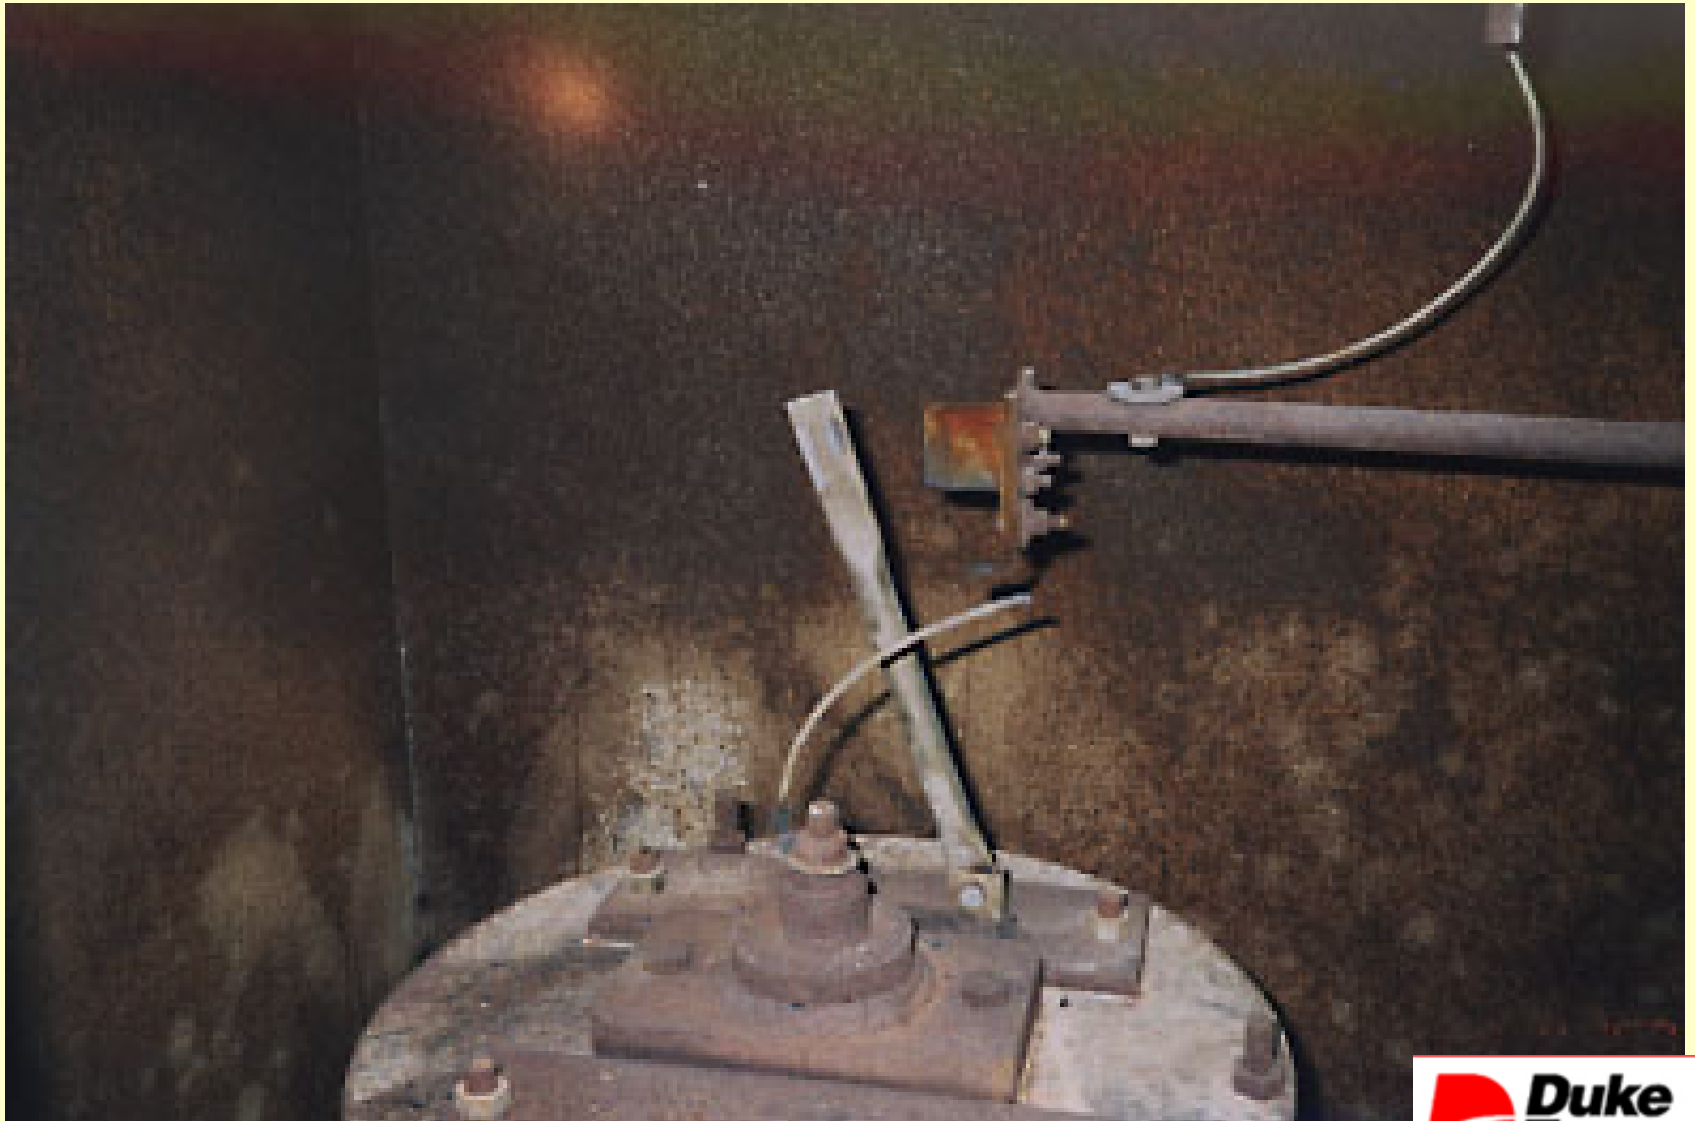
## Knife Blade Switch Arcing and High Voltage Cable Failure

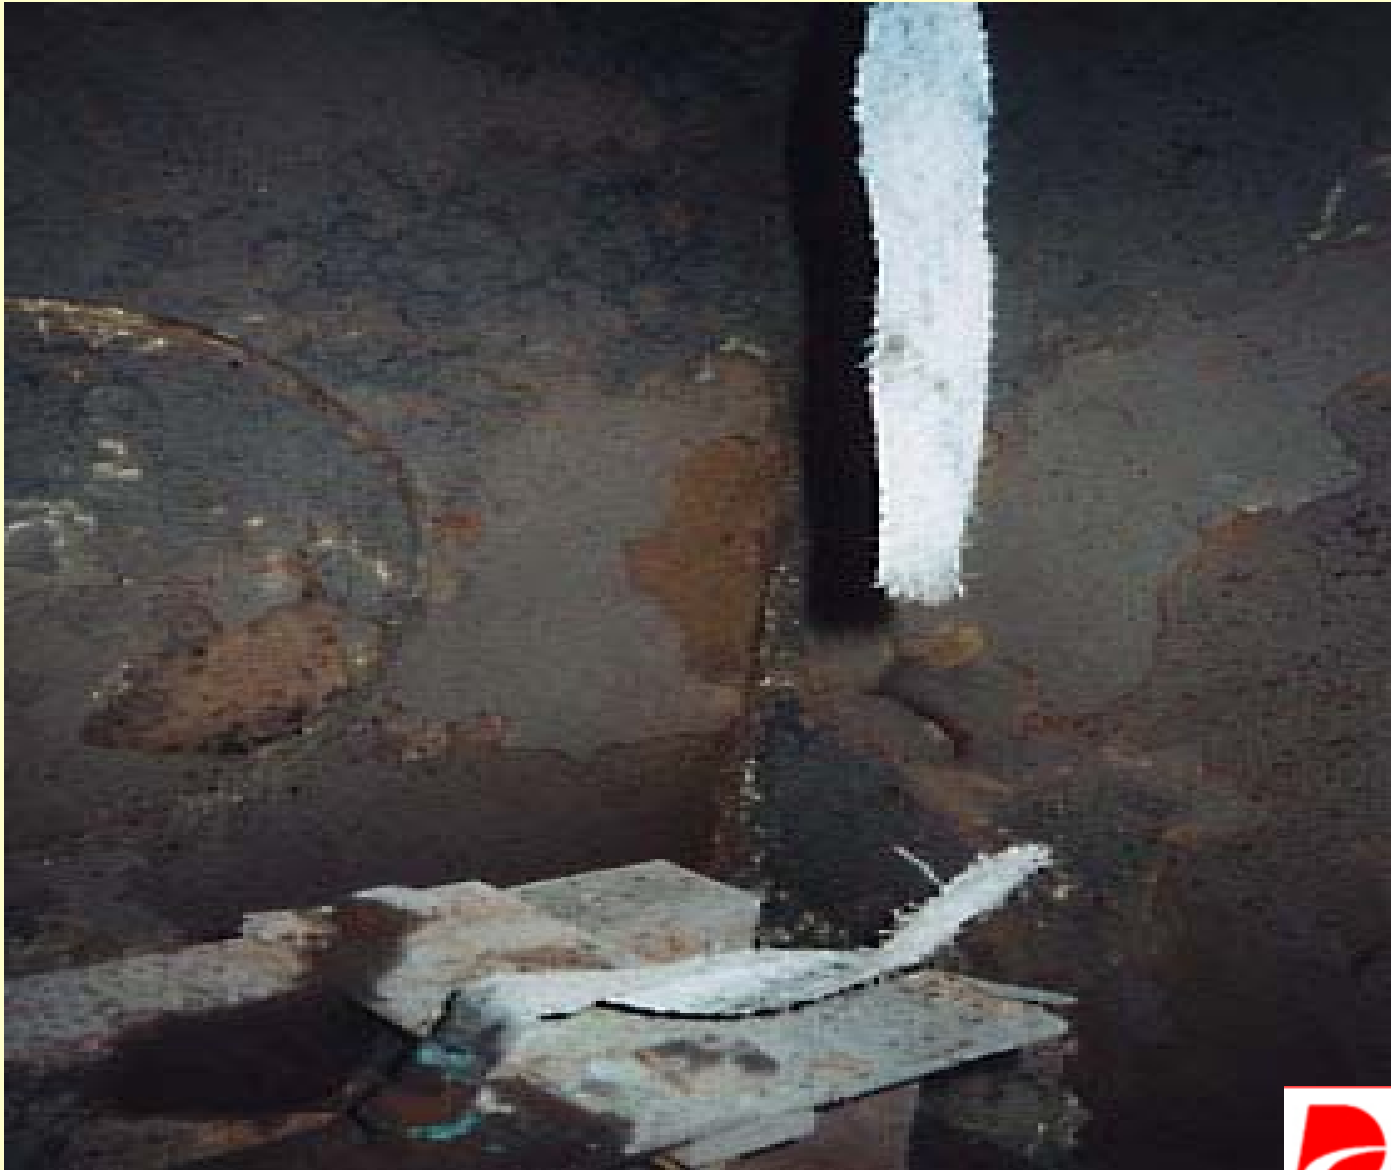
## Power Path High Voltage Failure

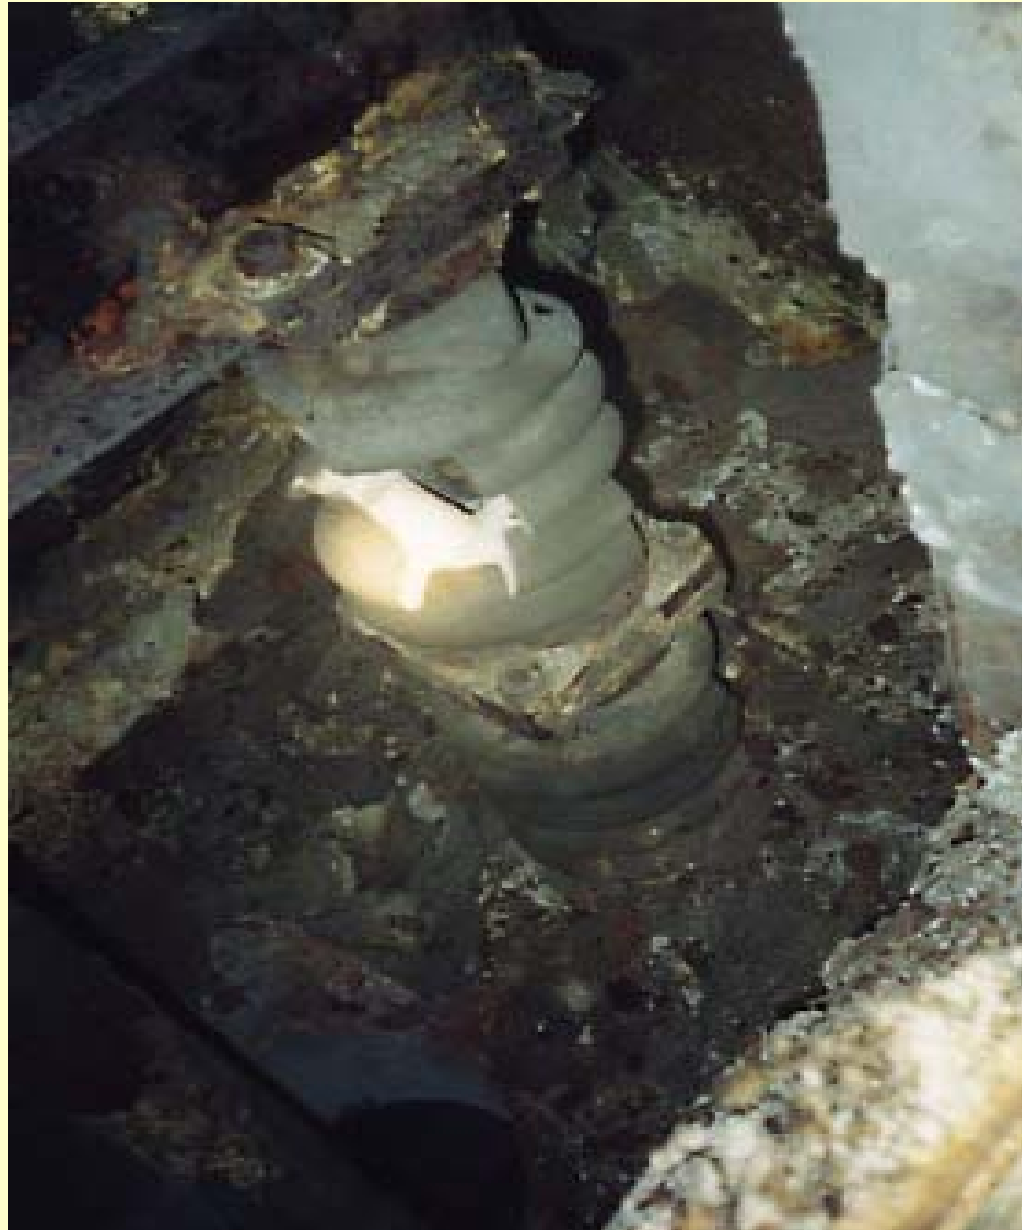
## Broken High Voltage Insulator

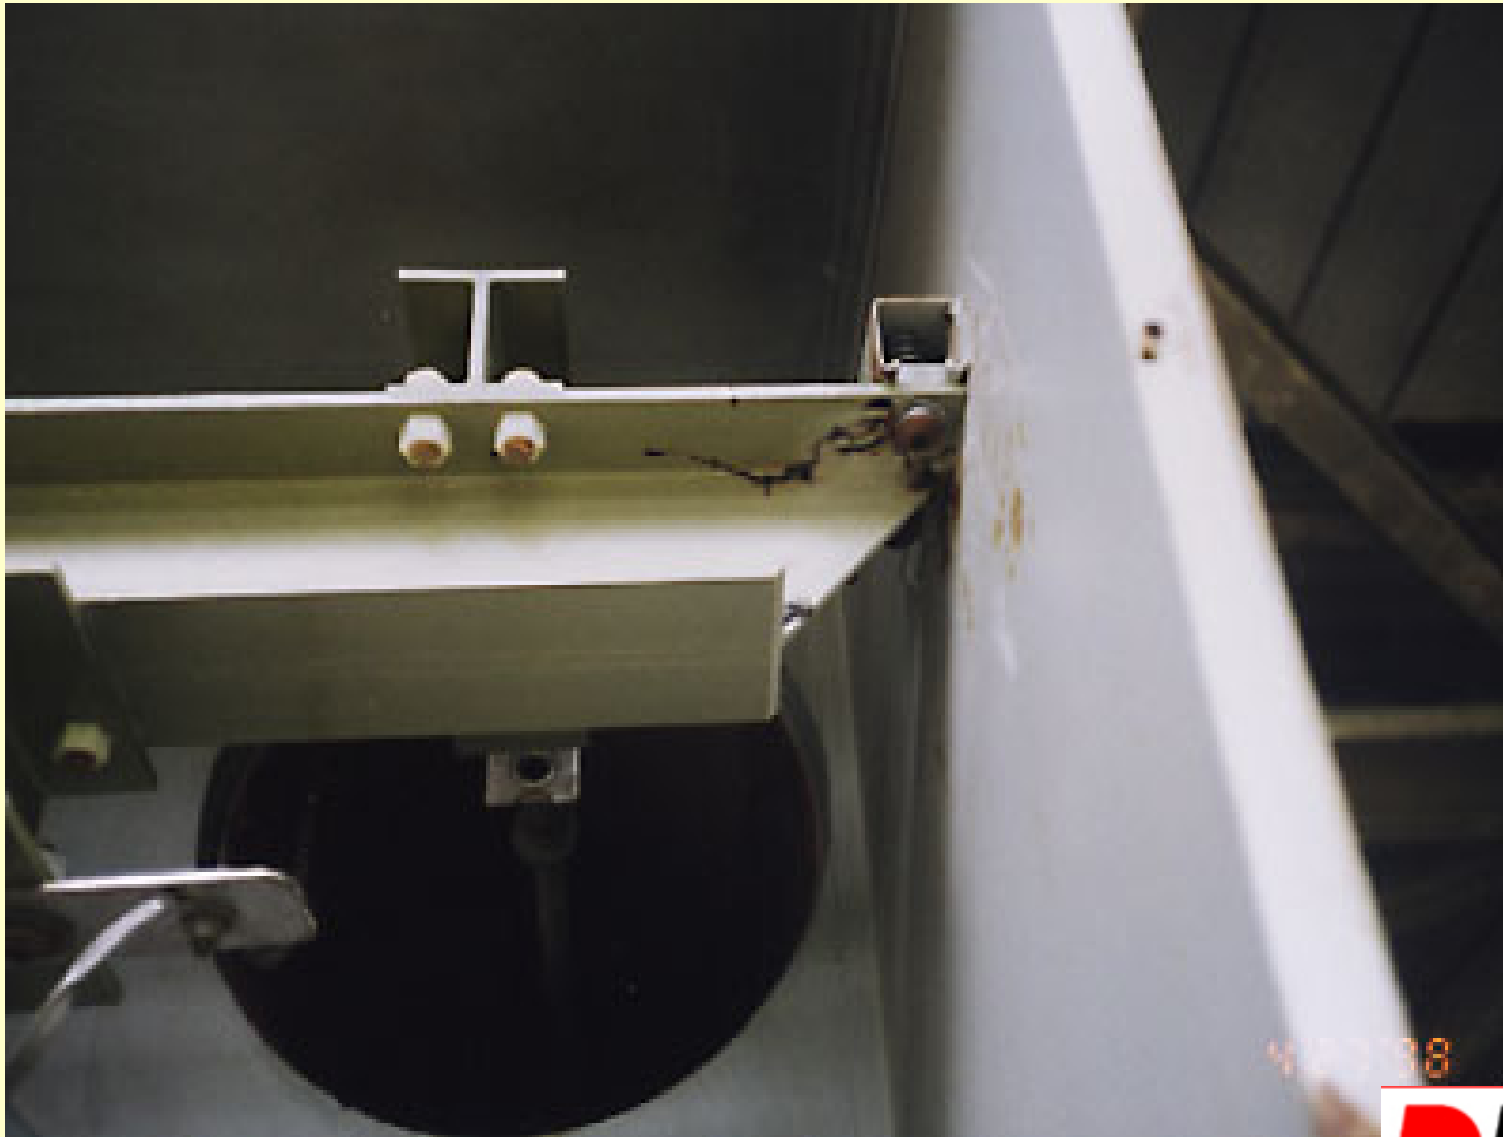
## Tracked Post Insulator Inside a T/R Set
