# Worldwide Pollution Control Association

**Ameren Seminar**  
**August 19–20, 2008**  
**Effingham, IL**

# Precipitator Maintenance and Operations

By Scott Williams

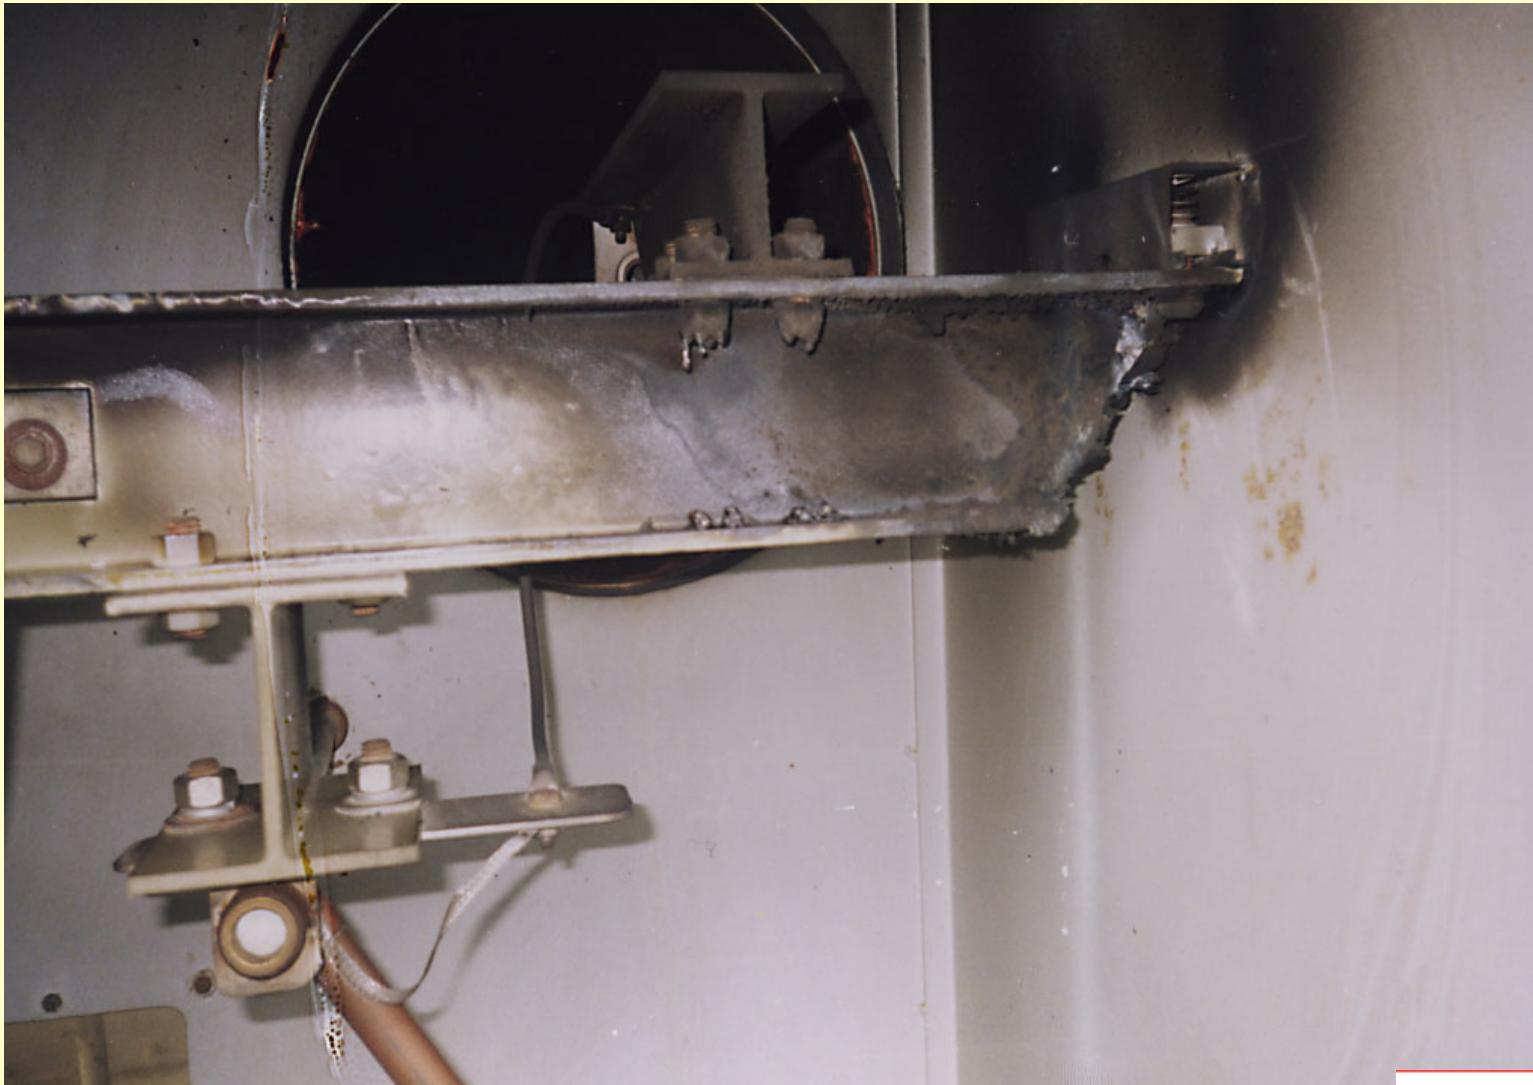
## Support Insulator inside T/R - Tracking

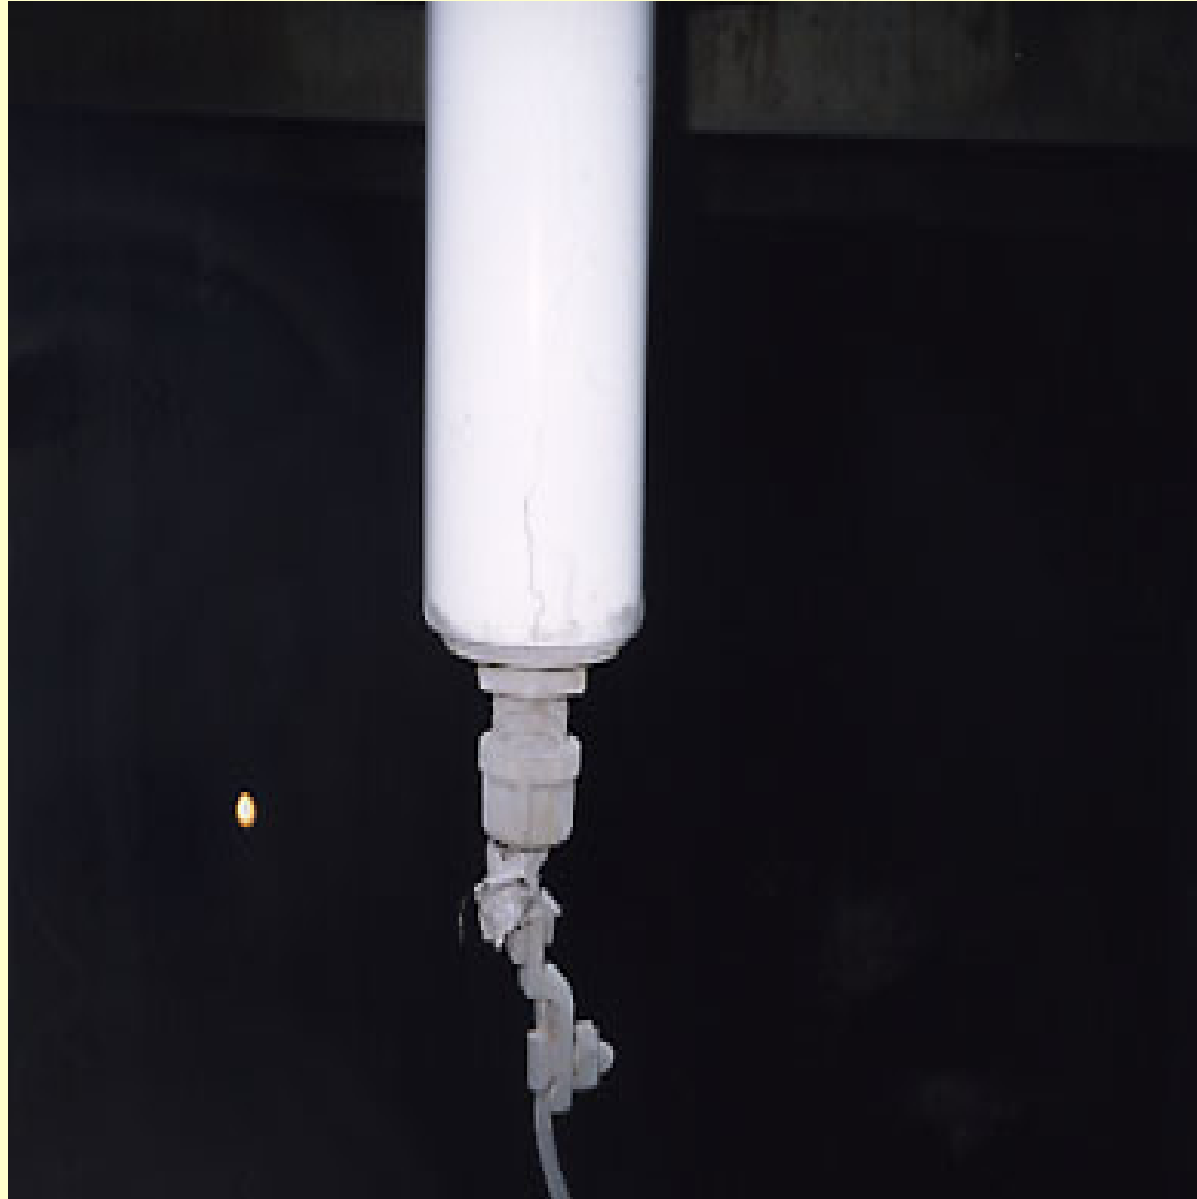
## High Voltage Insulator Tracking

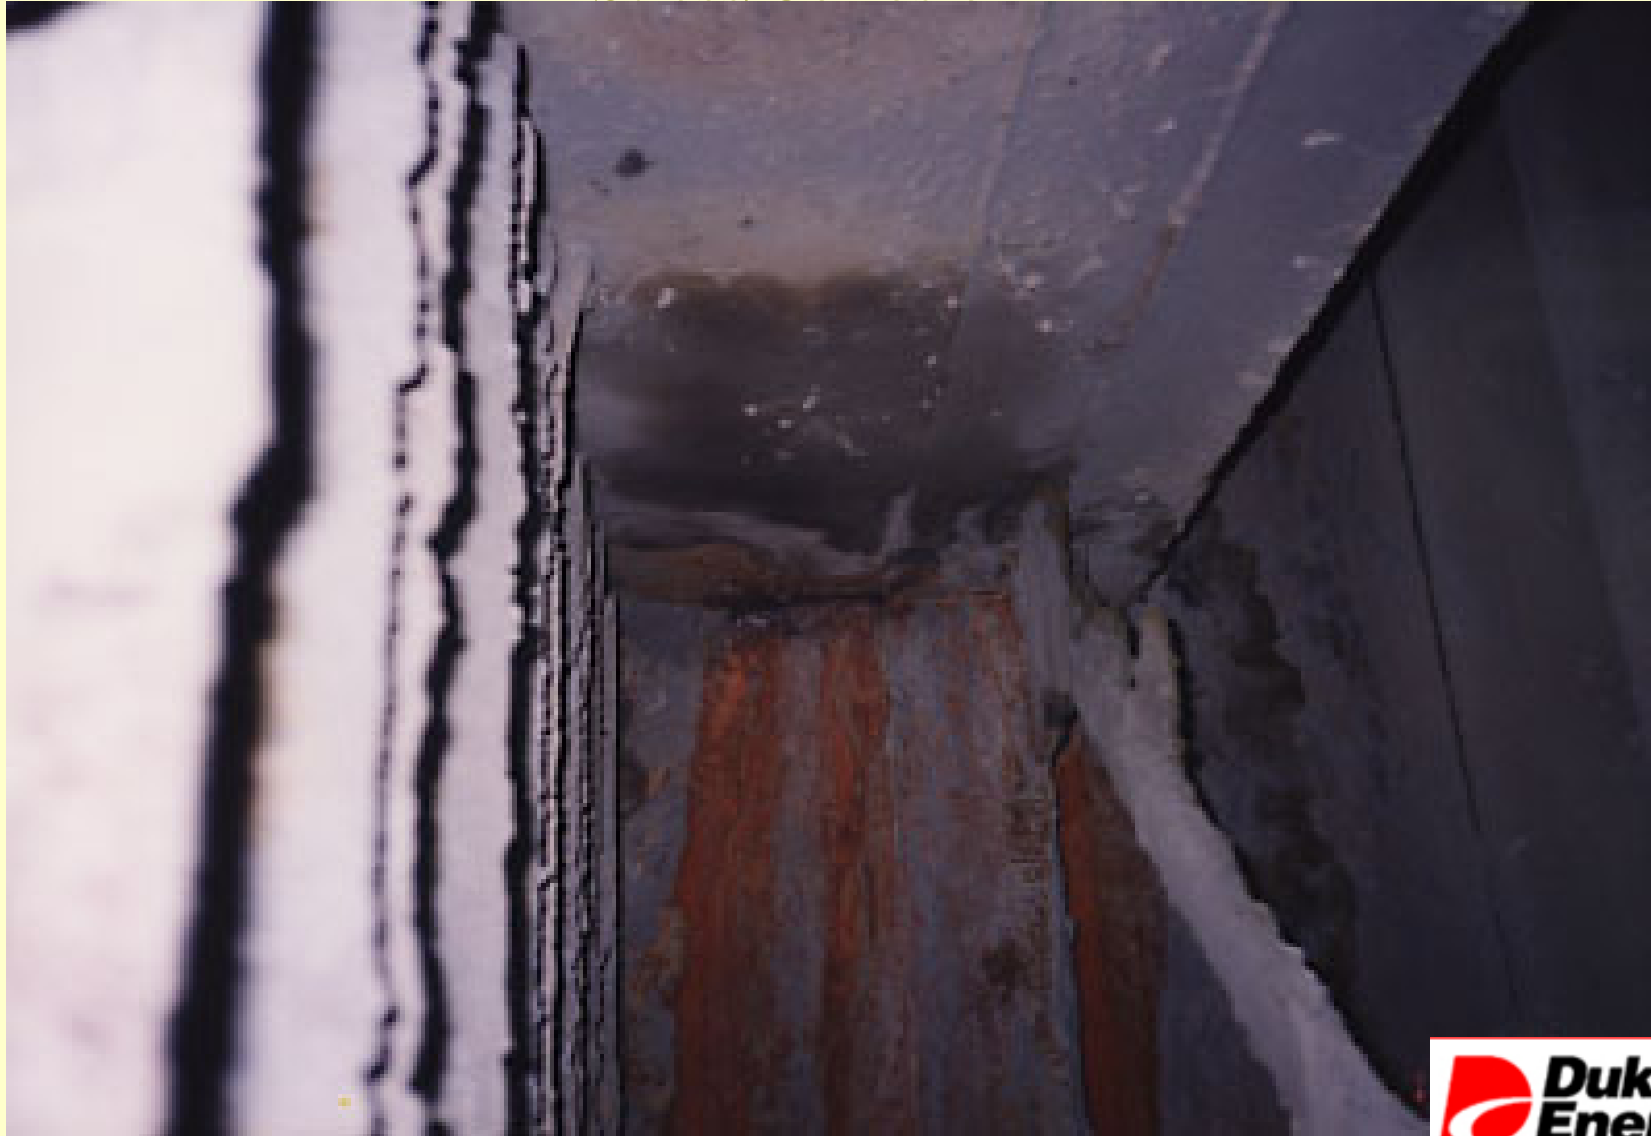
## A Hole in the Precipitator Hot Roof due to Thermal Stress/Corrosion

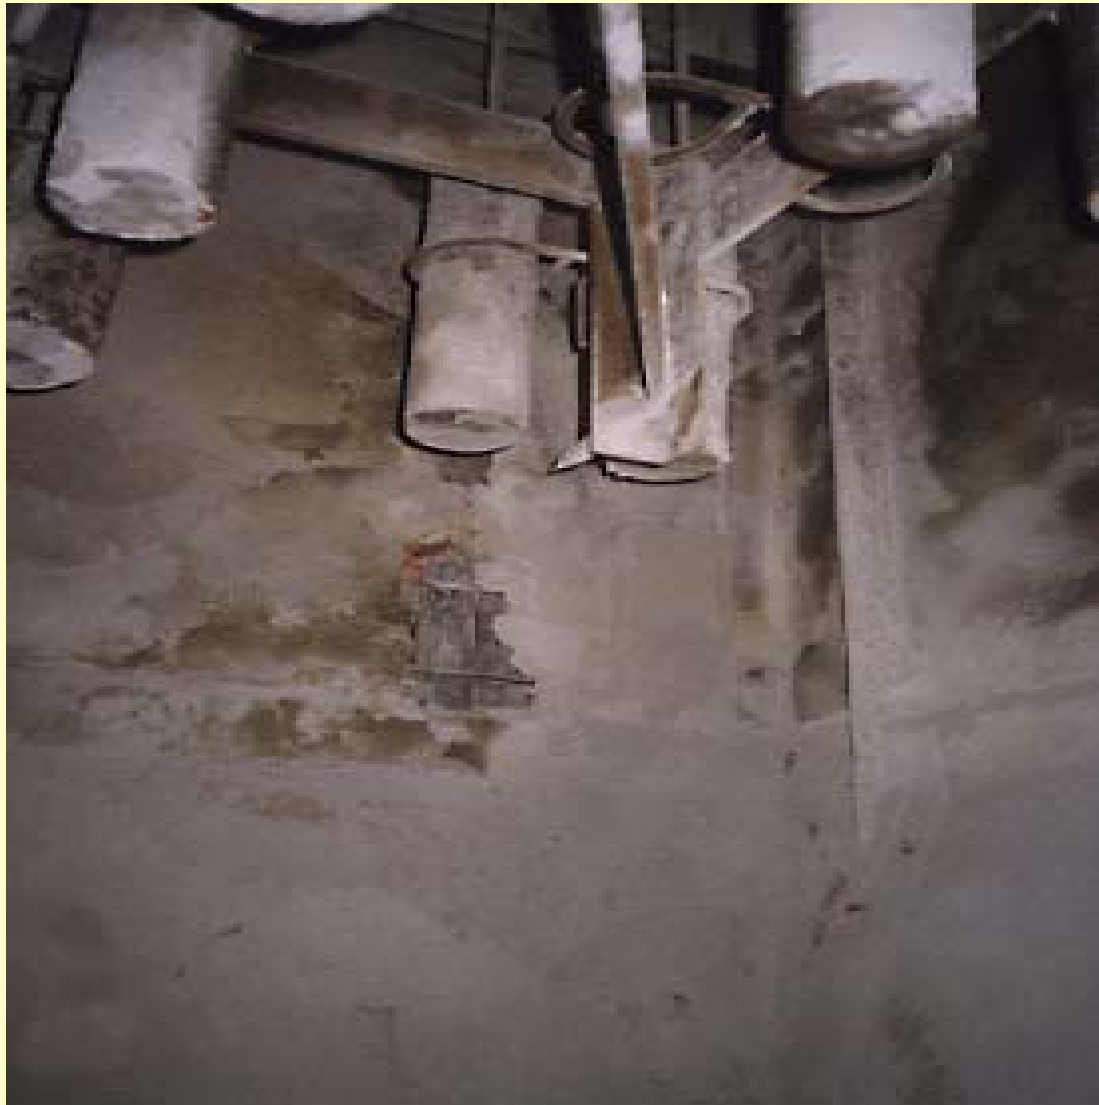
## Holes in the Side of the Precipitator Due to Corrosion

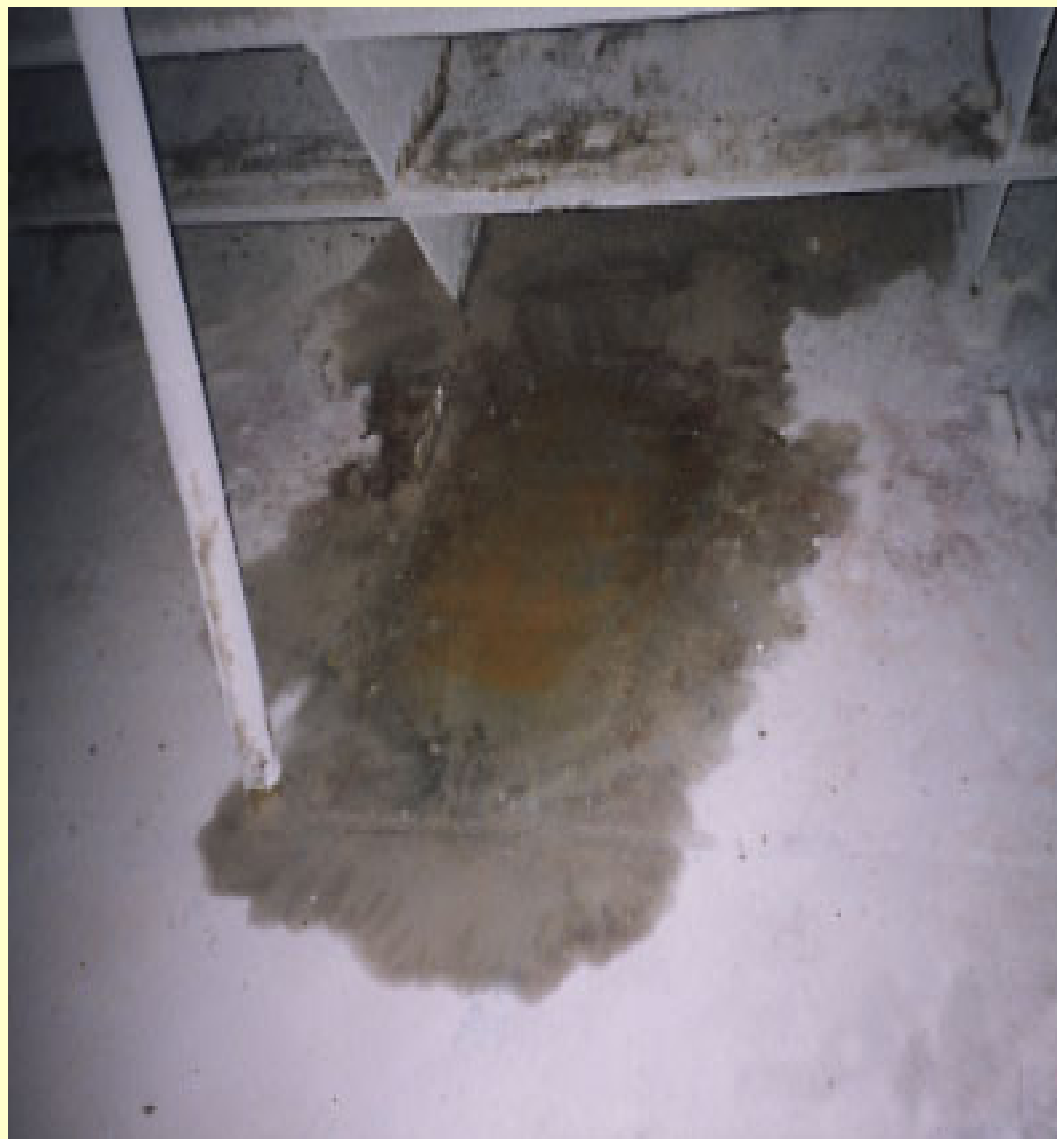
## Water Leaks From Ductwork

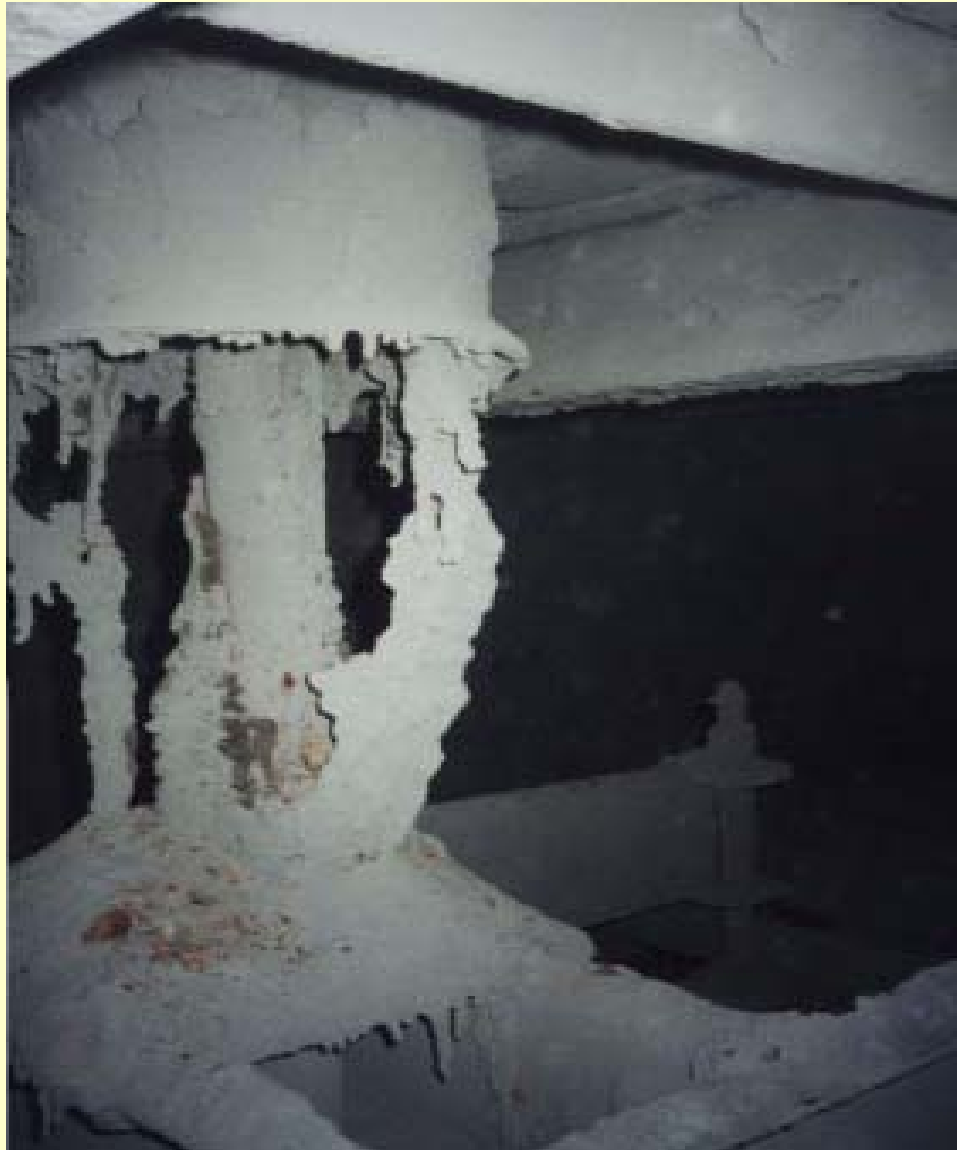
## High Voltage Guard Air Leakage

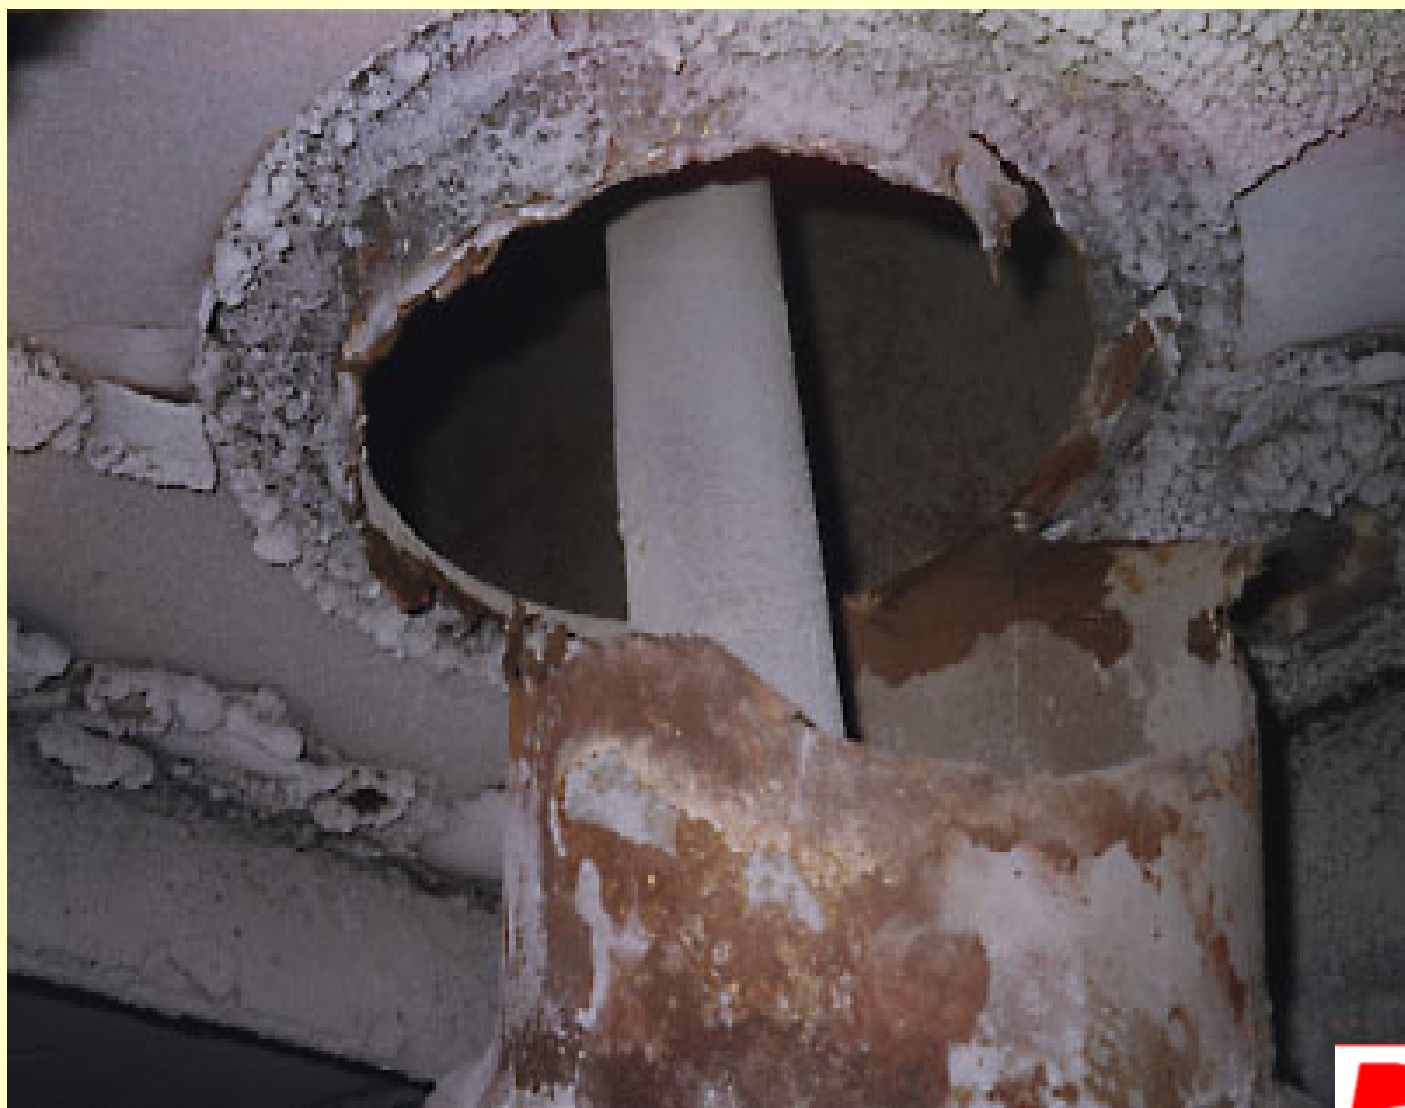
## Corrosion of High Voltage Guard Due to Air Leakage

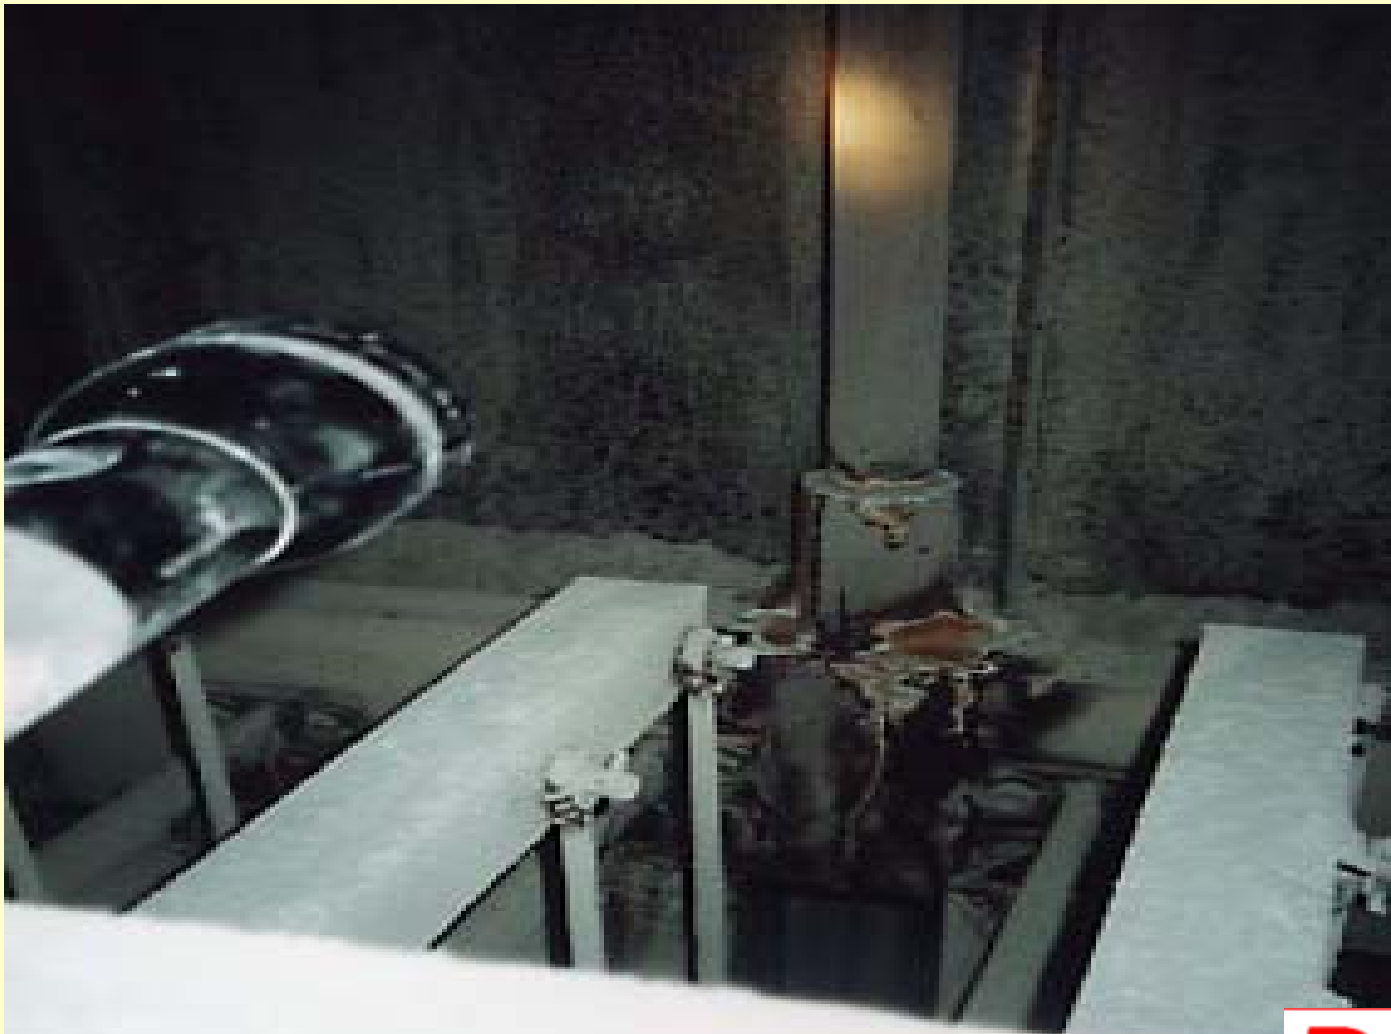
## Water Leakage Around Rapper Boot Seal

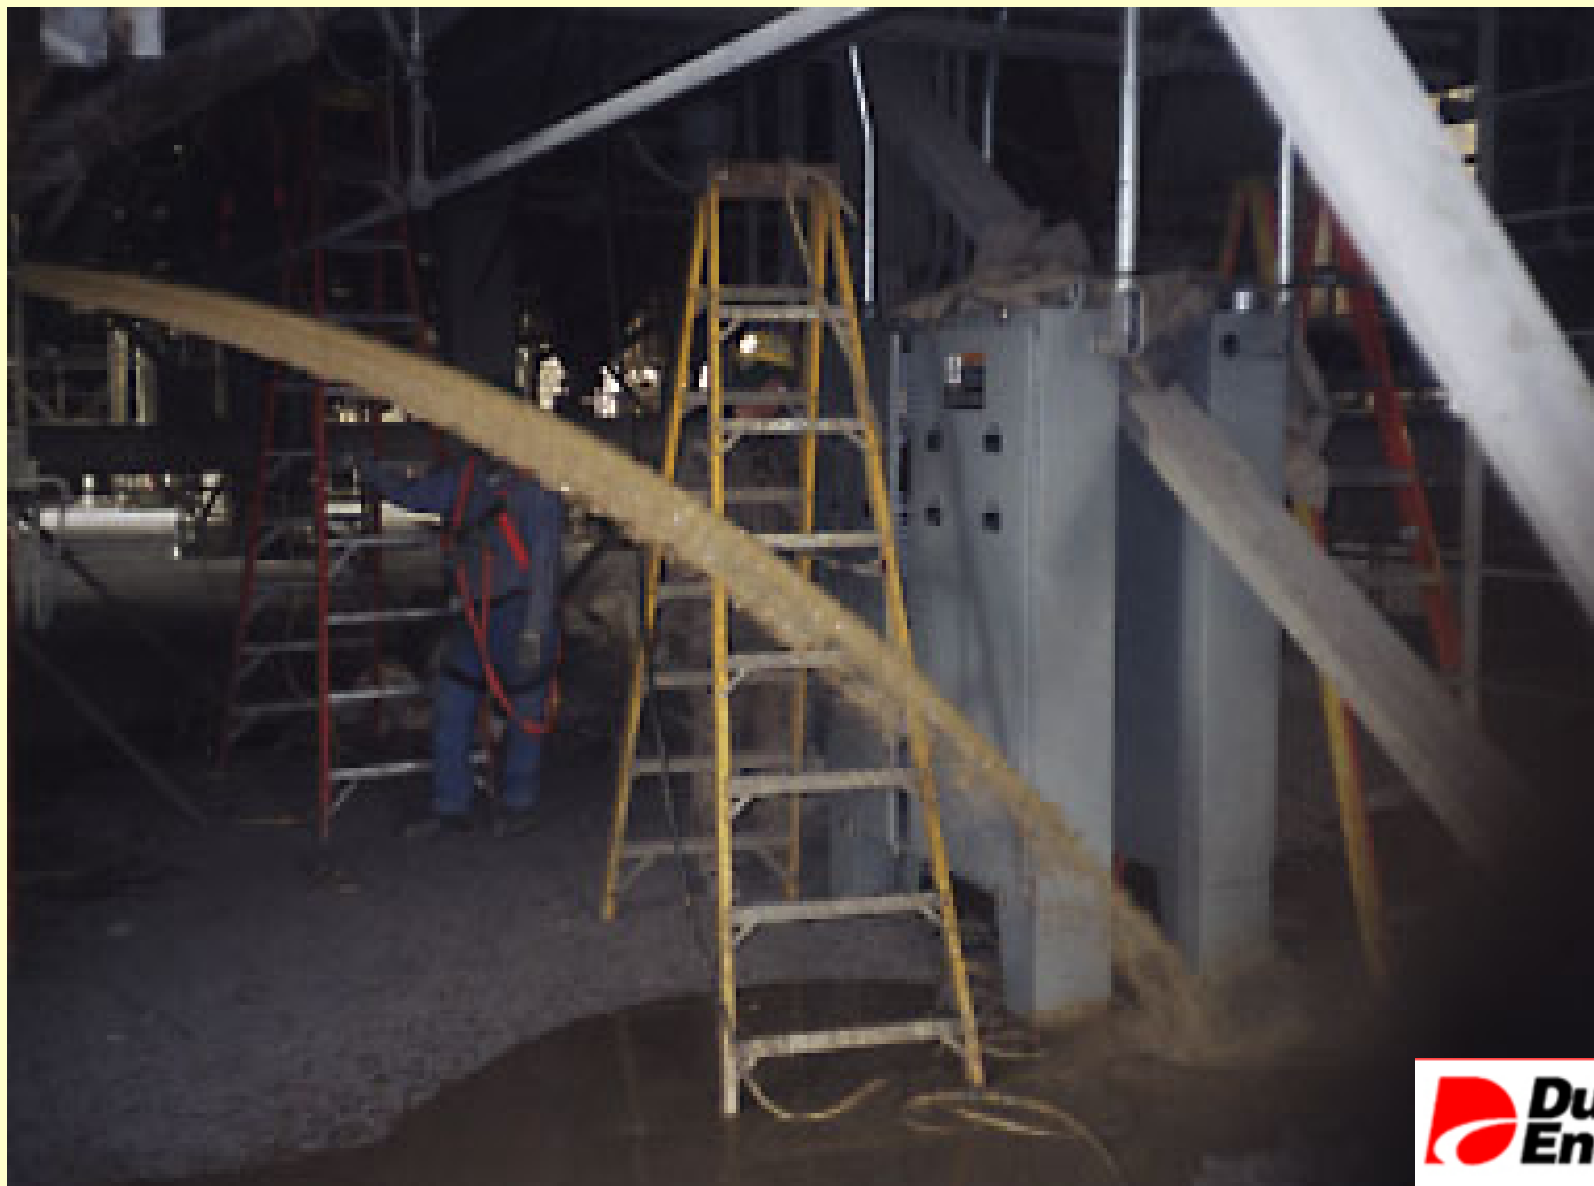
## Water Pouring From Precipitator Hopper

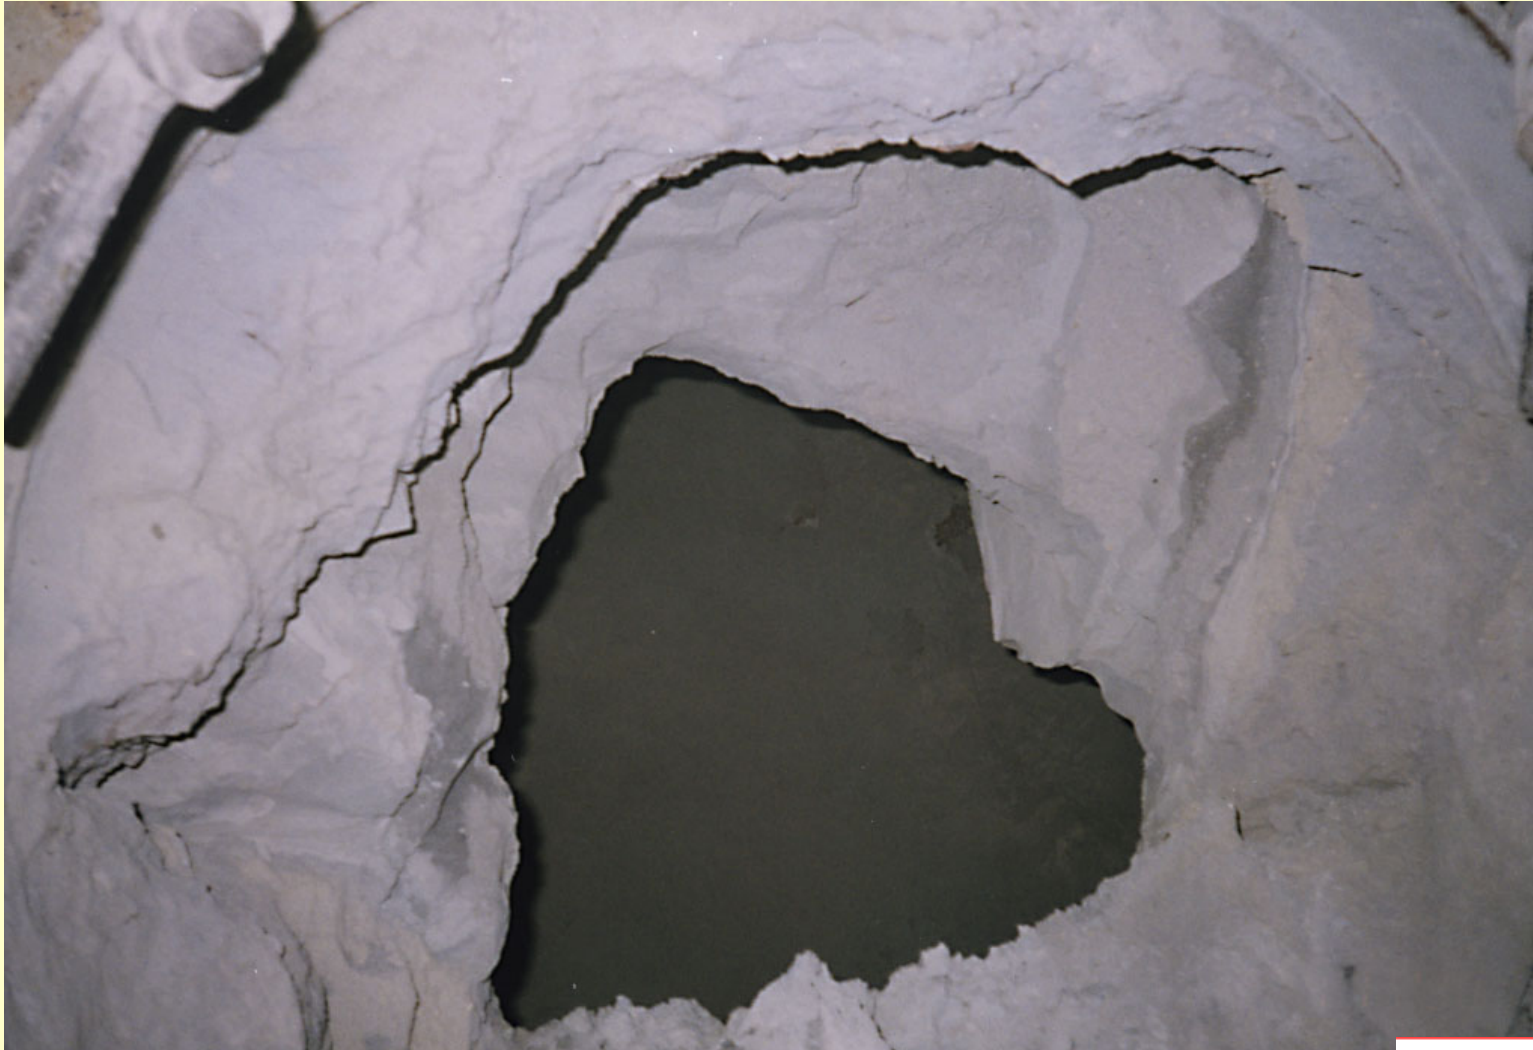
## Ash Buildup in Hopper

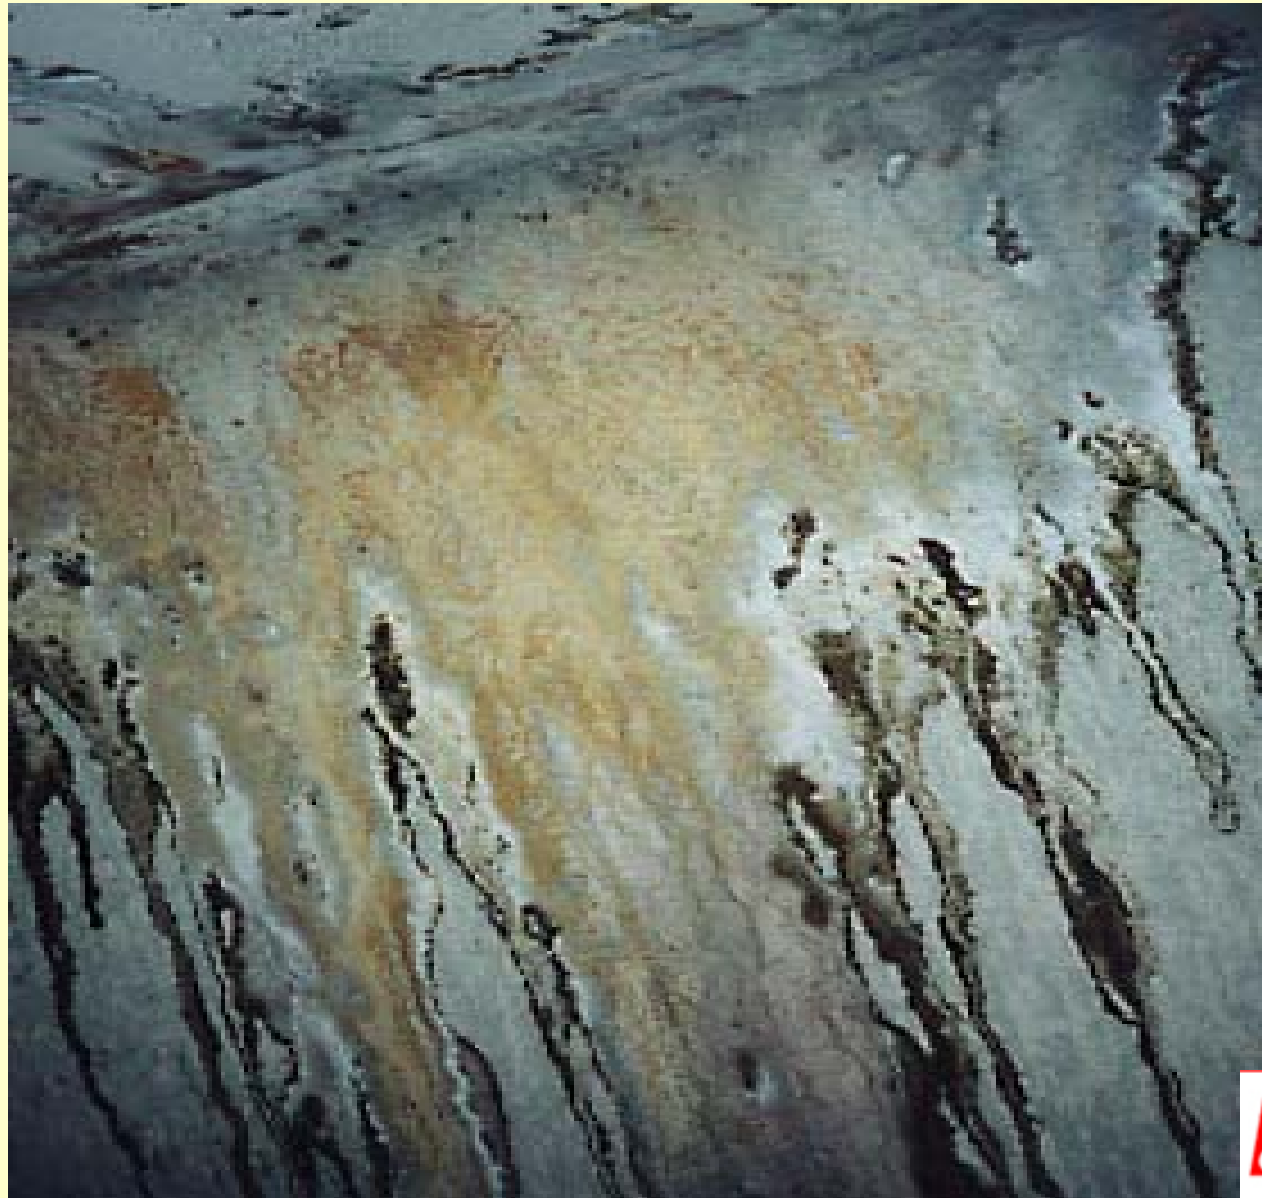
## Water Leakage Through the Precipitator Roof

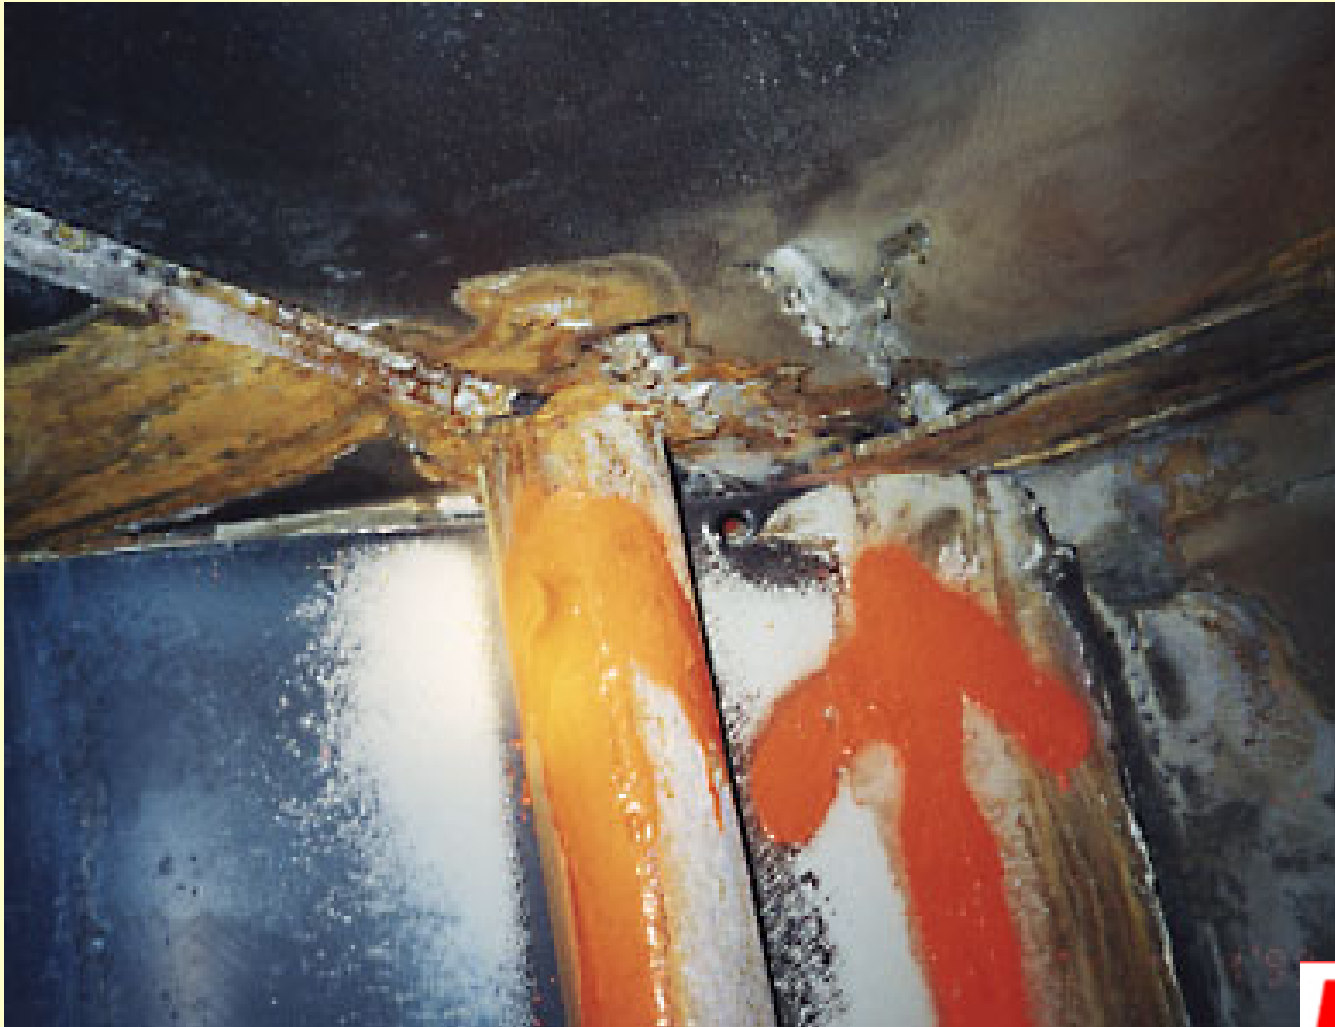
## Roof Corrosion Due to Water Standing for a Long Period of Time

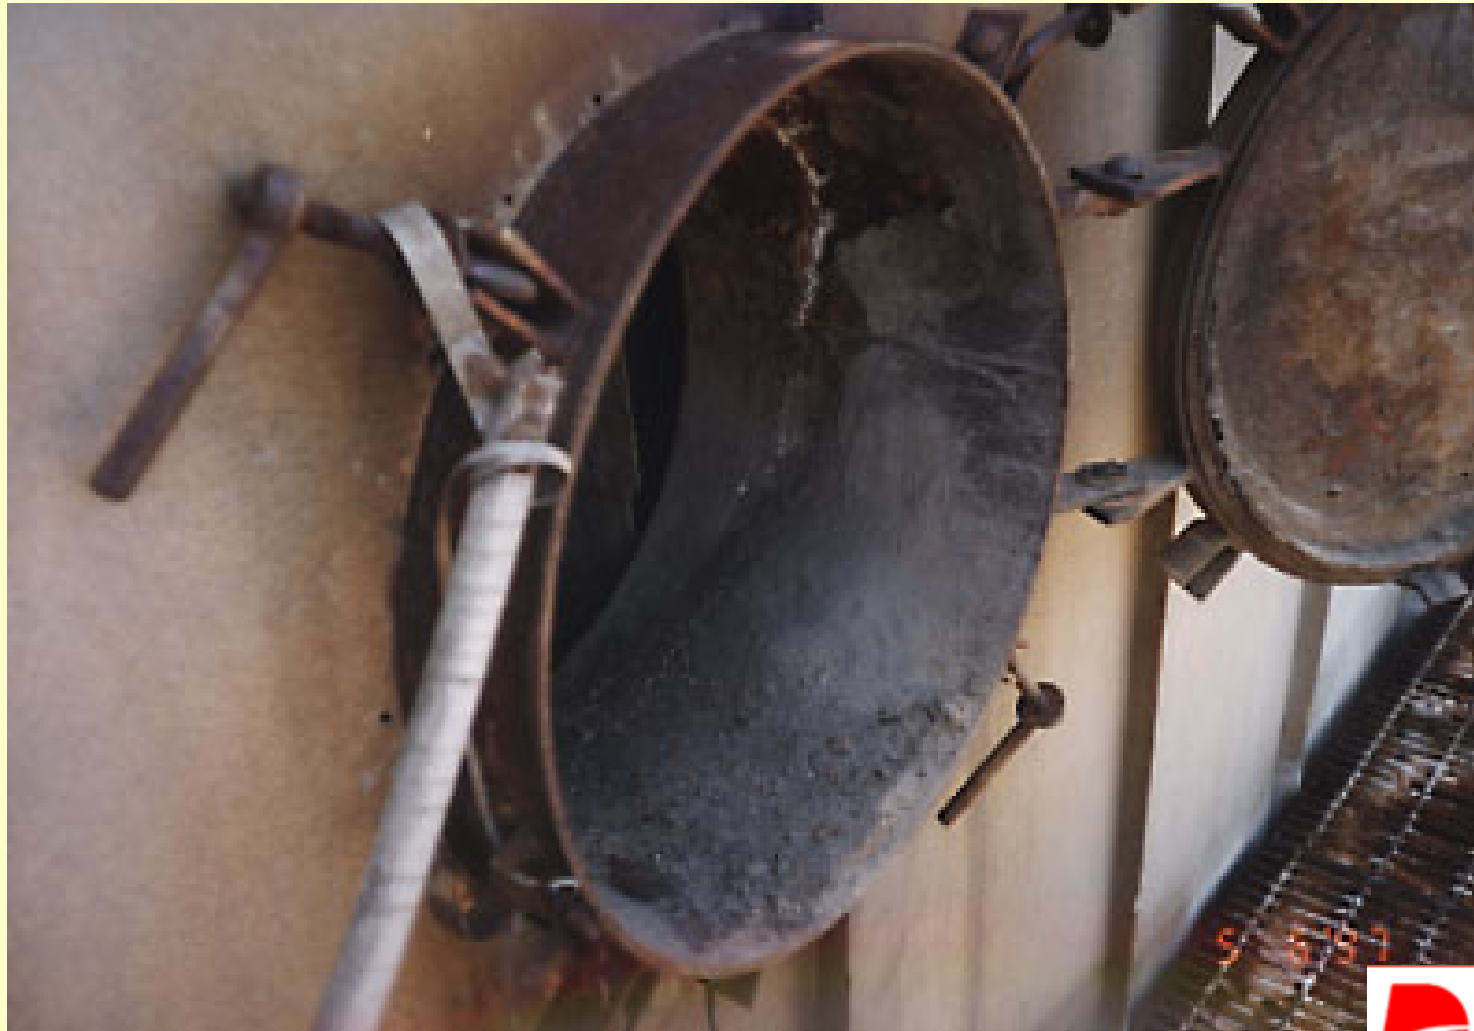
## Corrosion Around Access Door

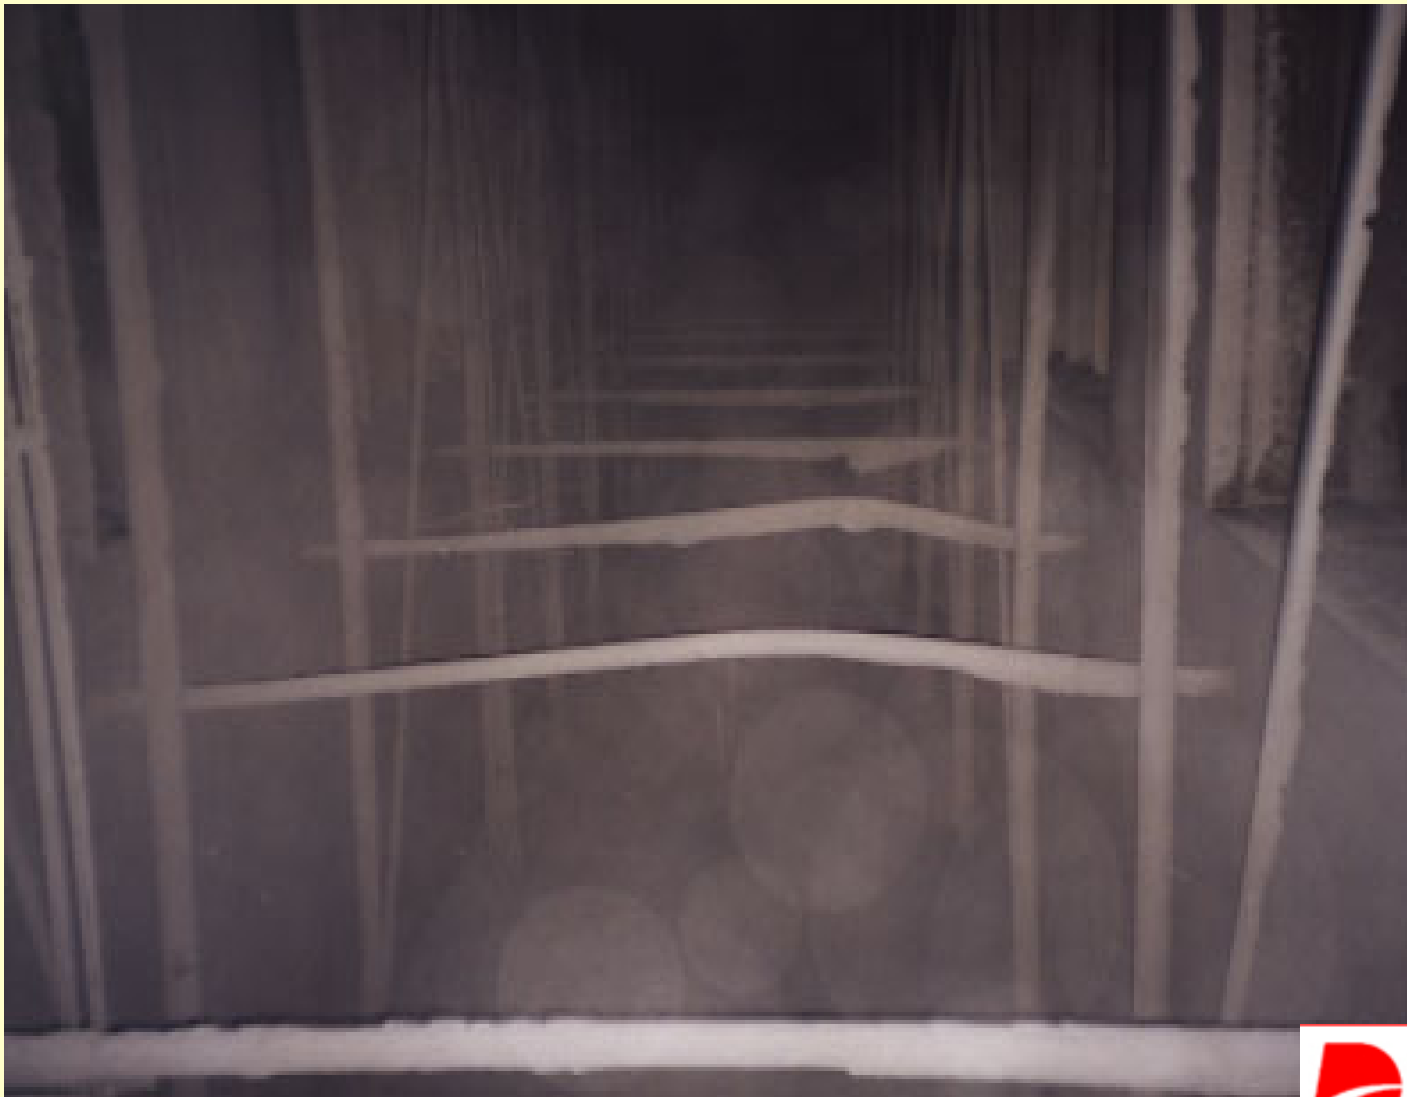
## Structural Component Bowing due to Thermal Stress

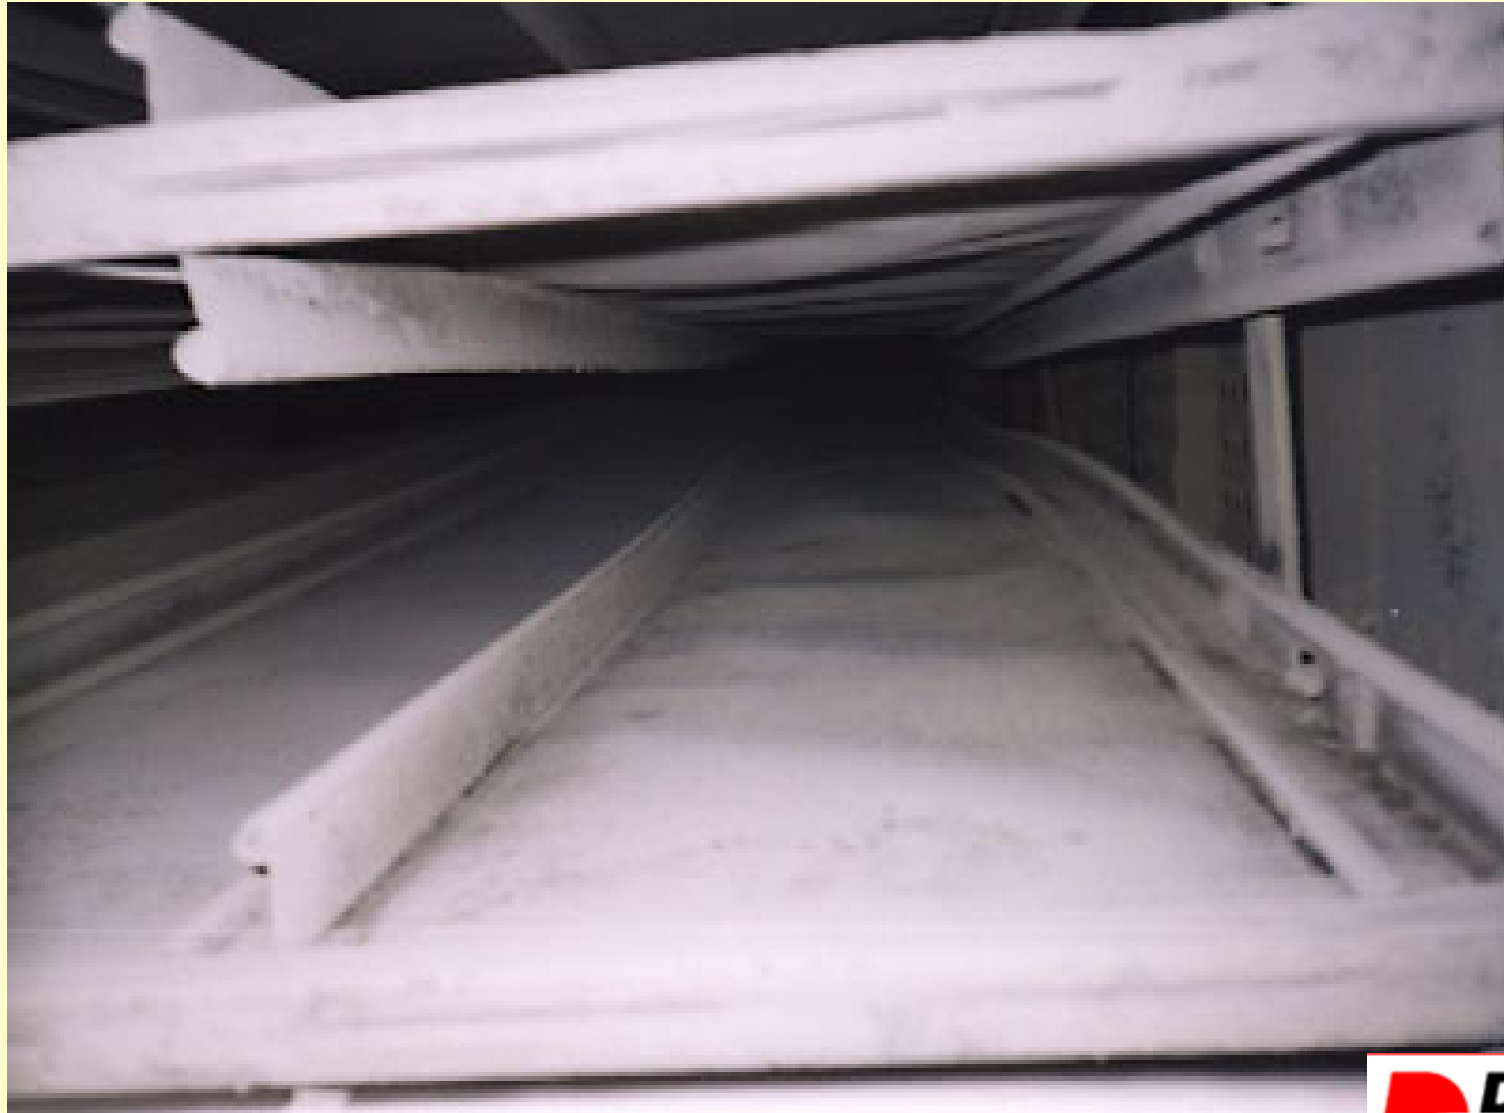
## Plate Bowing Due to Thermal Fatigue
