# Worldwide Pollution Control Association

**Ameren Seminar**  
**August 19–20, 2008**  
**Effingham, IL**

# Precipitator Maintenance and Operations

By Scott Williams

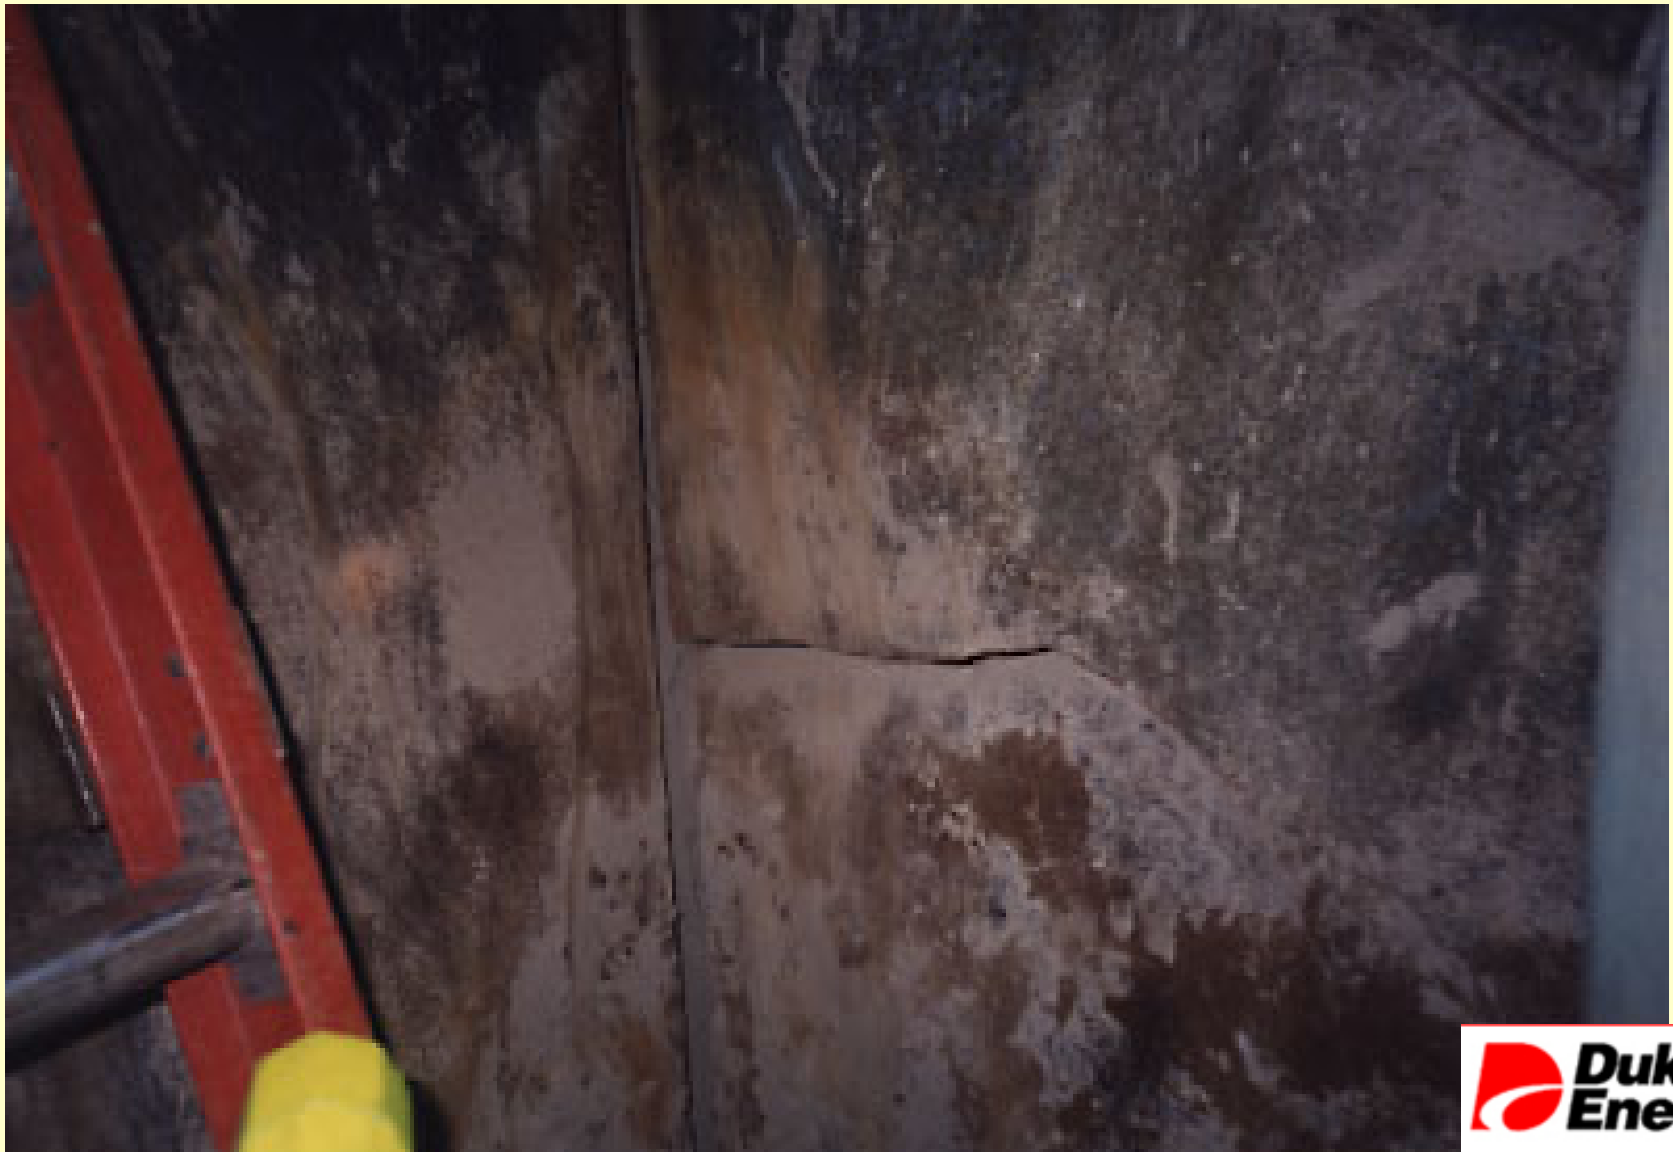
## Thermal Stress Crack in Casing

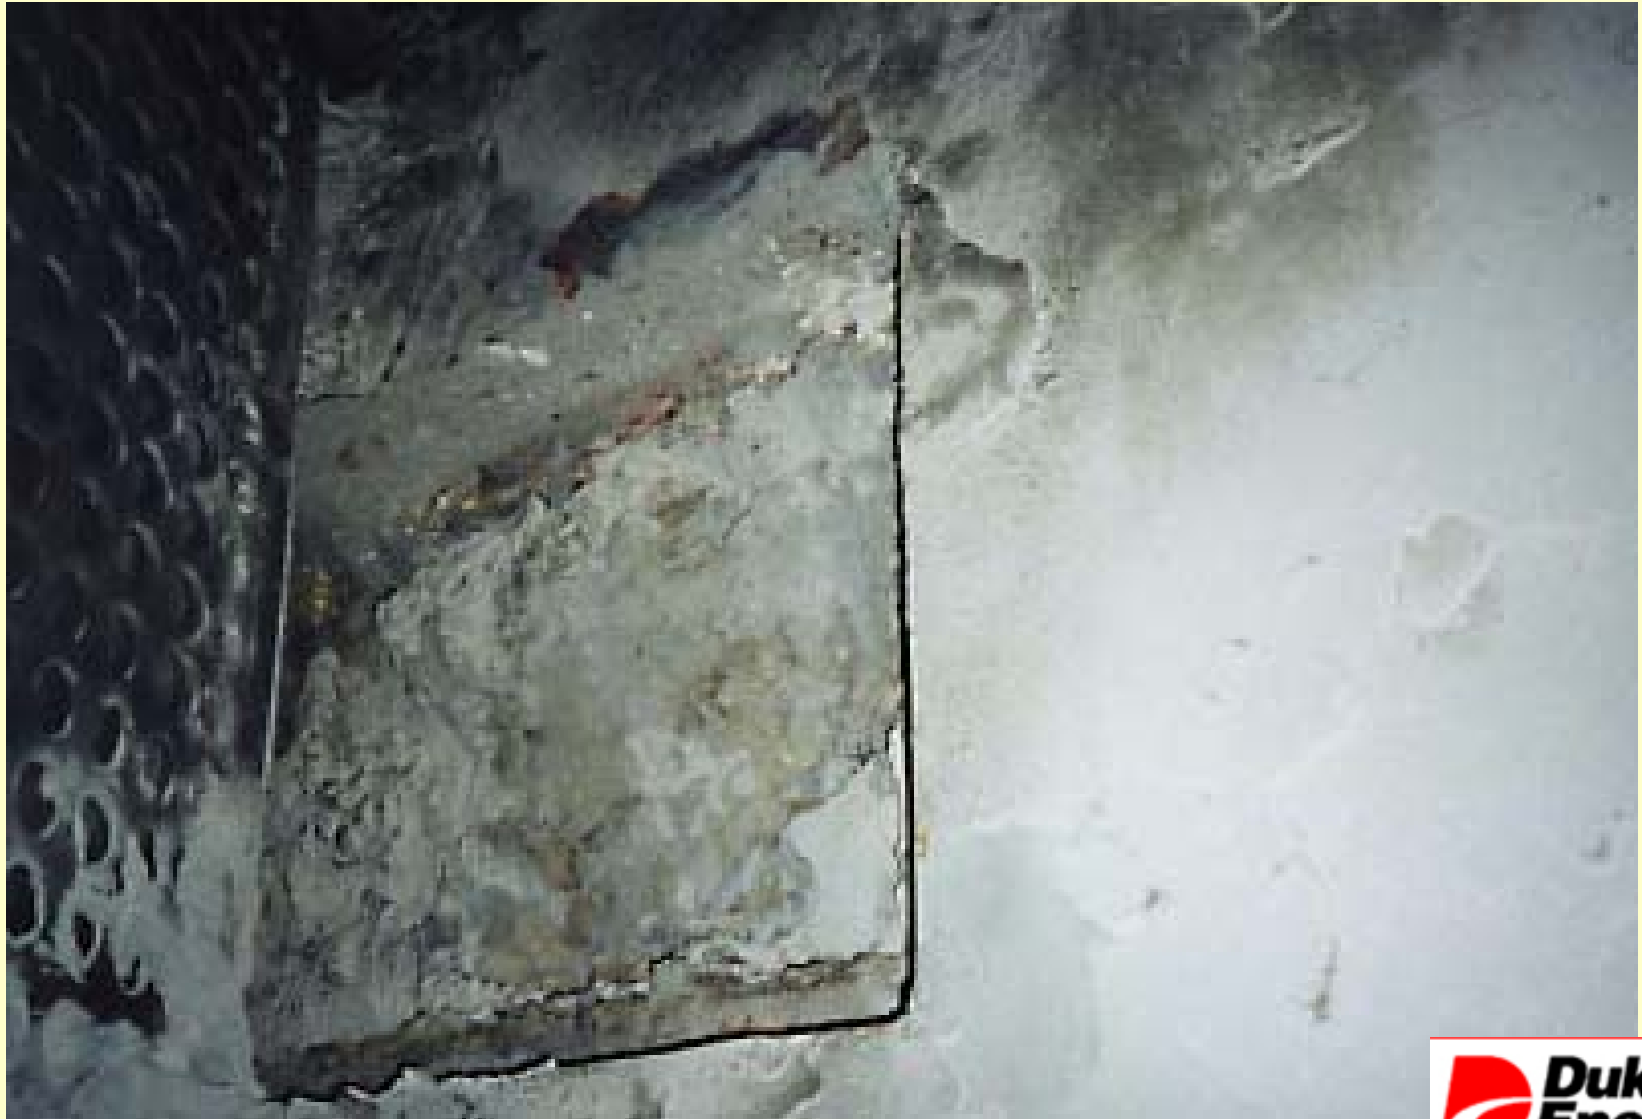
## Center Wall Cracking

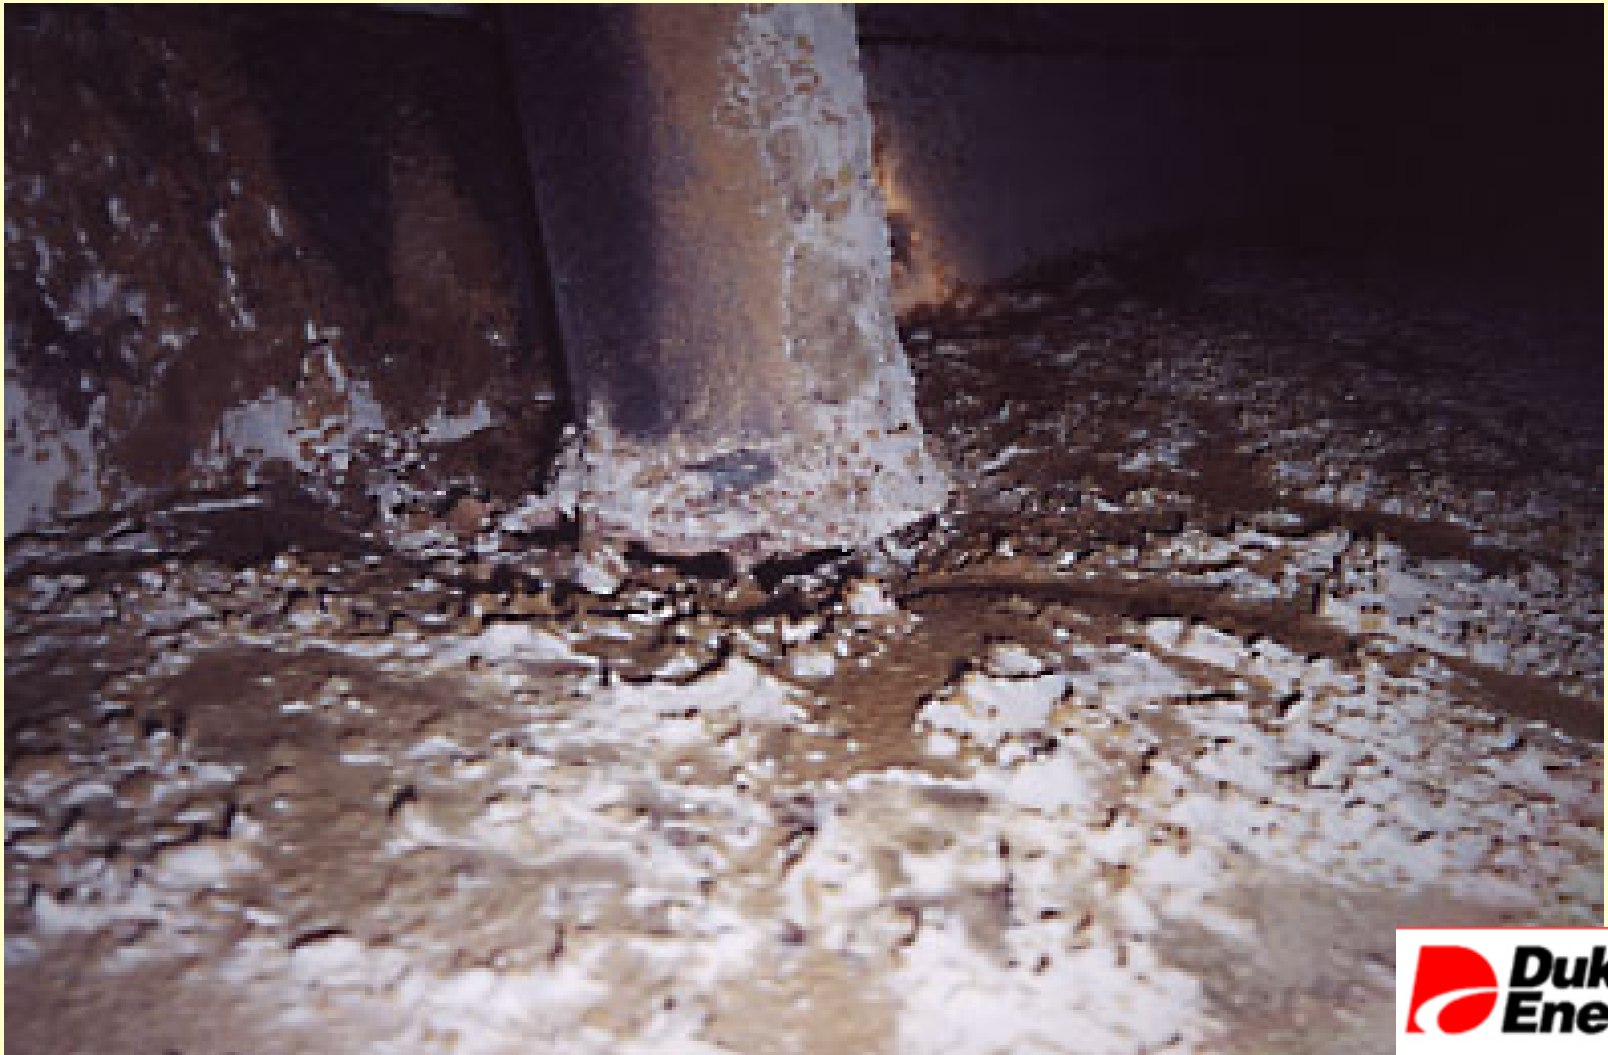
## Thermal Fatigue Cracking At Turning Vane Support

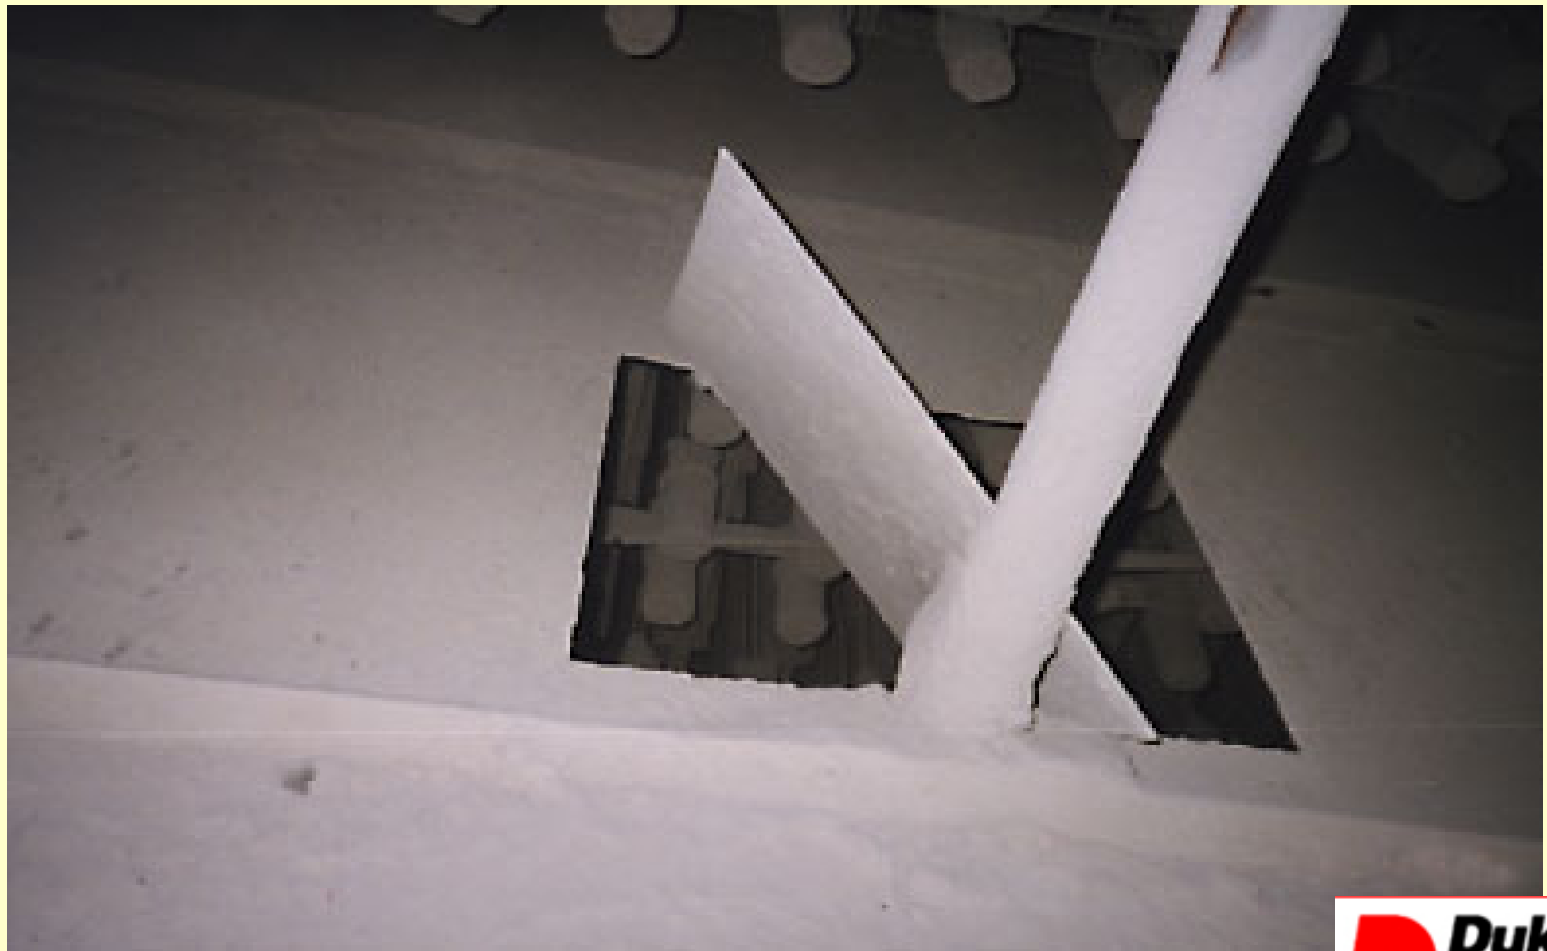
Hopper Baffle Door- This causes increased opacity

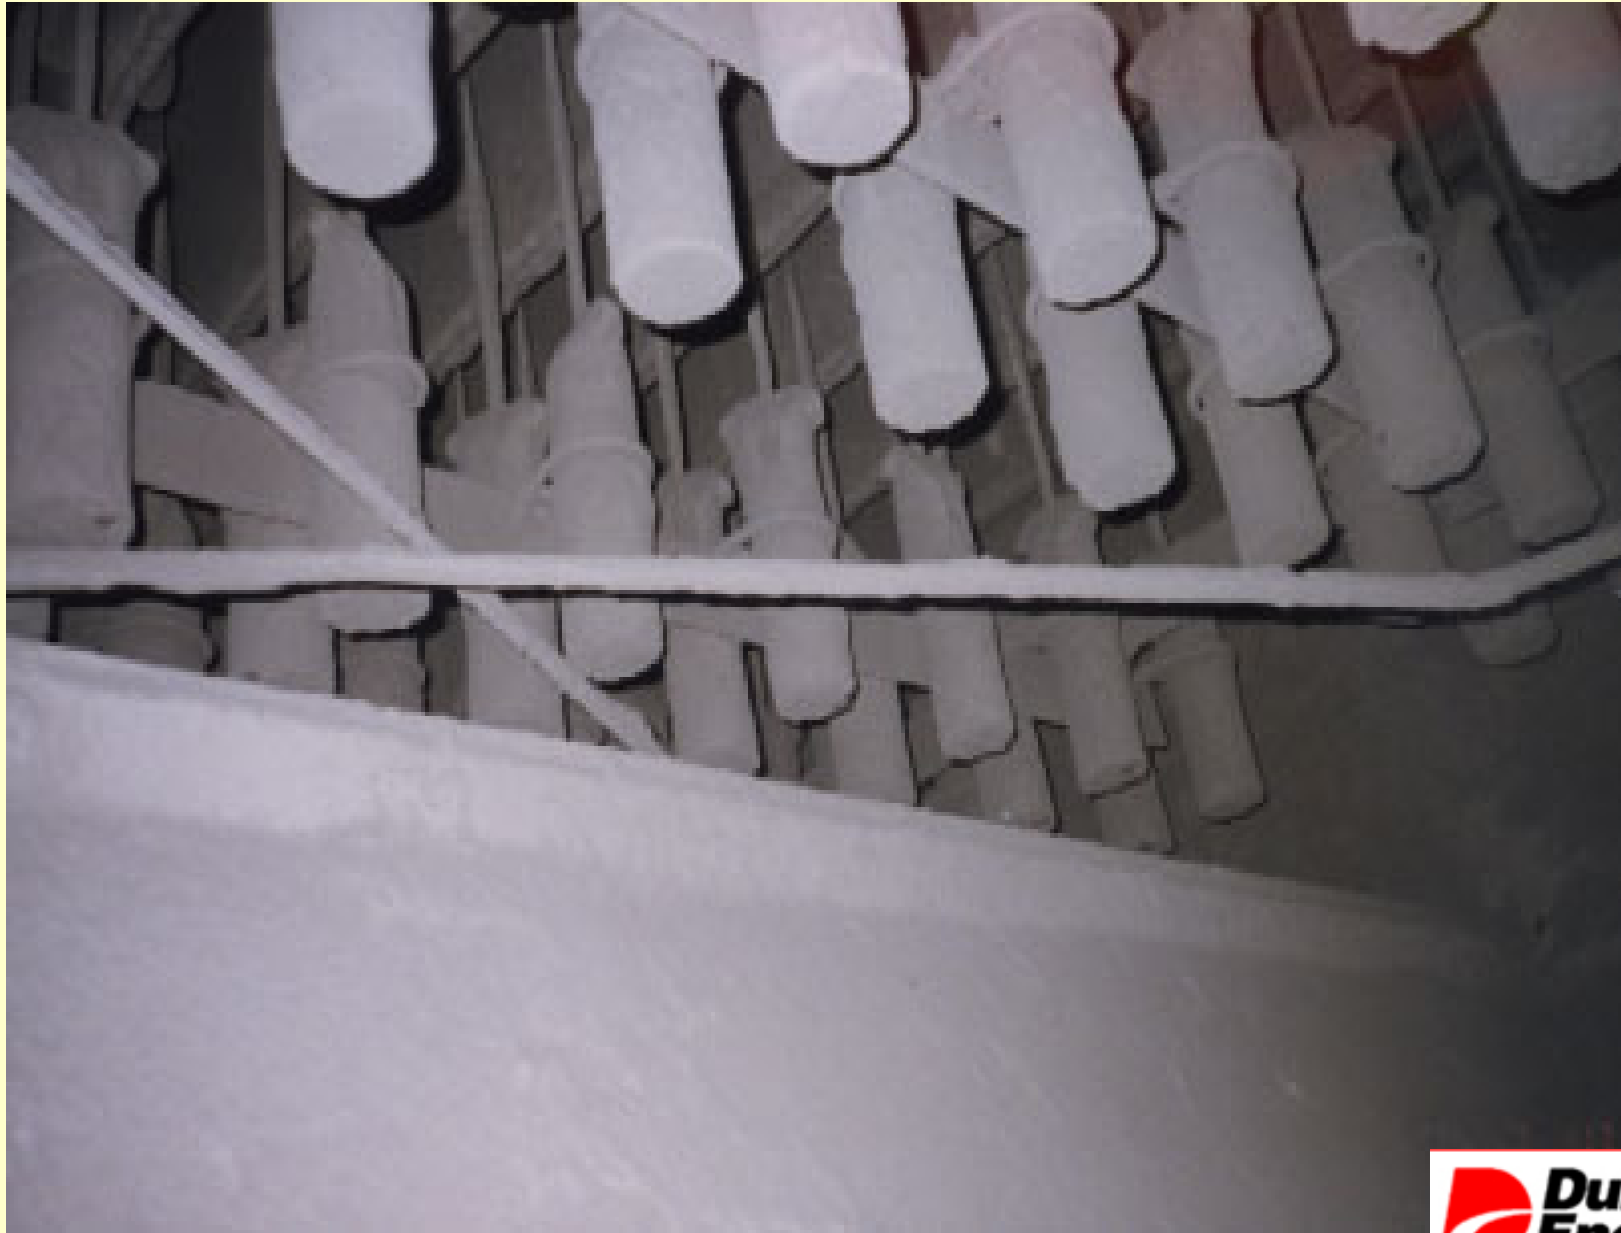
## Bent Structural Cross Bracing

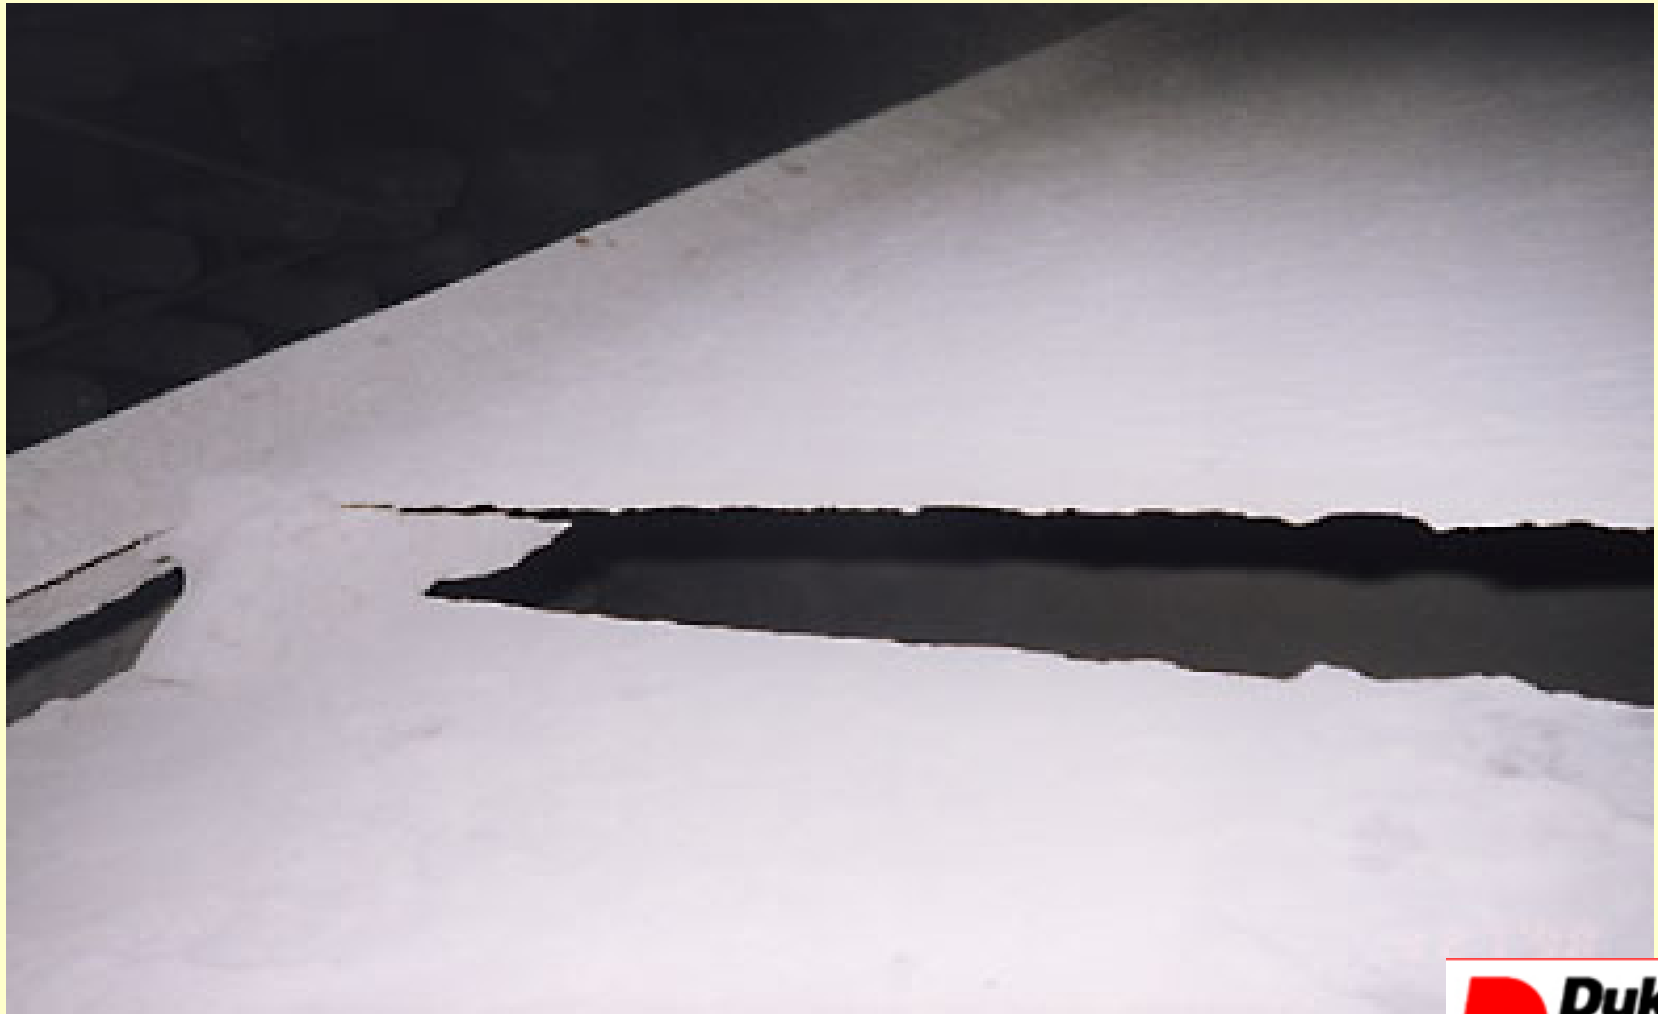
Baffle Component Failure- Gas will bypass the baffle

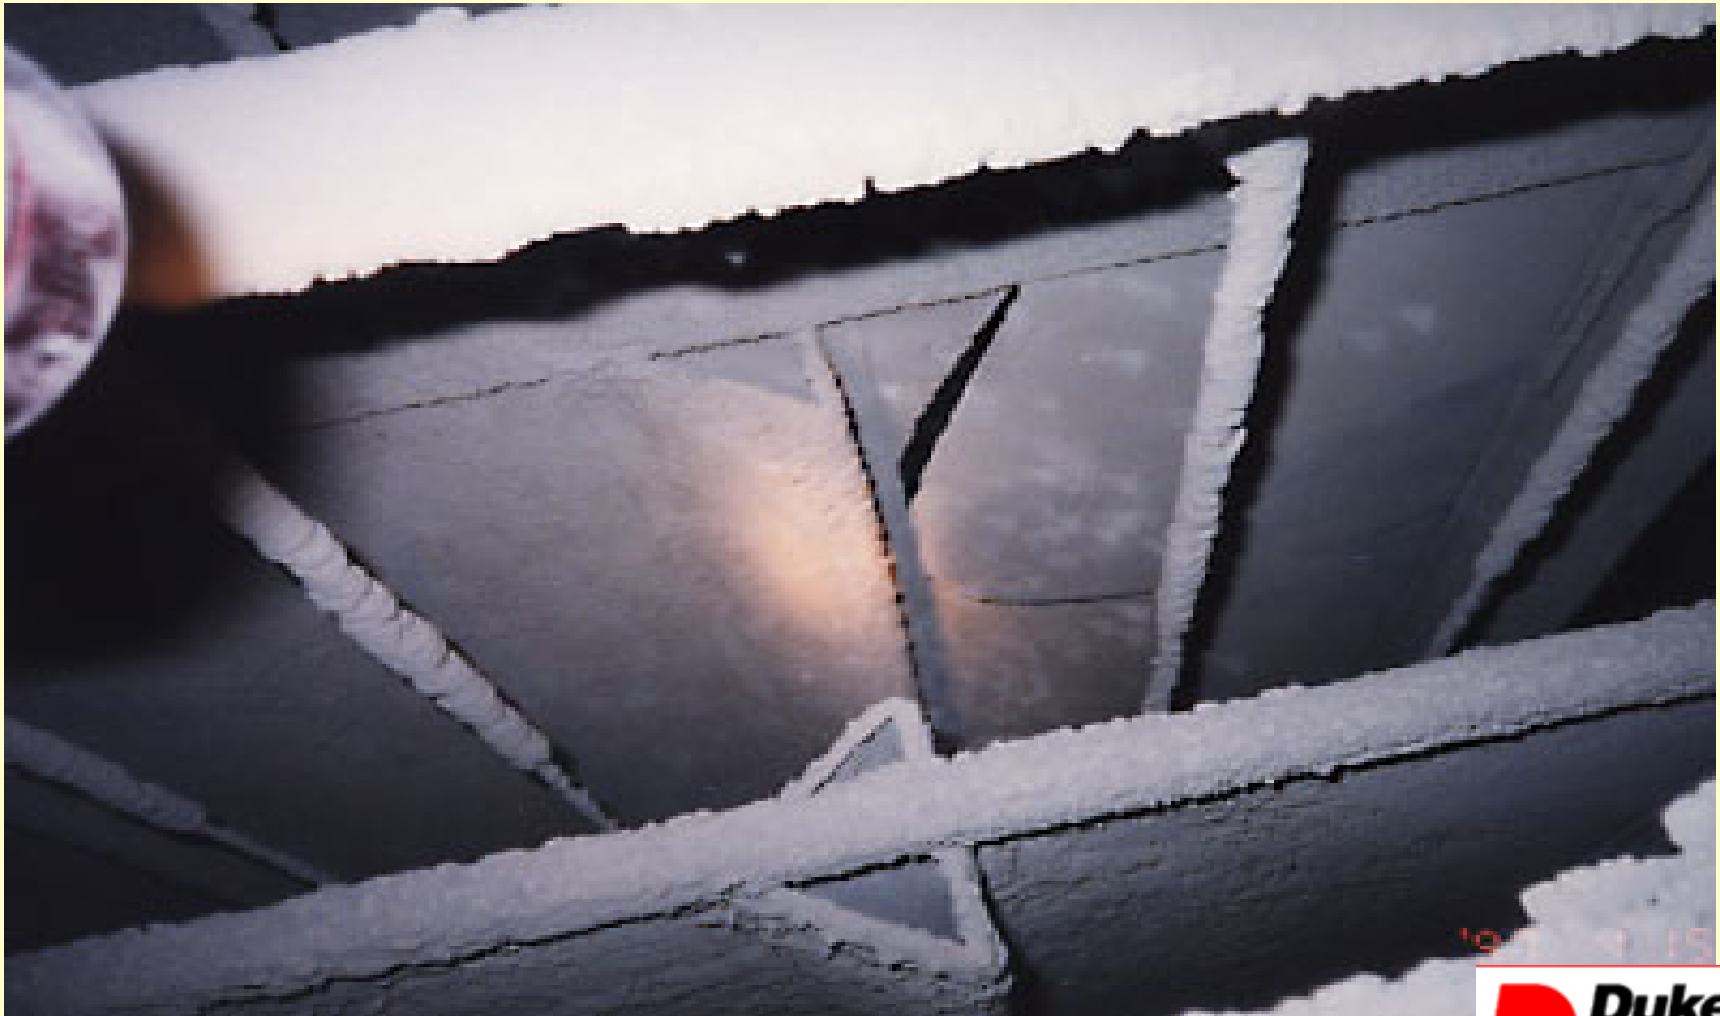
## Cracked Plate- Mechanical Stress

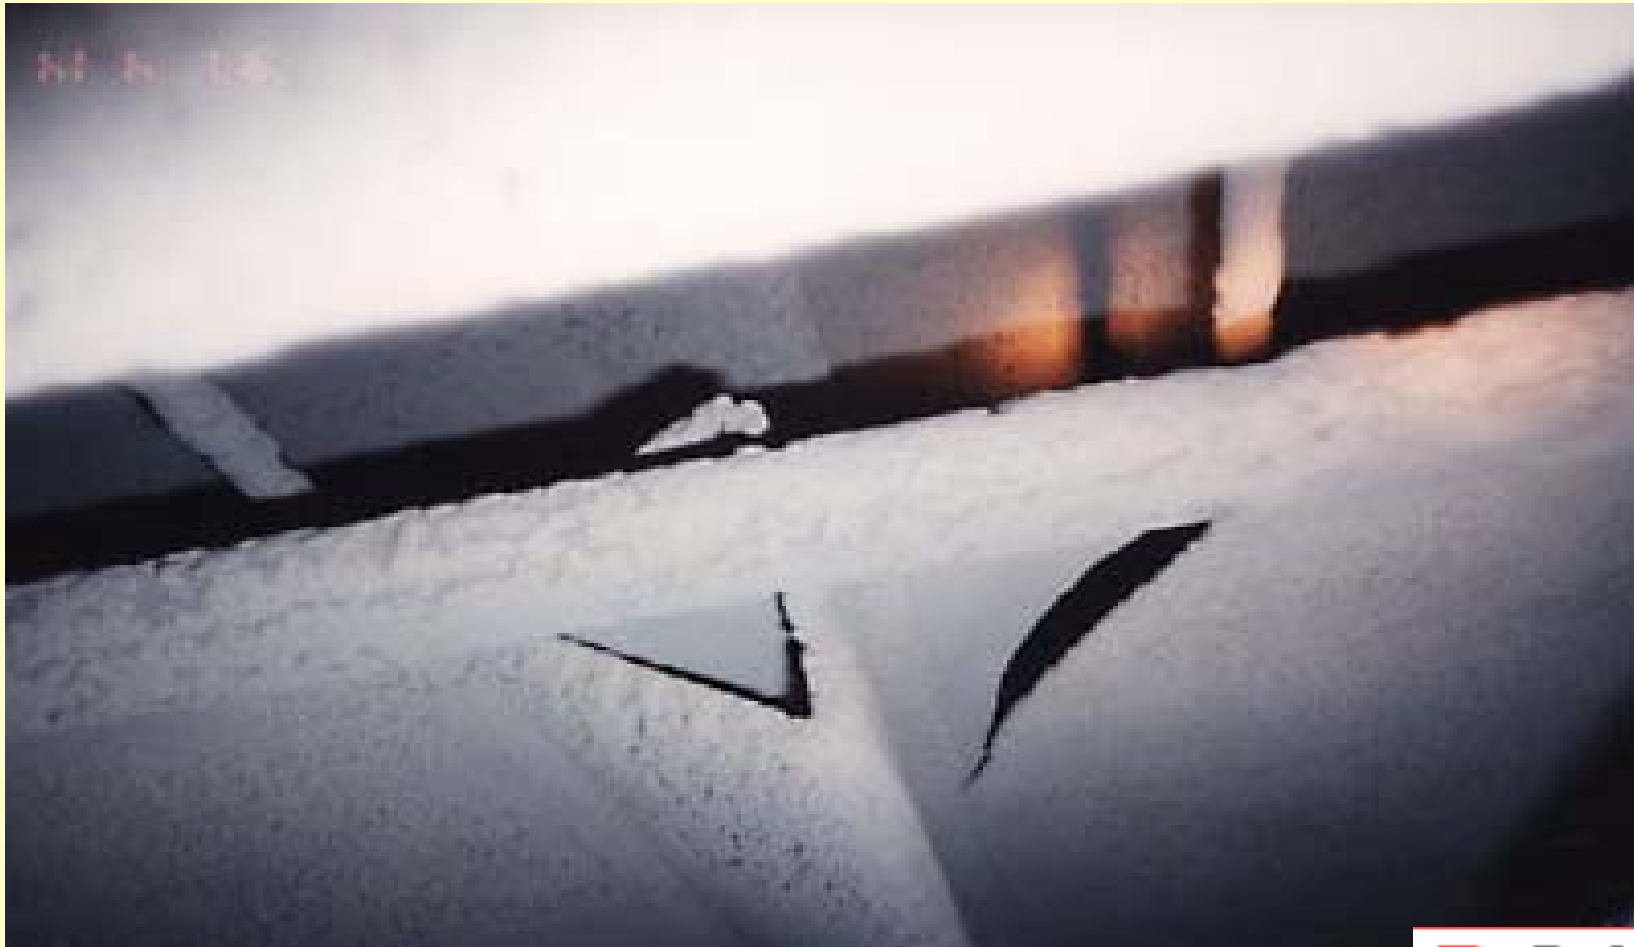
## Crack Plate

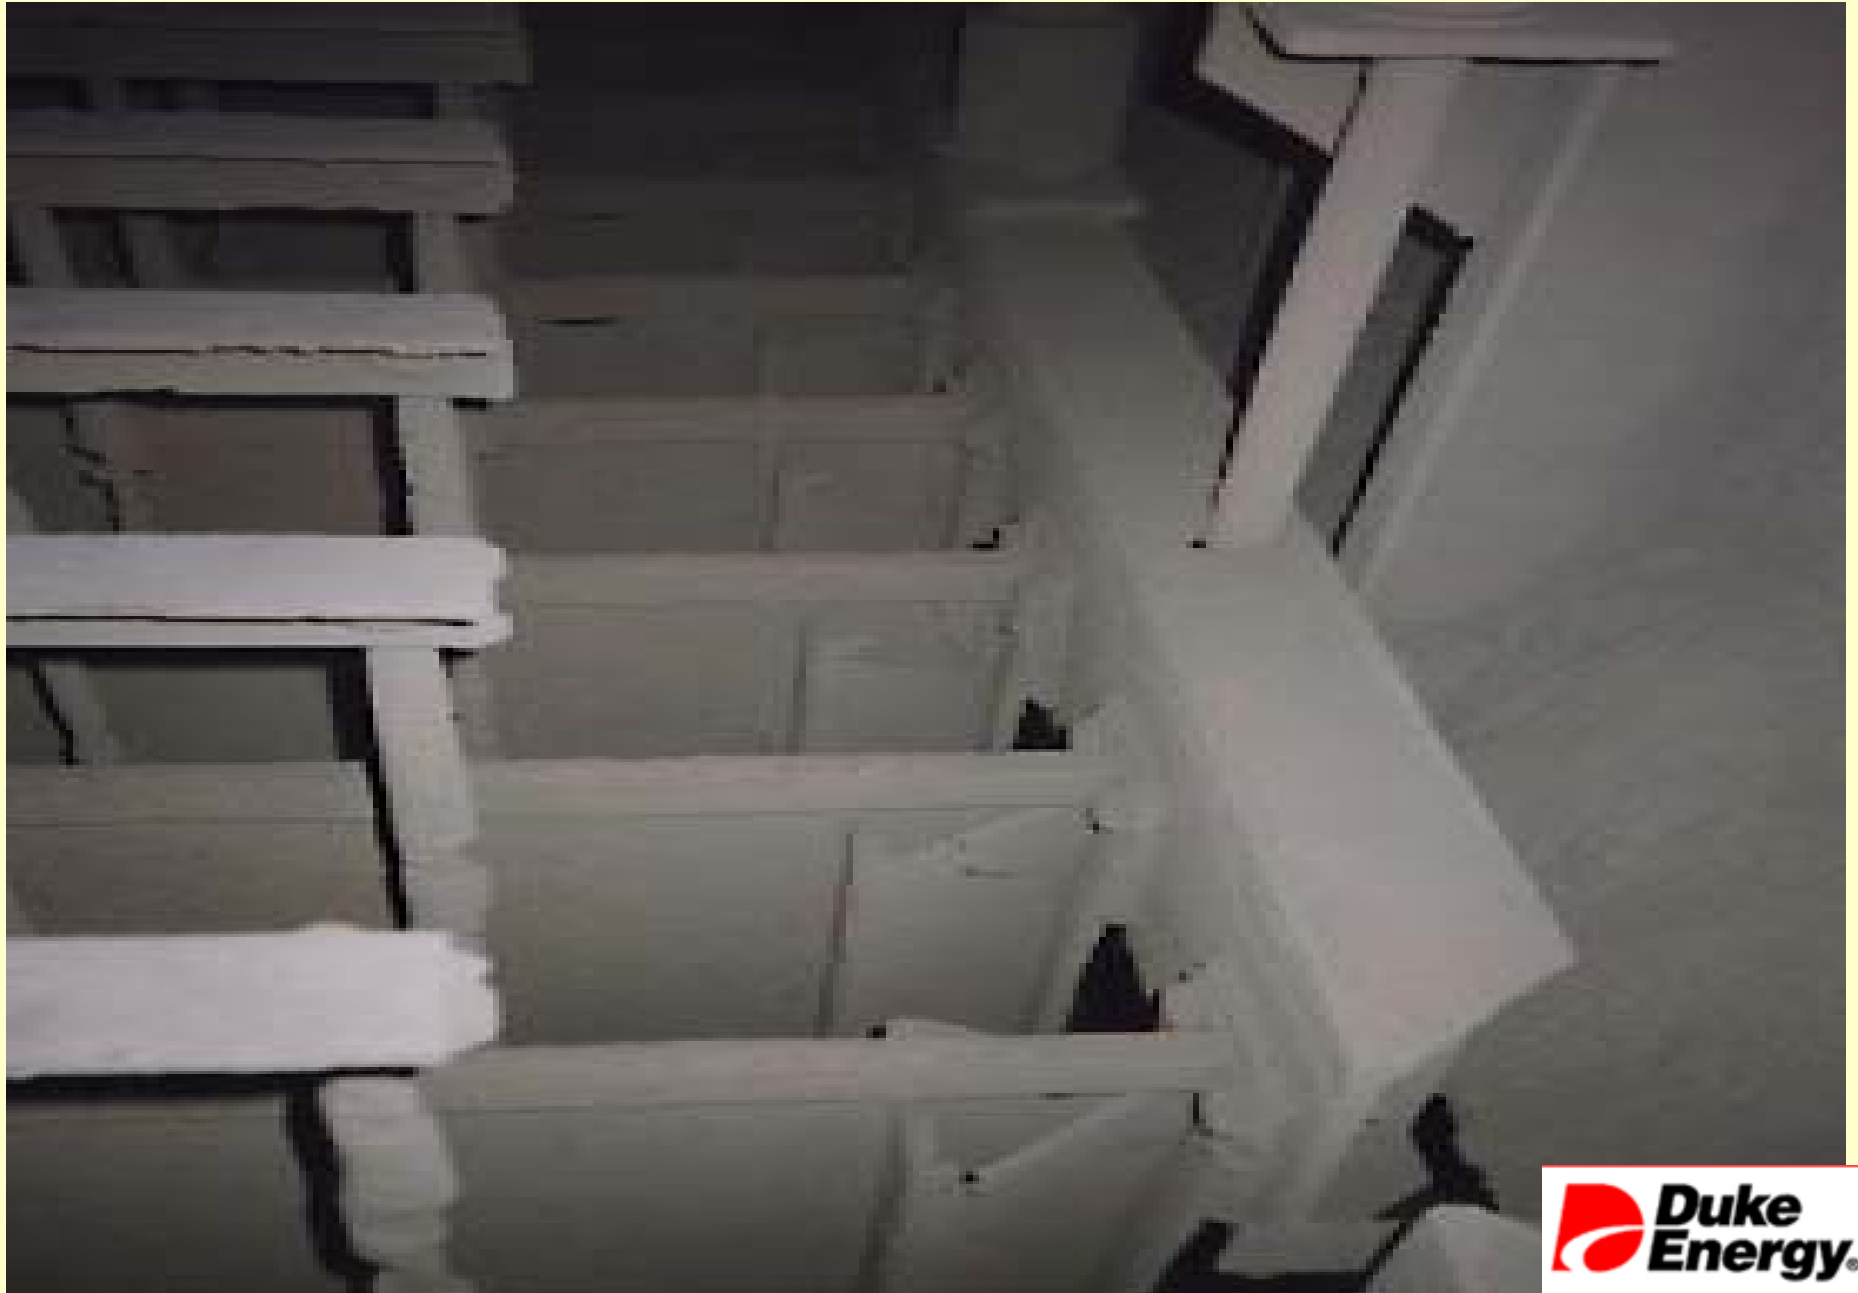
## Crack Plate Swords

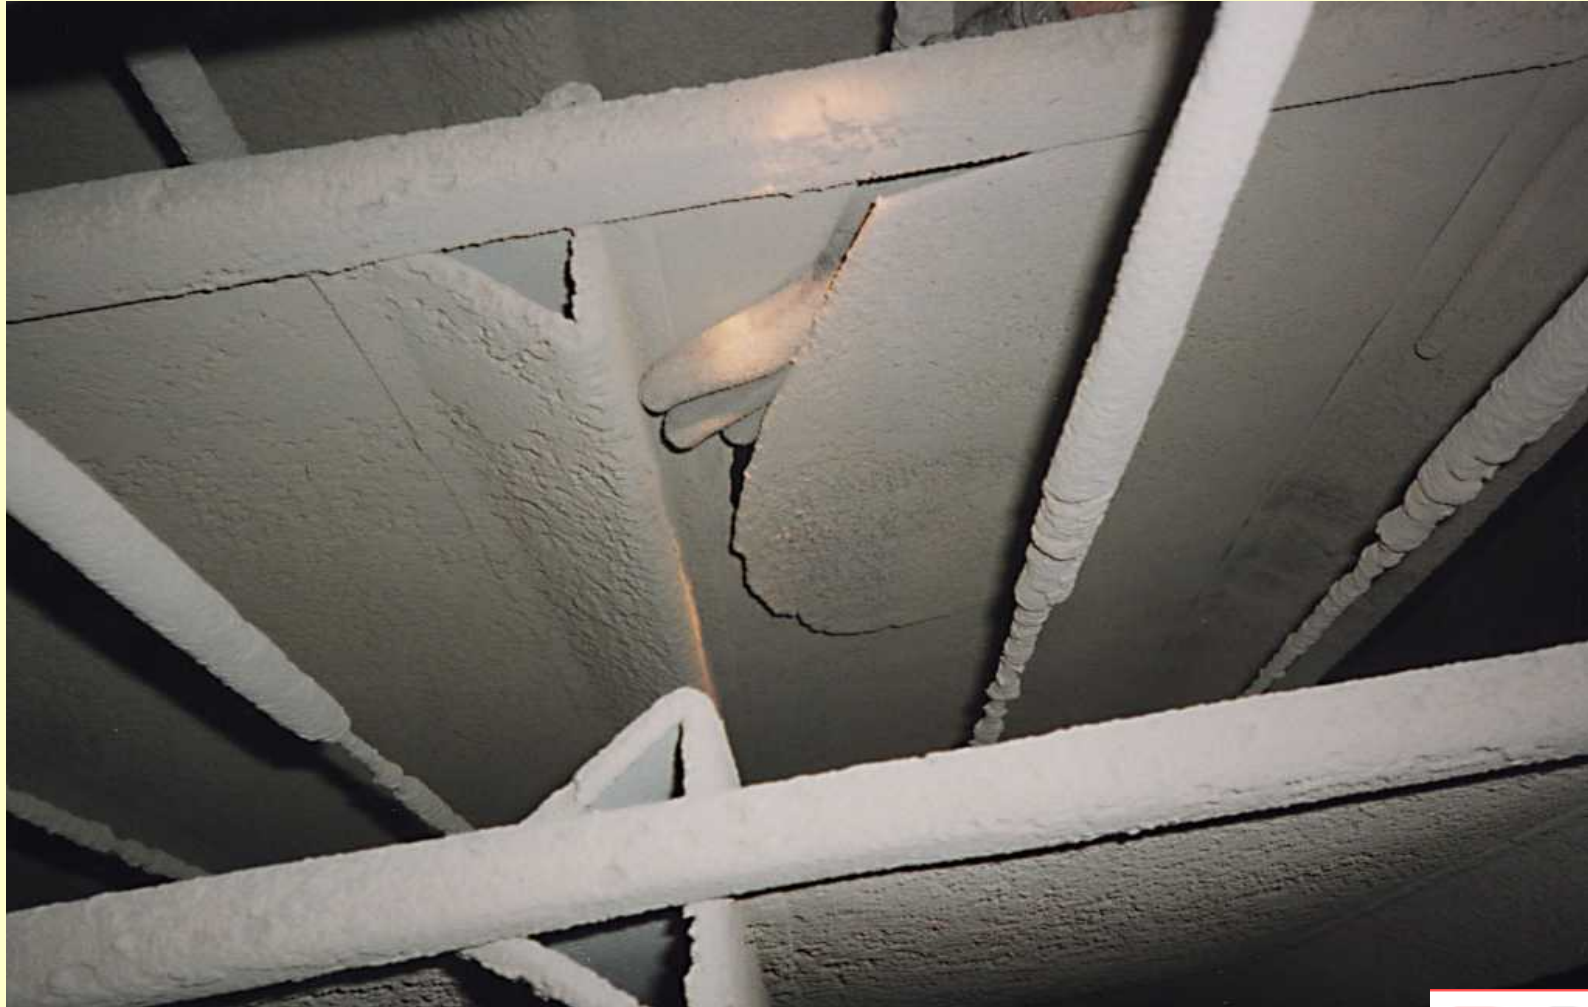
## Cracked Plate on top

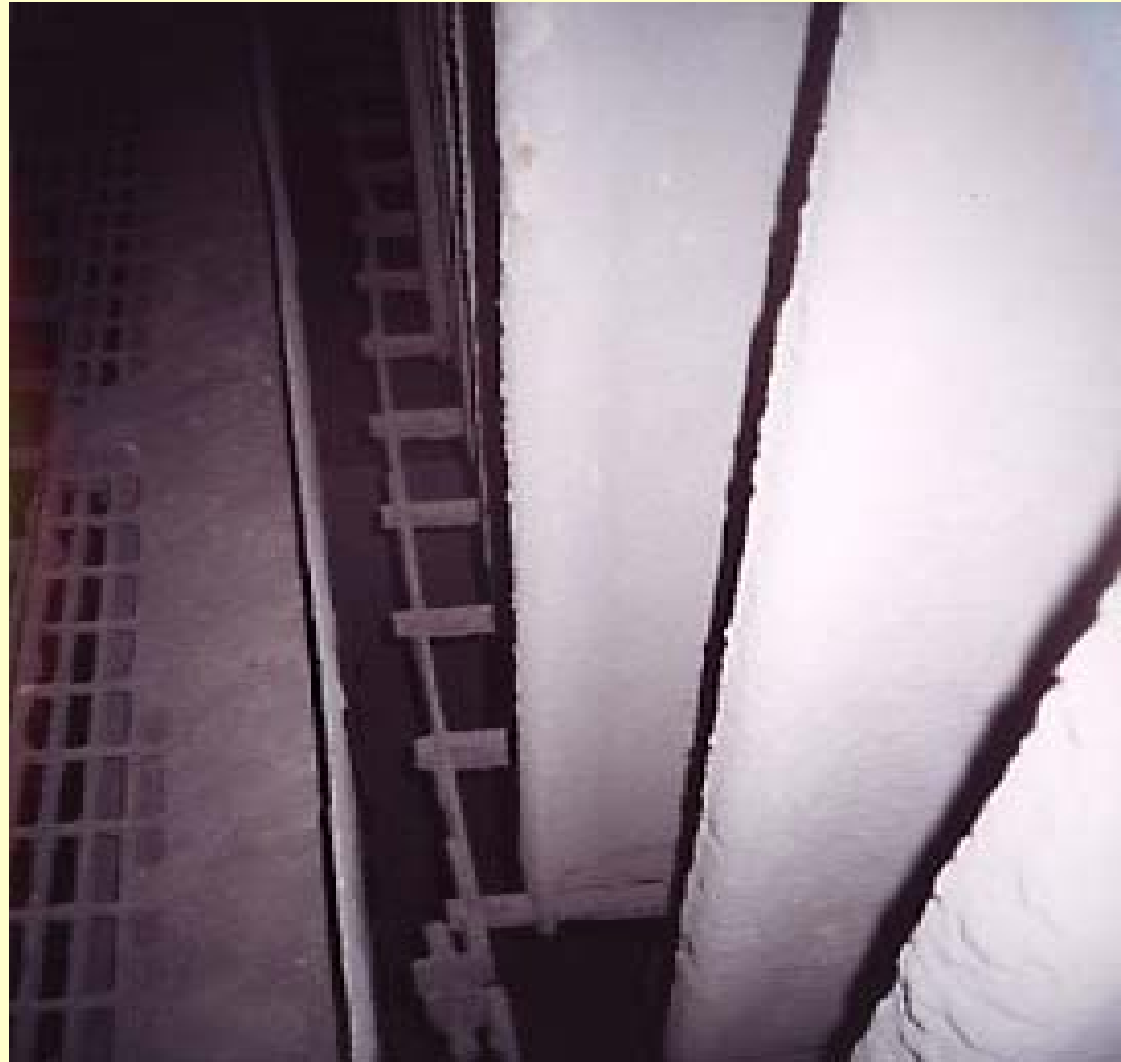
## Weld Failure At Top of Plate

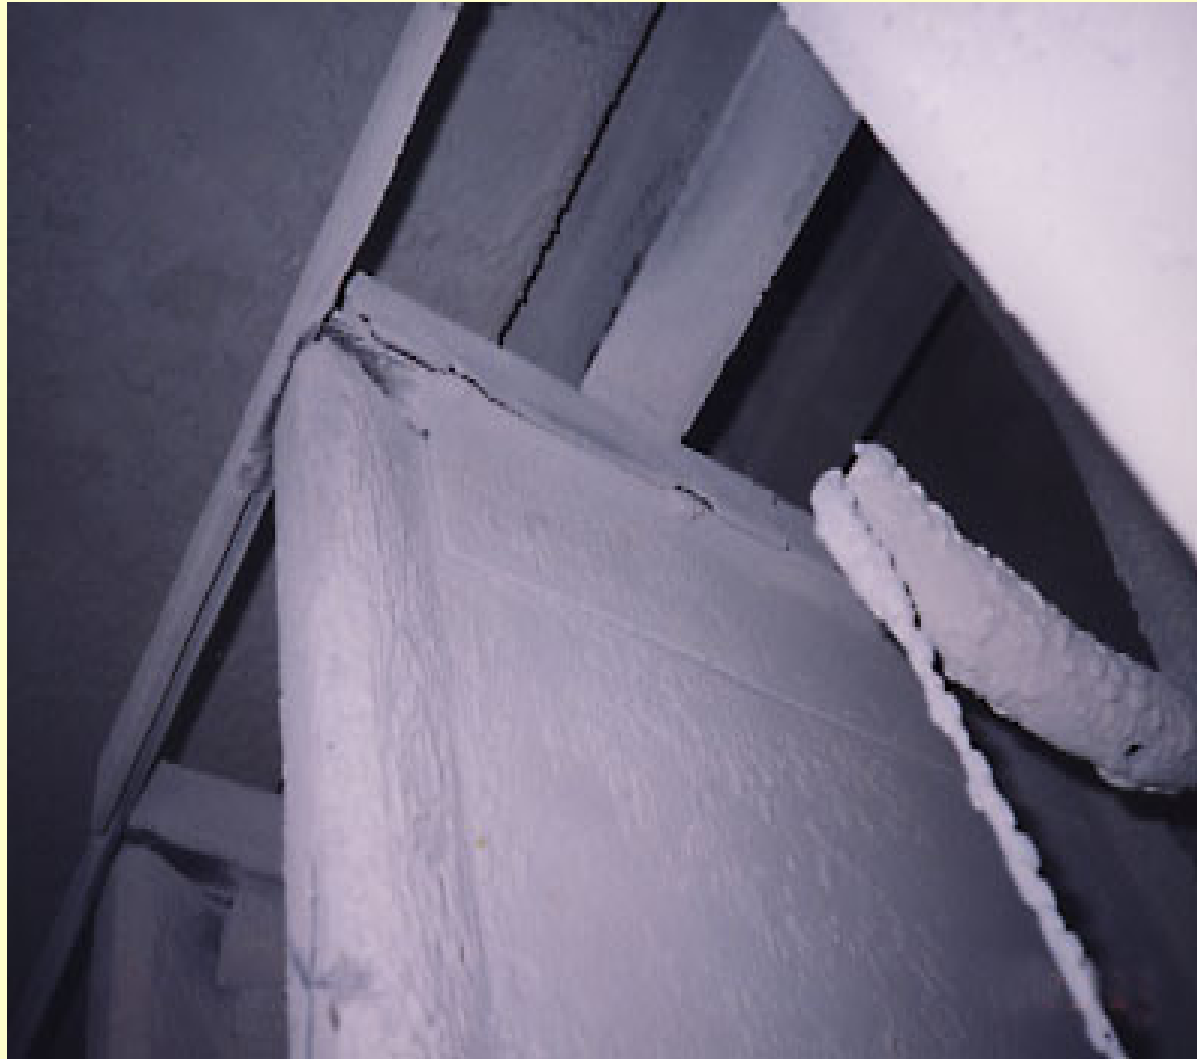
## Channel Cracking at Top of Plate

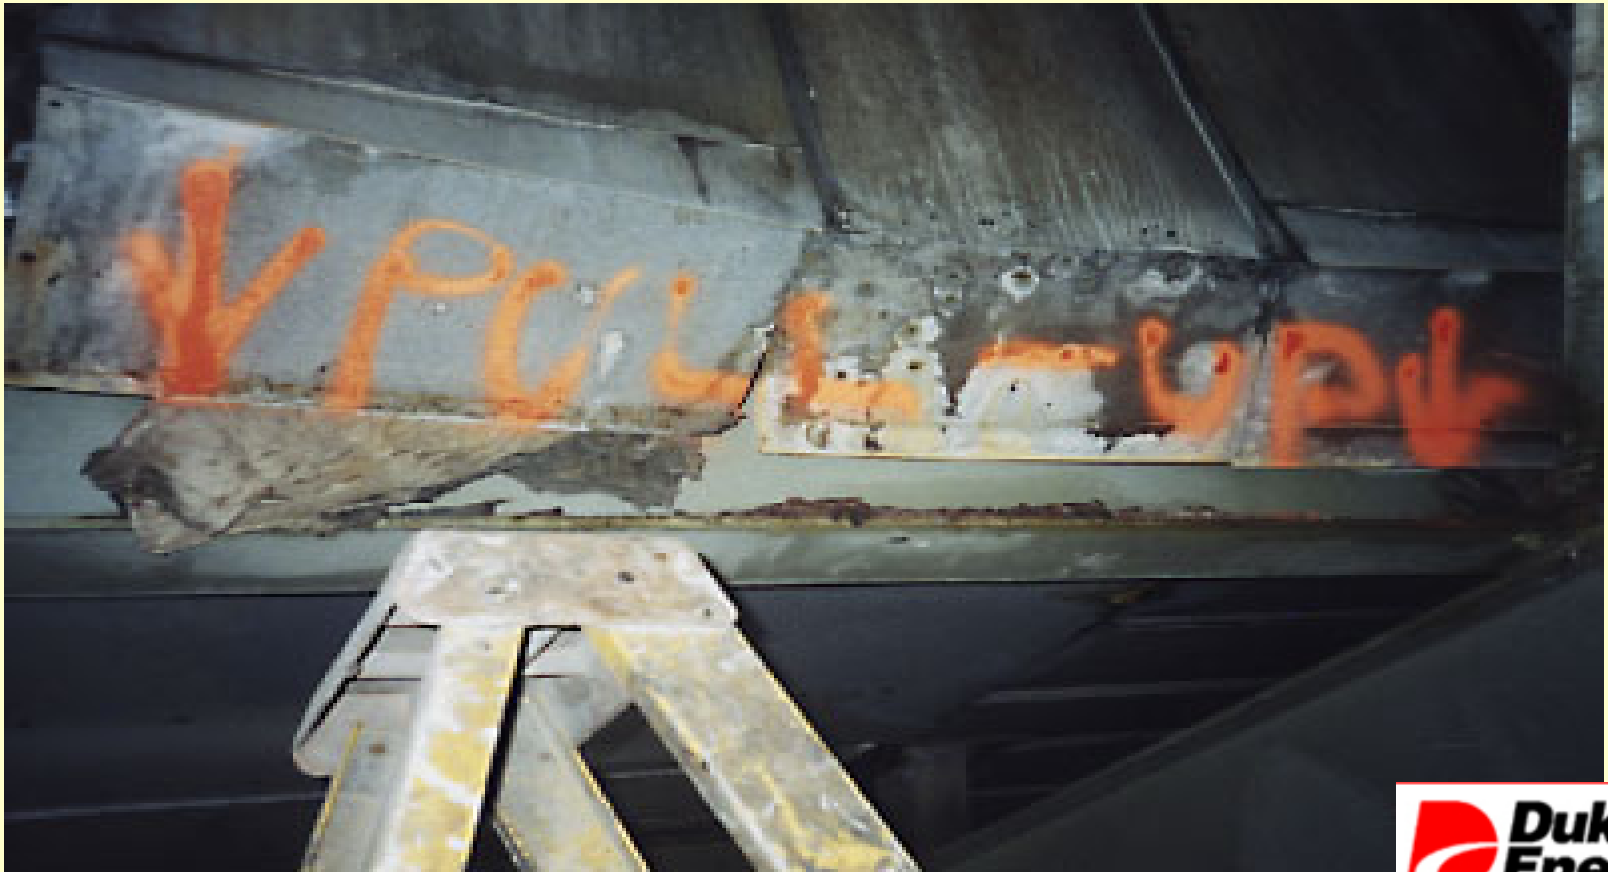
## Poor Insulation Can Promote Corrosion

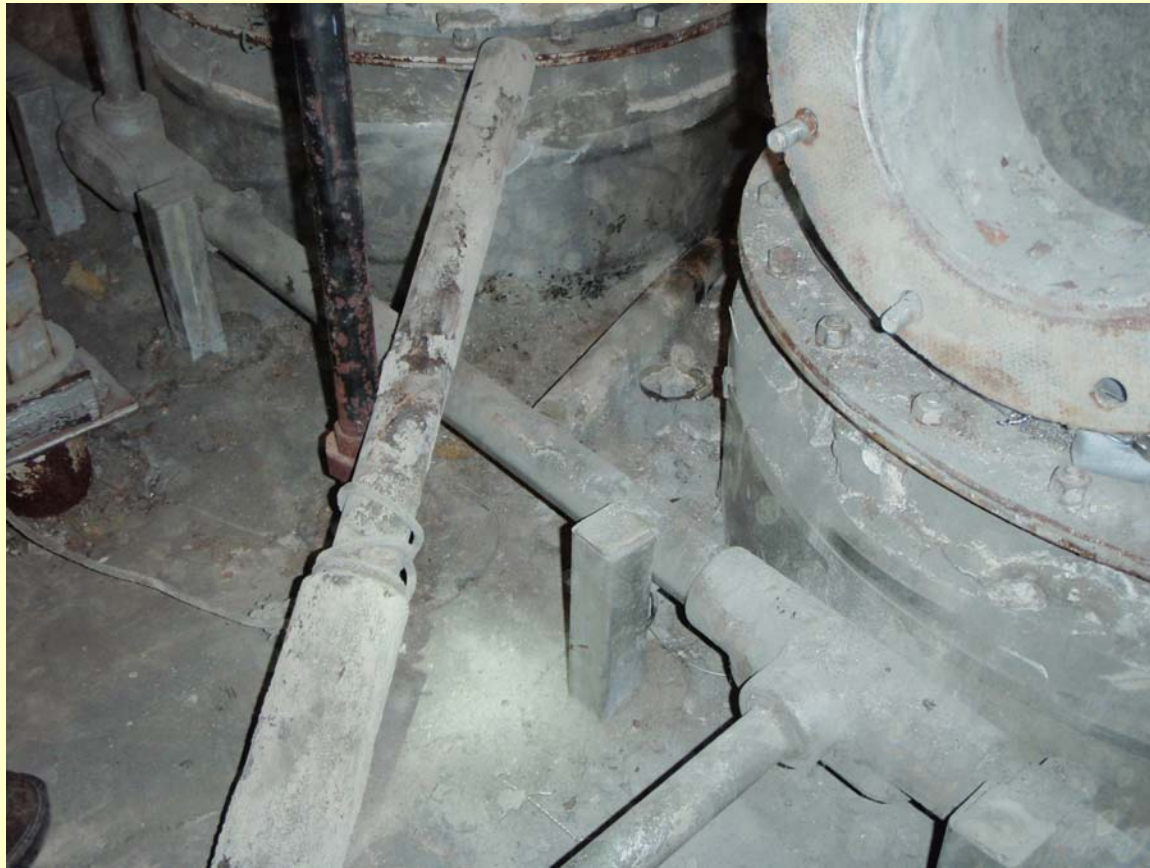
Broken rapper shaft fell down and touched wire and plate
