# Worldwide Pollution Control Association

**Ameren Seminar**  
**August 19–20, 2008**  
**Effingham, IL**

# Precipitator Maintenance and Operations

By Scott Williams

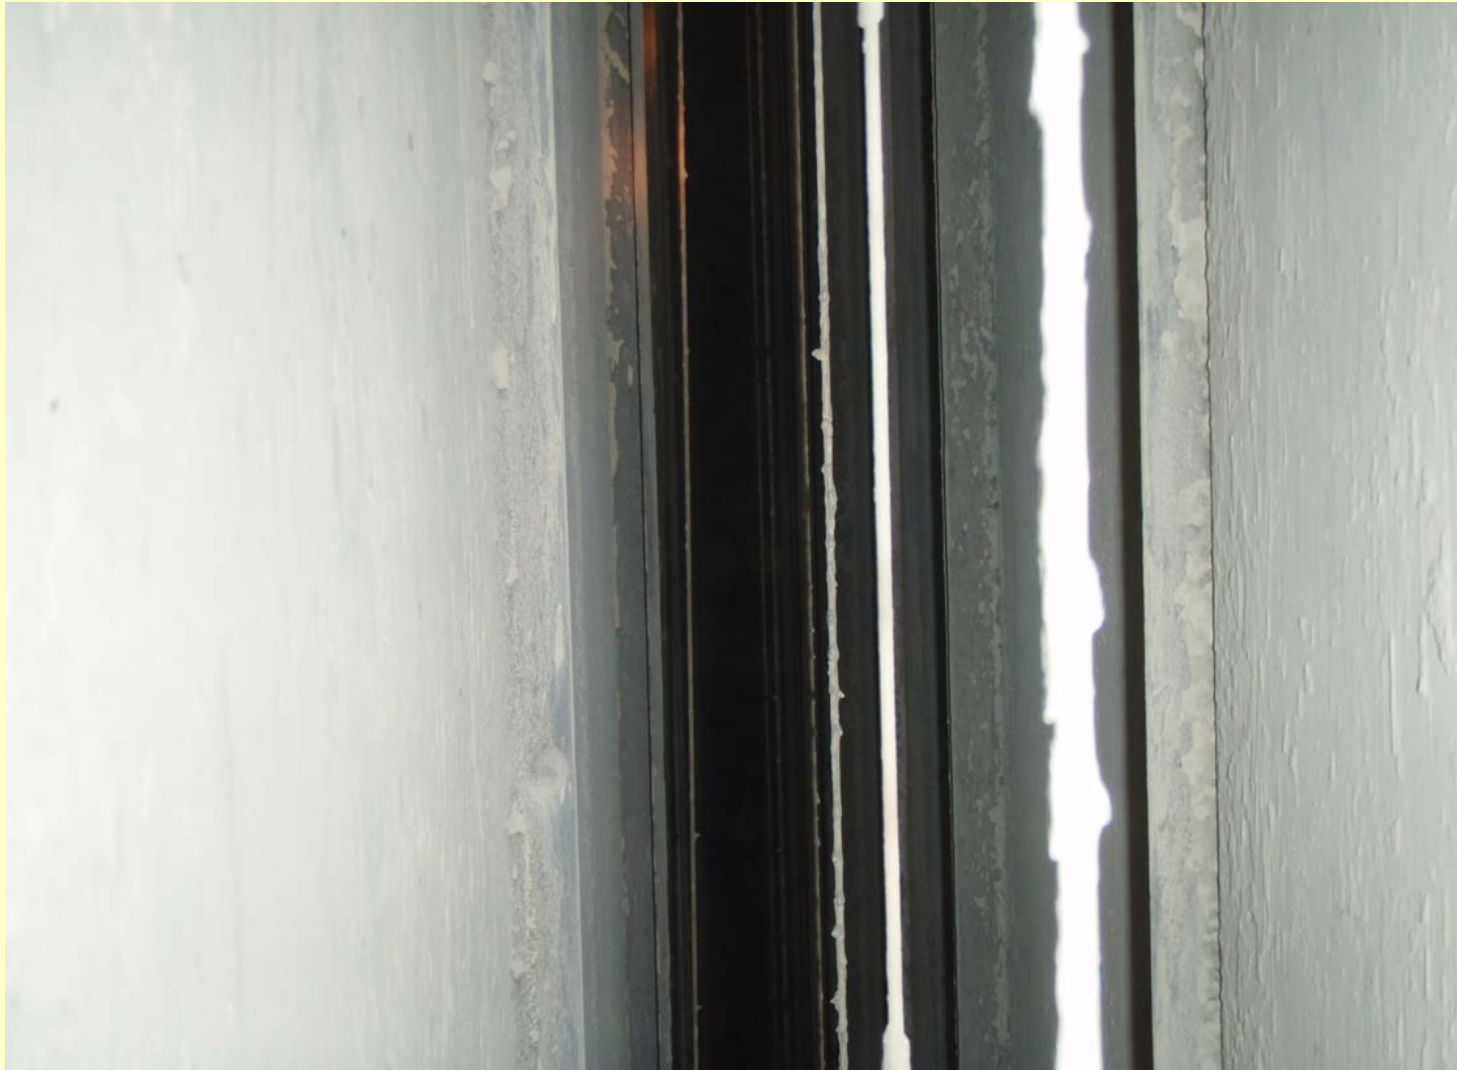
# Wire touching plate

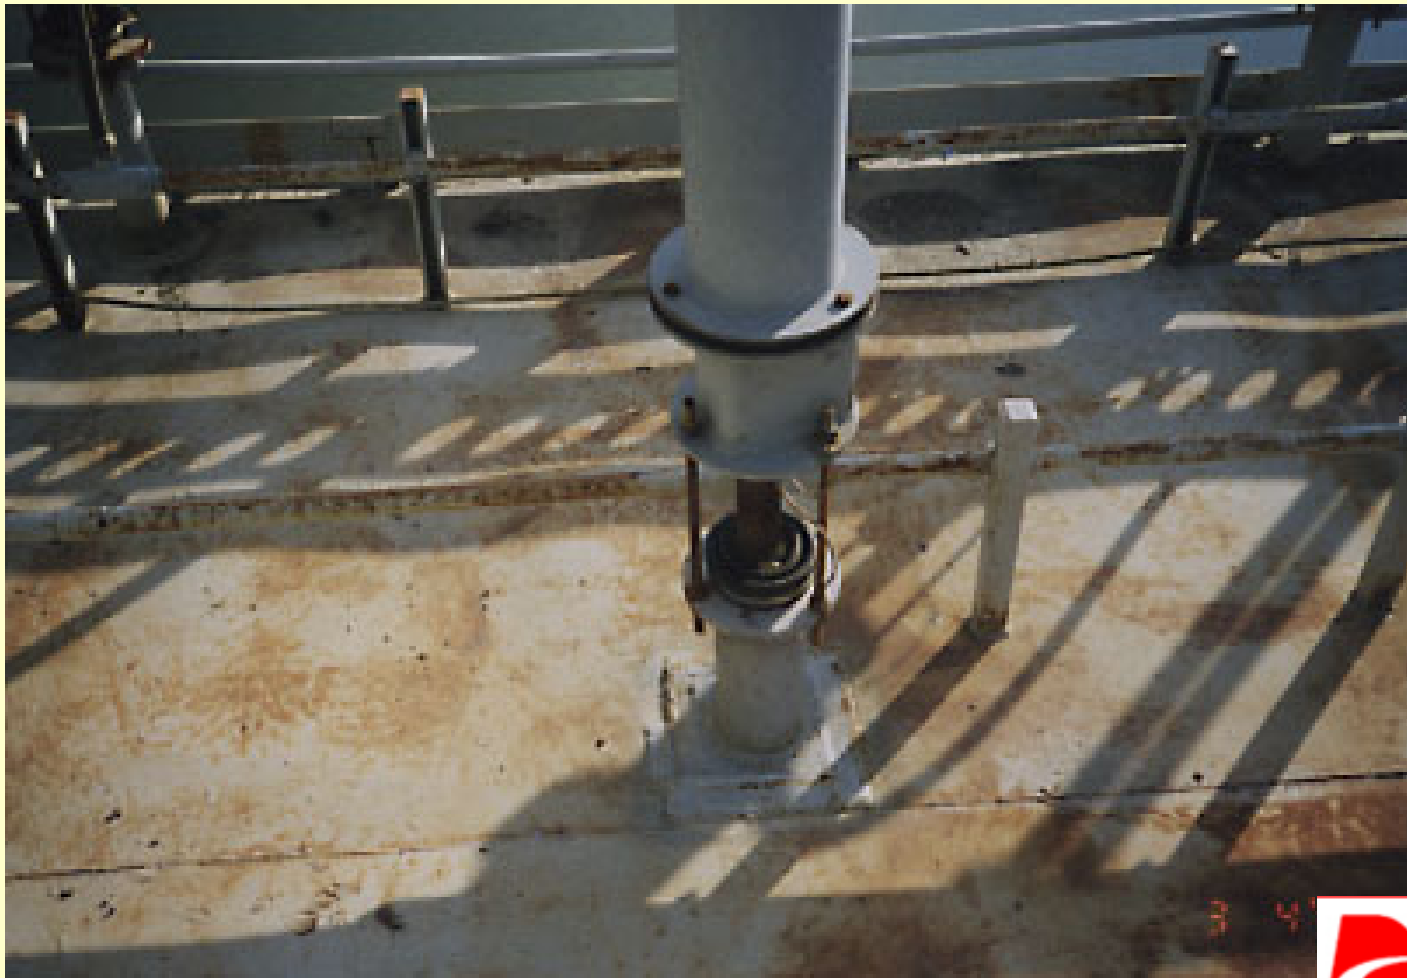
Rapper Shaft Cracked at Anvil Beam- Shaft has fell down

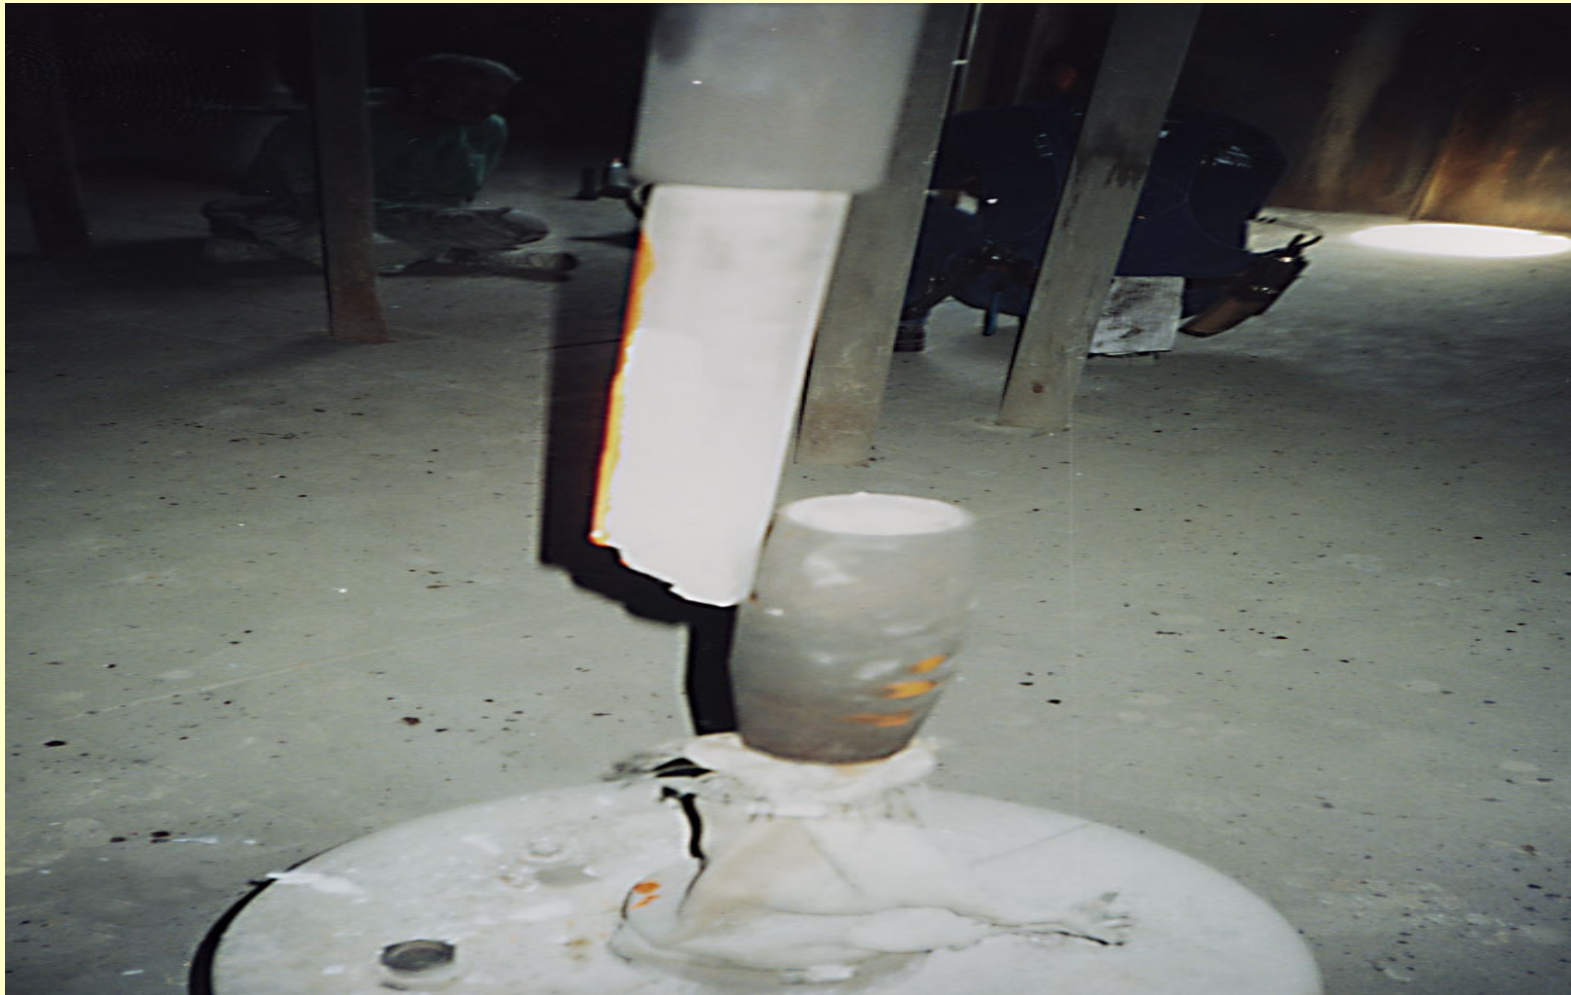
## Broken Rapper Shaft- In the Penthouse

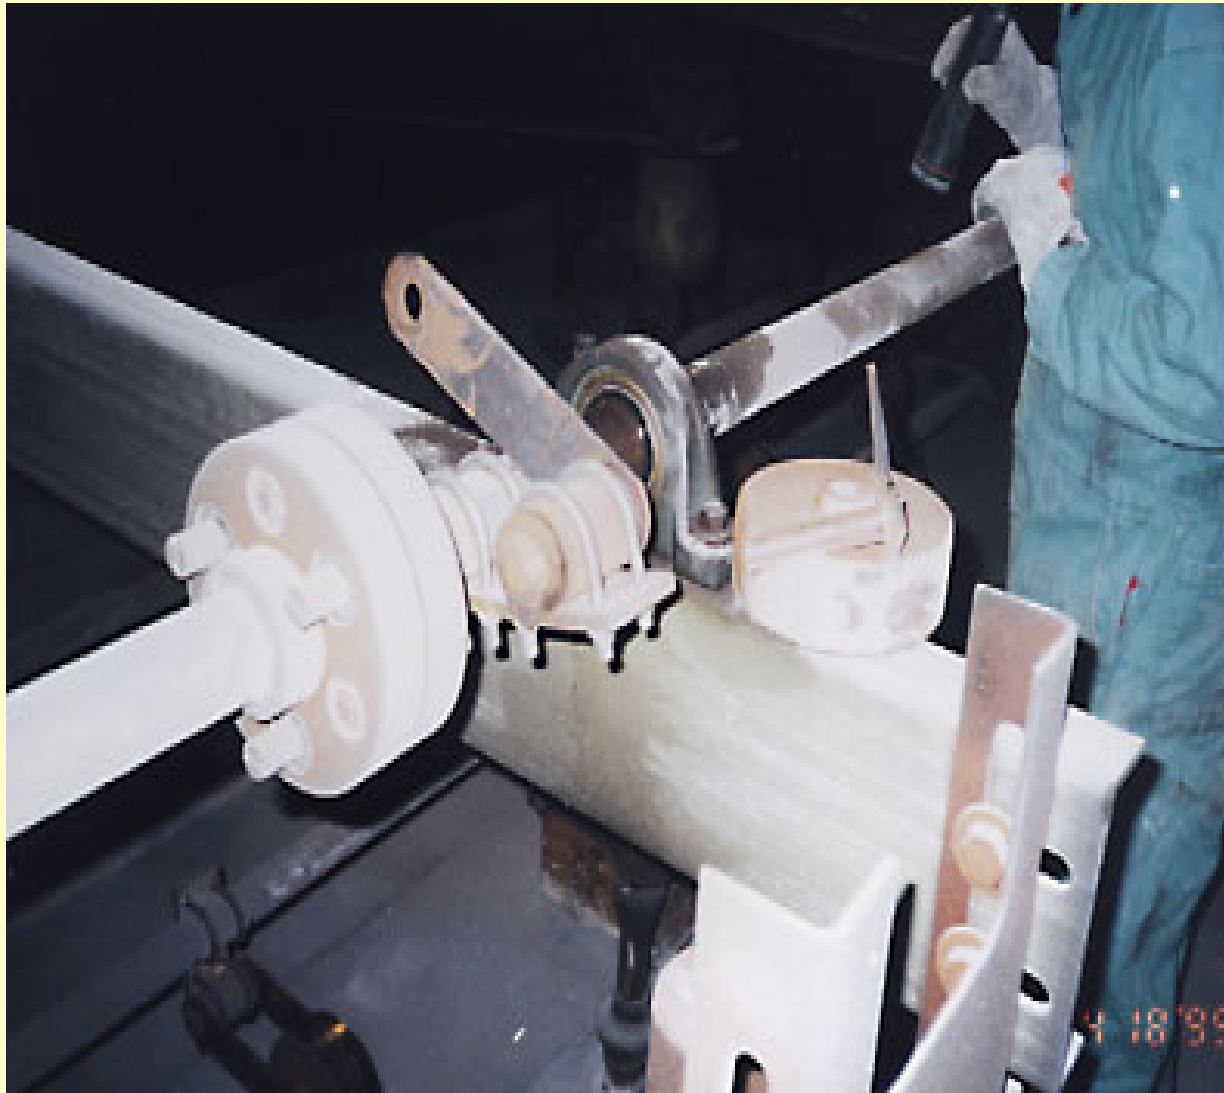
## Broken Tumbling Hammer

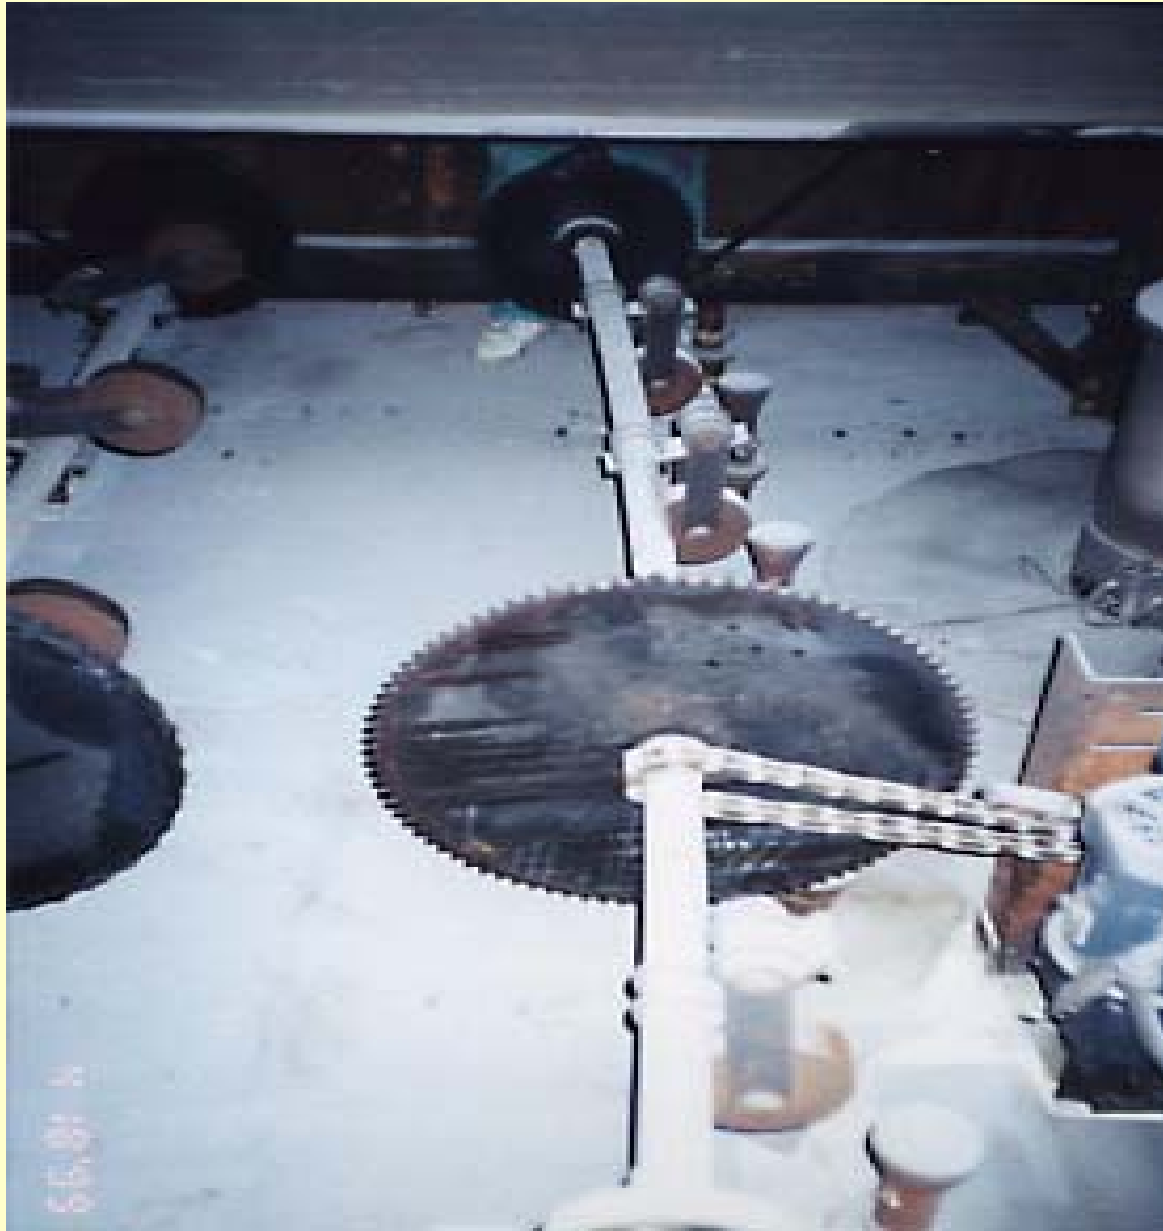
## Chain off Tumbling Hammer Sprocket

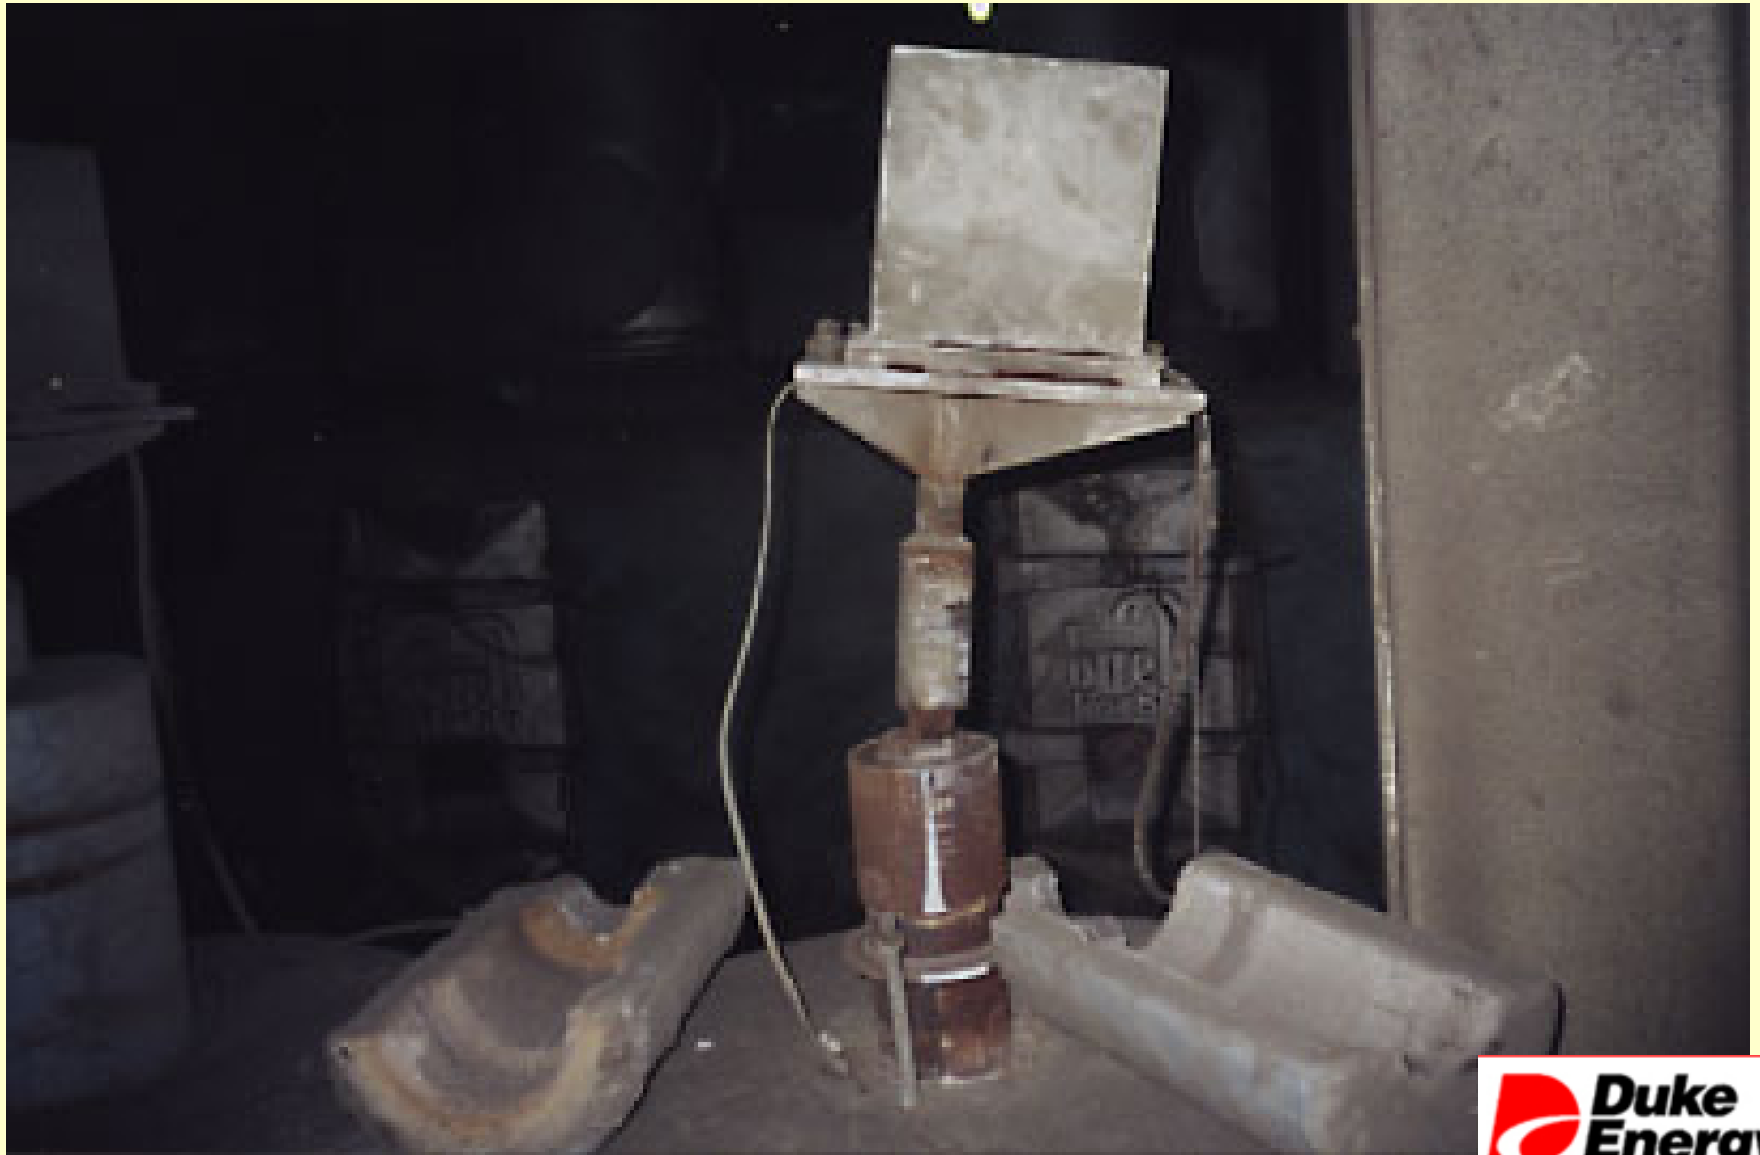
## Vibrator Shaft Broken

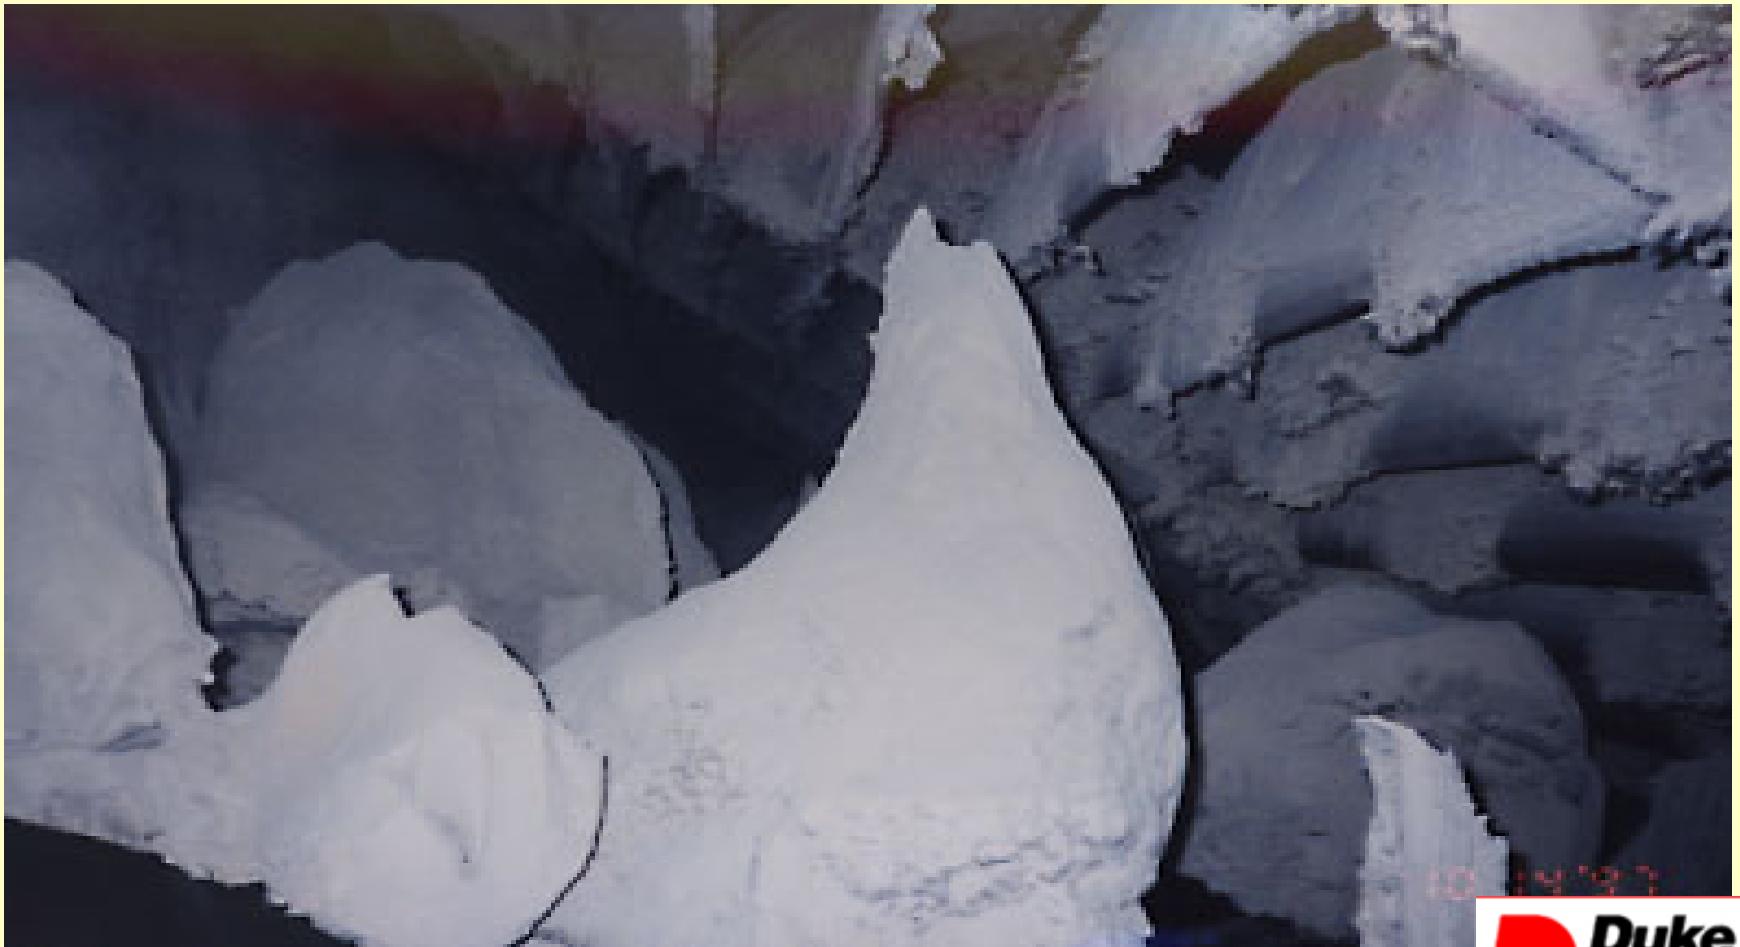
## Ammonia System Ash Buildup

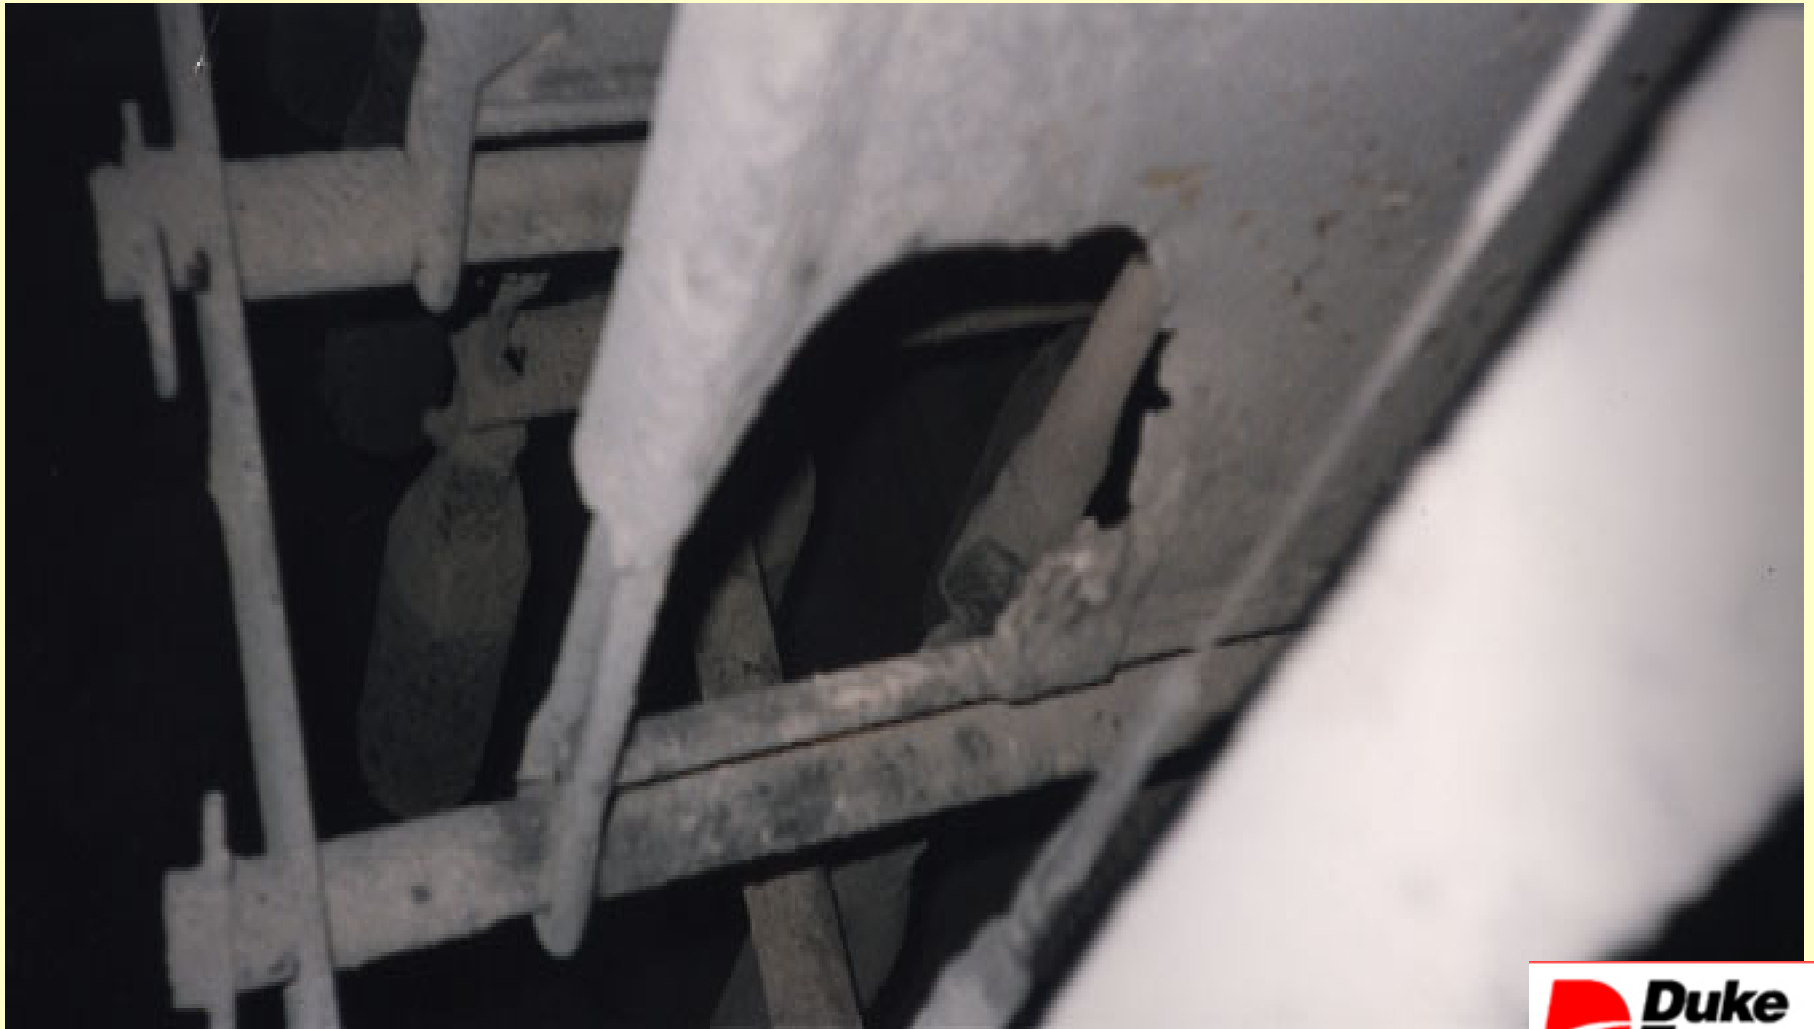
## Ash Hopper Overfilled

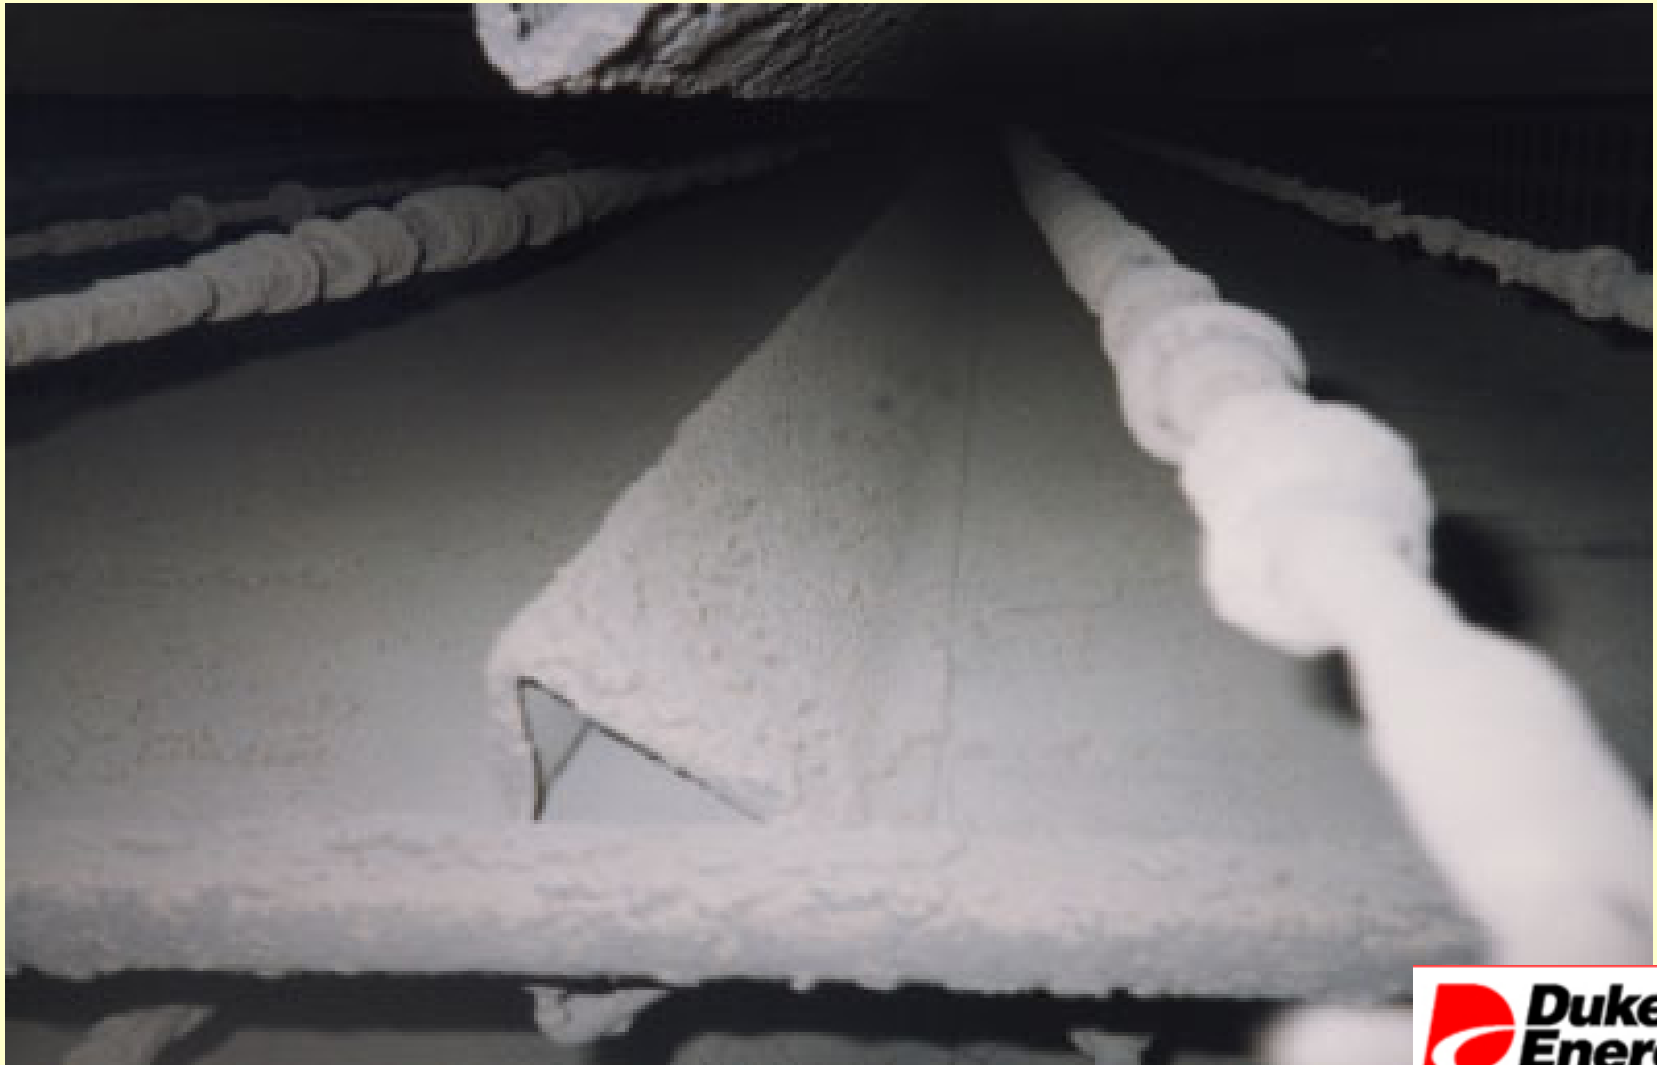
## Ash Buildup on Electrodes- Opacity Can Increase

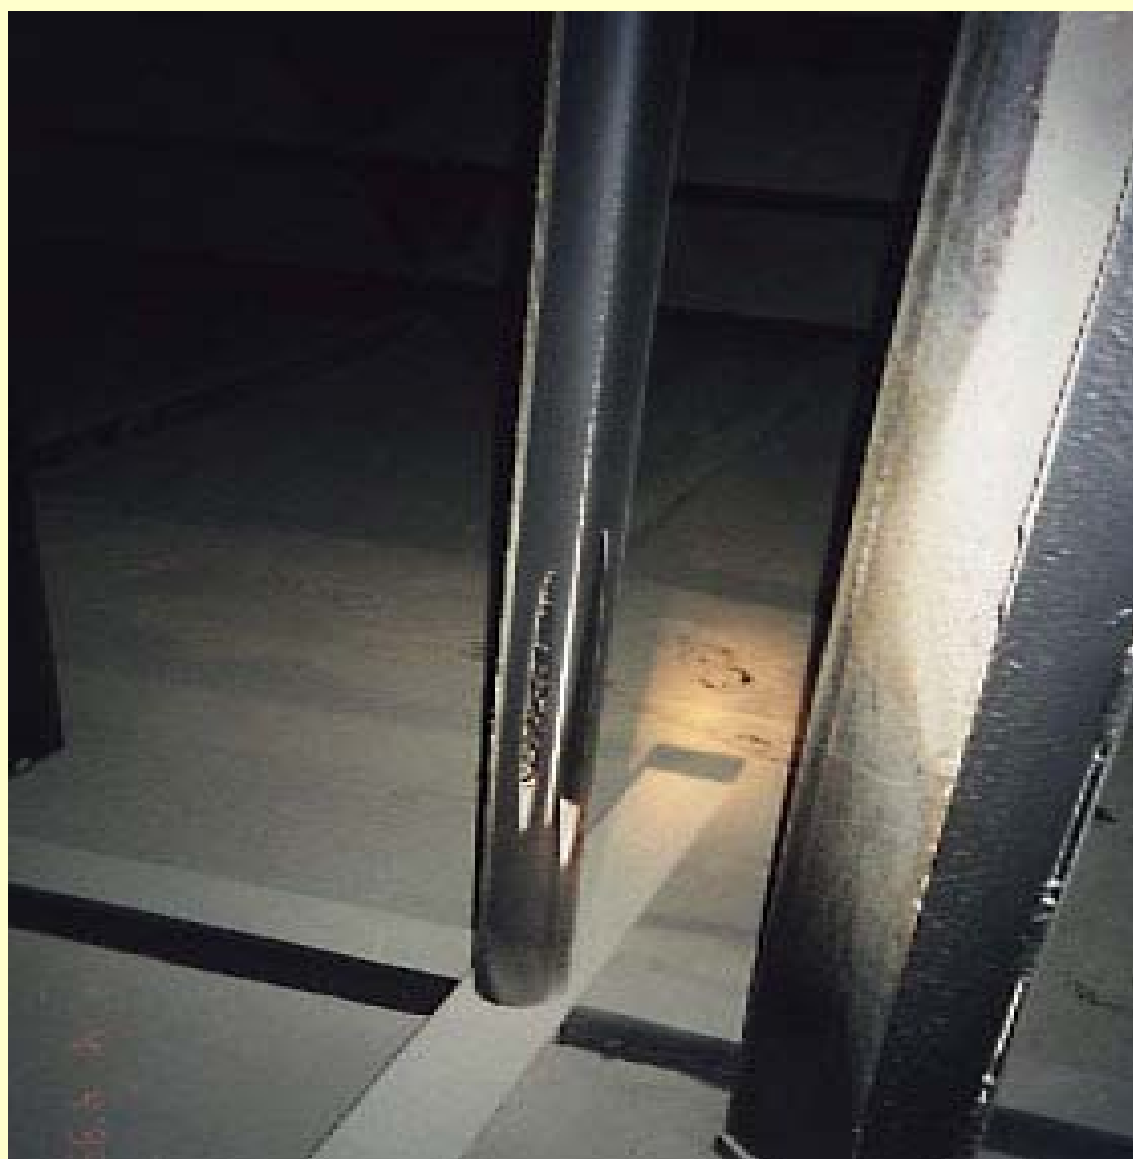
## Erosion Due to Ash if Flue Gas on Structural Support

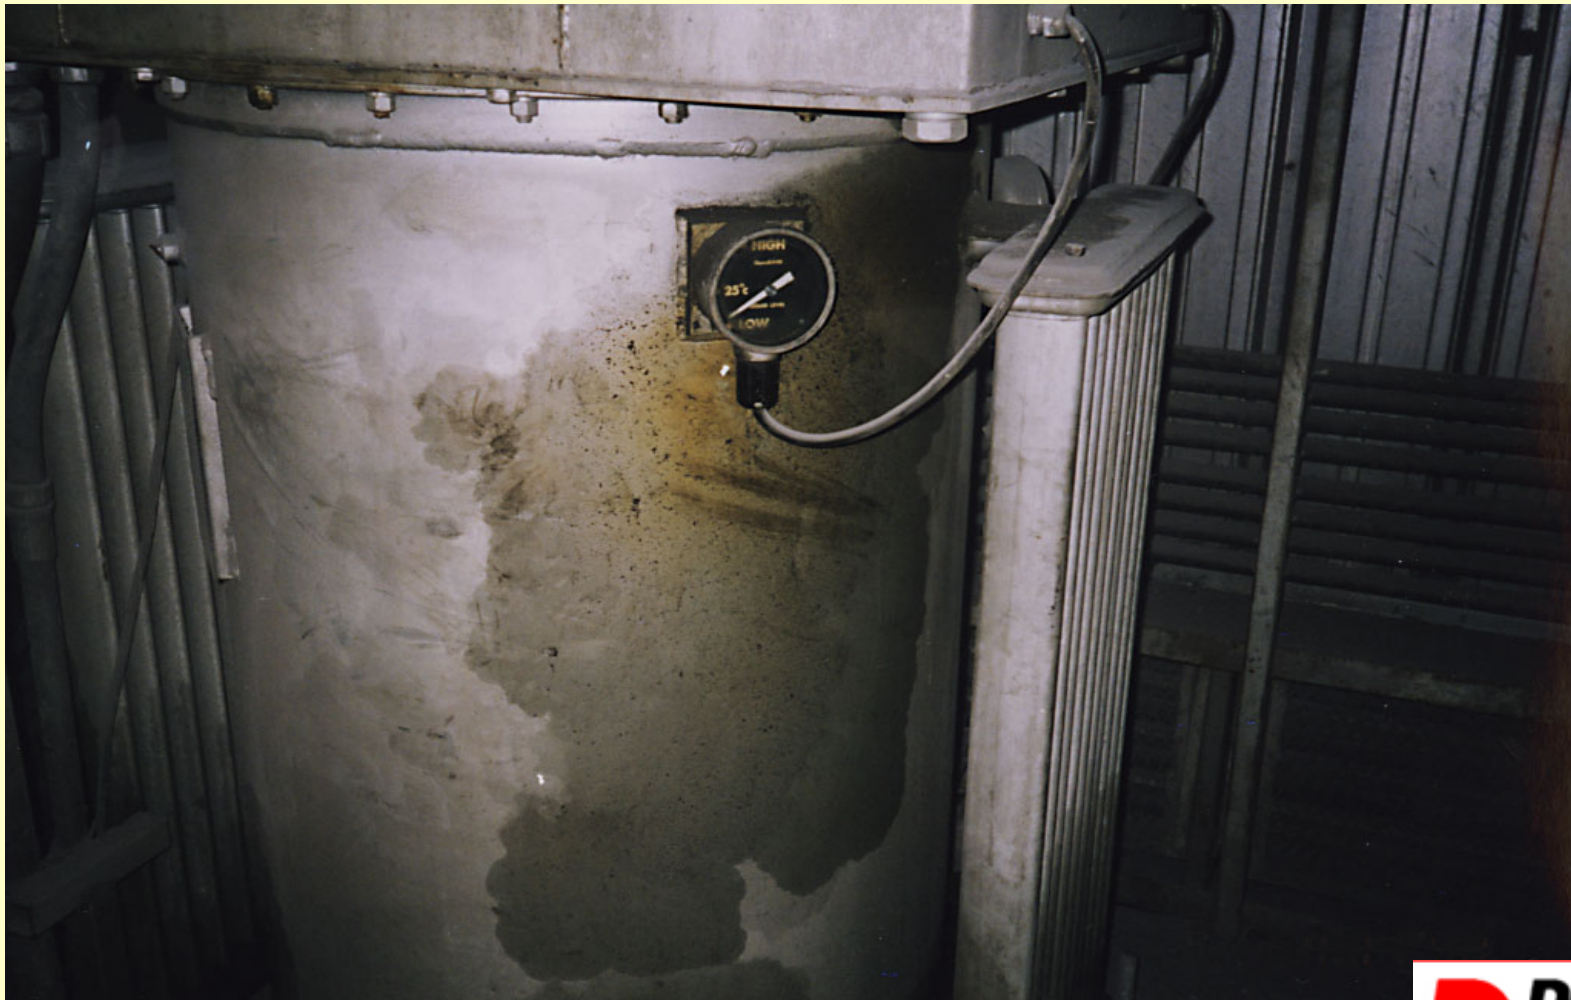
## T/R Set Oil Leakage
