Recent Industry Experience with Corrosion in Wet Flue Gas Desulfurization (FGD) Systems

J. Shingledecker

2011 APC Round Table

July 12, 2011 Cleveland, OH

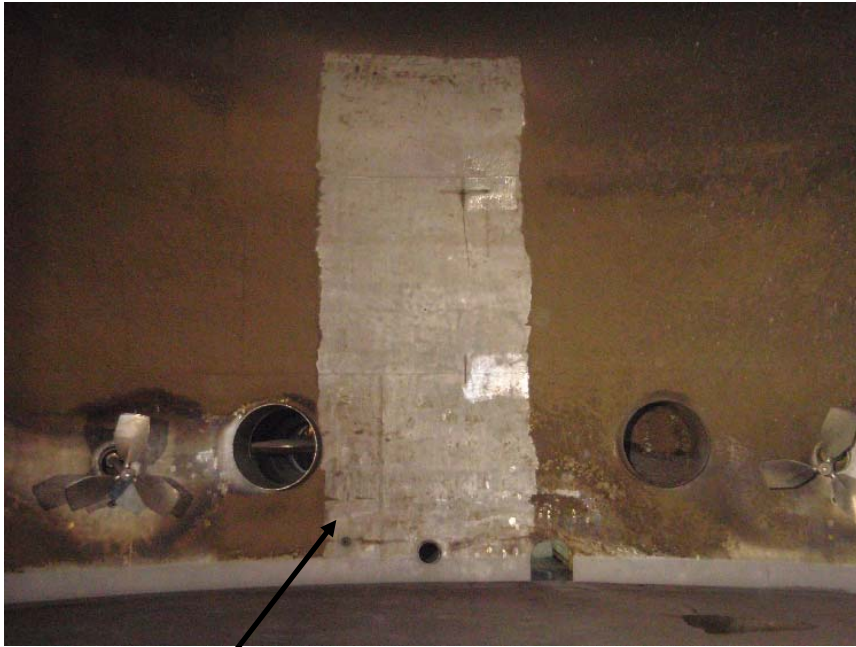
Cleaned location
for partial
vessel
inspection

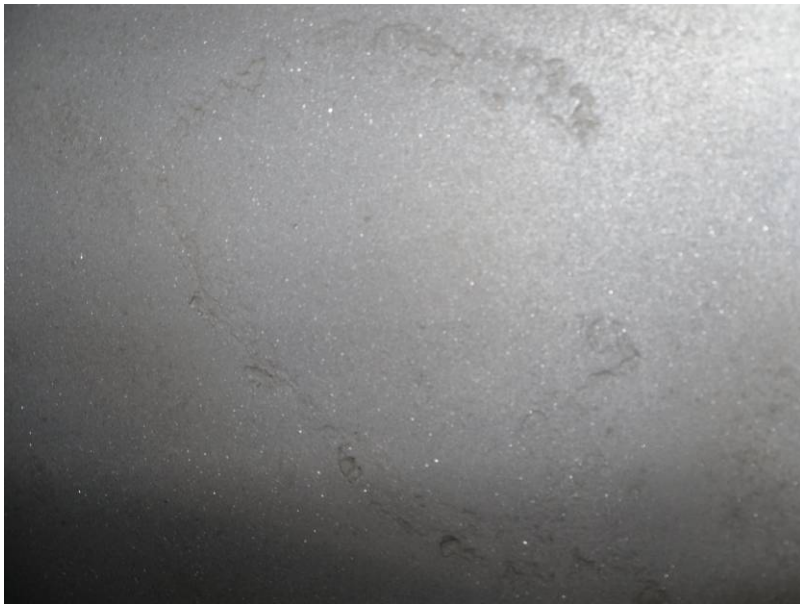
Direct lighting during typical visual inspection

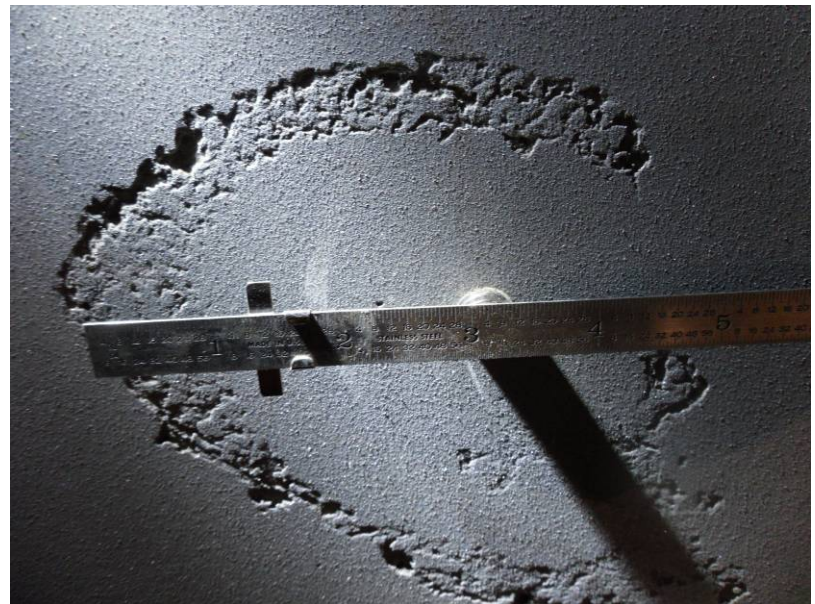
Indirect lighting with LED flashlight reveals corrosion

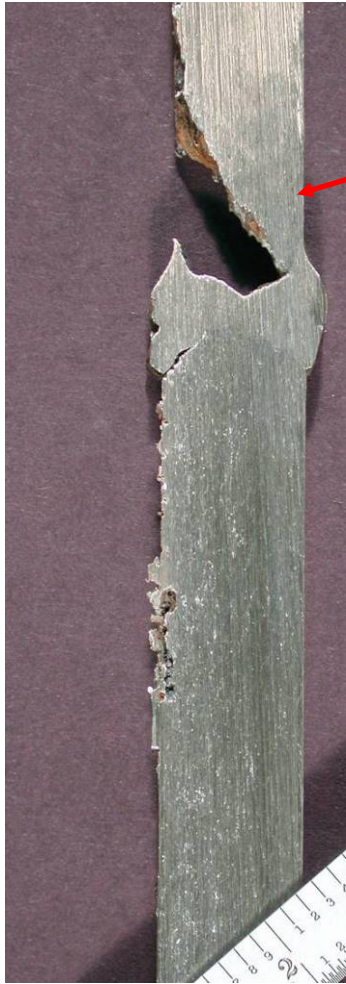
Corrosion in weld heat-affected zone causing through-wall failure of 11/16" (17mm) thick vessel wall (Duplex 2205)

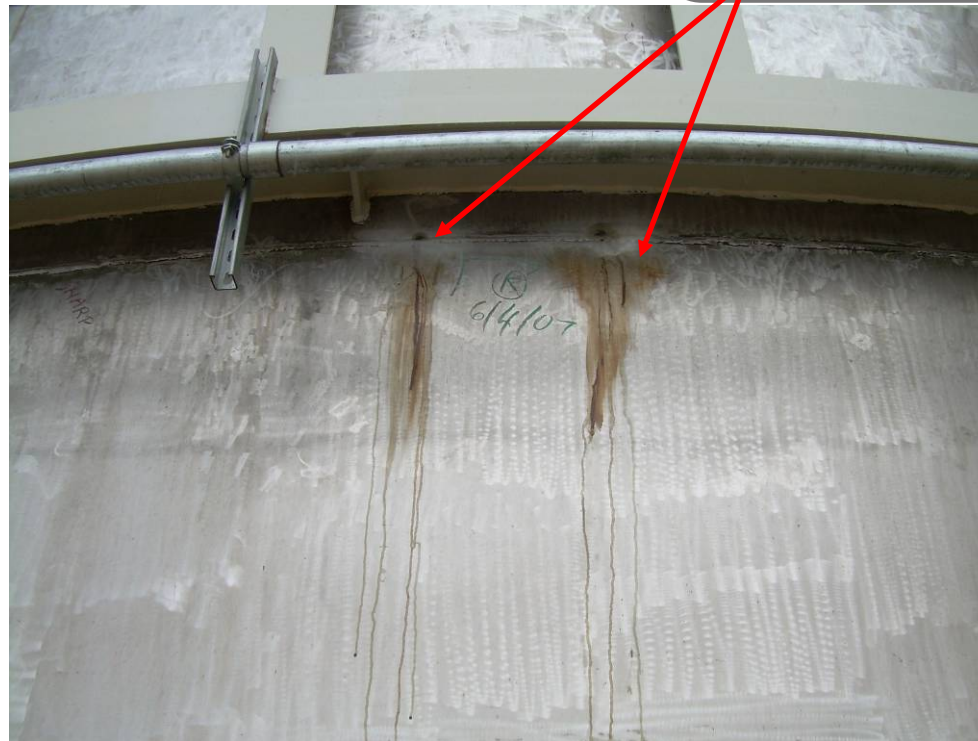
External view of through-wall HAZ leaks (11 months of service – Duplex 2205)

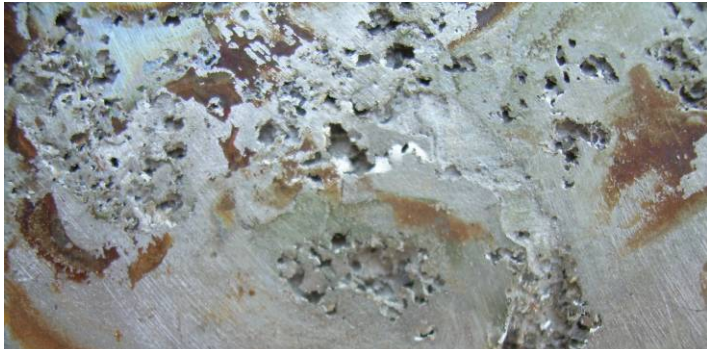
General appearance of corrosion pits in base metal (time not reported)

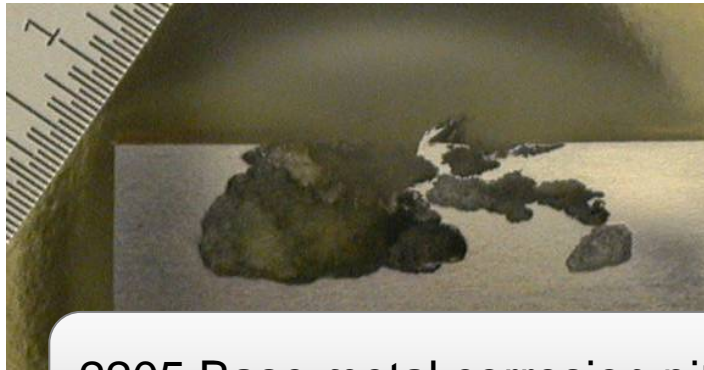
2205 Base metal corrosion pit after ~11 months of service

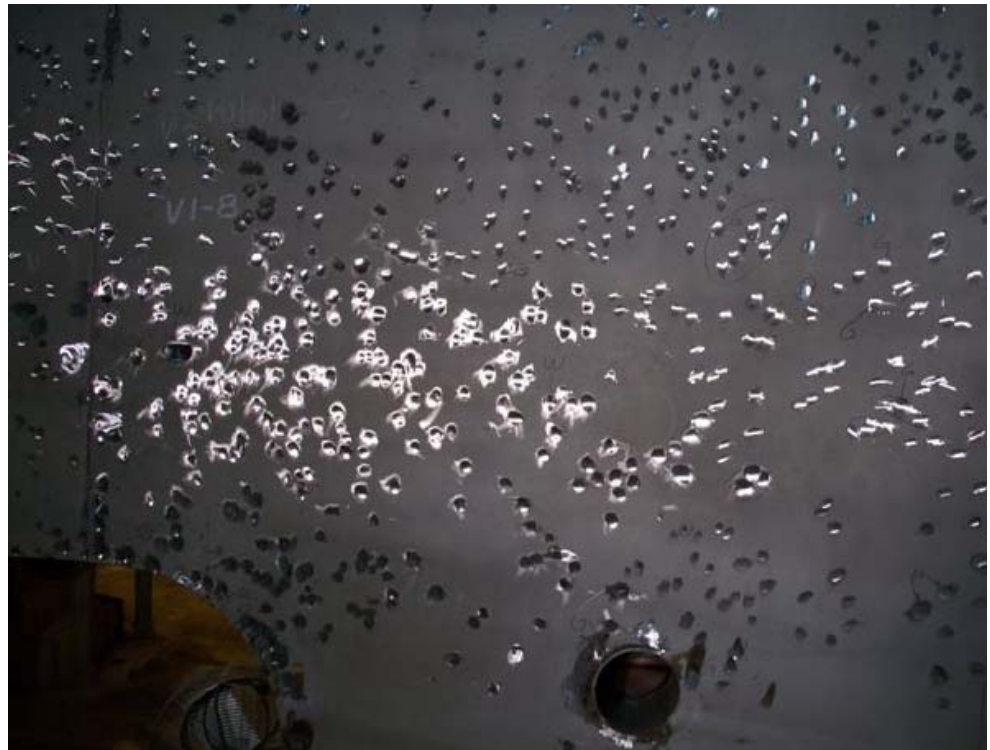
Extent of removed corrosion pits on 2205 absorber vessel walls after ~2 months of service (corrosion was ground out leaving divots)

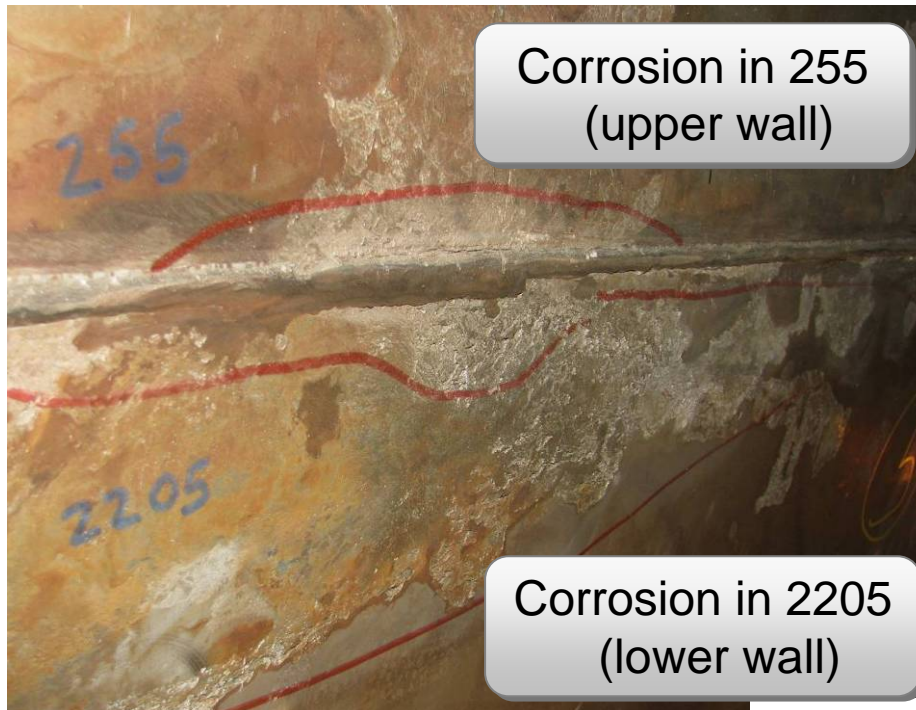
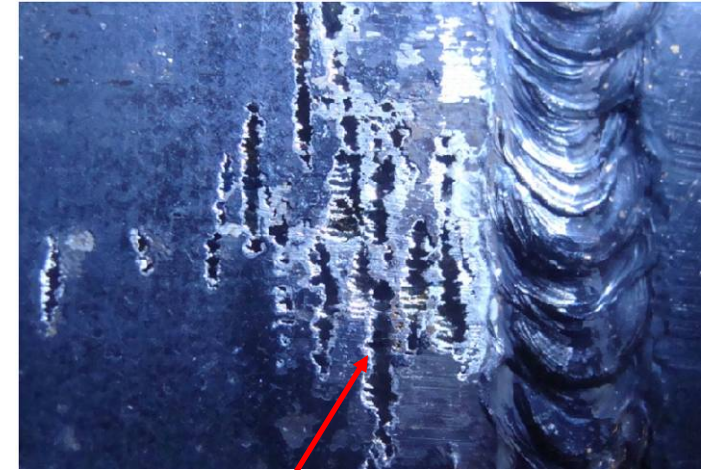
Significant corrosion in a
317LMN absorber vessel
after <1yr. of service

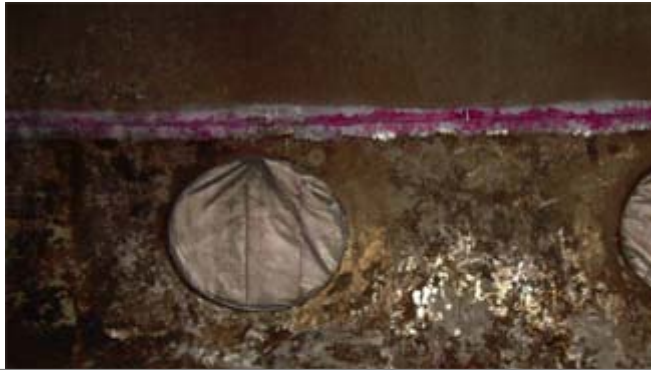
Dye penetrate reveals extensive corrosion in weld seams of spray tower

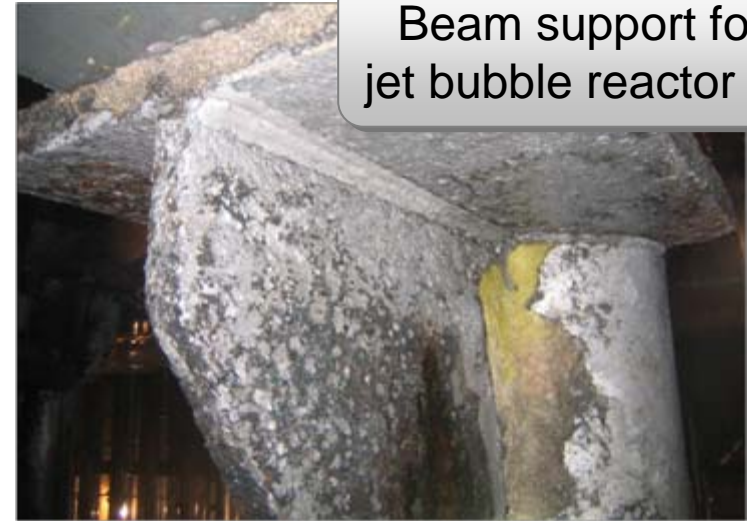
Beam support for a jet bubble reactor (JBR)

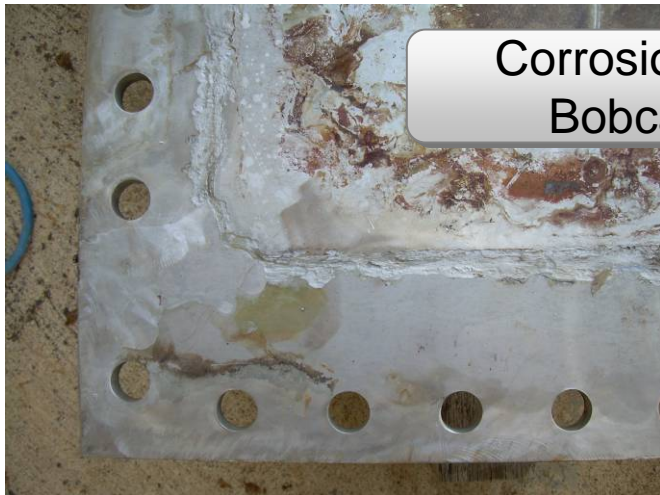
Corrosion on a Bobcat Door

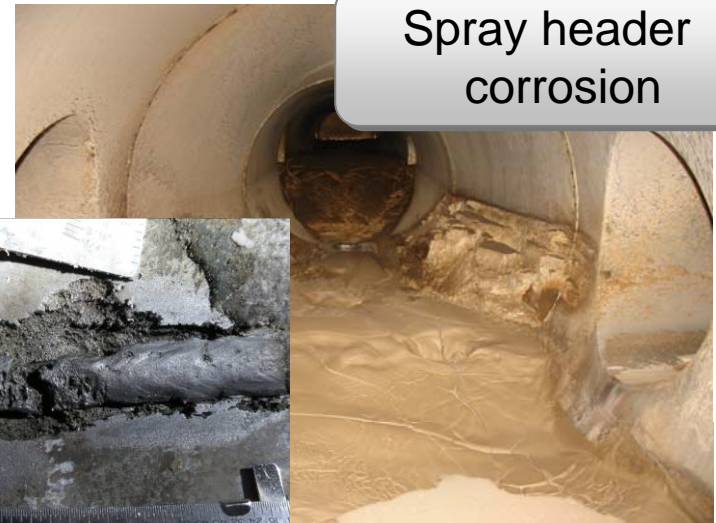
Spray header corrosion
