**2018 NO<sub>x</sub>-Combustion Round Table  
& Expo Presentation**

# Reinhold Environmental NOx Round Table February 19, 2018

Prepared by  
Greg Holscher and Stacy Steinhauer  
IBIDEN CERAM Environmental, Inc.

## “Midwest Utility” Reactor Inspection Review

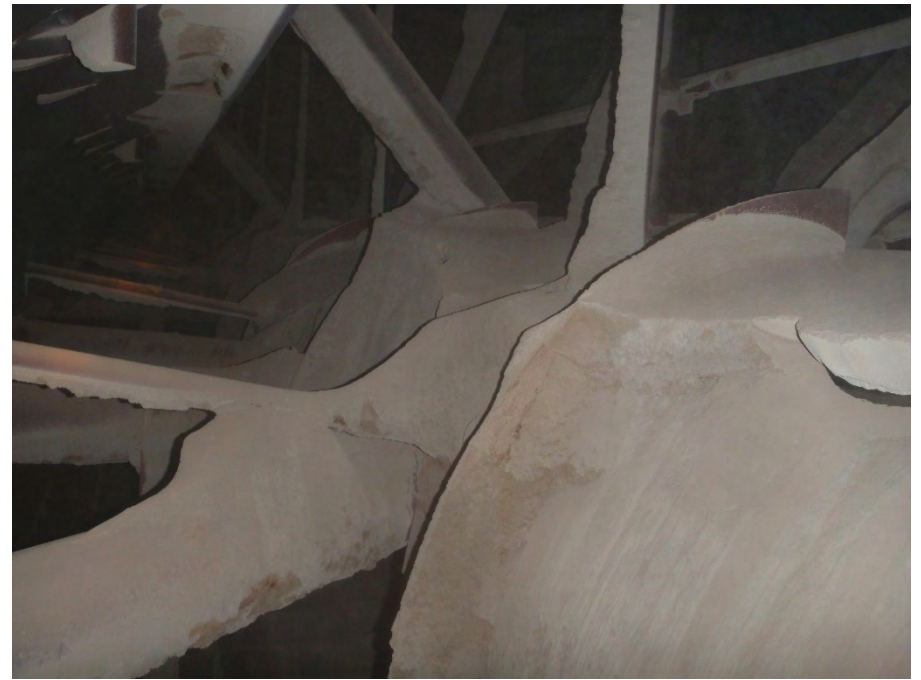
Ash Buildup “Dirty” Condition

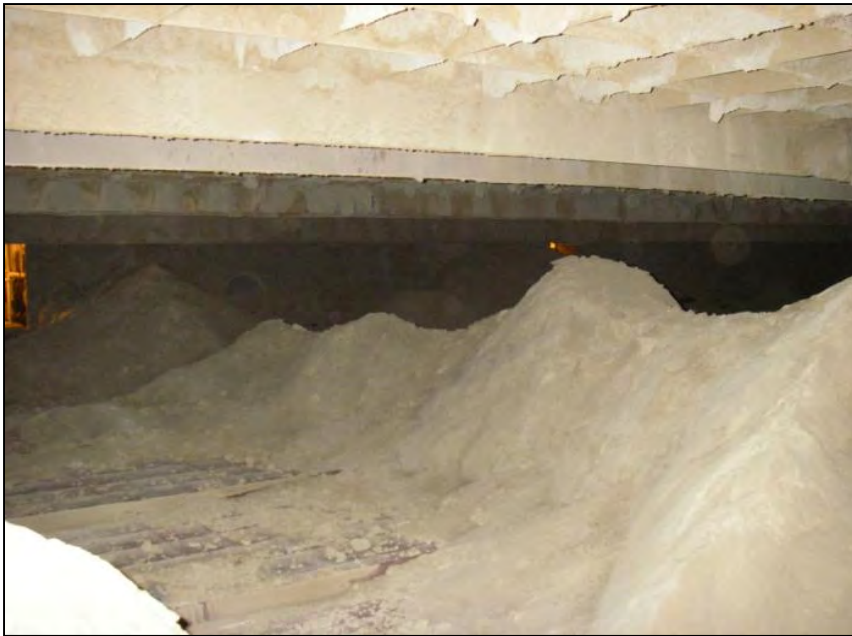
Larger Piles in L1-L3

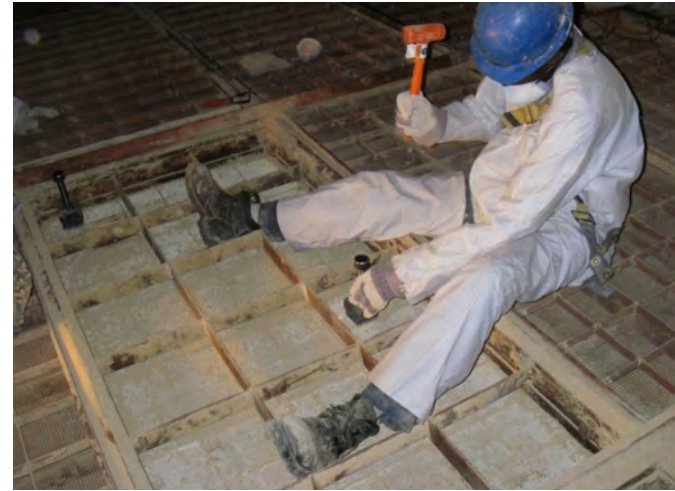
Moderate Erosion in L1 after 18,500 hrs

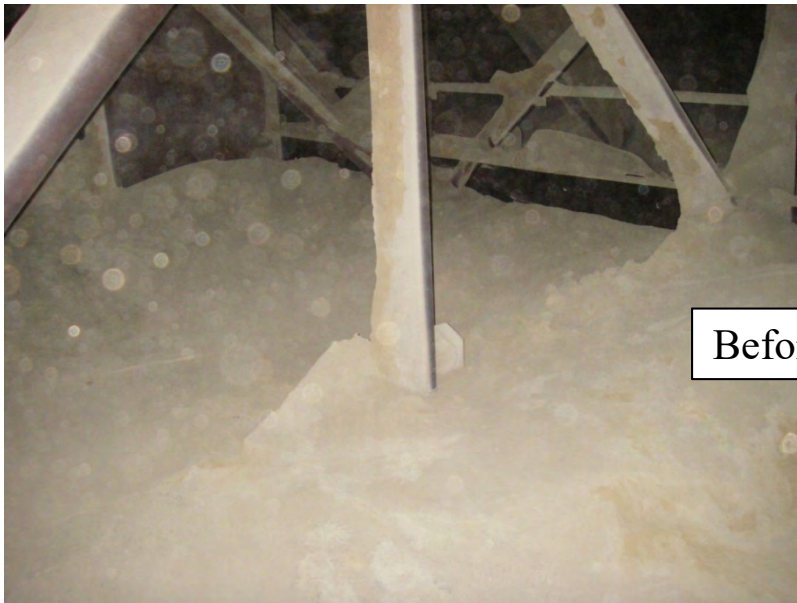
Mechanical Cleaning (Not Recommended)

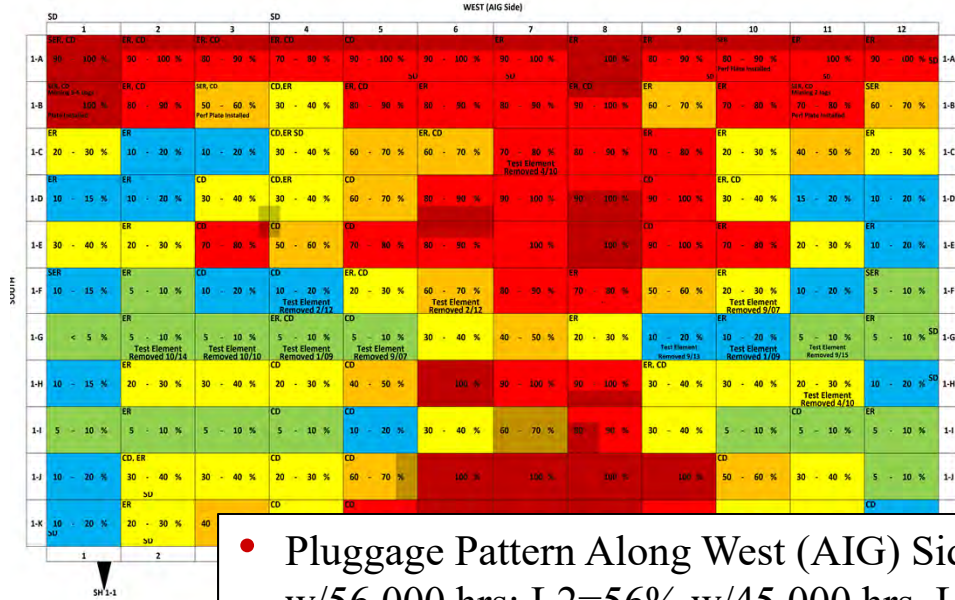
First Catalyst Level (9.2 mm Pitch)  
October 5, 2016

- Pluggage Pattern Along AIG Side and Center of Reactor (L1=34%, L2=20%, L3=44%)
- High Pressure Drop (5-6 in. w.g.)
- Erosion Will Increase
- 8.2 mm Pitch HC Installed in L4 in 2013. Accelerated Events Due to Pluggage
- Further CFD Modeling Recommended

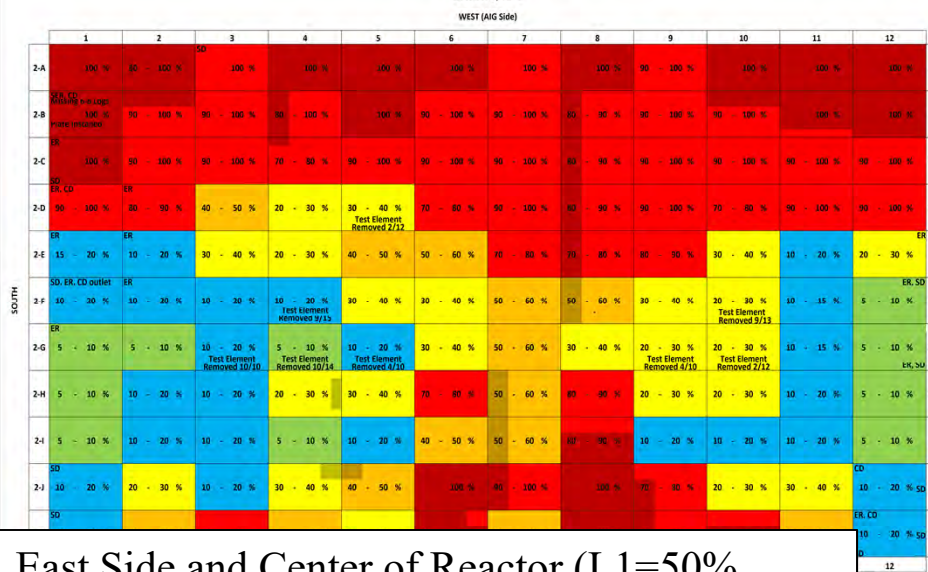
Second Catalyst Level (8.2 mm Pitch)  
October 5, 2016

- Pluggage Pattern Along West (AIG) Side, East Side and Center of Reactor (L1=50% w/56,000 hrs; L2=56% w/45,000 hrs, L3=31% w/27,000 hrs and L4=30% w/17,000 hrs)
- High Pressure Drop (6-8 in. w.g.)
- Erosion Will Increase
- Further CFD Modeling Recommended

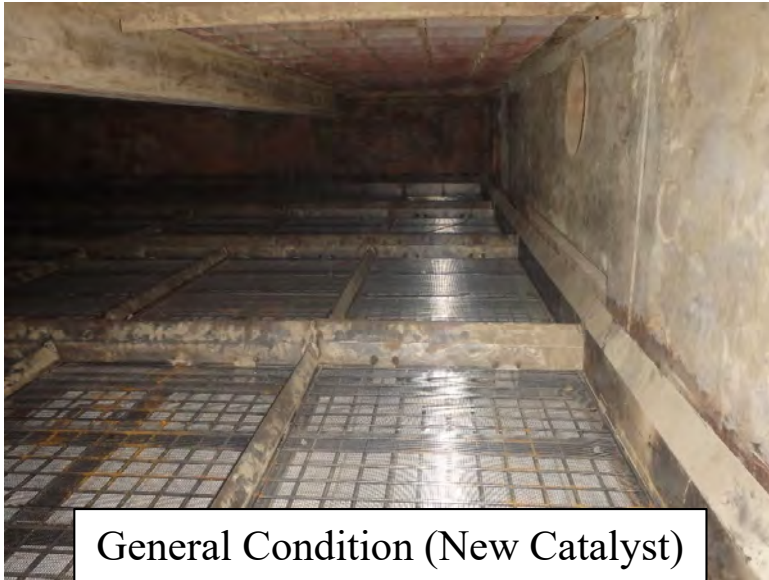
General Condition (New Catalyst)  
Will Install New Sonic Horns

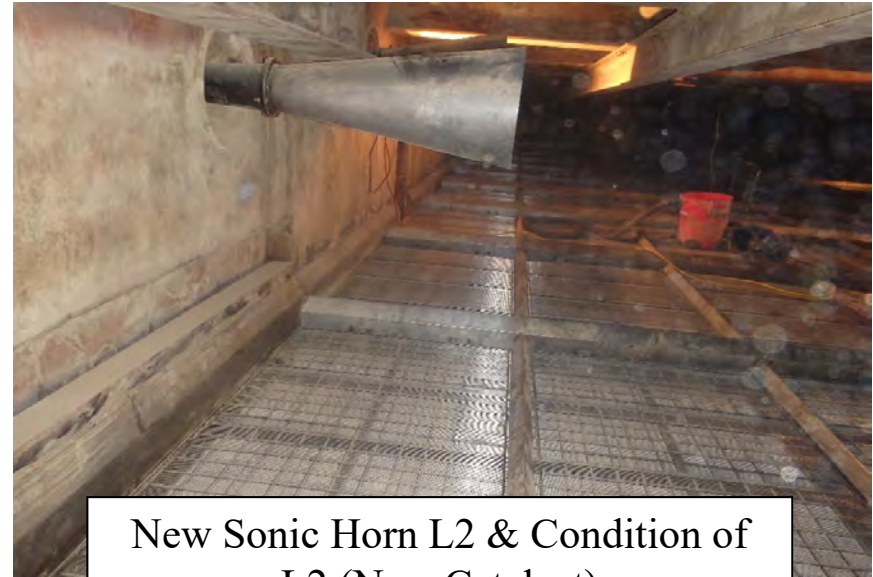
New Sonic Horn L2 & Condition of  
L2 (New Catalyst)

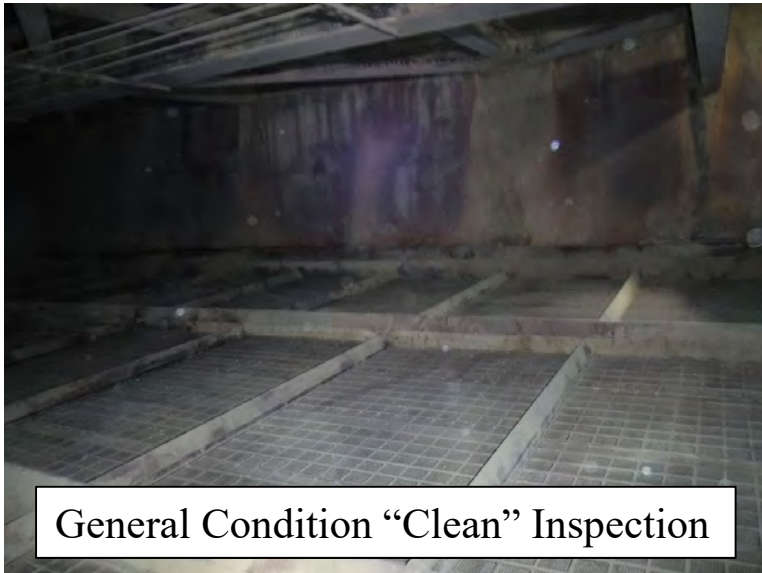
General Condition "Clean" Inspection

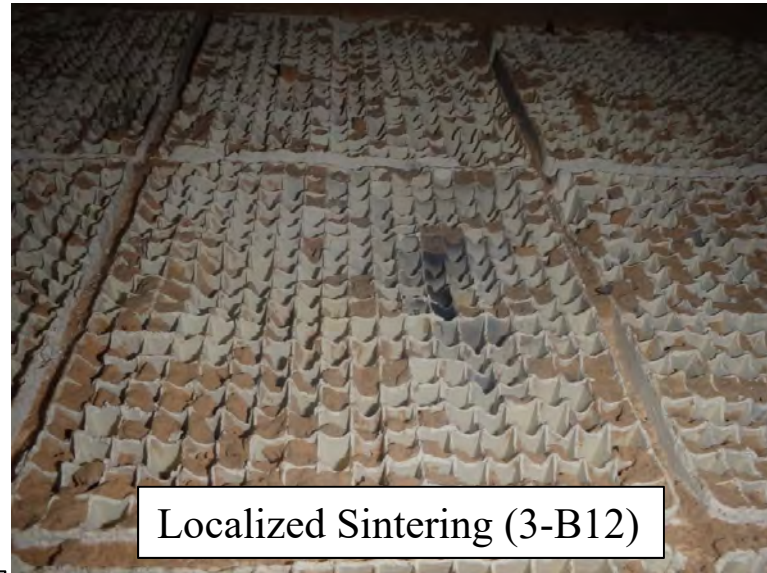
Localized Sintering (3-B12)

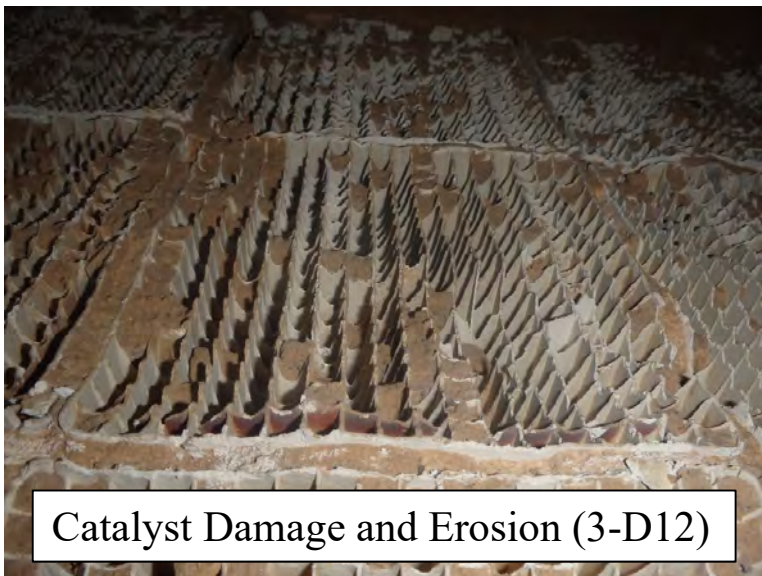
Catalyst Damage and Erosion (3-D12)

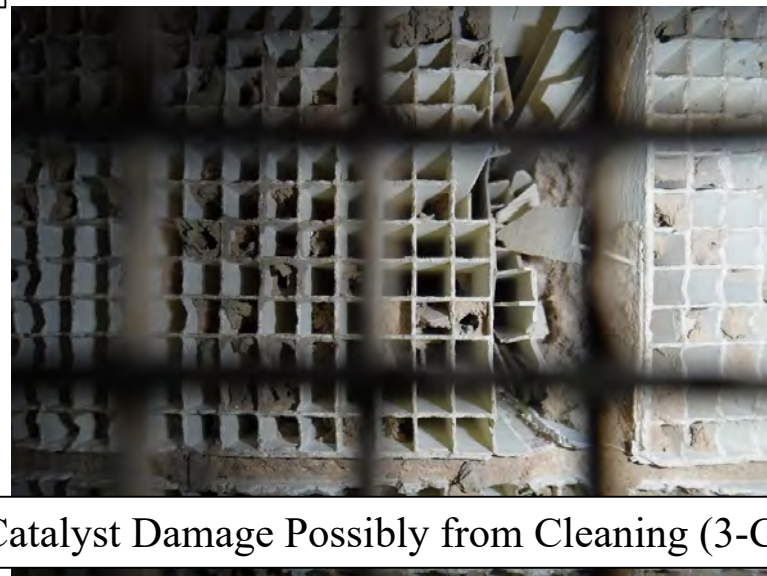
Catalyst Damage Possibly from Cleaning (3-C9)

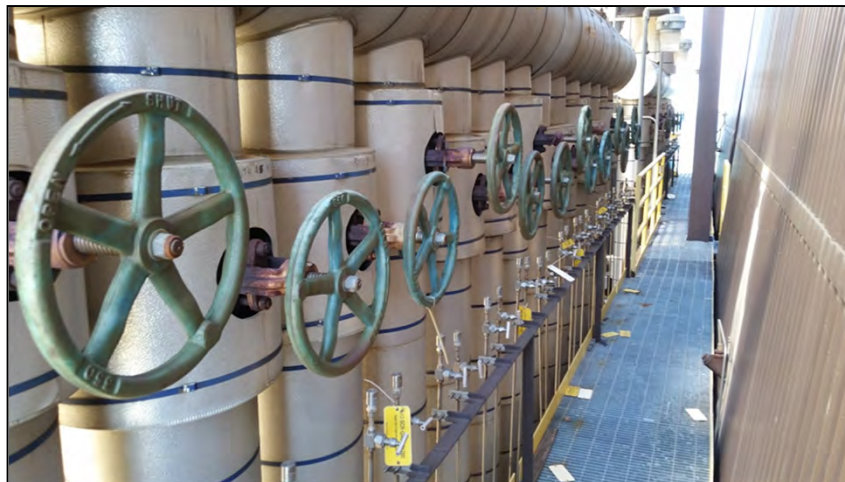
Missing tags on valves
