Photos of Precipitator Problems

John Walker Sr. Engineer Duke Energy

PCUG Roundtable
St.Louis-Host AMEREN
July 8, 2013

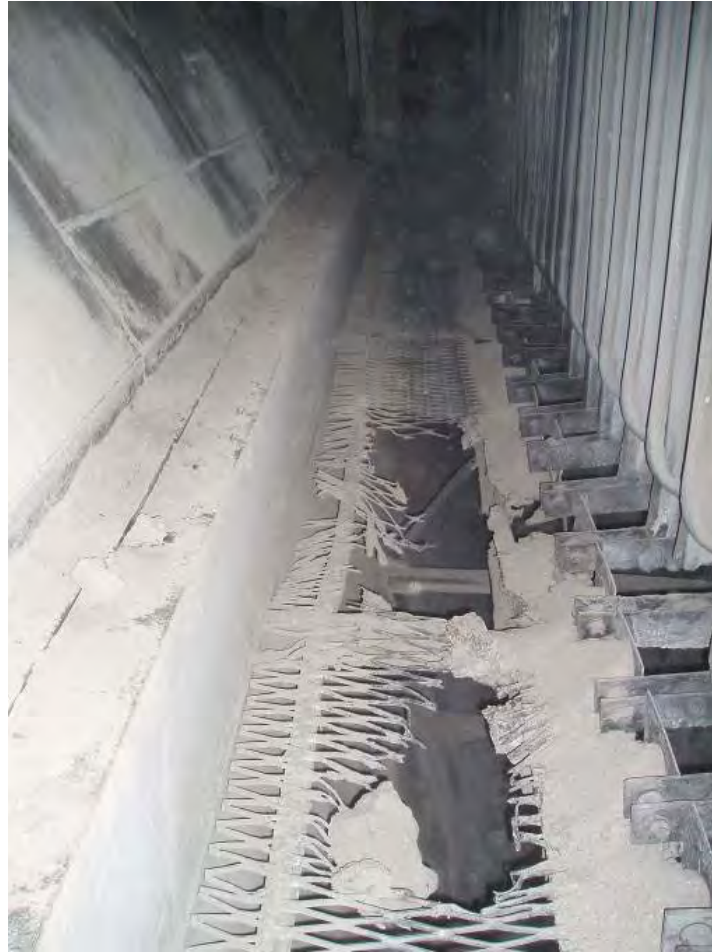
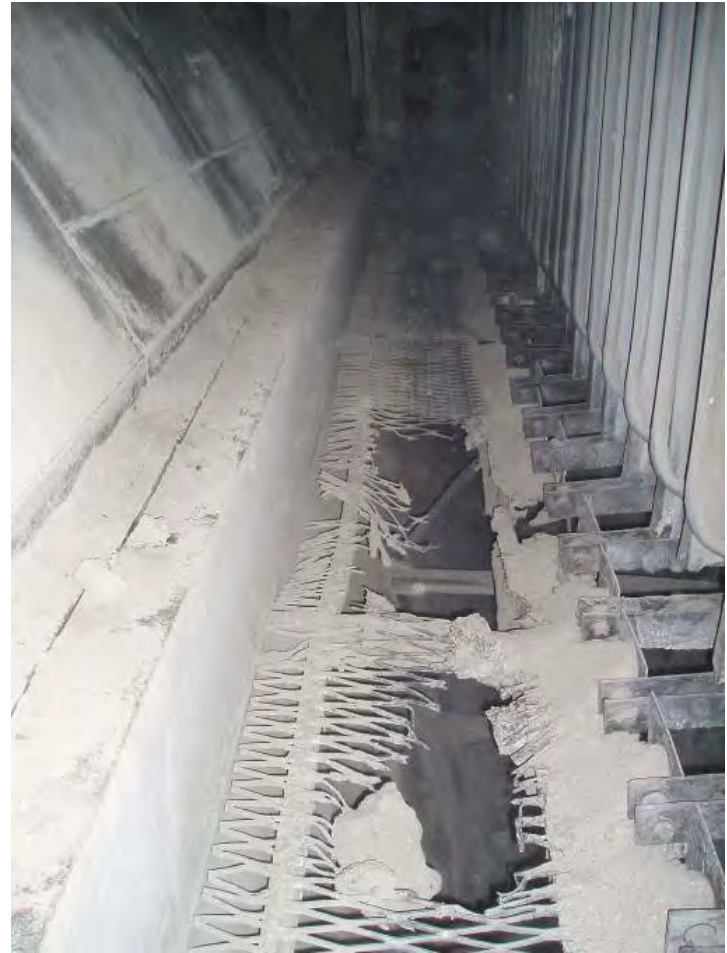
Hopper Fire

- RB Mill Inverted cone failure, allowed unburnt coal to enter the ESP hopper.

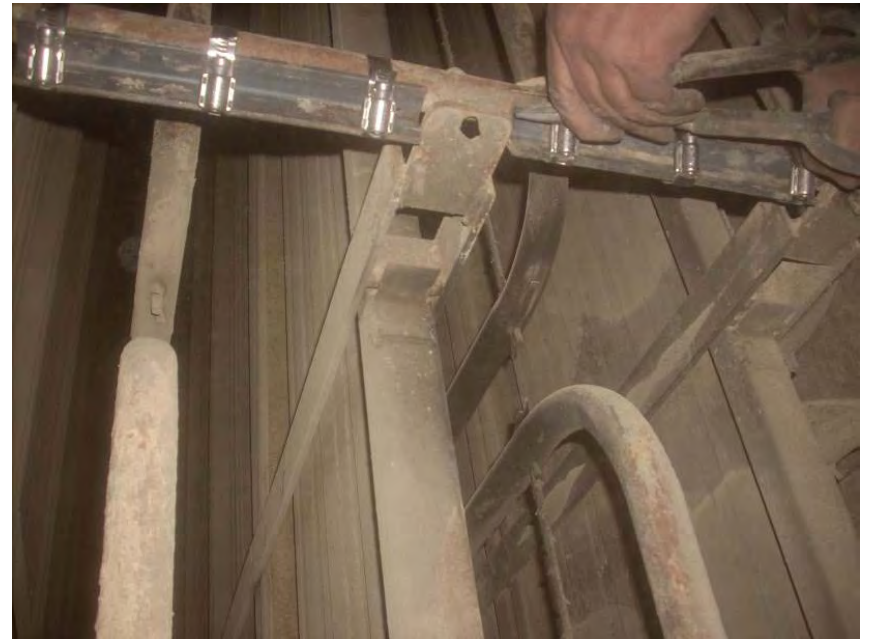
Center Guide Bolt Failure

- Fretting wore the bolt away.
- CE came into contact w/ DE when airflow increased.
- Temp repairs made 20' up.

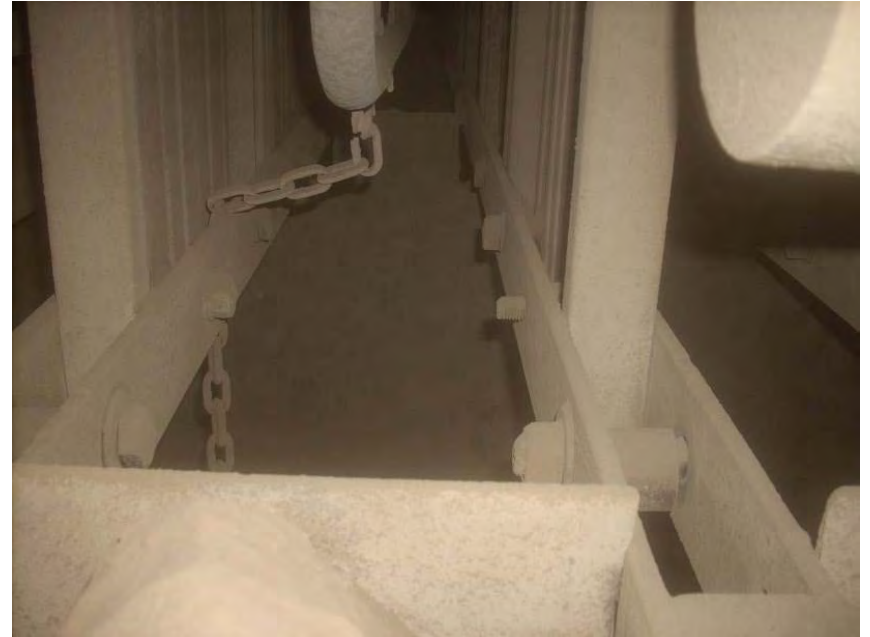
Ground

- High hopper lifted the chain and flopped it into the CE when the hopper was cleared.

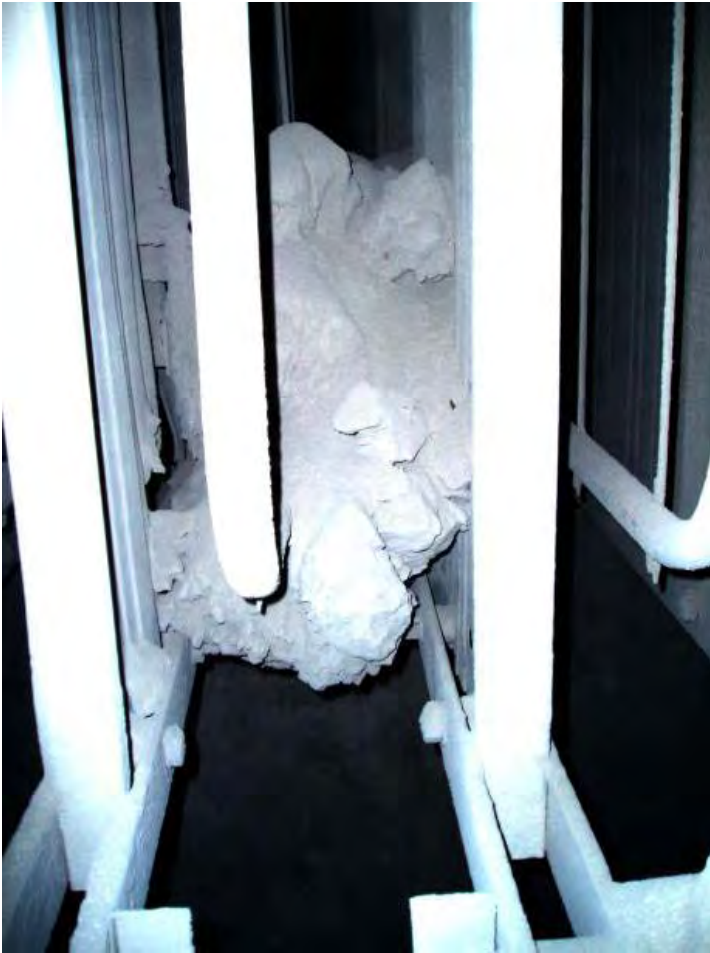
High Hopper/Clinker

- This is what you get when you have a high hopper and force the TR to stay on

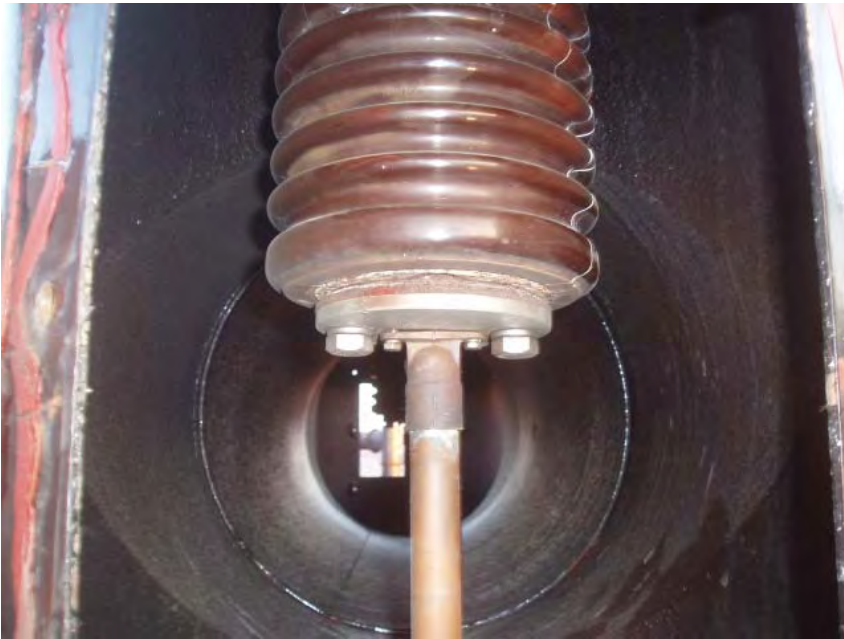
Standoff Insulator crack

- Root cause...Old age?

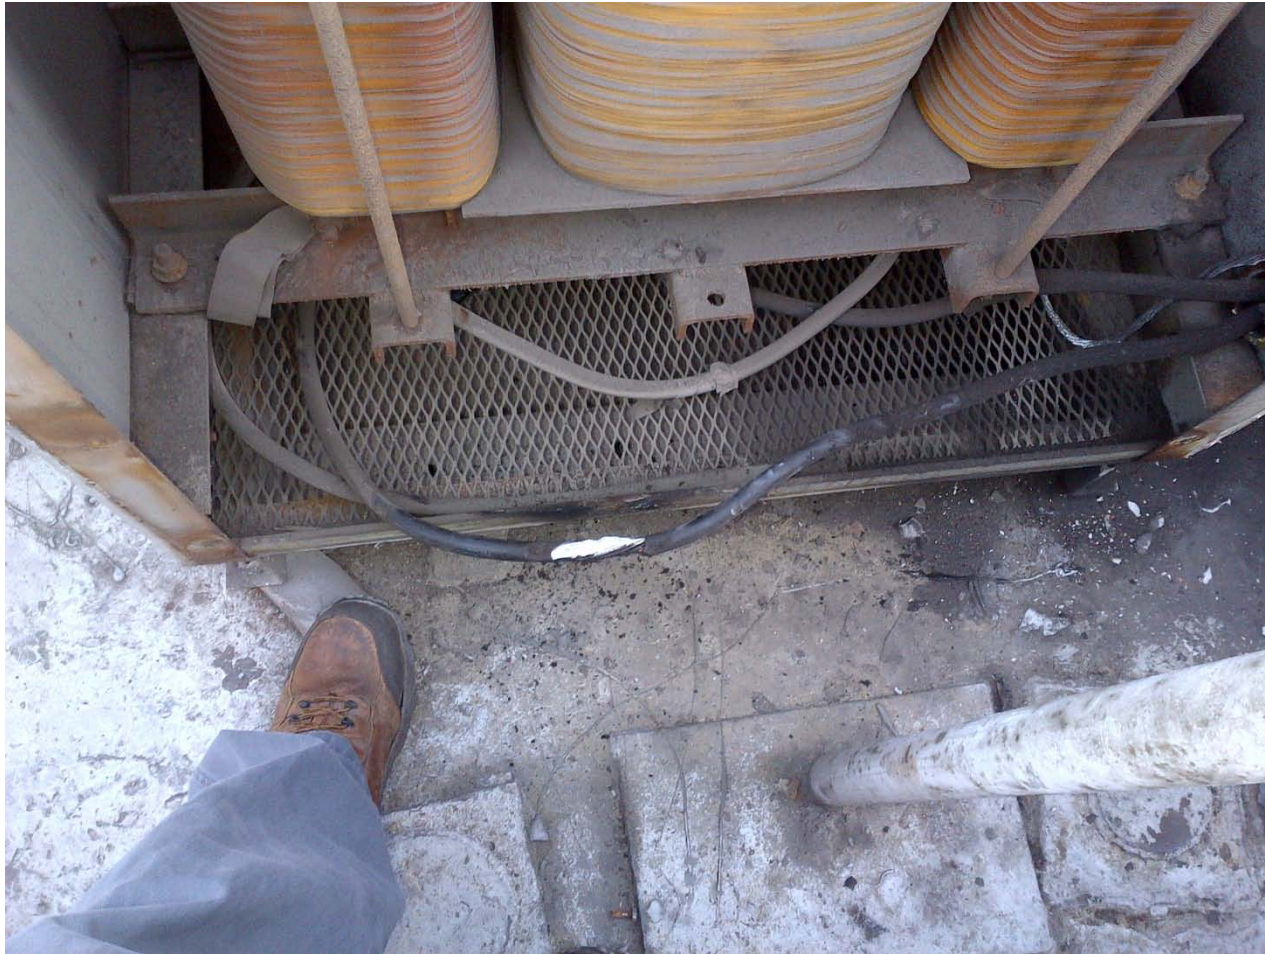
Reactor Cable Fault

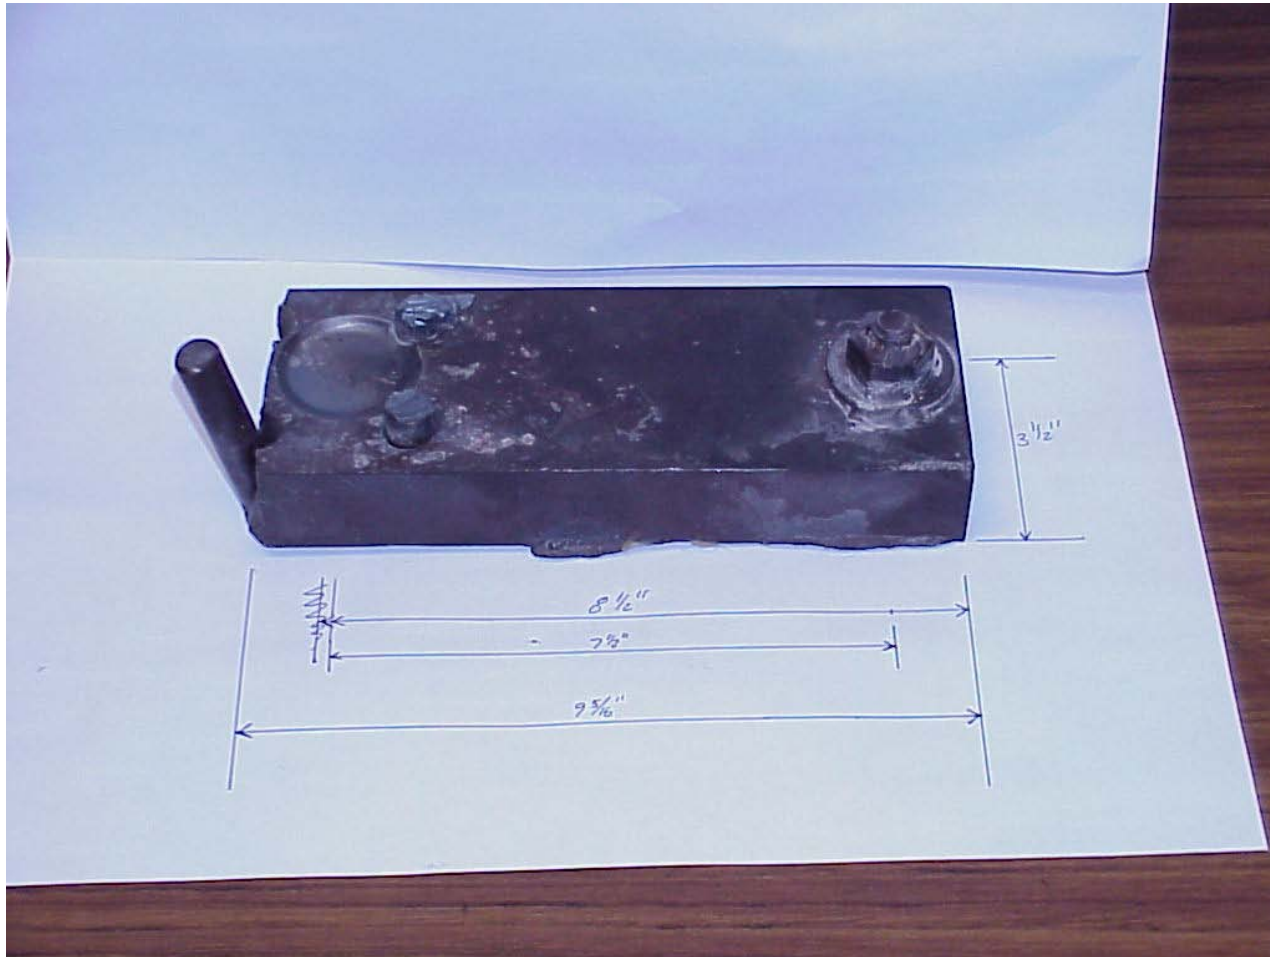
Rapper Anvil Beam Failure

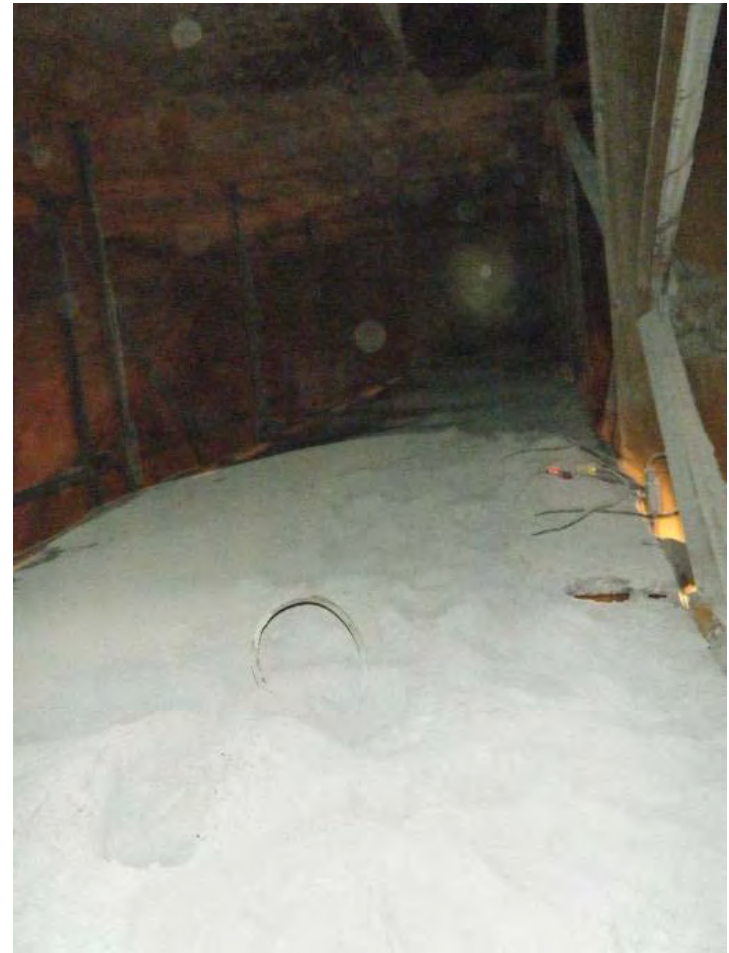
Unbalanced Flow

- APH Turning vane: heavy ash on B-side, not on A-side.
- RC: New FGD-transition to the common ducts didn't account for structural steel, 0.7" pressure drop between A&B sides.

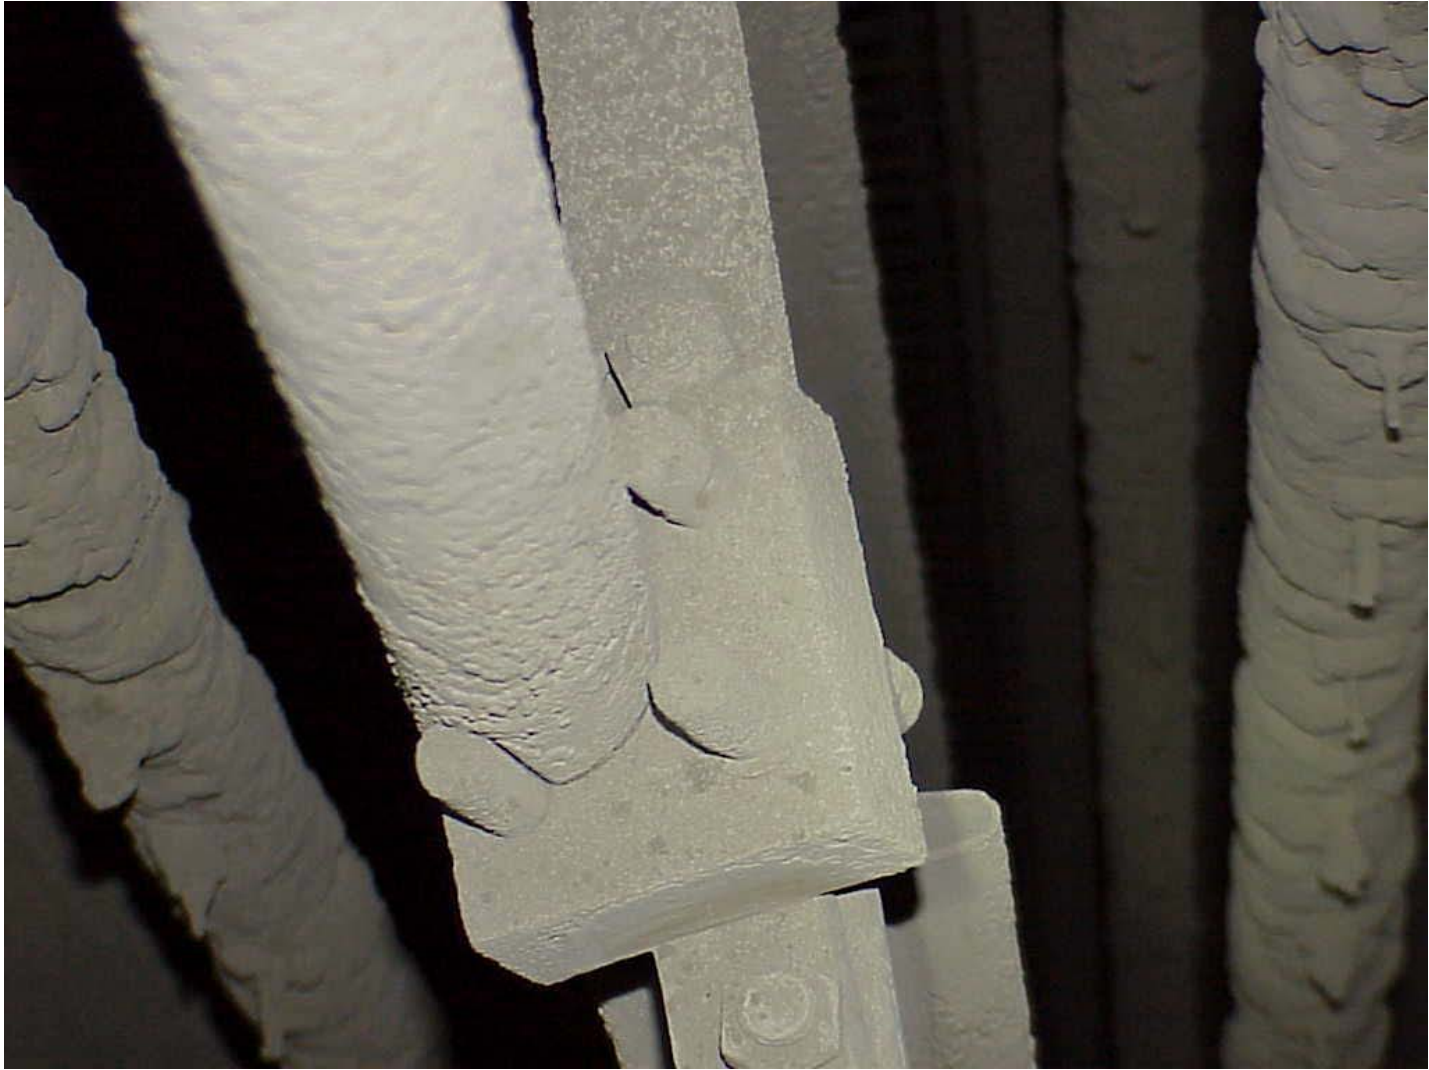
Single Anvil beam is rolling on it's plate support. The solution was to replace the anvil if necessary (due to wear) and add strut extensions to the adjoining plate.

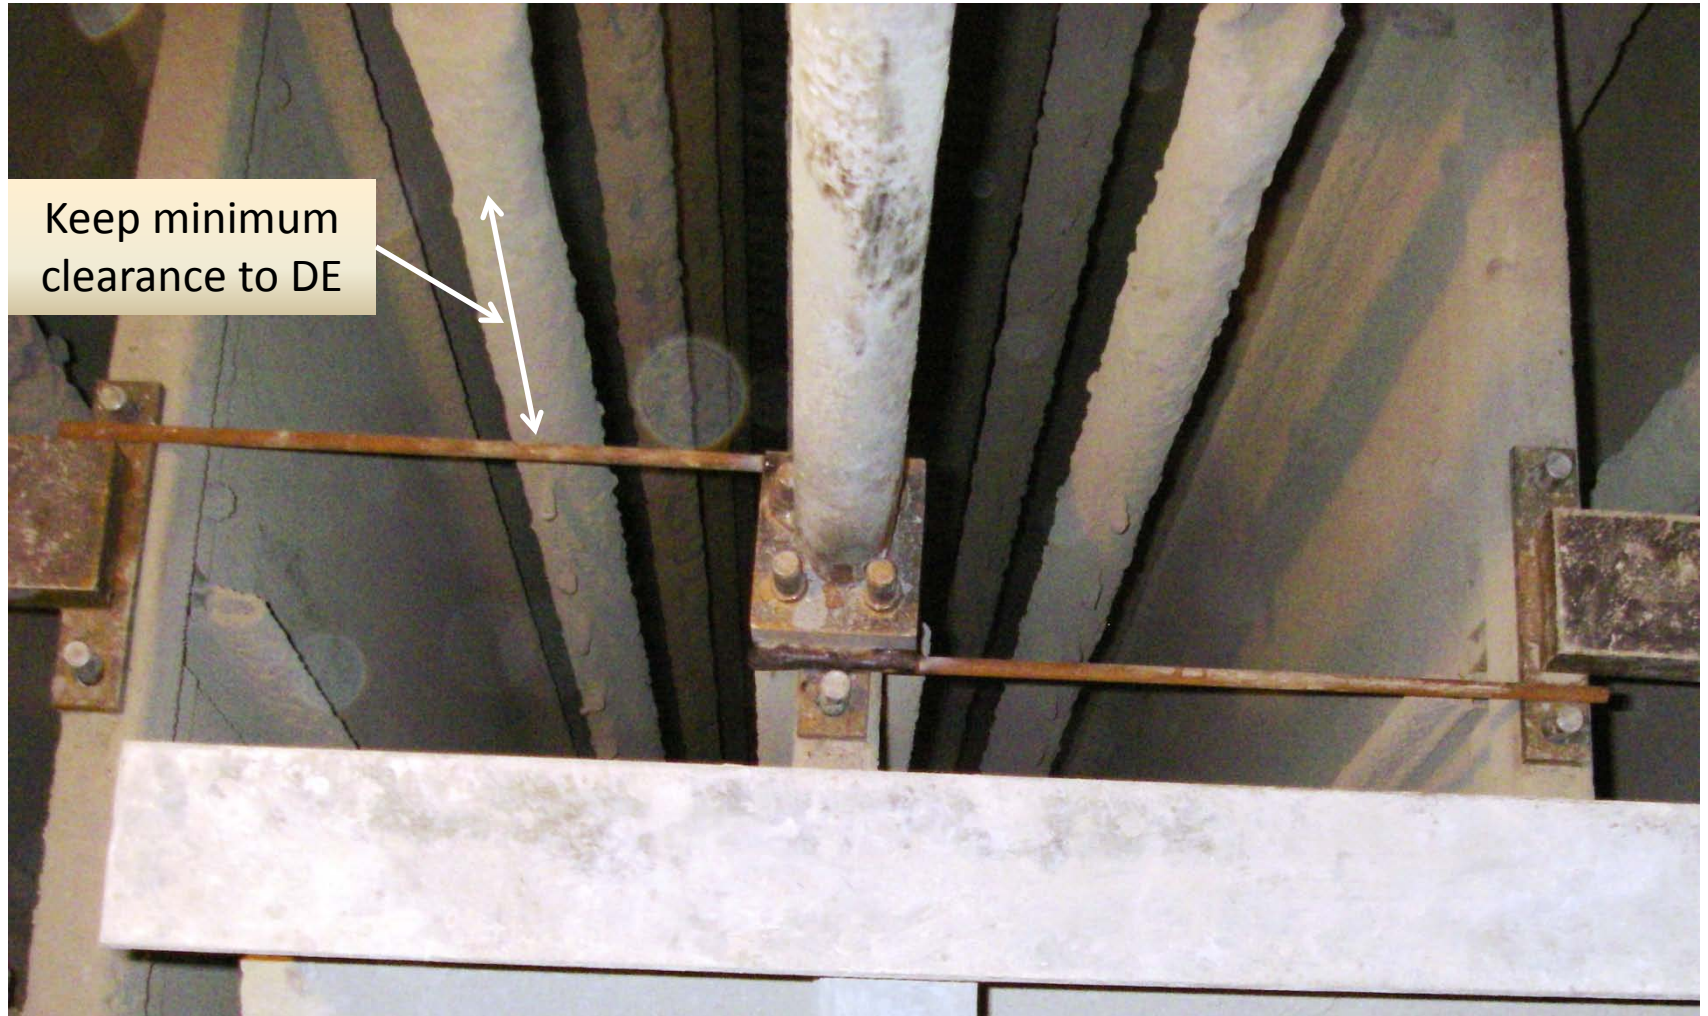
While we're on the anvil beams note how the positioning studs are worn

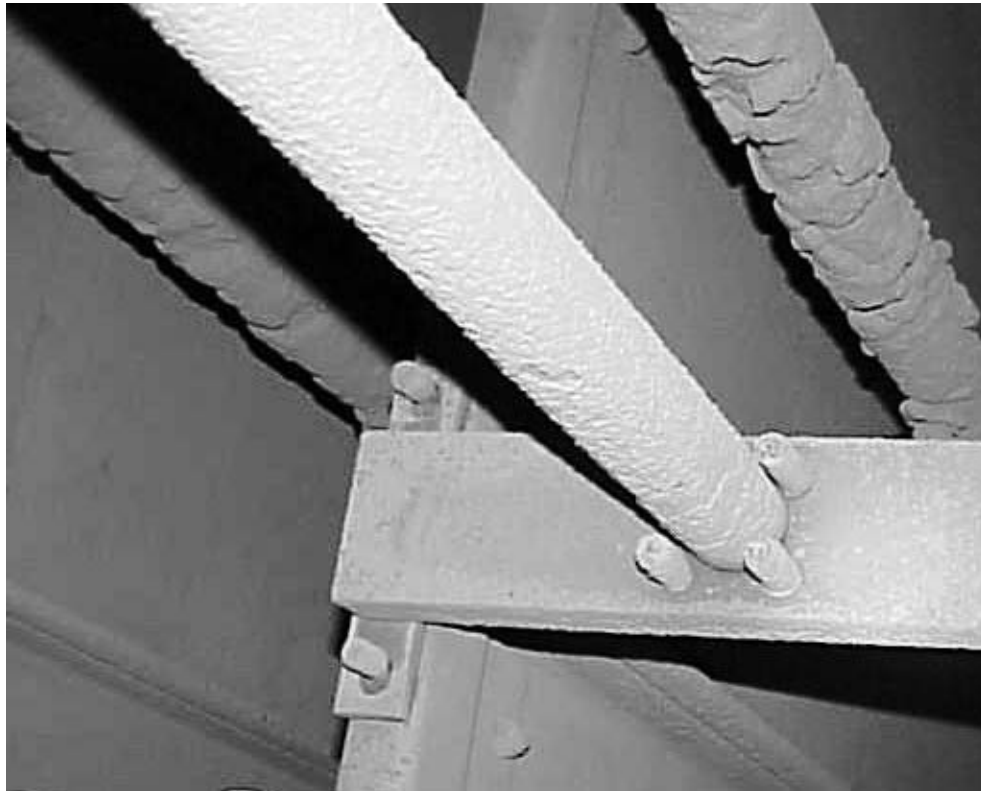
**Elongated
holes and in
some cases
the studs are
worn off**

We replaced the studs on the first row of rappers. These were the hardest hit rappers and the pins were in bad shape. We hired a specialty company to install them. Our on-site contractors removed the rappers and rapper shafts. All the new studs were installed in about a day.

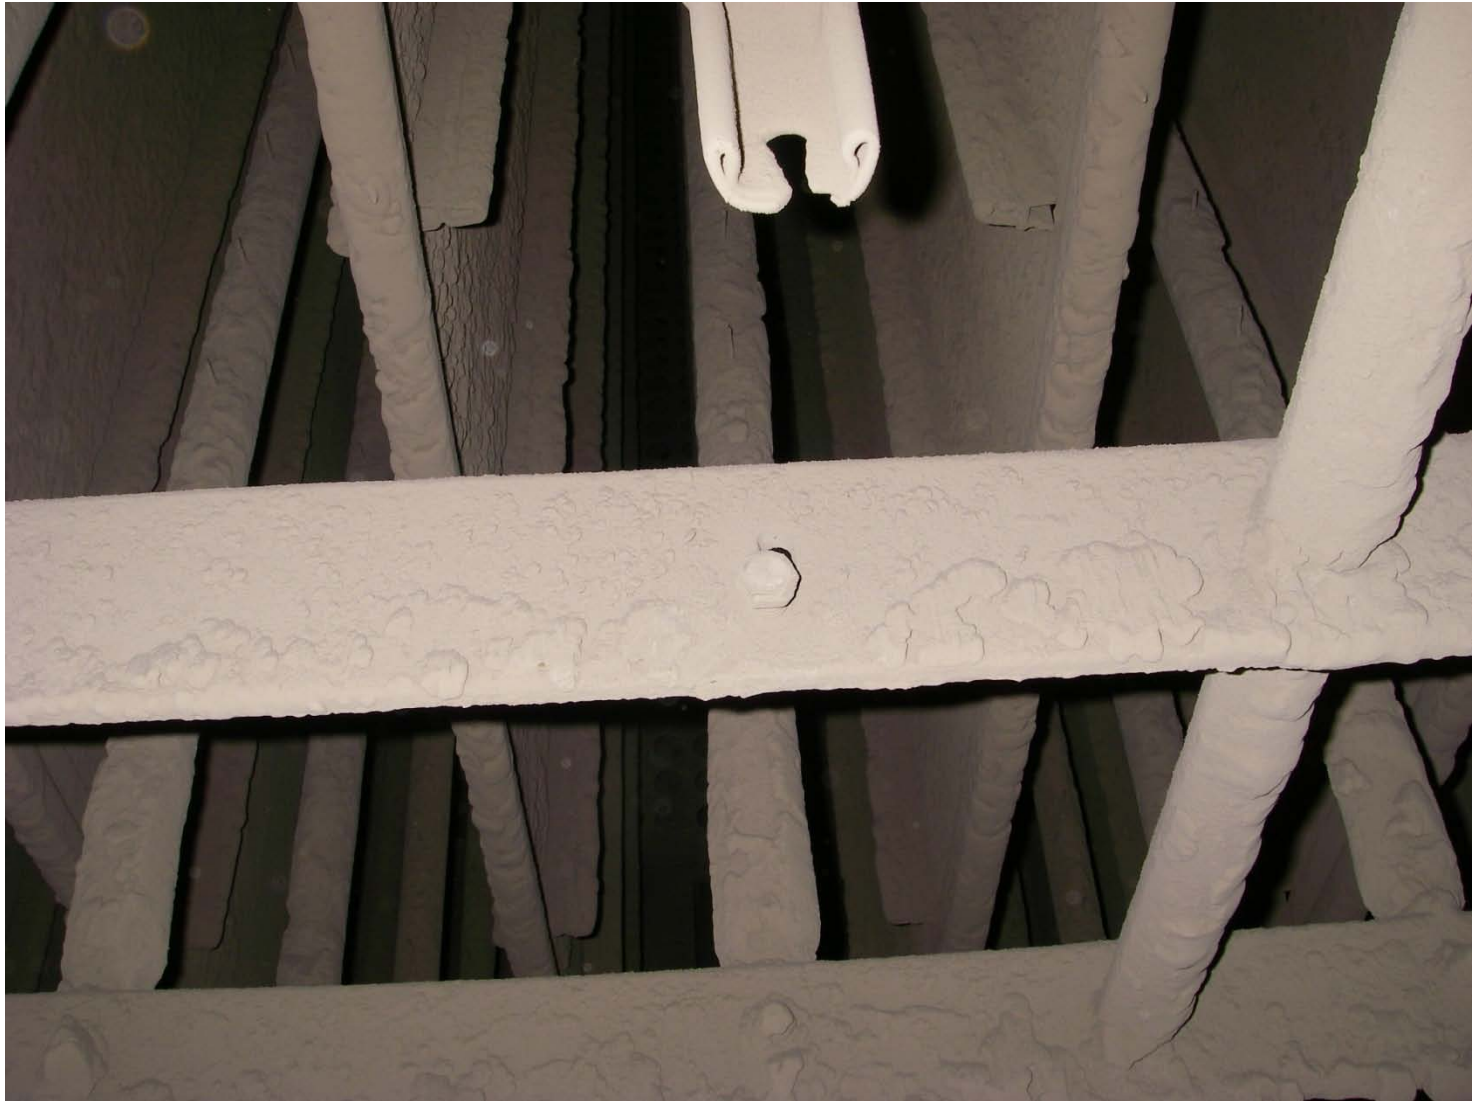
**RDE has slipped
off anchor bolt**

**Results in erratic spark
control/high sparking low
power**

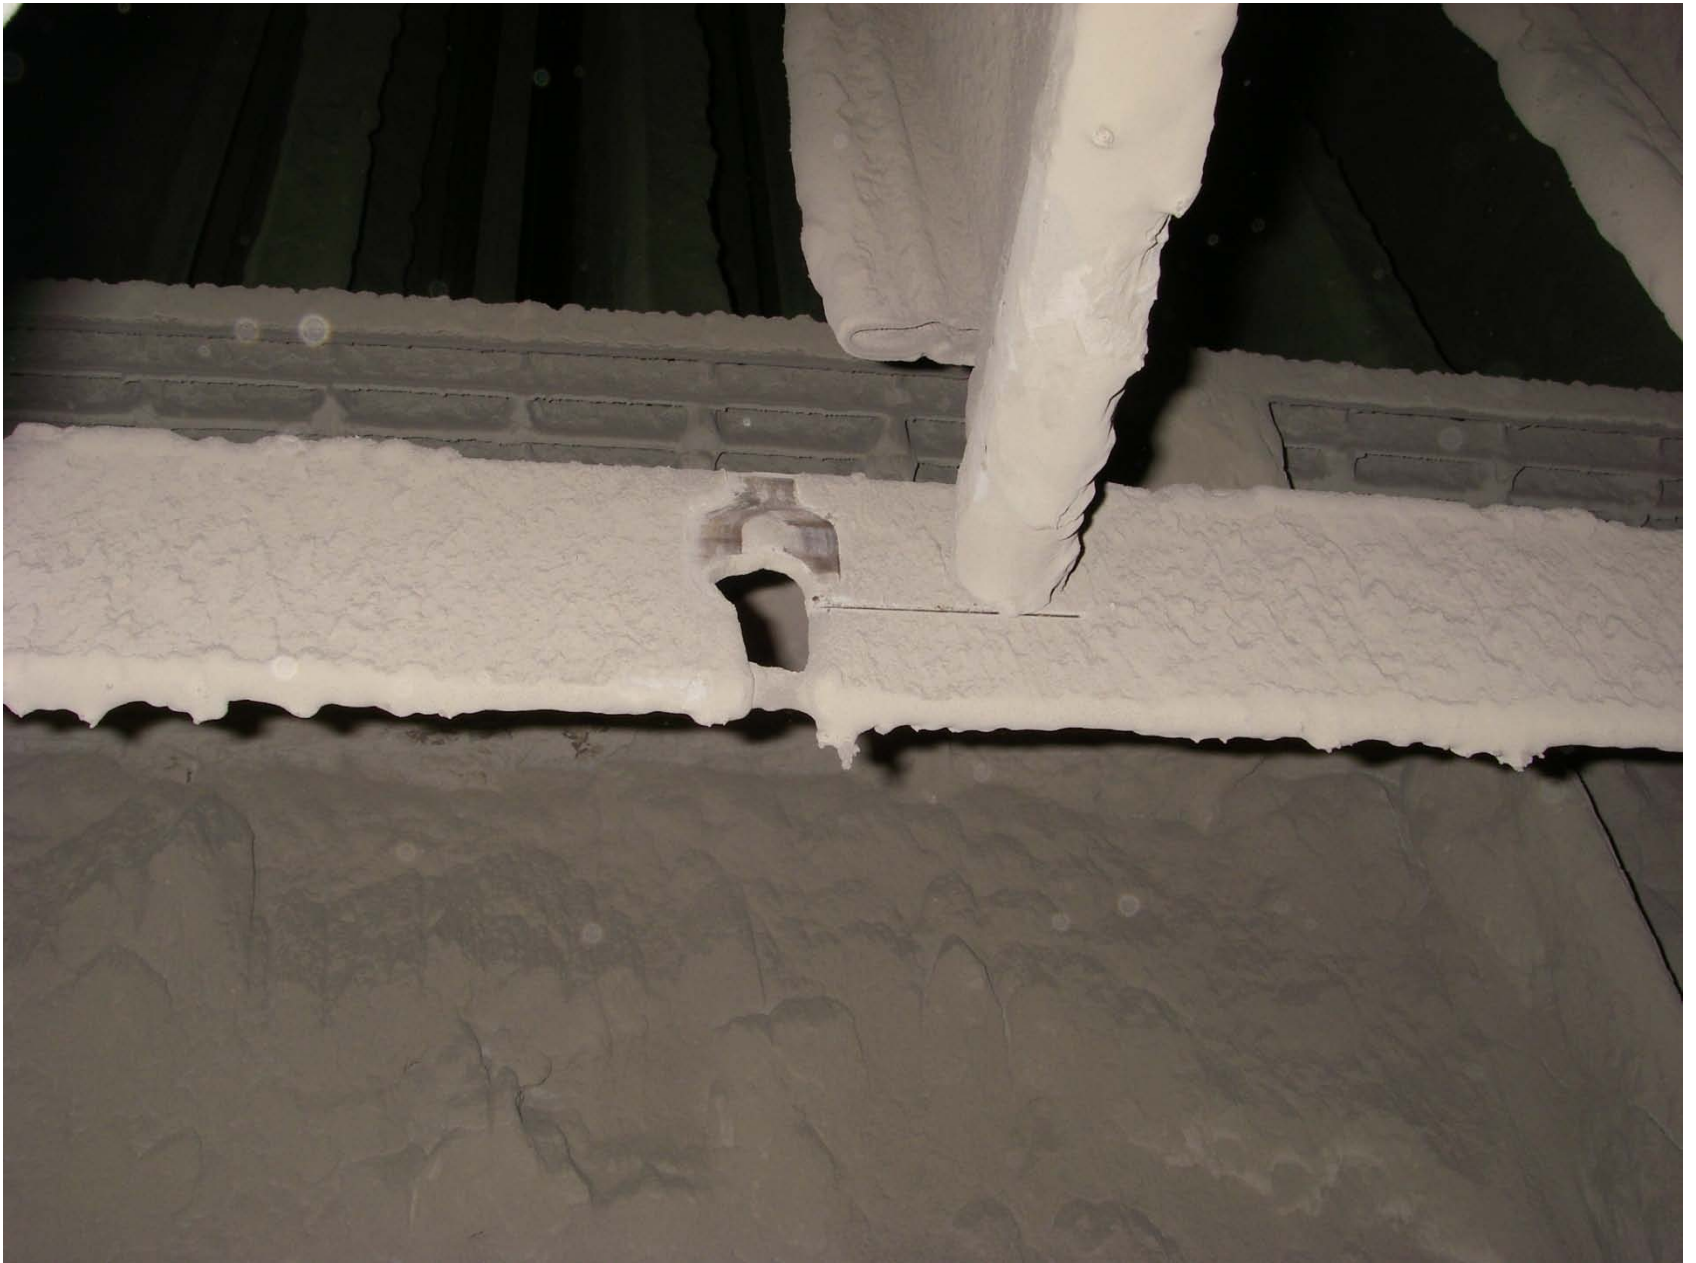
**Bottom plate
attachment has worn
off the anchor bolt.**

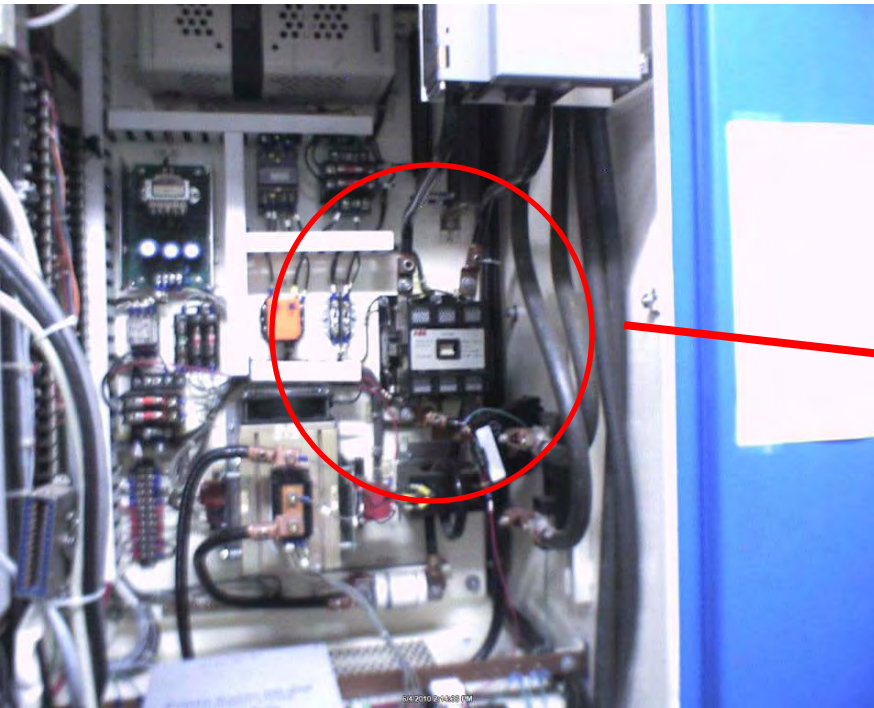
Hot Contactor

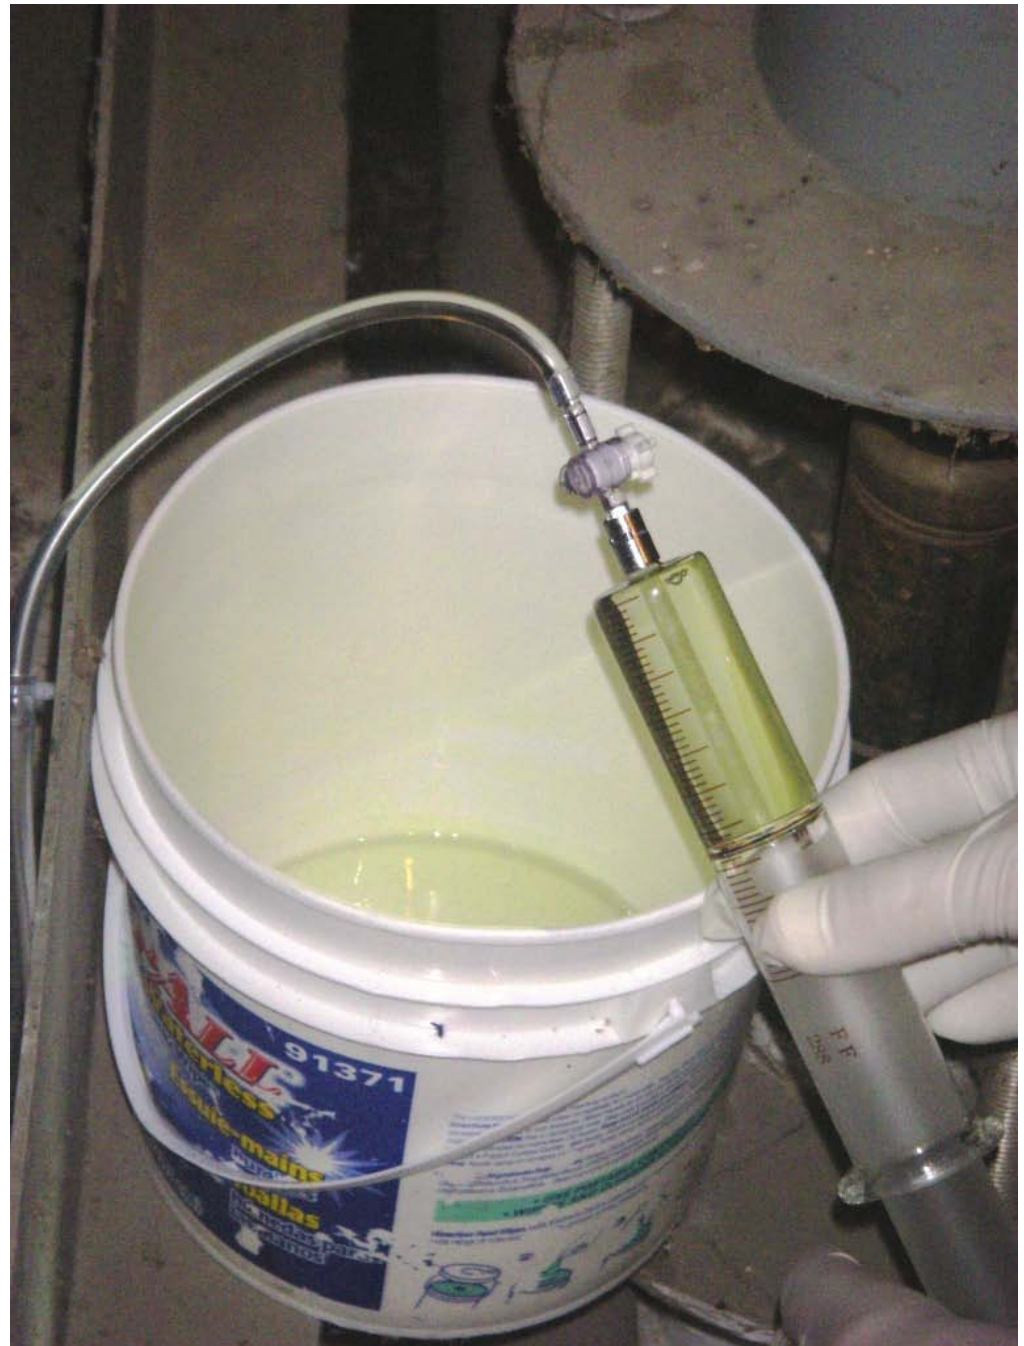
**Is this T/R set
oil good or
bad?**

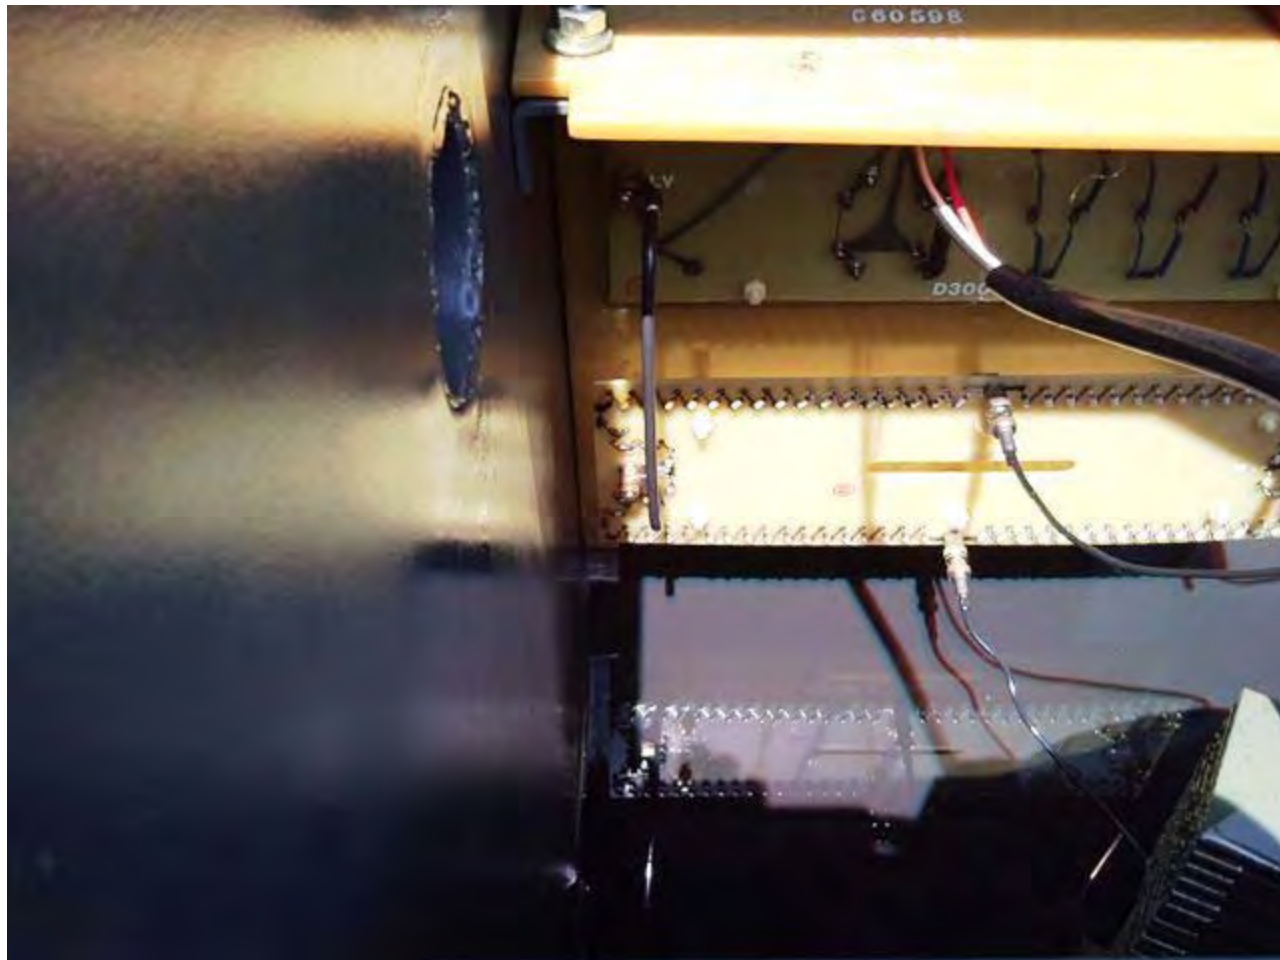
LV Exit Lead, Barrier or Boot

The following show some components of a T/R set that are failing and causing flammable gas readings via DGA testing. You can catch some of these before they cost you an expensive repair. Other common causes not illustrated are HV Choke coil and High Voltage Dividing Resistor.

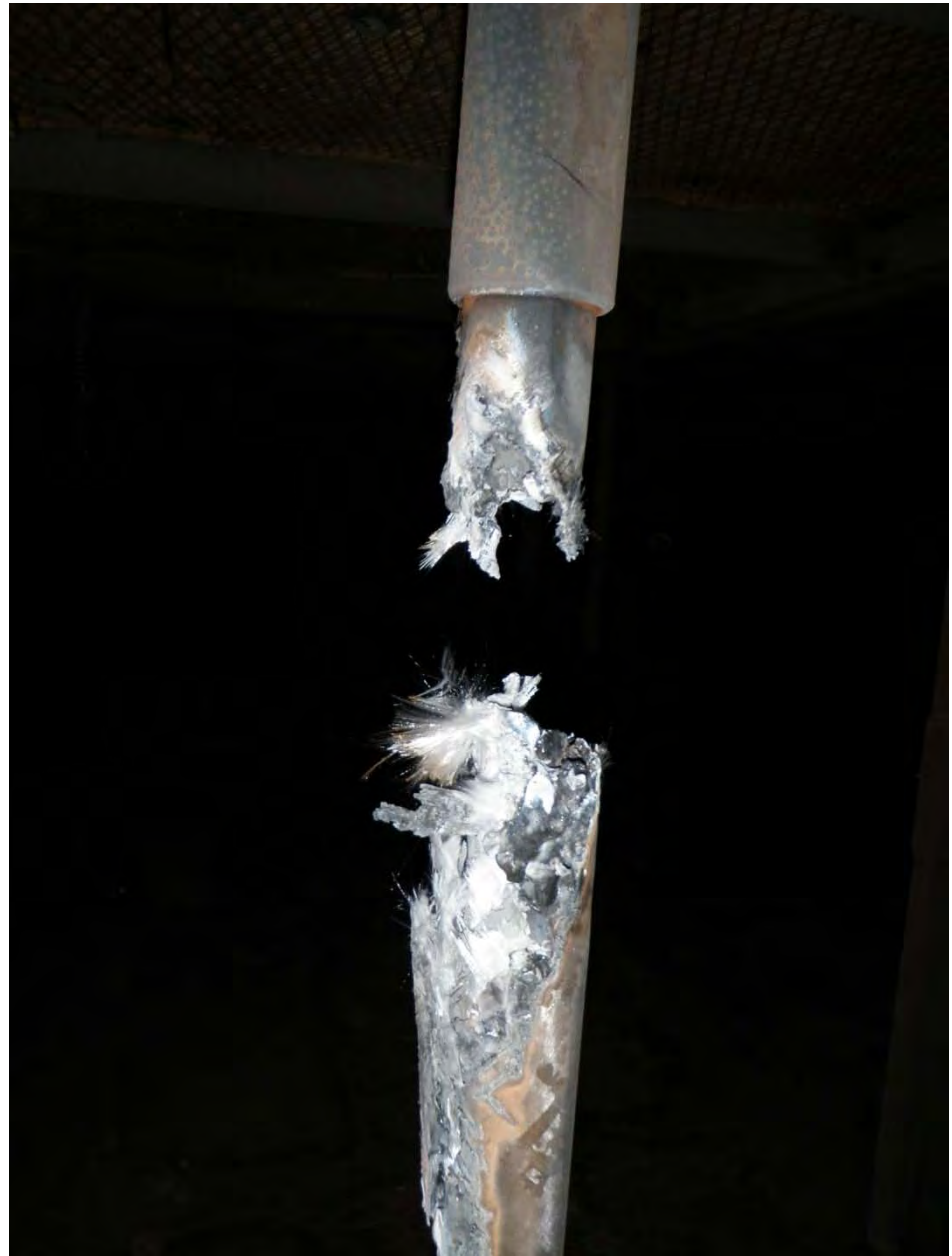
HV Rapper shaft insulation failure

**These are made of
fiberglass to insulate
the grounded rapper
hammer from the HV
Electrode frame.**
