Photos of Precipitator Problems

John Walker Sr. Engineer Duke Energy

PCUG Roundtable
St.Louis-Host AMEREN
July 8, 2013

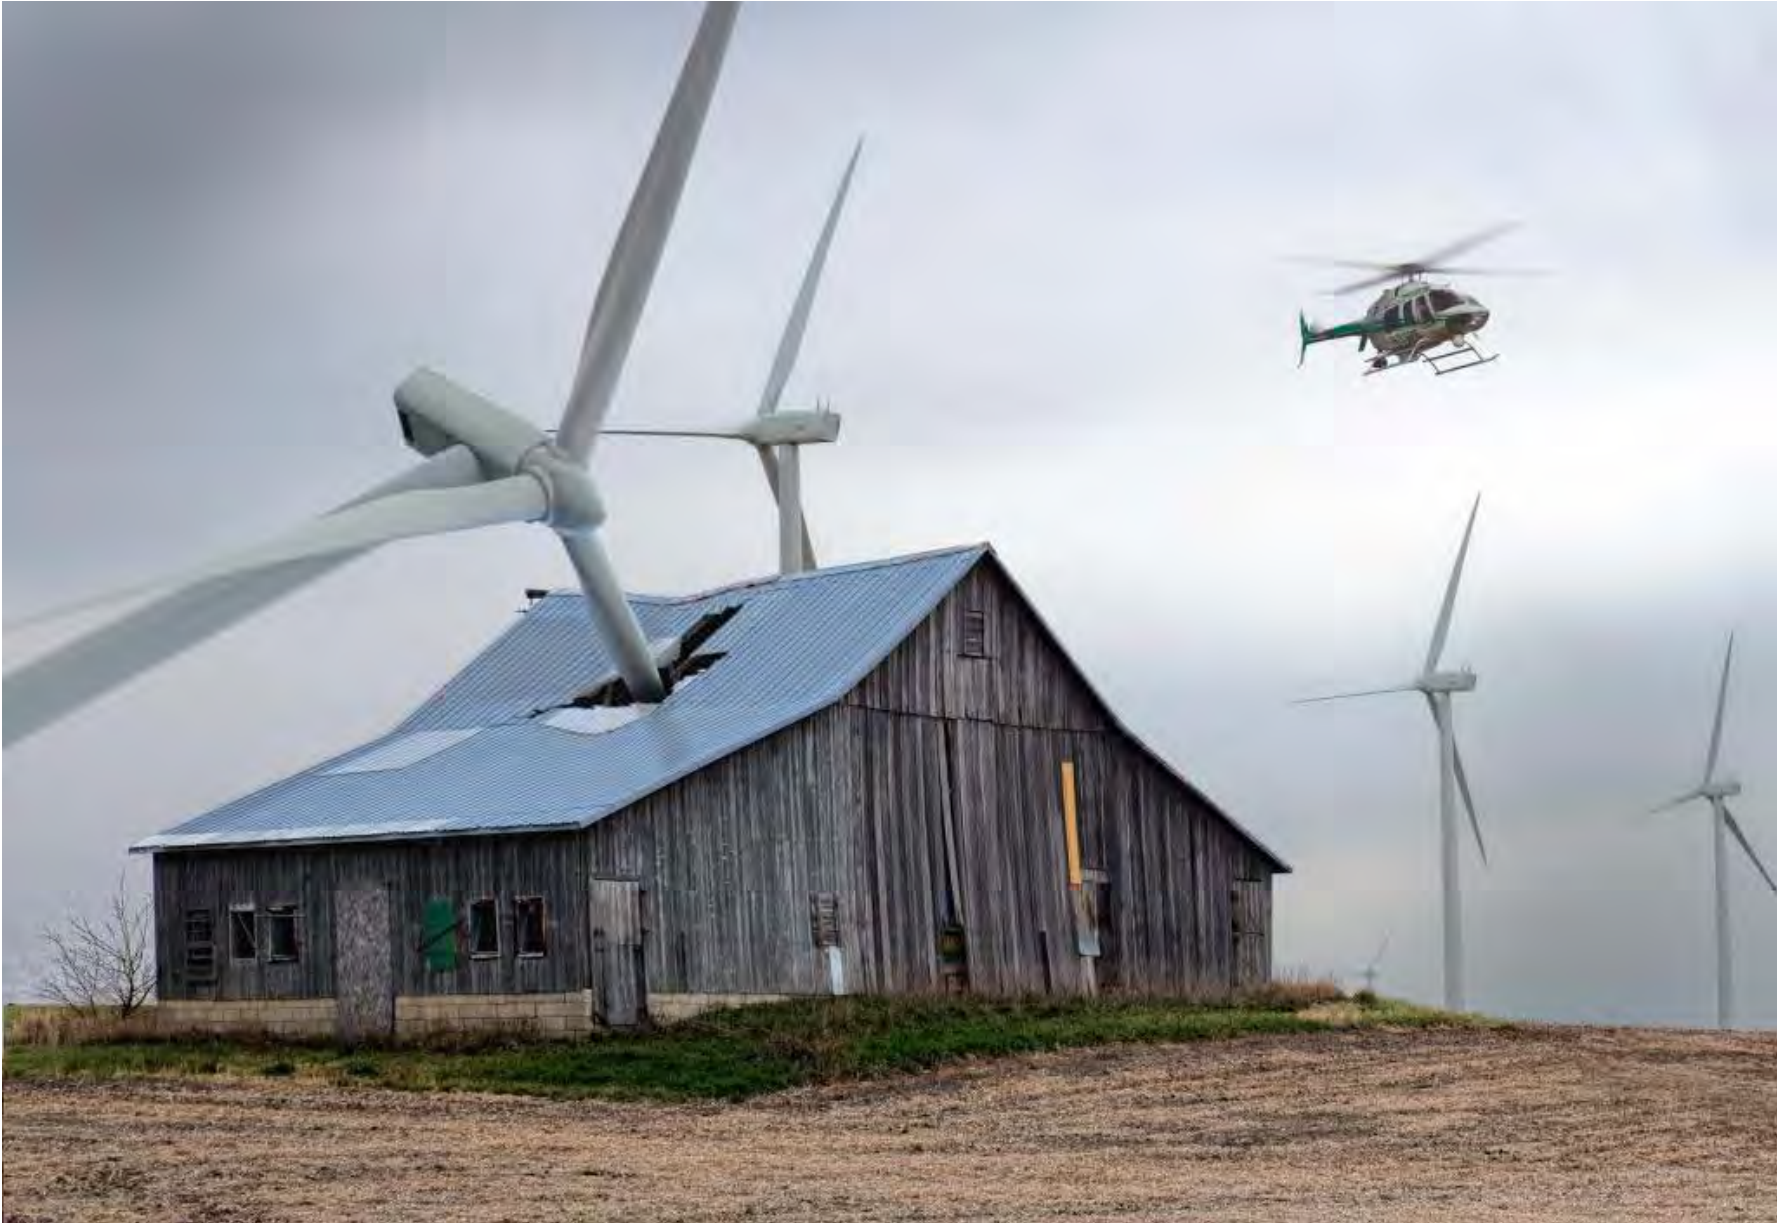
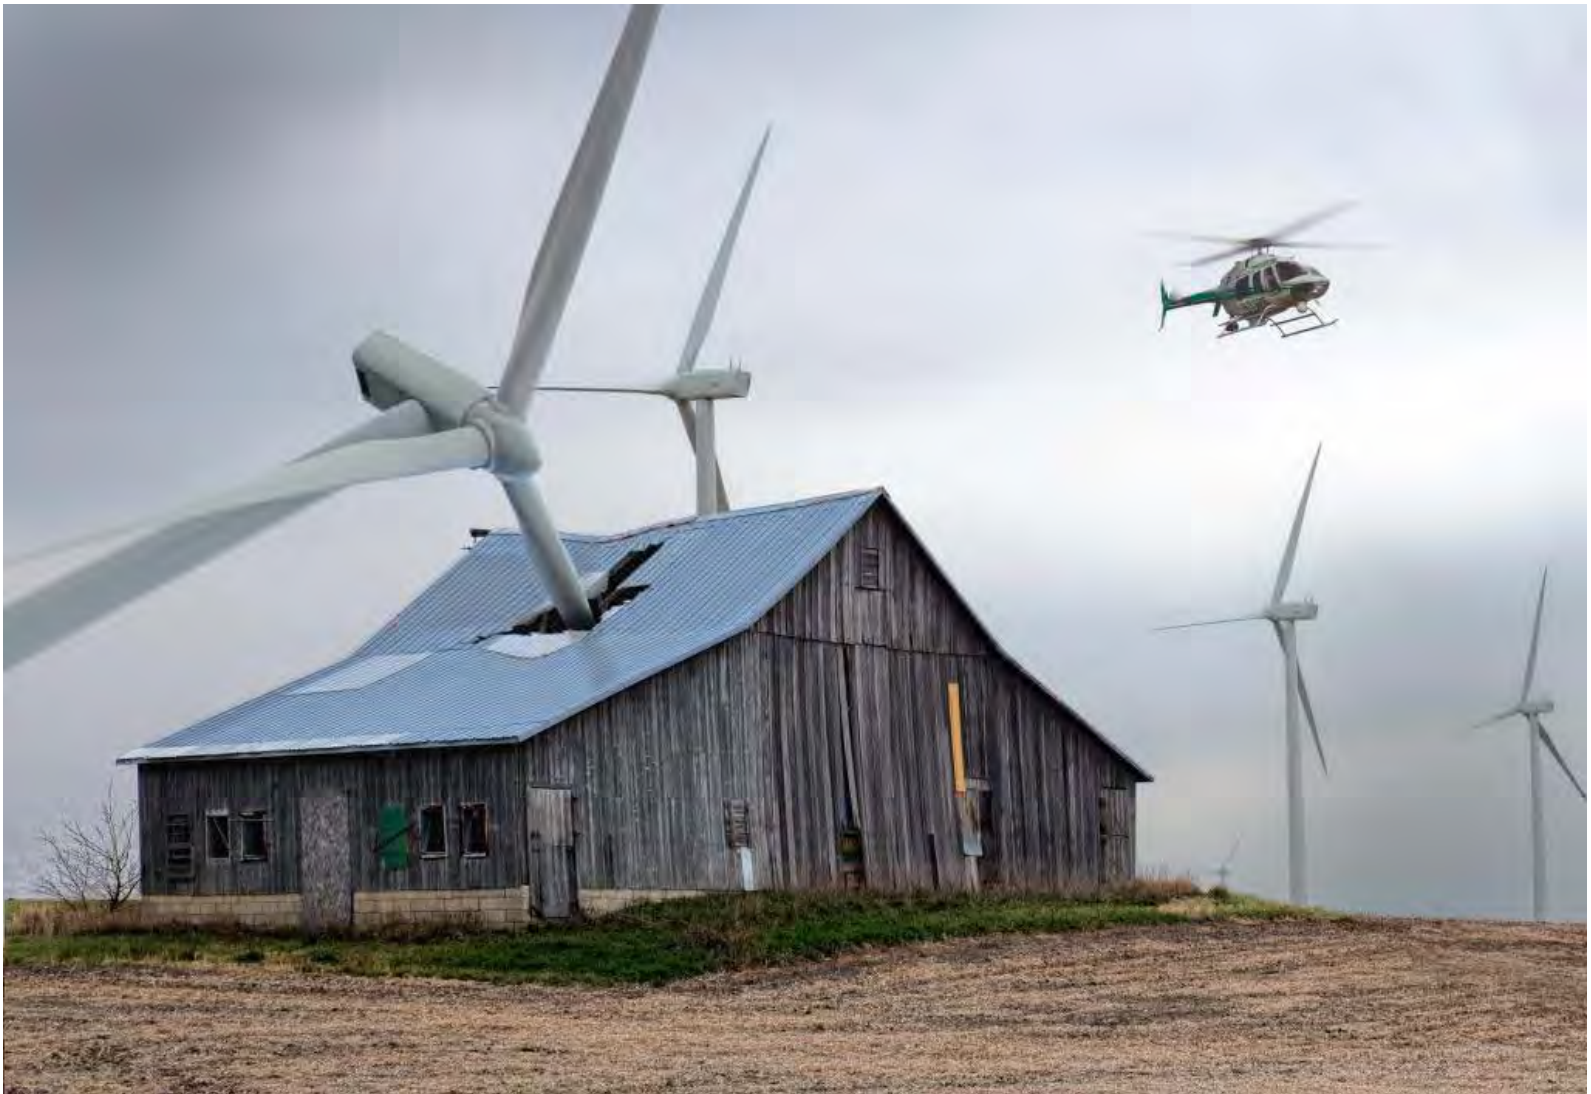
Every Industry has it's challenges. The root cause for this may have been cattle bumping the foundation or something.....
