2025 Reinhold/PCUG Round Table Presentation

SCR & LPA Screen Efficiency

APS Four Corners Case Study

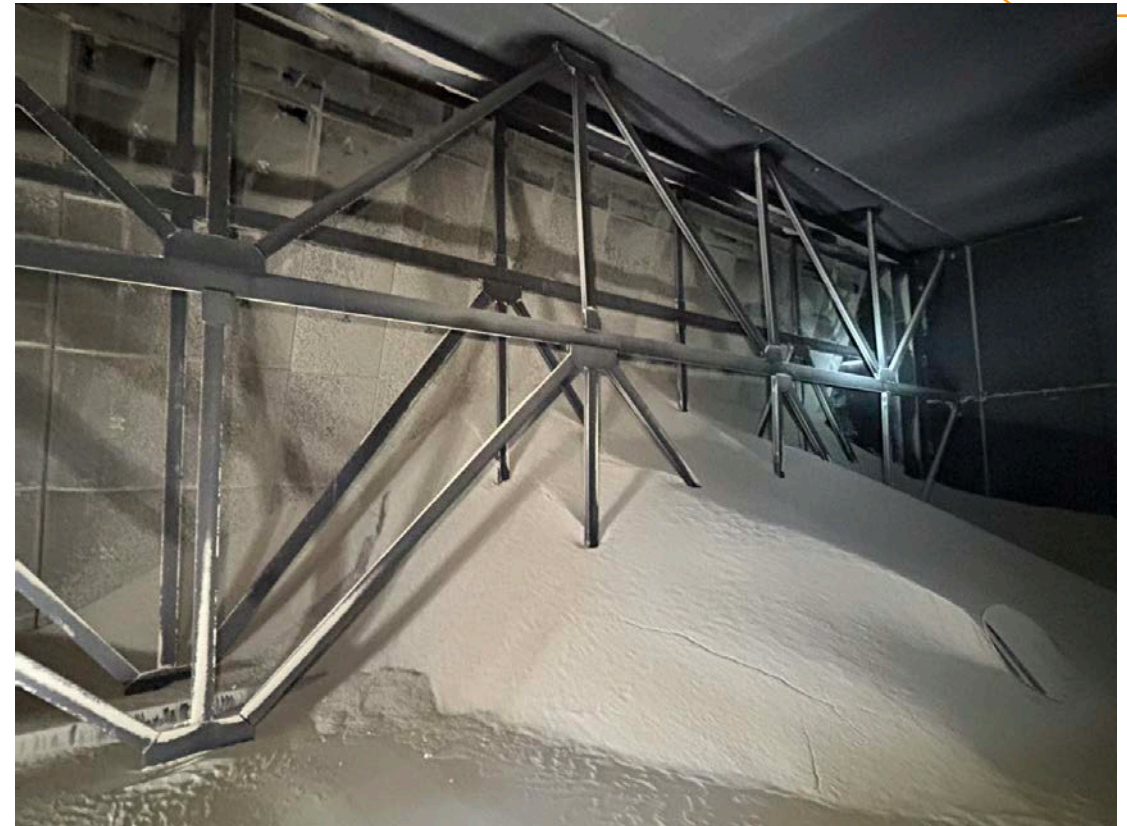
- Screw Conveyor was inoperable due to continued maintenance issues
- Ash Piled at Screw Conveyor Blocking >50% of the screen
- LPA at Four Corners exhibited characteristics of slag and ash LPA types with a porous, sintered matrix surrounded by fly ash agglomerates.
 - I.E Very Erosive
- Reduced LPA Screen surface area due to plugging

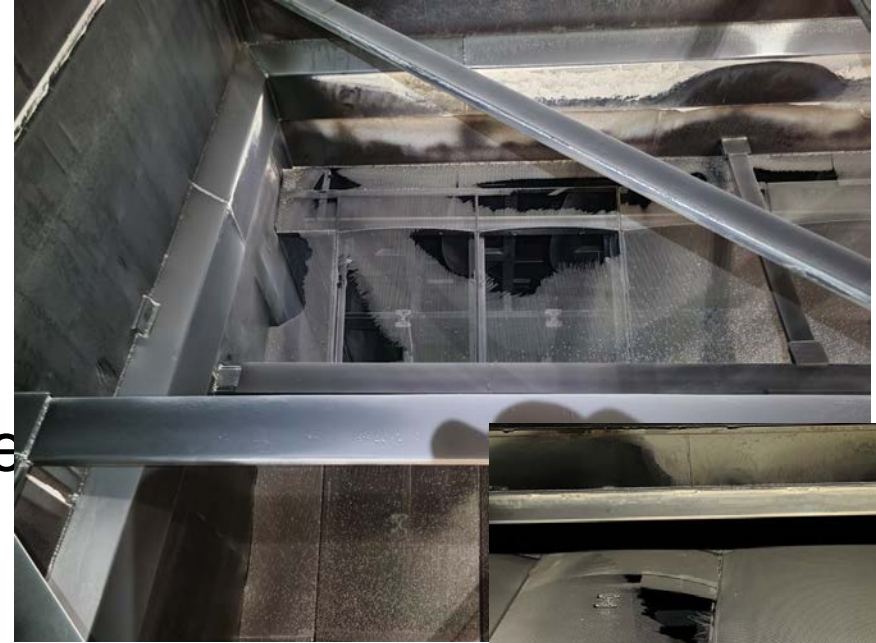
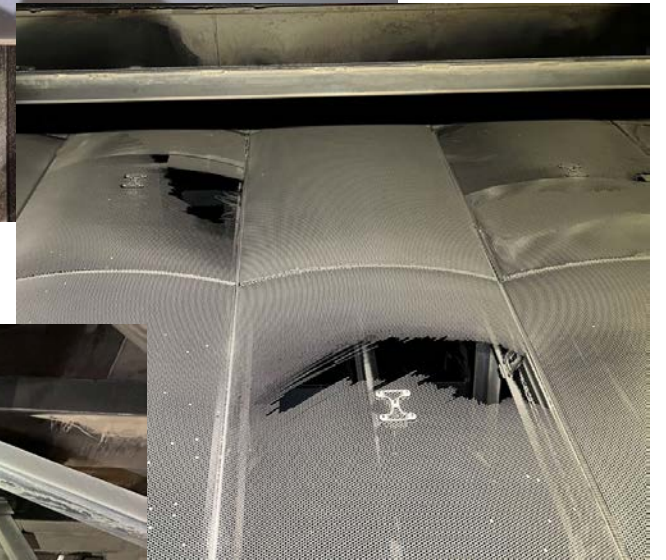
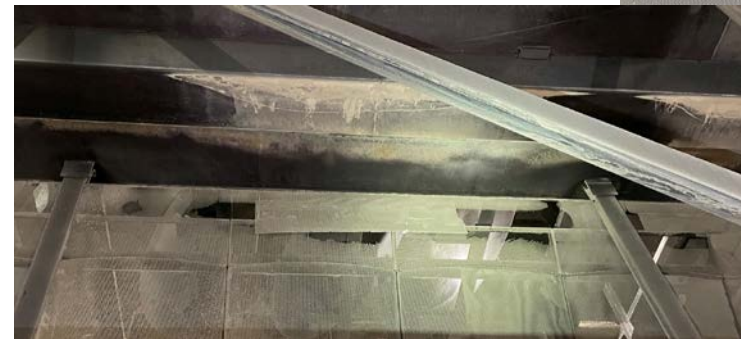
- Ash Piling Increased velocities through the screen, significantly decreasing screen life
 - Holes developed – they were incorrectly repaired or not repaired
 - LPA broke through to SCR, Preheater, Baghouse, etc.
- Rappers were ineffective in clearing screen due to flow disruptions

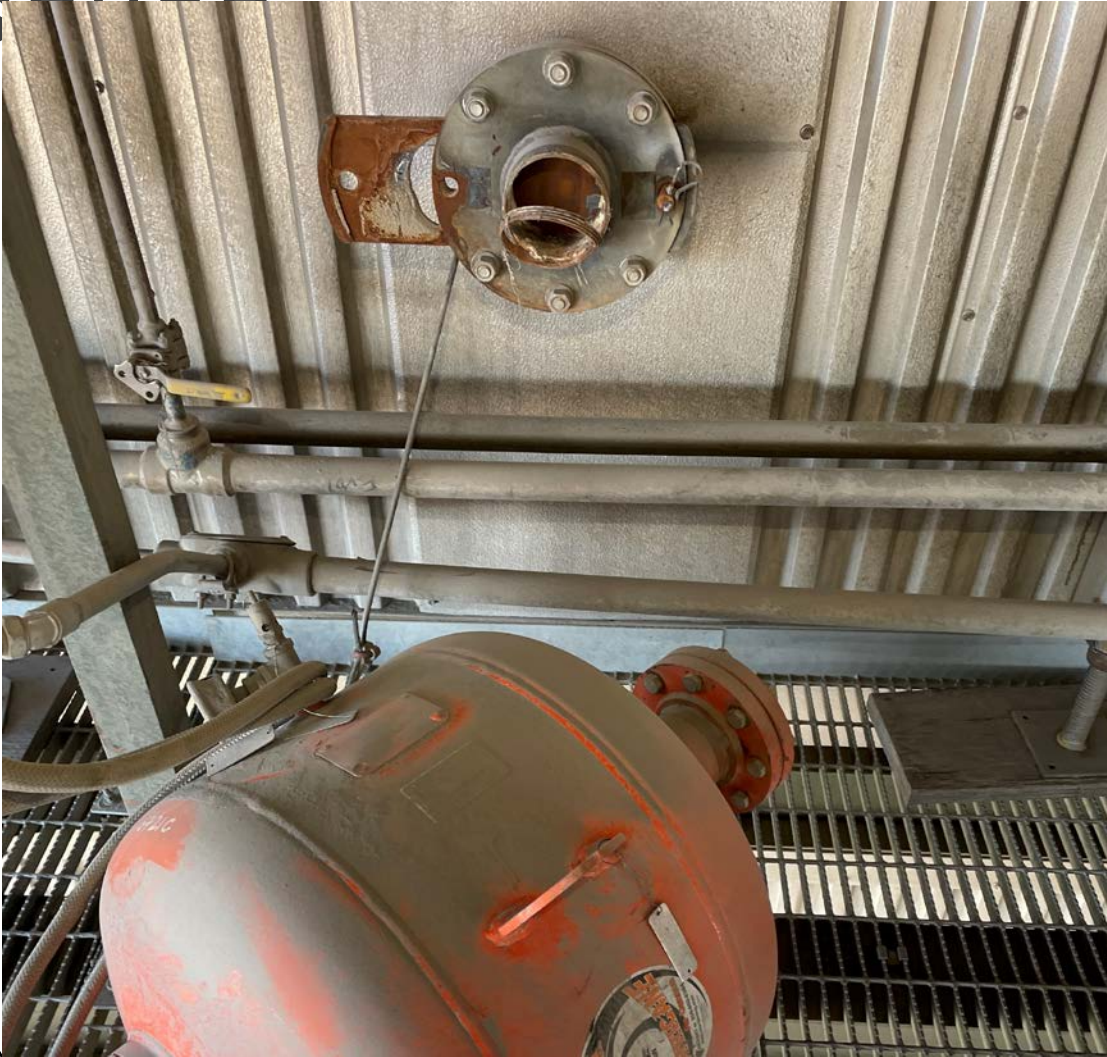
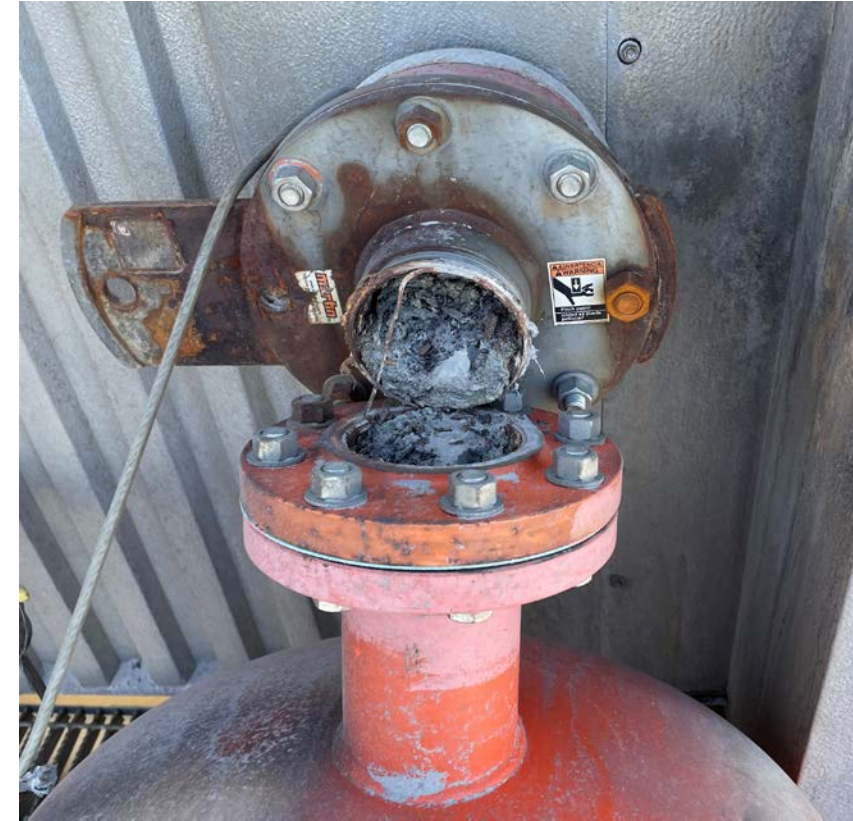
- Four Corners has a positive pressure system
 - Ash back flowed into Air Cannons
- Air Cannons Corroded
 - MI NDA determined end of life of Air Cannons would be 2028
 - Maintaining system required inspection on all 64 pressure Vessels and replacing pressure reliefs per ASME Code
- Thermal Safety Shields (Gate Valves) Failed causing Safety Issues
 - Sch. 40 Pipe was threaded, creating a thin area. Corrosion caused failure
 - Air Cannons were shooting off the unit – MAJOR safety concern.

Corrosion from Positive Pressure System

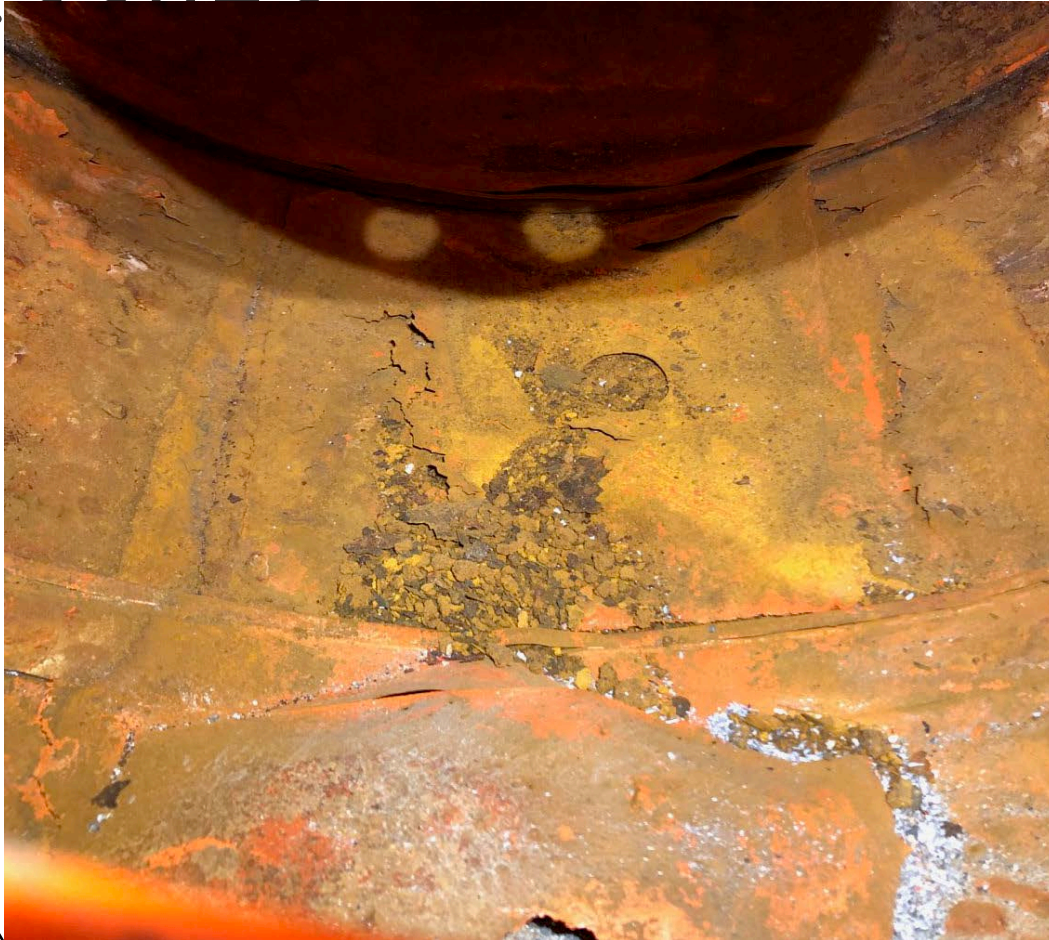
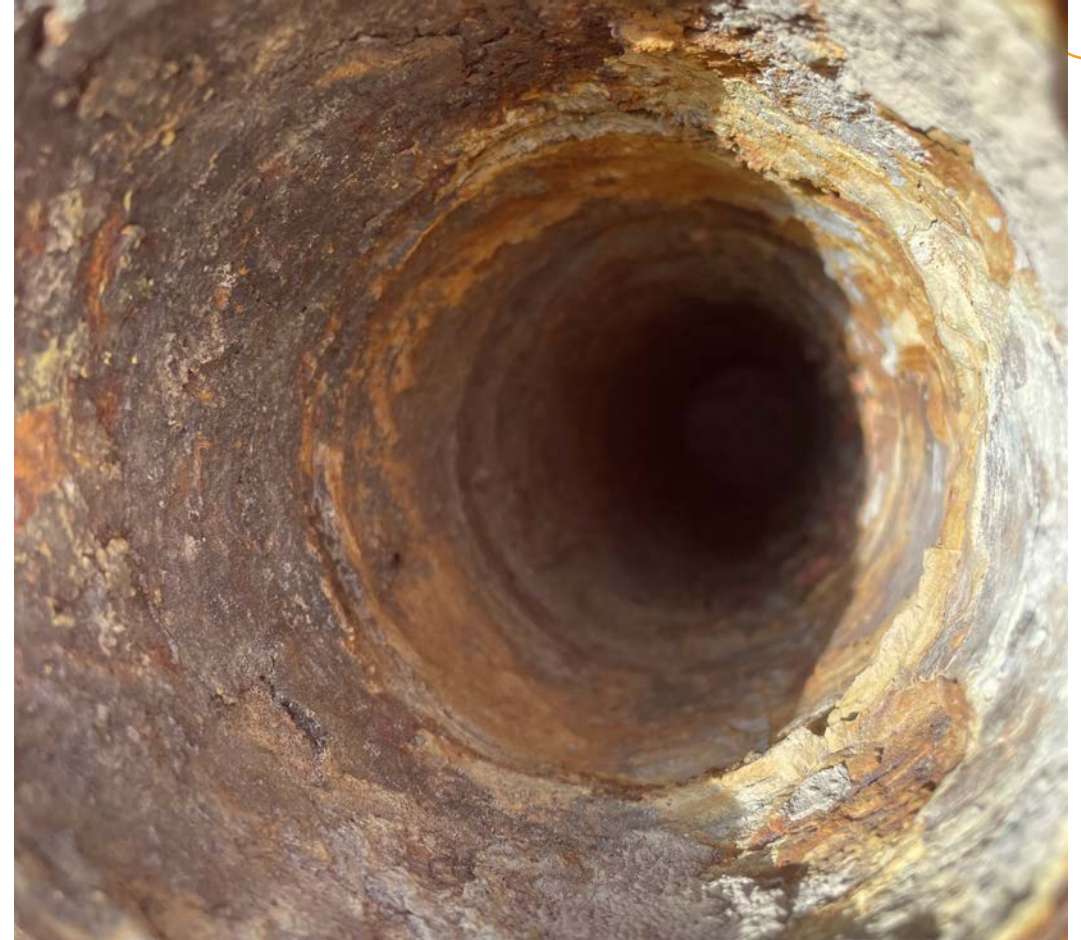
Corrosion from Positive Pressure System

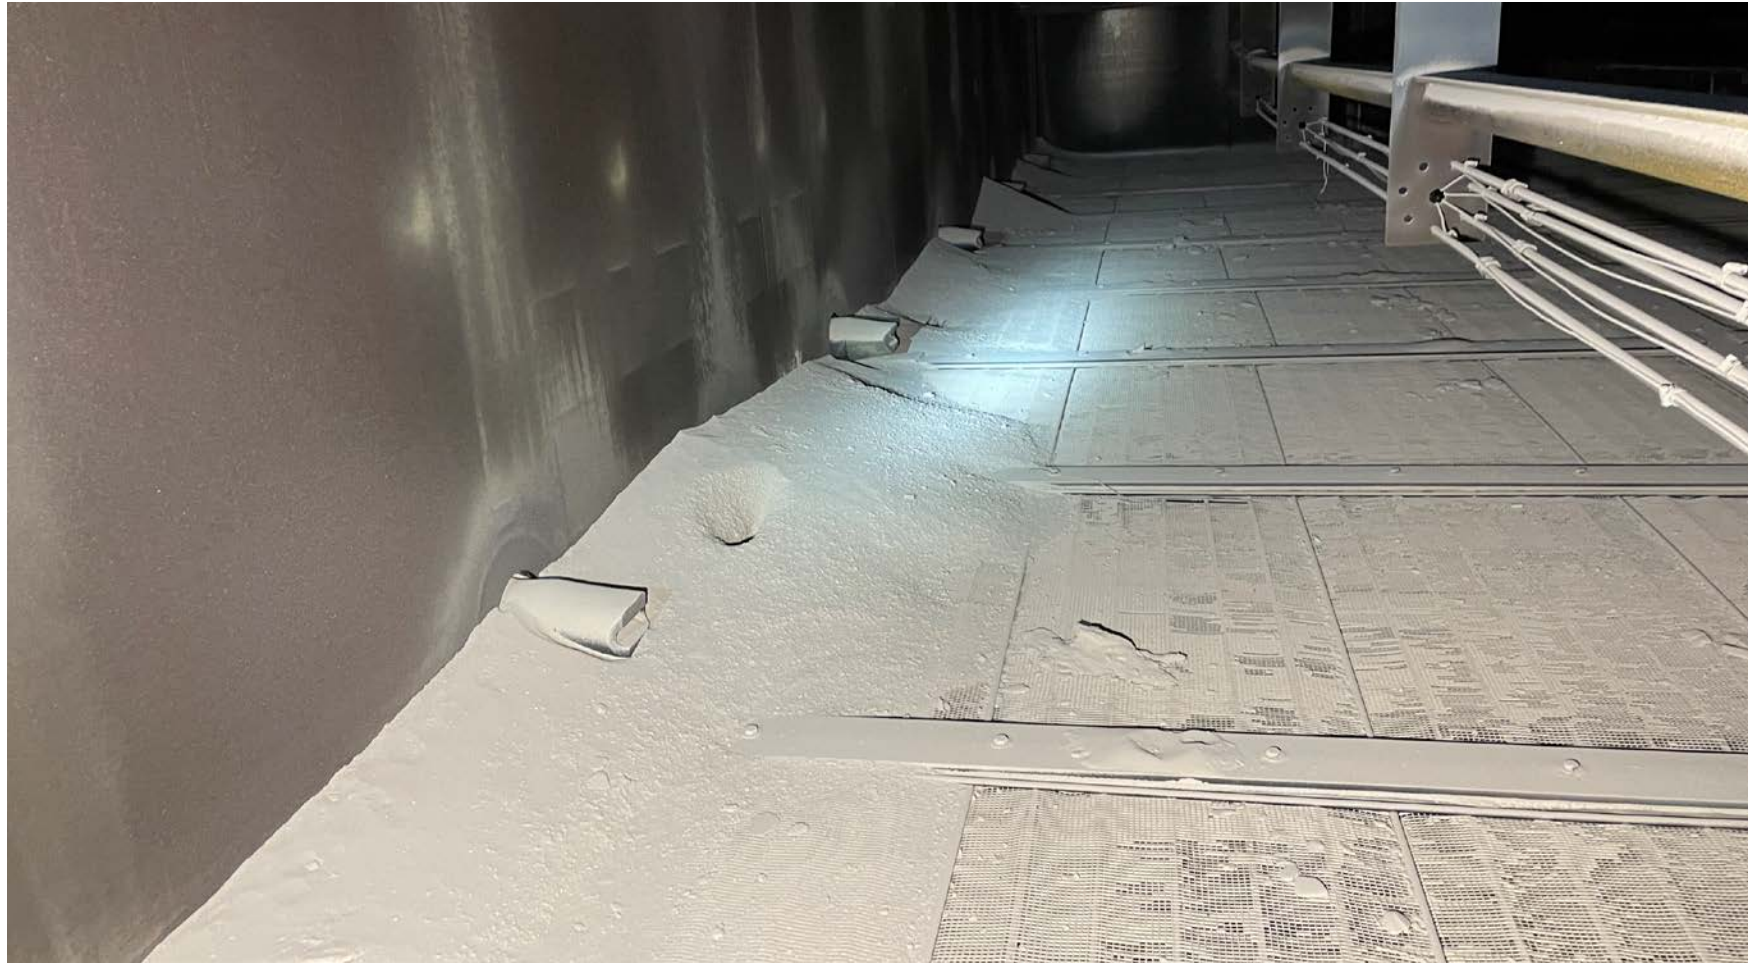
Unit 4 1st Layer Plugging

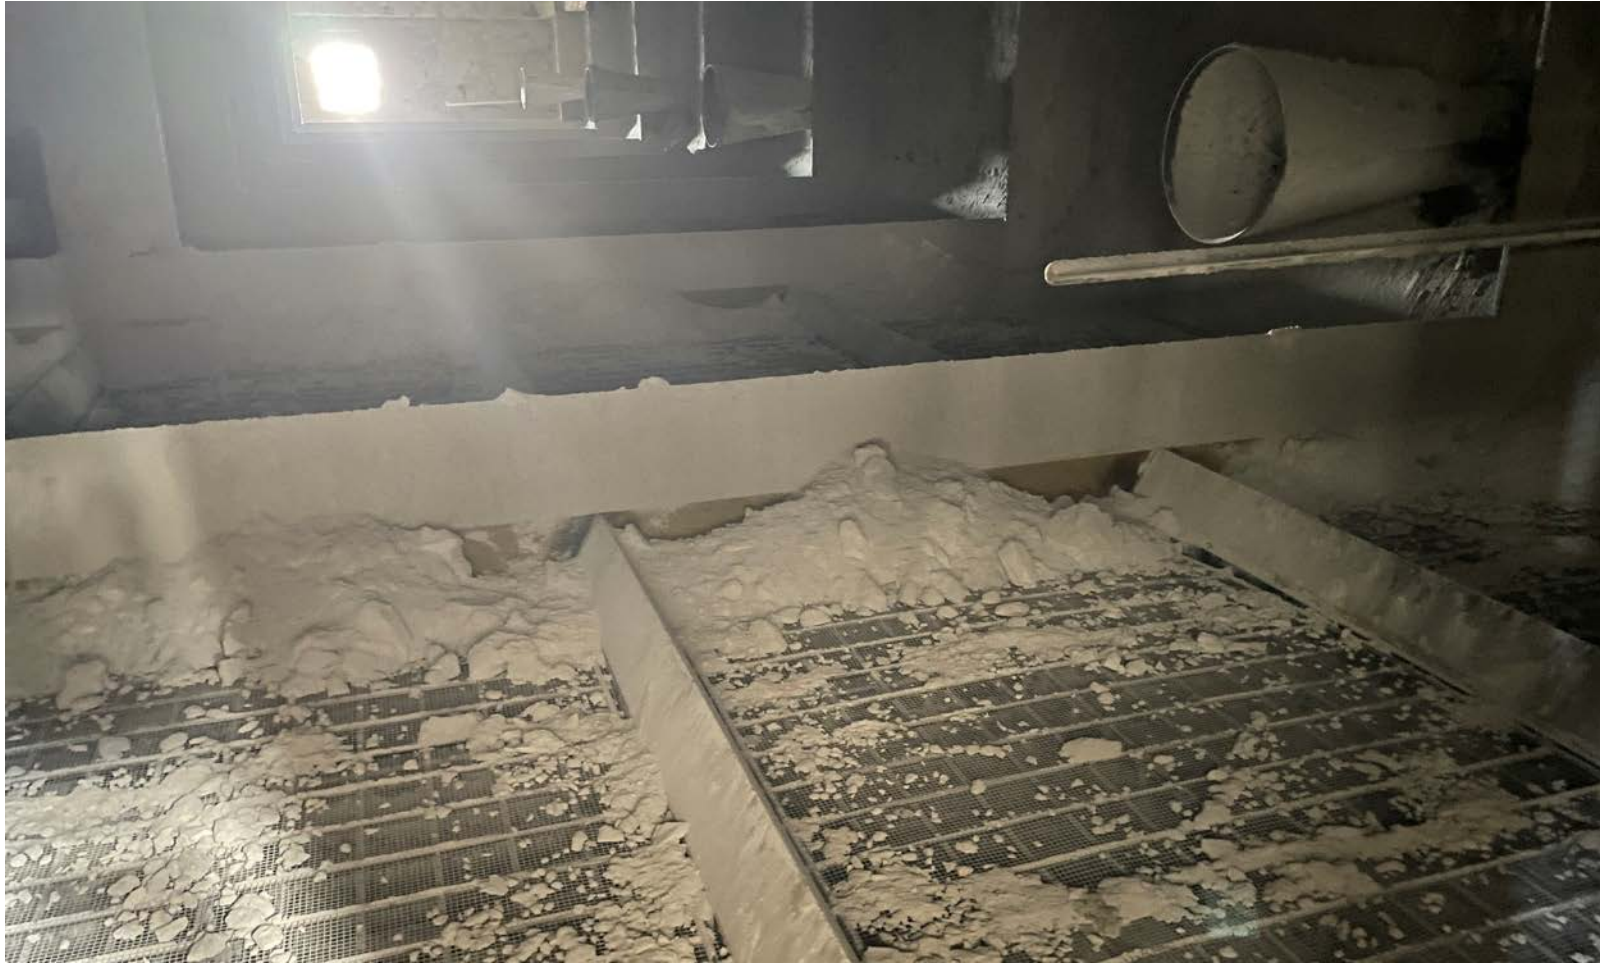
Unit 4 2nd Layer Plugging

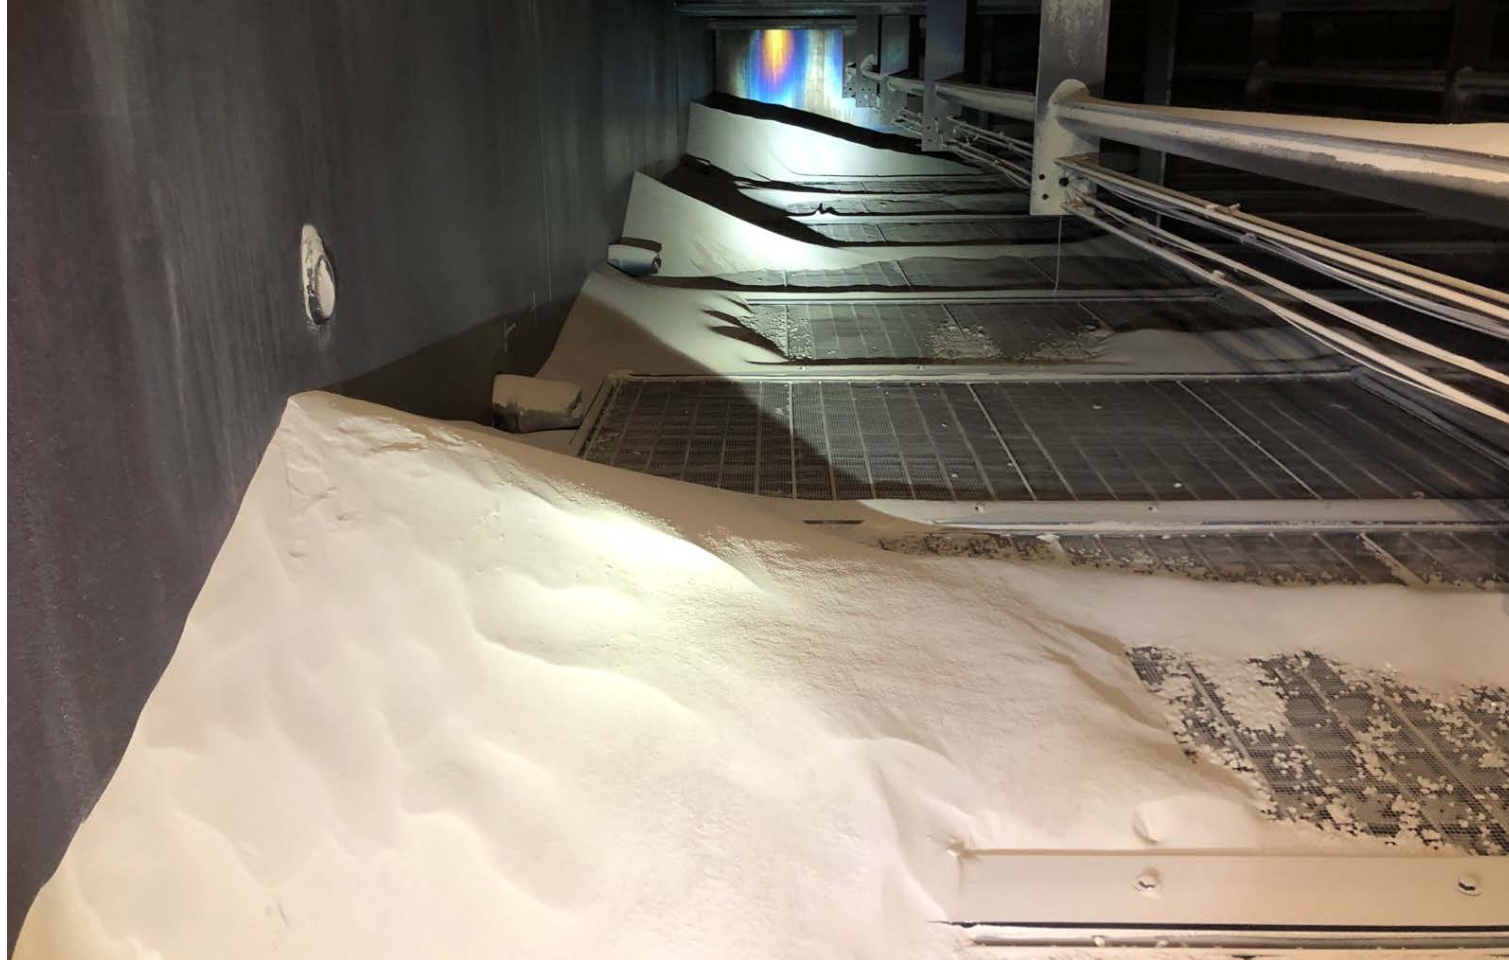
Unit 5 1st Layer Plugging

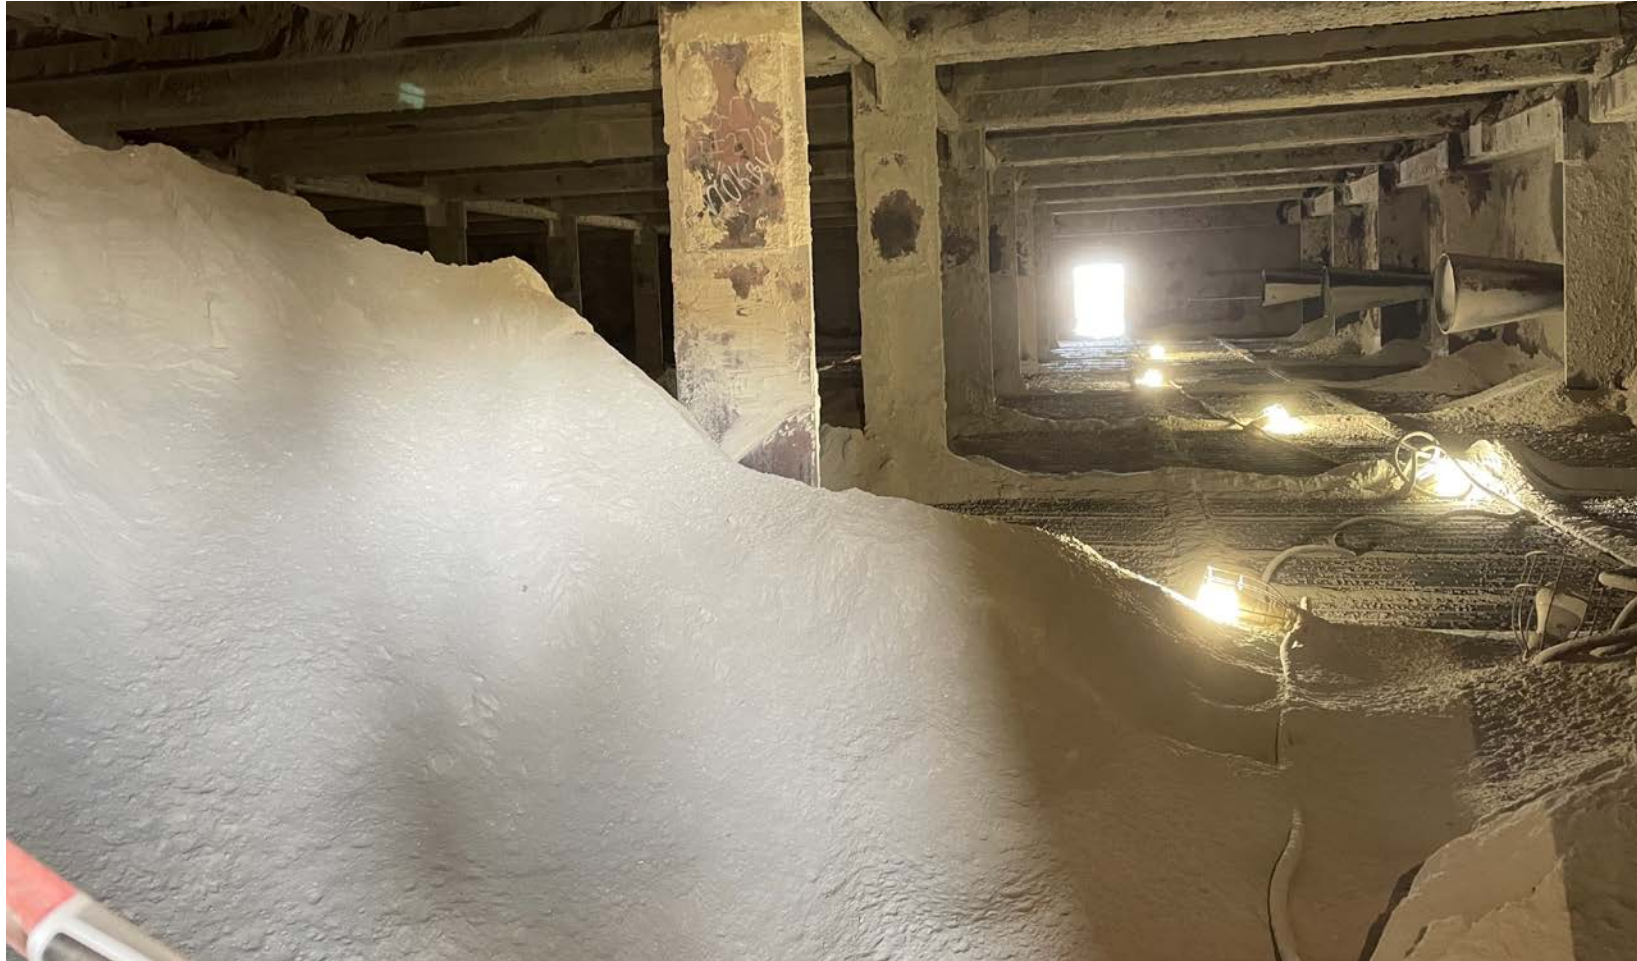
Unit 5 2nd Layer Plugging

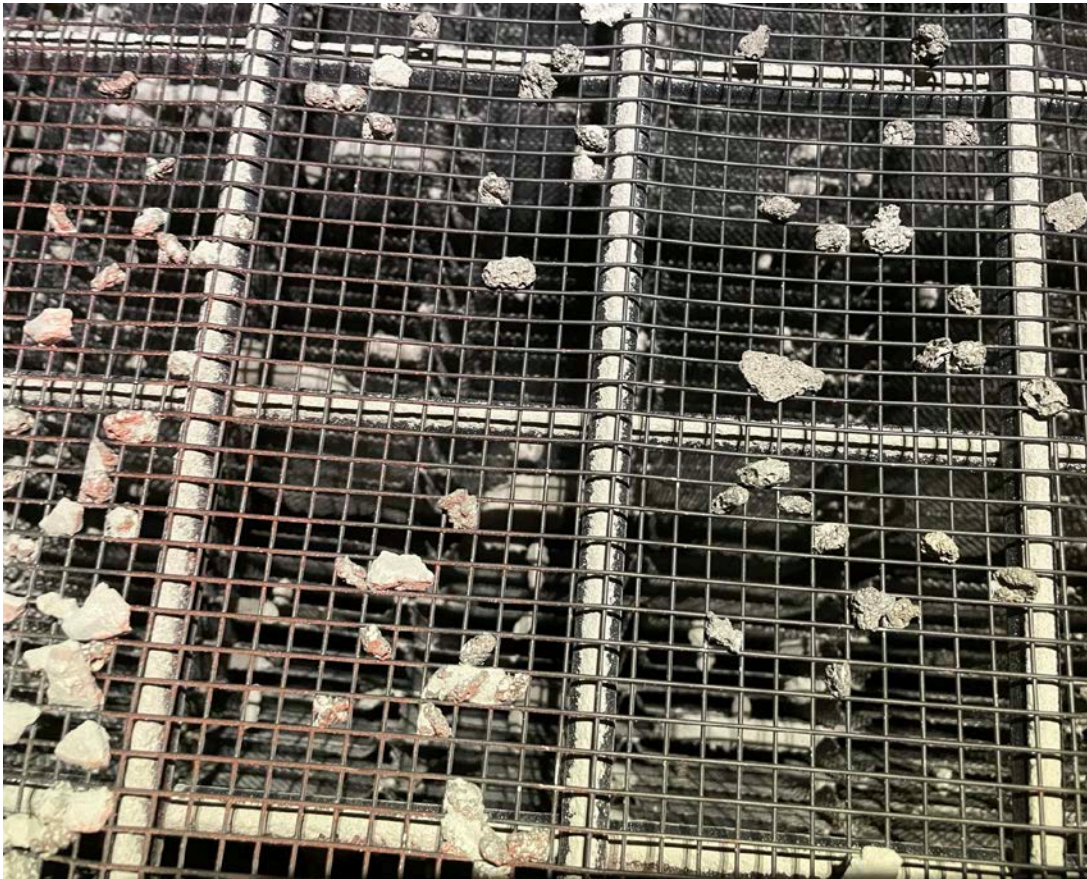
LPA Breakthrough

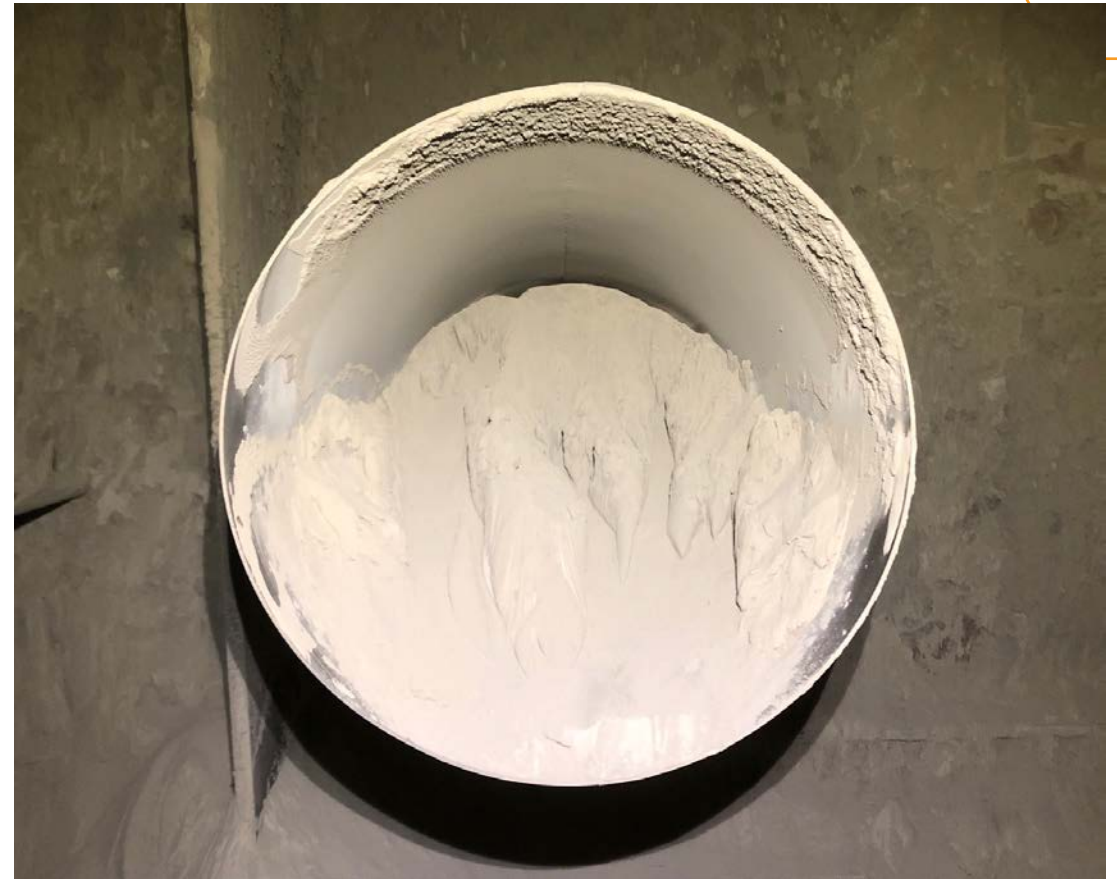
Plugged Sonic Horn

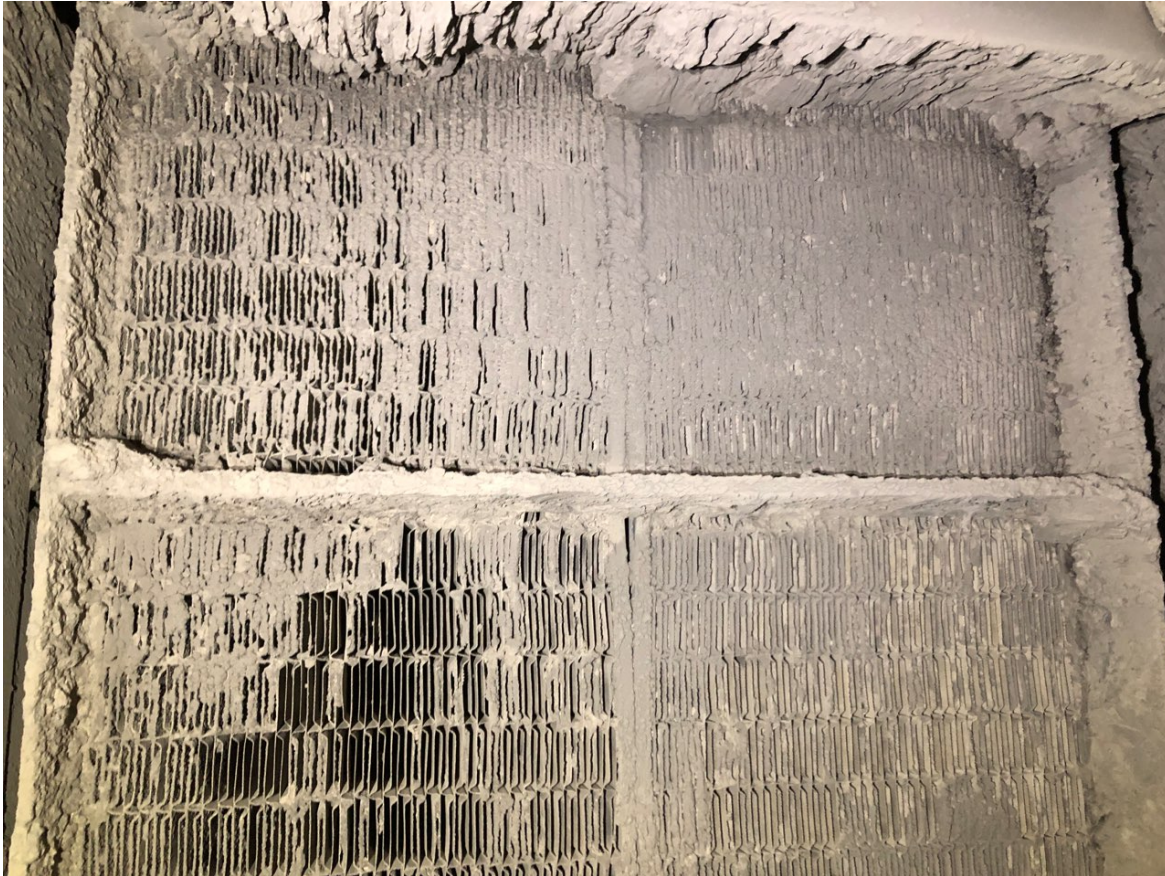
LPA Underside of Unit 5 SCR – Steam Event

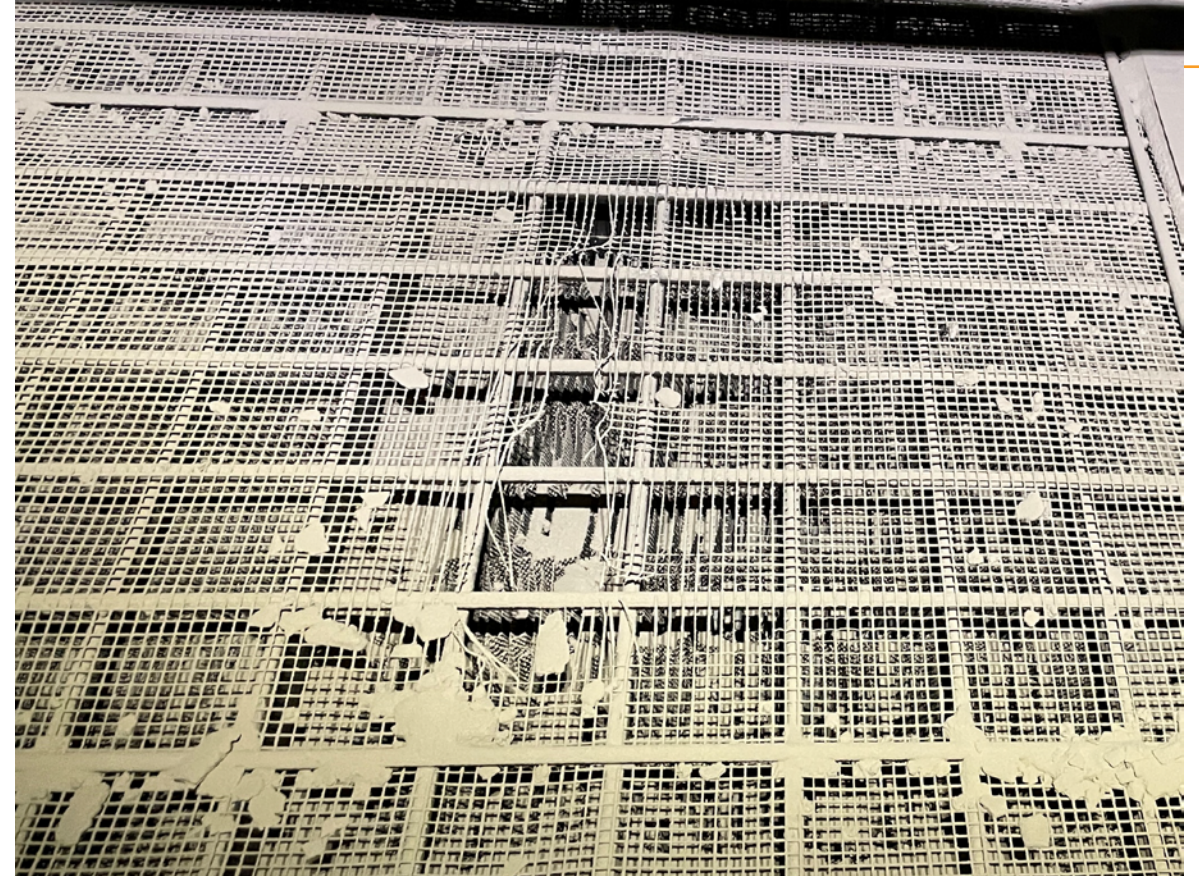
SCR Screen Failure

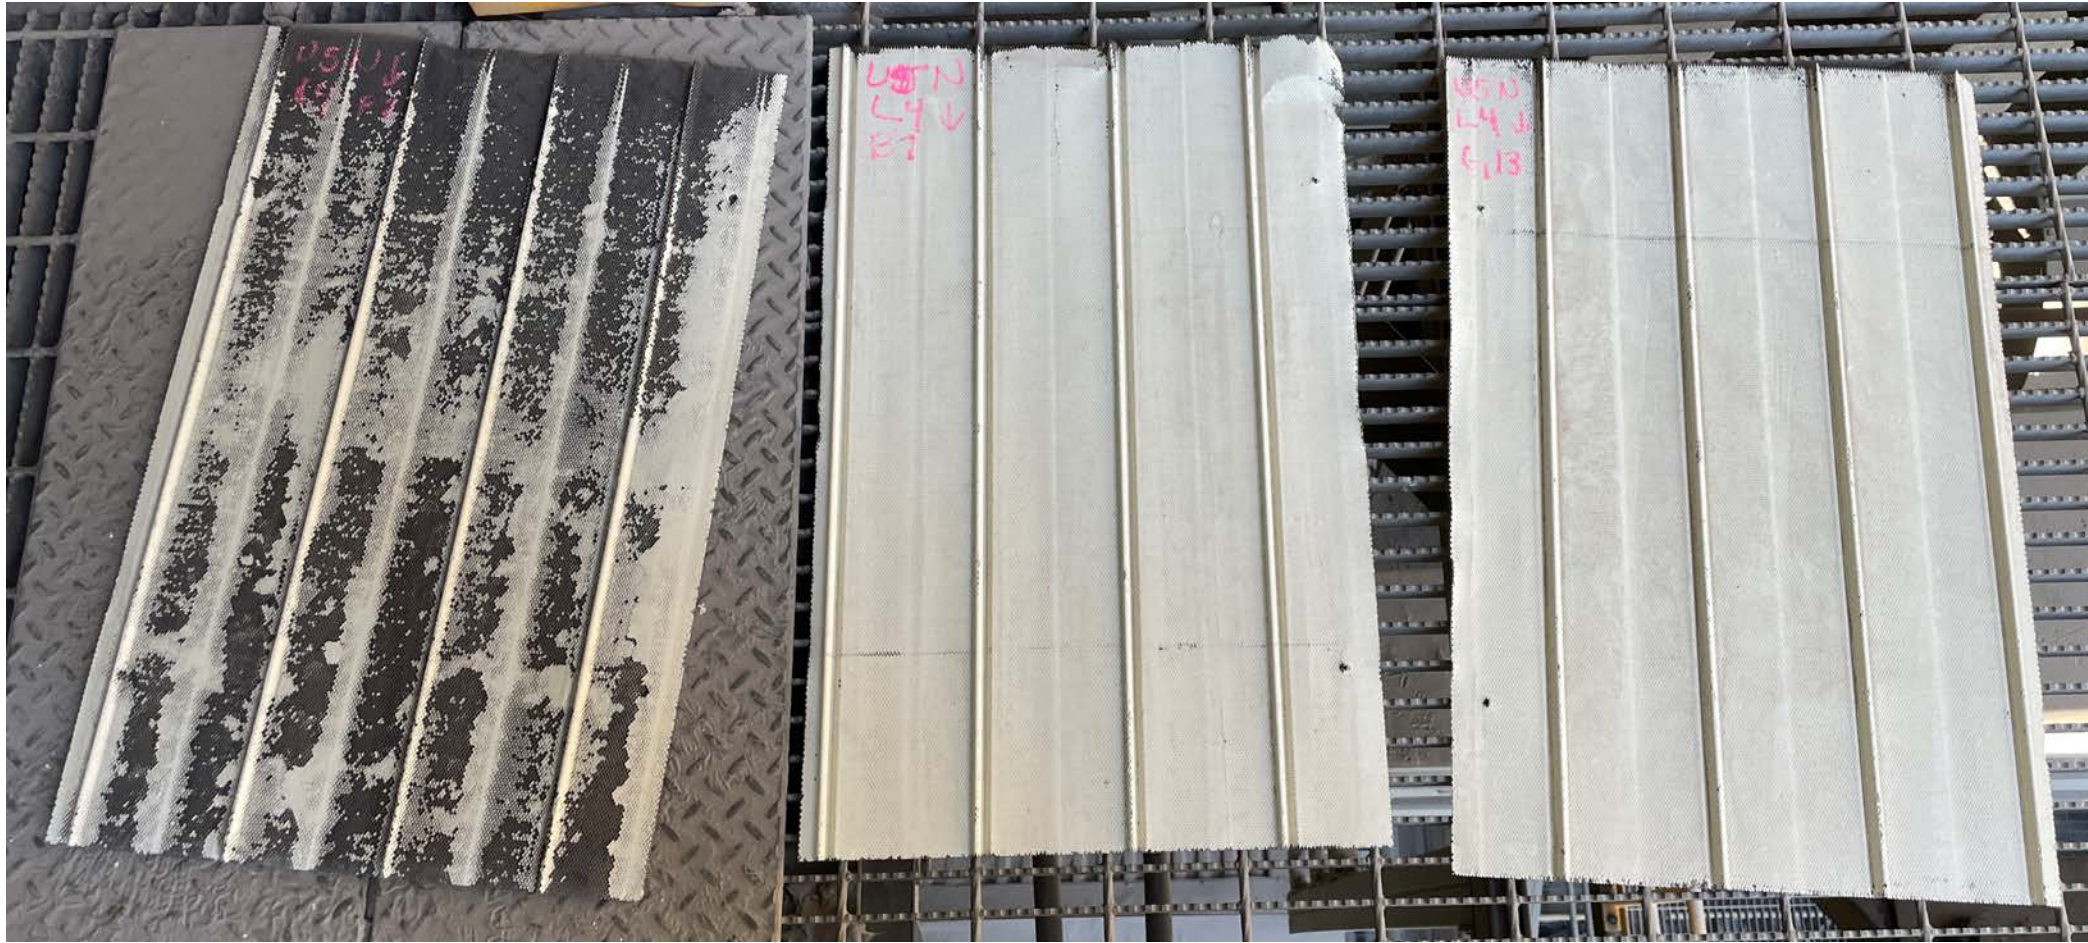
Unit 5 – Uneven Corrosion

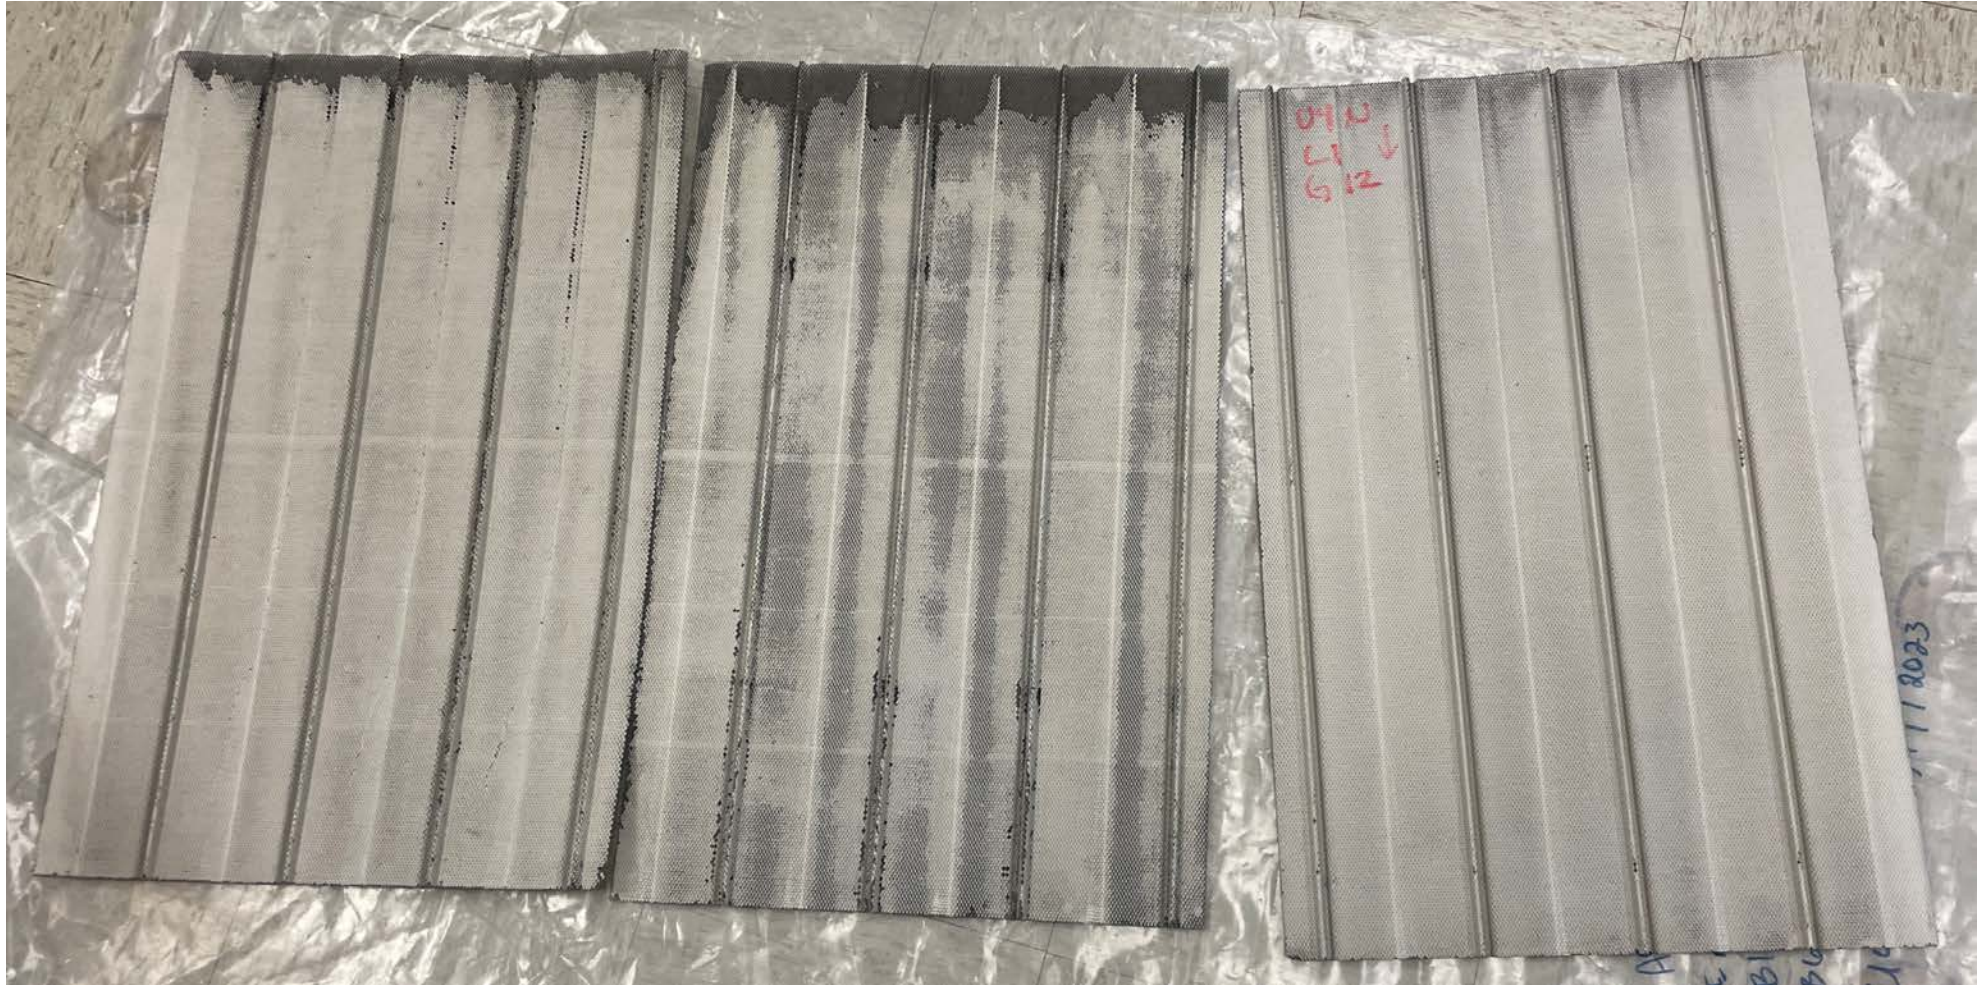
Unit 4 – Uneven Corrosion

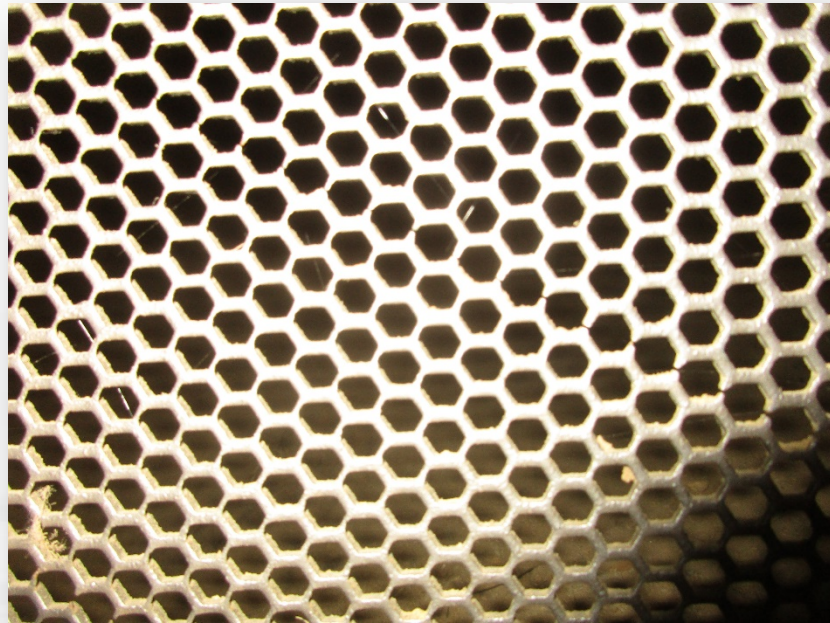
- *Early Signs of Failure, Plan for Change!*

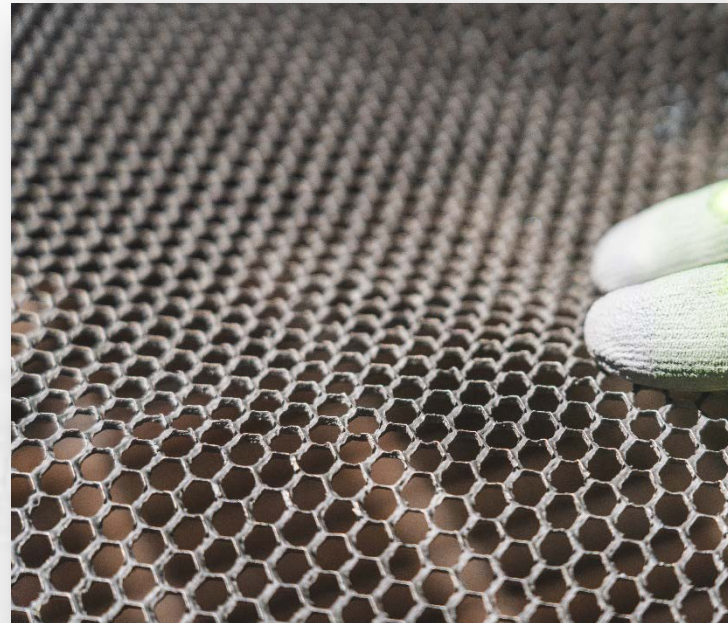
Failure Imminent, Change Now!

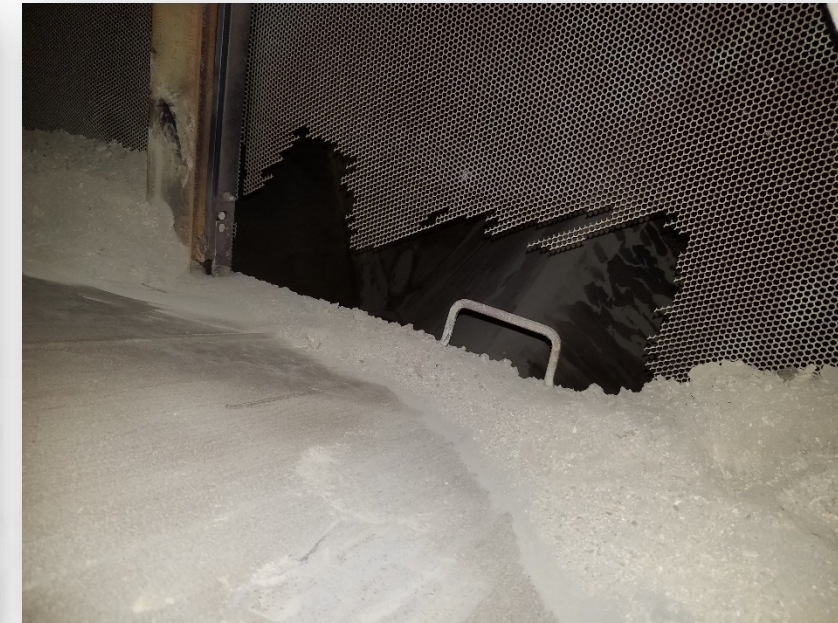
Severe Failure
