2025 Reinhold/PCUG Round Table Presentation

PJFF Troubleshooting and Lessons Learned

Emily Yadon, LG&E Mill Creek Station

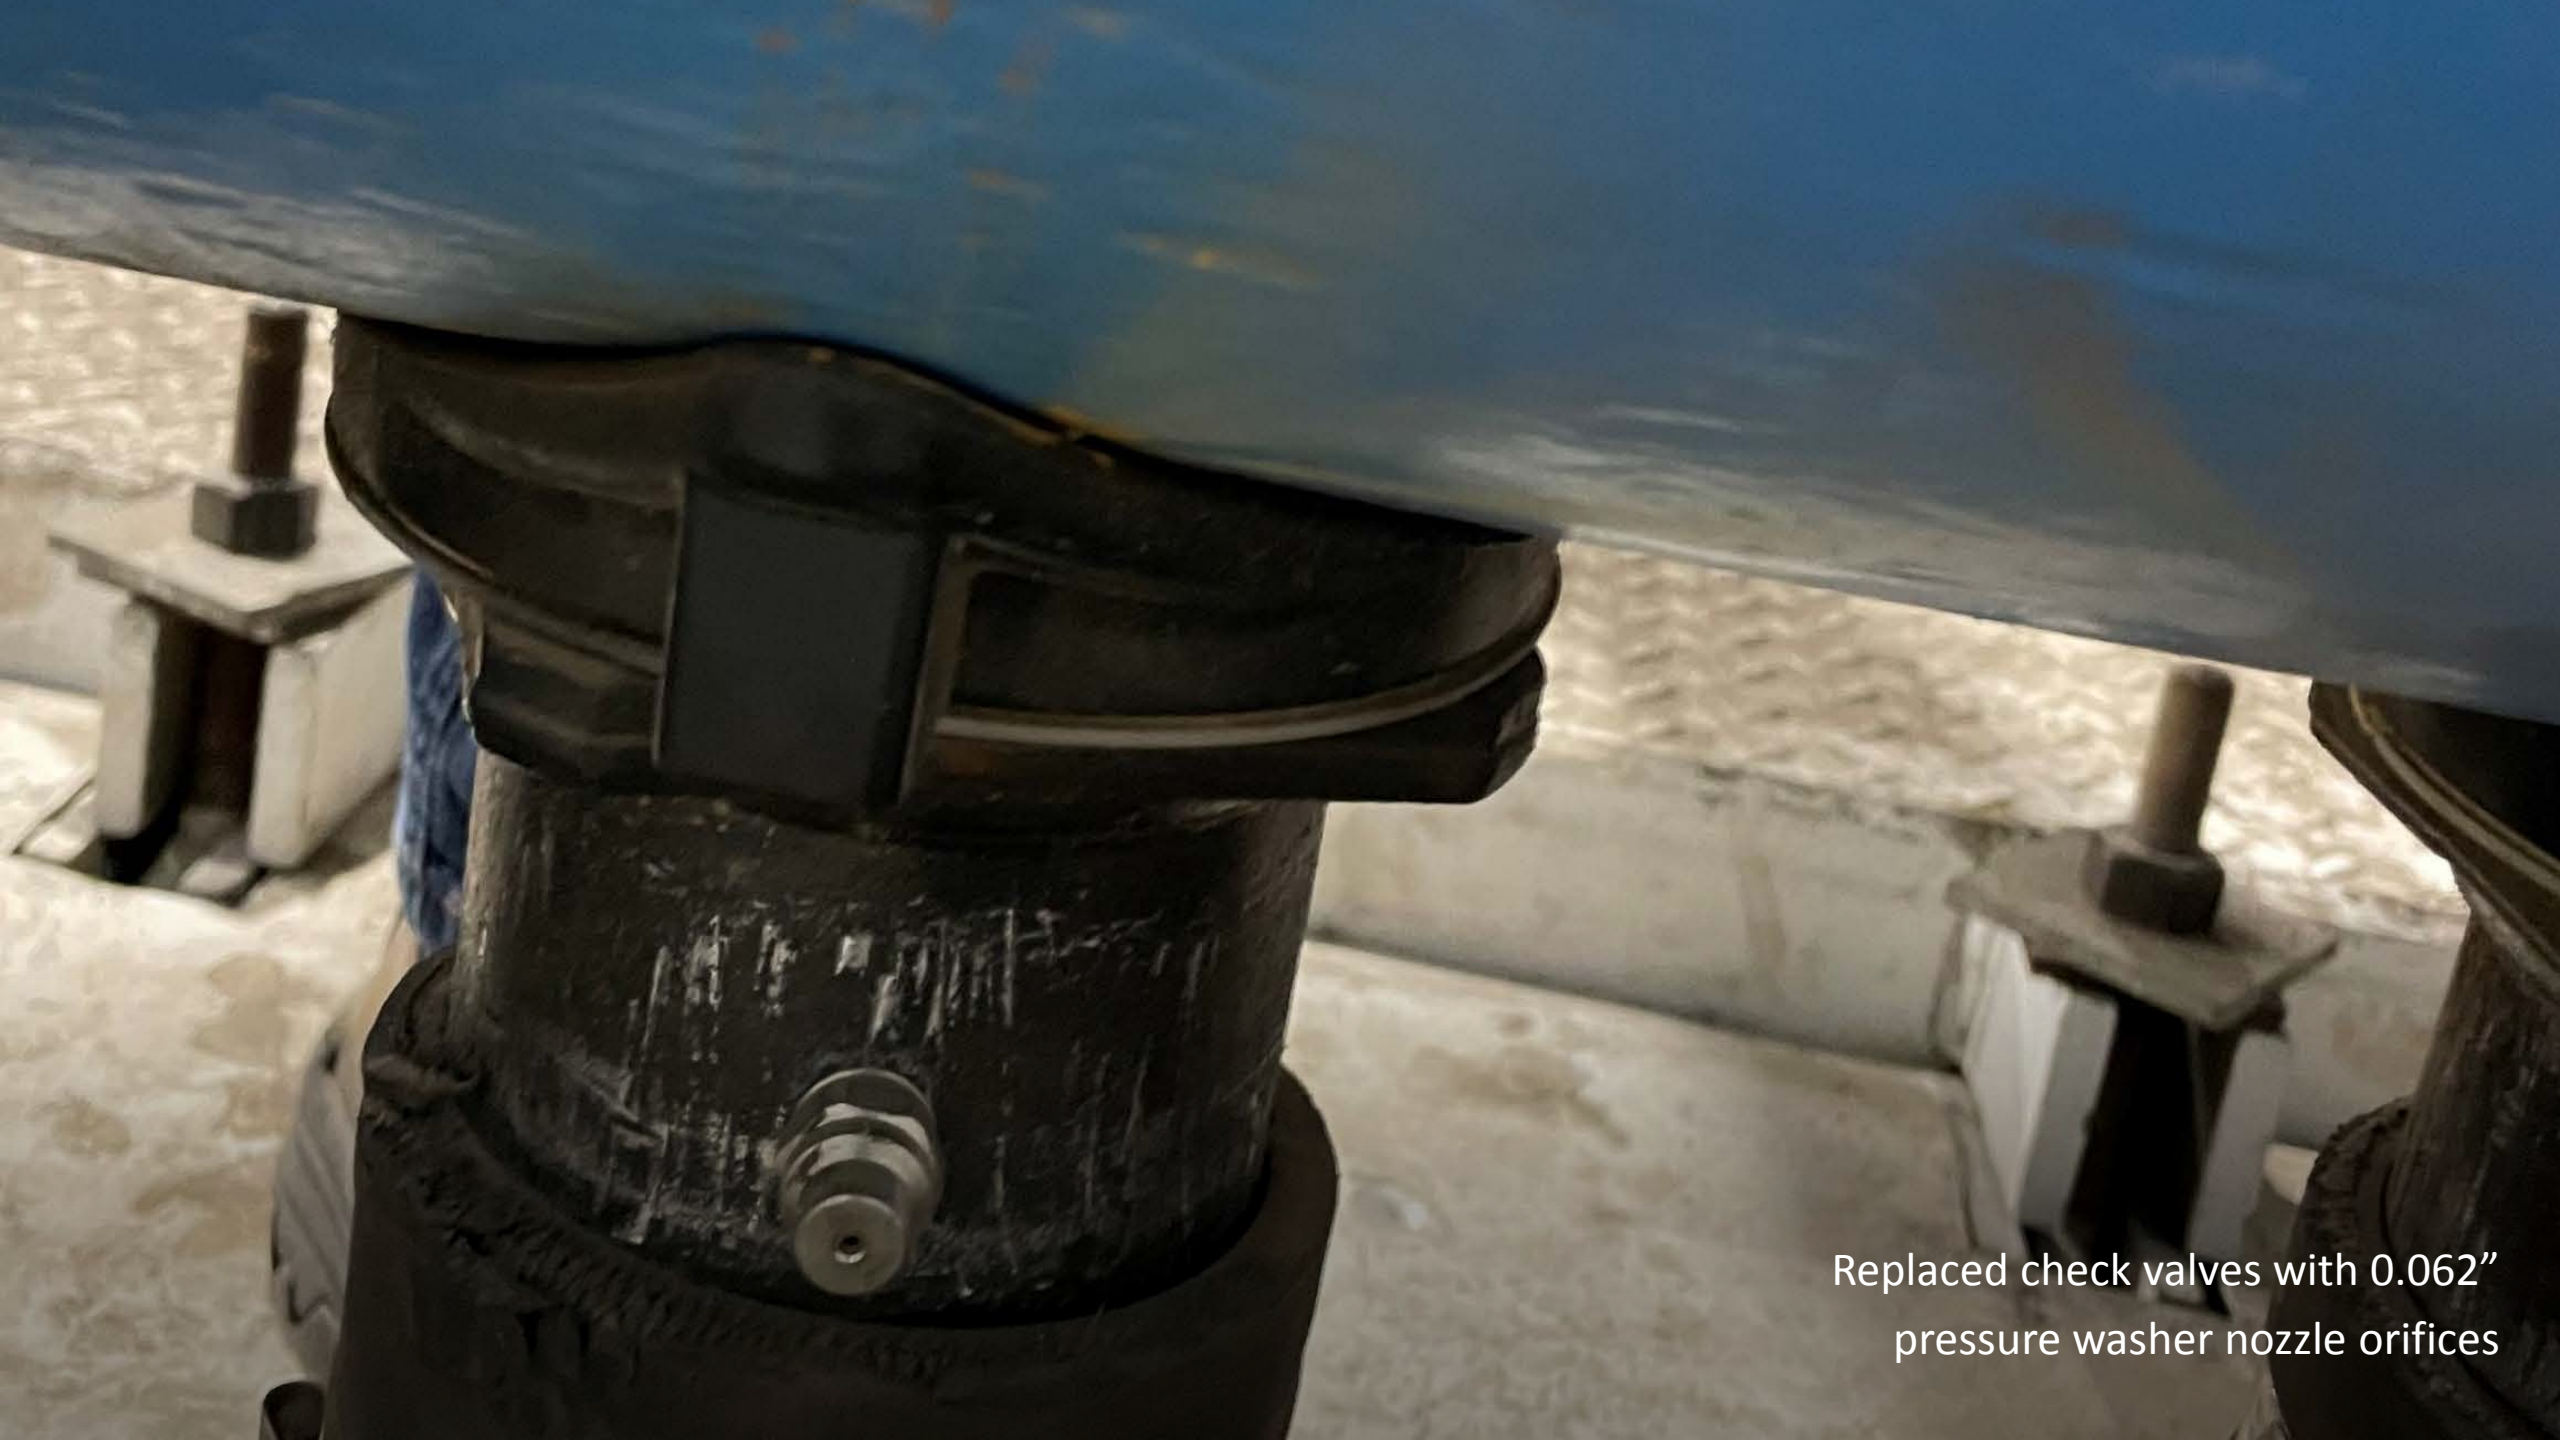
Replaced check valves with 0.062" pressure washer nozzle orifices

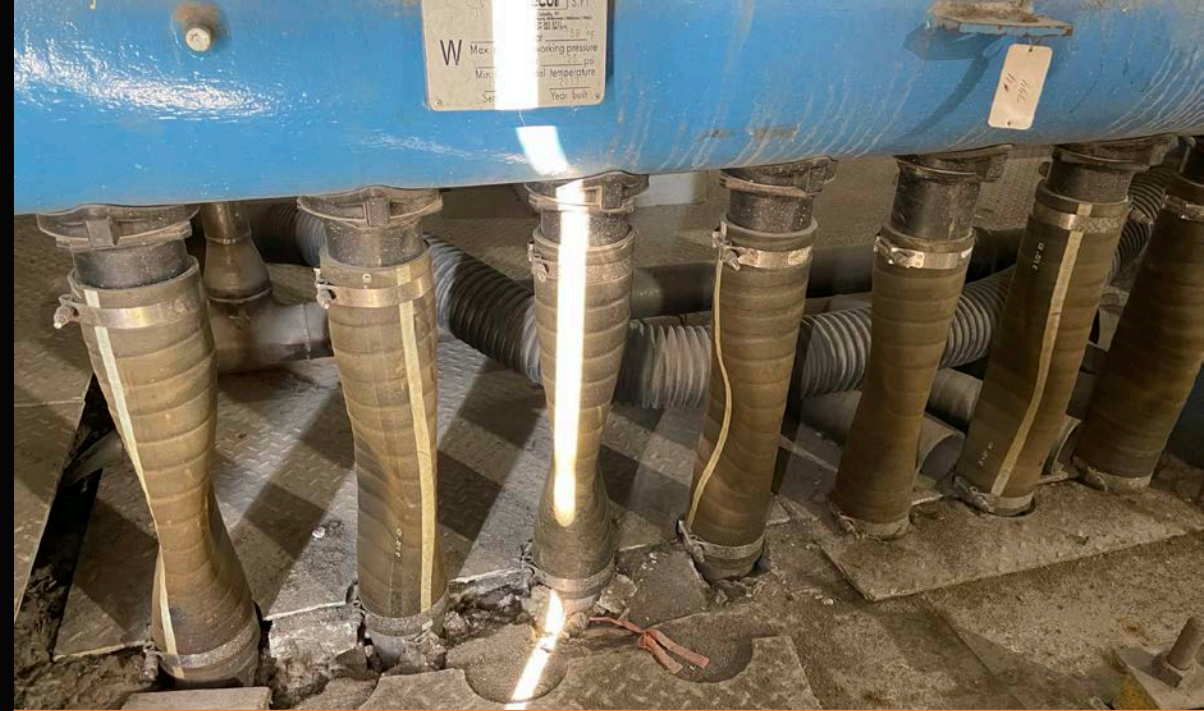
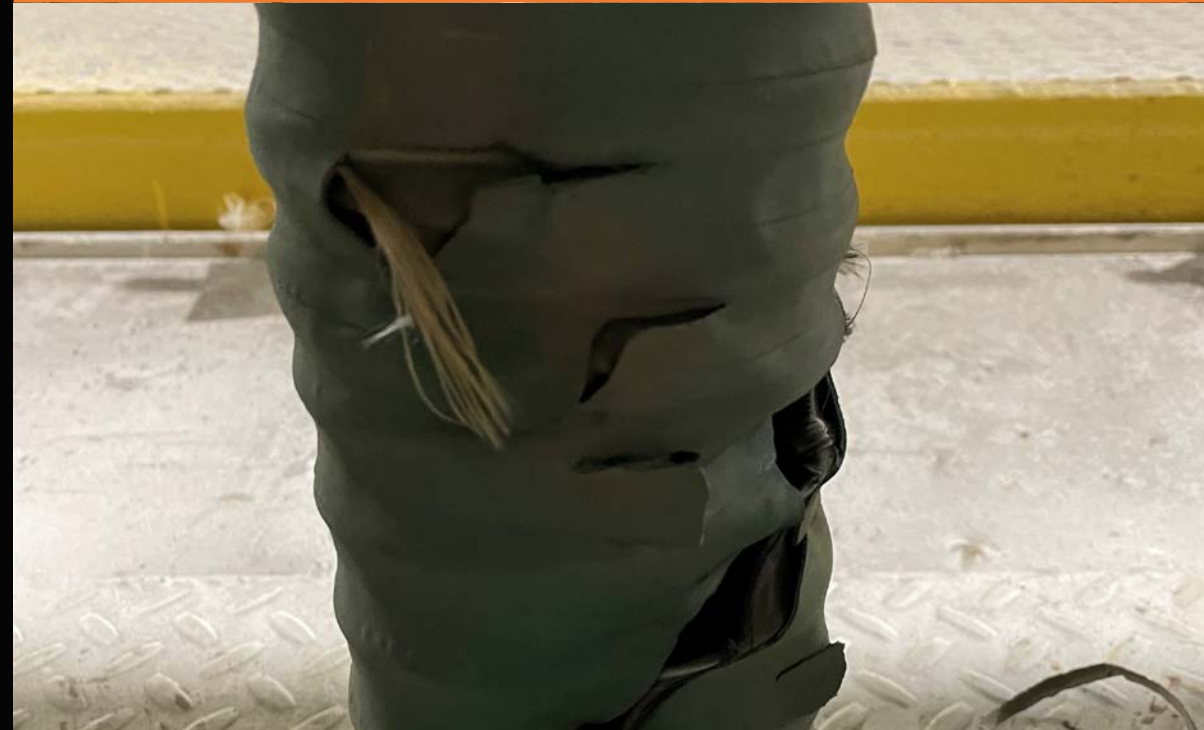
Pulse Air Headers

- Hoses have collapsed and failed due to vacuum
-

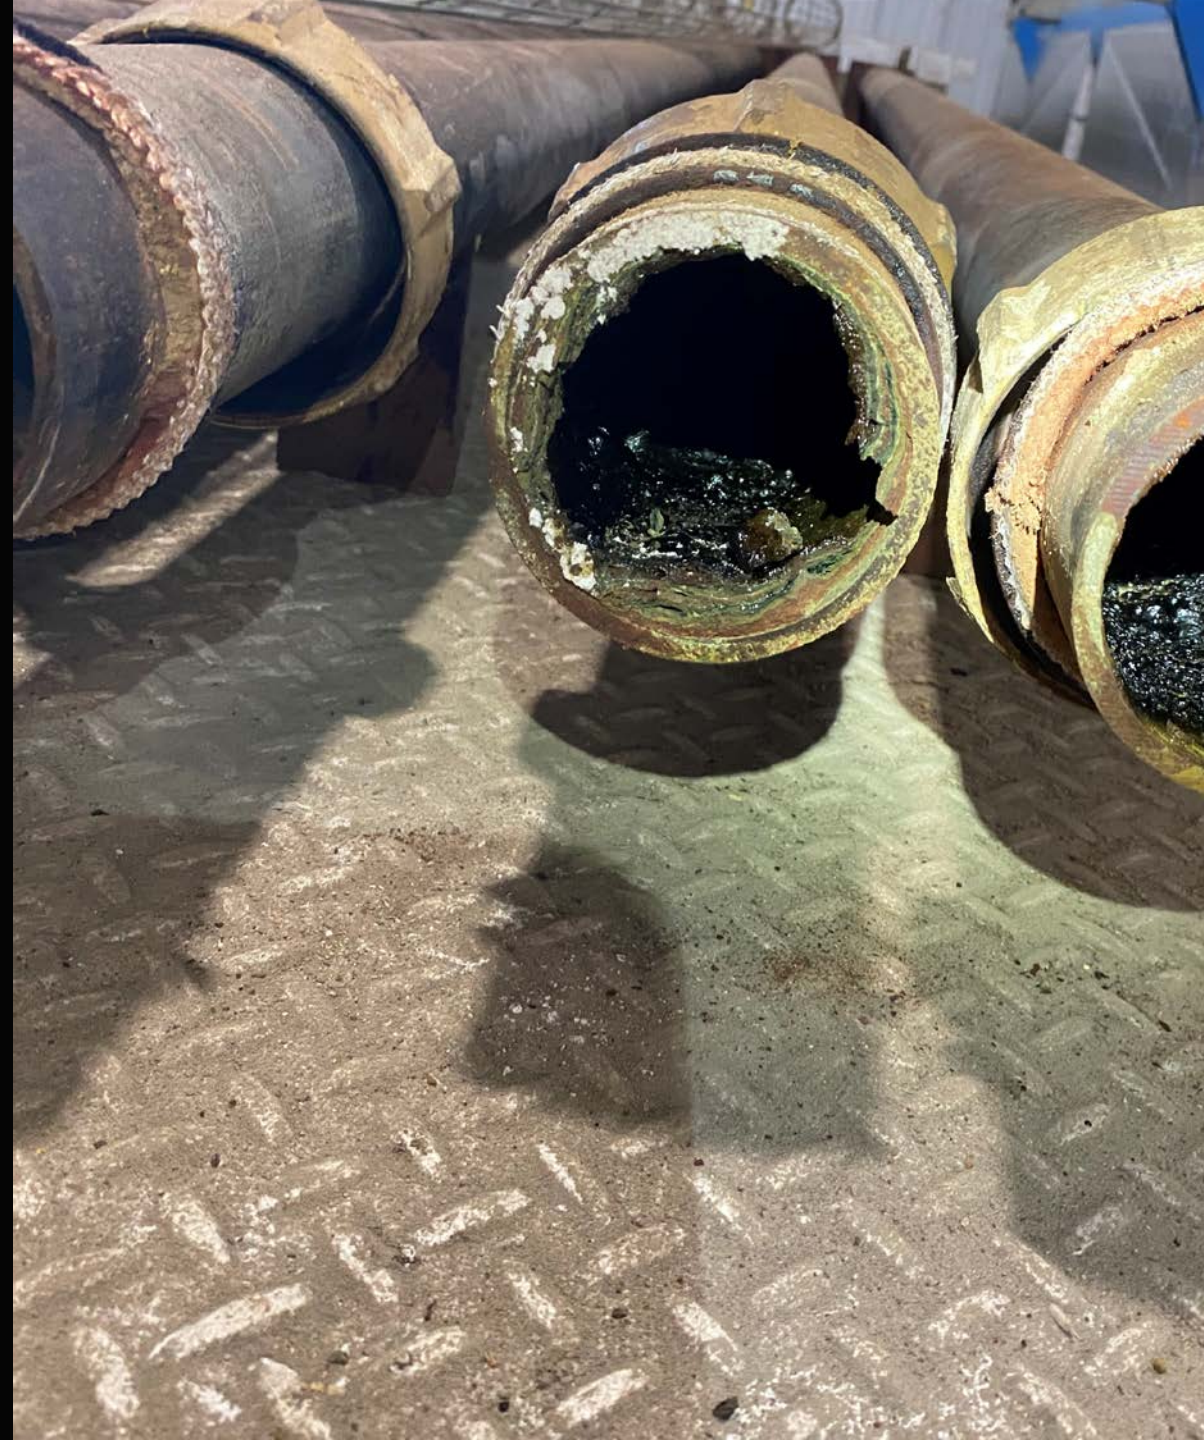
Pulse Pipe Build-up

- Have had to clean due to buildup
 - Checking during sampling or changeouts is essential
-

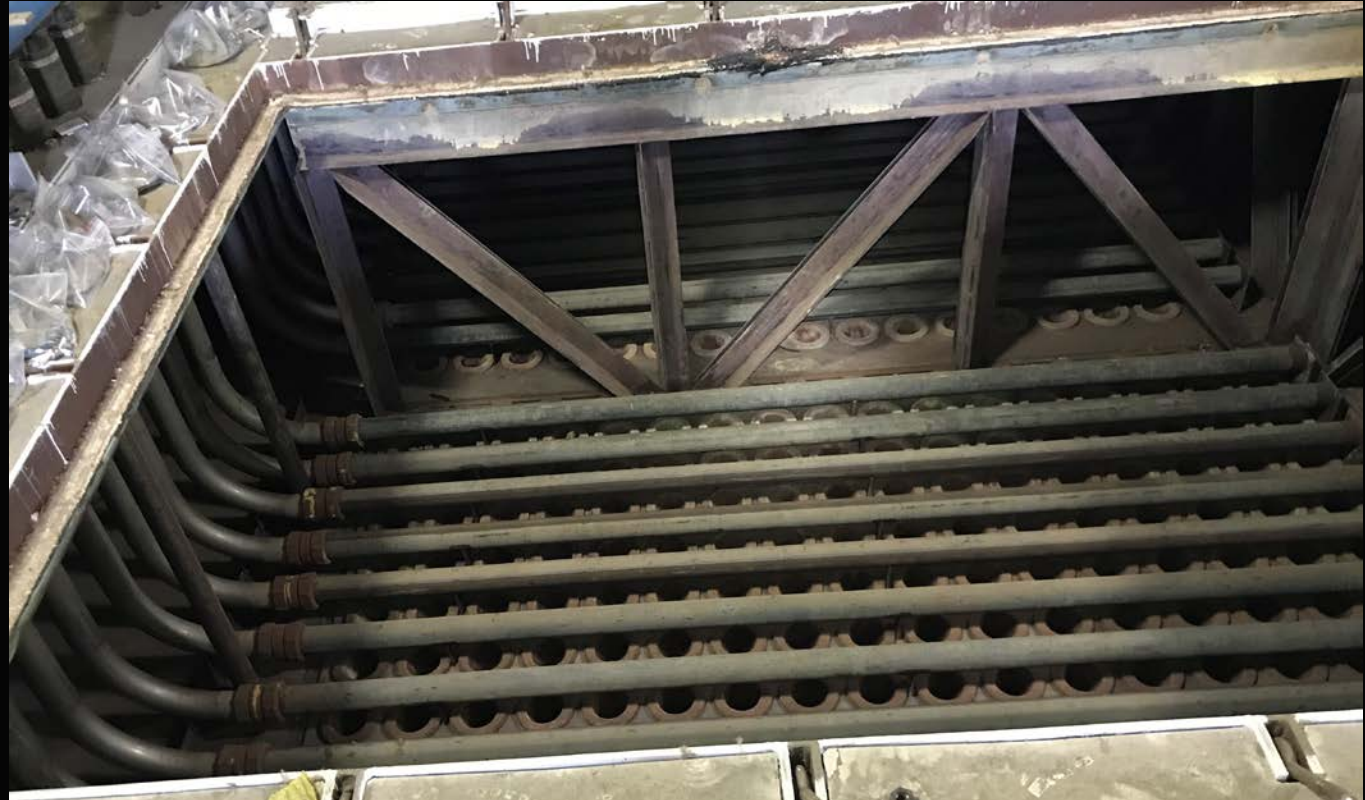
Unit 1 High Differential Pressure Issues

Changed bags March 2021

Unit 1 online (3/25/21 - 6/3/21)

Unit 1 offline (6/3/21 - 7/24/21)

DP started to creep up

ID fan load index alarms by November 2021

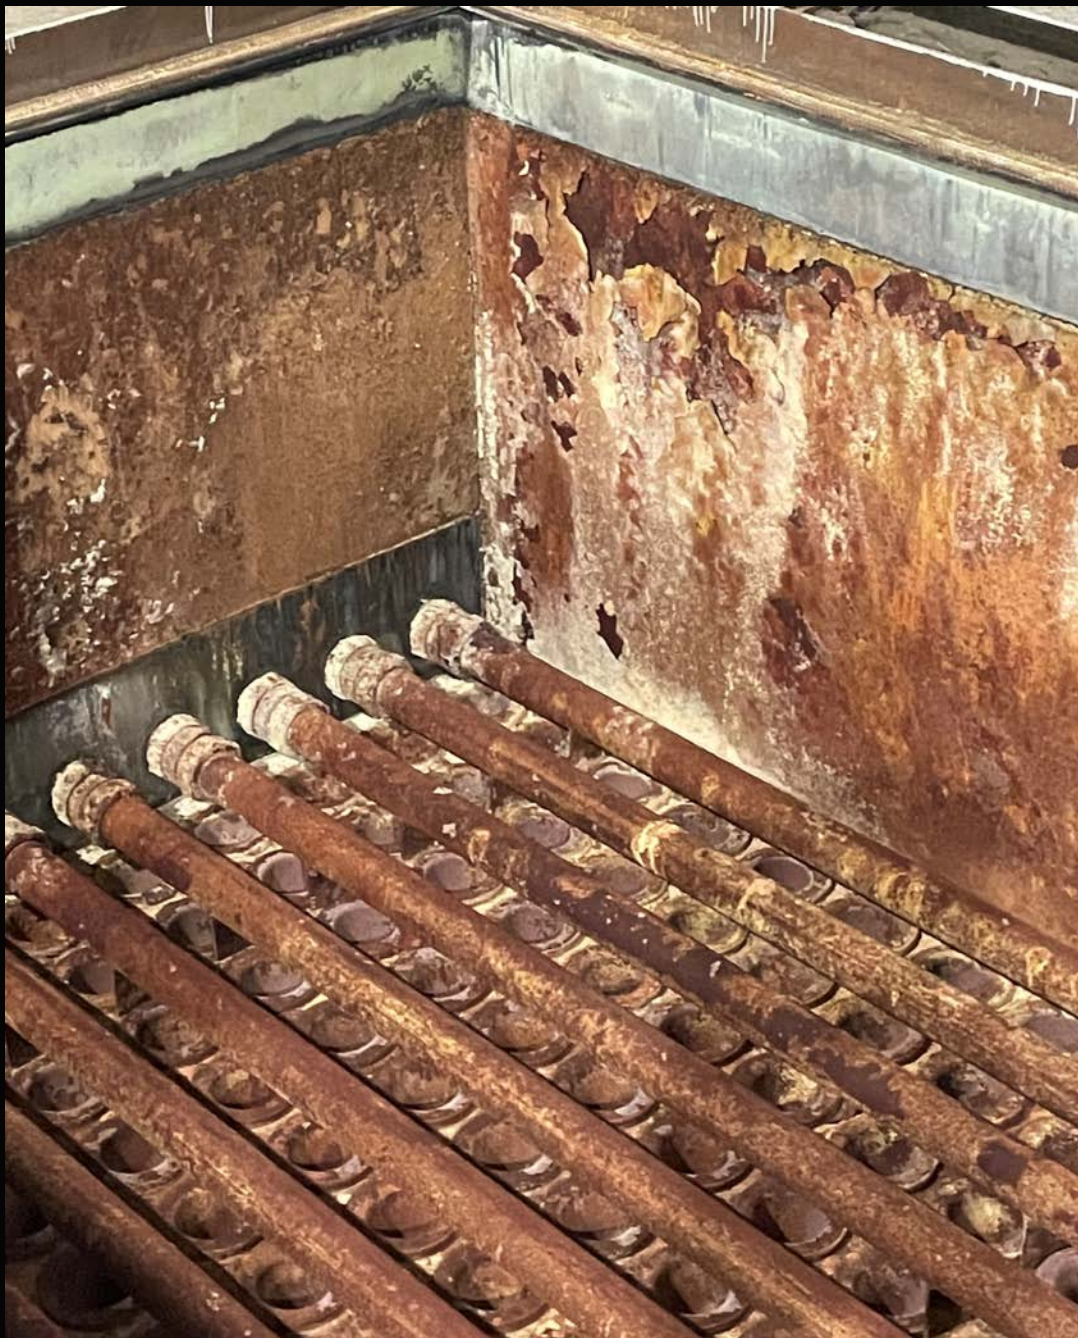
Root cause: leaking FGD isolation damper

- Flue gas leakage
- Permeability and bag performance impacts

- Ensure PJFF dampers were all shut on outages
- Monitor seal air system closely on FGD isolation damper
- Alarm if PJFF temperatures exceed 100 deg F while unit is offline

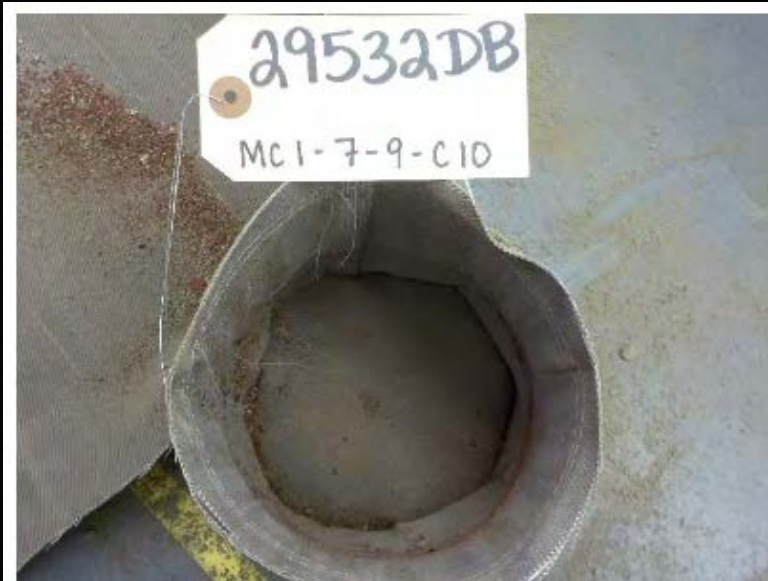
**APPEARANCE OF THE NON-COLLECTION
SIDE (BOTTOM DISC)**

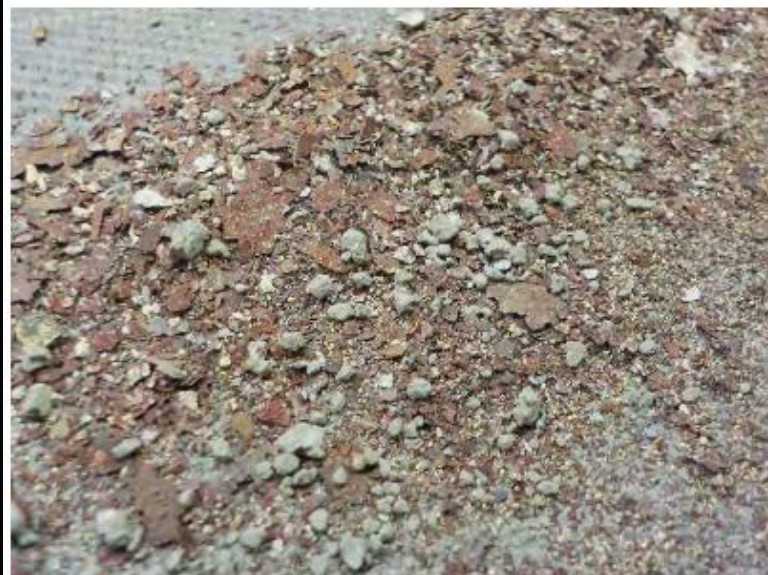
**APPEARANCE OF RUST PARTICLES IN BAG
BOTTOM (NON-COLLECTION SIDE)**

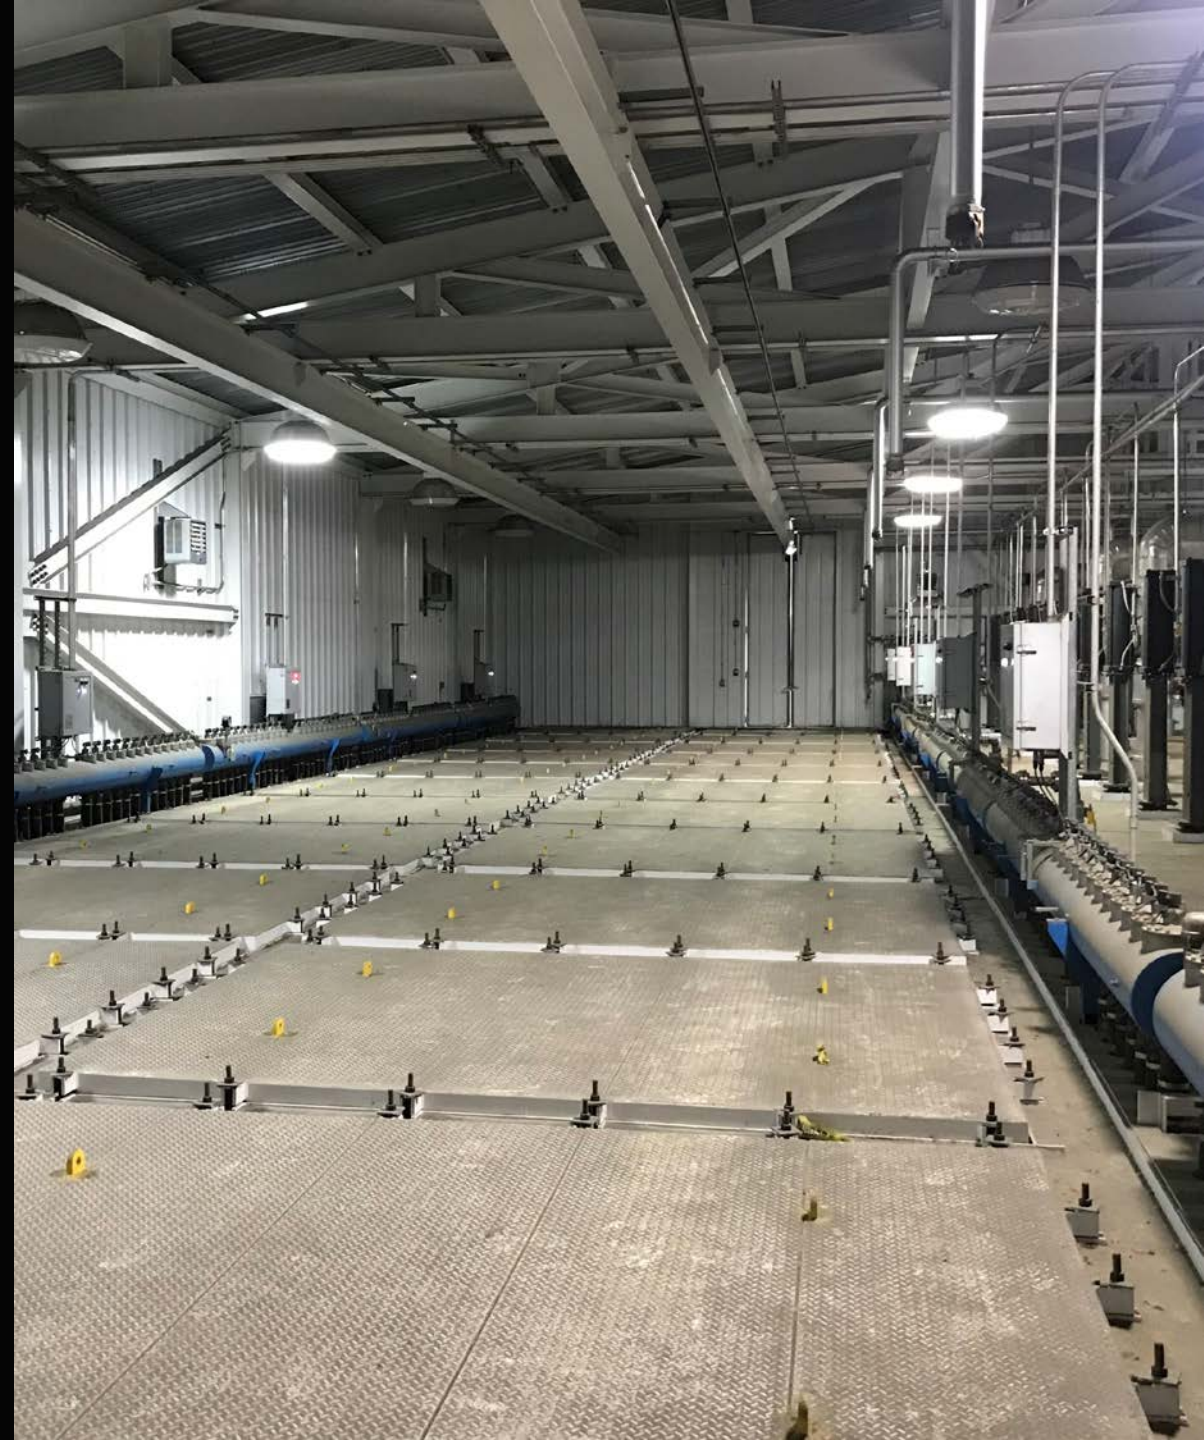
Compartment Lids

- Gasket:
 - Helps seal up doors
 - Prevents air-in leakage
 - Have swapped to square gasket
 - More costly up front, but holds up over time
 - Bolts for doors
 - Heat causing them to loosen
 - Bolts have bent over time
 - Have replaced some of the bolts
-

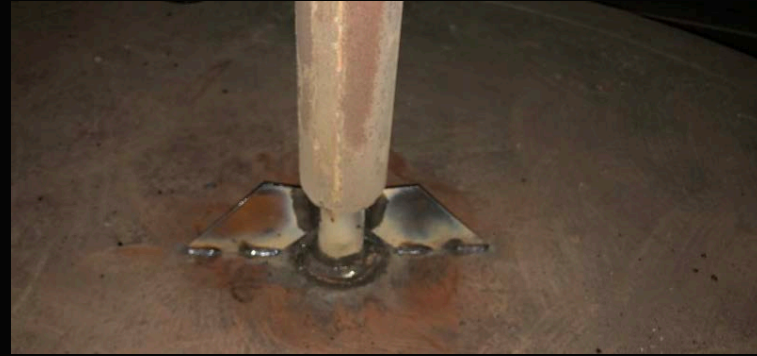
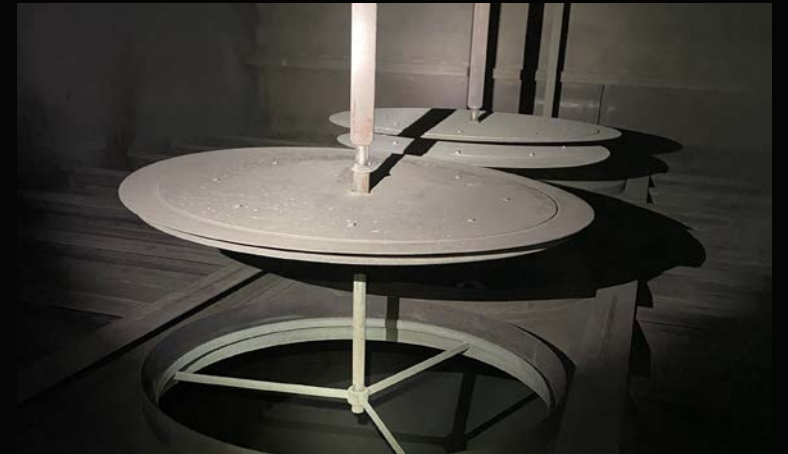
Bypass Dampers

- Poppet Inspections:
 - Open and check poppets are attached
 - Have had several bypass poppets fail:
 - Fixed in house with welders
