2012 APC Round Table & Expo Presentation

Southern Company Generation

Lessons Learned with Non-Metallic Materials in FGD Service

Gerald A. Van Beek

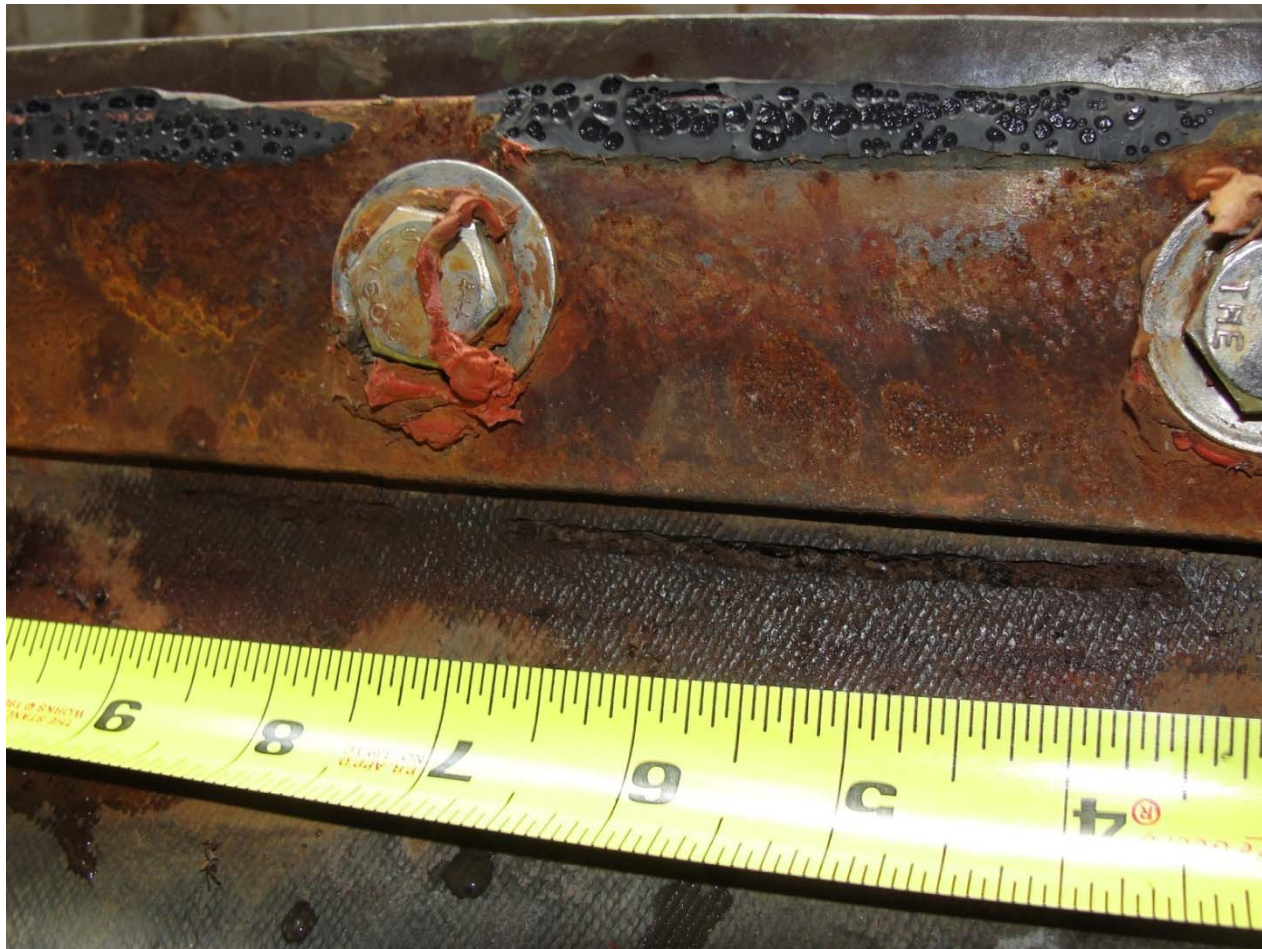
Cuts at Backing Bars

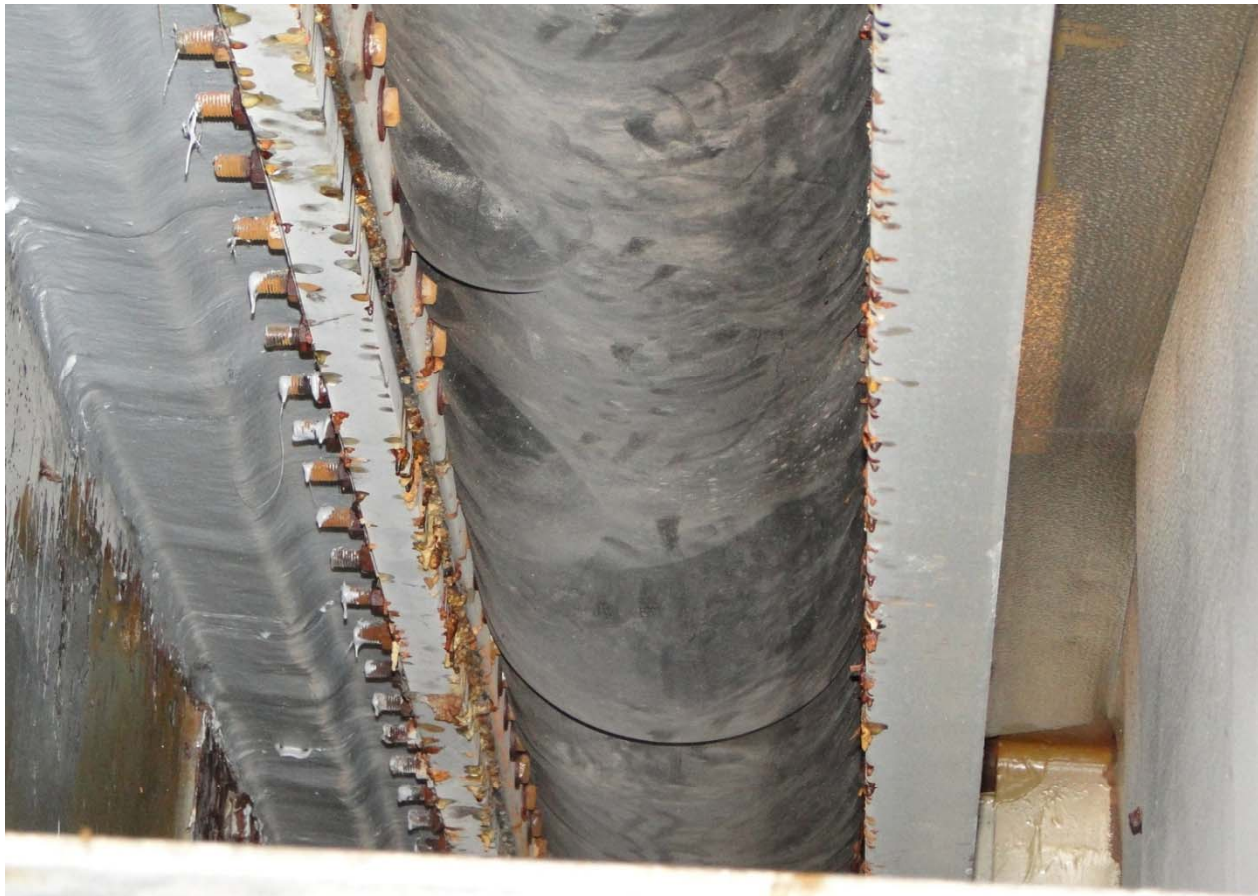
Blisters and Delaminations

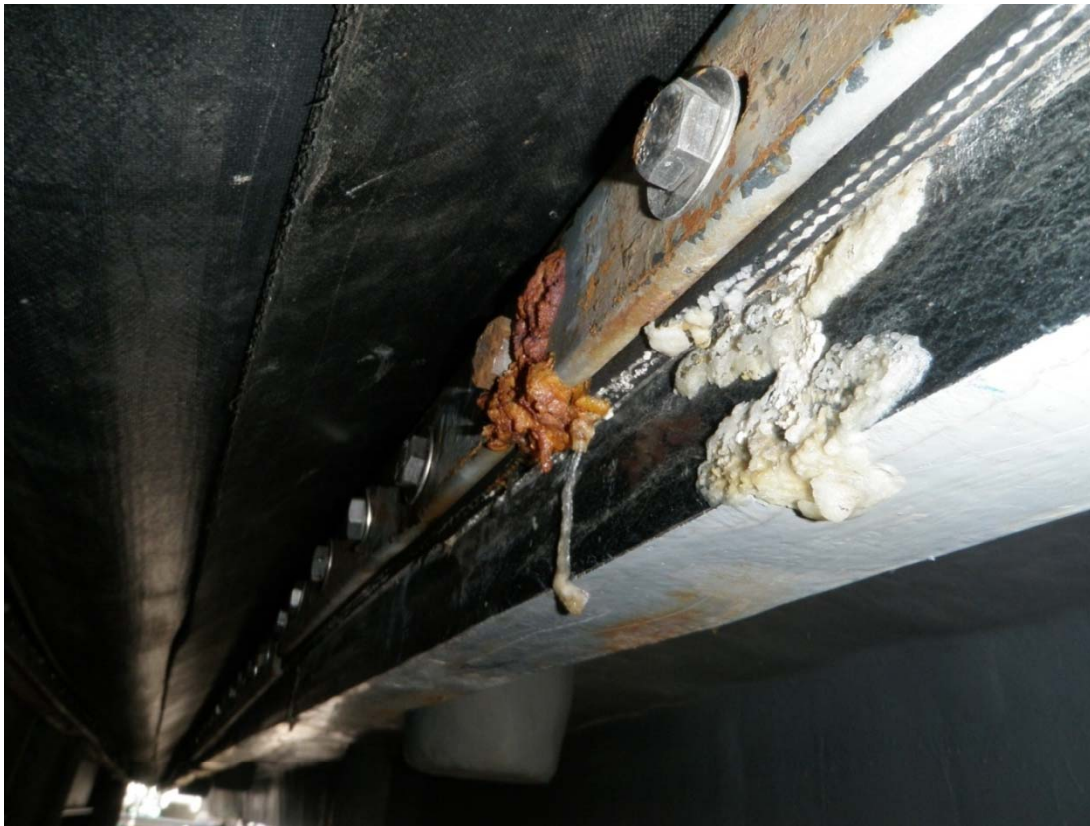
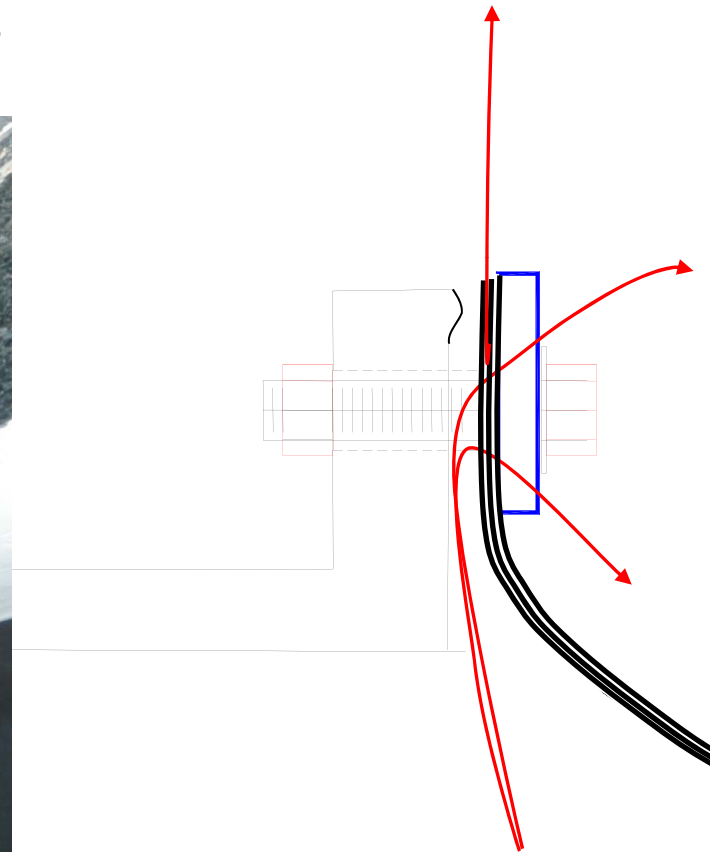
Leaks through Bolt Holes

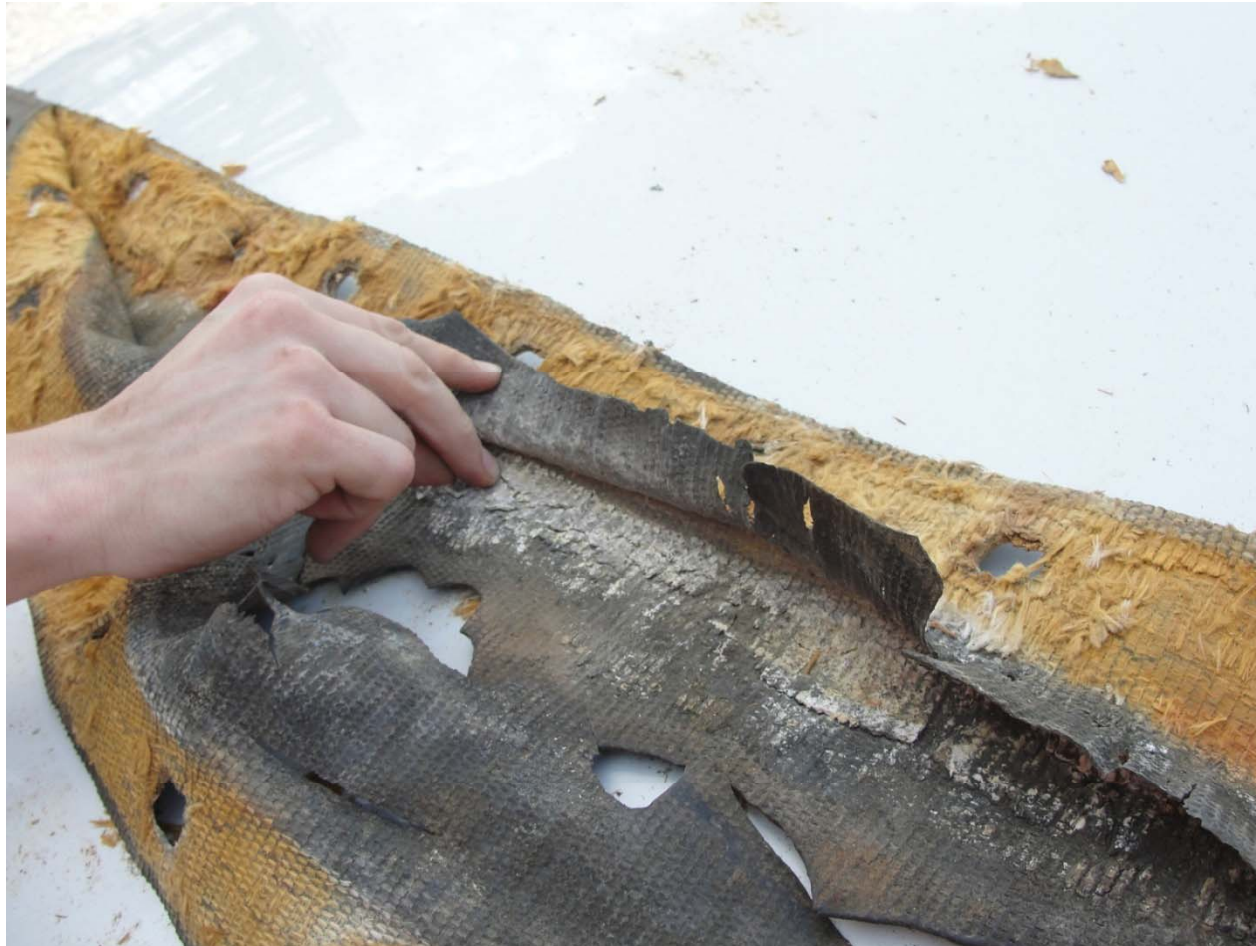
Wicking and Attack of Glass

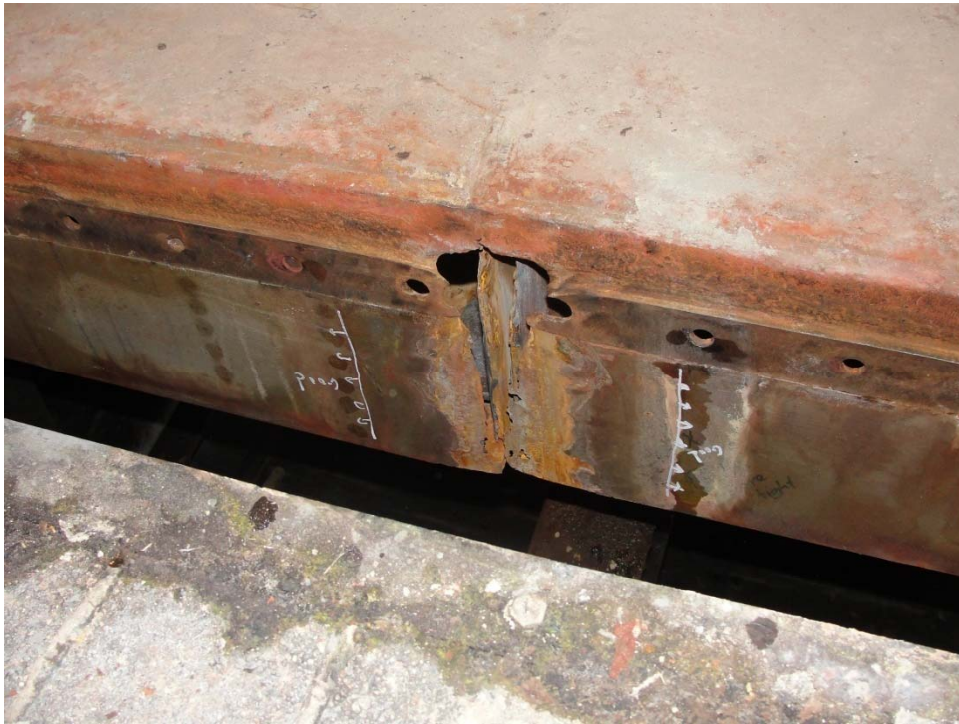
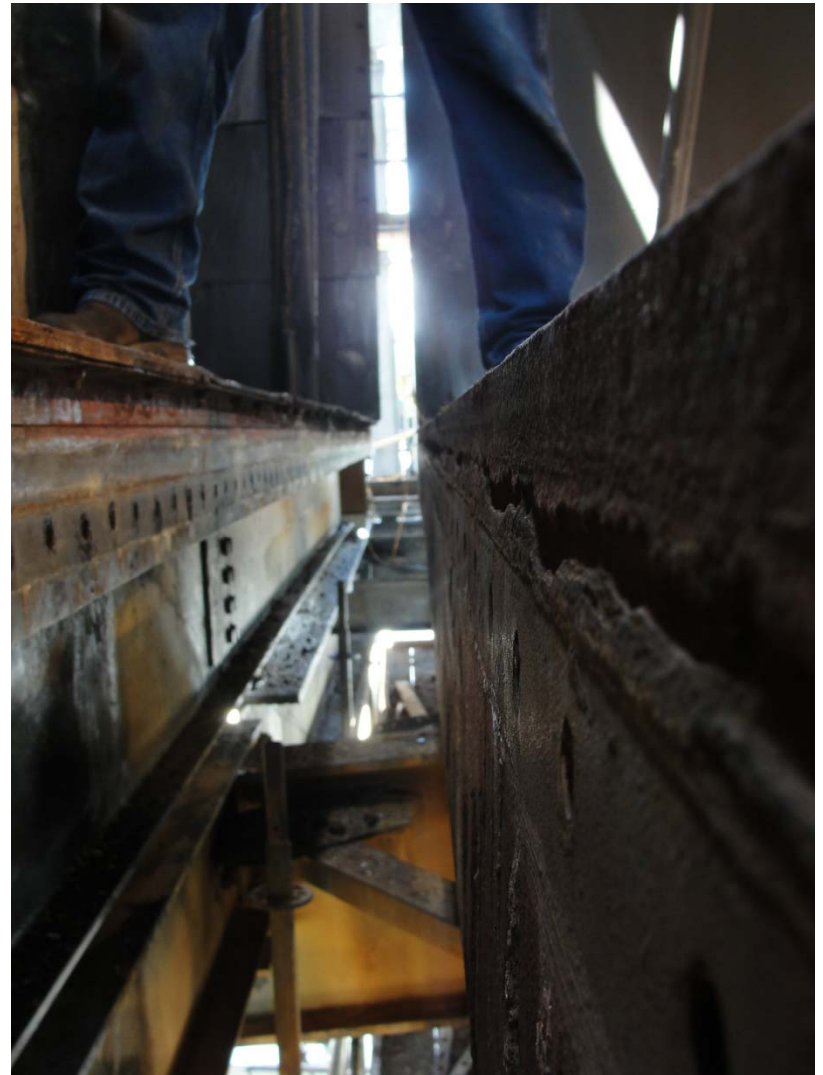
Acid Attack of Steel

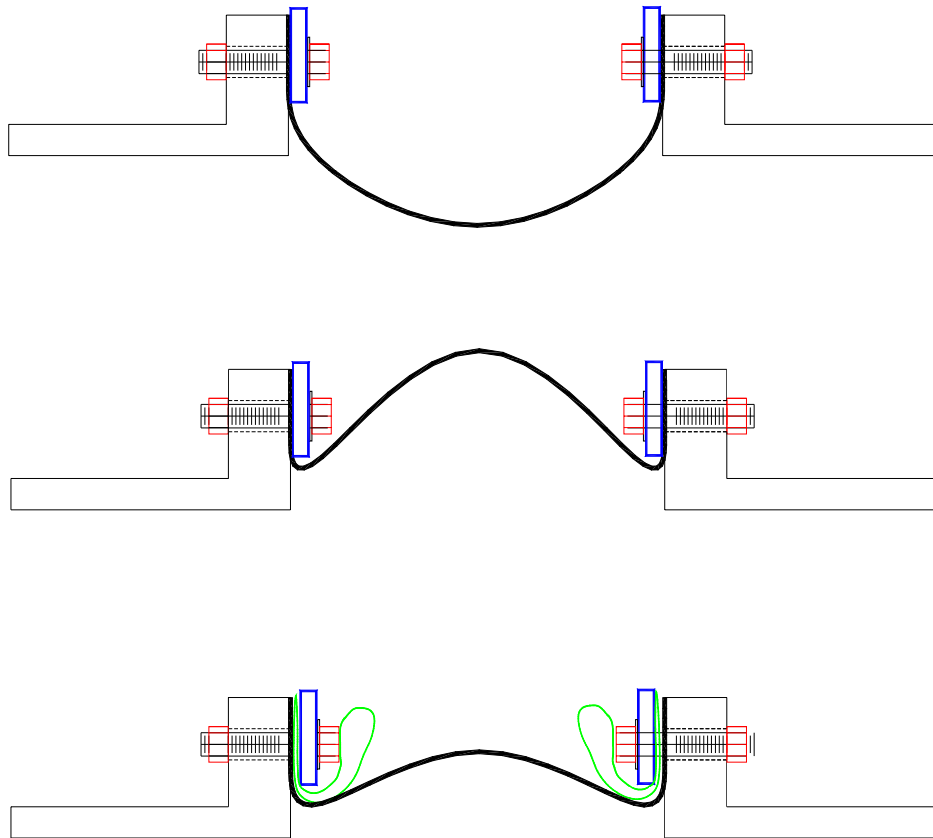
Root Cause Design

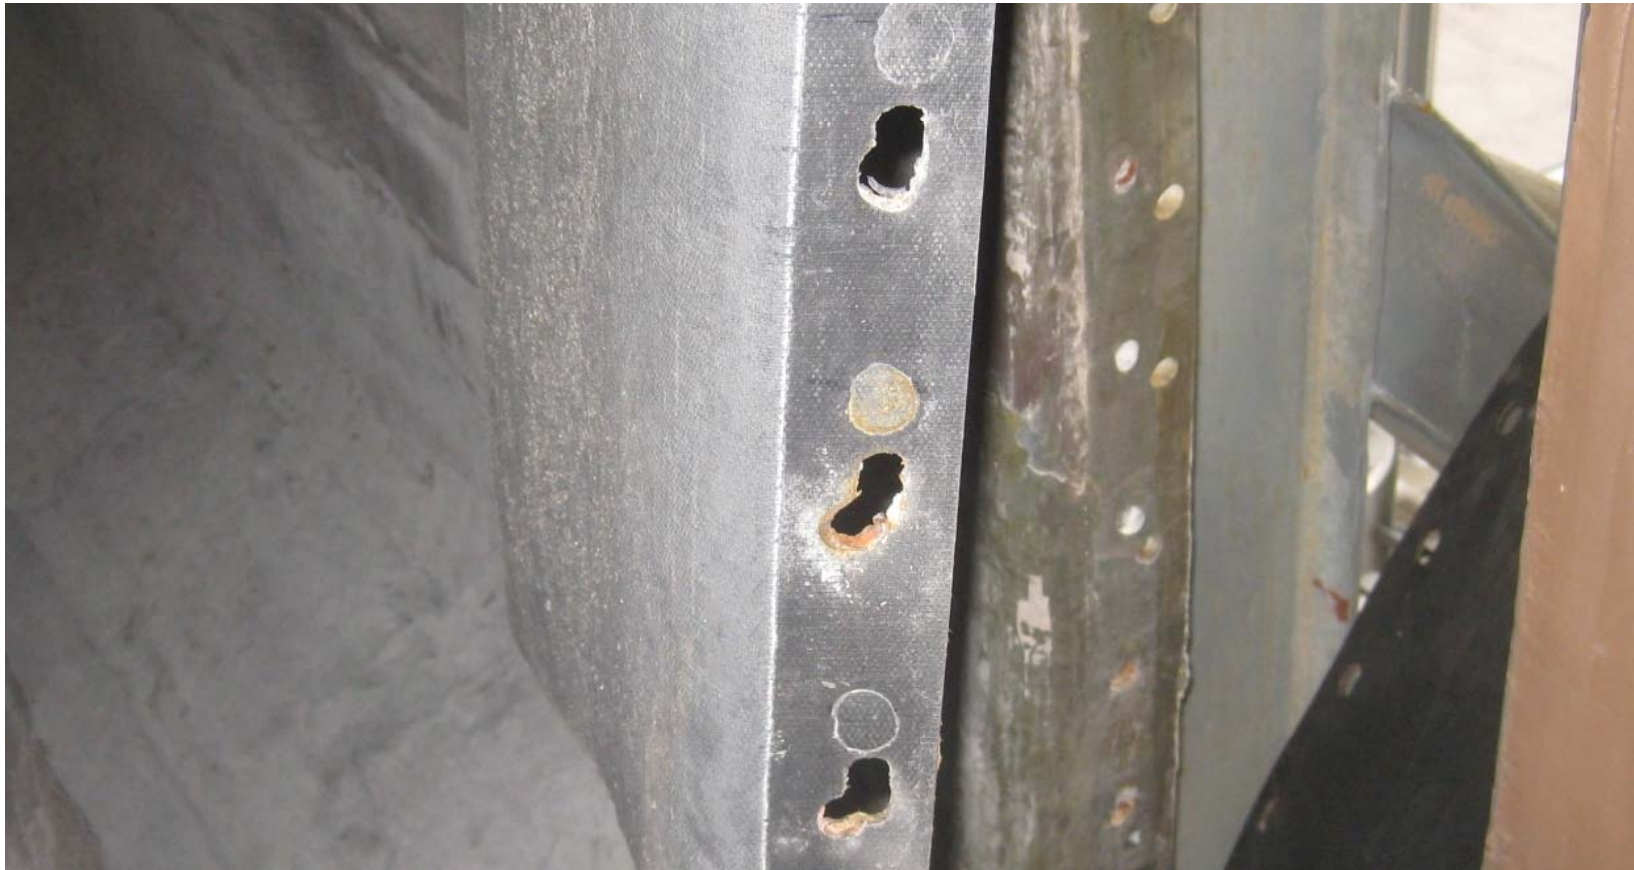
Root Cause Construction

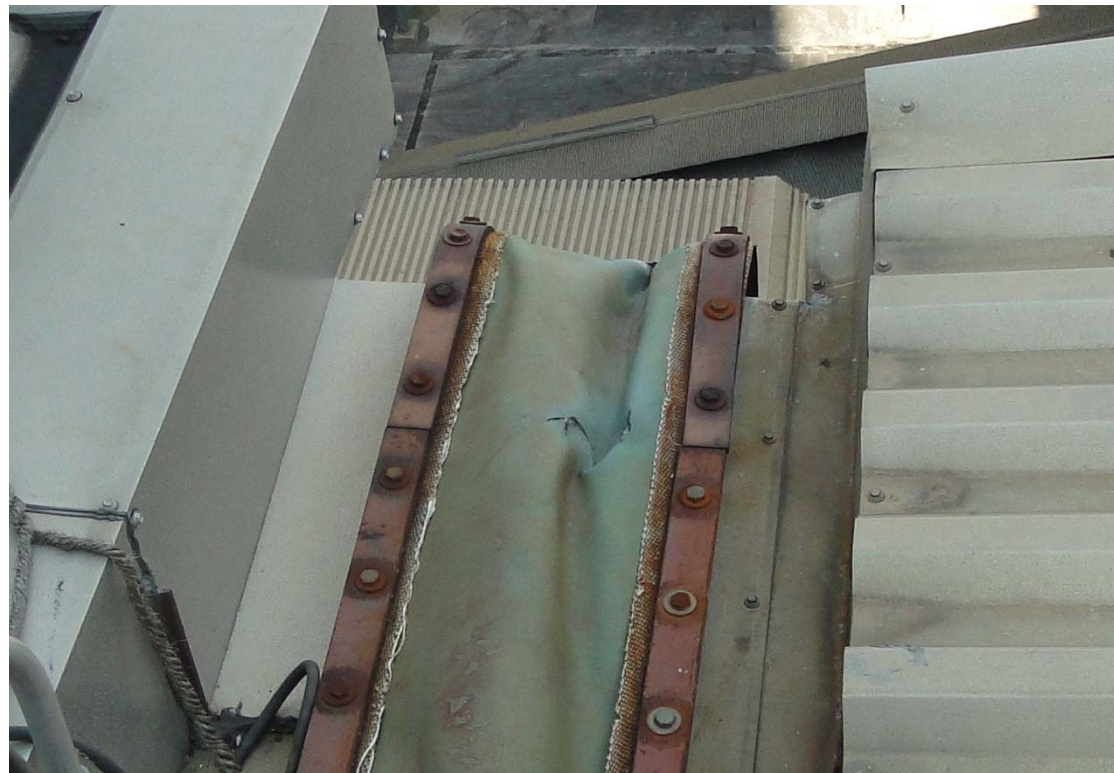
- Flutter is a killer.
- Typically at:
 - fan outlets
 - Locations near 0 psig or alternating + and – pressure.
- Commonly starts half way between flanges near the corners.

Single Layer Teflon - Flutter

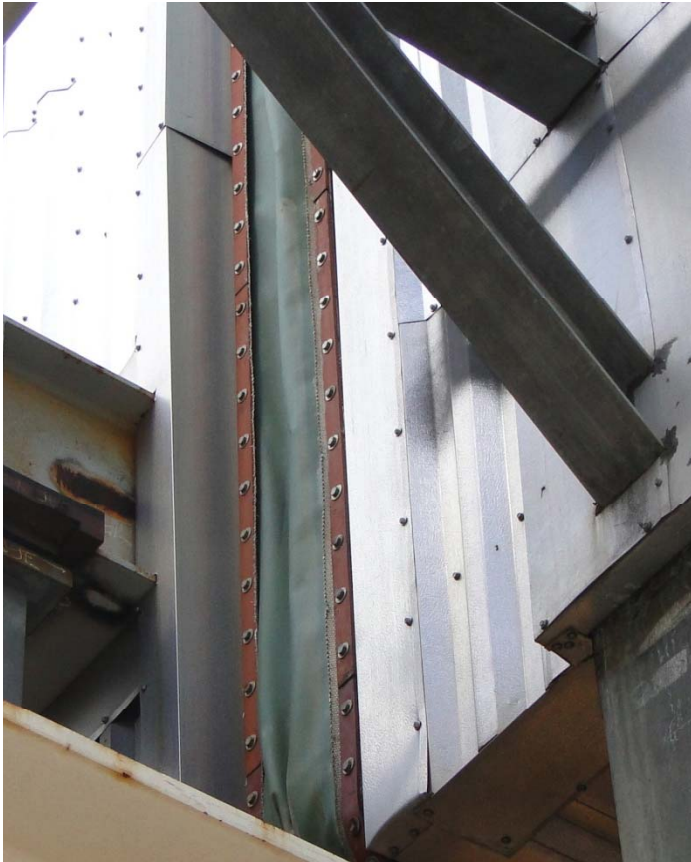
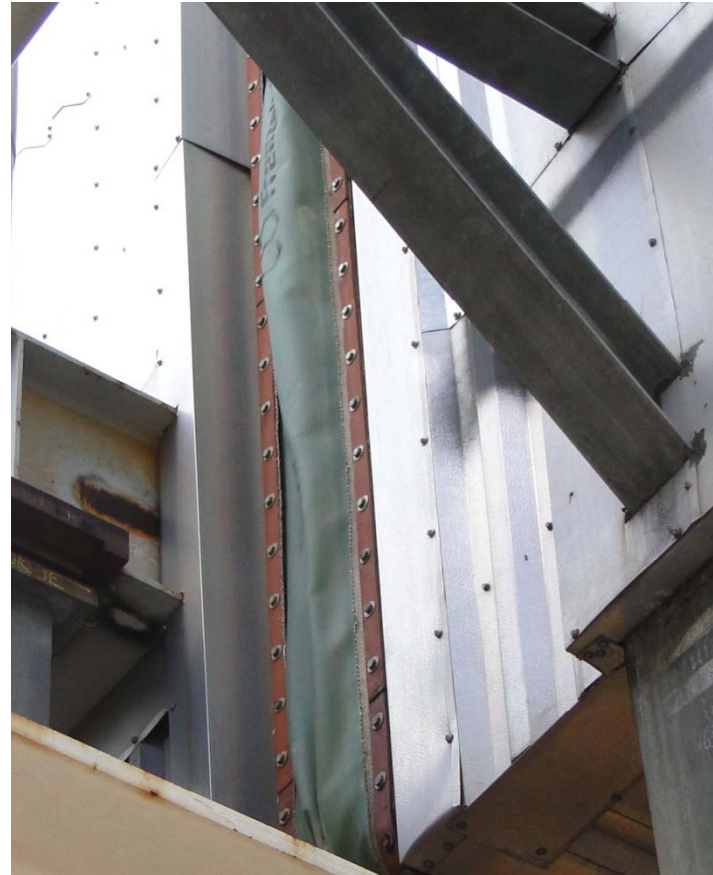
Single Layer Teflon - Reversal

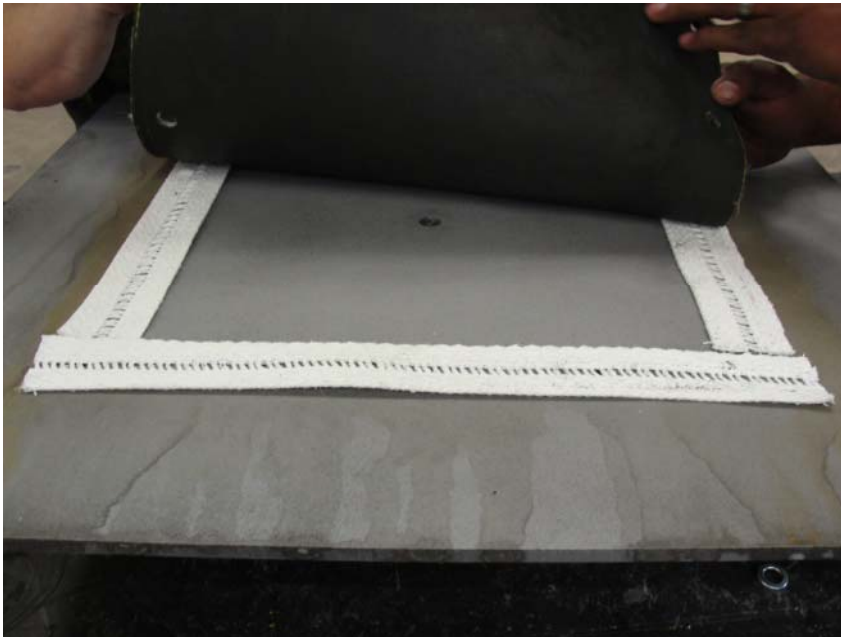
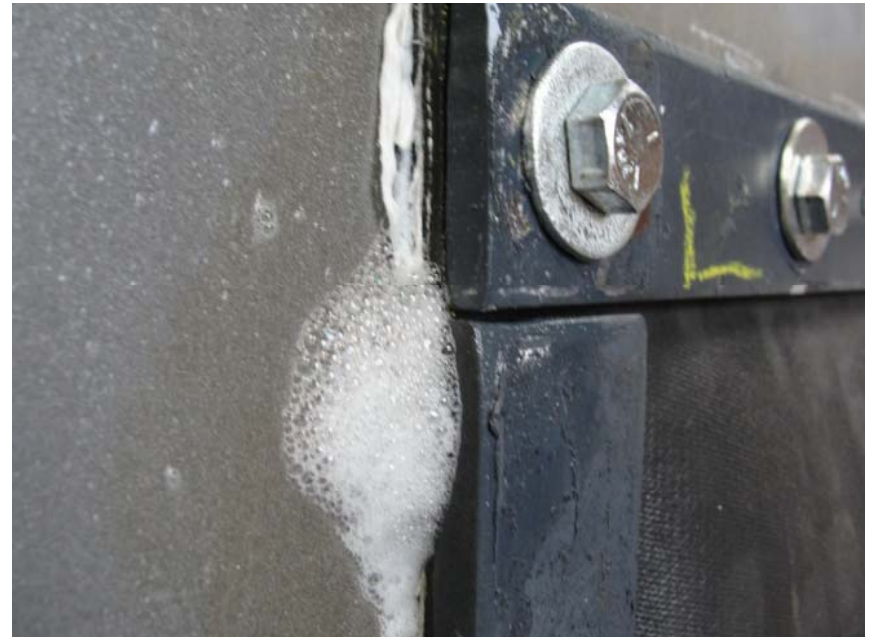
Drop Warp Gasket Should not be used on Sealing Surface.

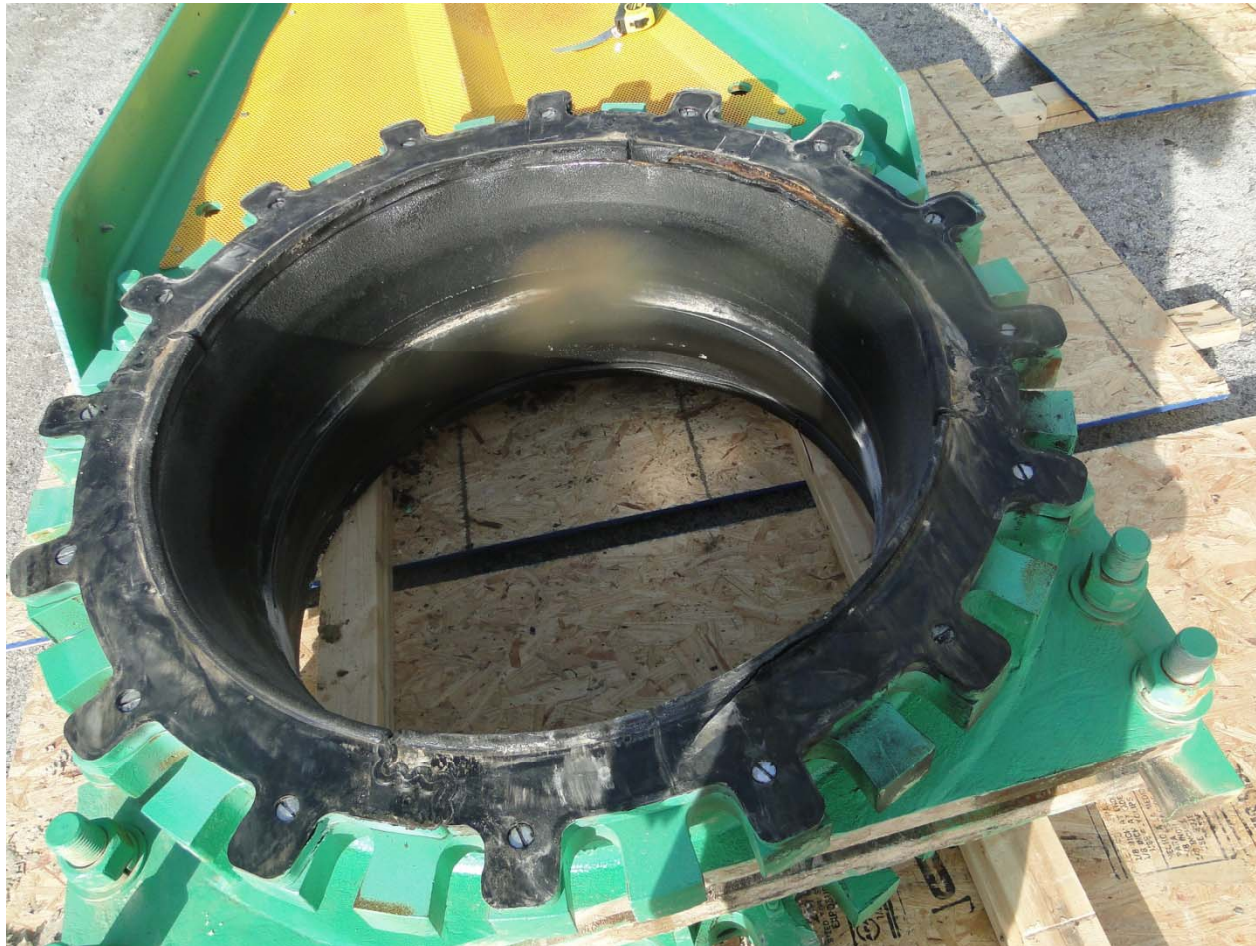
- Valves designed for rubber lined steel can have problems when mated to larger ID piping such as FRP.

Rubber Lined Valve

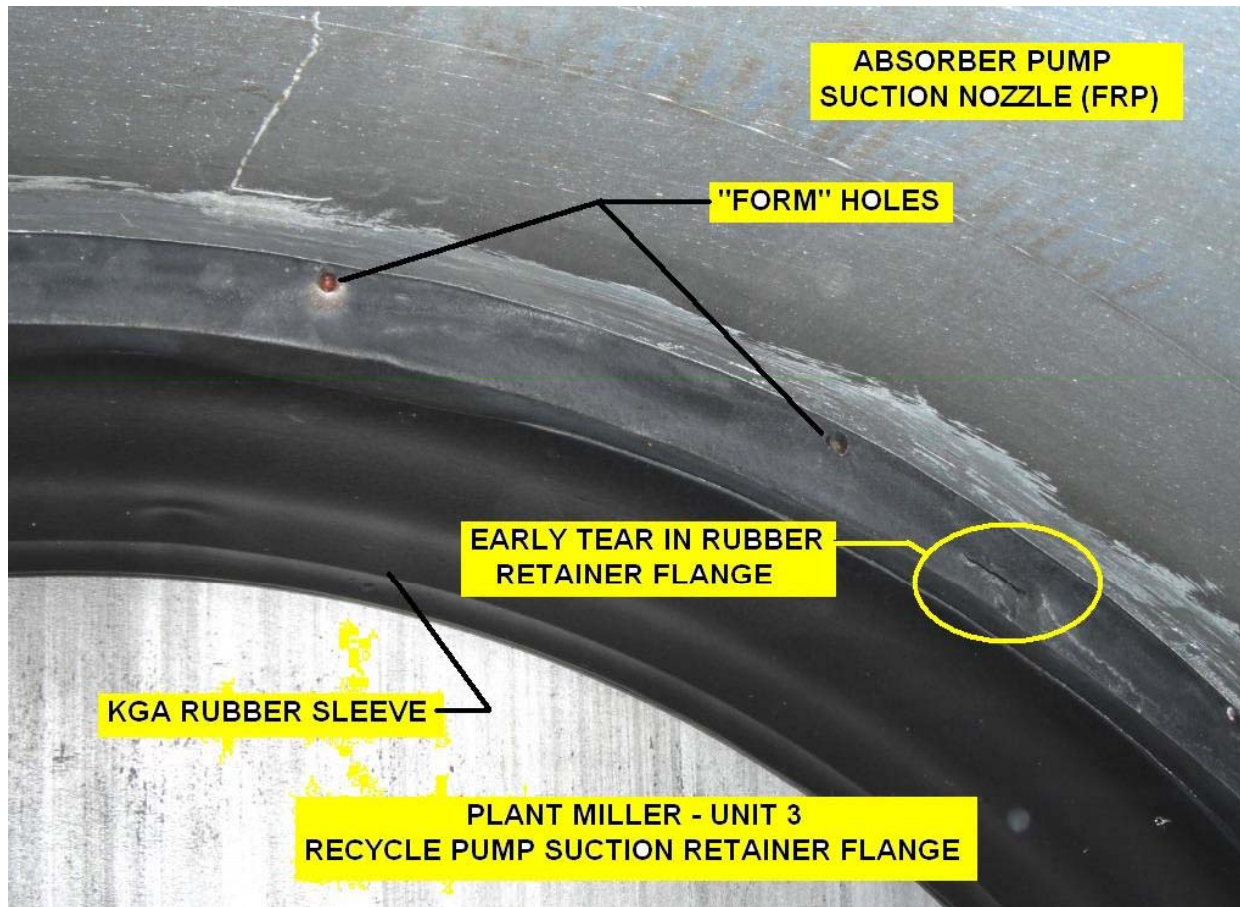
Rubber Lined Valve

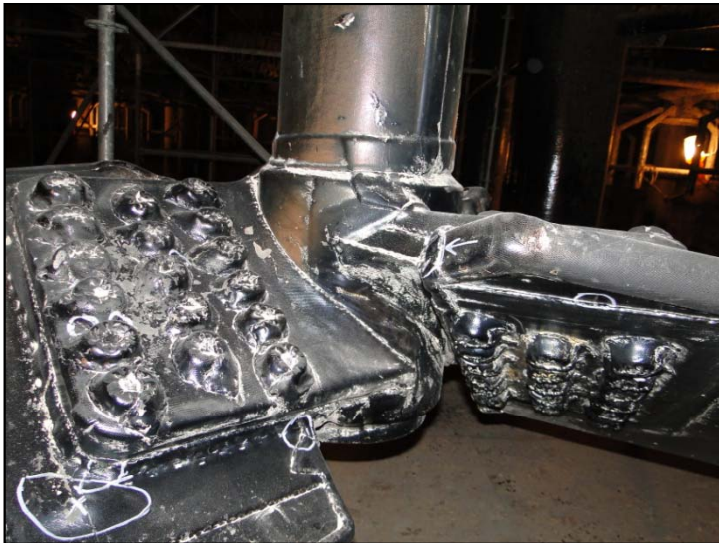
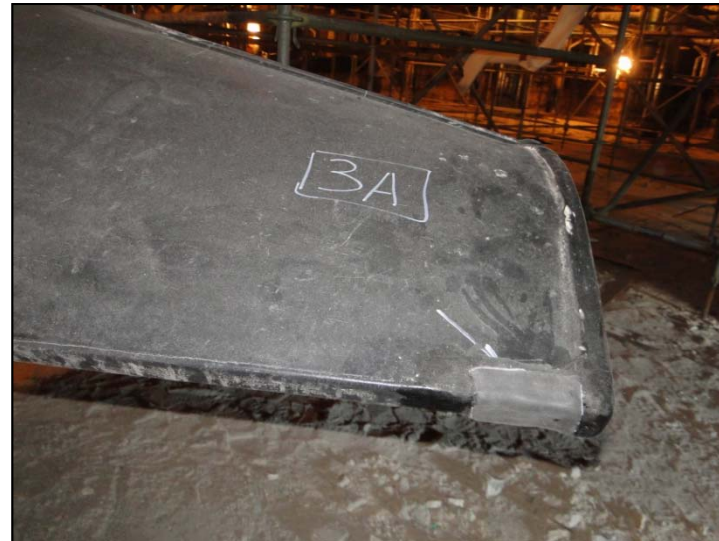
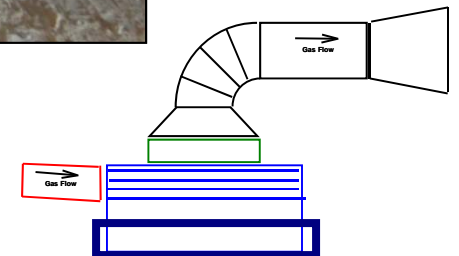
Agitator Rubber Damage

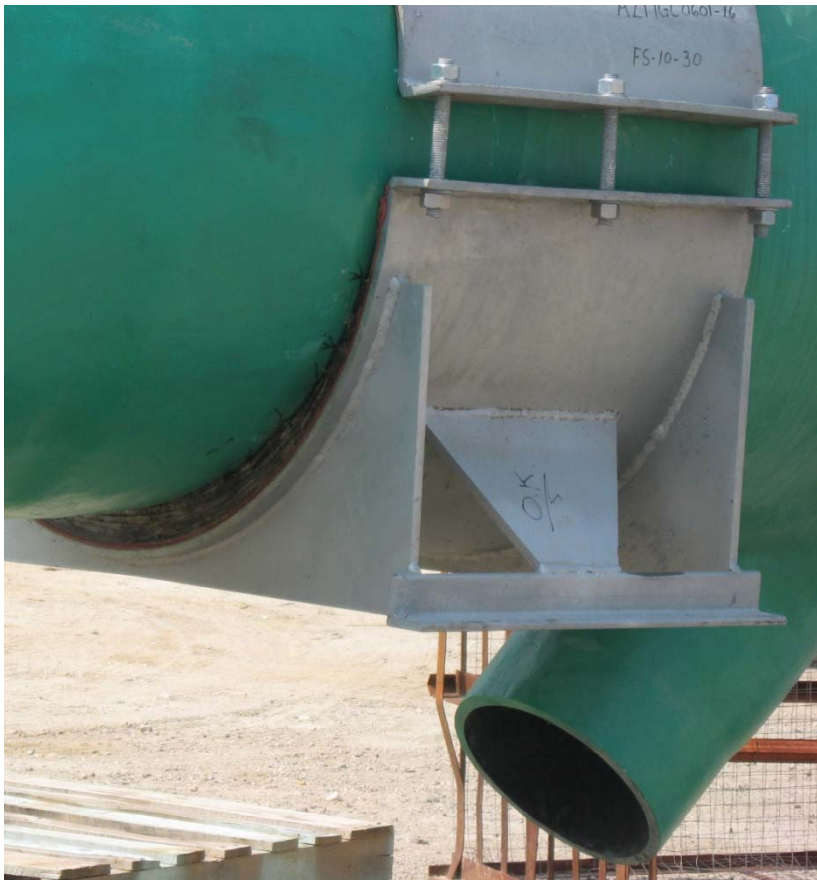
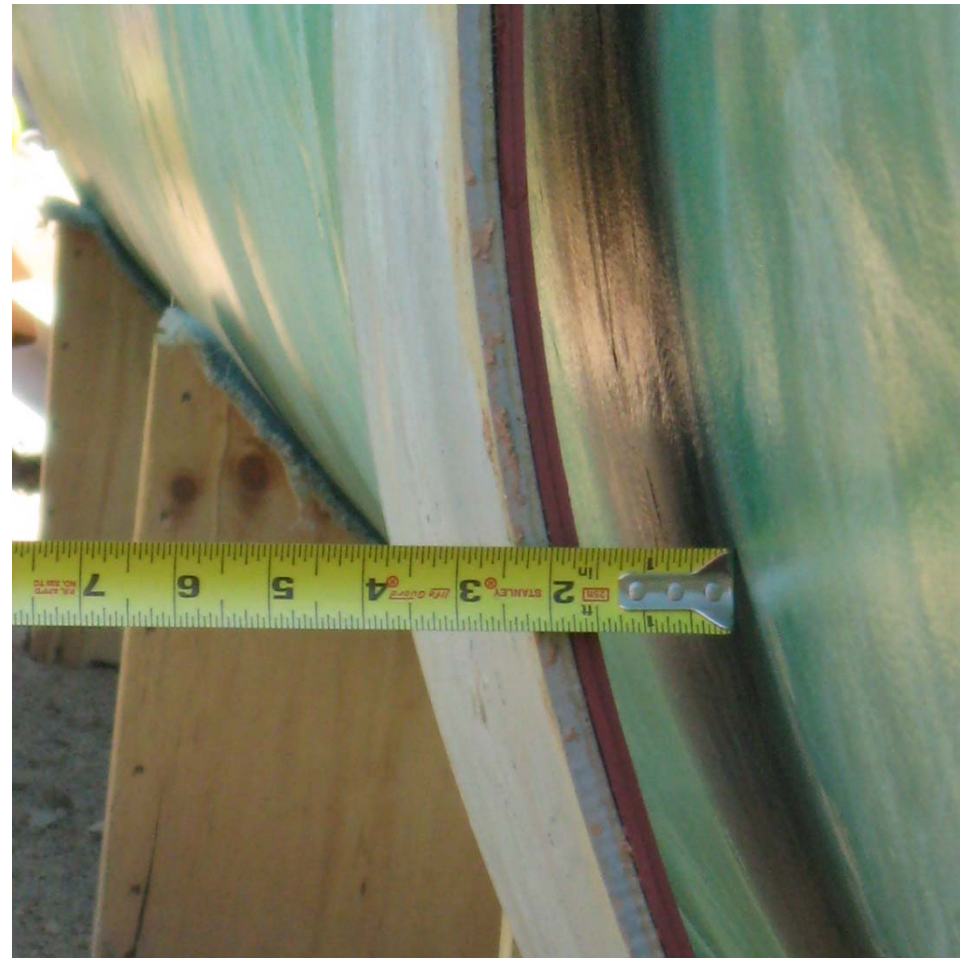
OD Variations Caused Support Issues

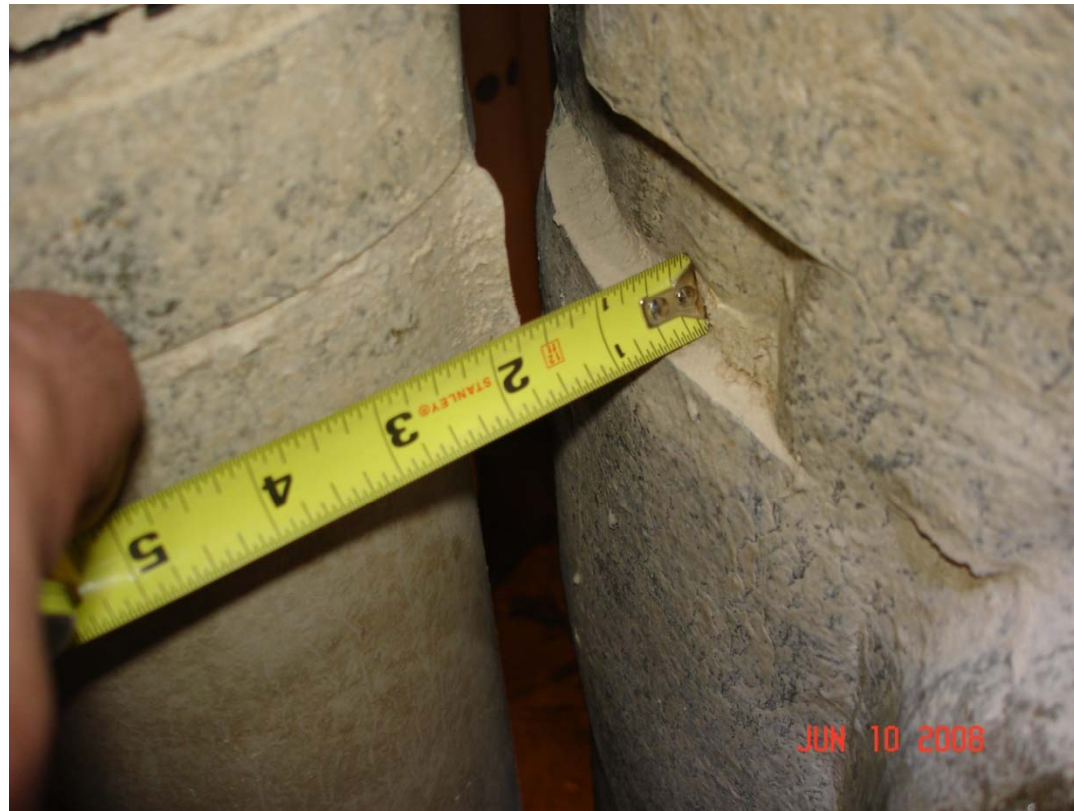
Relative Movement between Parts will lead to Significant Wear

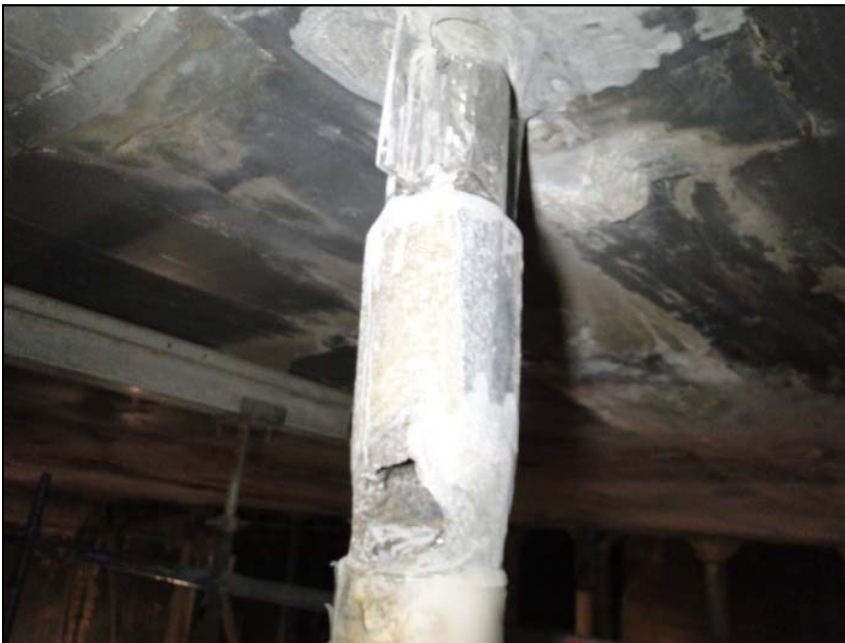
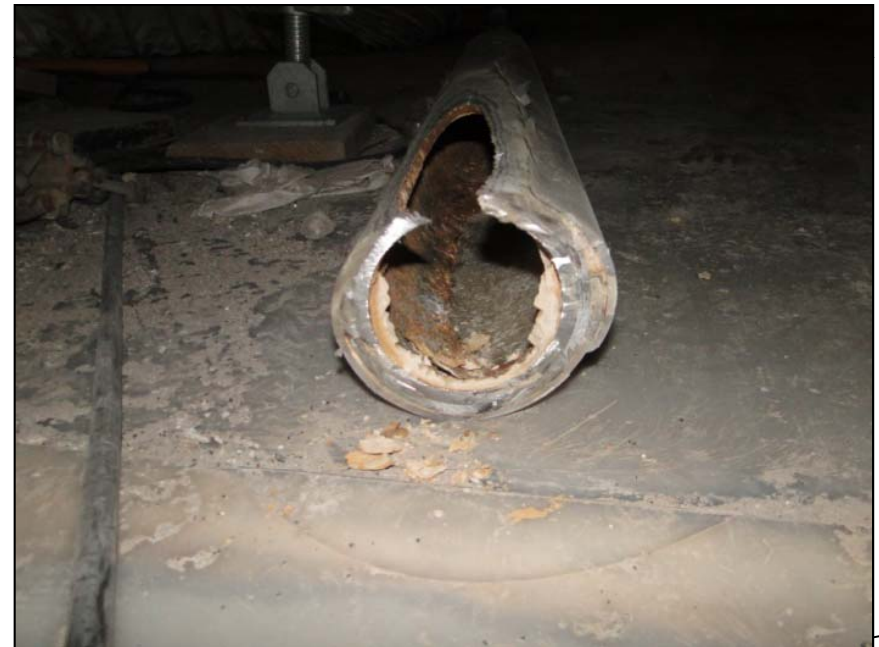
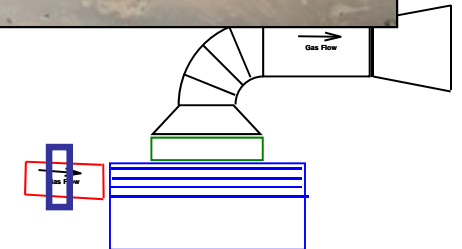
Particles in High Velocity will cause excessive erosion in surfaces normal to the flow.

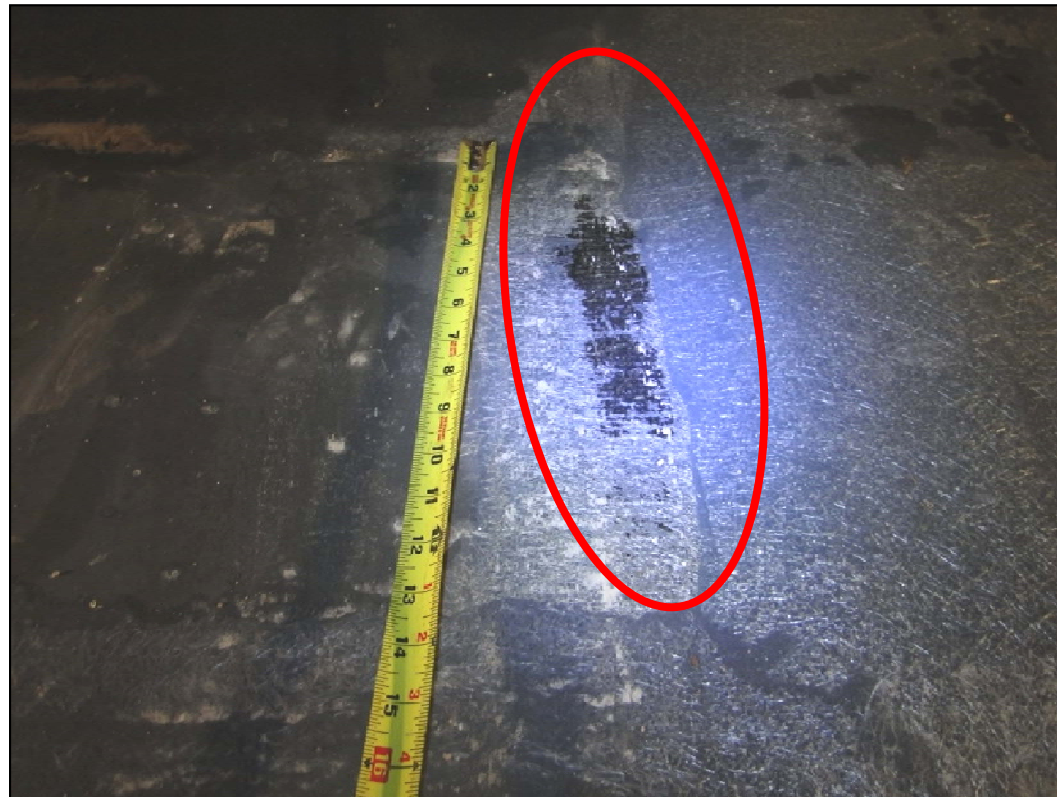
Erosion in surfaces parallel to flow will erode, but at a slower rate.

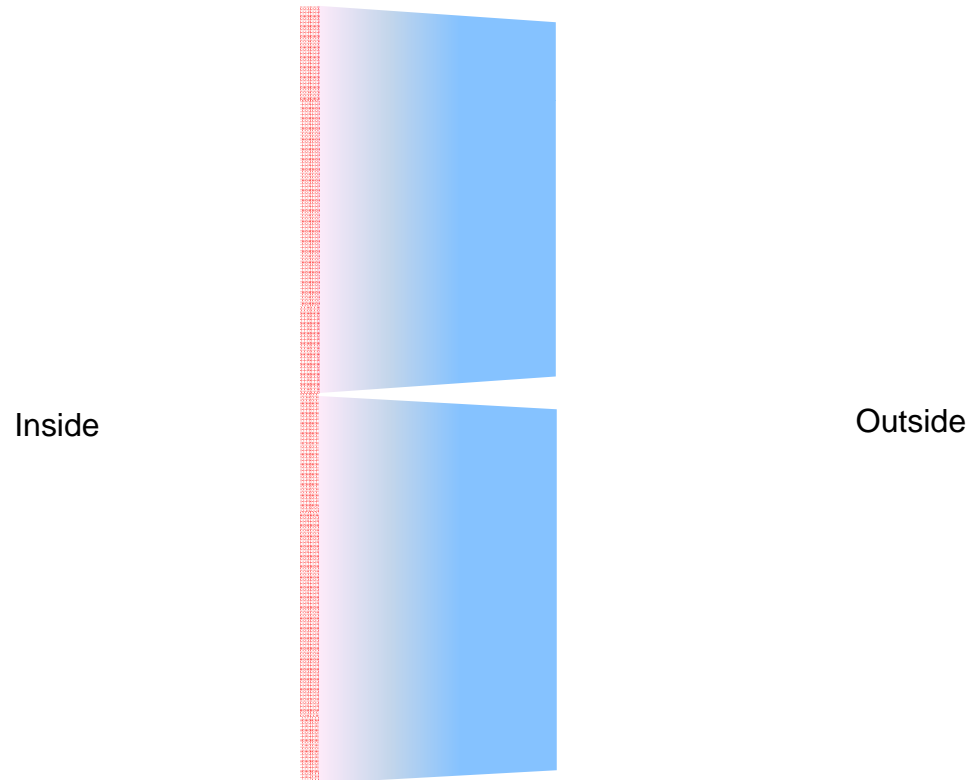
Through Wall Crack (running)

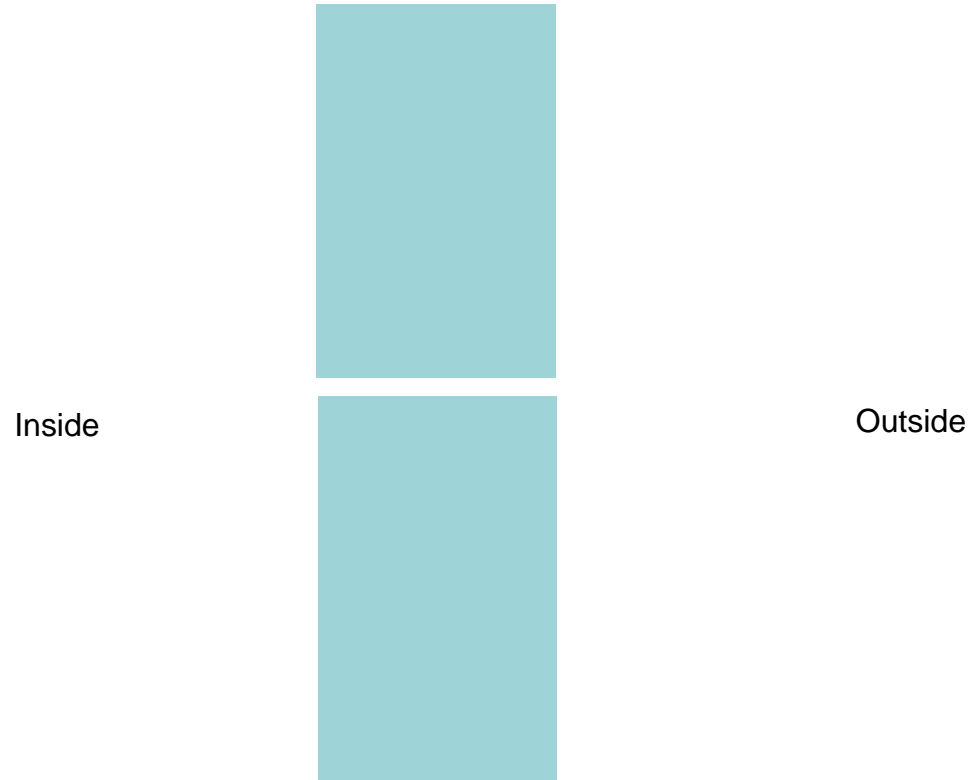
Through Wall Crack (start-up)

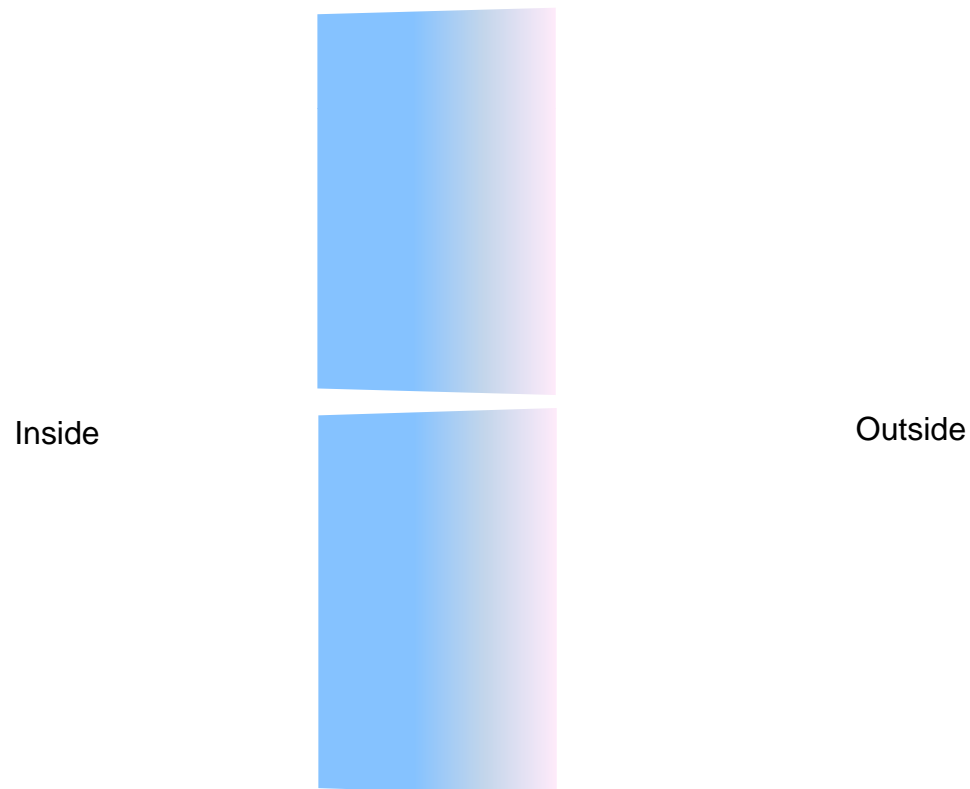
Through Wall Crack (dilution with cooler water)
