2012 APC Round Table & Expo Presentation

July 16-17, 2012, in Baltimore, MD / Hosted by Duke Energy, Entergy,
FirstEnergy, Southern Company & TVA

POLYMER LINING PROTECTION FOR DUPLEX 2205 ALLOY ABSORBER MODULES

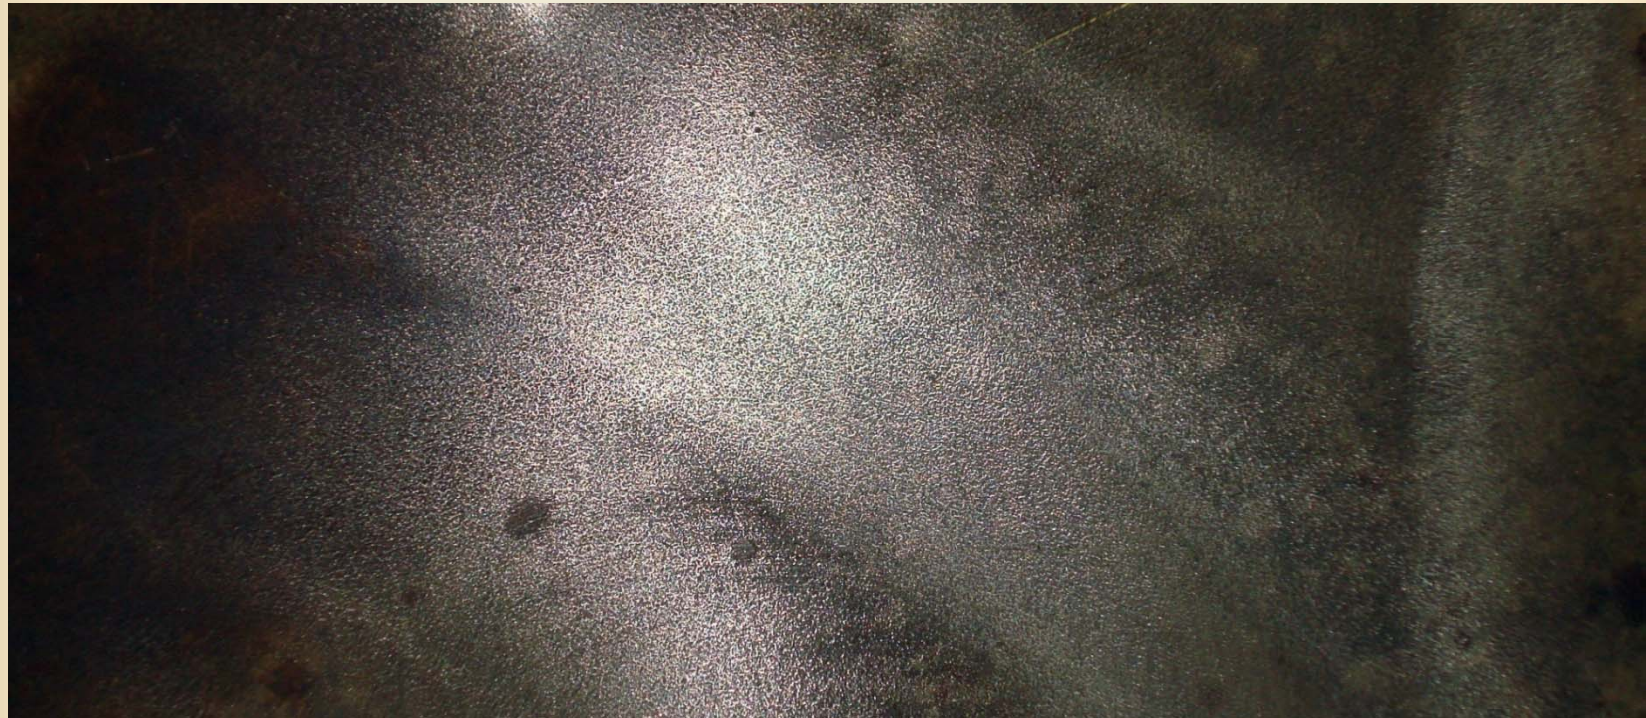
- FGD Environment very challenging for Duplex 2205 and 255 Alloy.
 - Operating temperature typically 125 F or greater.
 - pH is typically 5.
 - Chlorides of 5000 ppm with some reported at 20,000 ppm, dependent on coal utilized.
- Dissolved fluorides further compound the problem.
- DNV has established that 2205 Alloy does not have sufficient corrosion resistance for this service.

Darkened Surface is an Indication of
Active Corrosion

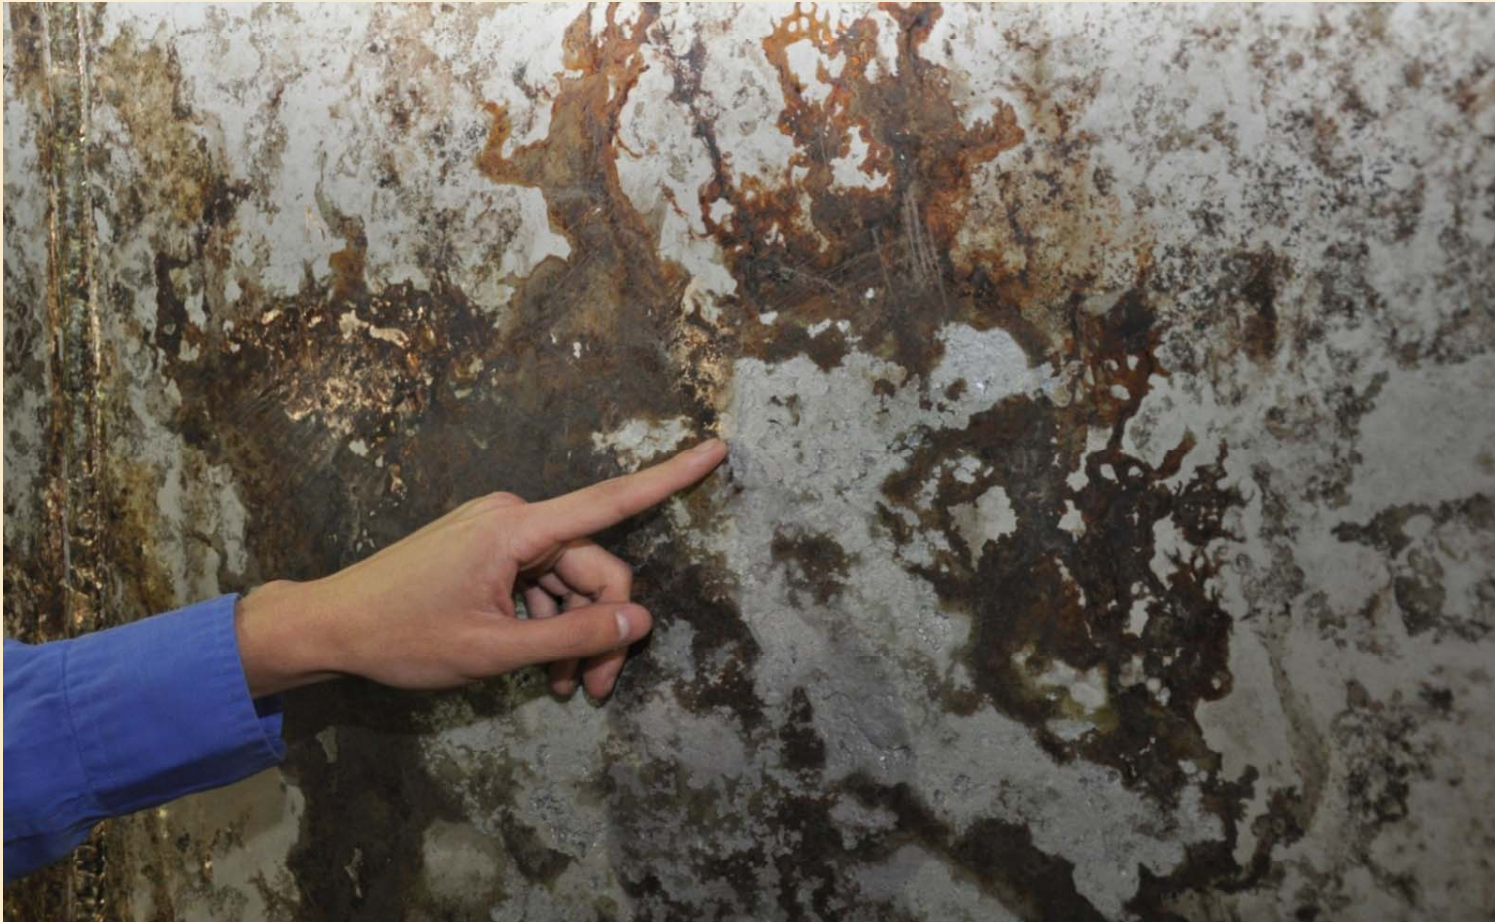
Active Pitting Found Under Slurry Buildup

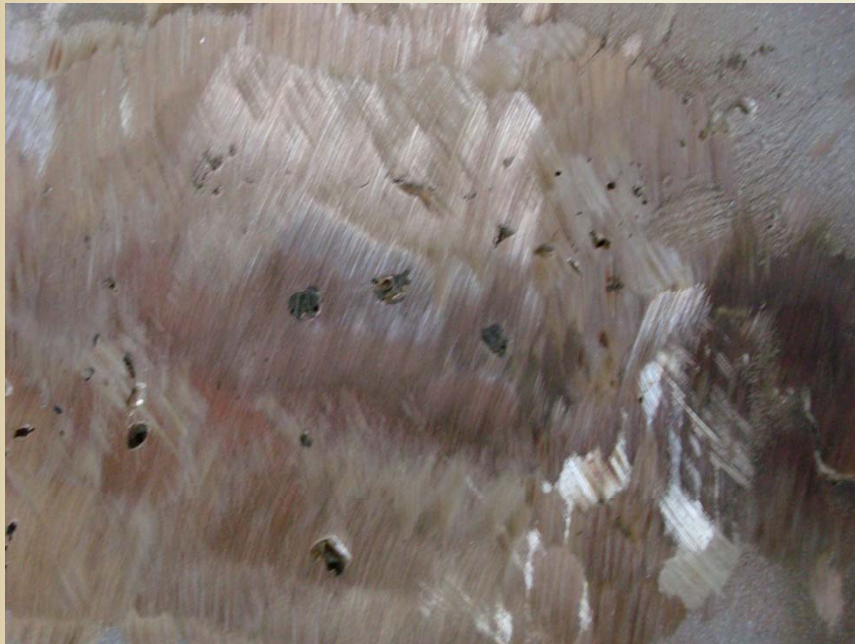
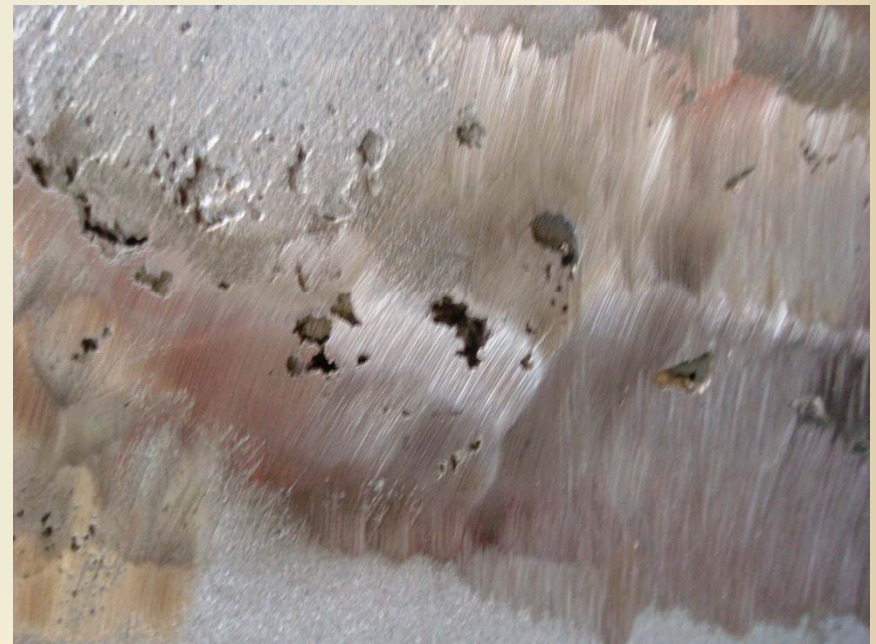
Pitting found in absorber after 12 –
18 months service

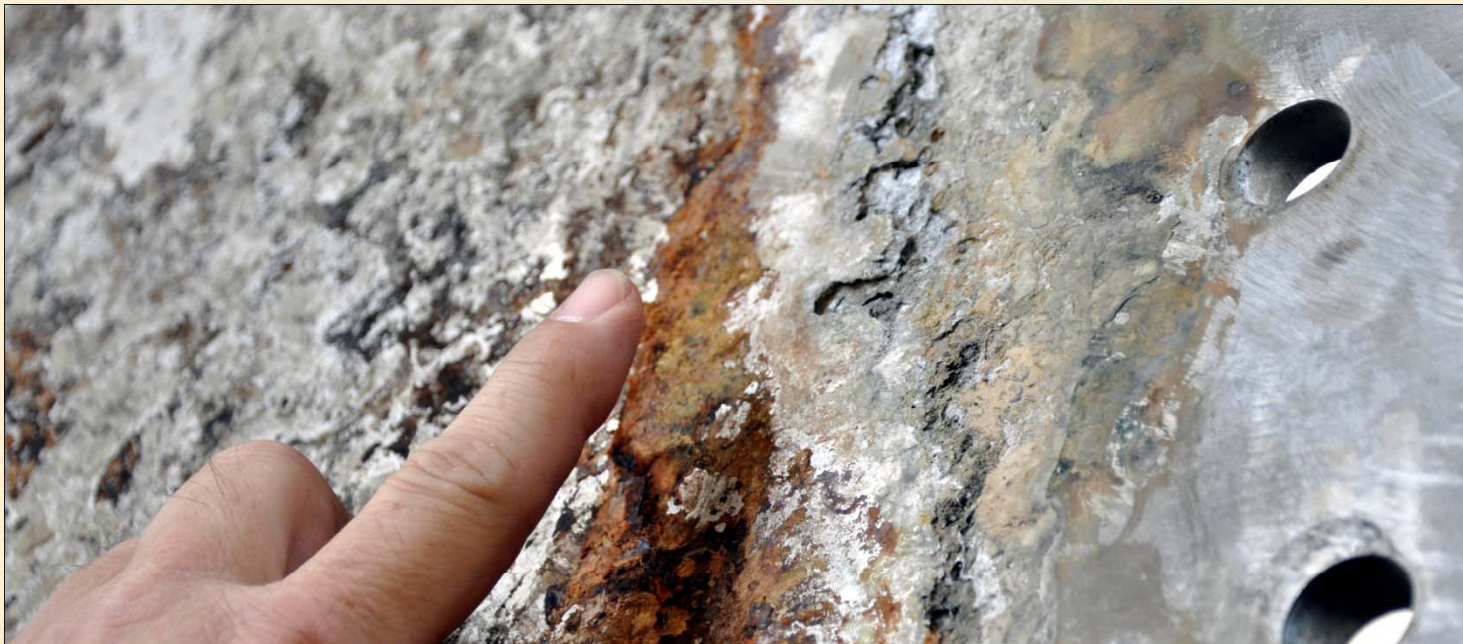
- ✦ Surfaces are abrasive blasted to clean and determine extent of damage
- ✦ Abrasive blasting reveals wormholes in the 2205

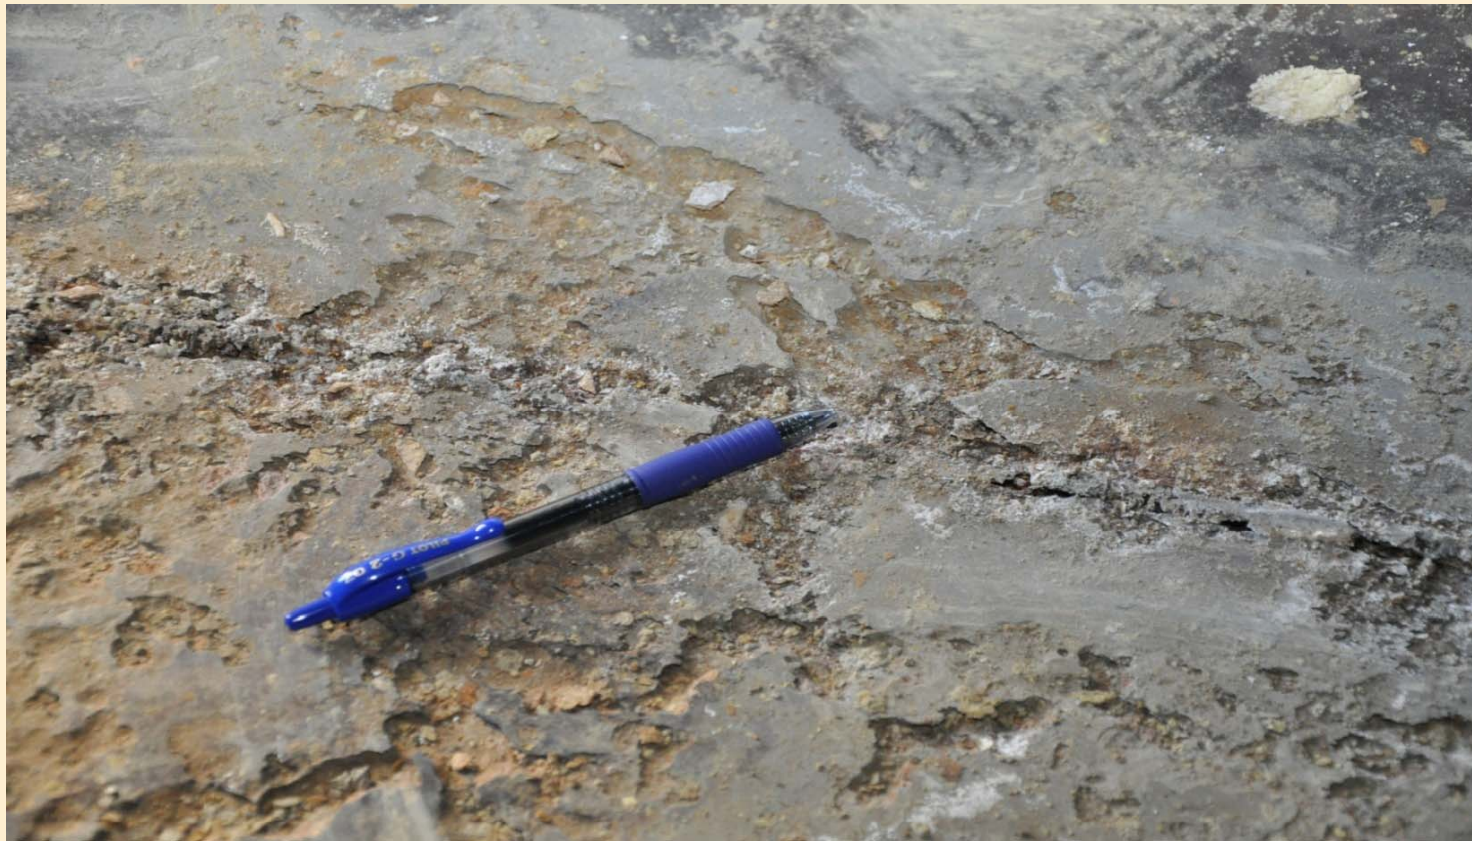
Floors With Full Through Corrosion

- ❖ Aggressive under deposit corrosion in alarming number of duplex 2205 absorbers.
- ❖ Through wall corrosion seen in as little as 3 months.
- ❖ Duplex 2205 & 255 deemed unsuitable for this service.

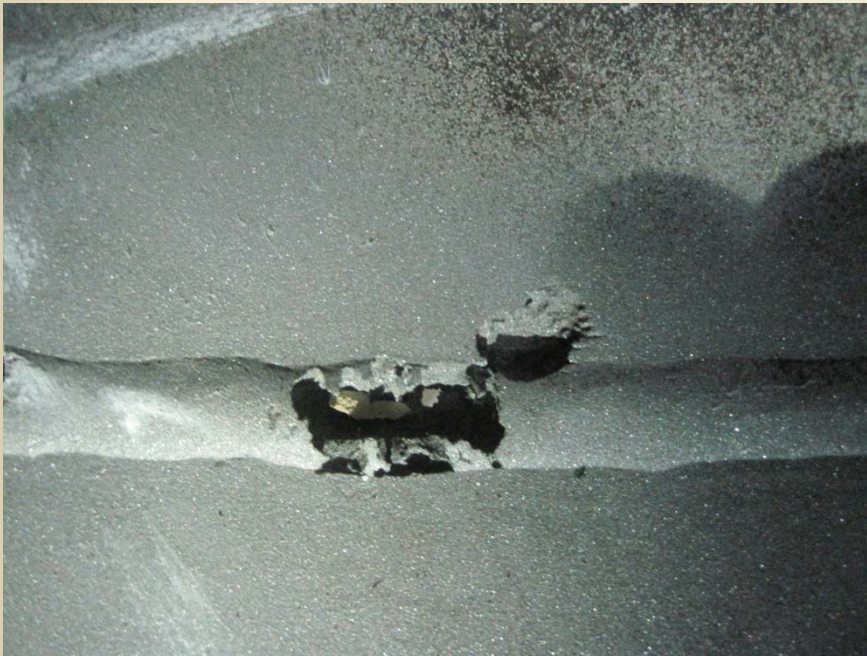
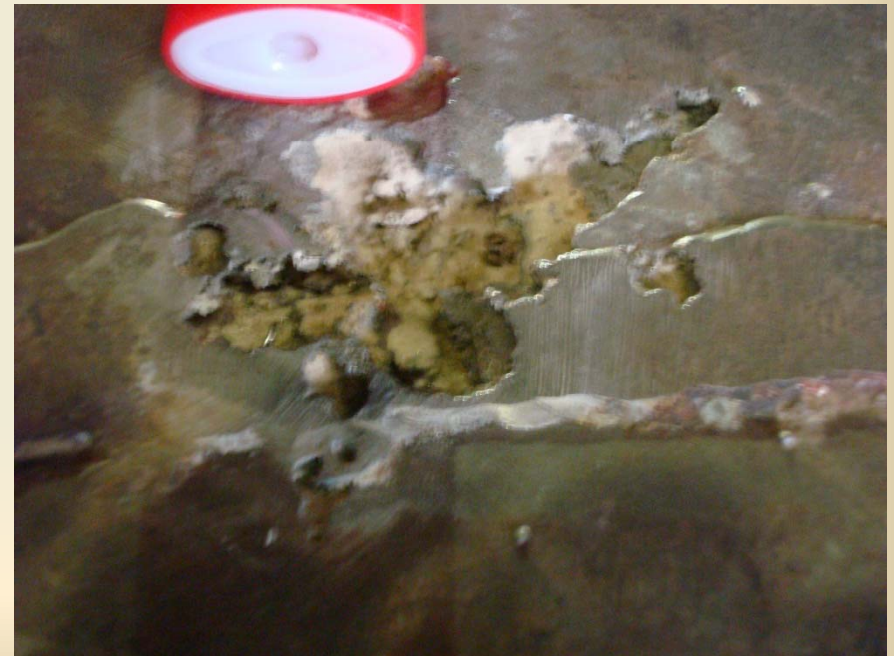
- ❑ Welds & HAZ's (heat affected zones) have been found to be very badly damaged.
- ❑ Abrasive blasting is required to clean and open the deteriorated welds.
