**2014 APC Round Table  
& Expo Presentation**

July 14-15, 2014, in Louisville, KY / Hosted by LG&E/KU

# Operation and Maintenance Electrostatic Precipitator “Mechanical”

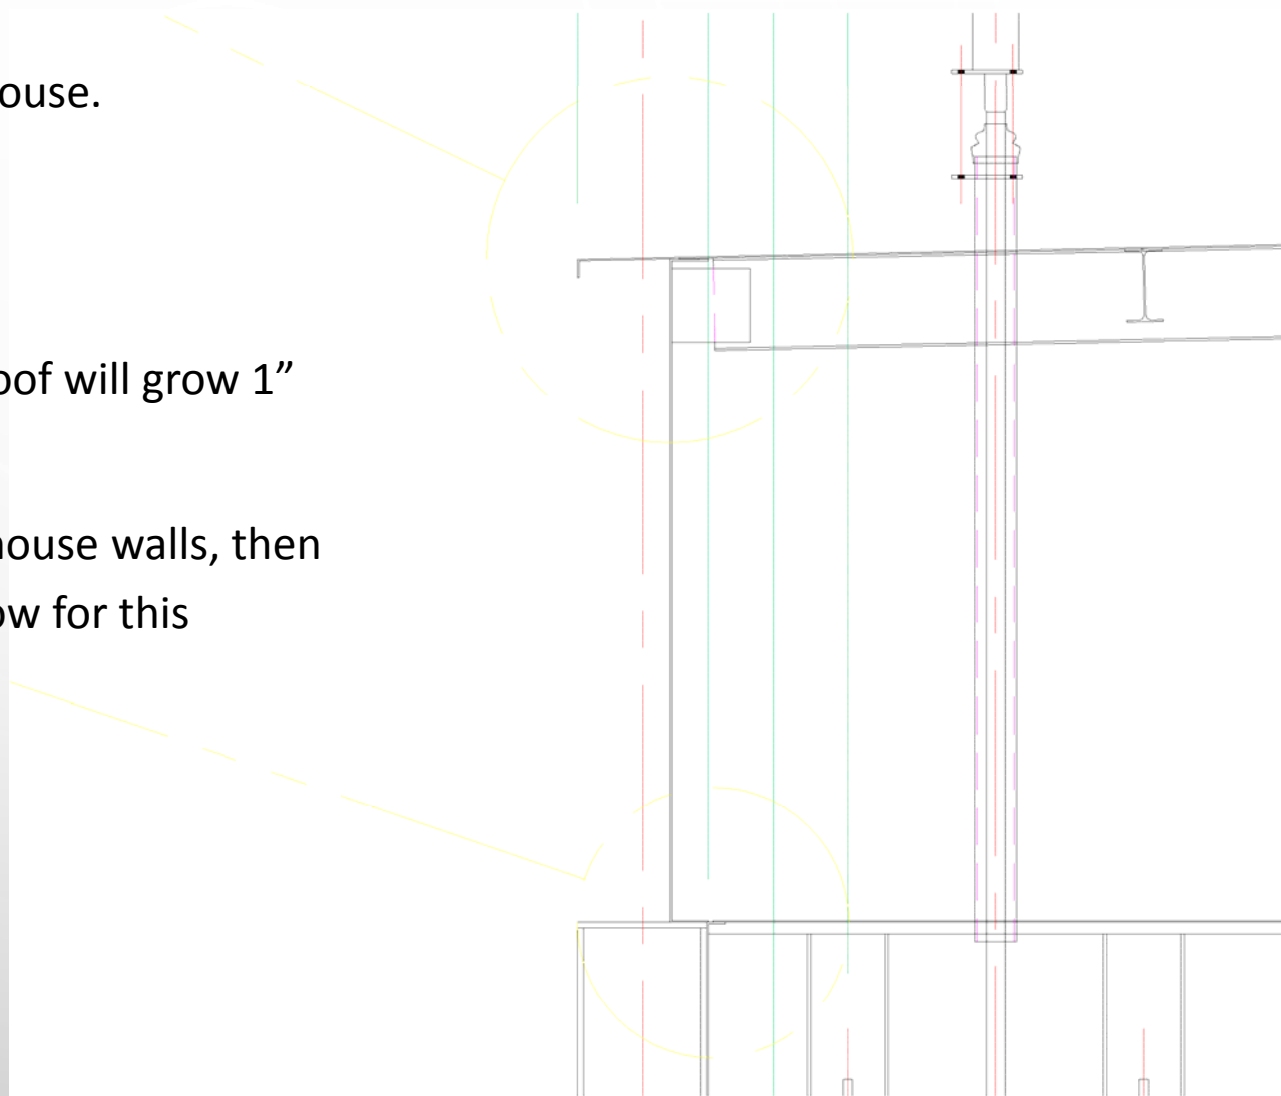
This is a blow up of the corner of the penthouse.

At the bottom is the hot roof. (350°F)

At the top is the cold roof. (100°F)

Assuming the roof is 50 feet wide the hot roof will grow 1" more than the cold roof.

If both of the roofs are welded to the penthouse walls, then some allowance must be designed in to allow for this differential growth.

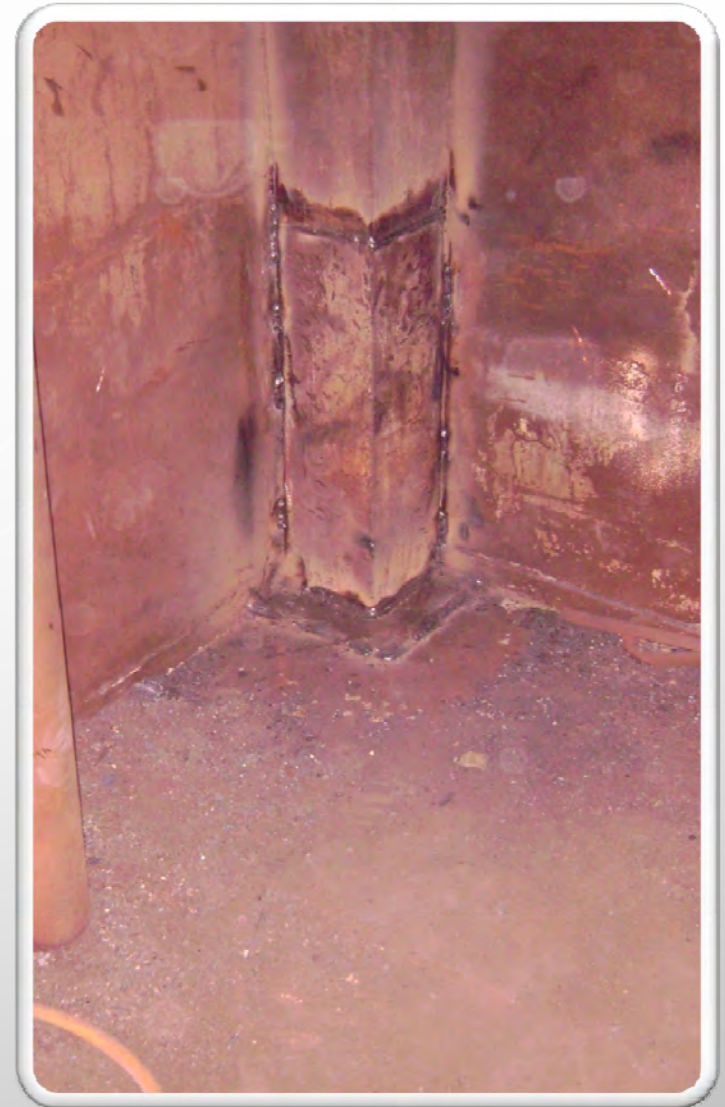
Without a place to grow, the cold roof will hold back on the walls and as the walls grow out the stress will increase and concentrate at the corners.

Eventually the corners will rise up tearing loose from the hot roof or peeling the hot roof off of the casing walls.

These corners get welded during outages on a huge number of precipitators every year.

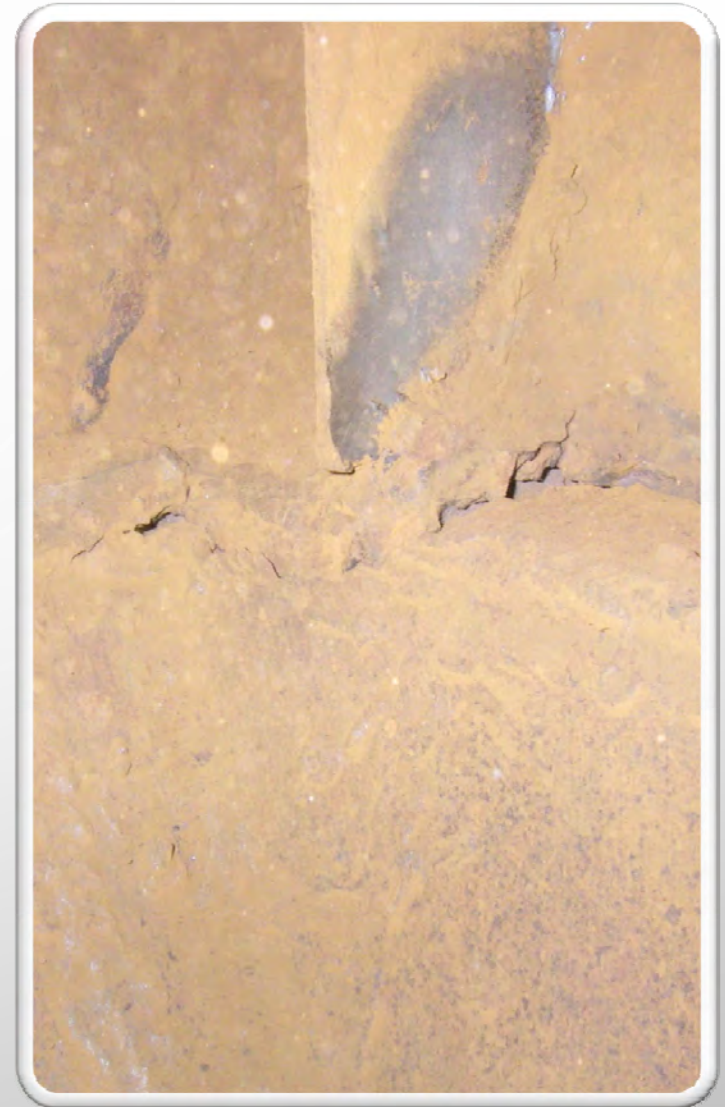
# Hopper Corners

The corners of the hoppers can also experience high stress concentrations from the push and pull of the slide bearings during start up and shut down.

Sometimes the slide bearing will not even move correctly.

Most precipitators will eventually have cracking as shown here.

This can be welded but will come back faster than before due to fatigue of the metal.

Permanent fixes require engineering and are always very expensive.

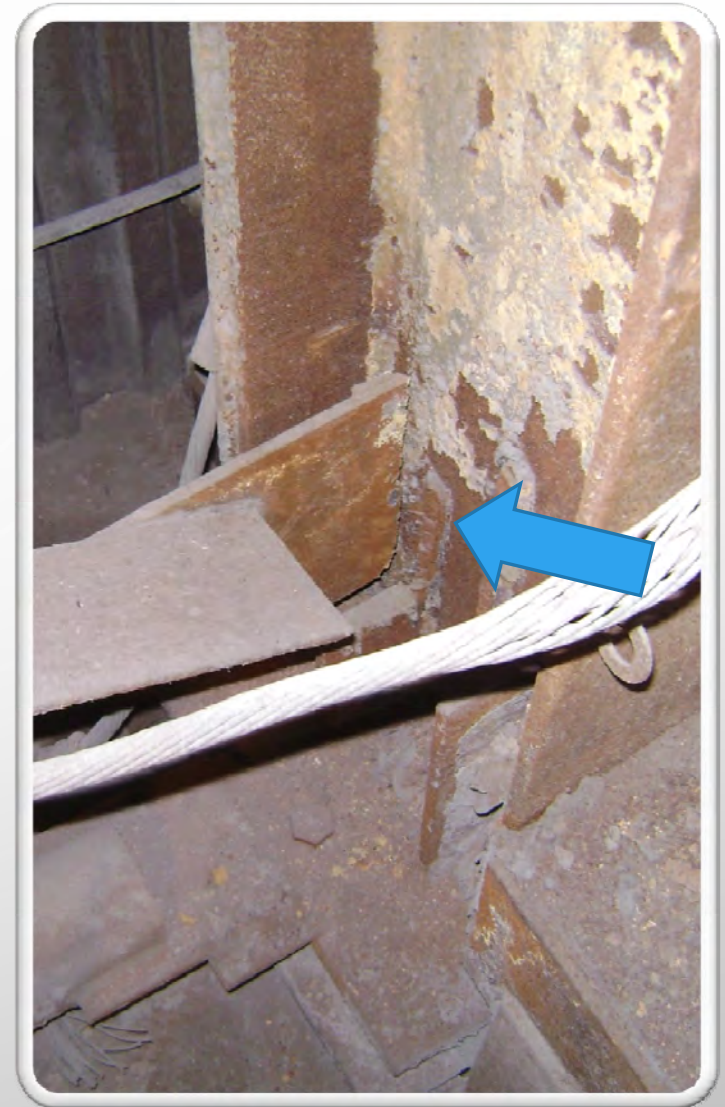
# Penthouse Weather Enclosure

This photo shows the column of the weather enclosure on top of the precipitator roof.

The wind bracing has broken loose from the column.

Obviously the slide bearing is not doing its job.

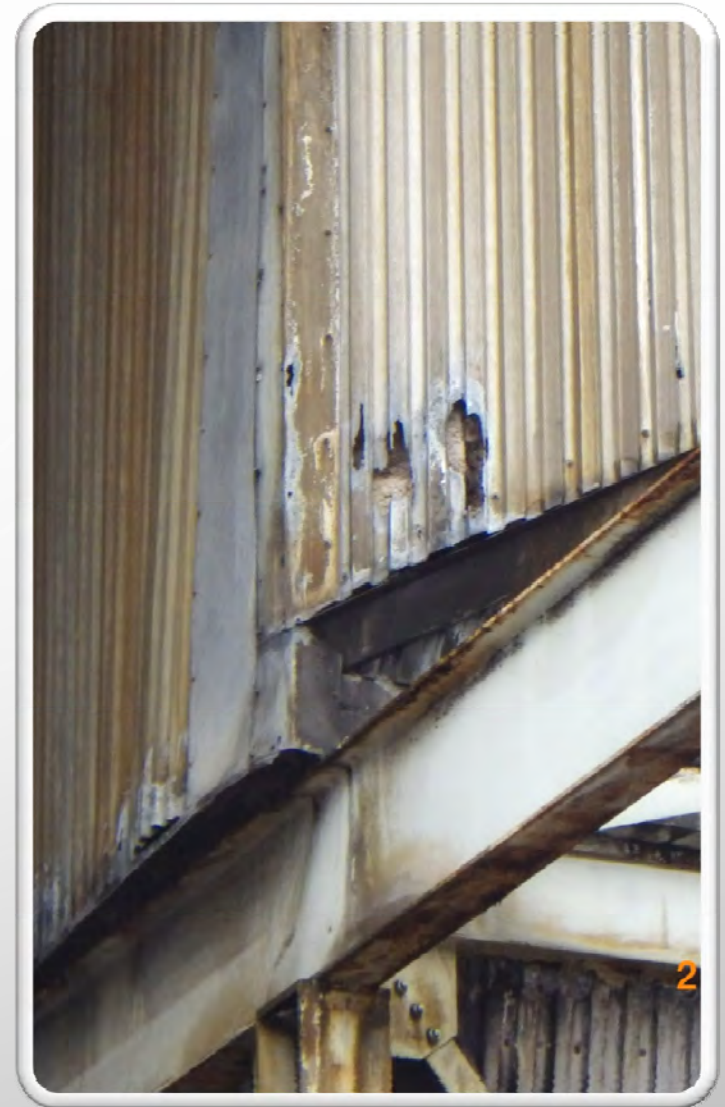
This is a picture of the joint between the outlet plenum of a precipitator and the vertical section above the hopper.

Once a hole corroded through the casing wall, the gases escaped and attacked the aluminum siding.

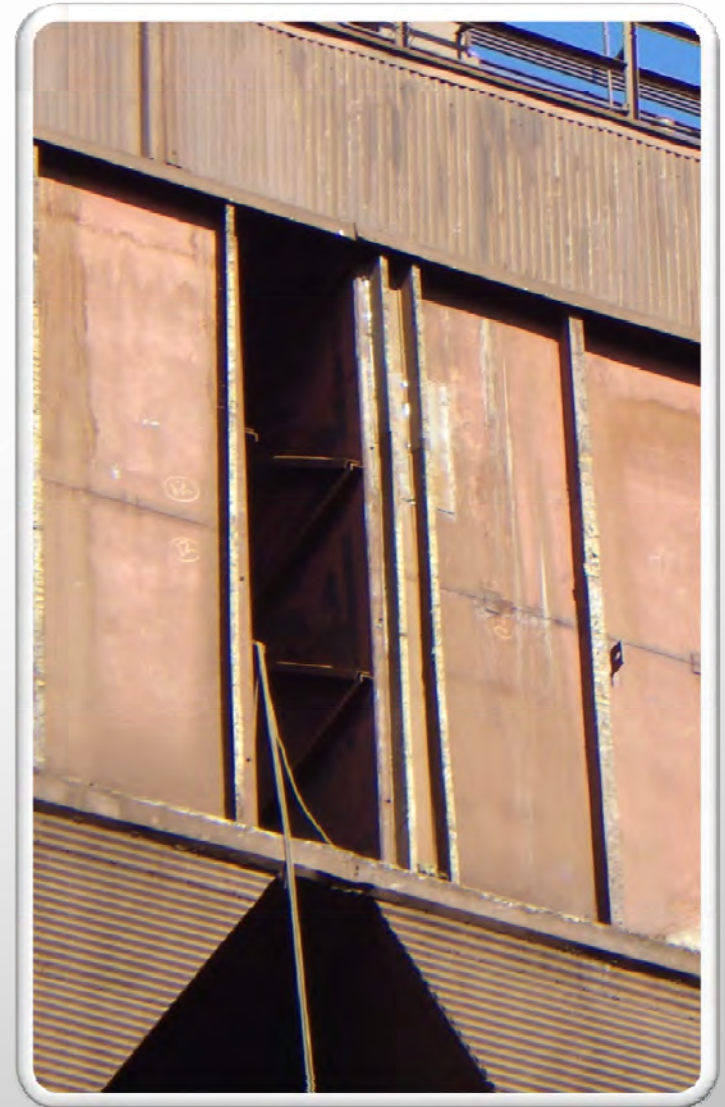
In this case there were multiple precipitator casing side by side.

In the areas between them cold air was drawn in at the bottom and hot air went out the top due to heating from the walls.

This cooled the side walls and condensation tended to form on the inside of the walls.

Eventually the walls corroded through in large areas.

In this photo the insulation and lagging have been removed so the crew can enter the space between the casings for repair.

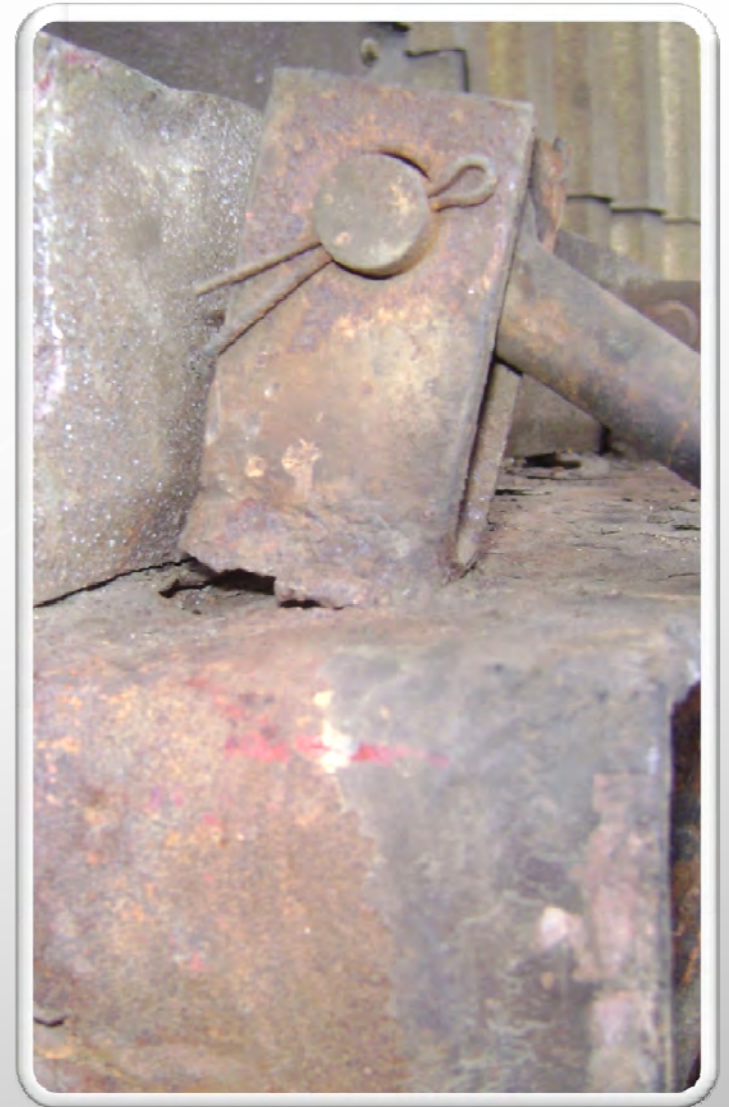
The problem with door latches like this is that once they crack loose then they don't hold the door closed correctly.

Then air leaks in and the corrosion accelerates.

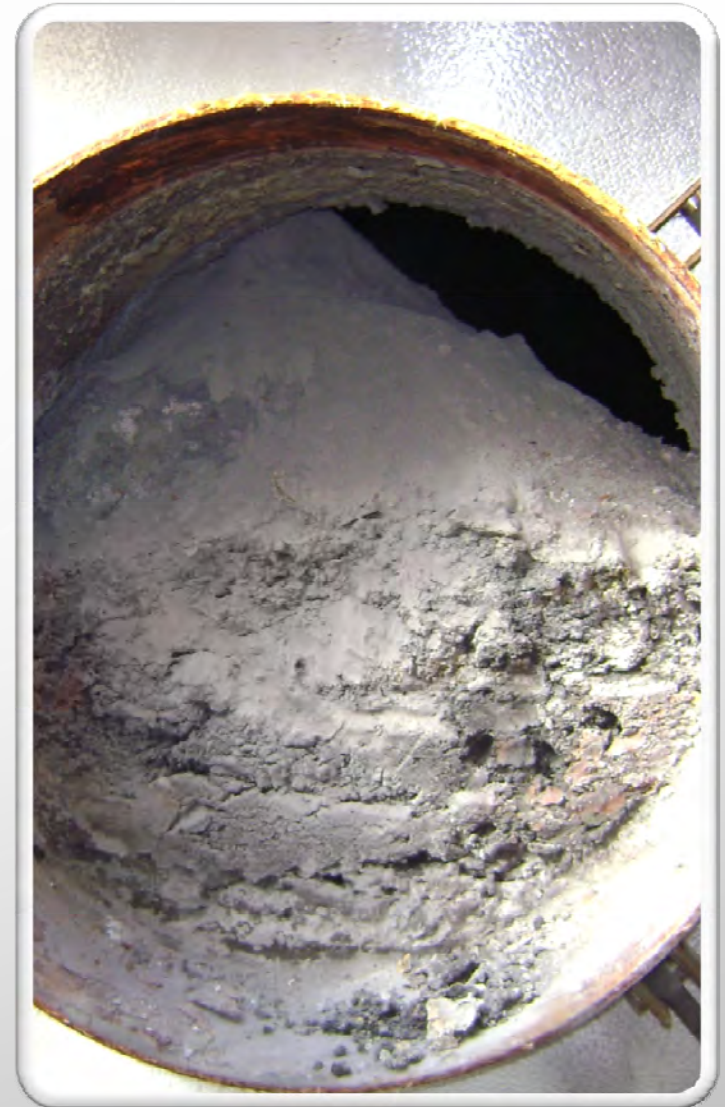
Depending on the door design, you get this.

In this case the door has a tube type combing that brings the door through the insulation.

These also corrode very fast because the side of the tube is exposed to both the flue gas and the cold winter air.

This pile of ash is hardened due to condensation. If this had been high sulfur coal ash, the door would last no time at all.

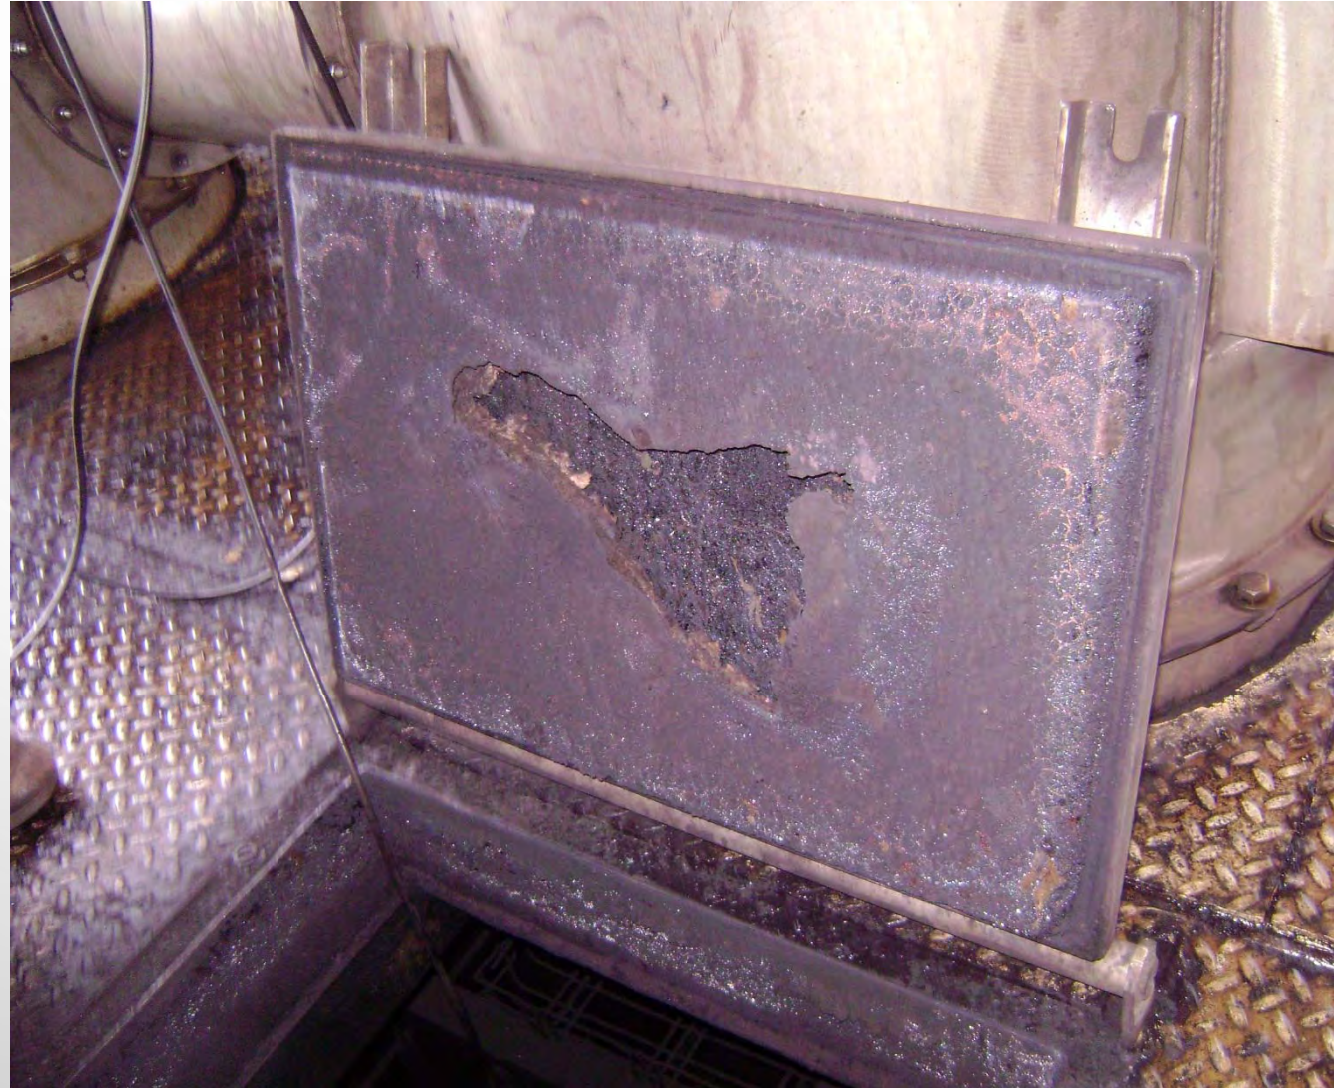
Here we have a rectangular similar design.

In this case the door itself has a bit of insulation.

As you can see, the corrosion happened anyway.

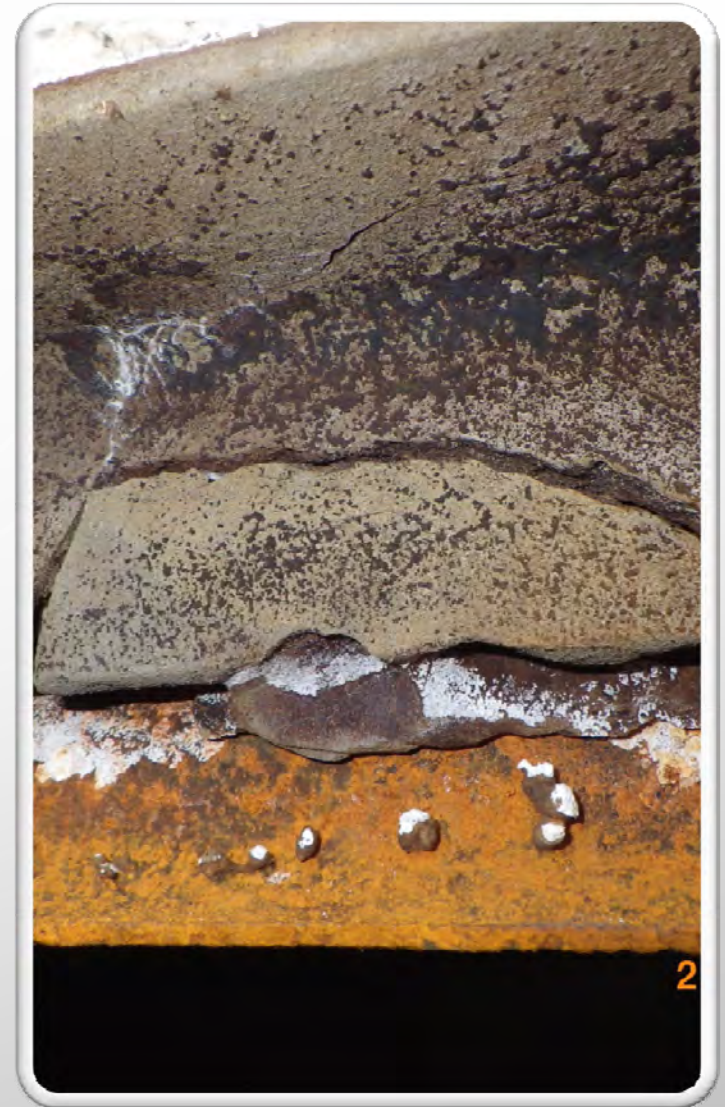
# Dissimilar Metals

Here is an example of stainless steel welded to carbon steel.

This was done just the right way with 309L rods and pre-heat and everything.

But stainless steel grows more than carbon steel, and in this case it grew more than the weld would stretch.

This particular weld was also attacked by the chlorides in the flue gas which made it more brittle.

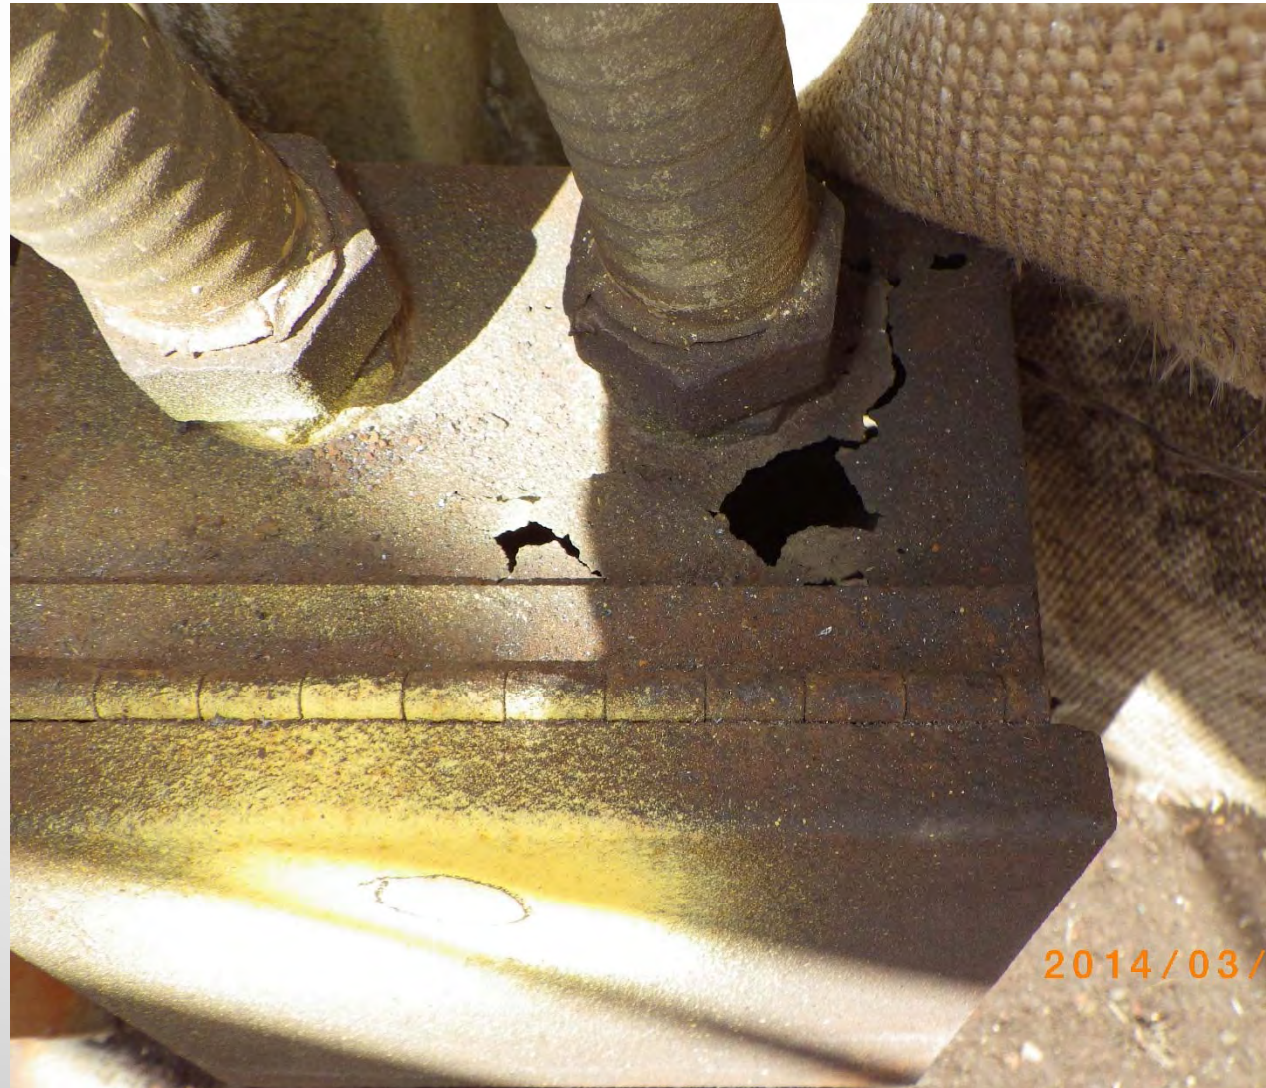
This is a small electrical box on the precipitator roof used to connect the high temperature wire from the insulator heaters to the normal feed cables.

The bottom of this box is a 1" conduit into the precipitator penthouse.

Gases came up into the box and condensed, then corroded the box.

Then it rained in the precipitator penthouse and corroded the hot roof.

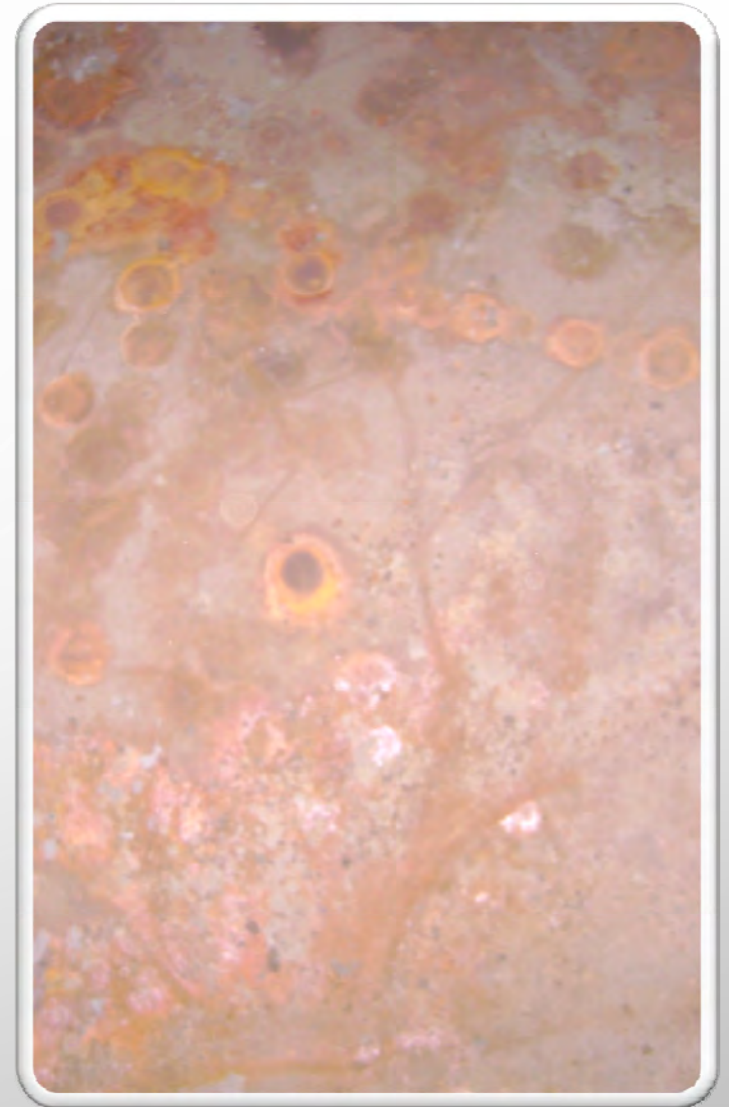
This is really why we noticed the conduit box.

It's hard to see the actual cracks in the floor, but this floor is so thin it was cracking apart.

When you put your foot on it, it would give way.

The spots are where the water ran around on the underside of the roof above and then dripped.

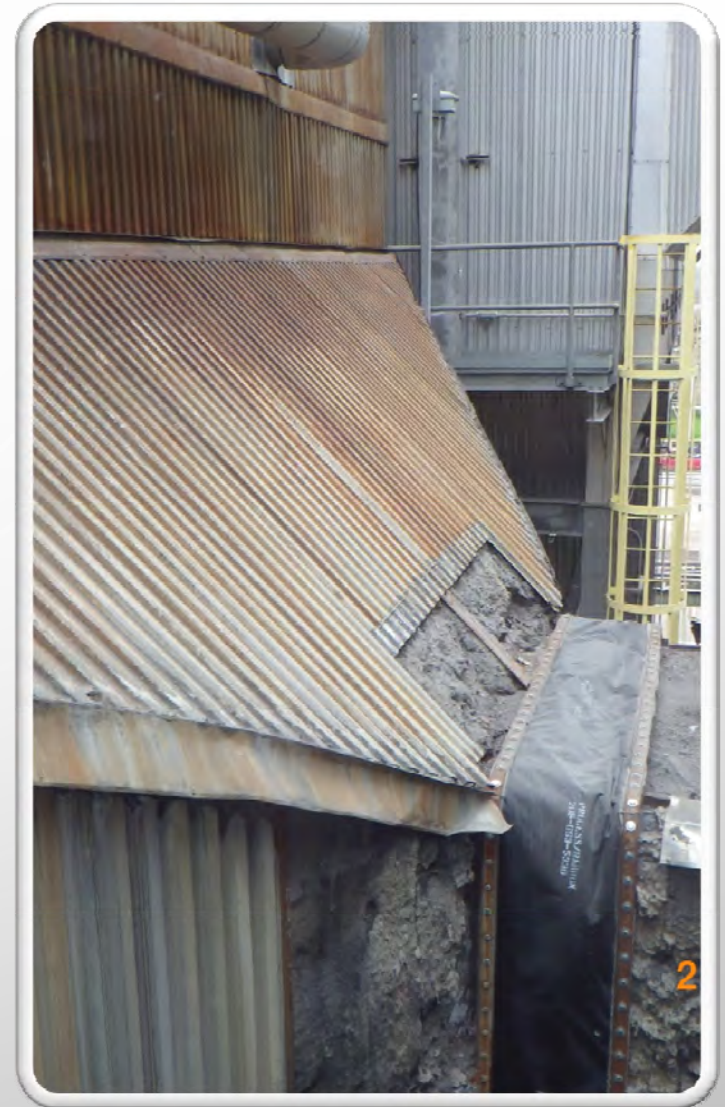
First the lagging was just left off after the expansion joint was changed. Now the insulation has been wet and is ruined and the life expectancy of the frame of the new expansion joint is probably now a couple of years.

Second. Even with the lagging in place. The lagging was installed wrong all along. Imagine the water running down the ribs like little gutters. To where? The expansion joint. Maybe that's why it failed to start with.

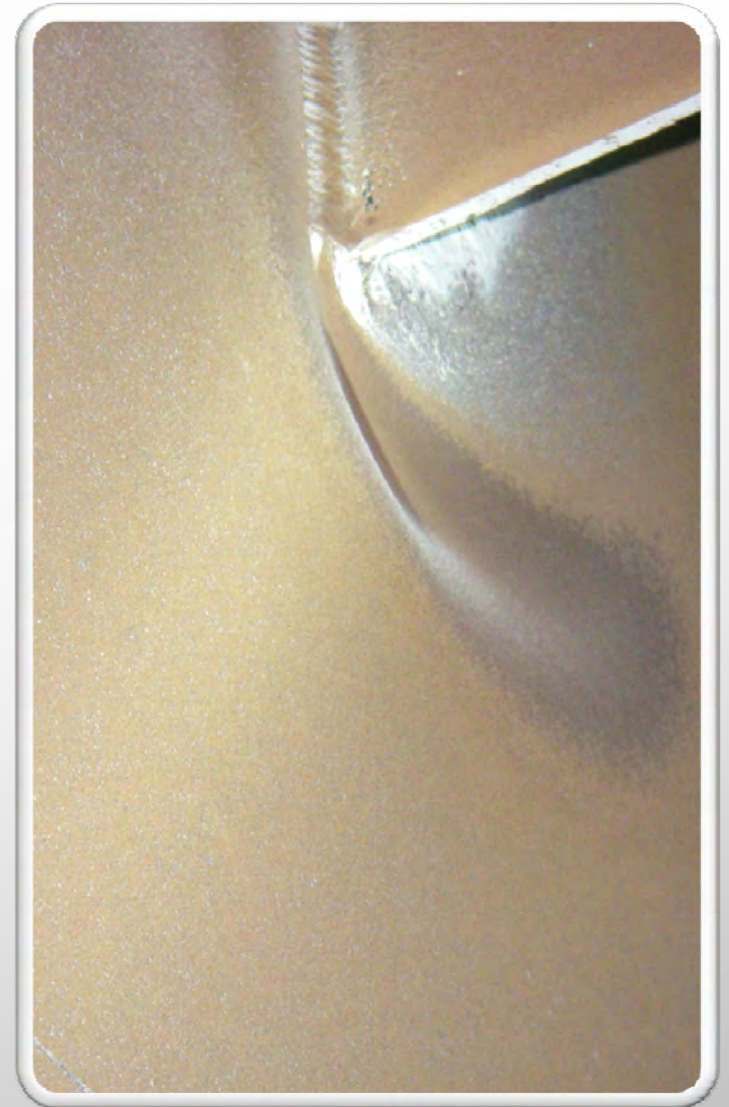
This is a picture of the edge of a turning vane.

Note that the high velocity gas flows around the edges of the vane.

This will wear through the side wall of the duct.

This can be reinforced in advance much easier.

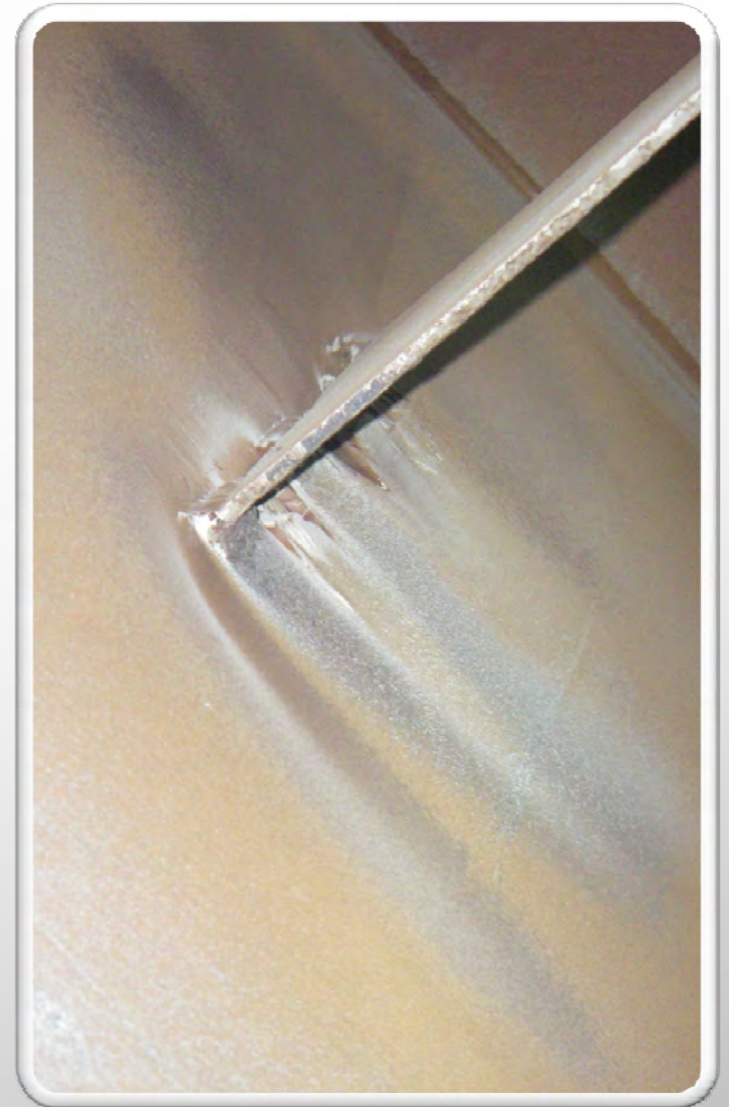
Almost all turning vanes are stitch welded.

But look behind these vanes. The gas sneaking through the gaps in the stitch welds wore holes right through the duct wall.

You don't need continuous welds, but a backing angle would have made this much stronger and prevented most of this flow.

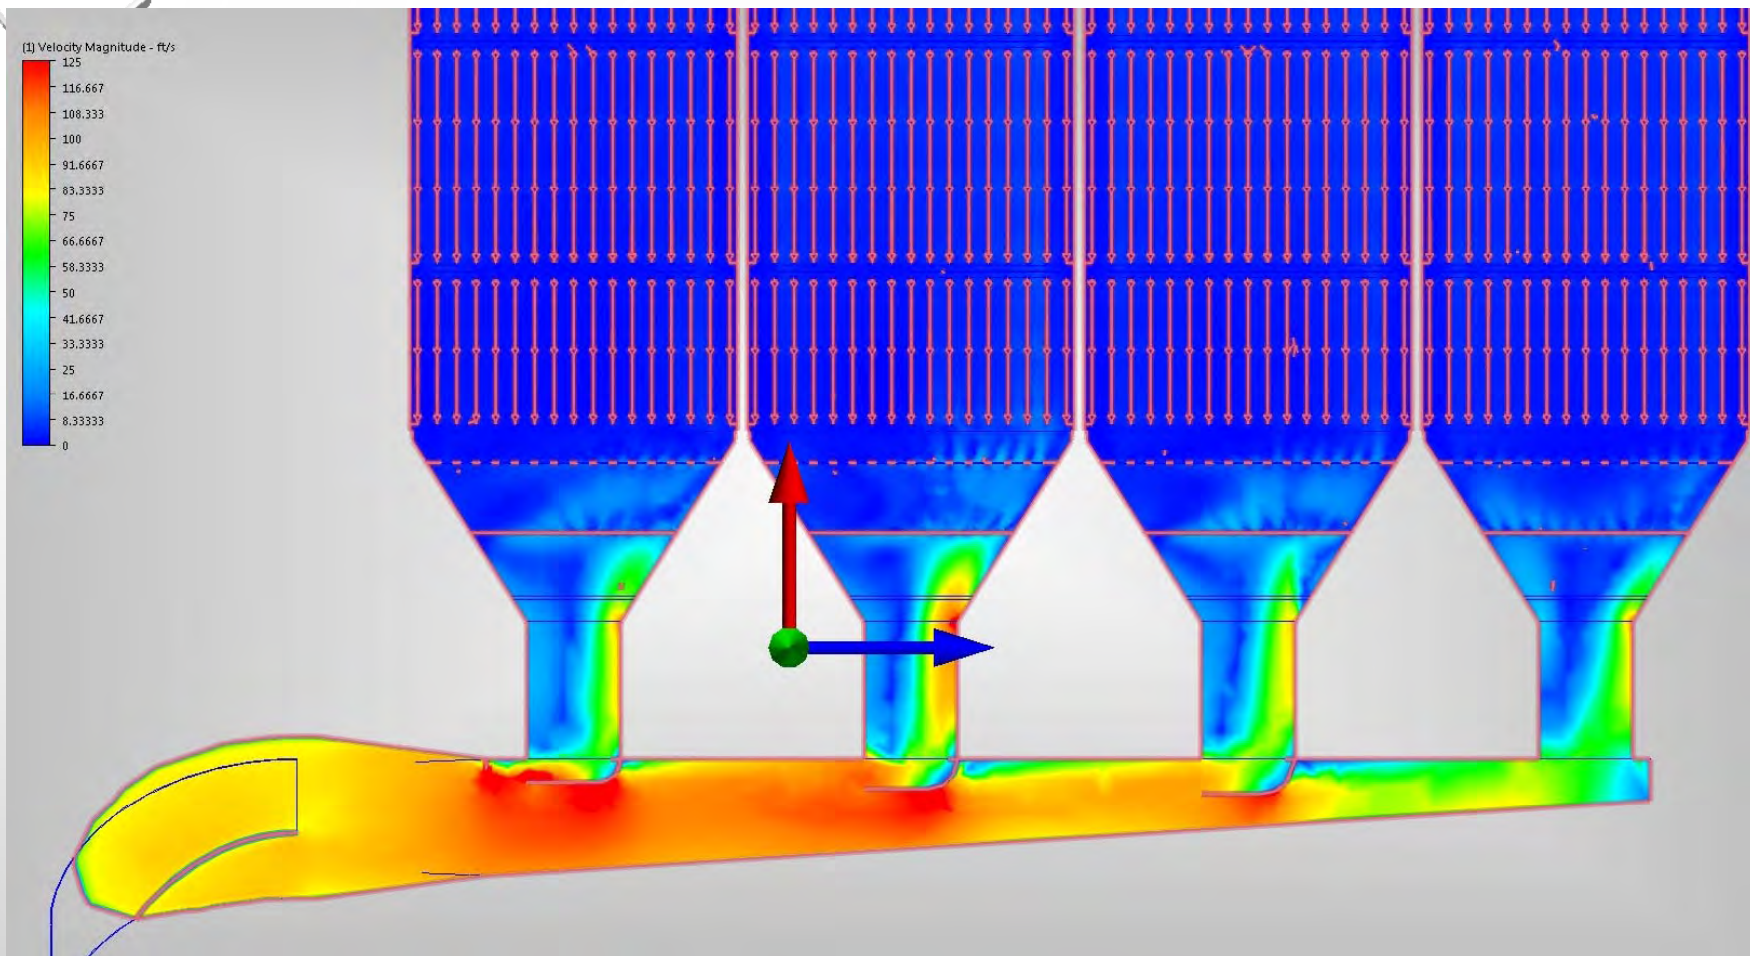
Just an example of what bad gas flow actually looks like. This unit continuously wore through the perforated plates at the right side wall. Everyone knew there was an issue, but finding it and correcting it are never easy.

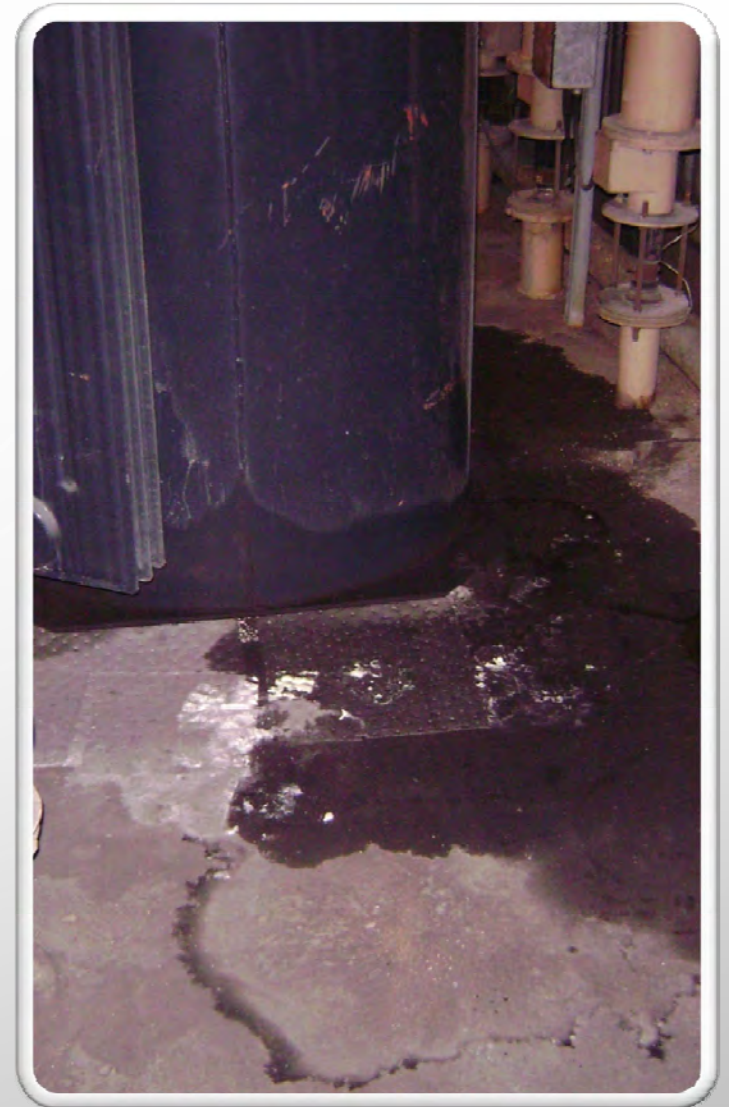
Here we see some clean up cloths placed to retain the leaking oil from an older TR set.

The operator in this case just refilled the tank and it looked like this a year later.

I know of one plant that nearly burned down a precipitator because TR set oil ran into through into the penthouse and caught the hot roof on fire. In that case they didn't know it was leaking because it leaked through the output bushing into the closed bus duct.

But most power supplies today have gauges. Check them from time to time.

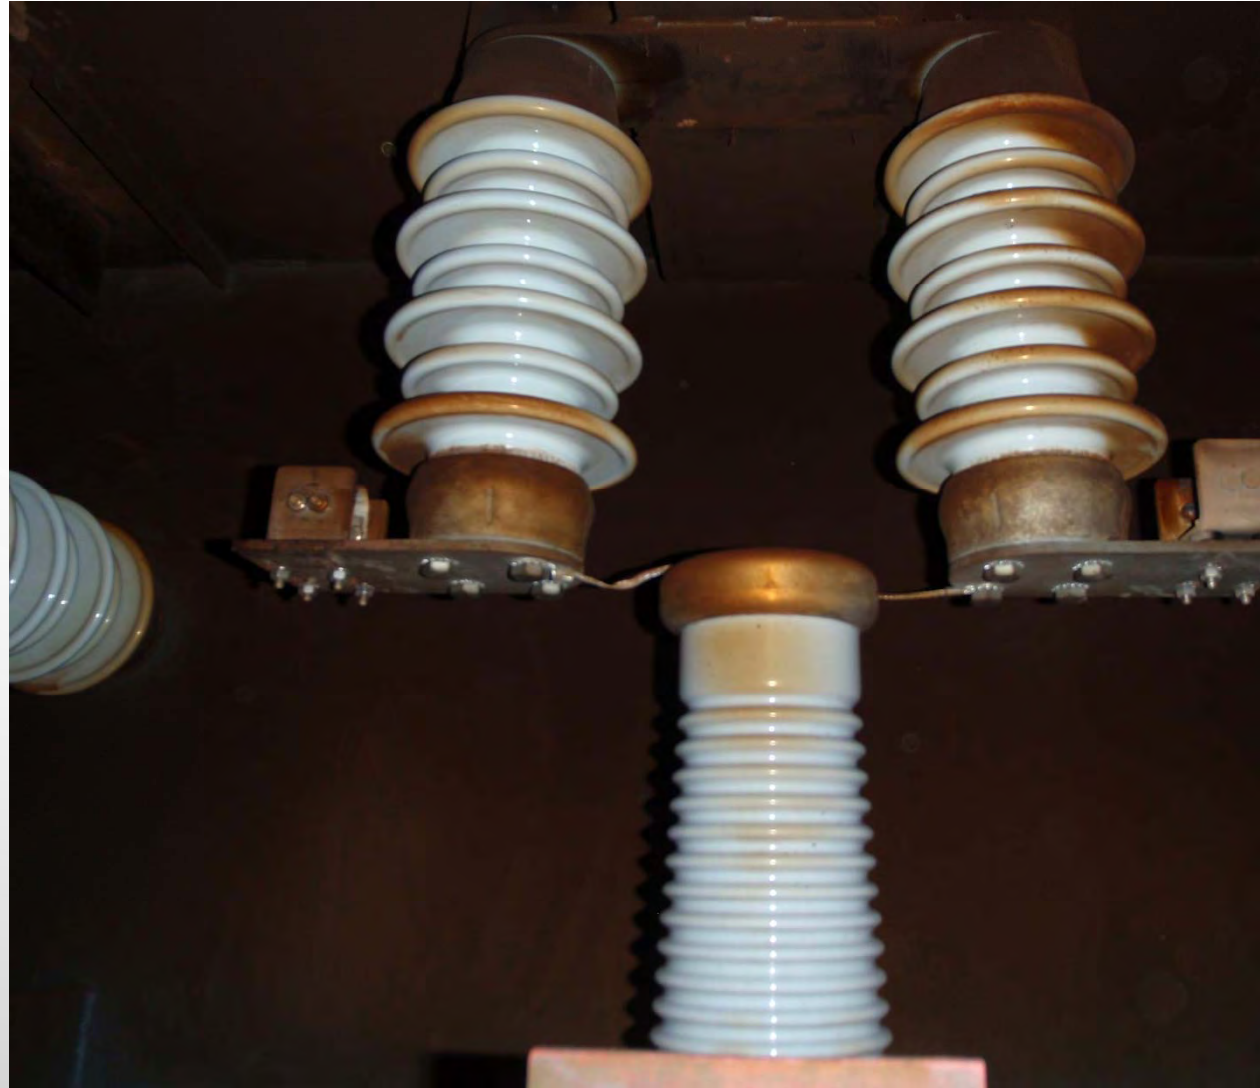
The insulator at the bottom is a power supply output bushing.

This unit is switch connected to two (2) electrical sections of the precipitator.

See how the dirt is just on the one side of the one insulator.

This is because the purge air from the penthouse is creating more pressure on the one side and blowing dirt out of one penthouse into the other.

These insulators should be cleaned every year or two as required.

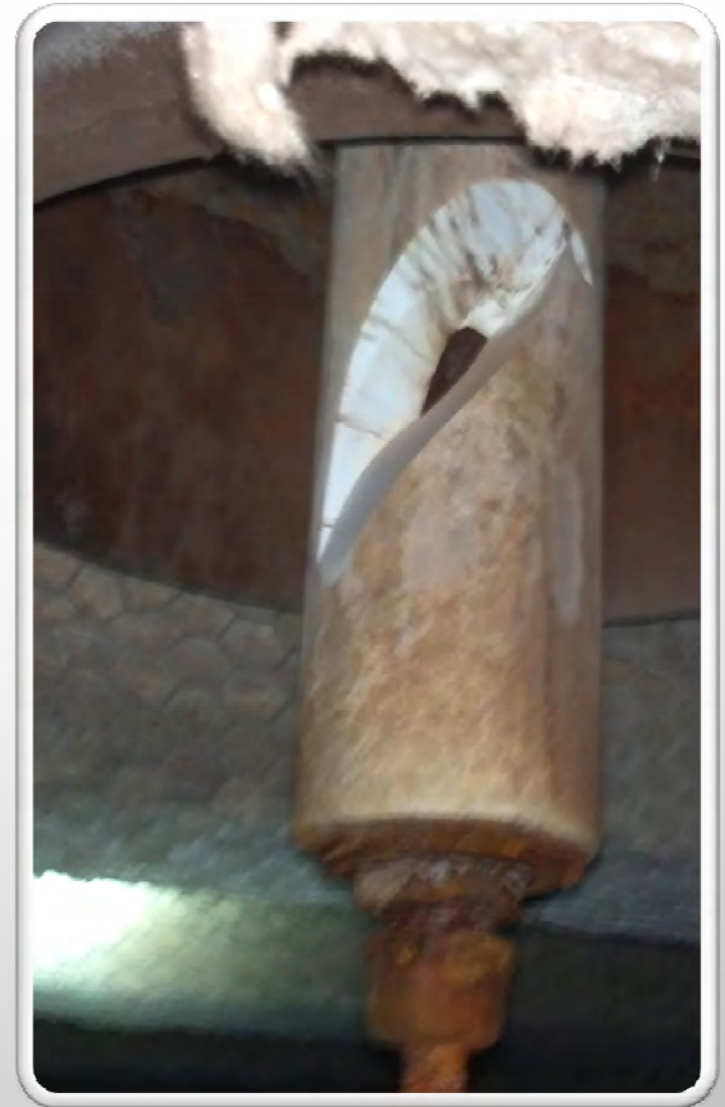
This is one of those through bushings used to connect the power supply to the field.

This type of crack was likely caused by either stress from the bus bar being too tight or flue gas got inside and corroded the bar and made it swell.

This one also really needed cleaning.

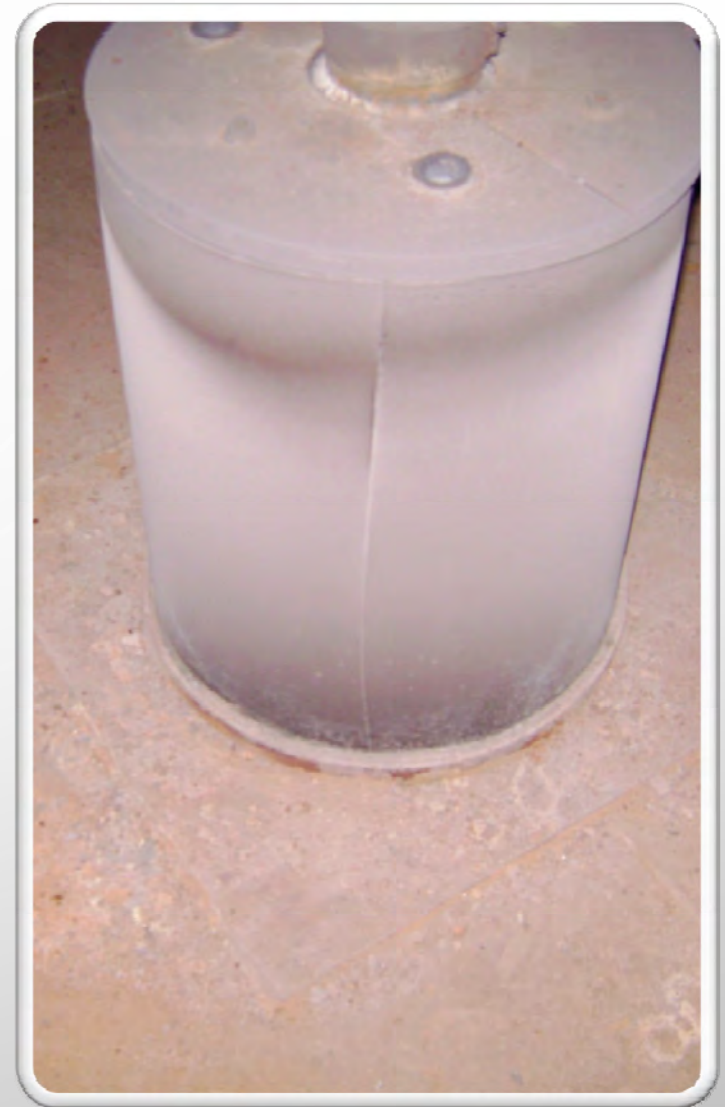
This is a good example of a typical broken insulator.

This vertical crack on the outside looks nice.

On the inside, it likely sparked over causing rapid heating and non uniform thermal expansion. This is what actually breaks most insulators.

There have been cases where the rappers on units were simply hitting so hard that the insulators shattered, but thermal shock from sparking is the most common issue.

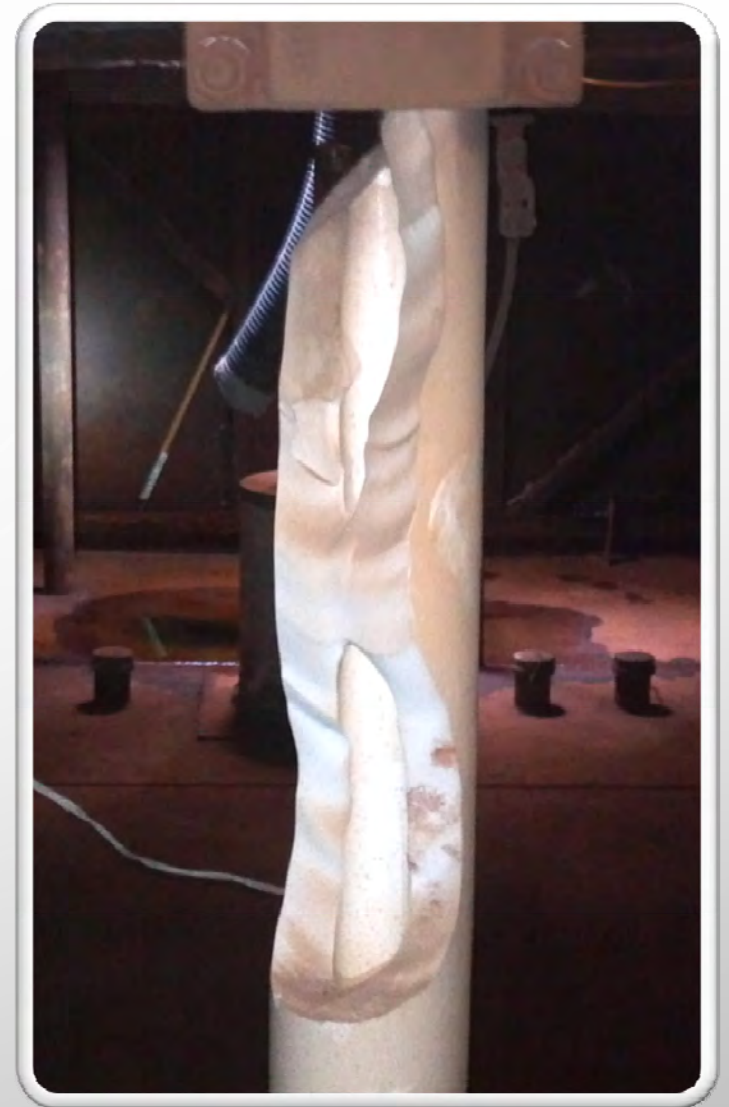
This photo actually shows an insulator that failed due to heavy impact.

In this case, it was not because the rapper hit too hard. It was because the clamping mechanism that held the shaft came loose.

Then the end of the insulator laid right against the end of the casting.

This created a lot of shock force as the hammer hit the end of the shaft.

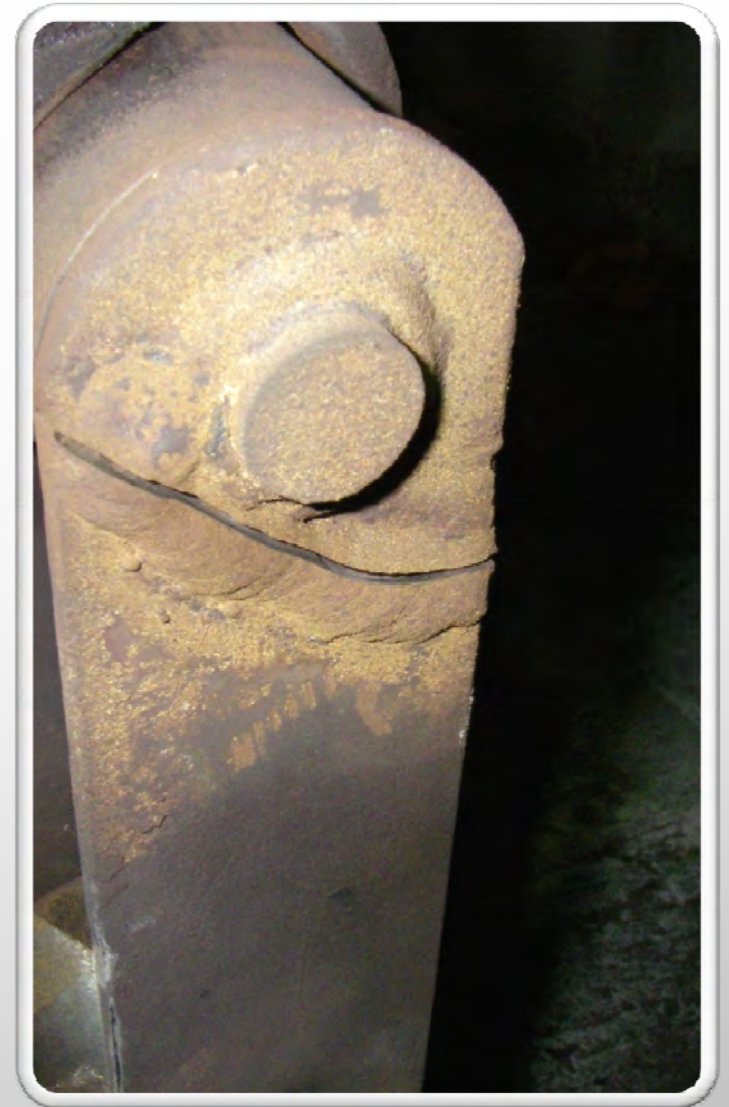
Before everyone says “ wow, bad weld. It broke right through the center of the weld.”

Why was there a weld here?

Because this is where it broke before.

Instead of replacing the failed hammer they welded it back.

(never works)

It's best to just replace the hammer.

Most of the designers of these systems will actually tell you it is best to simply replace them all on a schedule.
