**2014 APC Round Table  
& Expo Presentation**

July 14-15, 2014, in Louisville, KY / Hosted by LG&E/KU

# Operation and Maintenance Electrostatic Precipitator “Mechanical”

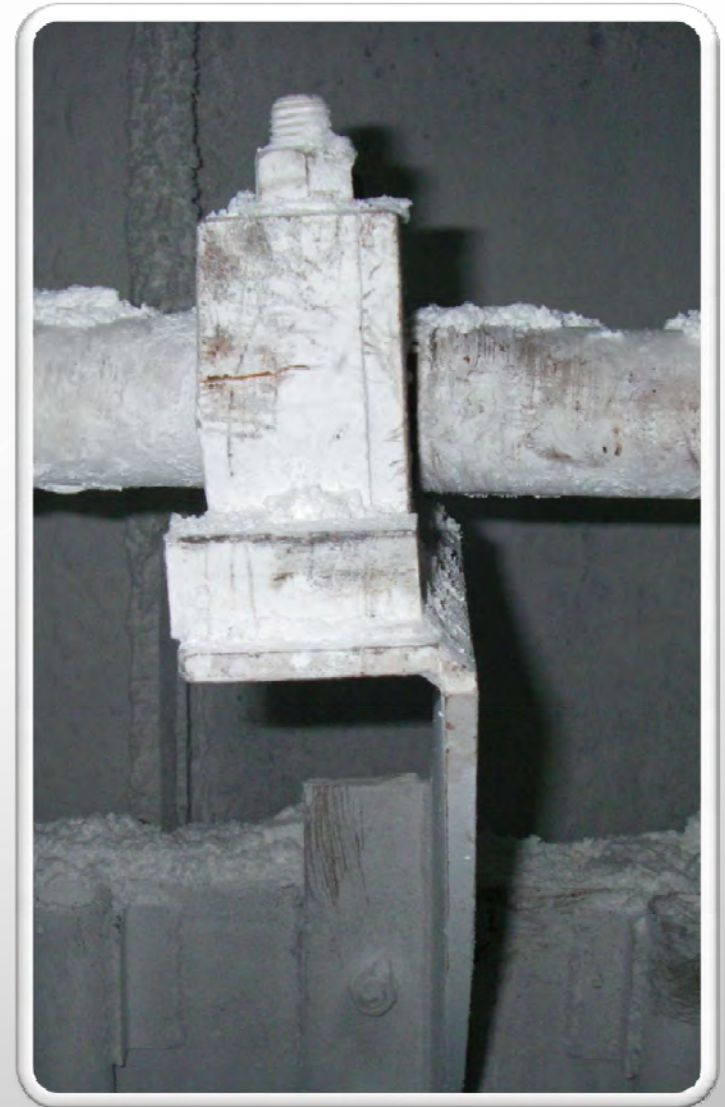
Over time the plate sagged and caused the bearing to try to bind.

This created a lot of wear on the bearings, shafts, motors and gearboxes.

In this case we straightened the bracket and modified the design to stiffen it.

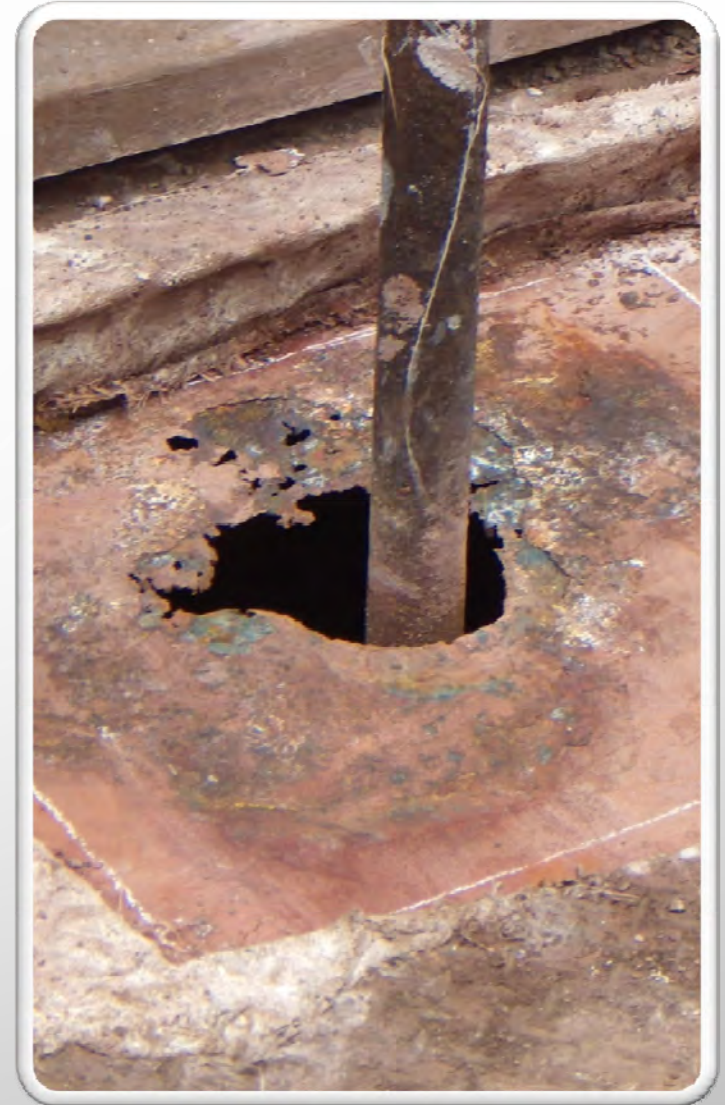
Here we see that the vertical rapper pipe sleeve that normally has the seal on it is completely gone and the roof around it is corroded out.

But this roof had been in service for 48 years.

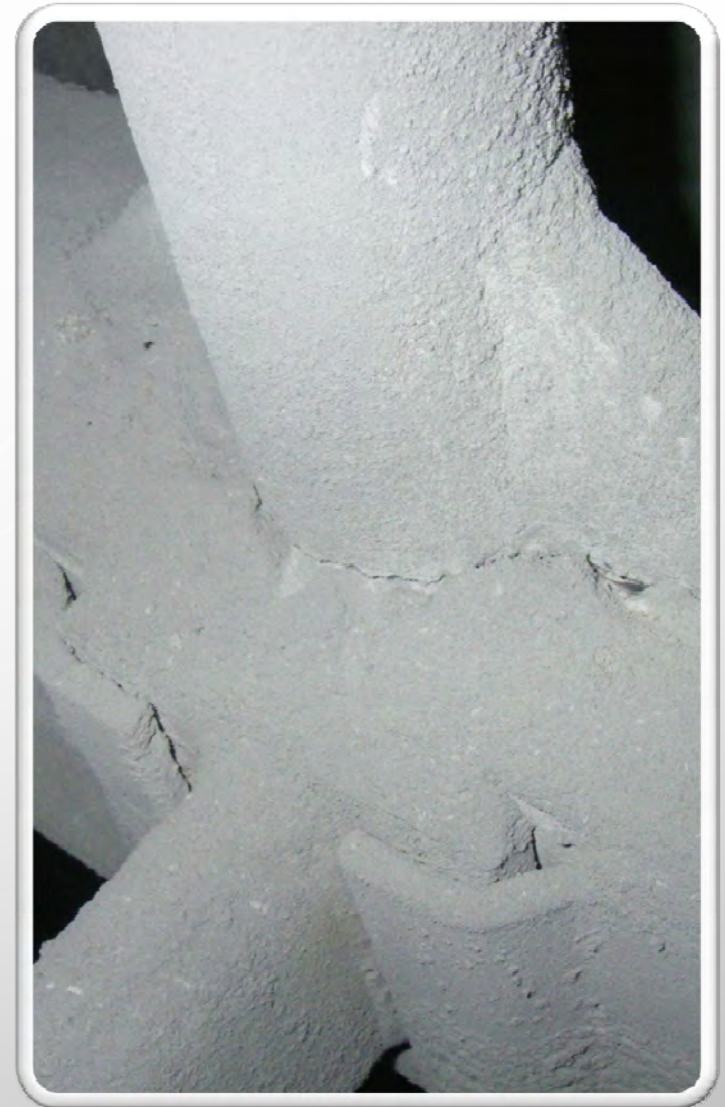
The crack is right at the top edge of the original weld.

These cracks can be hard to see, so you have to look at each shaft.

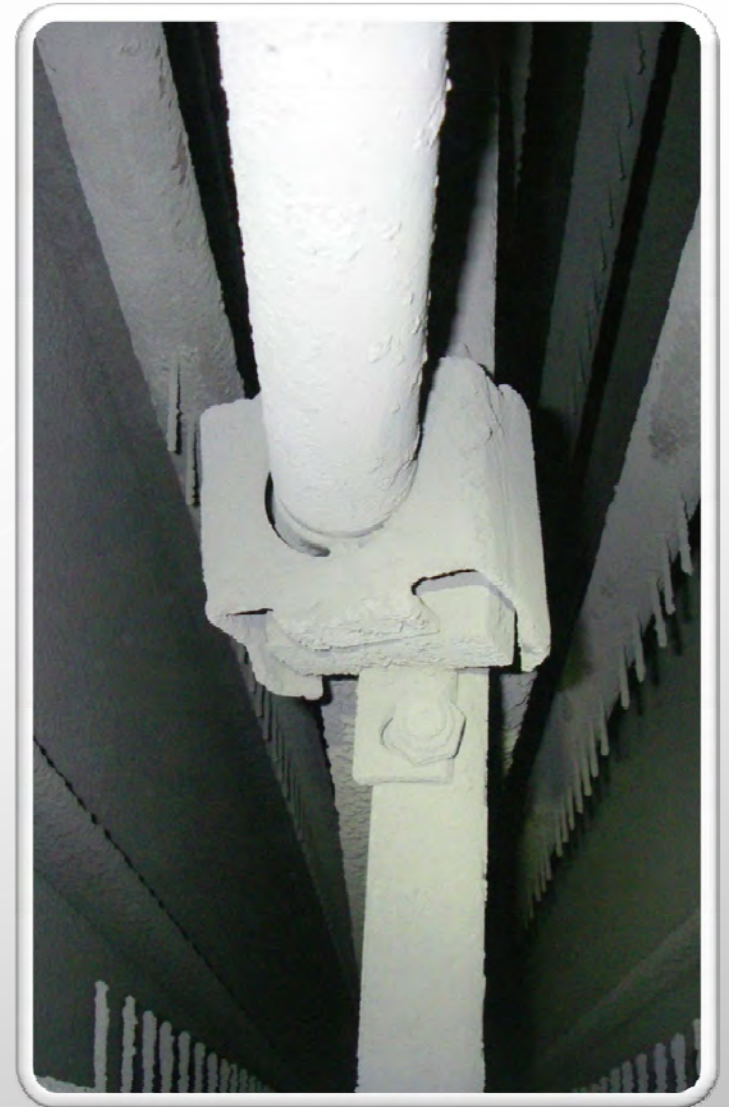
This worked well until the bolt holes shown here began to wear allowing the whole object to lean.

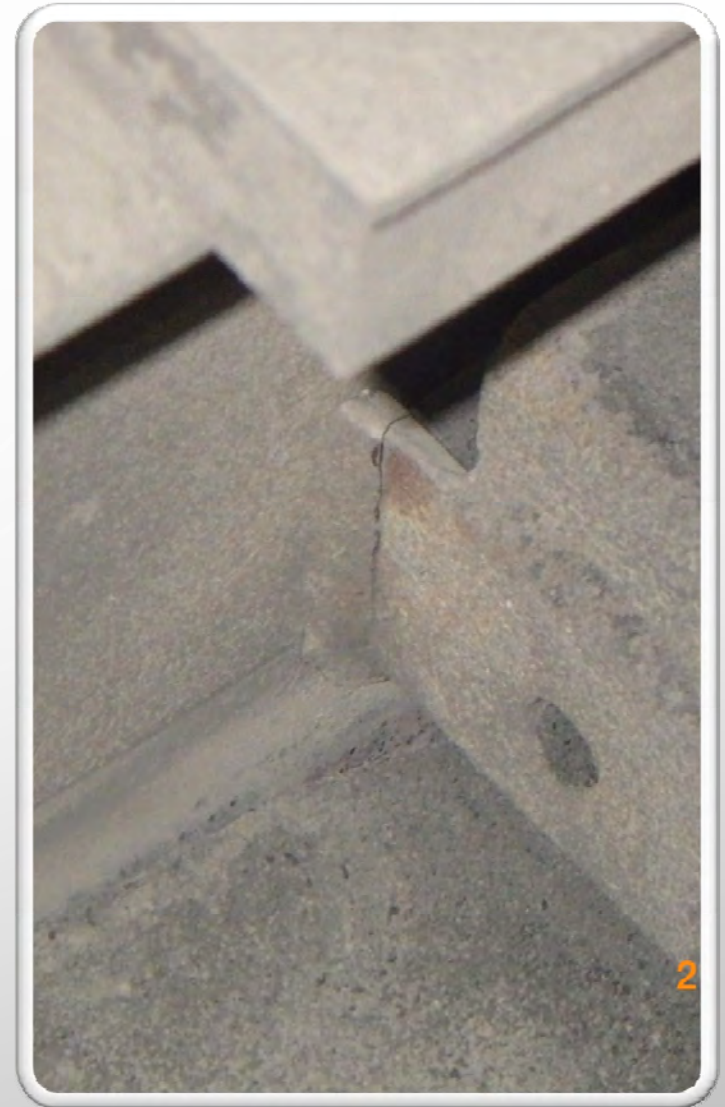
The clip material has broken right at the edge of the weld.

Typical for a fatigue type fracture.

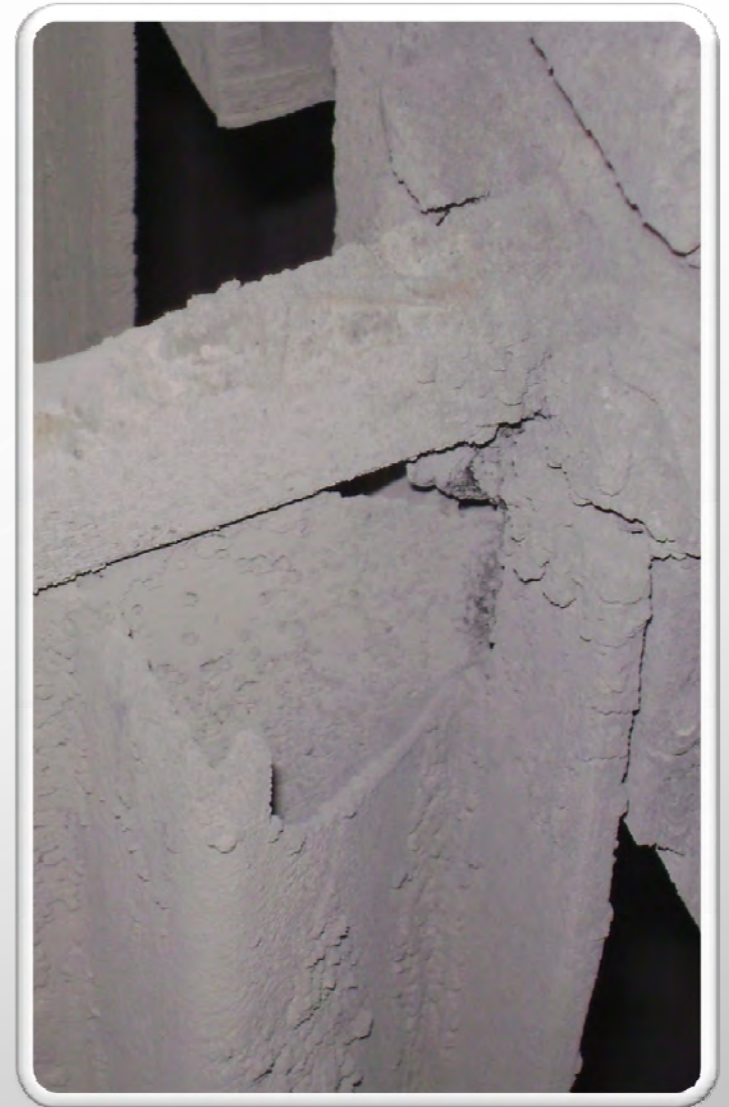
In this case the lower part of the collecting plate has begun to crack loose from the end plate clip.

Straps were used to reconnect these as a field repair.

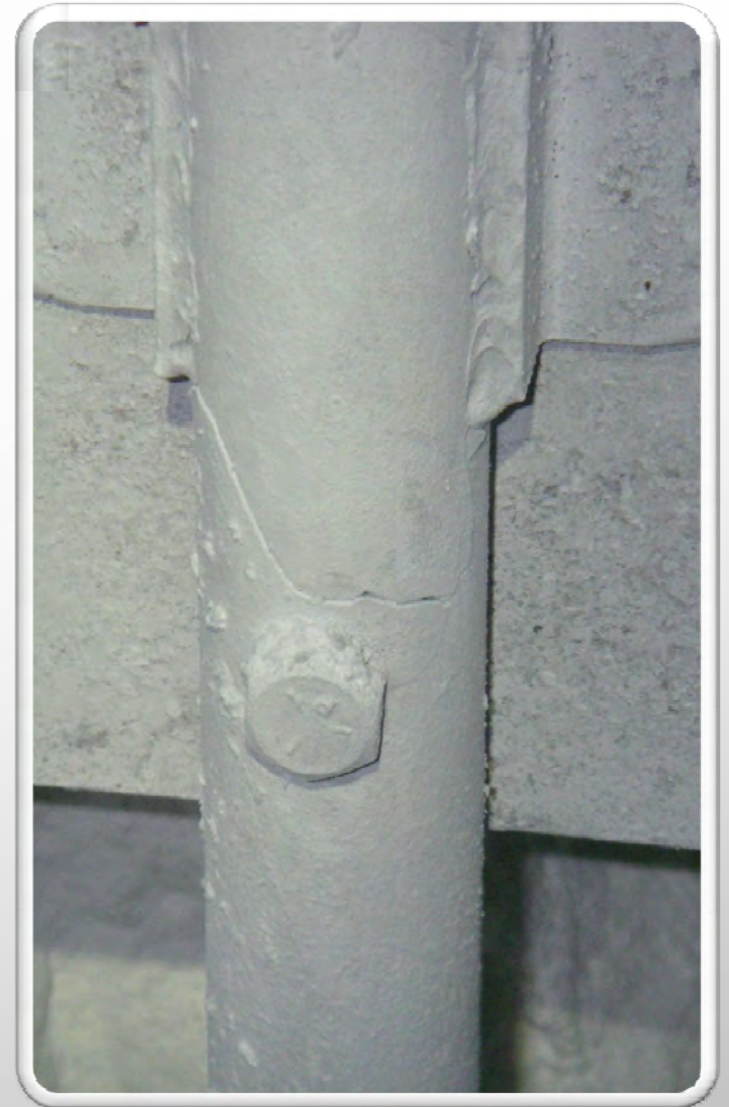
In this case the original connection was bolted and failed.

This caused a different failure but the end result was the large horseshoe crack shown here.

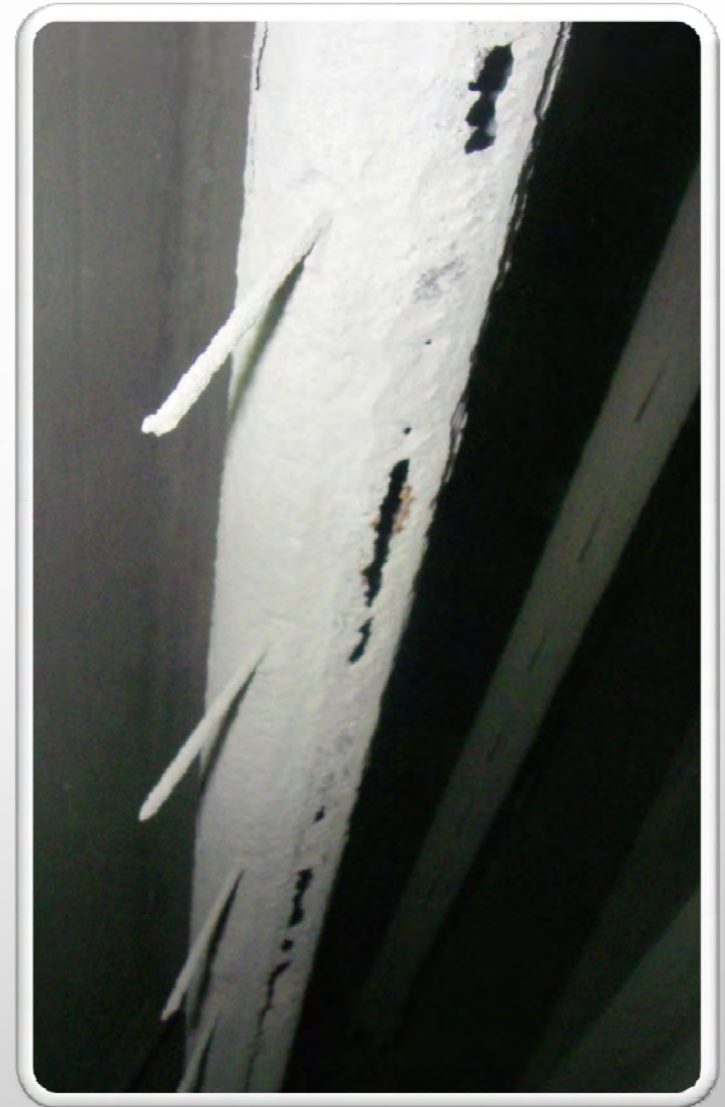
Here is an actual photo of a rigid electrode that has been eaten away by the sandblasting effect of poor gas distribution.

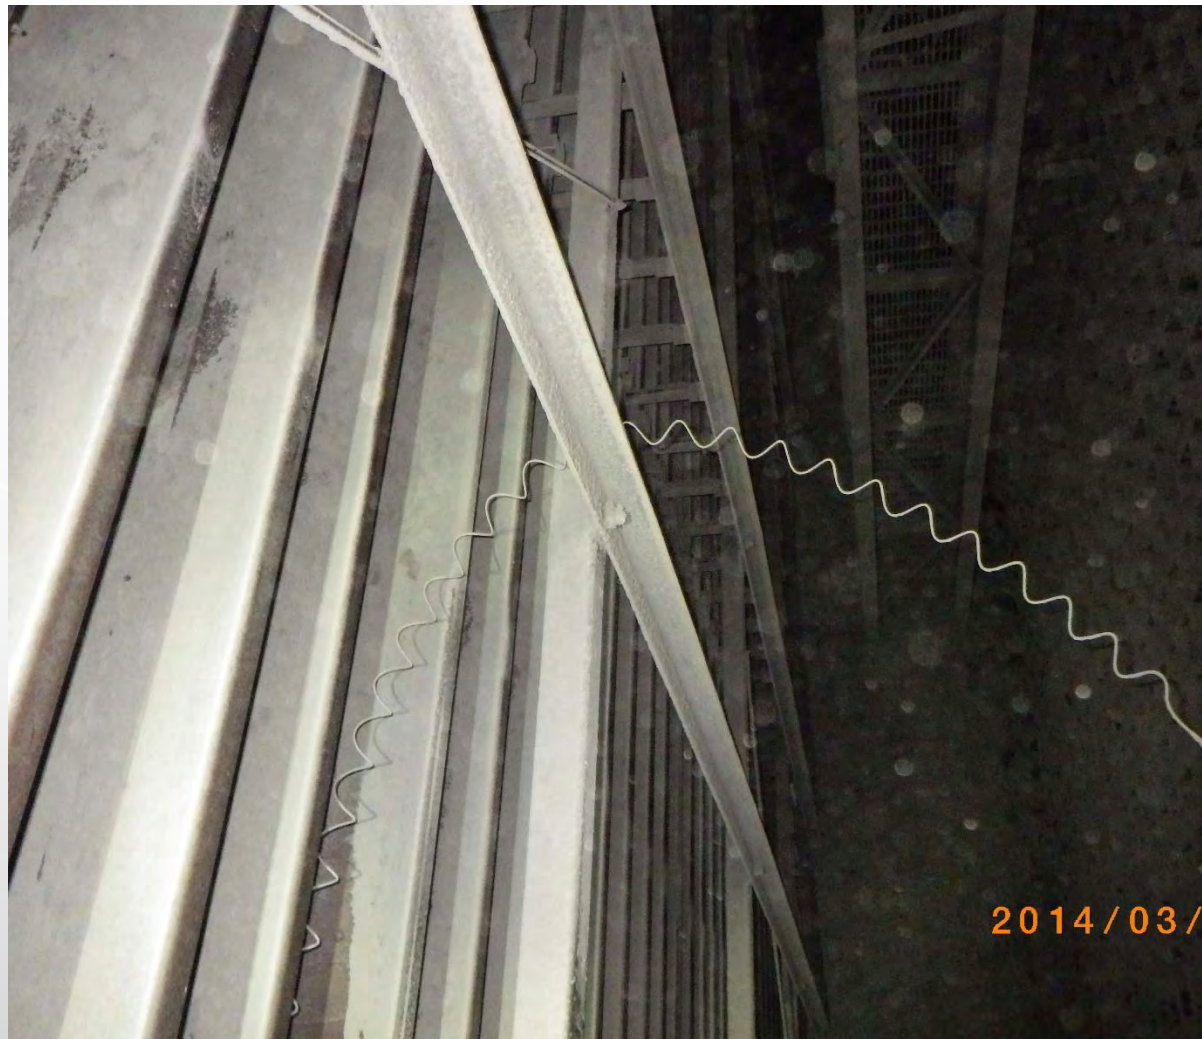
In this photo we see a typical broken wire. This is a particular design, but all wires break.

In this case, the wire did not short anything out and the operators had no idea it was loose until we went inside and looked.

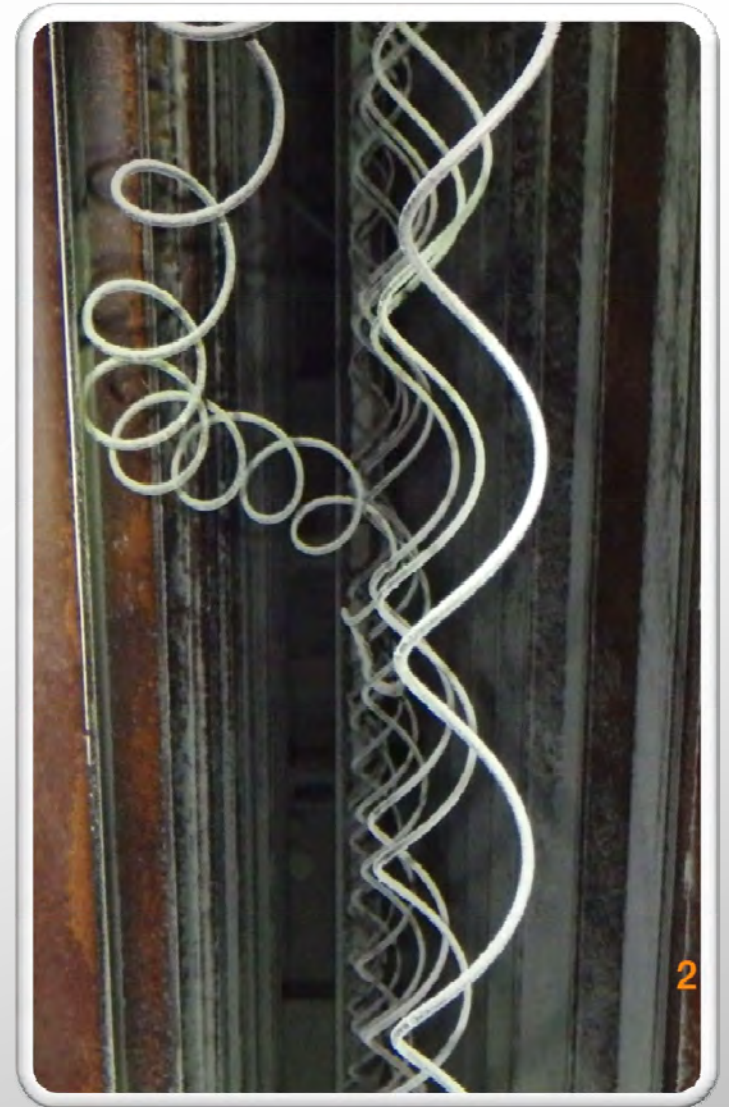
Not the same wire, but I do believe it is a wire in the same precipitator.

In this case the wire actually laid out through the field and shorted out the electrical section.

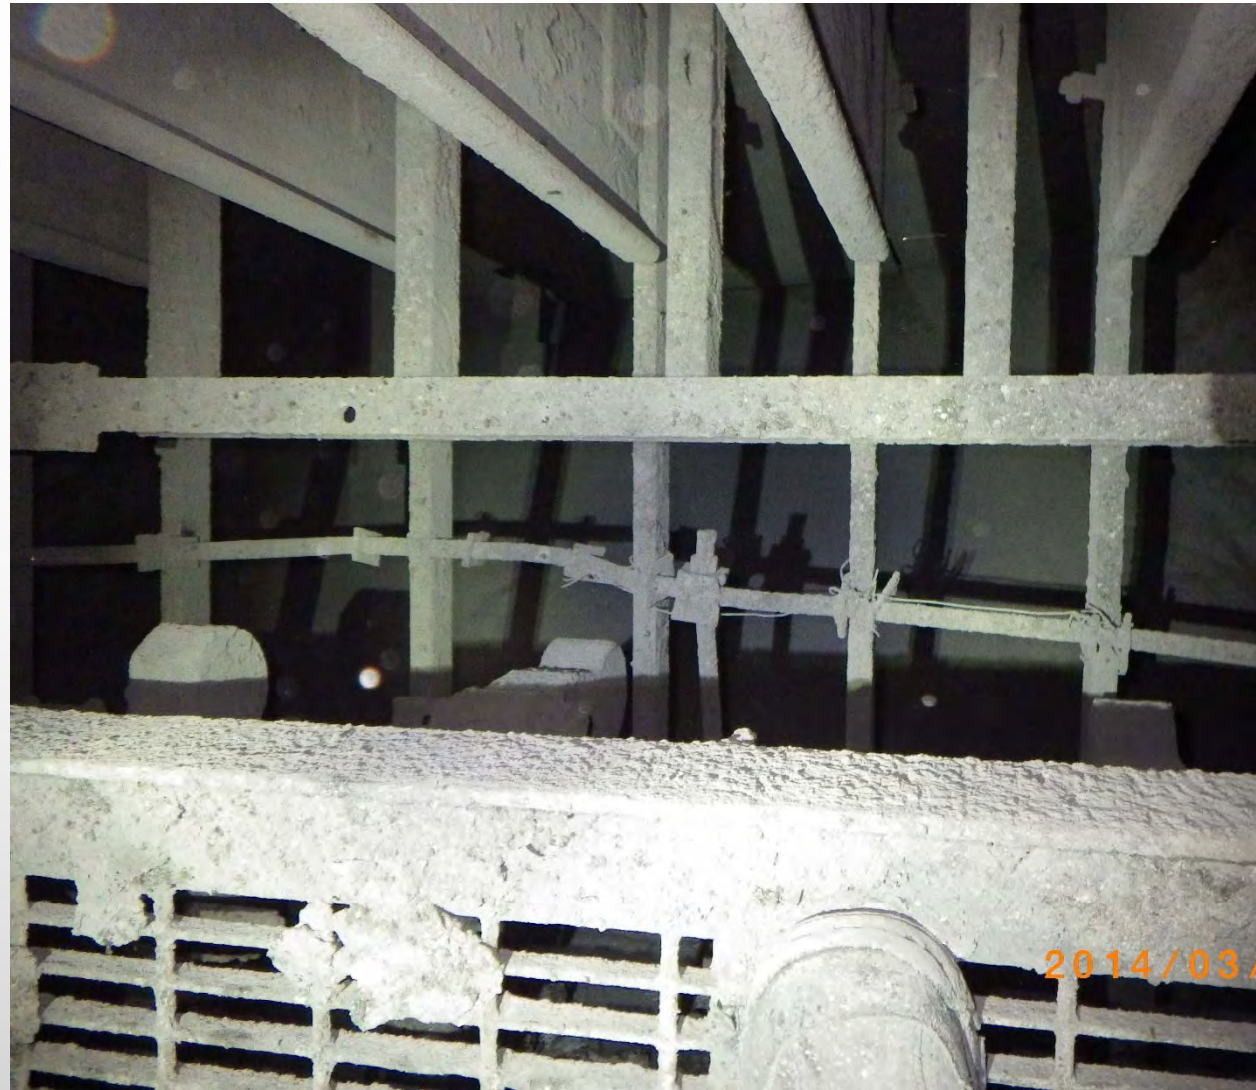
Ok, in this case the wavy looking bar is actually the alignment bar for the collecting plates.

This will not last very long and may not even last until the next outage.

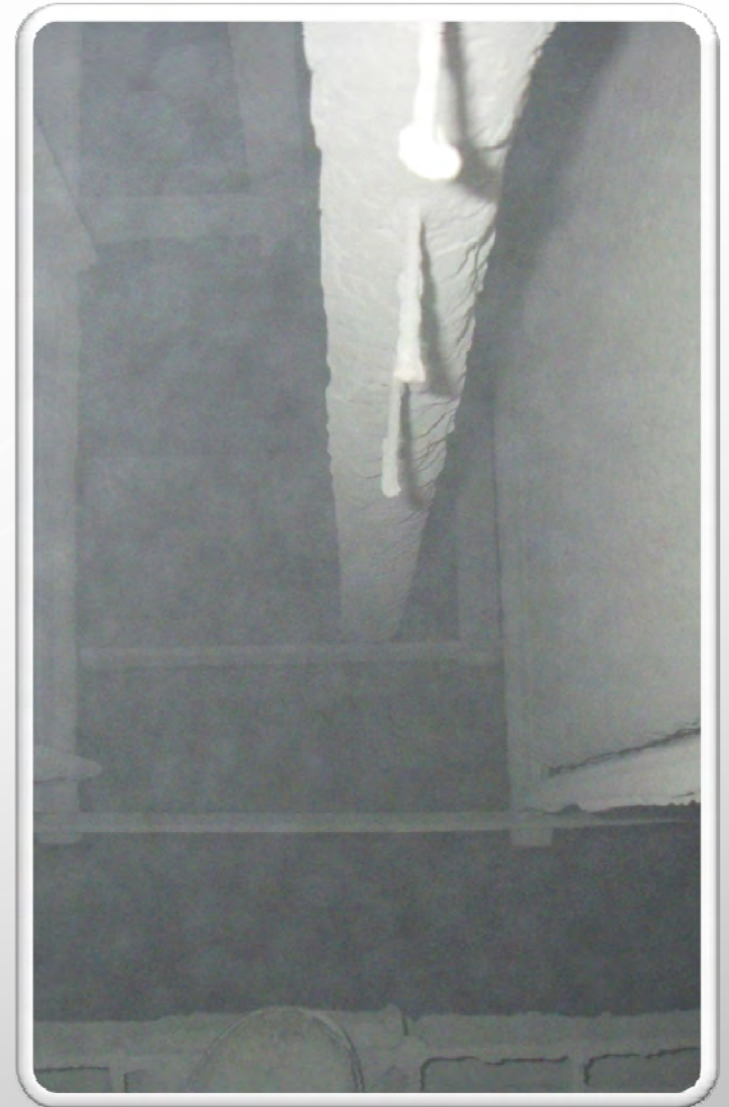
Another photo of misalignment.

This one looking down from the side walkway at the lower framing.

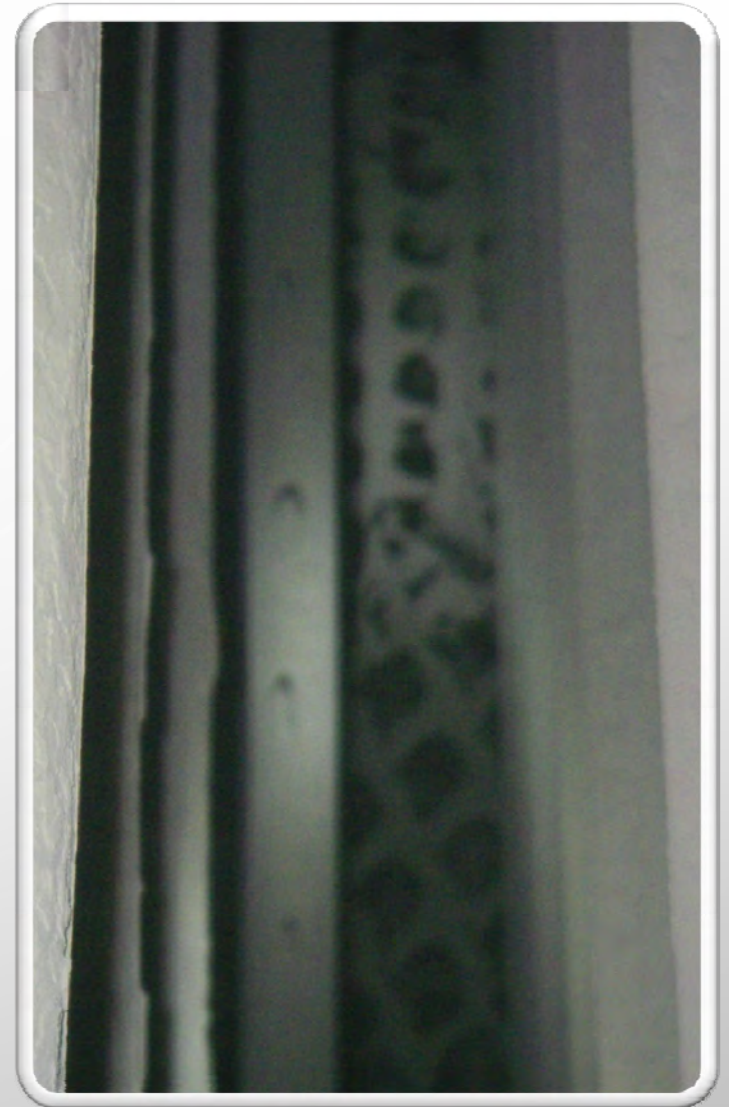
And yet another photo of an alignment issue.

Also...note the fallen piece of perforated plate on the other side of the field.

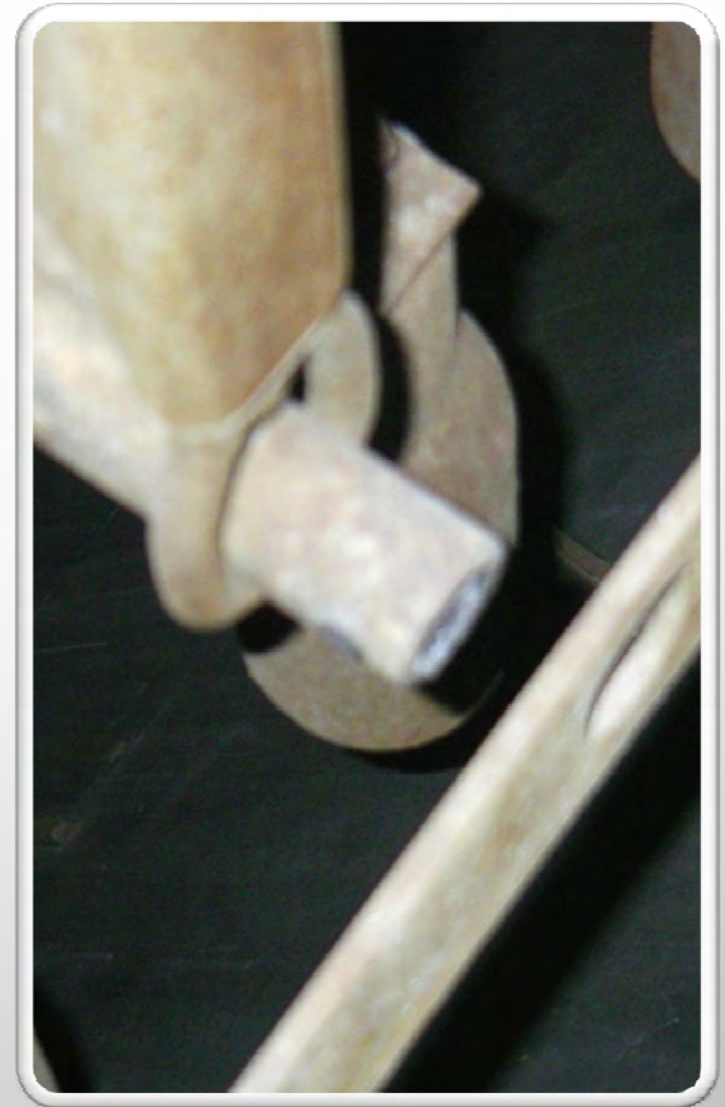
This is another case where the collecting plate has come loose from the lower alignment bar.

Once this connection comes loose the collecting plate can swing causing odd intermittent clearance issues.

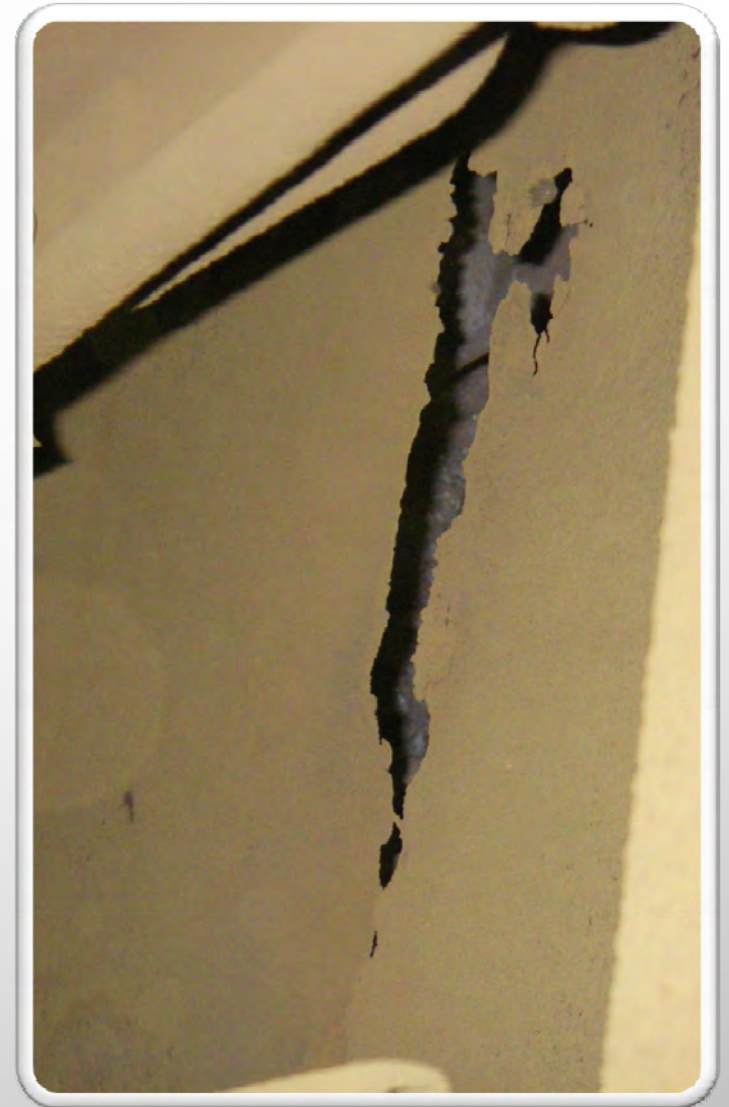
As you can see it is paper thin and falling apart from corrosion.
