WPCA-  
Southern Company  
Mercury Seminar  
October 30-31, 2012

# MERCURY OXIDATION ACROSS THE AIR HEATER

John Guffre  
Paragon Airheater Technologies  
[WWW.PARAGONAIRHEATER.COM](http://WWW.PARAGONAIRHEATER.COM)

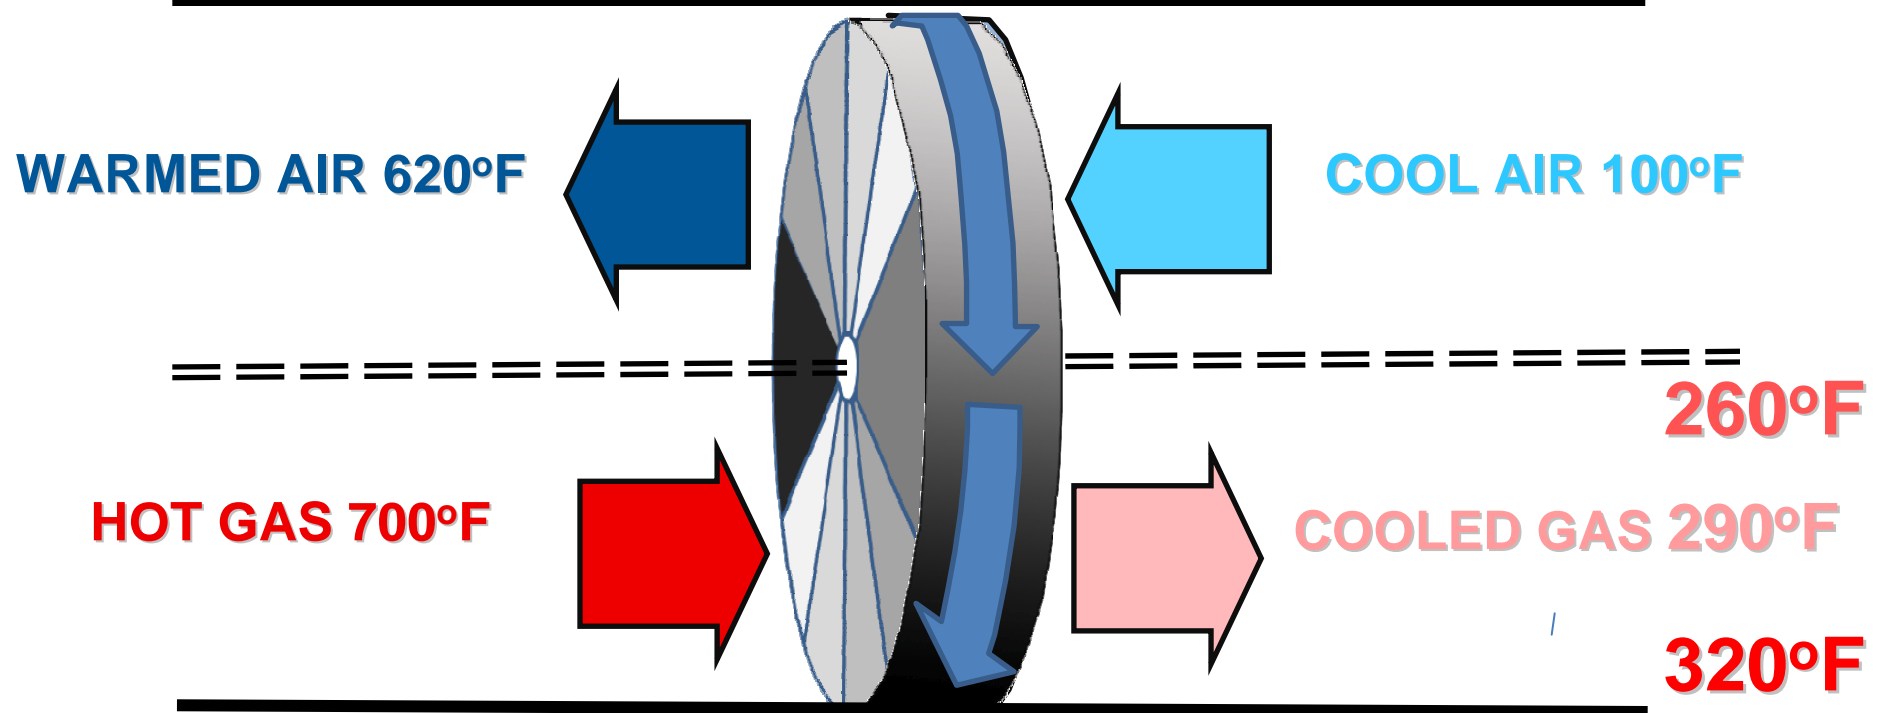
# Function of an Air Heater

- Extracts Waste Heat From Exhaust Gases
- Recycles That Heat to the Incoming Air

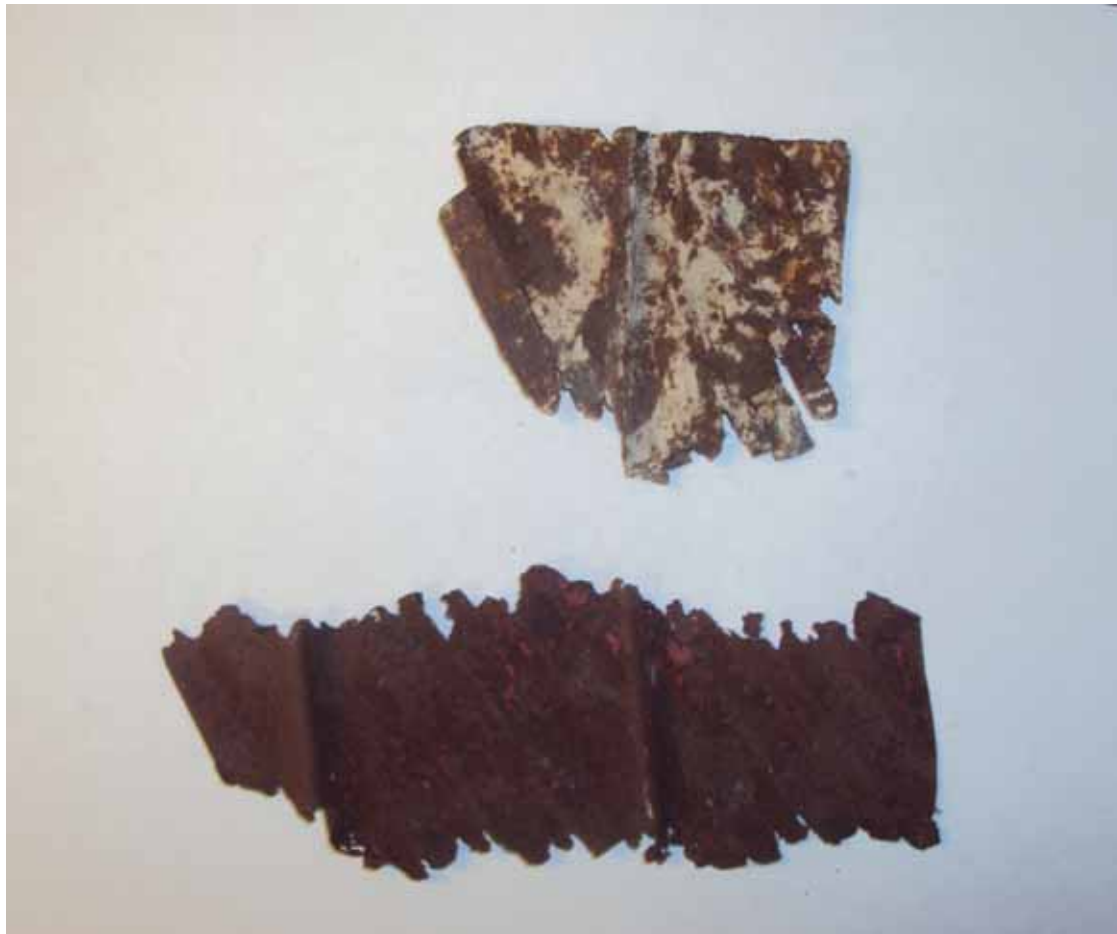
# BROMINE PAC PROBLEM?

## RAPID CORROSION OF AIR HEATER ELEMENT

- **ACI INJECTION ON HOT SIDE 6 TO 25 FEET FROM INLET TO AH**
- **DETERIORATION OCCURRED IN THE COLD END BASKETS ONLY**
- **DETERIORATION USING AMMONIATED BROMIDE PAC OR GASEOUS BROMIDE IMPREGNATION**
- **NO DETERIORATION OBSERVED WITH SODIUM BROMIDE PAC**

- **SUSPECTED SOOTBLOWER EROSION BUT METALLURGICAL AND CHEMICAL ANALYSIS OF FAILED SECTIONS CONFIRMED CORROSIVE MECHANISM**
- **CONSULTATION WITH INDUSTRY EXPERTS (EPRI, LEHIGH UNIVERSITY) SUGGESTED AN AMMONIA LINK**
- **AMMONIA ODOR DETECTED IN FLYASH WHEN WET. THIS WAS PRIOR TO SNCR OPERATION.**
- **CORROSION NOTICED USING AMMONIATED BROMIDE AND GASEOUS DIFFUSED BROMIDE PAC. NO CORROSION OBSERVED USING SODIUM BROMIDE PACS**

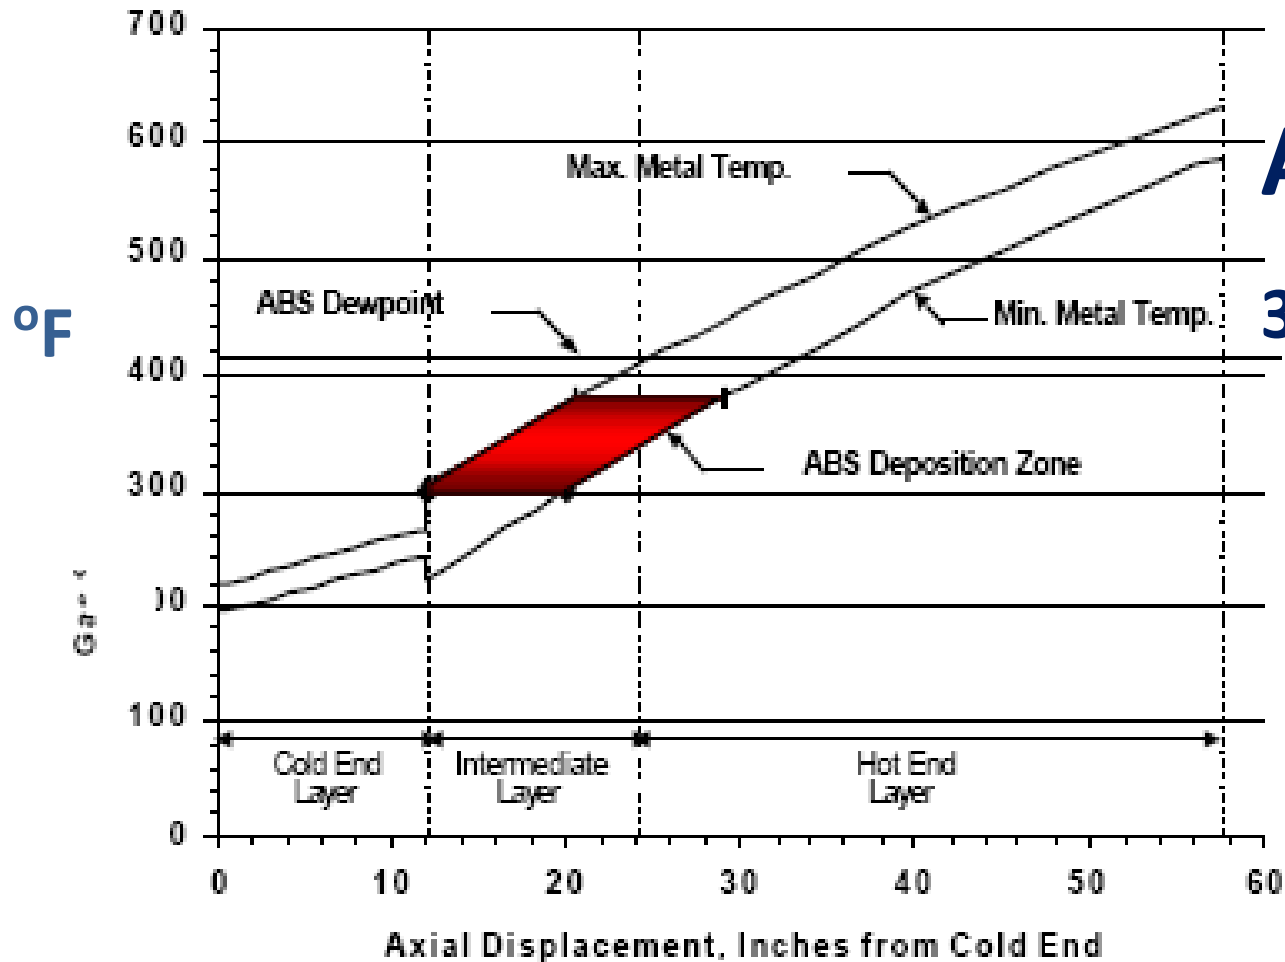
# ABS Deposition Temperature

**ABS**

**300°F TO 390°F**
