Worldwide Pollution Control Association

Duke Energy Seminar
September 3 – 5, 2008
Concord, NC

Pulsed Detonation Technology Application at

FirstEnergy.

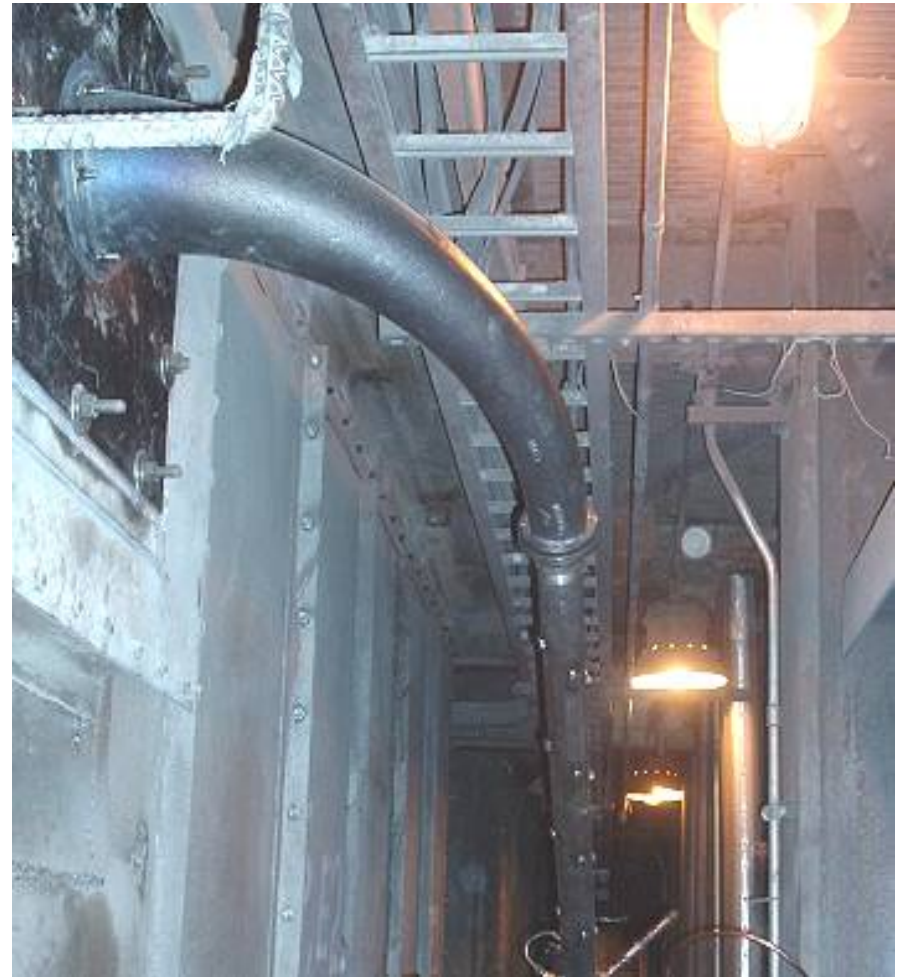
Impulse Cleaning Background

- High magnitude/energy shock impulses
- Multi-directional penetration of wave
- Non-line of site cleaning
- Deeper penetration of stronger pressure waves
- Size allows for multiple installation points with minimal intrusion
- Online, Pro-active cleaning method

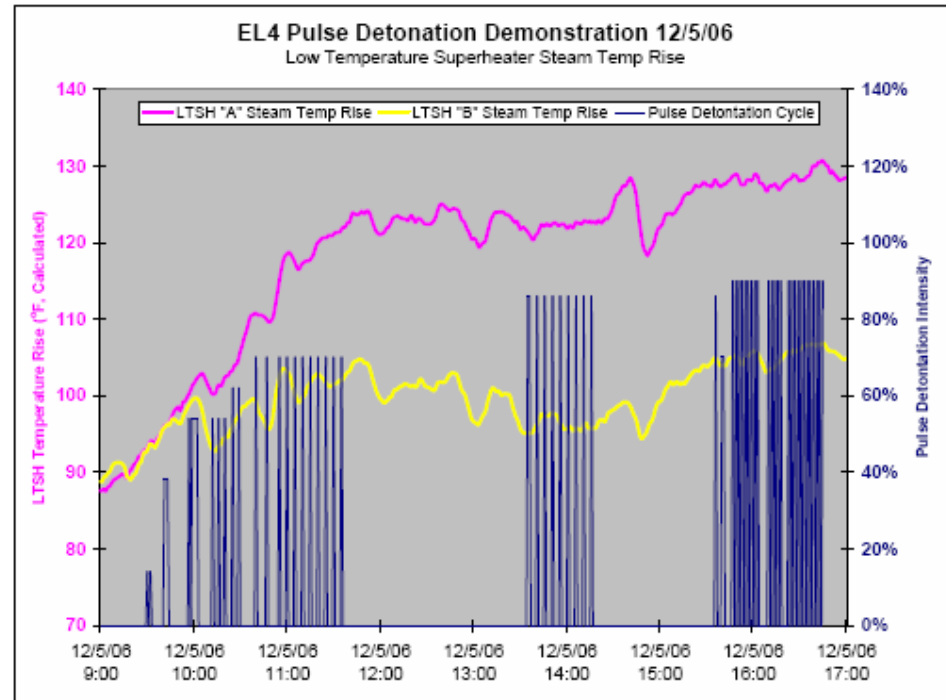
EL4...Did it work?

- Noticeable improvement in the air heater gas inlet temperature.
- Rise in “C”-side may be attributed to plugging of A and B sides.
- Over 20 degree increase in steam outlet temp across SH LTSH.
- Difficult to grasp a boiler performance improvement w/ the missing hoppers.
- Moved to Ashtabula as an EPRI TC project.

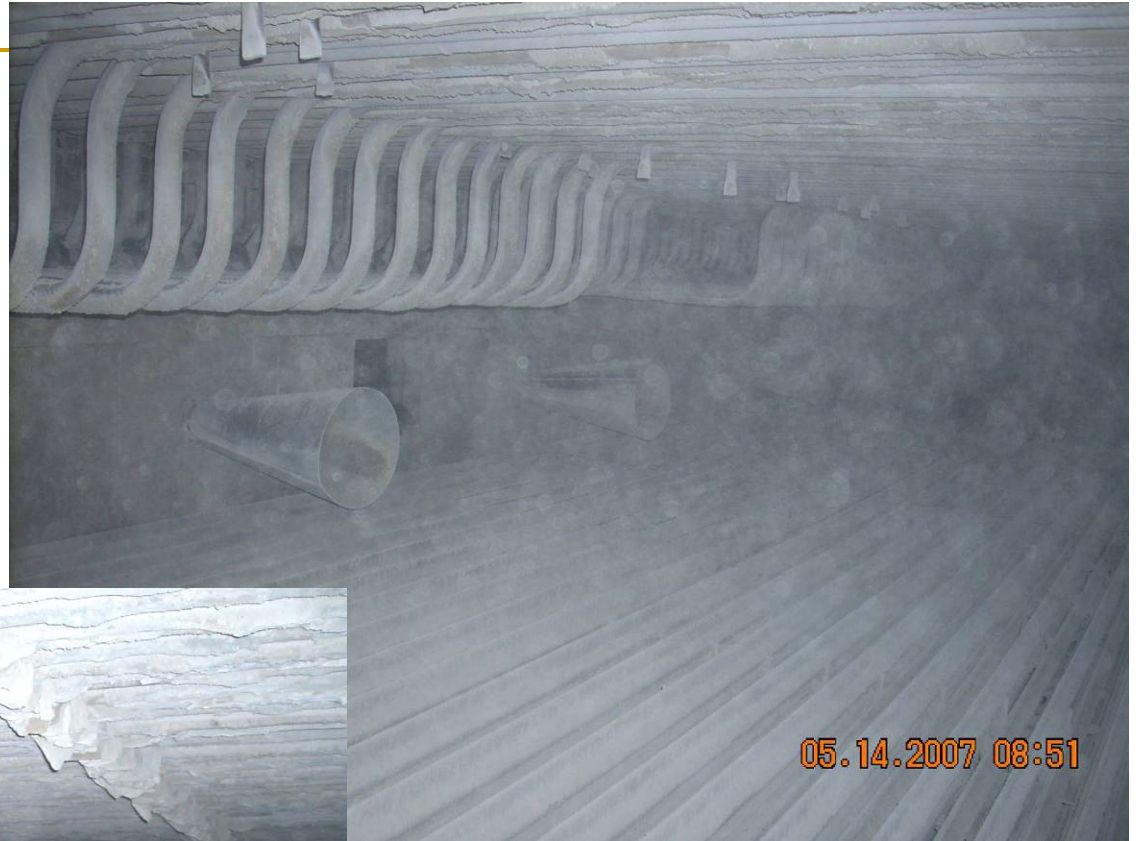
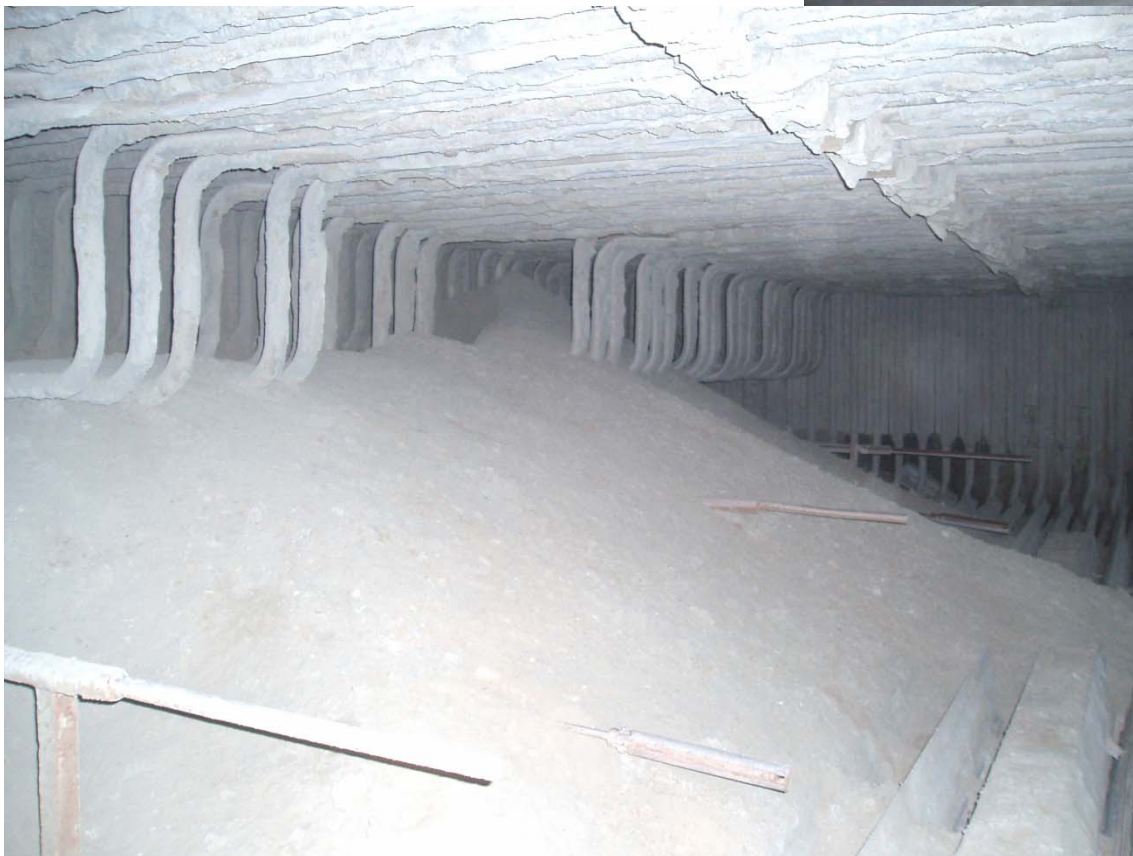
View of
PowerWave+
Unit from Inside
Boiler

- RH Boiler test Jan 2007, on a dirty boiler (trial)
 - 6 Units installed in March 2007, Inspection Outage & in service April 2007
 - Two units installed above Upper LTSH
 - Two units installed above Lower LTSH
 - Two units installed above Economizer
-

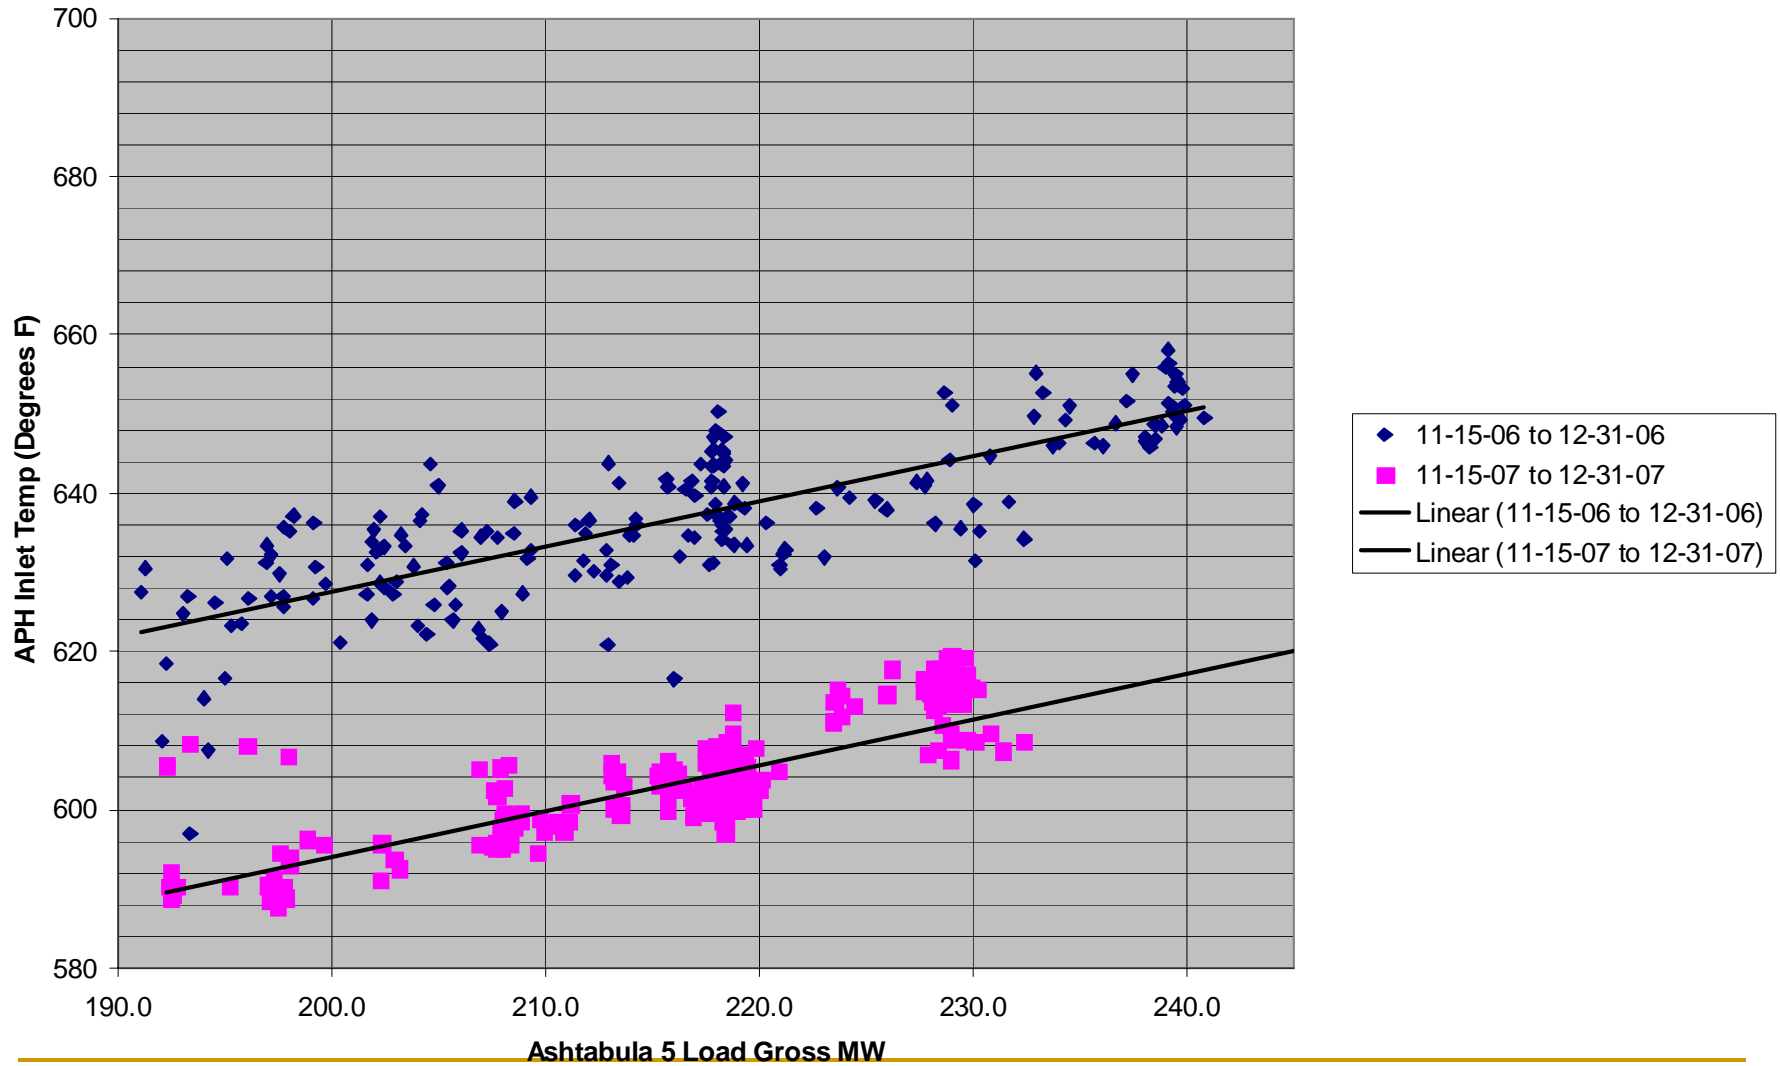
APH Gas Inlet Temp vs Load

- Internal inspections have shown the boiler to be maintaining cleanliness
 - Average air heater outlet gas temperatures have remained below 320 deg F
 - Average air heater differential pressure drops have remained below 6 in. H₂O
 - APH Delta P sustained all year.
 - Permanent installation during 2008 scheduled outage.
-
