Duck Creek – Fixing the SCR Reactor

Reinhold Environmental 2012 NOx-Combustion Round Table
February 14, 2012

Jim Chaney – Ameren Energy Resources
Douglas W. Bullock – Steag Energy Services, LLC

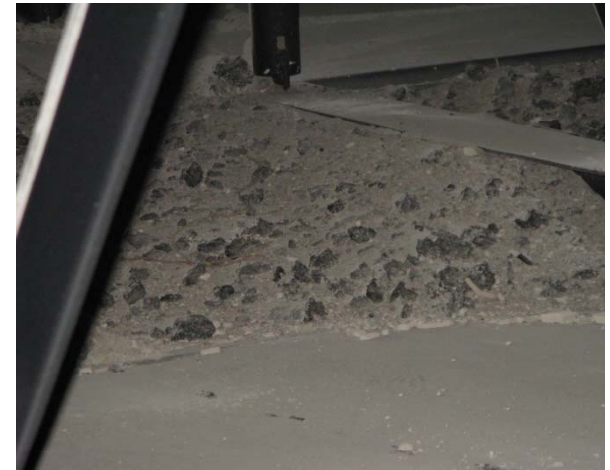
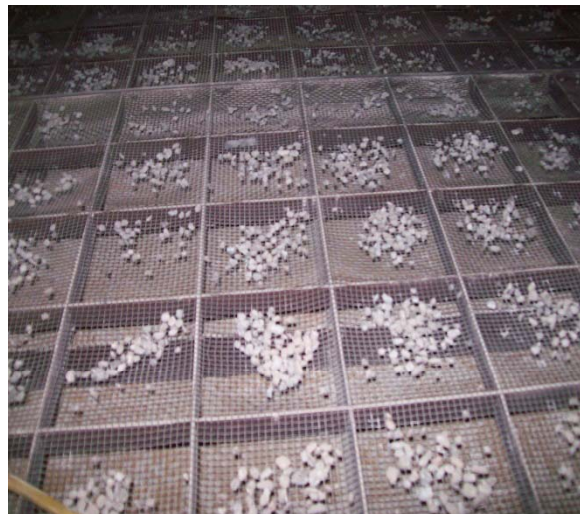
- Flat LPA screens
 - Plugged easily
 - Eroded heavily
- LPA screen pluggage shown right is for 2 months of operation
- Slagging / LPA was evident past the LPA screen
- LPA was found on and inside the catalyst

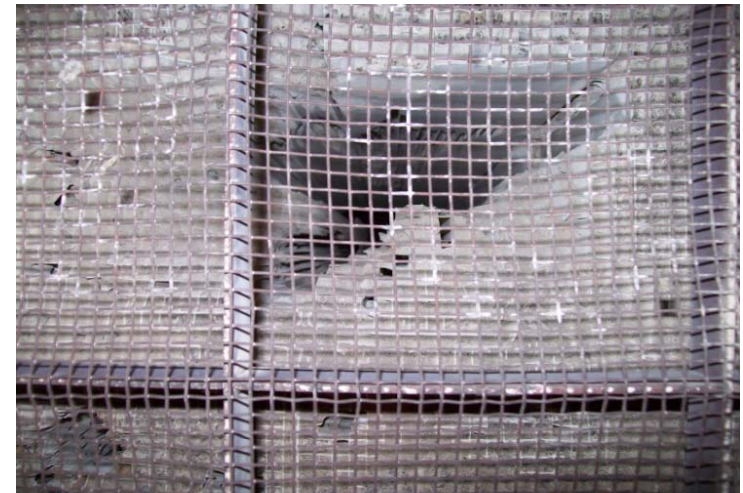
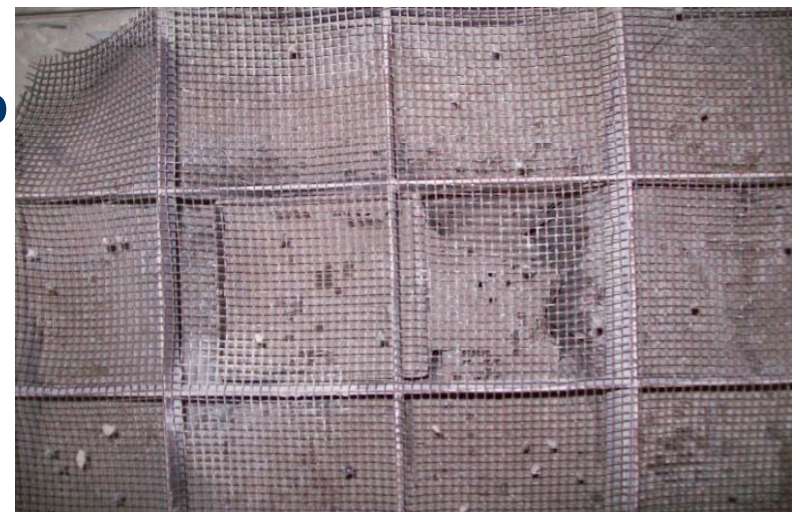
- **Extremely high velocities:**
 - in the economizer outlet > 100 fps
 - through the SCR catalyst > 30 fps
- **Excessive erosion damage of LPA screen and catalyst layers**
- **12+ inches dp across 3 honeycomb catalyst layers due to pluggage**
- **Plugged and eroded 4½ honeycomb layers in less than 2 years**
- **Catalyst pluggage mostly located along edges of reactor, erosion in the center**

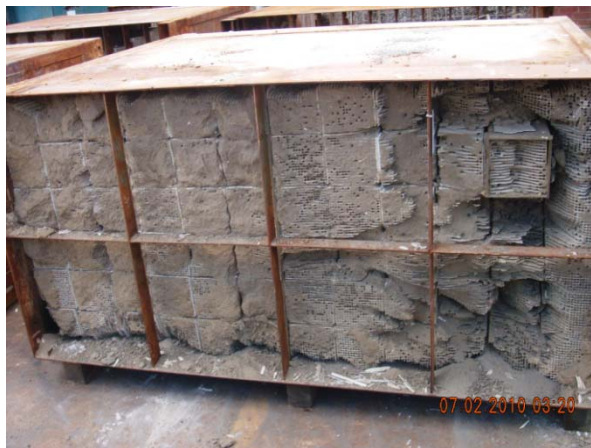
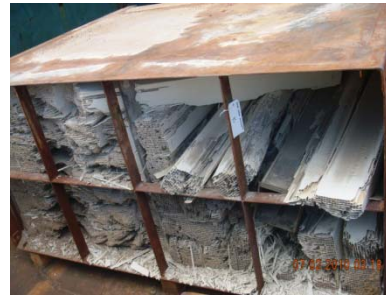
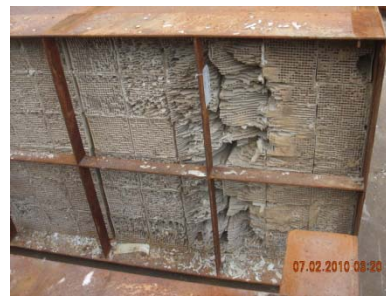
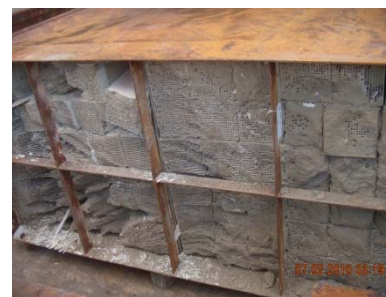
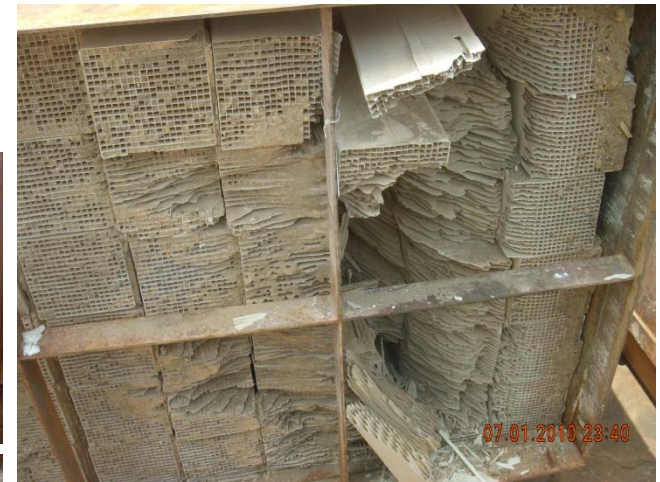
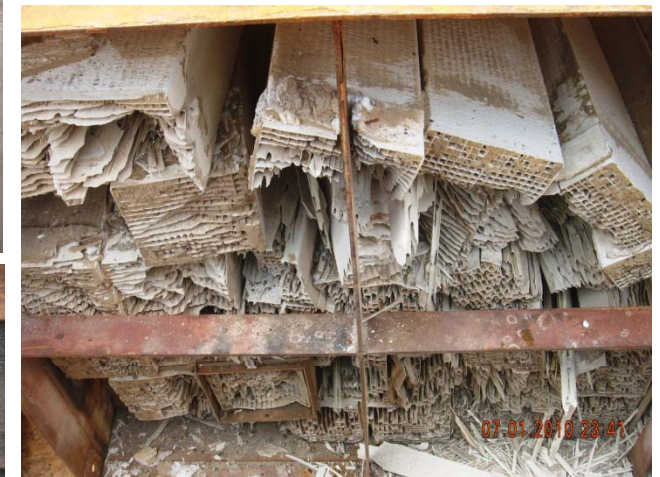
Pluggage and erosion history:

- Startup of unit after boiler upgrade in 3/09. First time at new MCR 12/09.
- Honeycomb catalyst layer replacements:
 - 1 layer in April 2010
 - 1/2 layer in October 2010
 - 2 layers in April 2011
 - 1 layer in October 2011

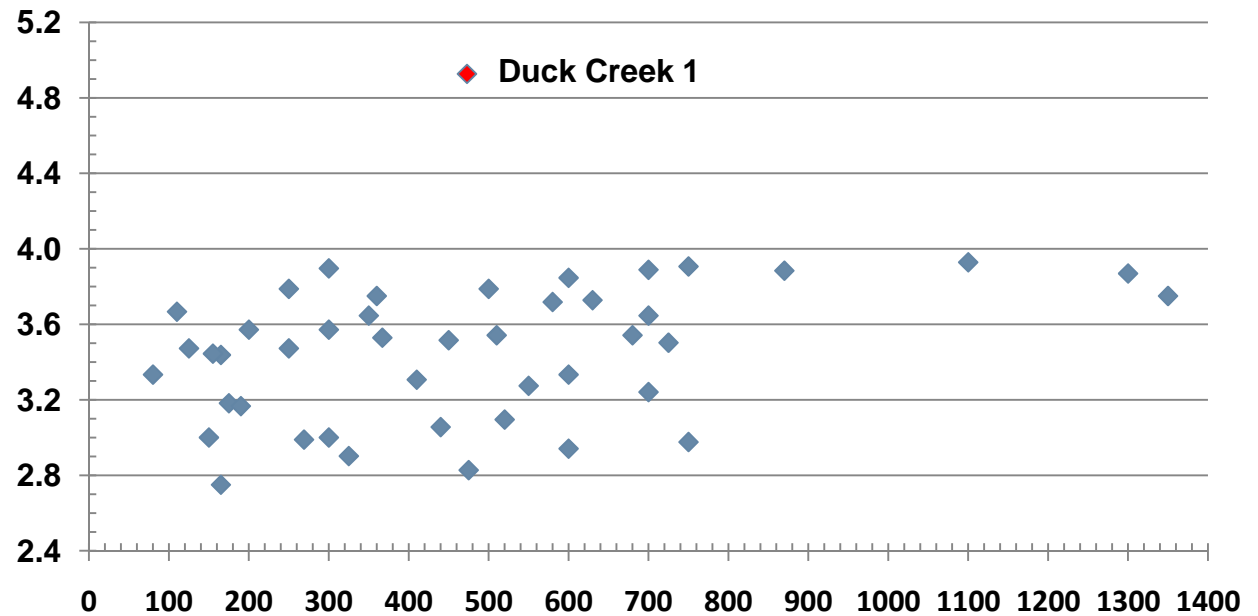
- Simple comparison of MWs per catalyst module to other SCR units clearly indicates that the Duck Creek SCR reactor is too small for the increased boiler rating from 360 MW to 475 MW.

Specific number of MW_{gross} per catalyst module

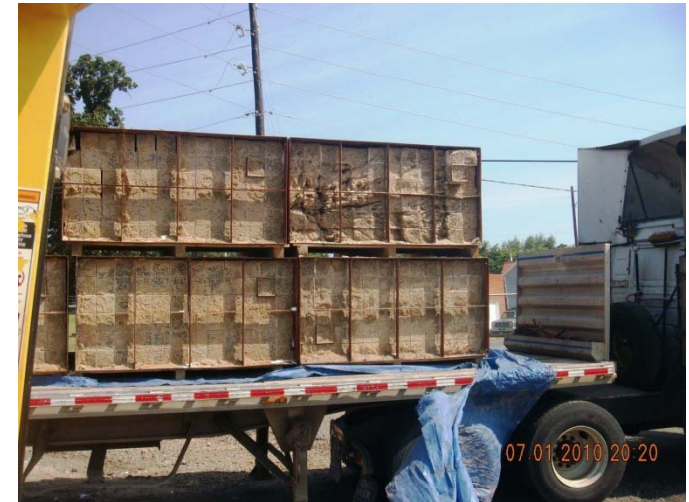
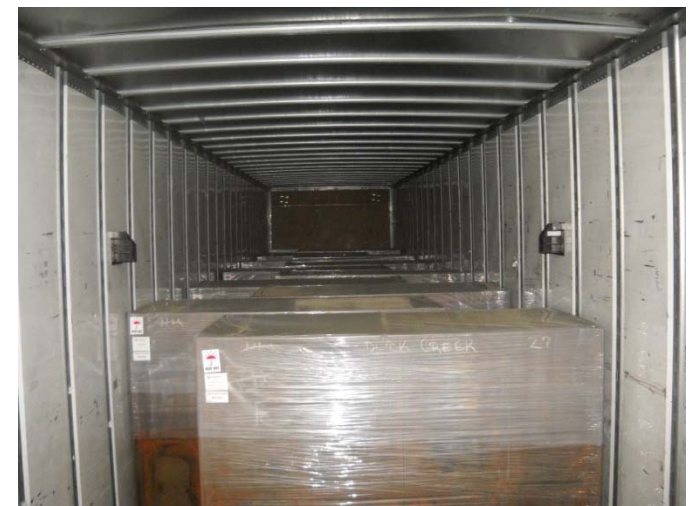
- Initial fill of 3 honeycomb layers (6.7 mm pitch, 1,190 long), startup in May 2003.
- All 6.7 mm pitch honeycombs replaced by 8.2 mm pitch honeycombs in 2006 – 2009 due to pluggage problems including LPA.
- All honeycomb catalyst layers (8.2 mm pitch, 1,300 mm long) replaced with 3 regenerated plate catalyst layers (5.6 mm pitch, 2 x 625 mm long) in 2011.
- Catalyst layer seal design modified for easier installation and removal.

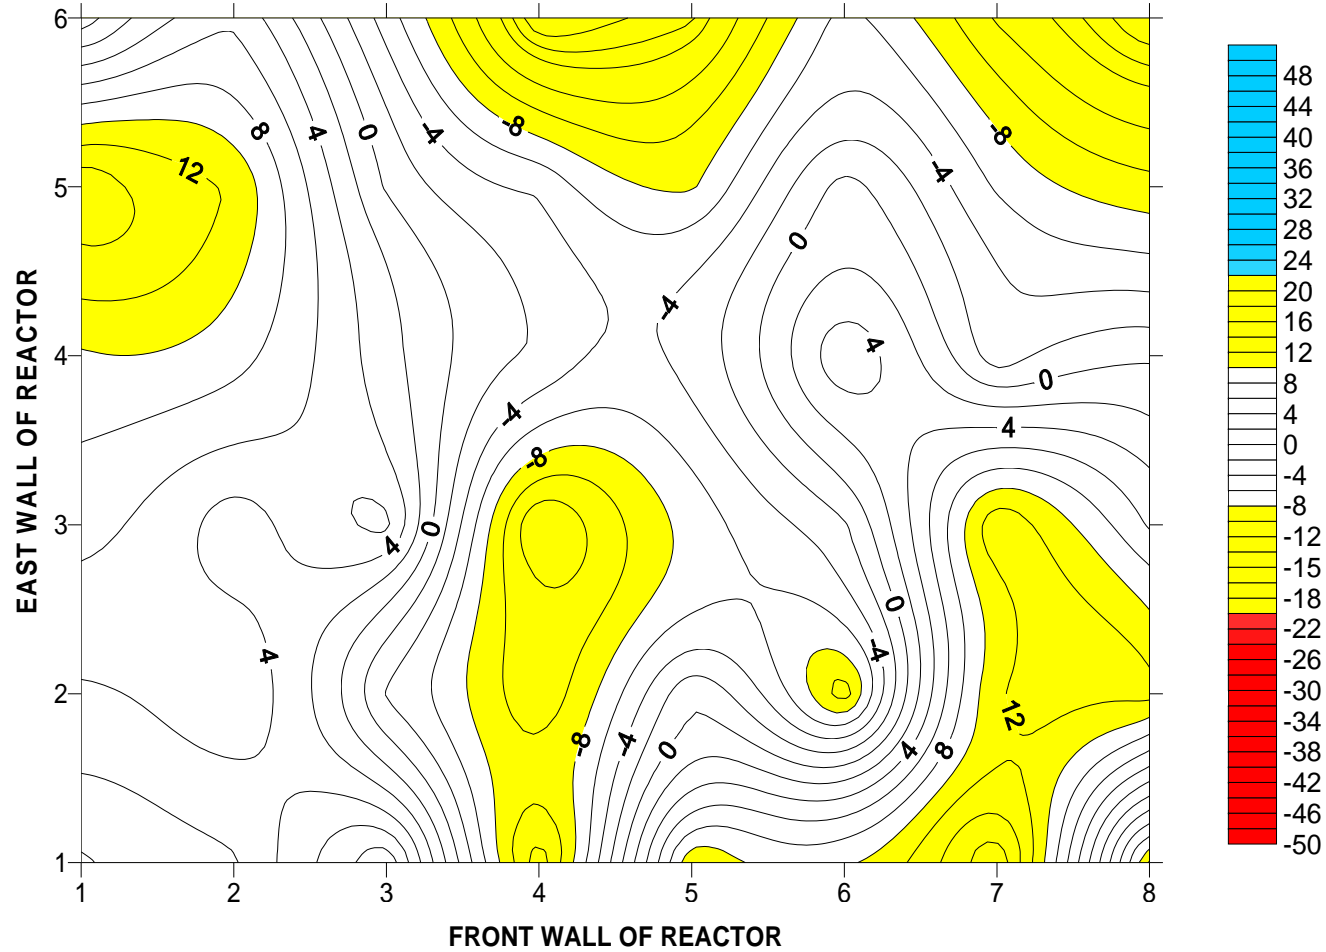
DUCK CREEK UNIT 1 - AS LEFT NO DEVIATION PROFILE
