***2007 APC Round Table & Expo
Presentation***

EFFECTS OF POOR AIR HEATER PERFORMANCE ON BACK END APC EQUIPMENT

John Guffre

Paragon Airheater Technologies

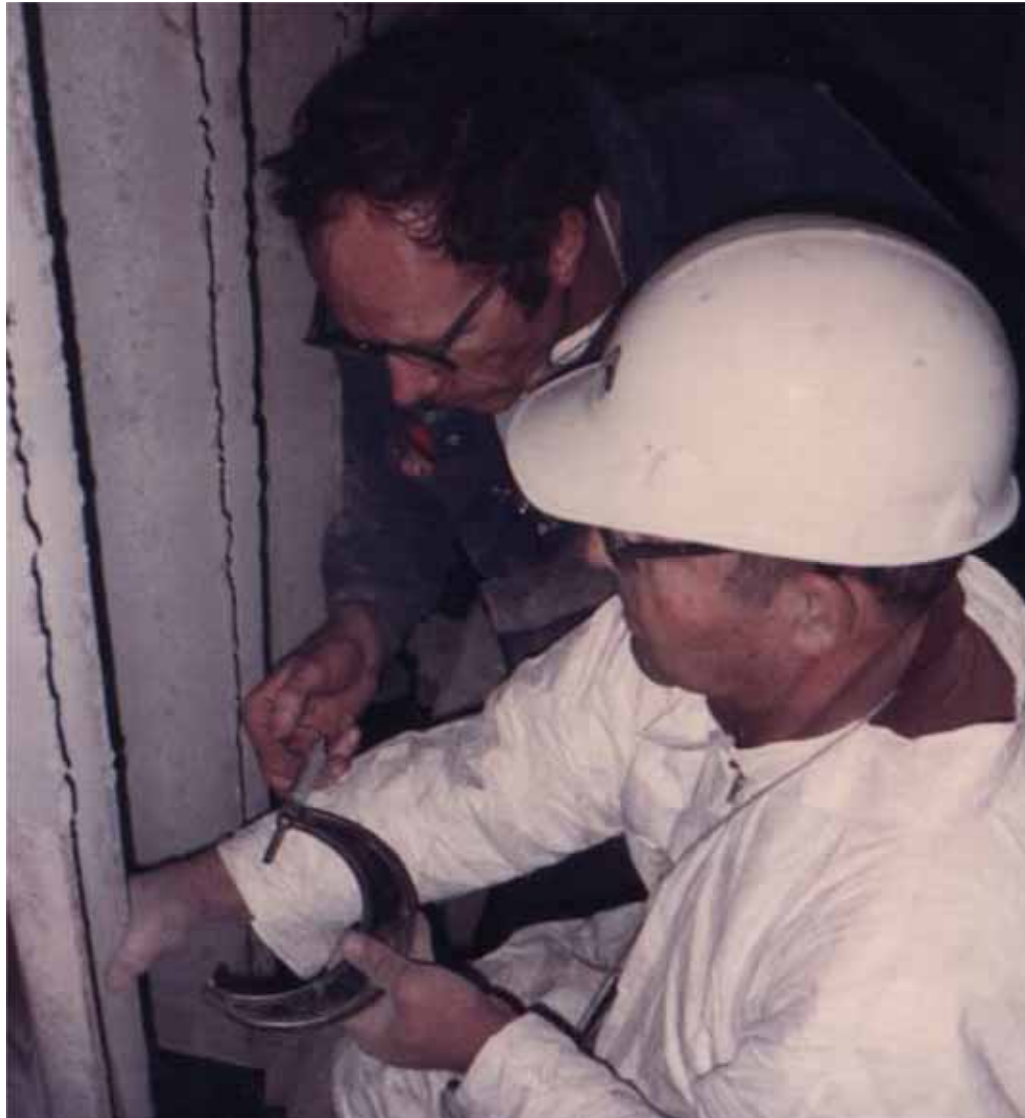
ESP MICROMETER MEASUREMENTS

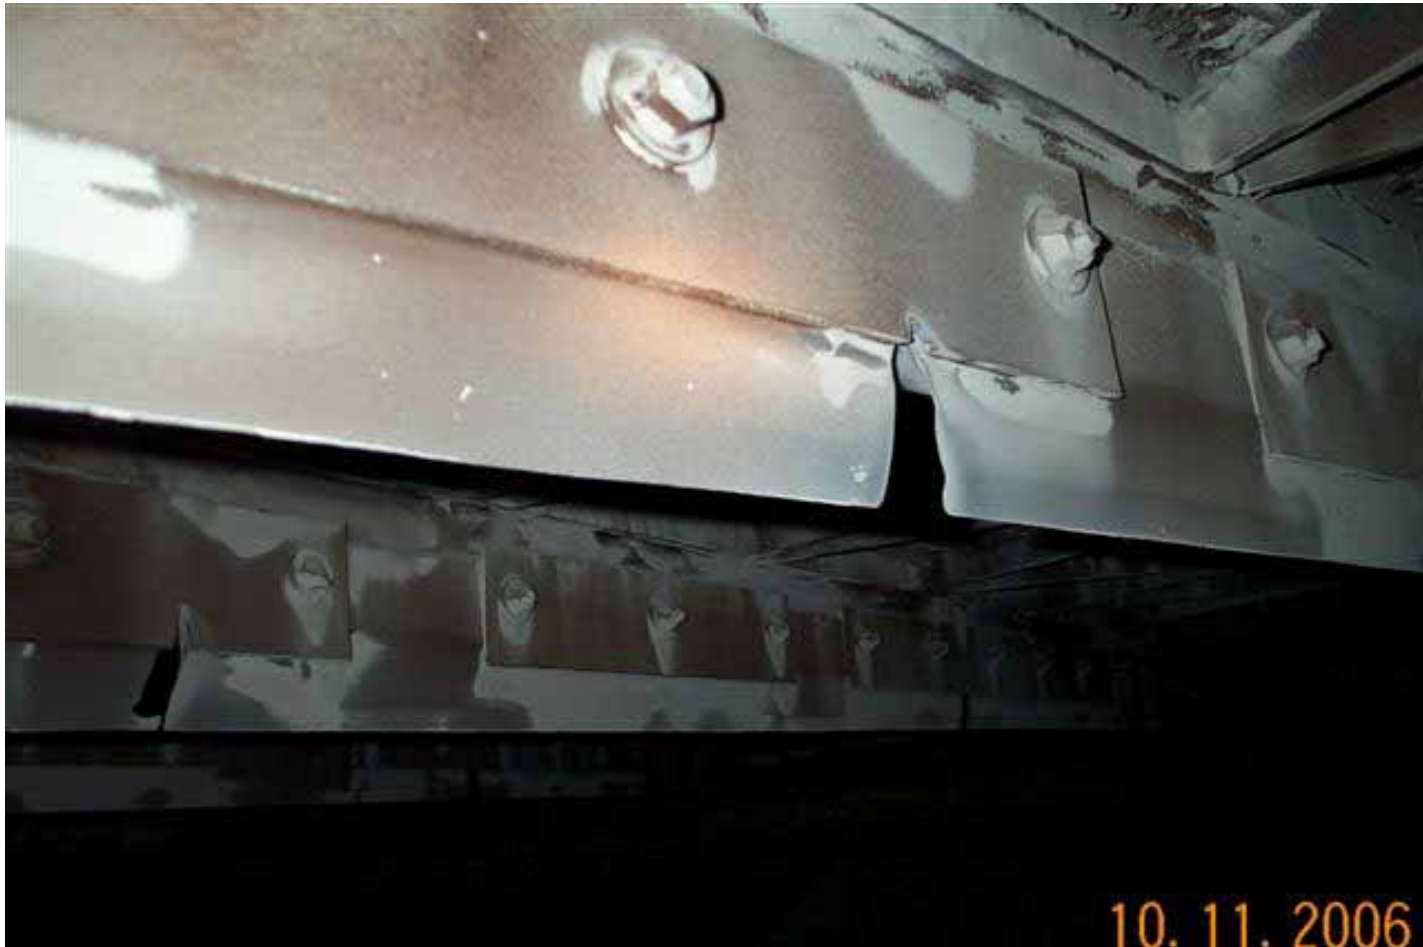
EROSION CAUSED BY RADIAL SEAL LEAKAGE

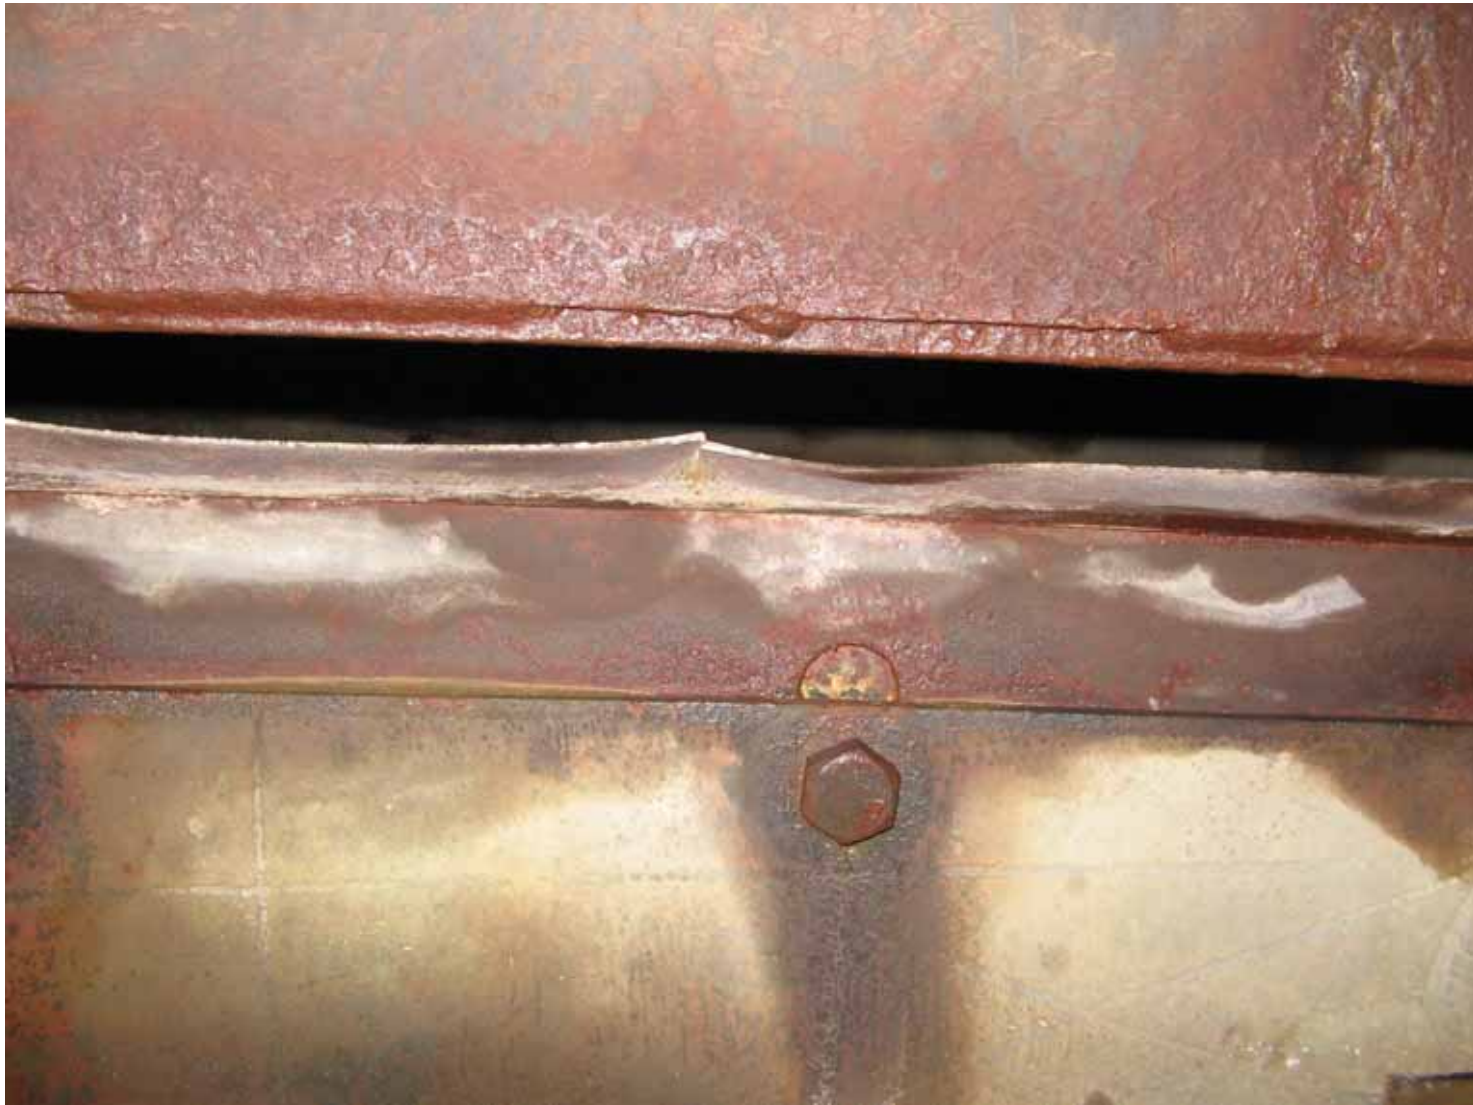
GAPS BETWEEN STANDARD RADIAL SEALS (DAMAGED) AND SECTOR PLATE

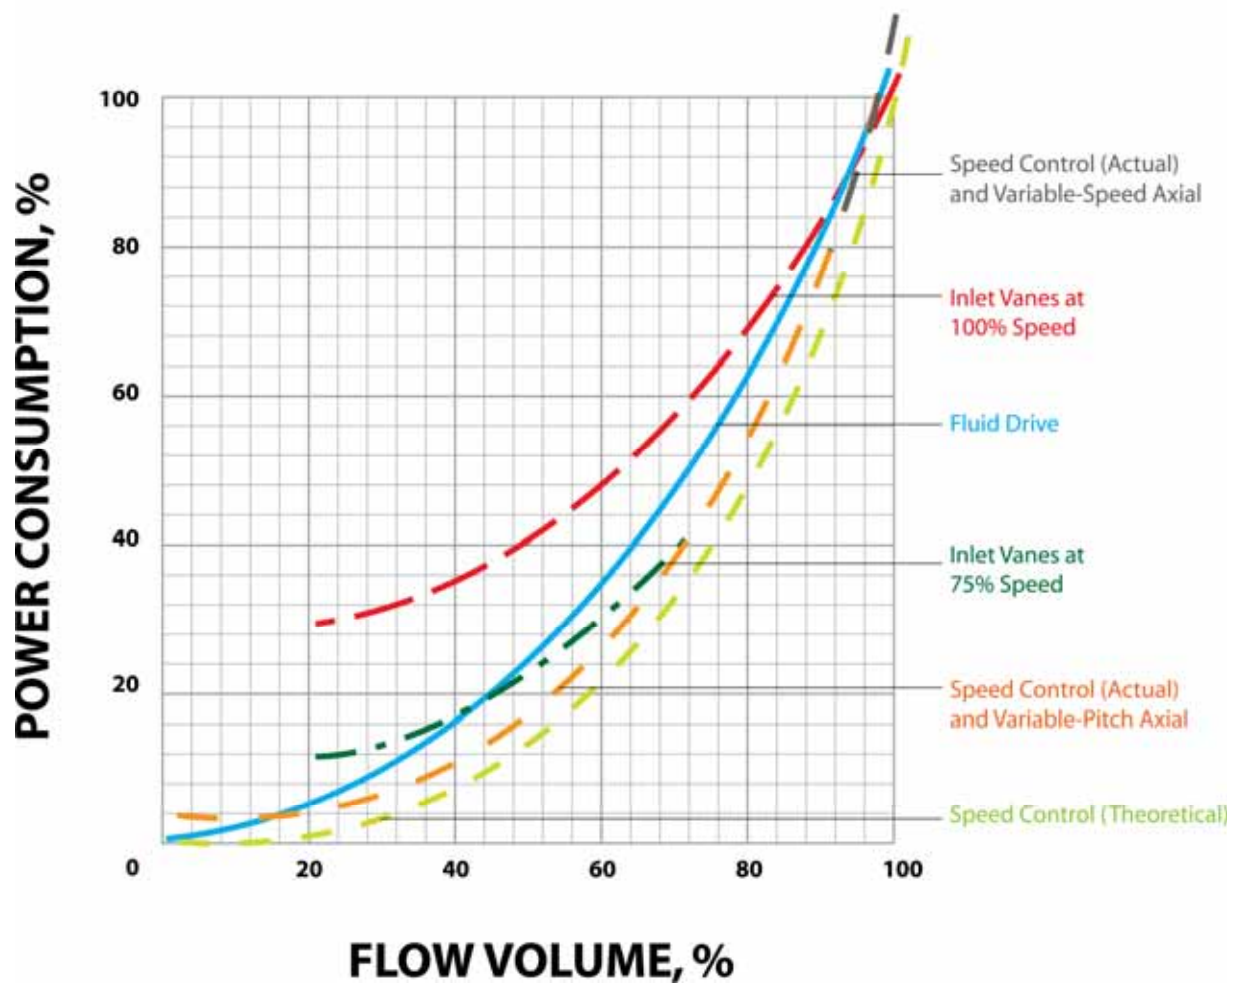
FAN POWER SAVINGS FROM REDUCED LEAKAGE

Power Consumption vs. Volumetric Flow

FAN	Before (AMPS)	After (AMPS)
3A ID FAN	572	459
3B ID FAN	691	468
3A FD FAN	131	125
3B FD FAN	128	113

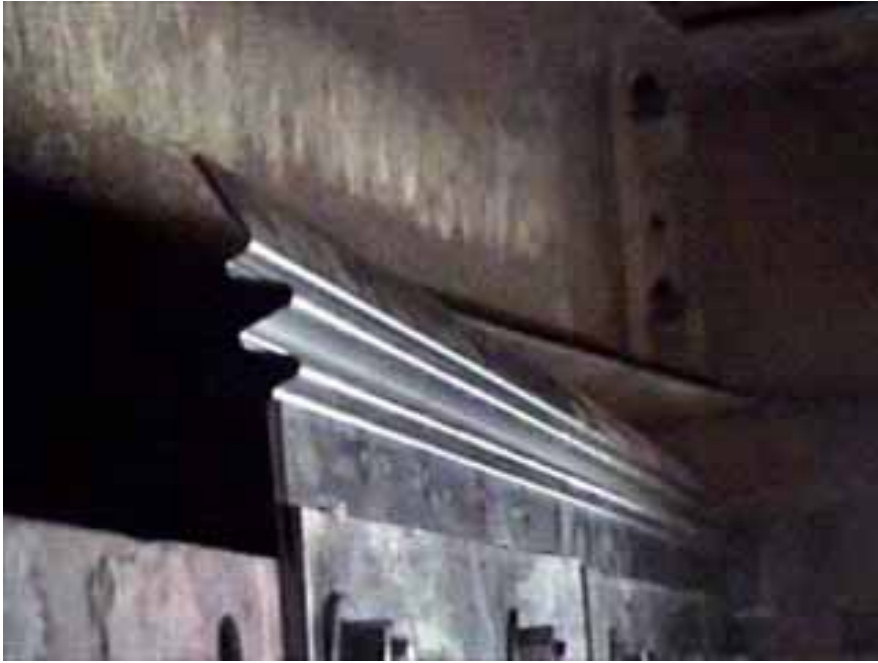
BEFORE CONTACT

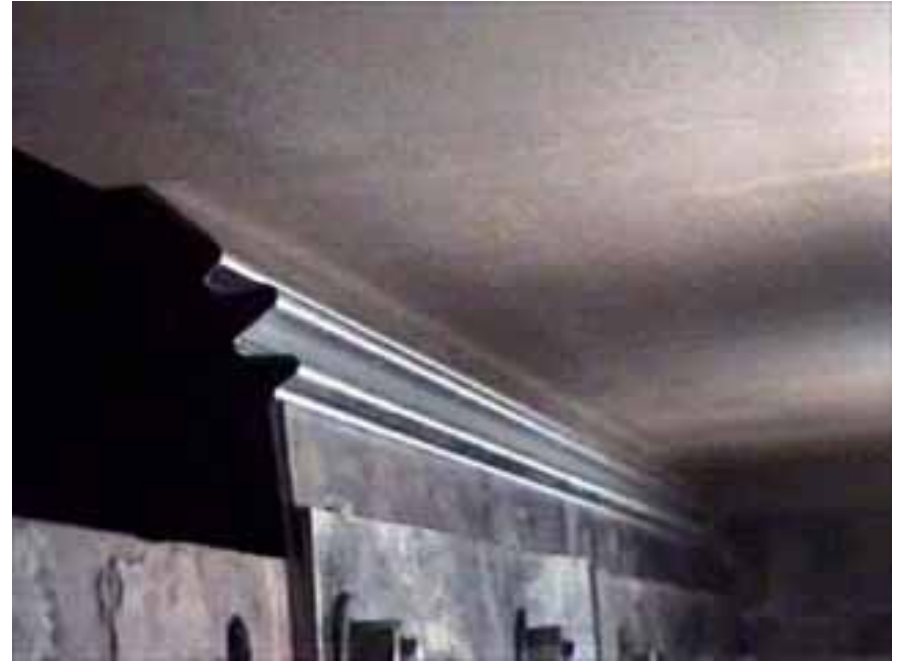
**CONTACT WITH
SECTOR PLATE**

DURAMAX RADIAL SEAL

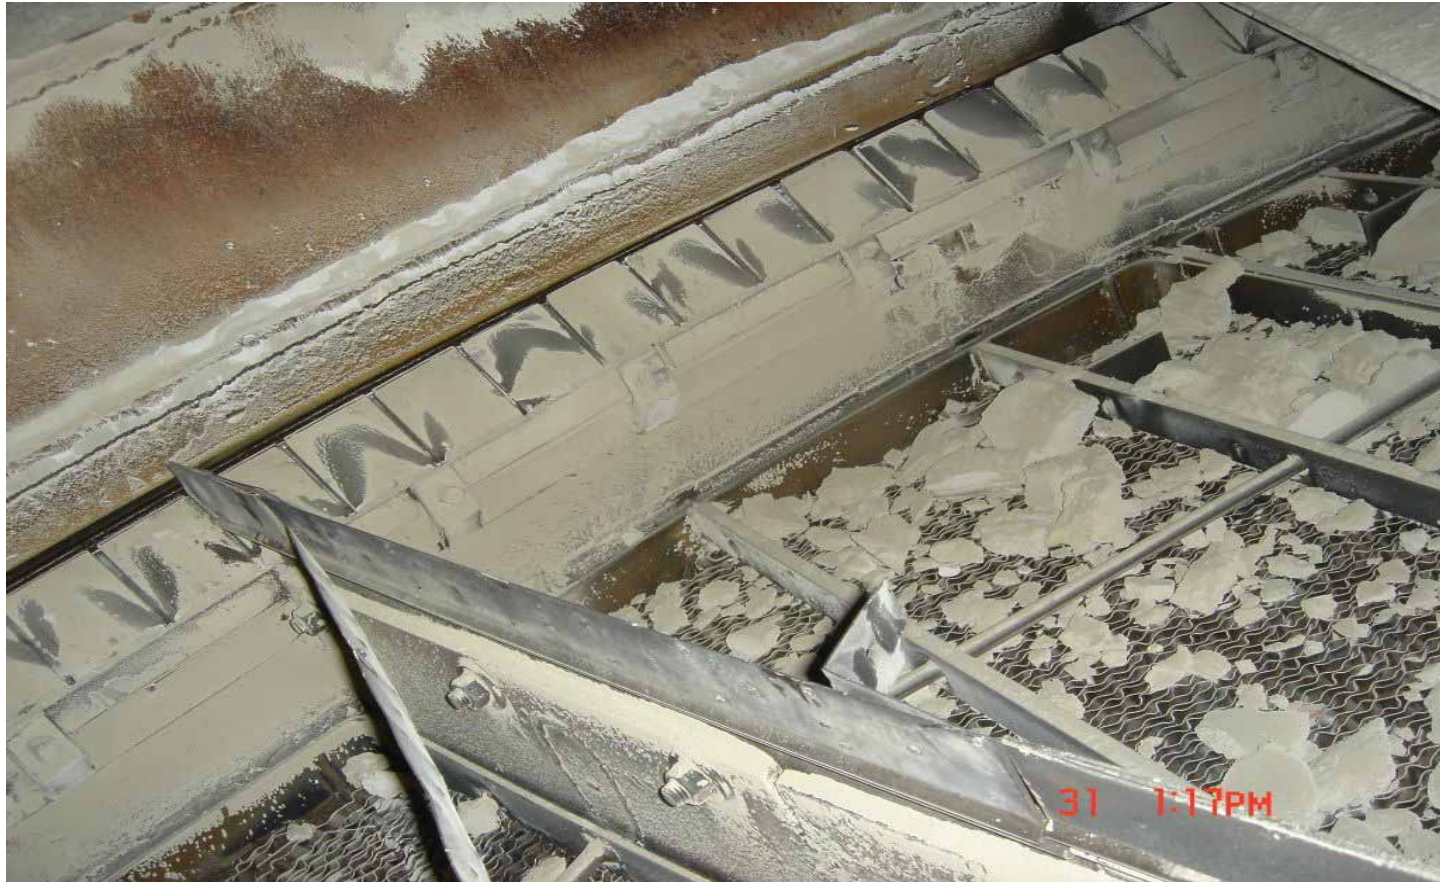
TYPICAL LEAKAGE GAPS IN CIRC SEALS

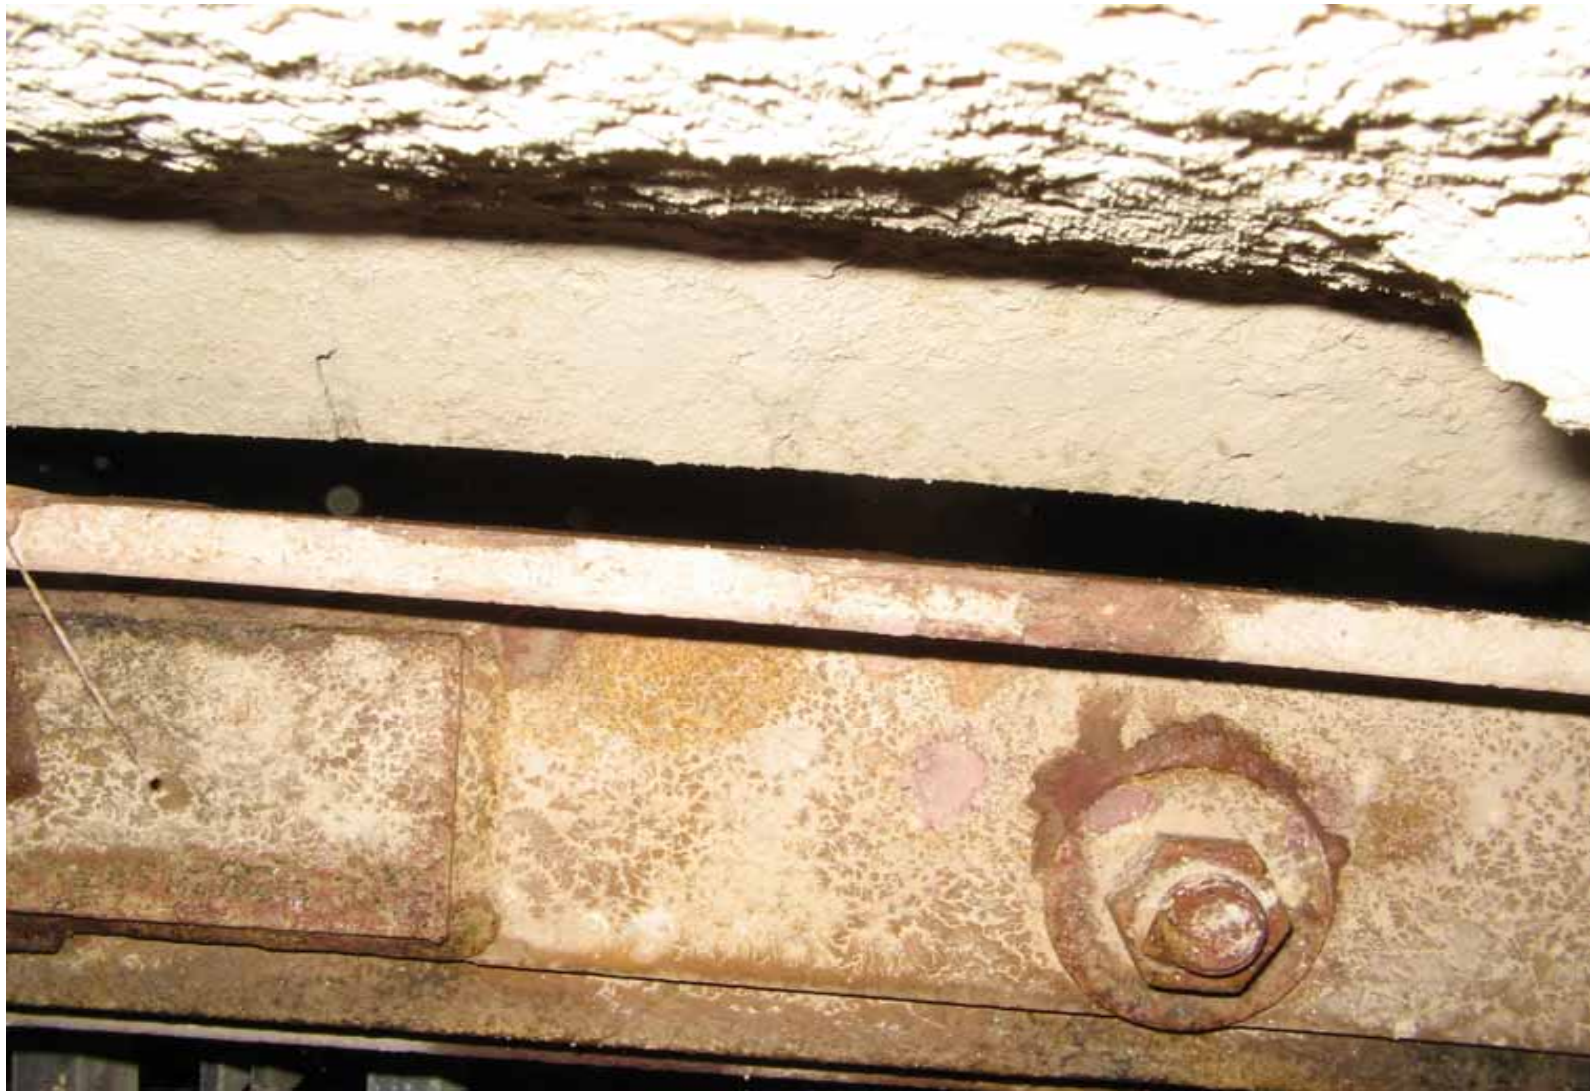
**PERIMETER LEAKAGE GAP BETWEEN
BYPASS SEAL AND ROTOR**

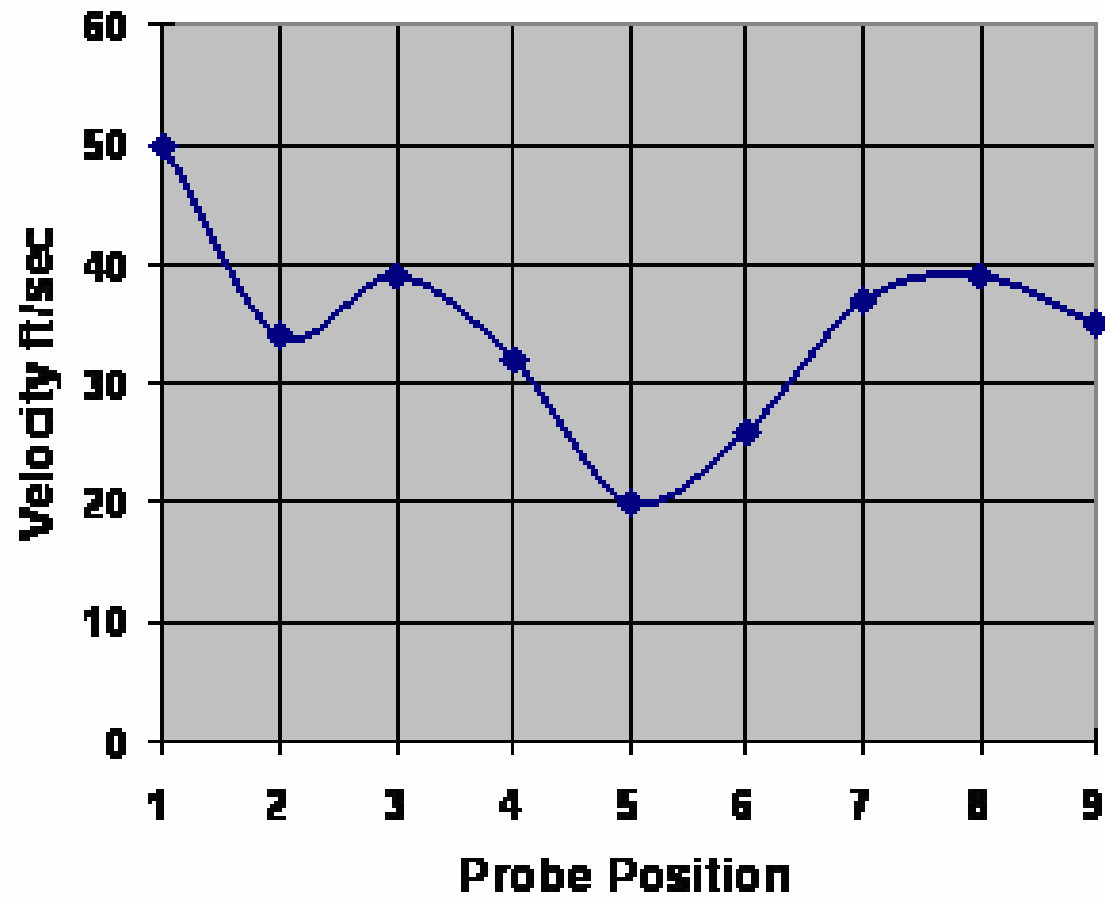
Flue Gas Velocity Distribution

3. Flue Gas Flow Calculations: Test 1: 613 MWn, no ID fan bias

Test ID:	Test Date	Start time	End time	Test Load / Description	Location	Parameter	Units	Basis, other
1	9/3/2003	13:15	16:30	Max load, bias as found	ESP Inlet	Velocity	ft/sec	calc'd

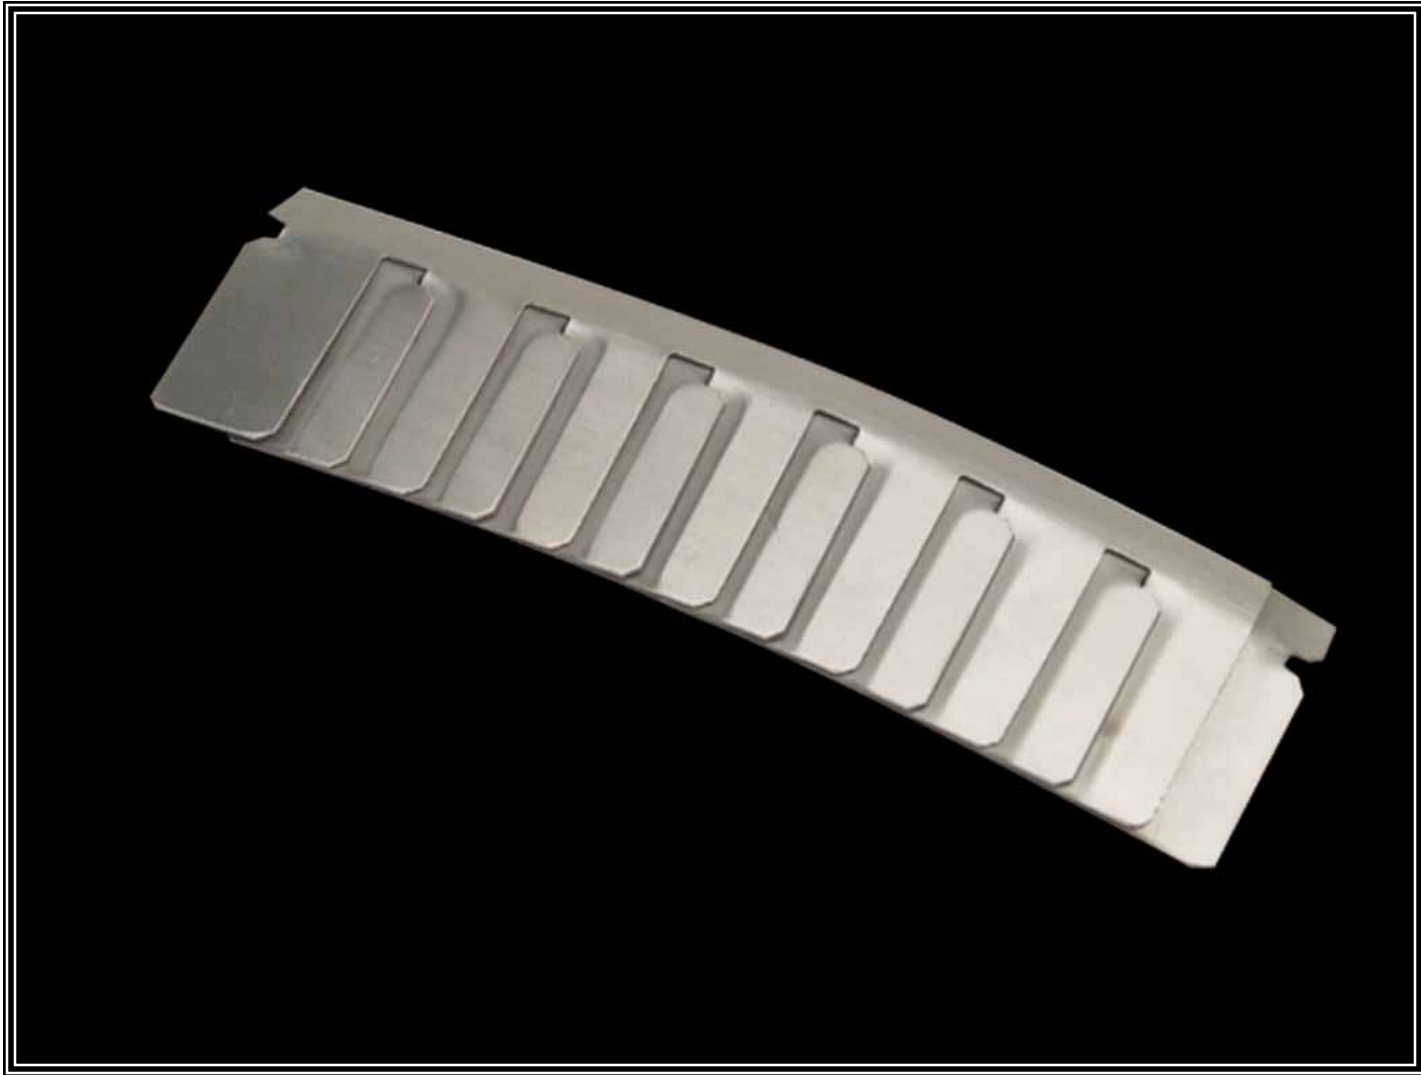
DURAFLEX CIRC SEAL

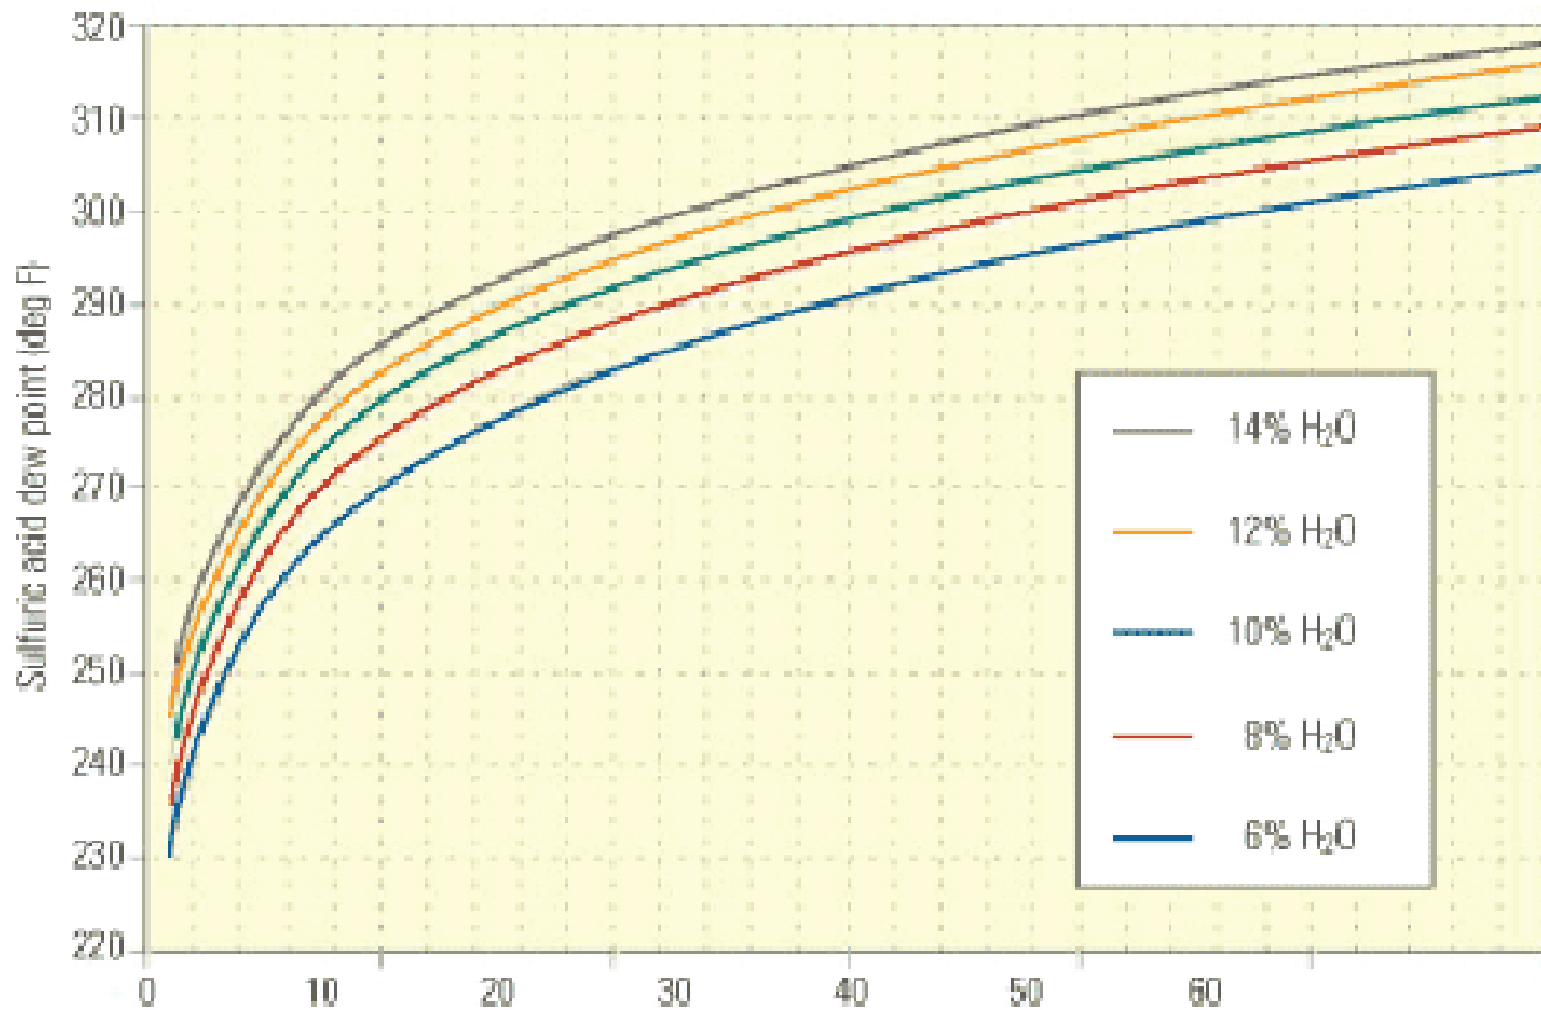
Flue Gas Temperature Effects

SO₃ DEW POINT PROFILE

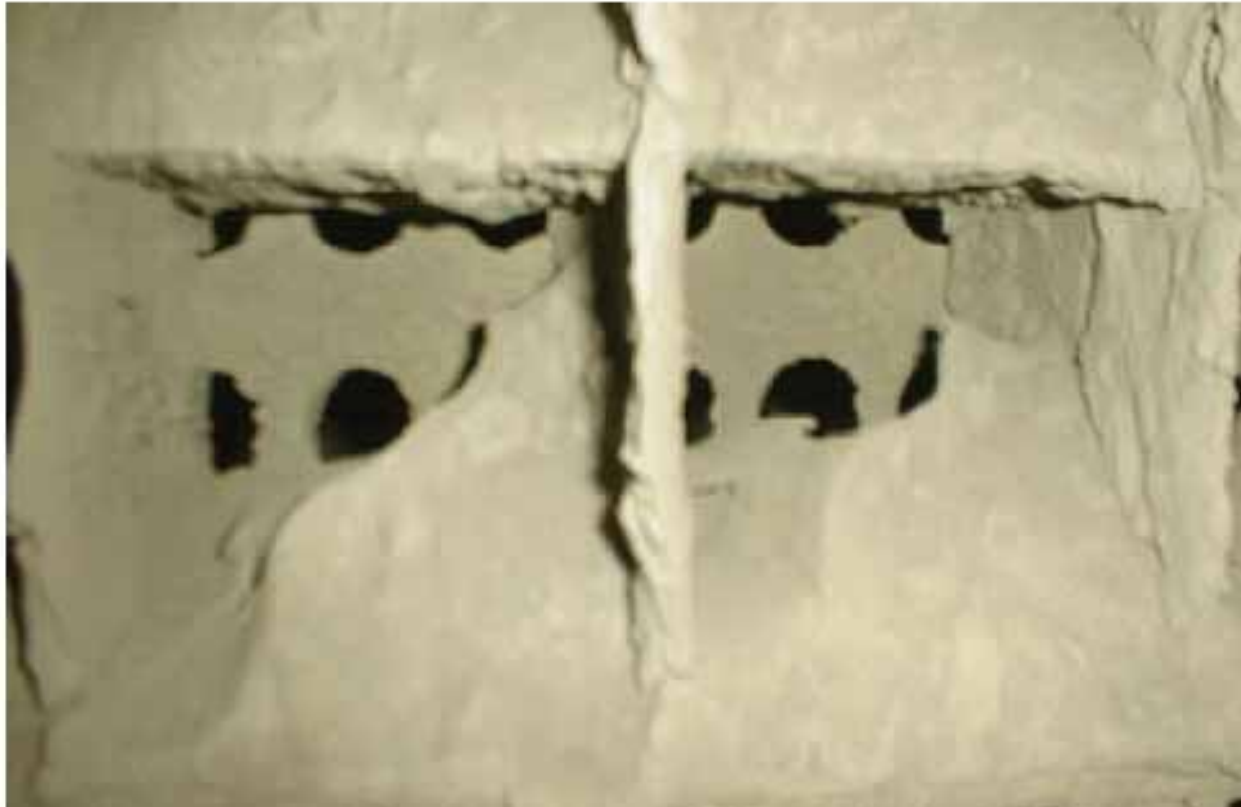
ABS BUILD-UP AT PRECIPITATOR INLET

Ammonium bisulfate deposits at ESP inlet in a coal-fired boiler with ammonia injection for NO_x control.

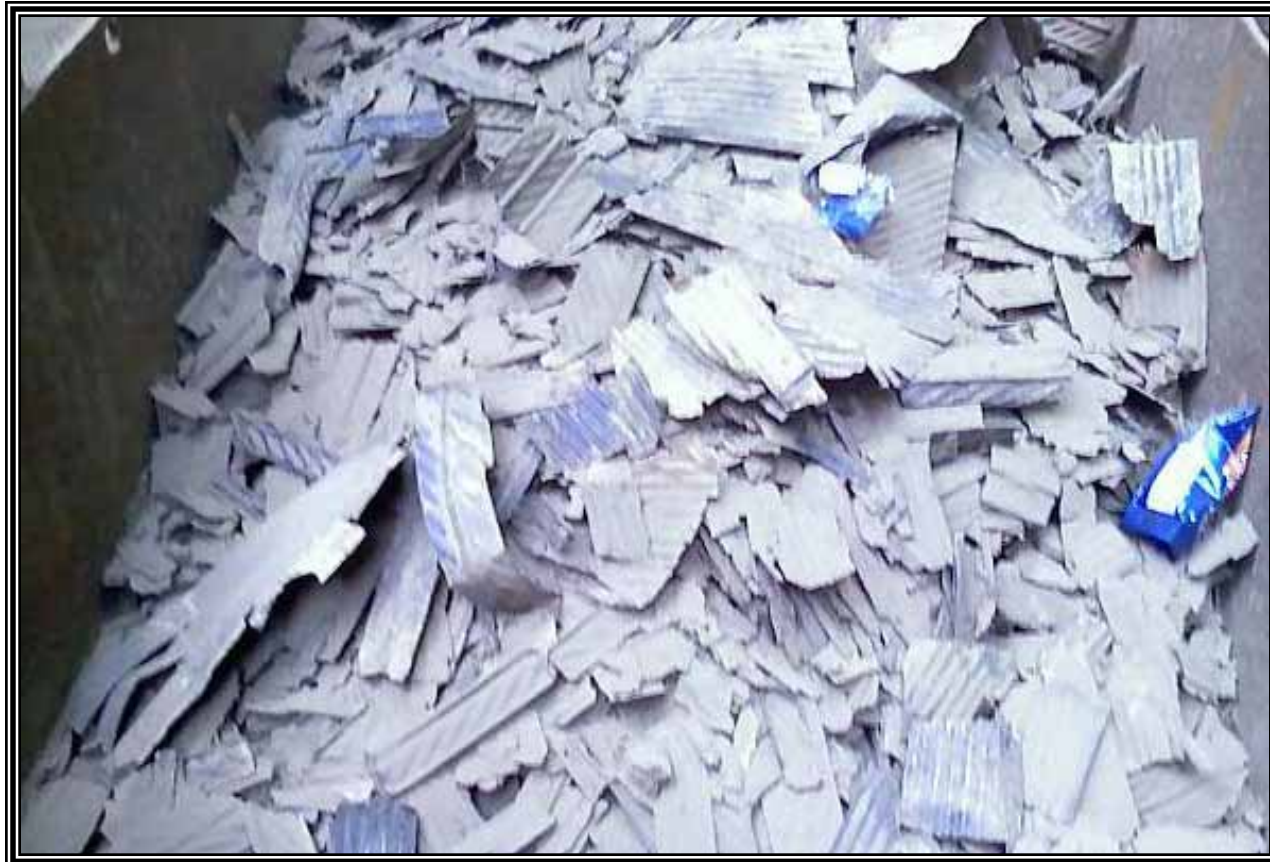
AIR HEATER ELEMENT FAILURES RELATED TO ABS BUILDUP

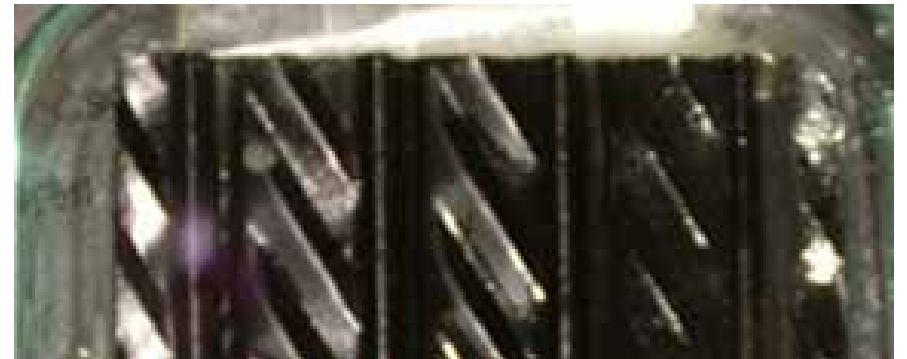
PARAGON COATING

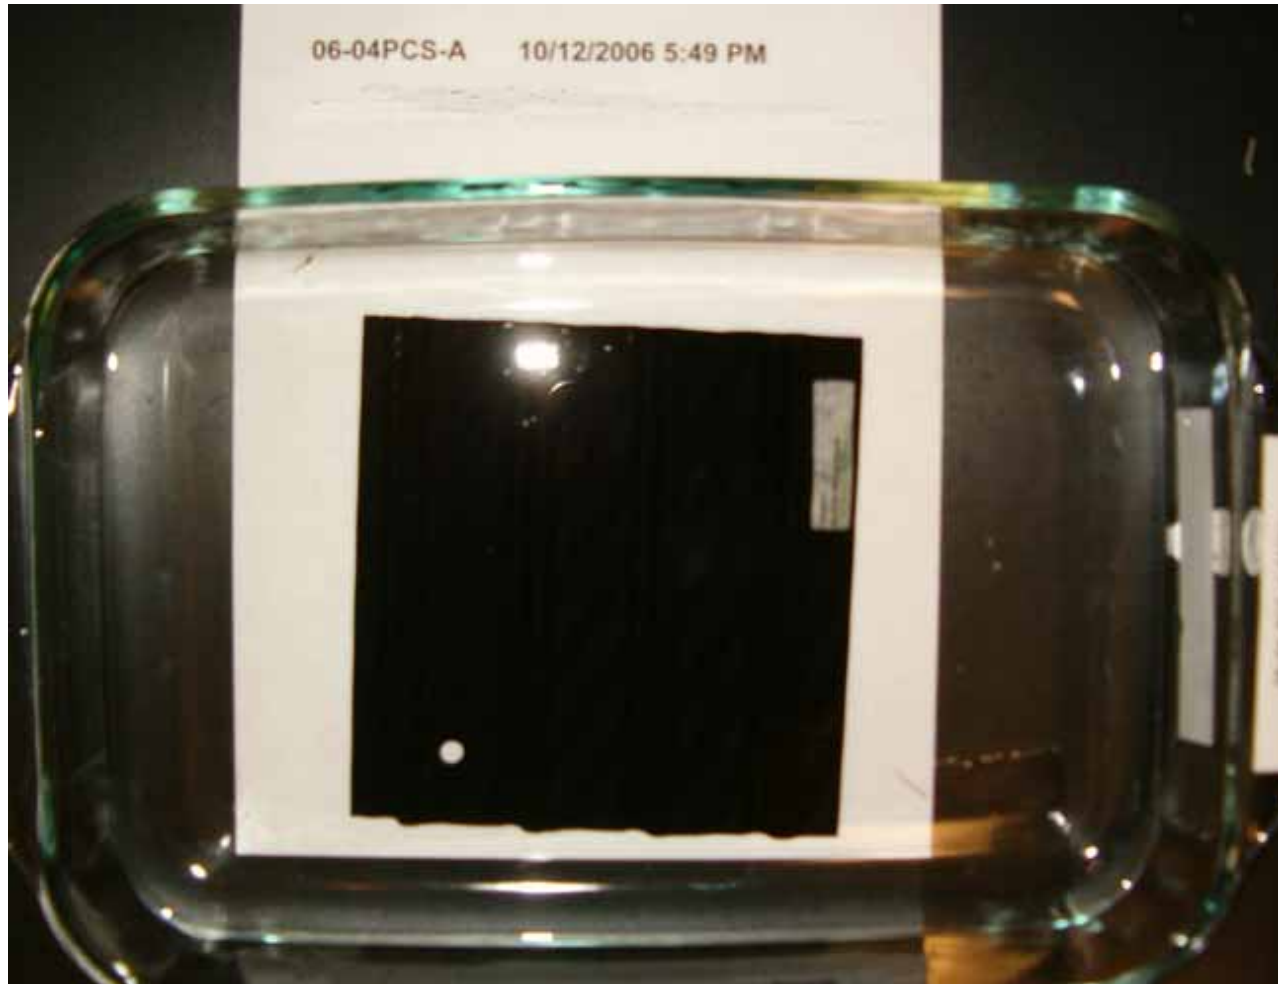
SAMPLE COLD TEST
