***2007 APC Round Table & Expo
Presentation***

***July 8-10, 2007
Chattanooga, TN
Hosted by TVA***

GE Powerwave+™

Study into the Effects of Cleaning on PRB Ash

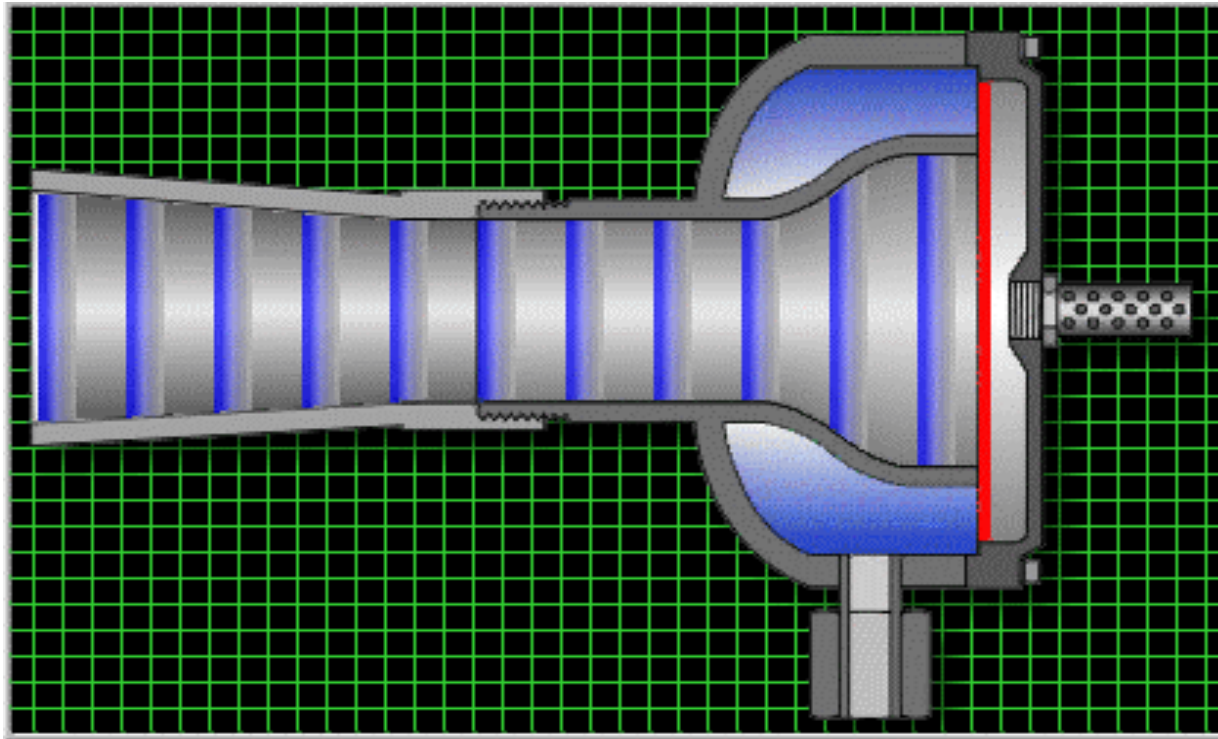
Acoustics Driven By Air

Air operated cleaners produce low frequency, high energy sound waves

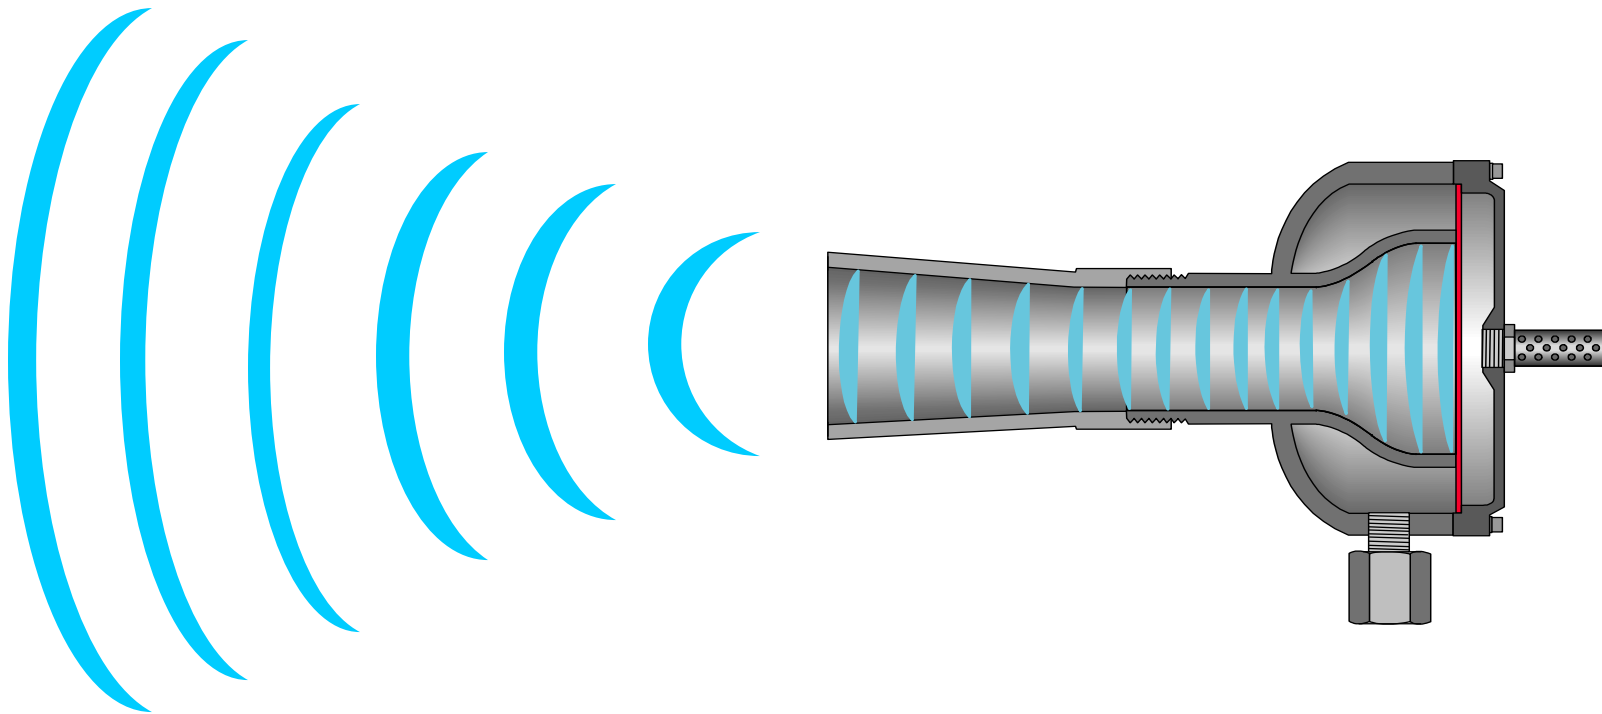
How do Acoustics Work?

Sound waves resonate and dislodge particulate deposits from structural and dust collection surfaces. Acoustic cleaners perform this without causing damage because the range of frequency is well above the resonant frequency of the structure.

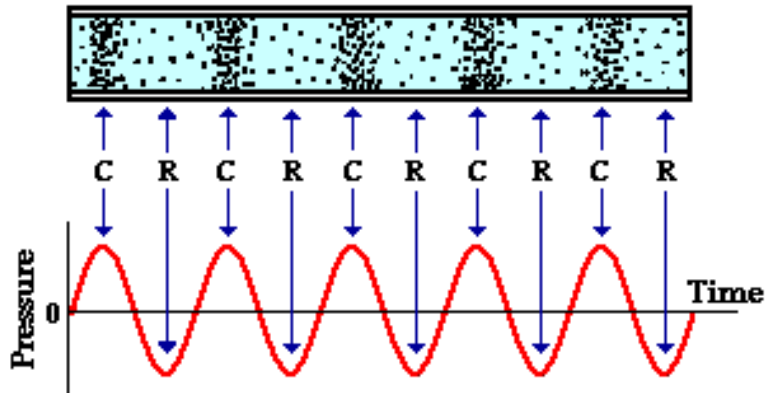
Sound Wave vs. Impulse Wave

NOTE: "C" stands for compression and "R" stands for rarefaction

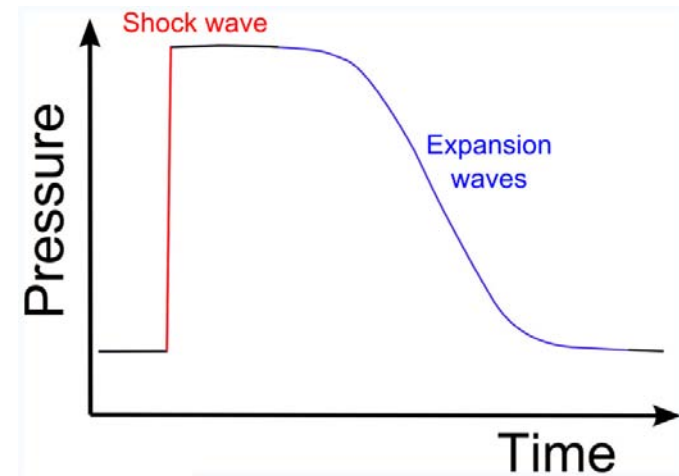
An impulse wave is characterized by a discontinuous increase in pressure and temperature across a boundary.

- Higher magnitude peaks
- Excites numerous frequencies in slag

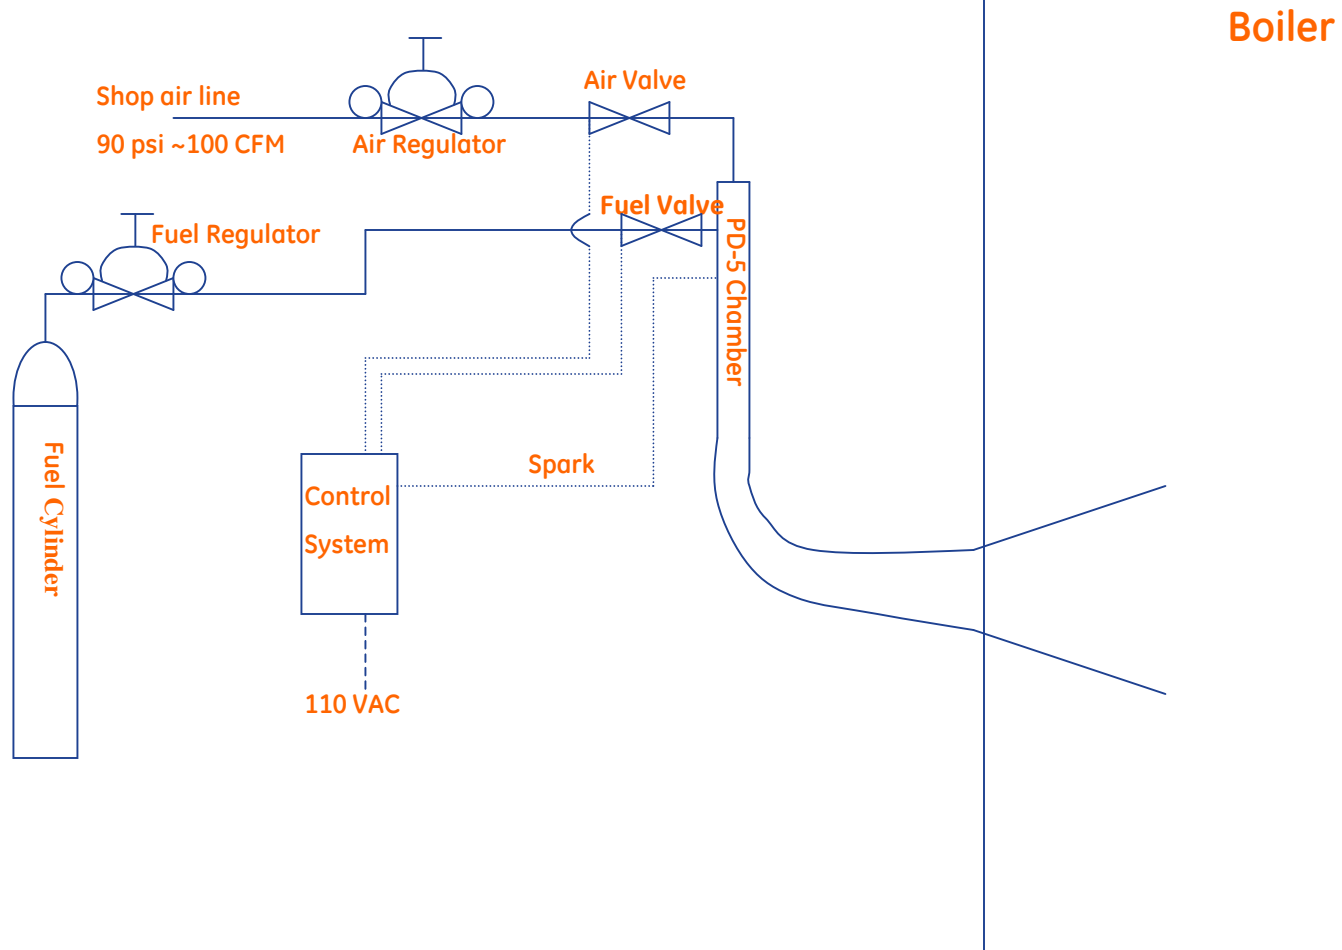
Process Diagram of Installation

- Electrical: 110 VAC
- Air: ~80-100 SCFM (90 psi), plumbed to location
- Fuel: Ethylene Gas (C_2H_4) high pressure cylinder
- Mounting: Access door with at least 16" diameter clearance and bolt circle machined (provided)

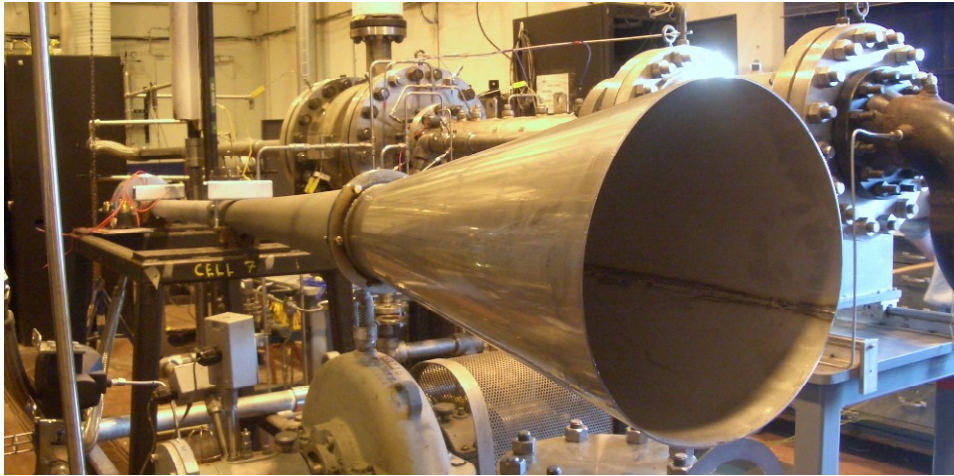
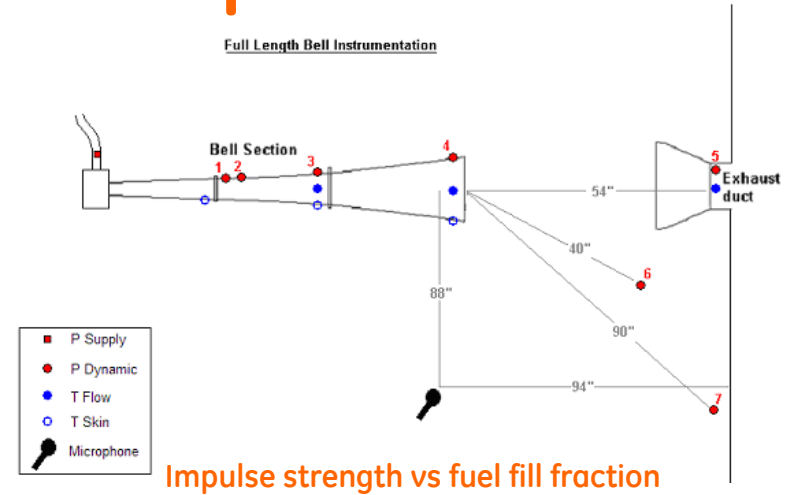
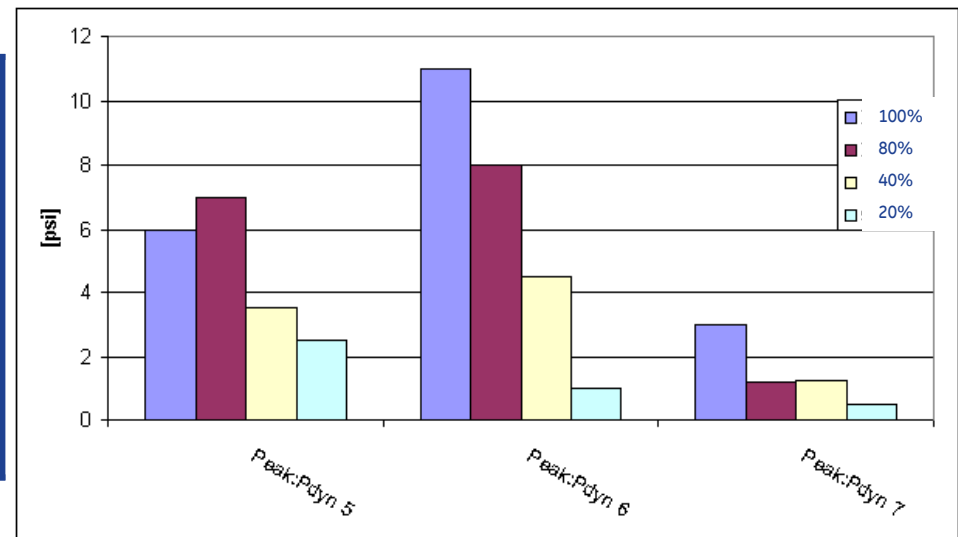
Cleaning Technology Comparison

Acoustic Horn (DC-75)	Powerwave+
dB level (average over 3 seconds)	130	142
Dynamic Pressure Peaks [psi]	<.25	13

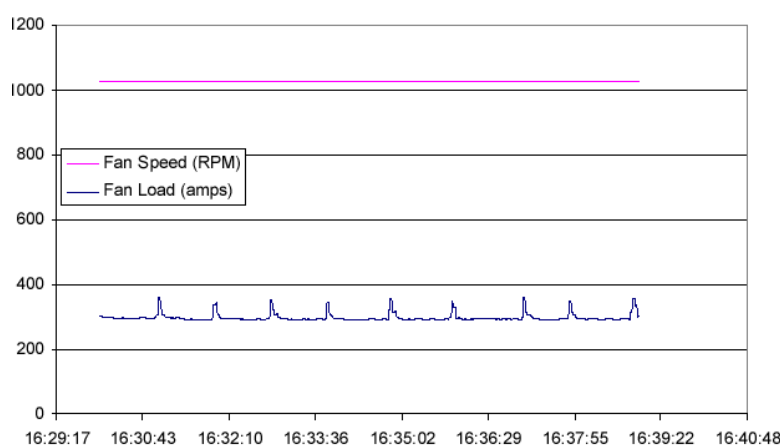
PD Operation: Acceptable variation in fan load

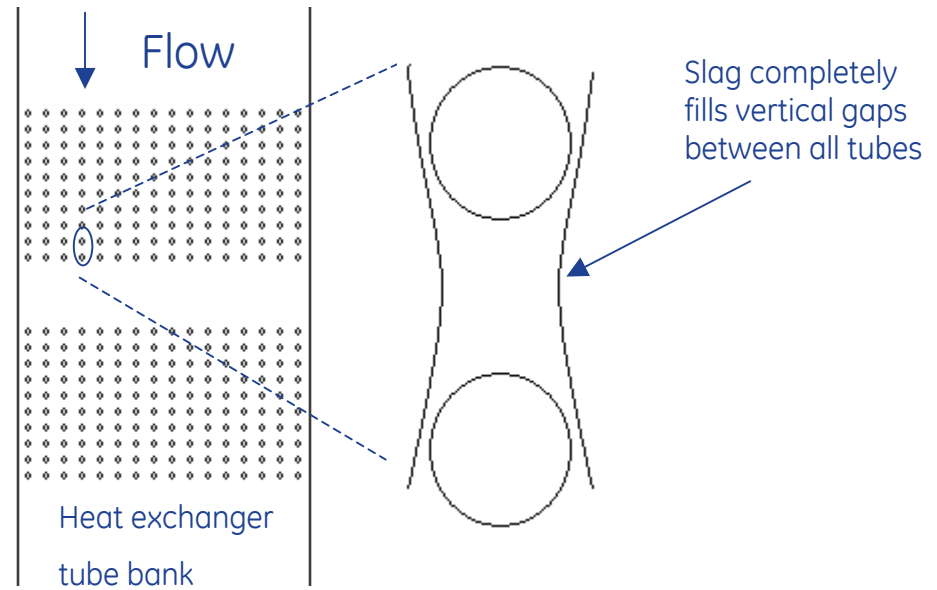
Layout and Problem

PRB coal leading to platenization in back passes

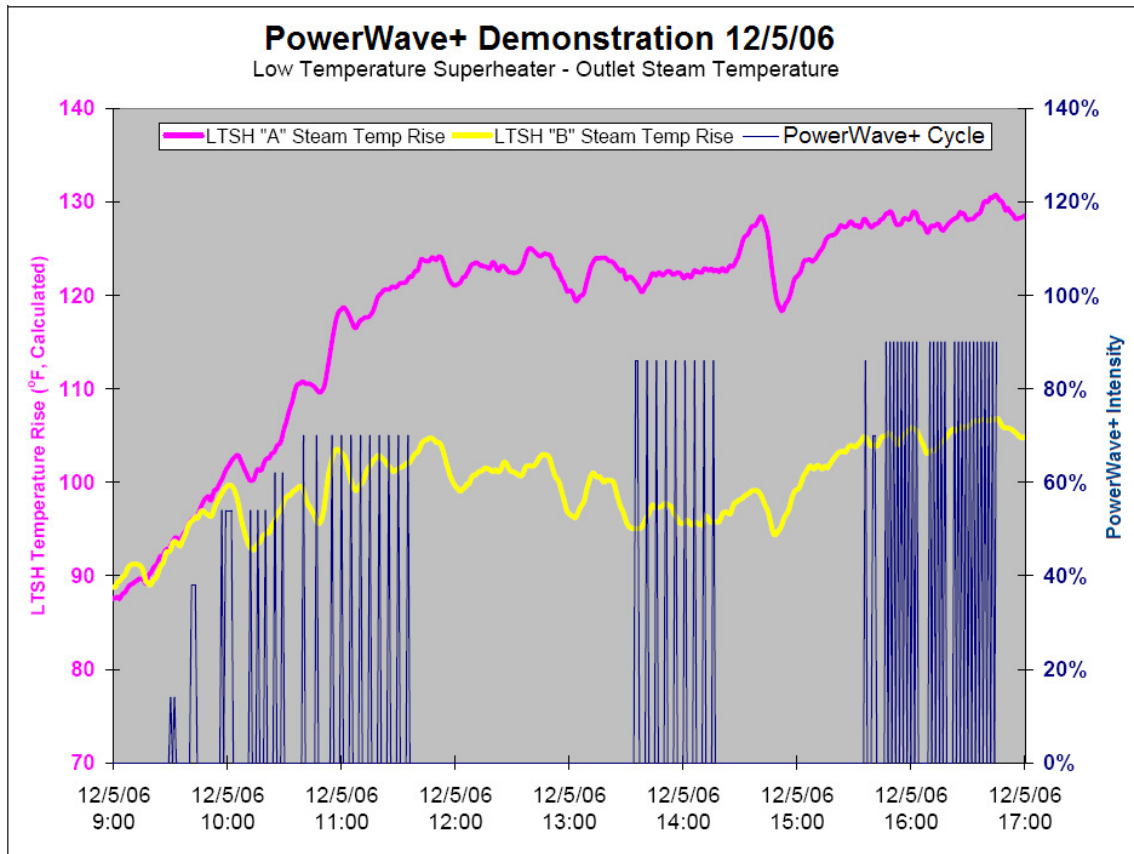
Results

Over 20 degree increase in steam outlet temp across LTSH

- 20 degree improvement in LTSH steam temperature
- 10-20 degree improvement in inlet gas temp to air heater
- Obvious dislodging of slag from surfaces

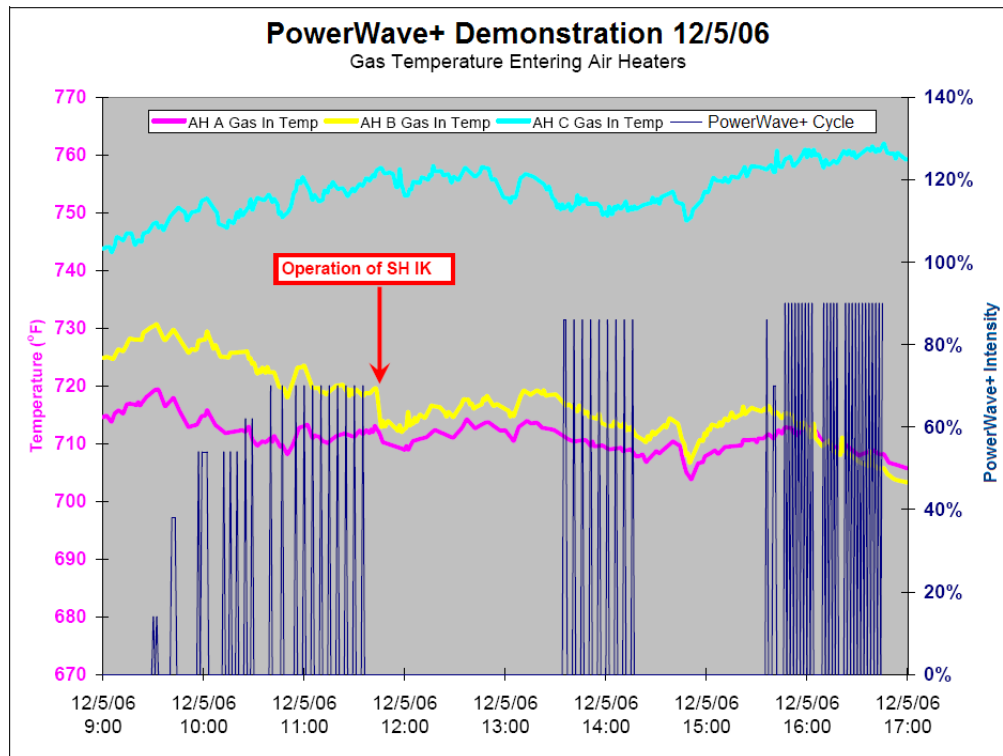
Results

- Noticeable improvement in gas temp at inlet to air heater
- Rise in C-side may be attributed to pluggage of A and B sides

10-20 degree improvement in inlet gas temp to airheaters

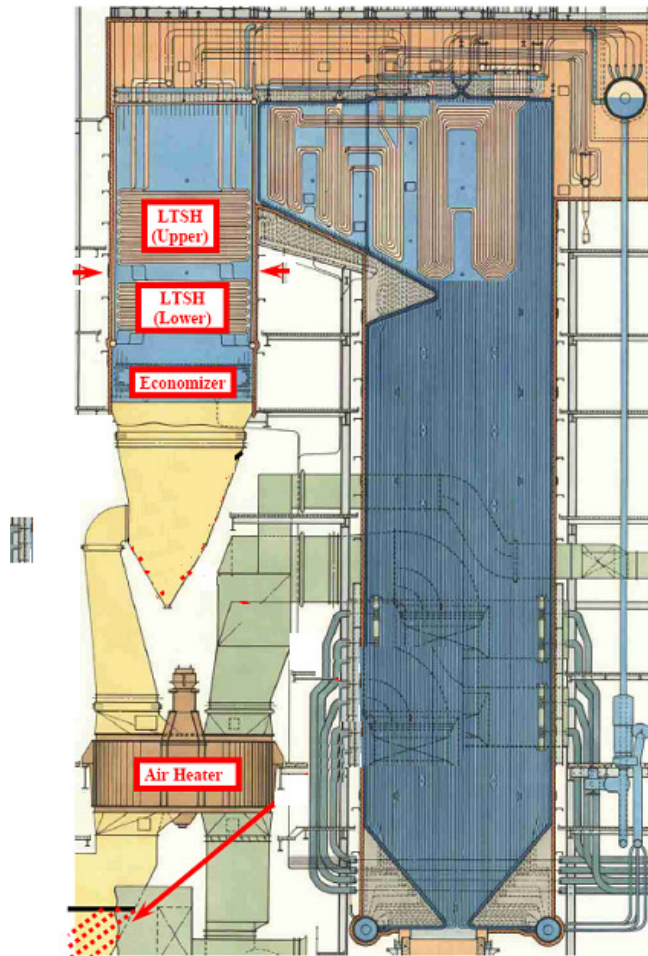
Day 1 – two units in Reheat LTSH

Fin Tube Installation:
Plugging in backpasses
Results:
Evidence of debris
cleaning during startup

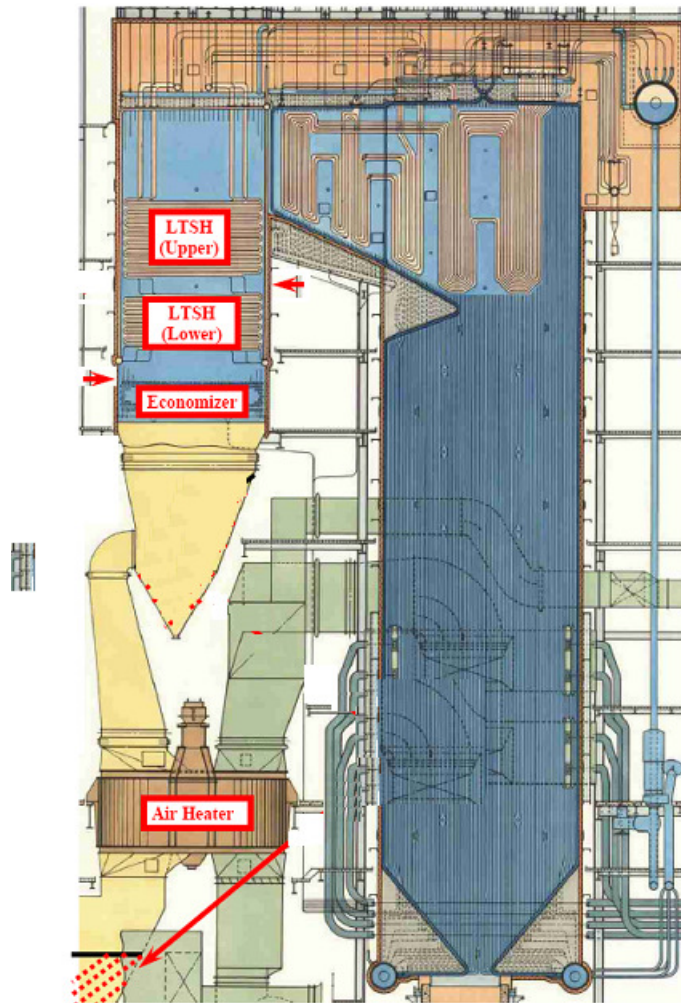
Day 2 – Economizer and LTSH

Improvements in feed water temps
in economizer

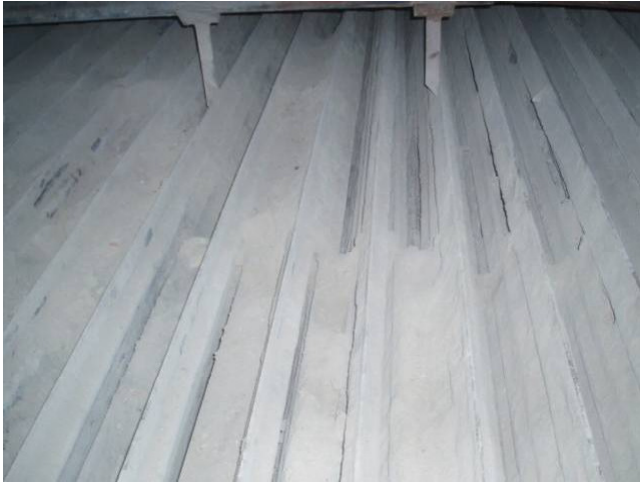
Typical Economizer Fouling

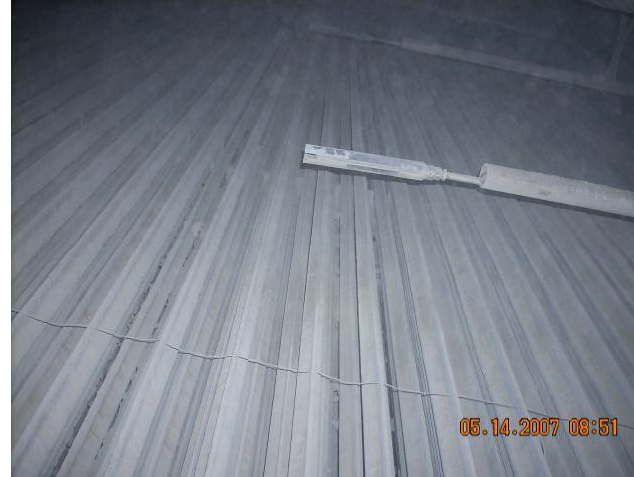
Economizer with Powerwave+

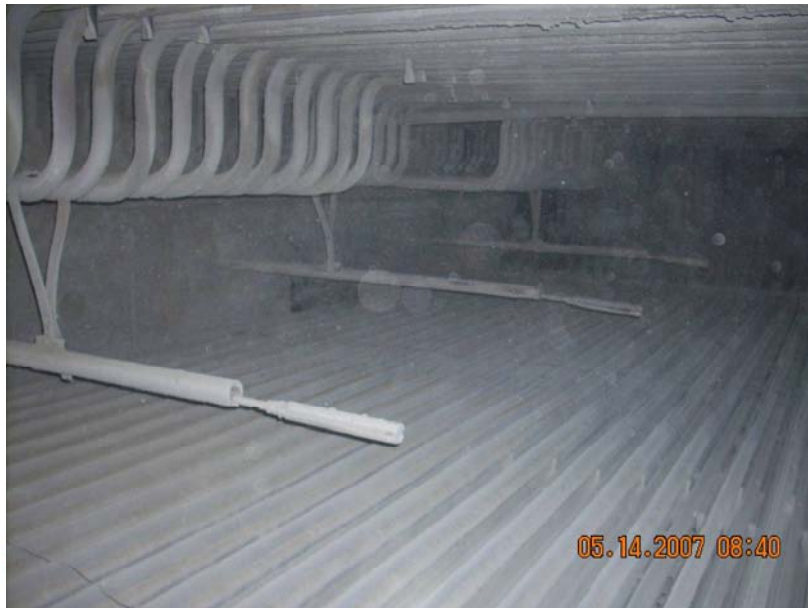
58 days of Powerwave+ operation

This installation also has four 75Hz acoustic horns Installed

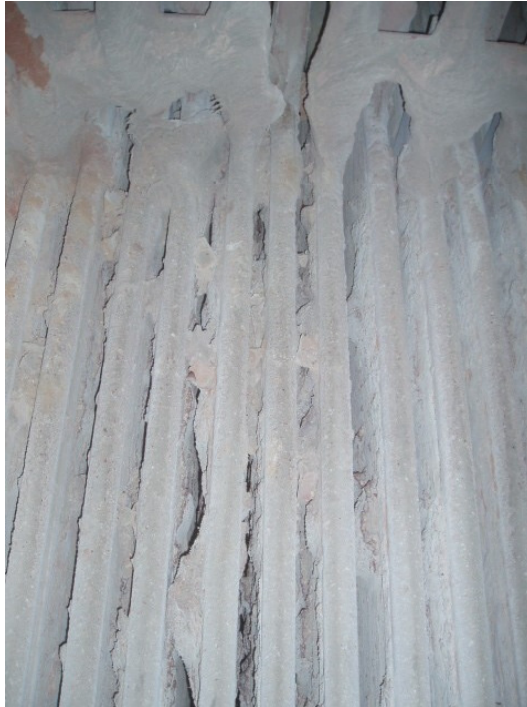
Fouled upper bank LTSH

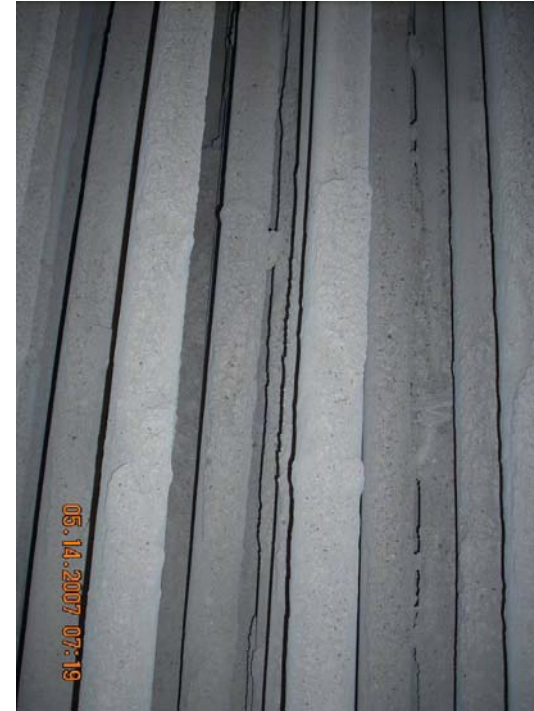
Upper bank LTSH with Powerwave+

Back-passes noticeably cleaner after 58 days operation

Have visually noticed a cleaner back pass since they have been installed and are actively monitoring progress.
