Reinhold Environmental Ltd.

2008 APC Round Table
& Expo Presentation

July 13-15, 2008, in Savannah, GA

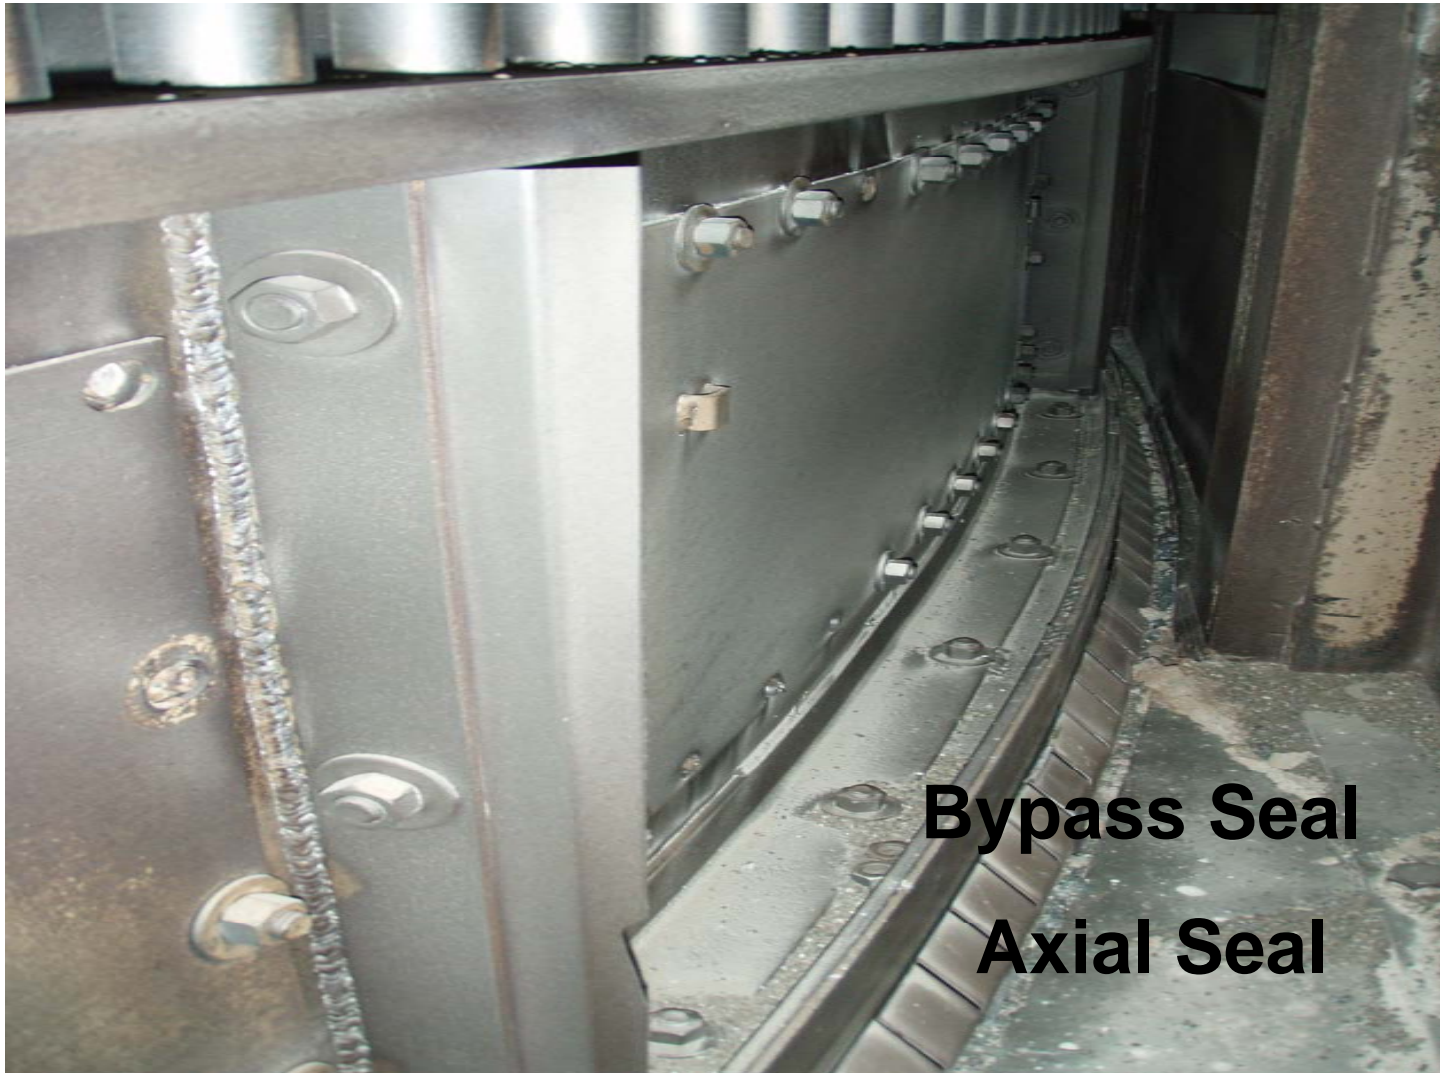
Bypass Seal

Axial Seal

Perimeter Leakage Gap Between Bypass Seal and Rotor

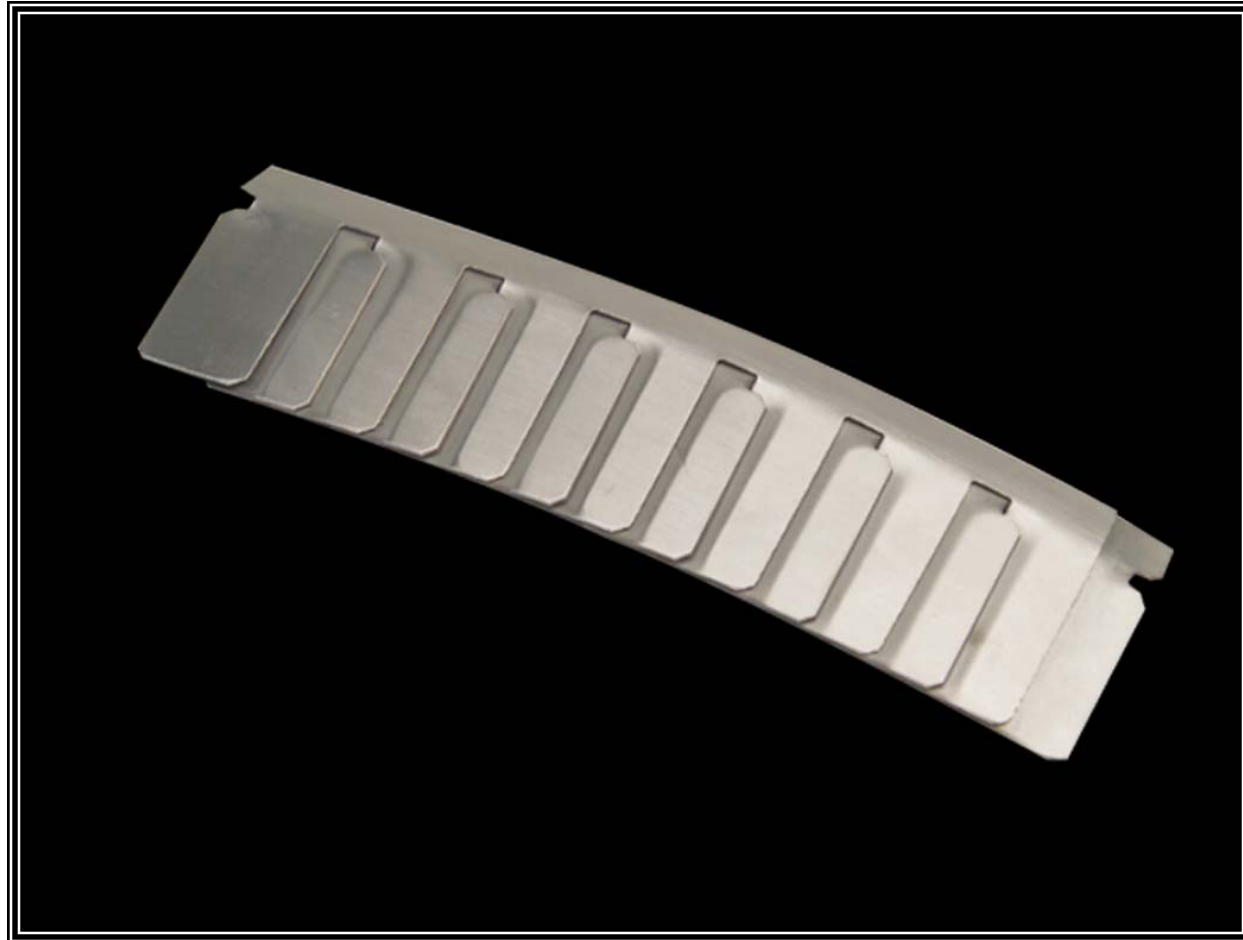
DuraFlex™ Circumferential Seal

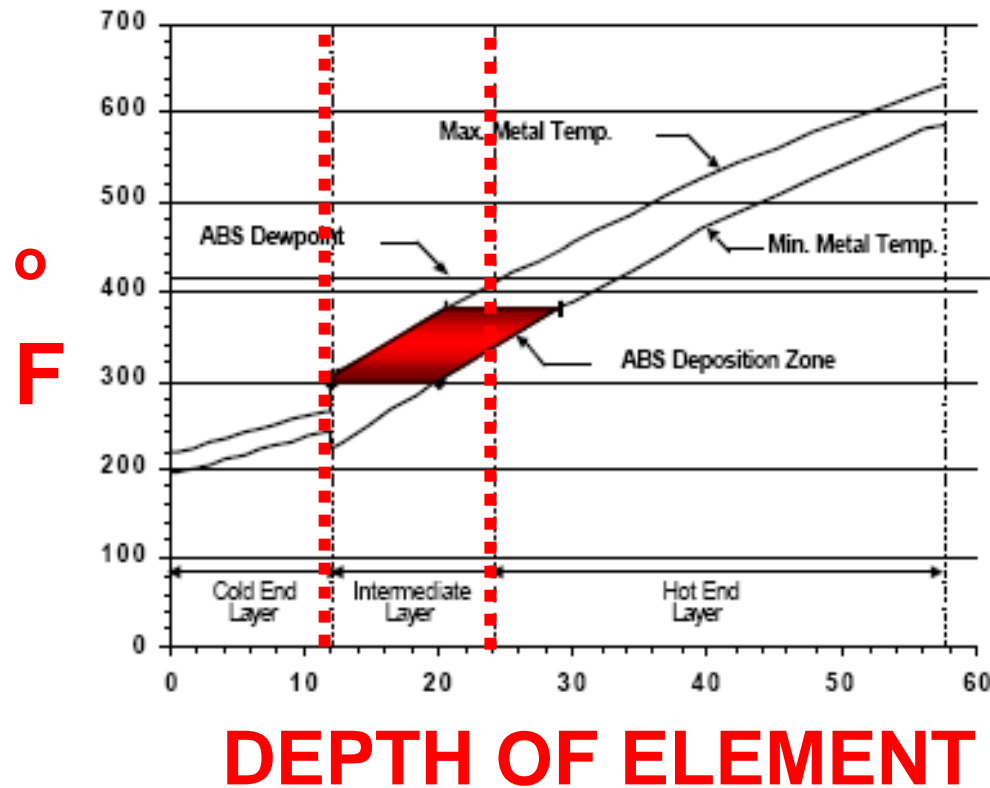
ABS Temperature Zone

ABS

**12
INCHES
TO 30
INCHES**

**300°F
TO 390°F**

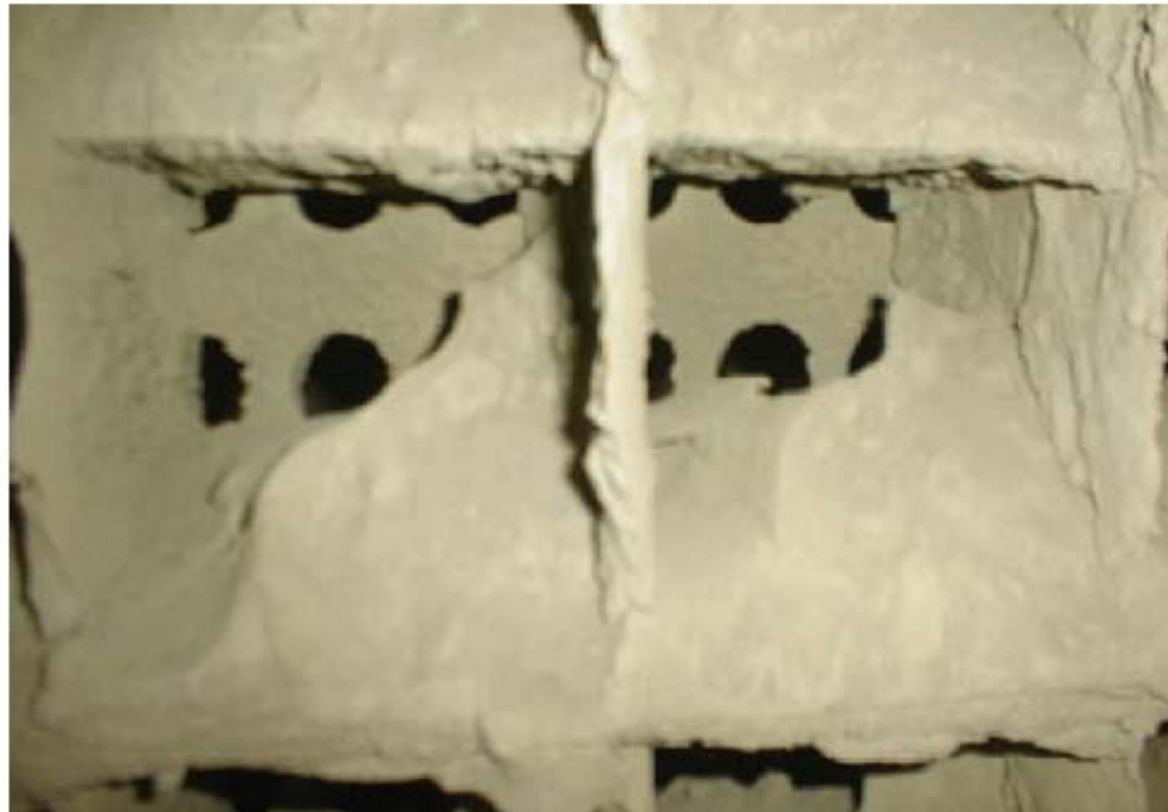
ABS Buildup at Precipitator Inlet

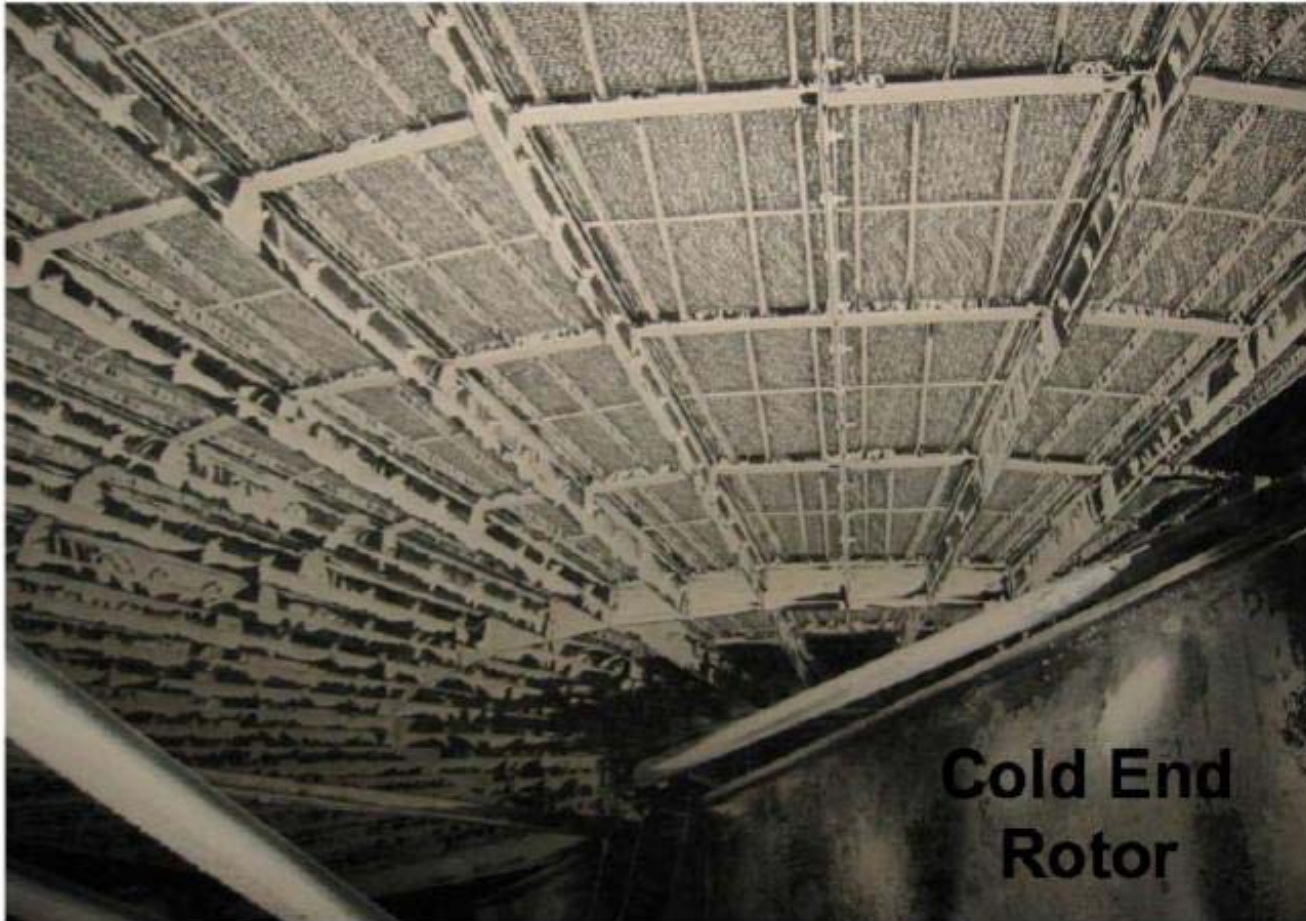
TWO ABS ELEMENT STYLES

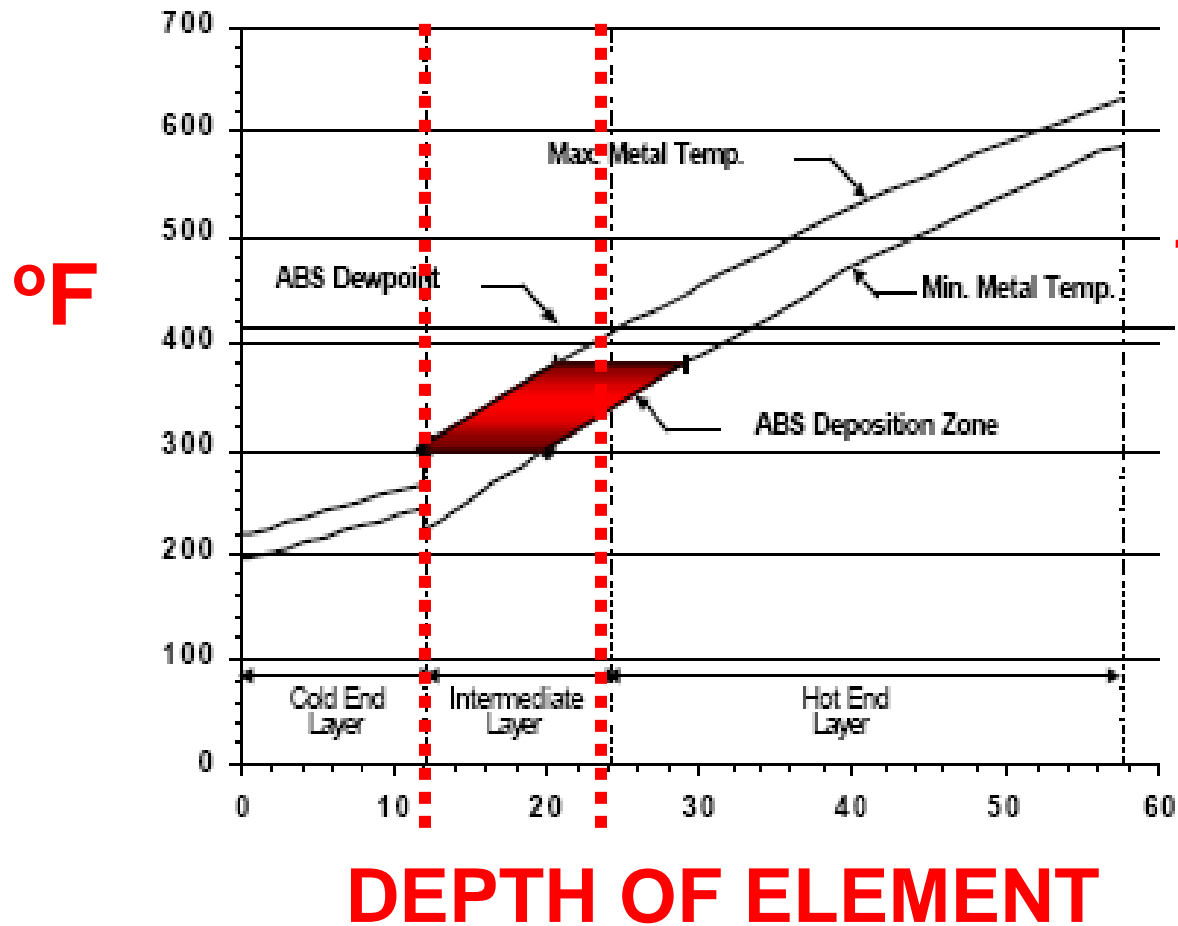
ABS Build-up Zone

ABS
12 INCHES
TO 30
INCHES
390°F TO
300°F

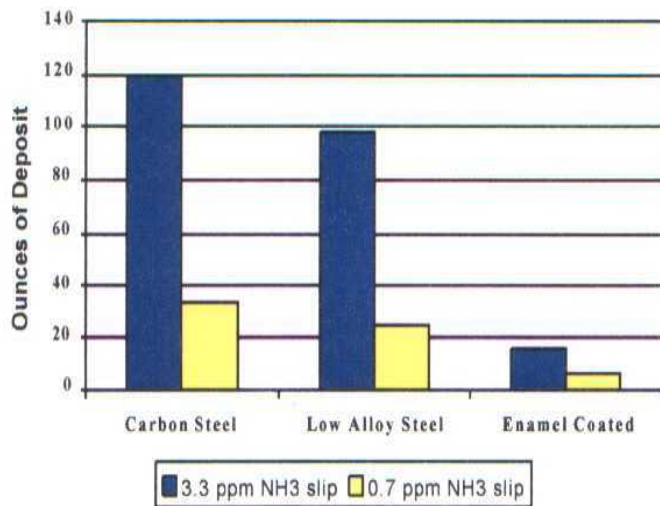
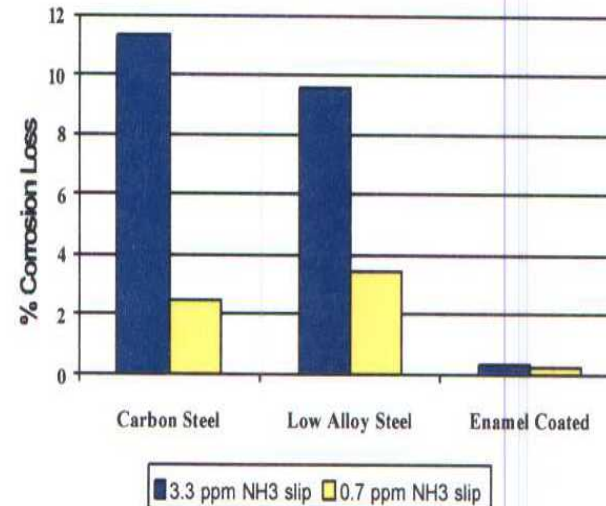
Benefits of Corrosion Resistant and Lubric Coating in the ABS Zone

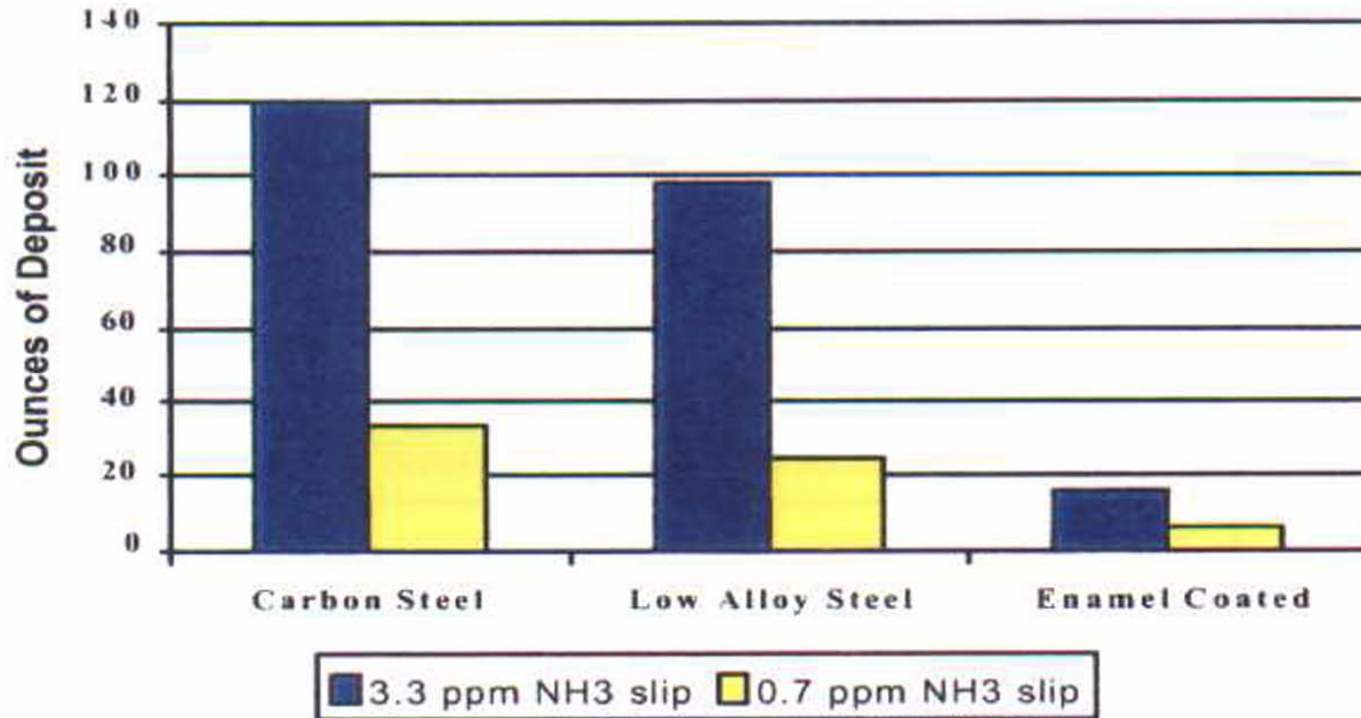
Enamel Coated Element for ABS

RESISTANCE TO ABS BUILDUP

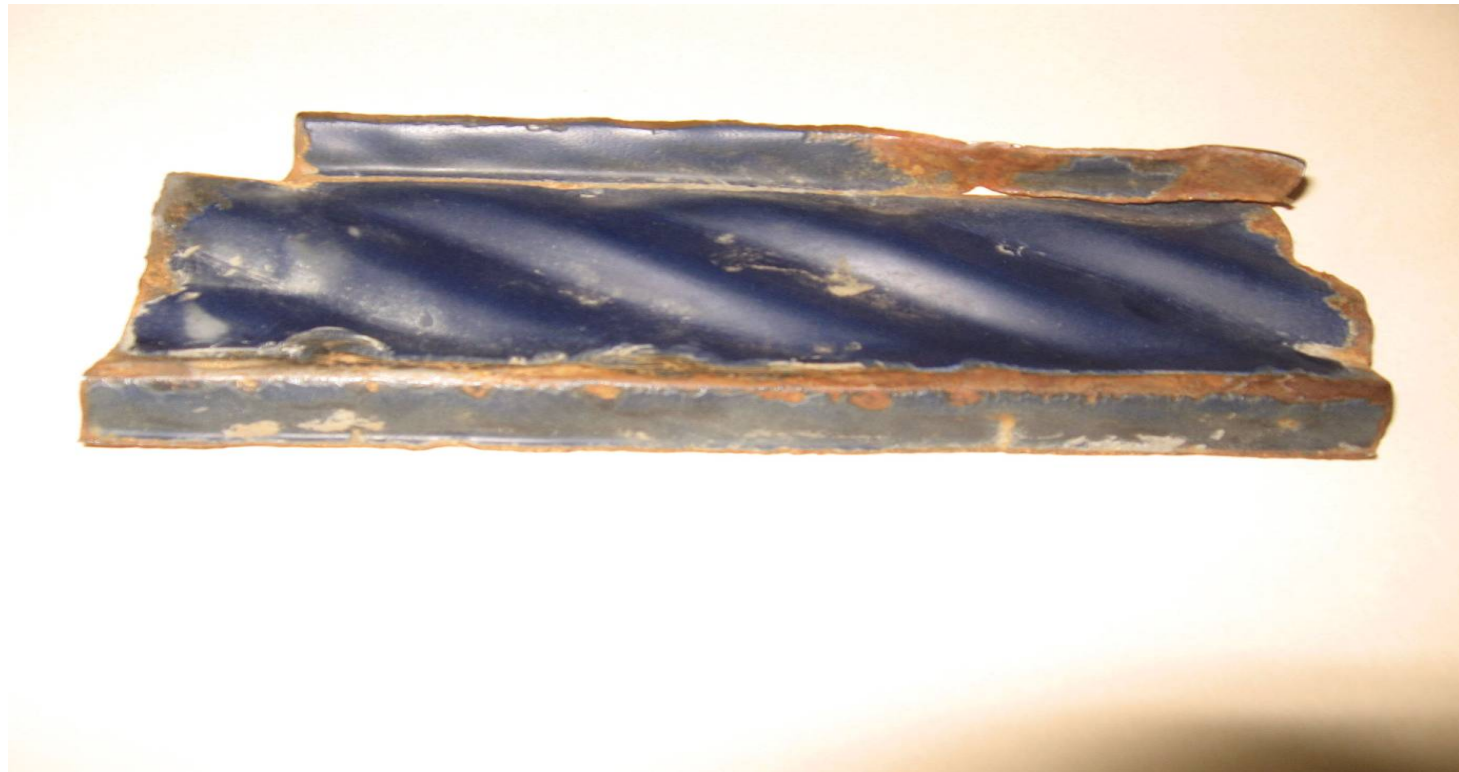
Competitive “NEWER” Coating

ELEMENT CRACKING FAILURES MOST LIKELY DUE TO
CORROSION UNDERMINING THE COATING AND
NON-DUCTILE METAL SUBSTRATE FATIGUE FAILURES

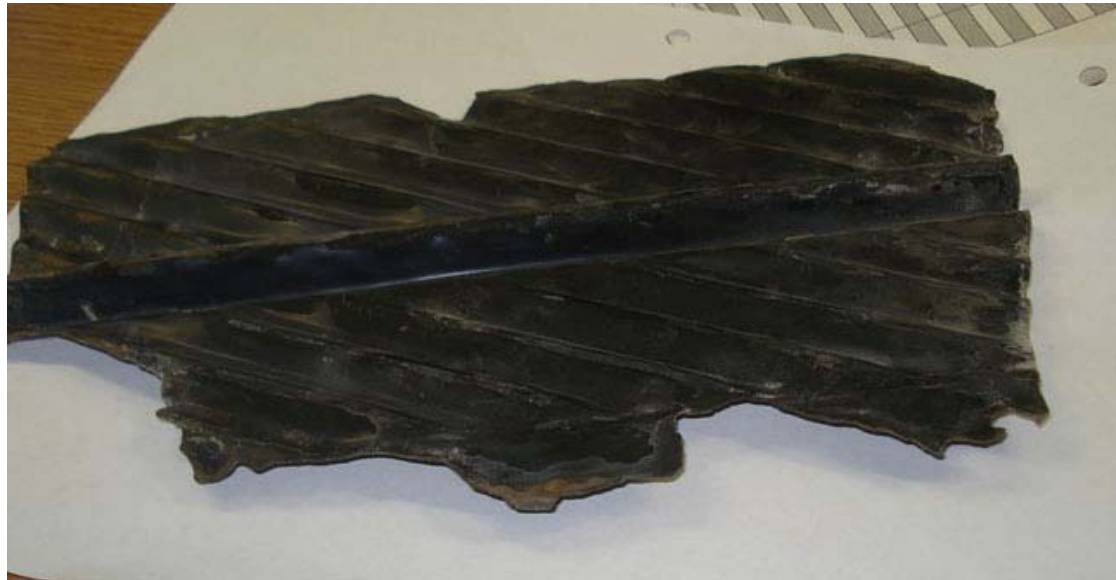
Failed Coated Element Showing Substrate Failure

THE USE OF A FORMABLE CORROSION RESISTANT
SUBSTRATE IS CRITICAL TO SUCCESS

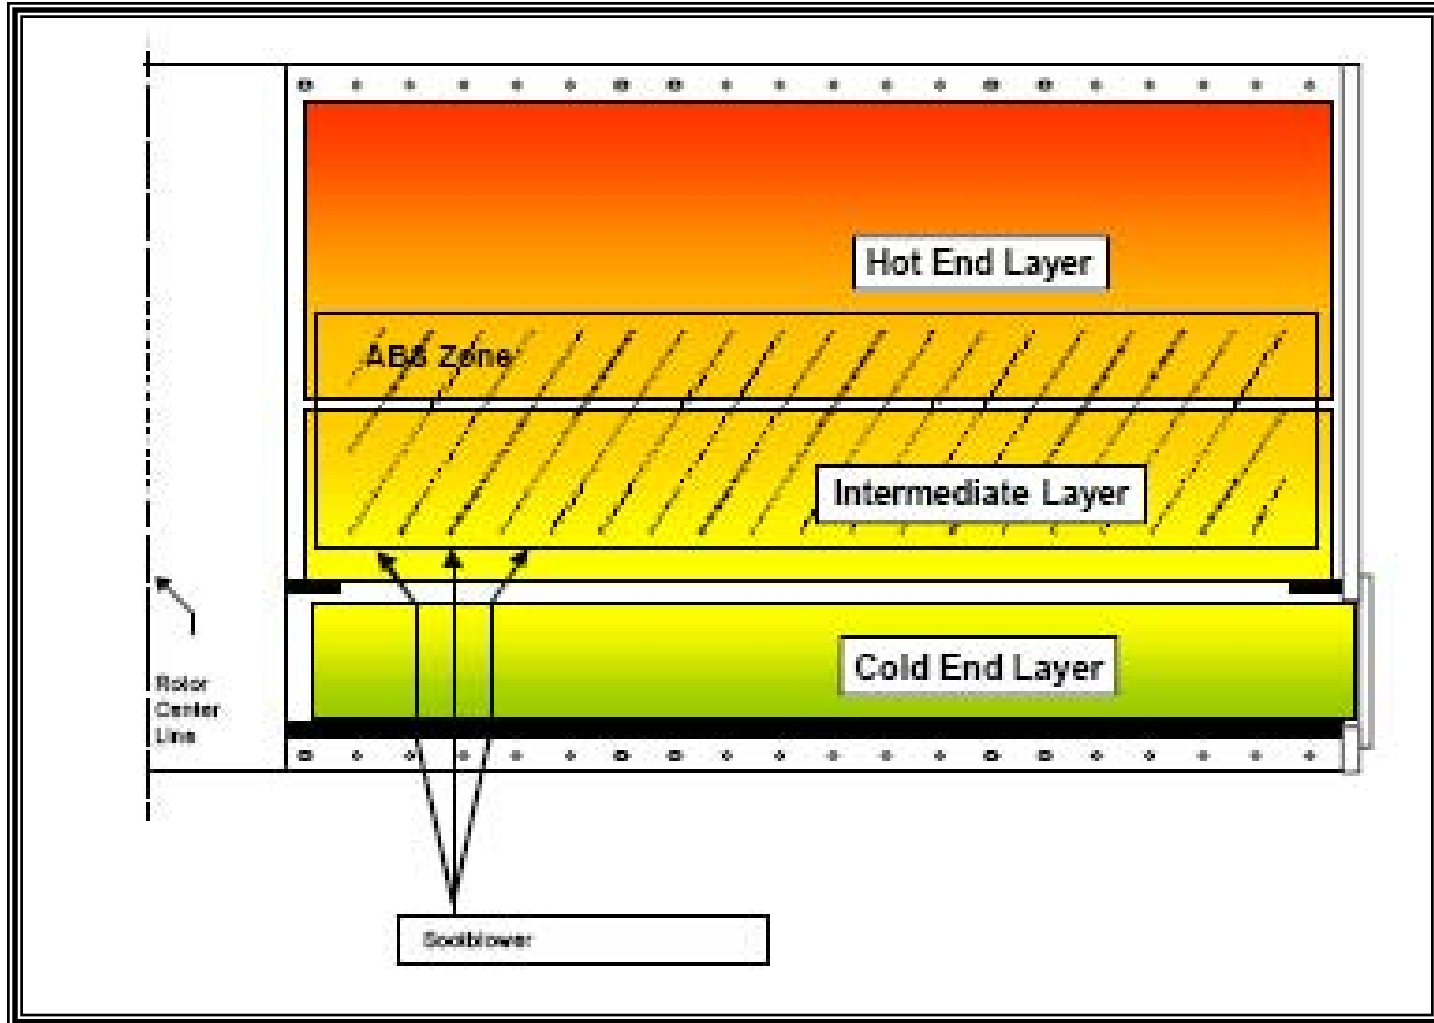
ABS Build-up Zone in Traditional Airheater Layers

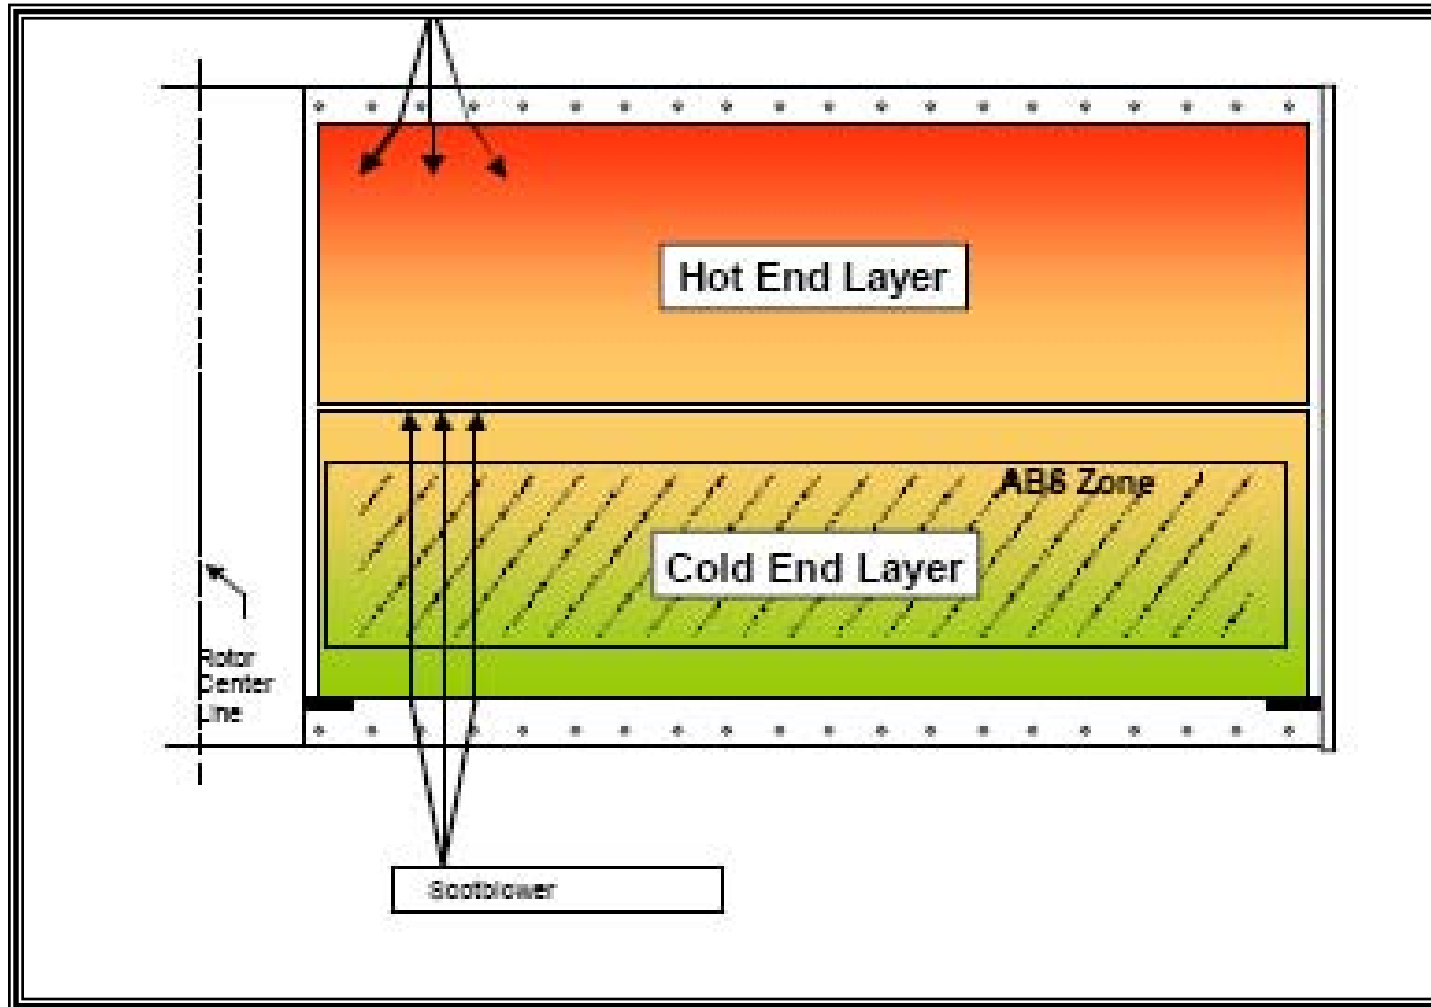
ABS Build-up Zone in Two Layer Airheater Modifications

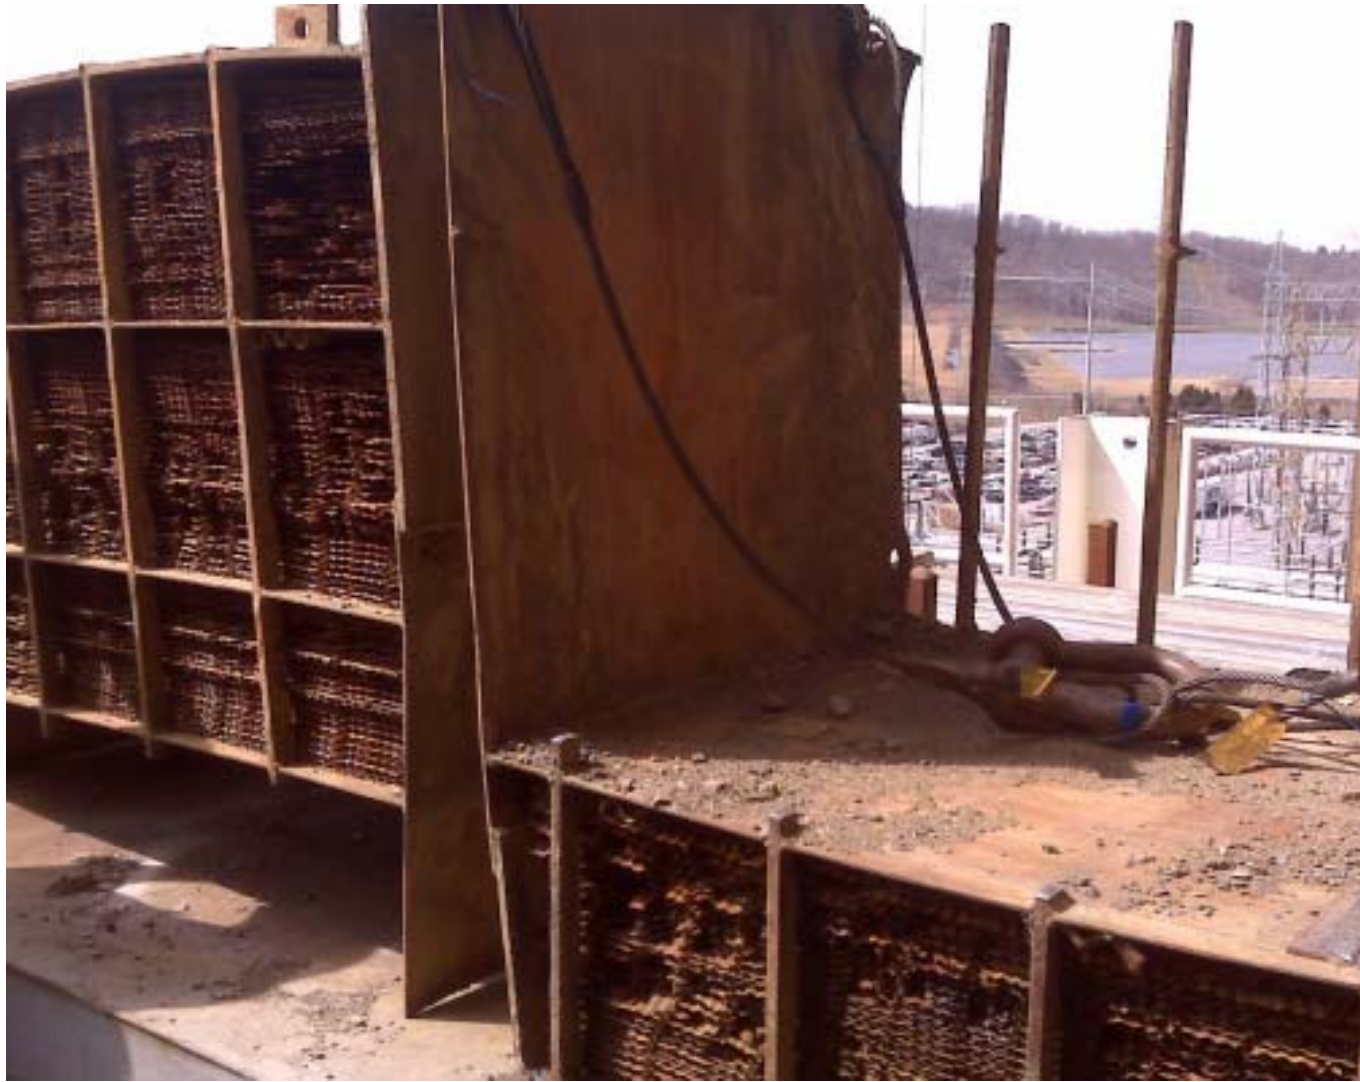
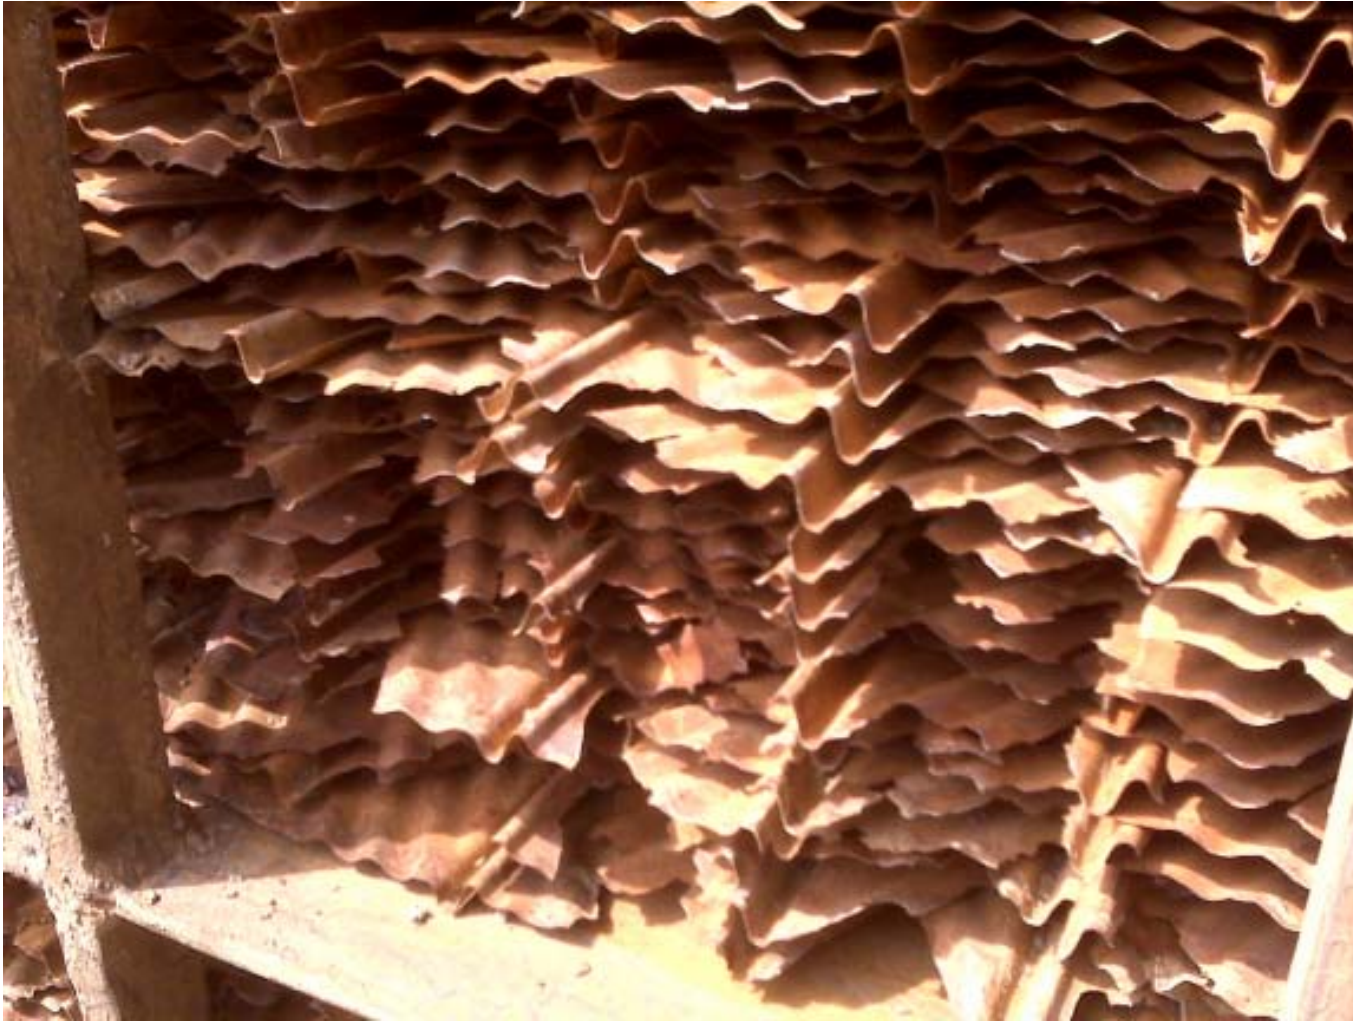
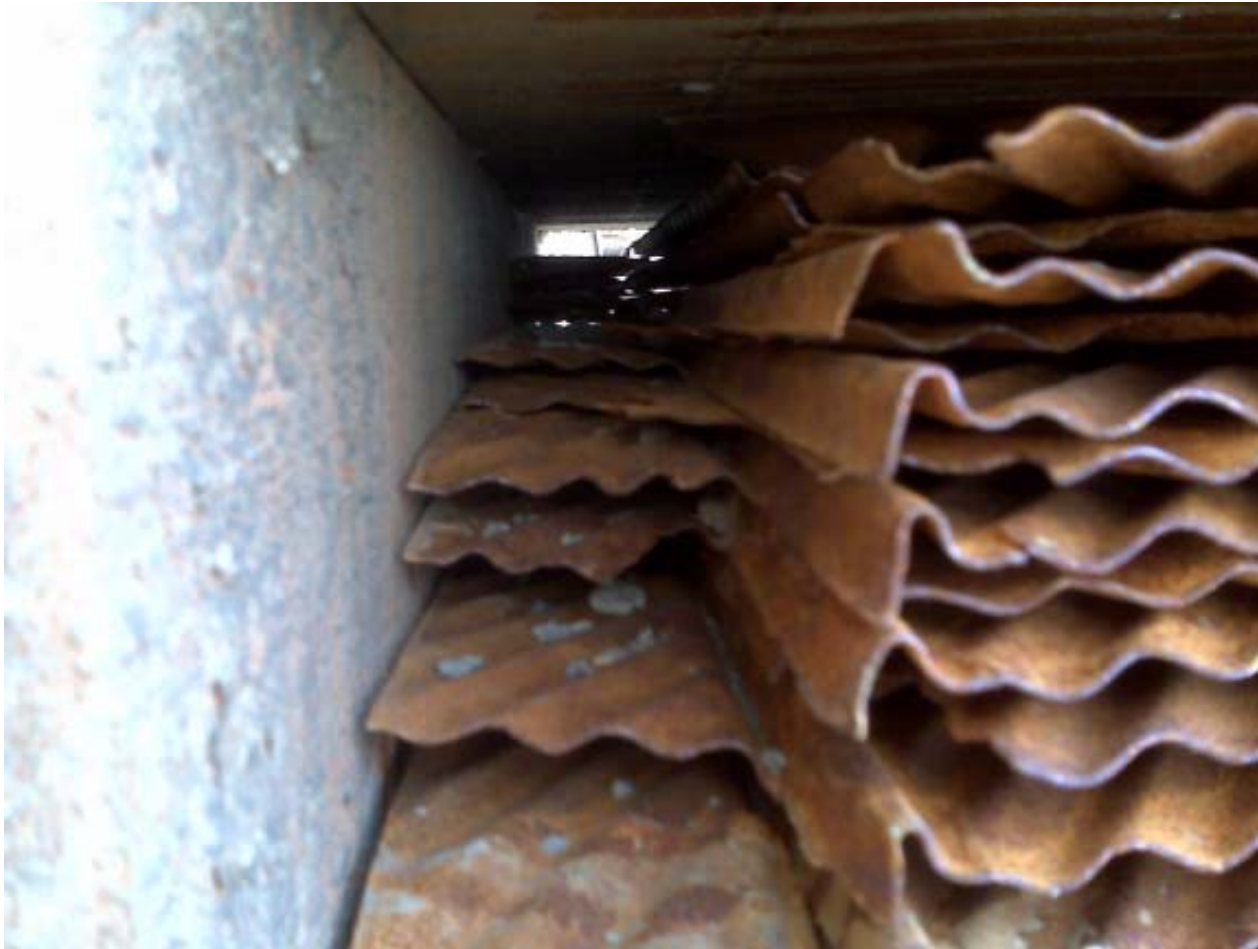
TWO LAYER COLD END DAMAGE

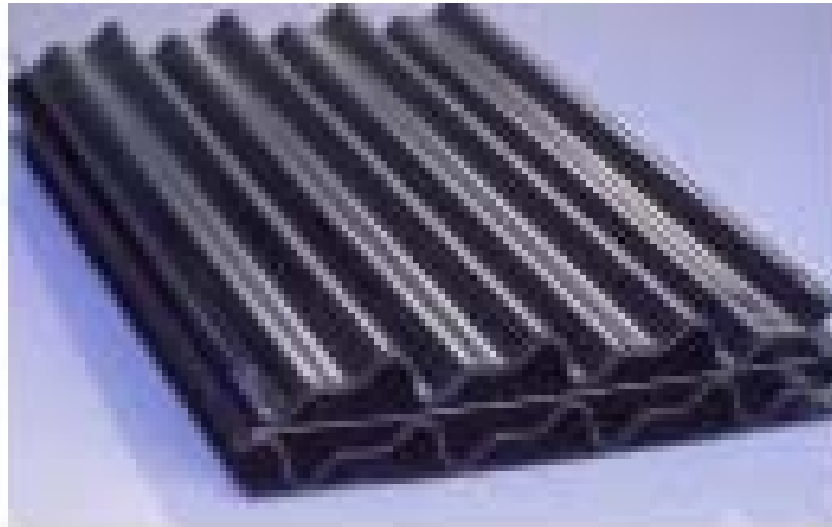
STANDARD

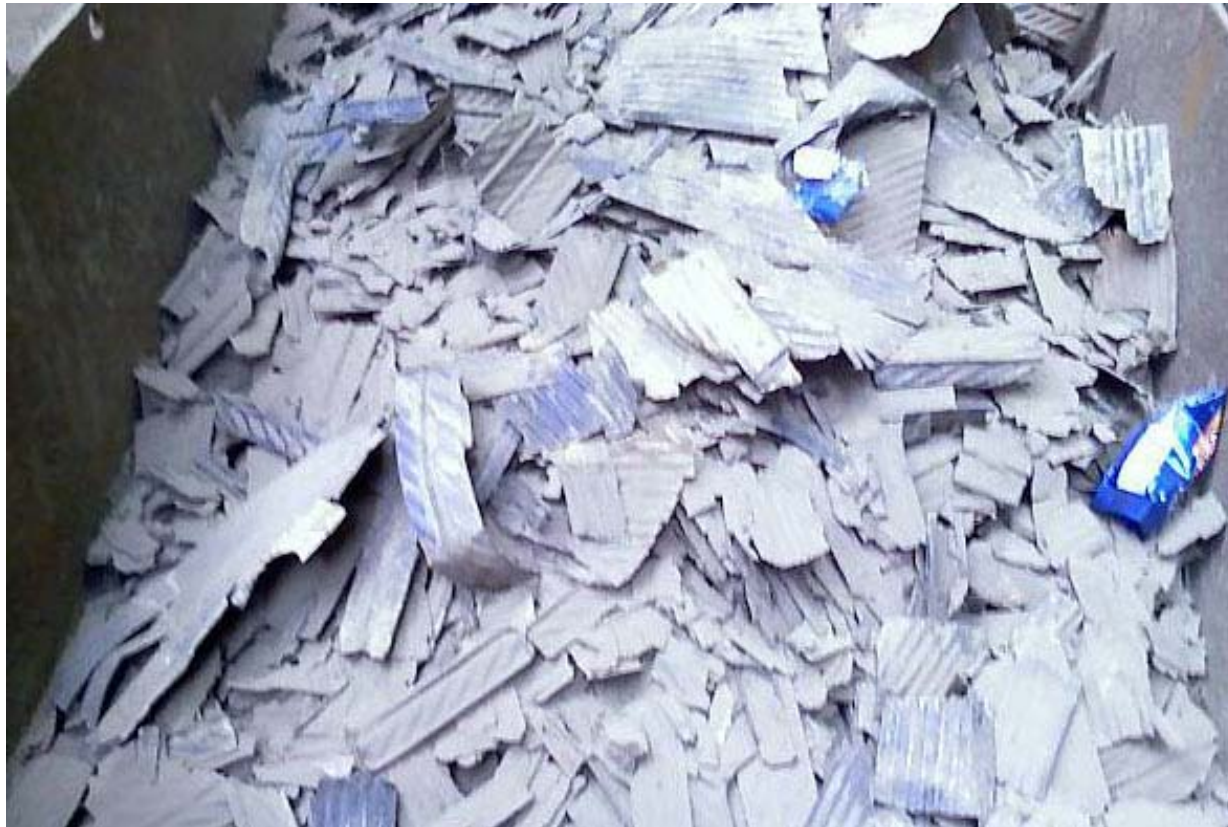
Failed Coated Element Sheets with Substrate Failure Station

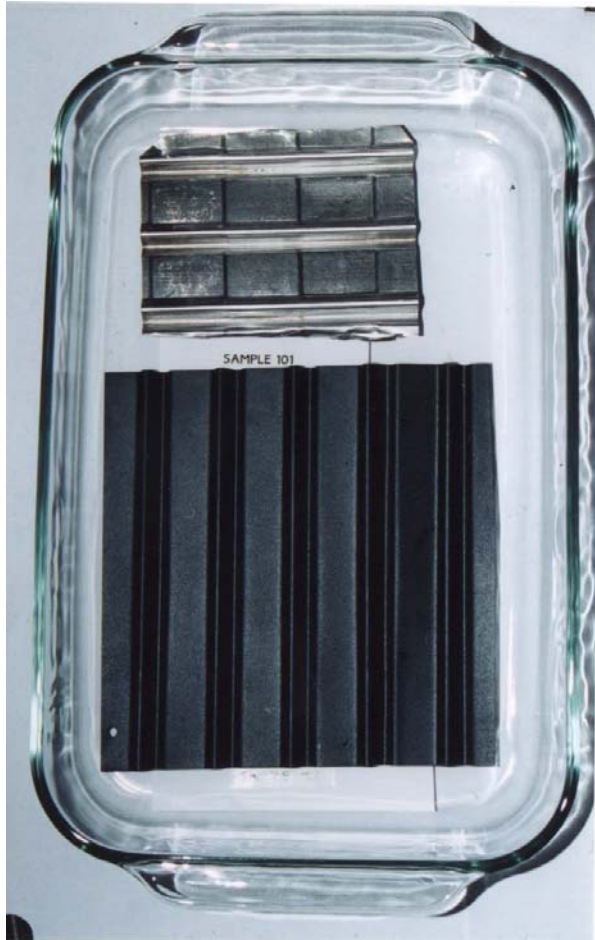
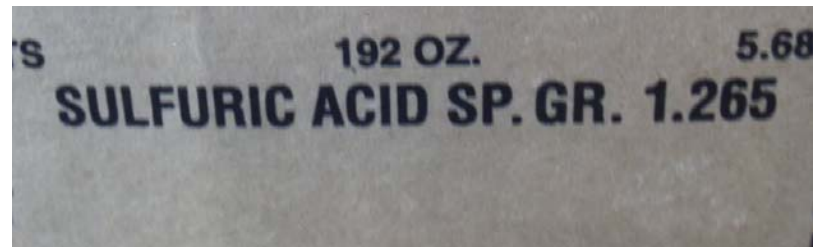
Start of Corrosion Test

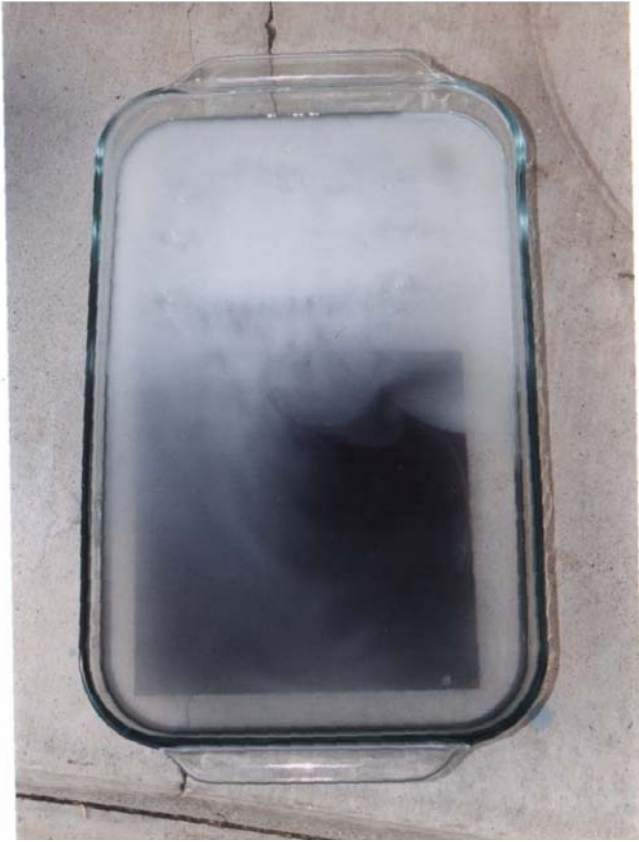
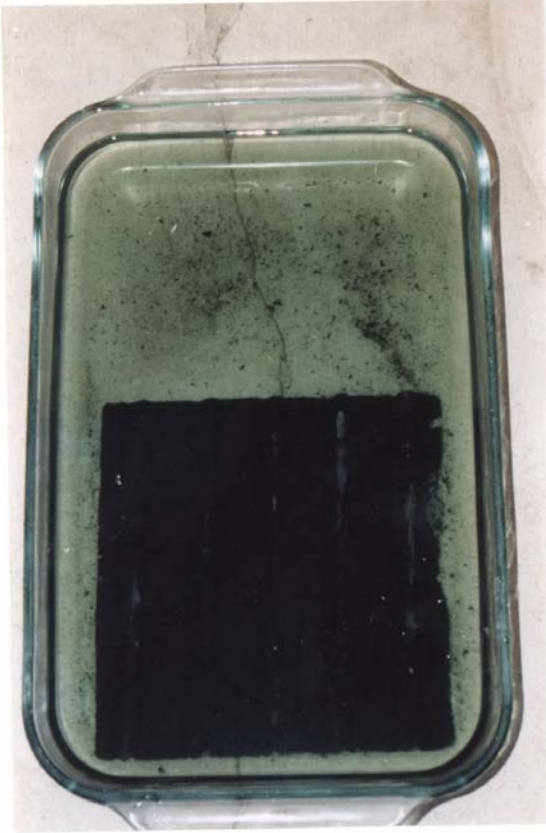
Coating Acid Test

2 HOURS

4 DAYS

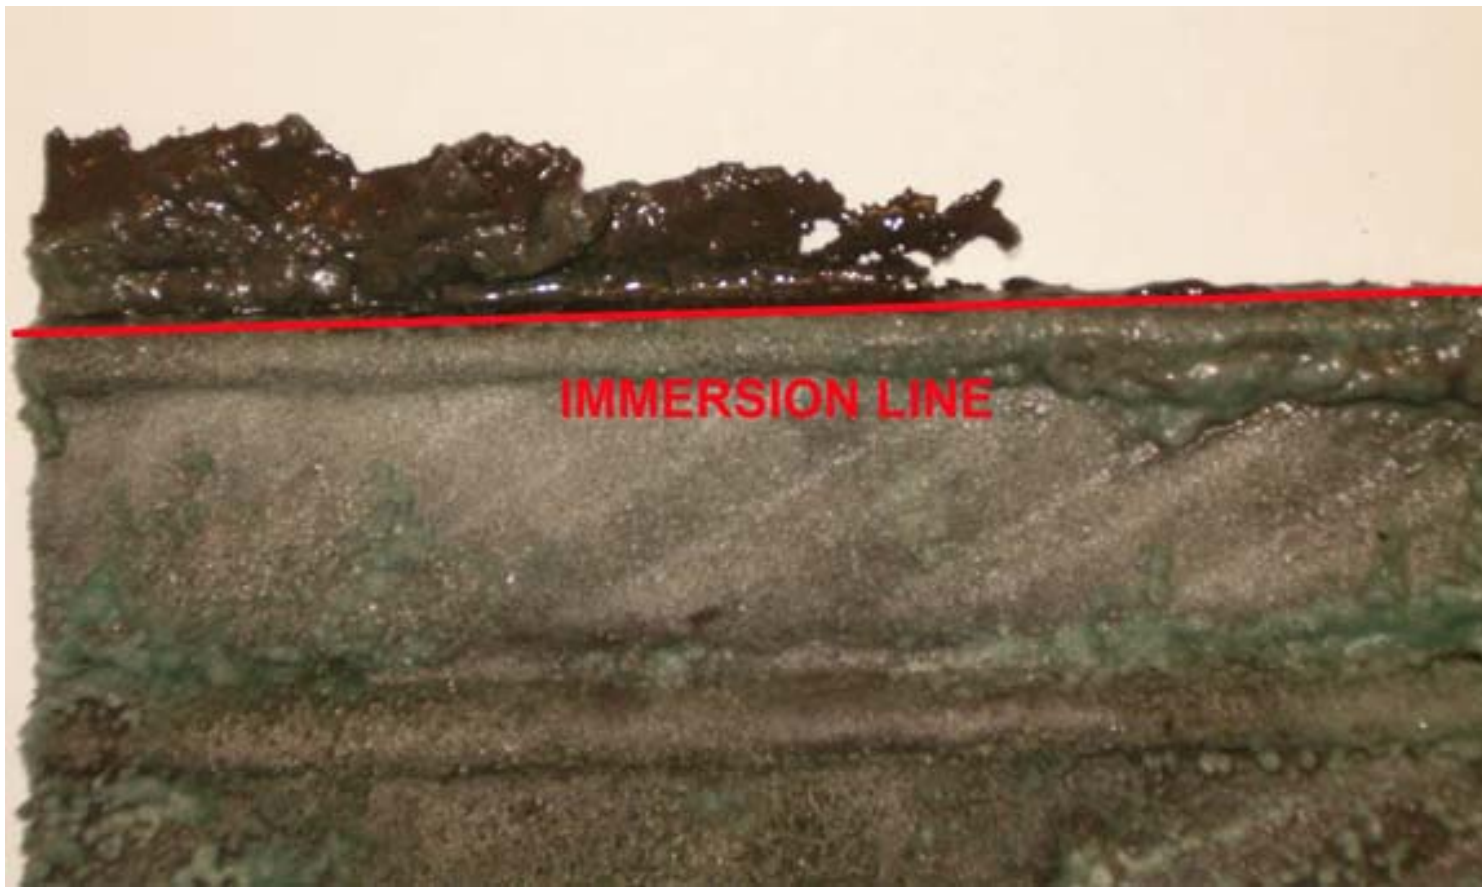
Uncoated Corrosion Resistant Alloy Steel in 30% Sulfuric Acid After 30 Days

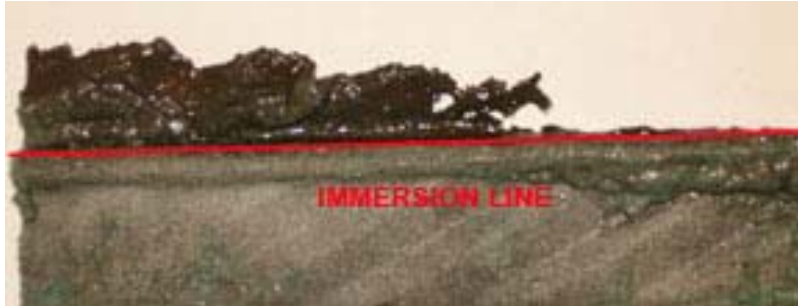
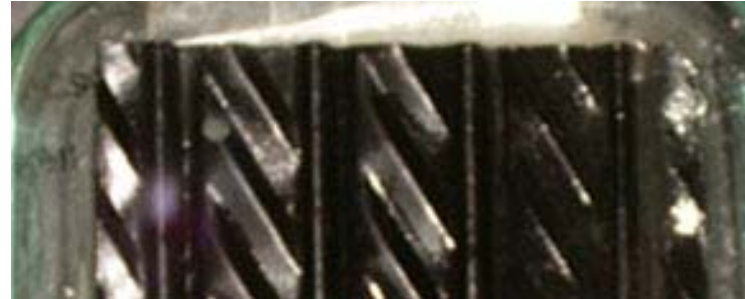
30 Day Cold Acid Test

UNCOATED LACR

PARAGON COATING

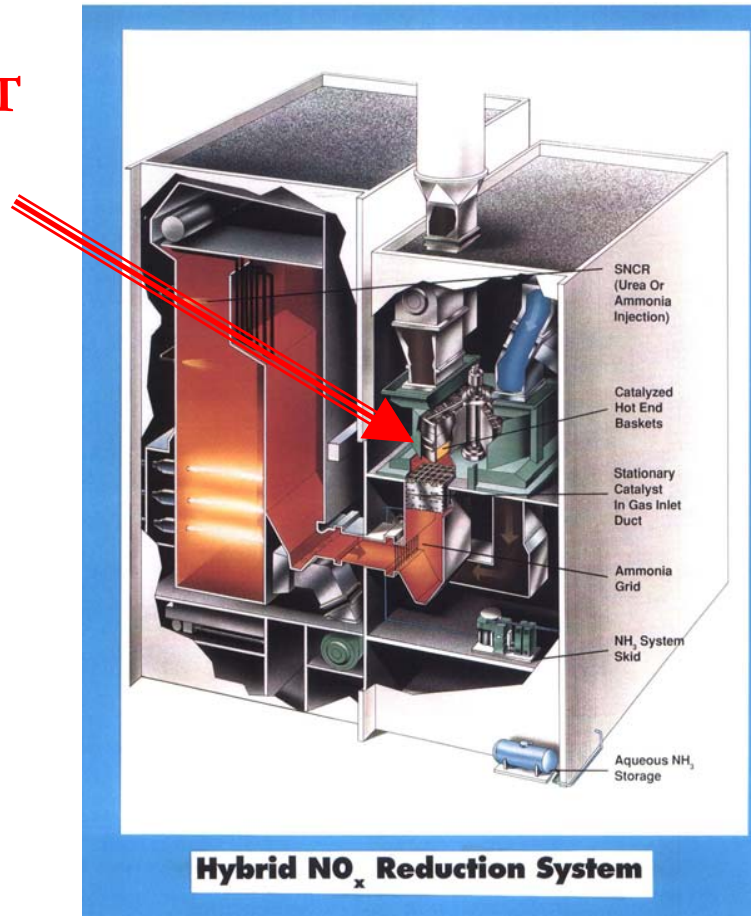
Catalytic Air Heater

**CATALYST
LAYER**
