Reinhold Environmental Ltd.

2008 APC Round Table
& Expo Presentation

July 13-15, 2008, in Savannah, GA

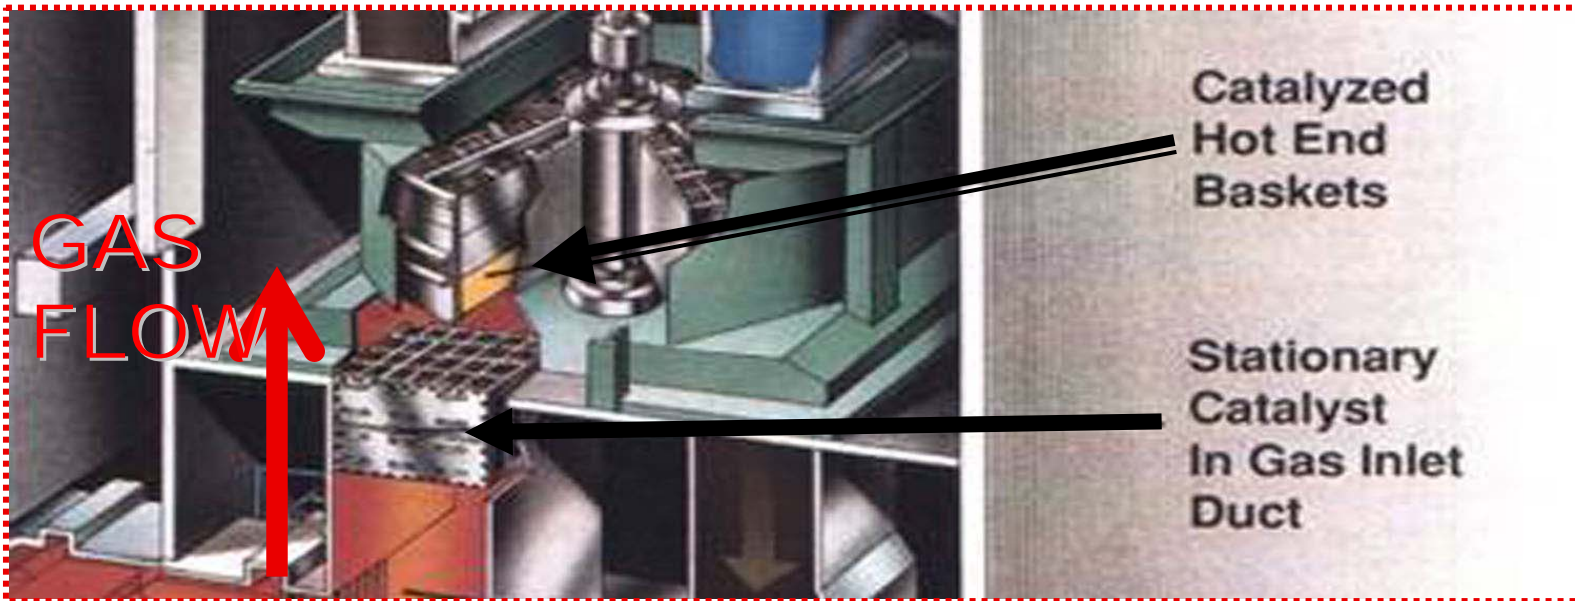
Catalyst in Airheaters
