TENNESSEE VALLEY AUTHORITY

Protecting Scrubber Internals

2008 APC/PCUG Conference

PARADISE UNITS 1&2
OUTLET DUCTS
Materials of Construction
Conversion to no Reheat

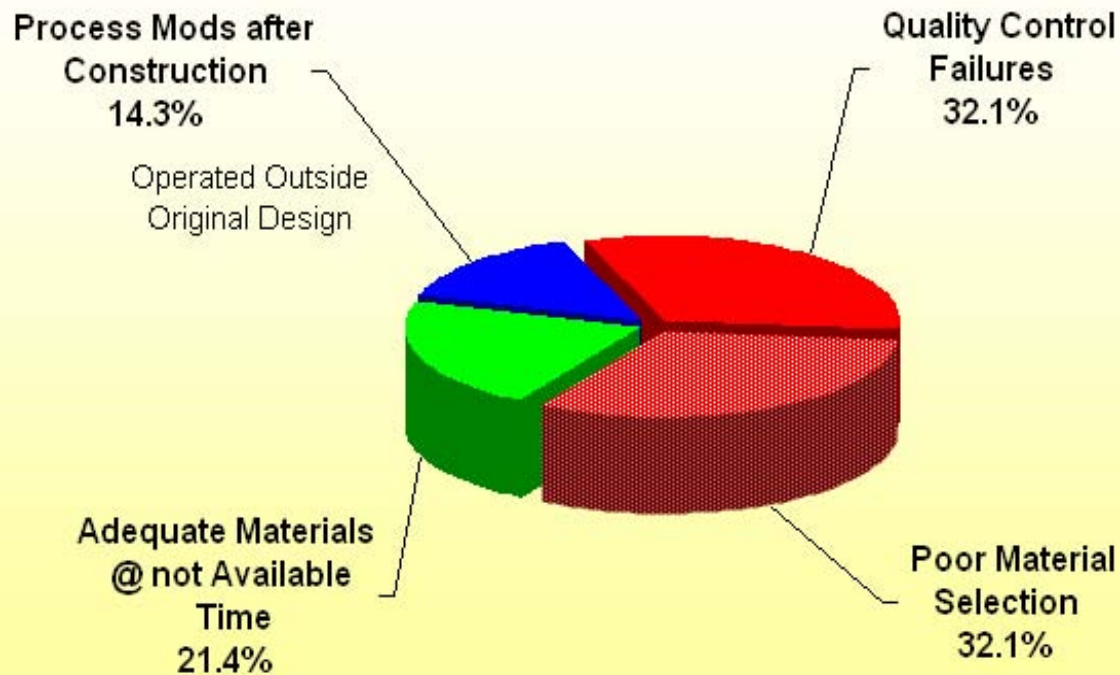
64% of FGD System Material Failures are due to premature failure of material of construction

Causes of FGD Material Failures,
1982 - 1993

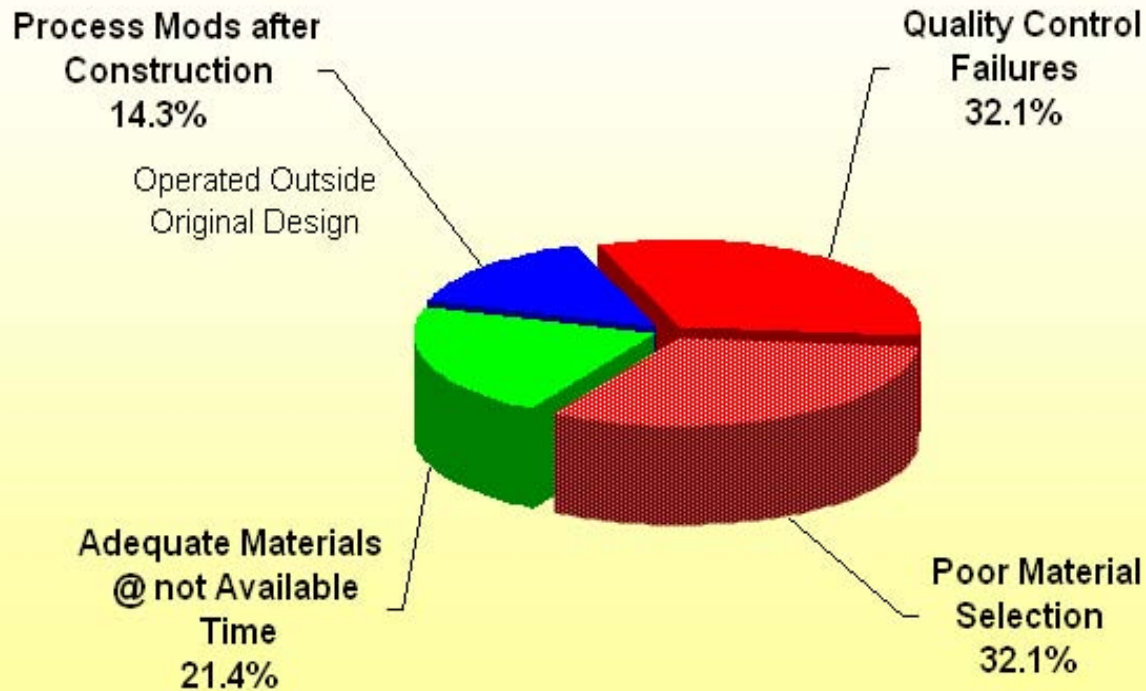
**Causes of FGD Material Failures,
1982 - 1993**

Quality Control Failures

- Design modifications not followed
- Poor QC of raw material
- Poor QC during installation

Poor Material Selection

- Material Specs written contrary to known conservative practices

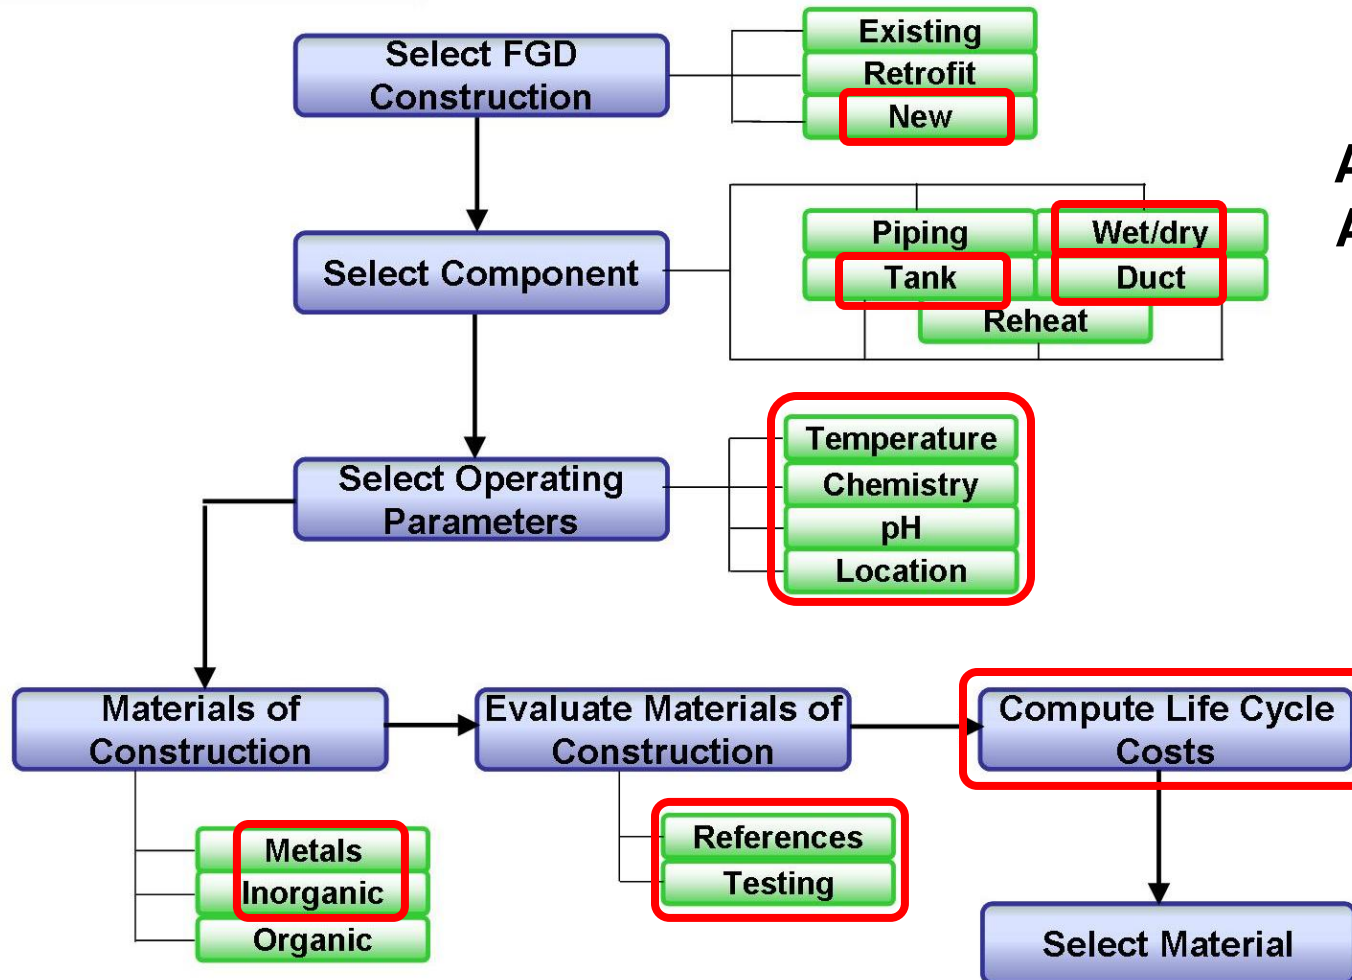
Decision Logic

Advatech
Absorber
Vessel
Module

Alloy

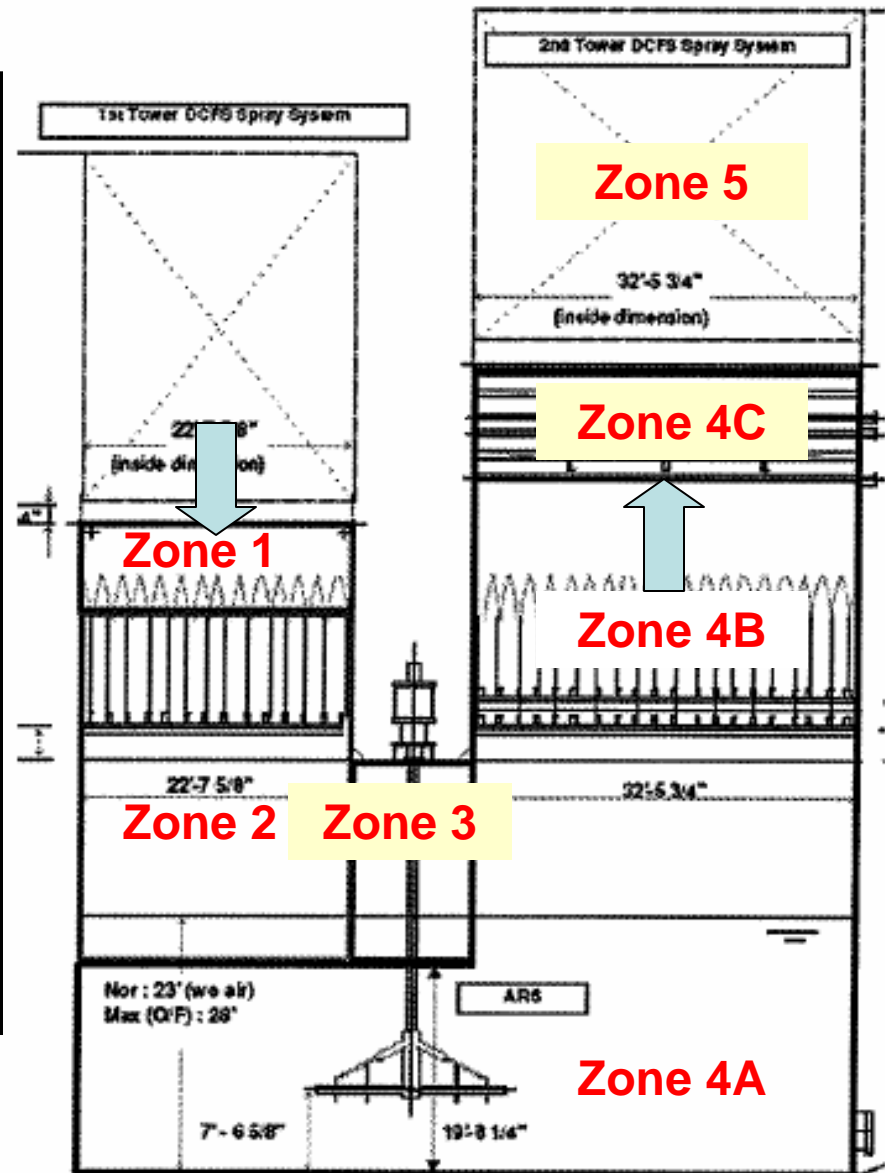
4. Kingston Absorber Vessel Alloy Selection (typical of all new FGDs)

Area	Location	Corrosion	Erosion
1	Wet/Dry	Very Severe	Mild
2	1 st Tower Spray Contact	Moderate	Moderate
3	Crossover	High	Mild
4A	Recycle Tank	Low	Low
4B	2 nd Tower Spray Contact	Low	Moderate
4C	Mist Eliminator	Low/ Moderate	None
5	Outlet Transition	Low/ Moderate	None
6	Outlet Ductwork	Low/ Moderate	None

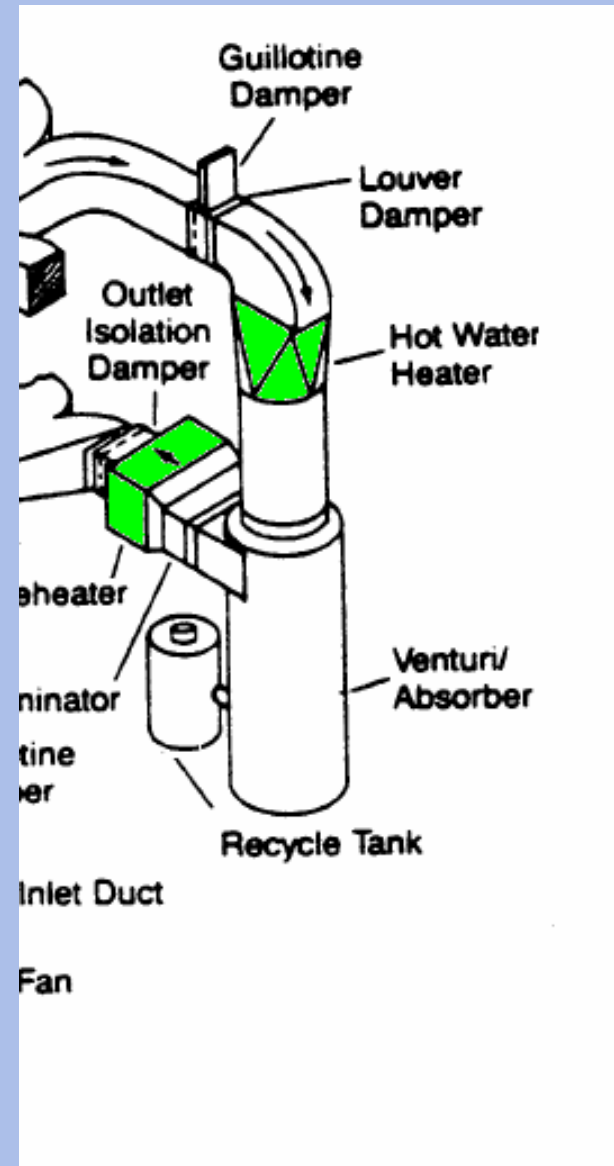
Paradise Units 1&2 Original Reheat Design

- **Designed** to heat FGD saturated outlet gas to 170°F
- Closed loop boiler quality H₂O recycled system.
- **FGD Inlet** – Flue gas cooled and H₂O located in reheat coils is heated.
- **FGD Outlet** - Heated H₂O in the reheat coils transfers the heat to the scrubber outlet flue gas.

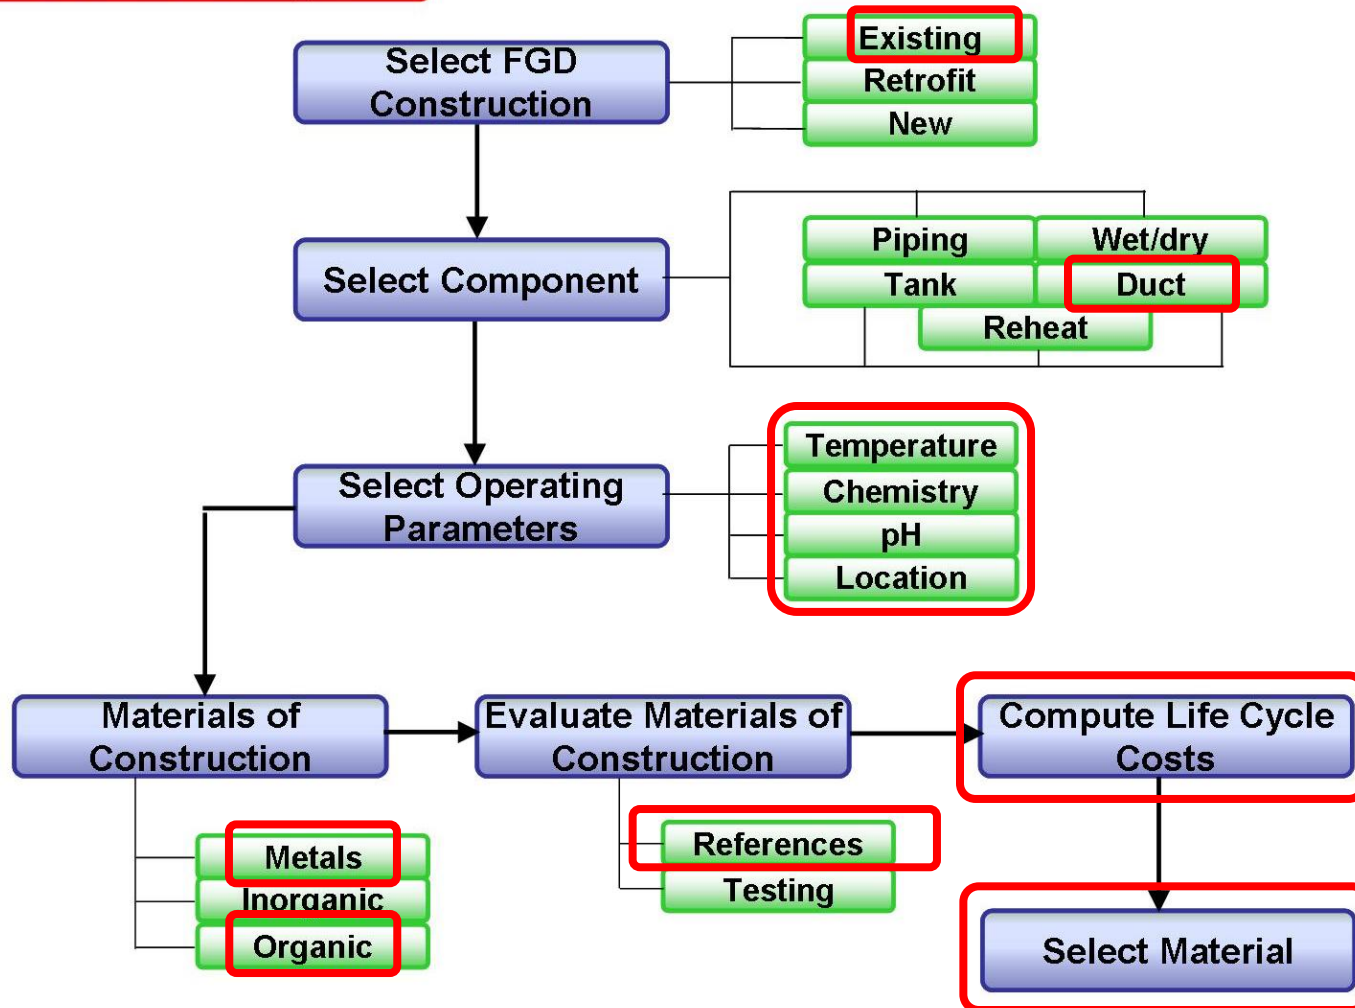
#2 Existing - 2007/2008

Decision Logic

2006/2007
Relined the
317L
cladded
duct with
Vinyl Ester
Resin (VER)

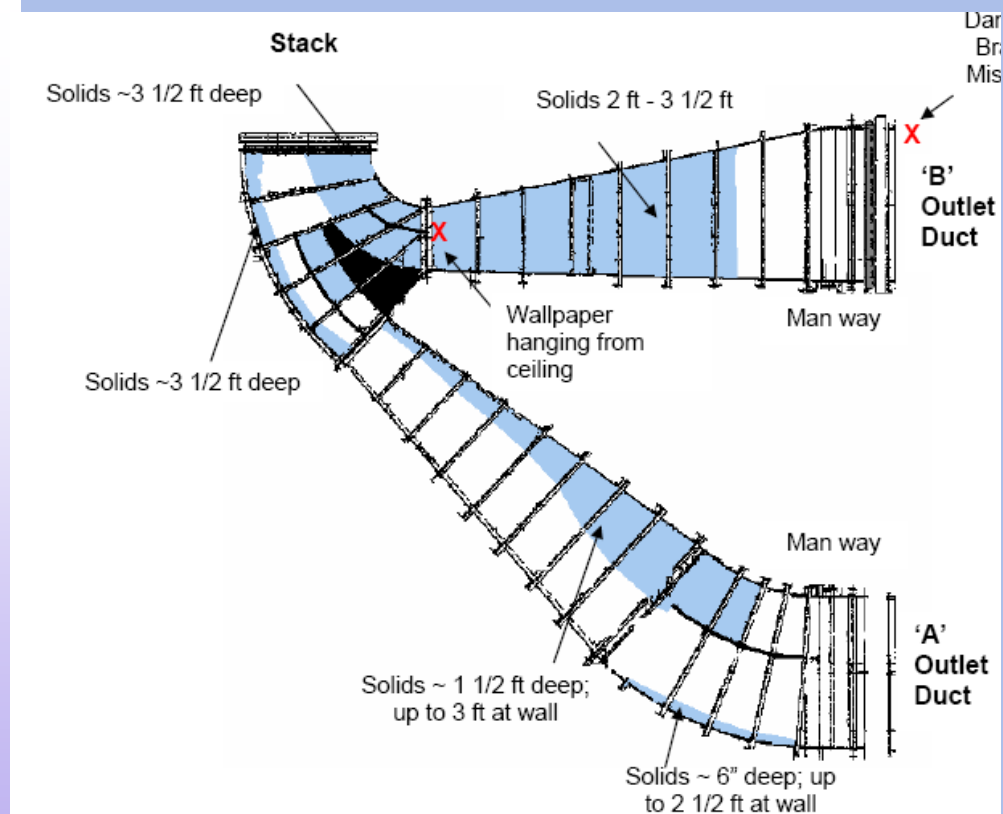
Fall 2007 – Unit 1 Outlet Duct Relined with Ceilcote 140 VER

1. Previous MEs allowed solids build up on floor approximately 3.5 ft deep, up to 6 ft deep in some areas. In addition, walls, turning vanes, structural supports, liquid collectors, expansion joints and drains covered with buildup

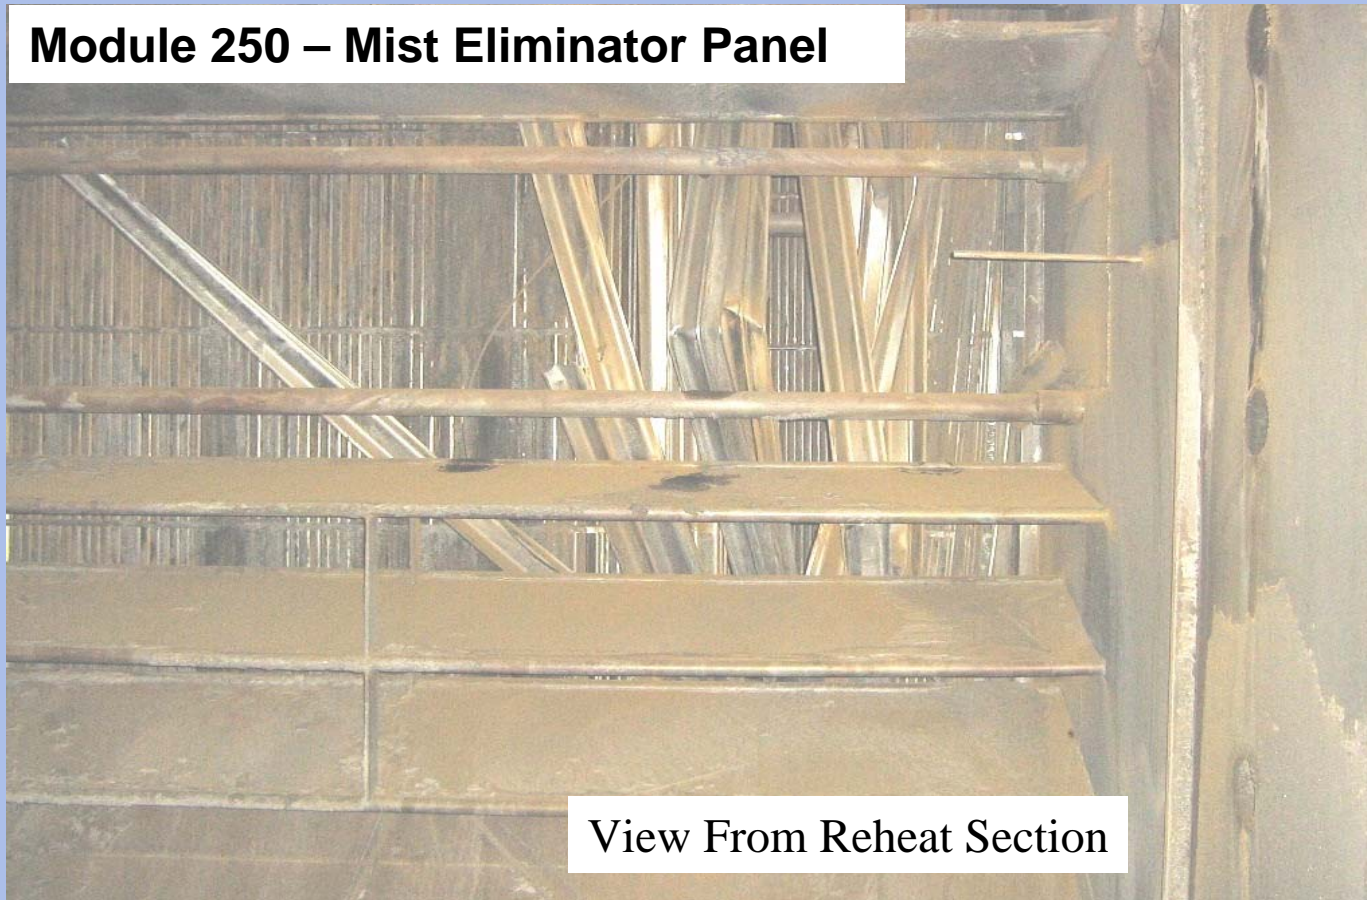
Module 250 – Mist Eliminator Panel

Poorly working mist eliminators caused heavy buildup in outlet ducts
(mist eliminators had been replaced in 2006 and wash system upgraded).

View From Reheat Section

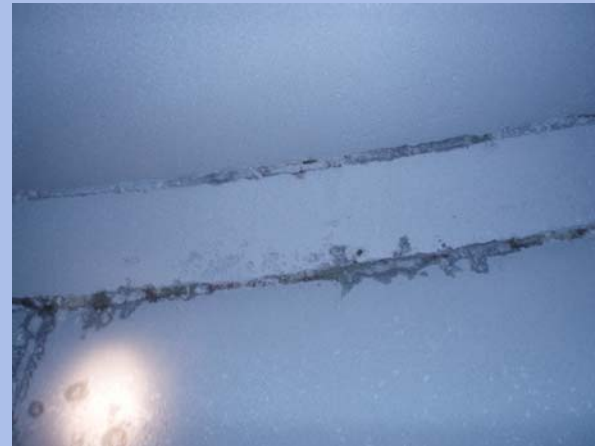
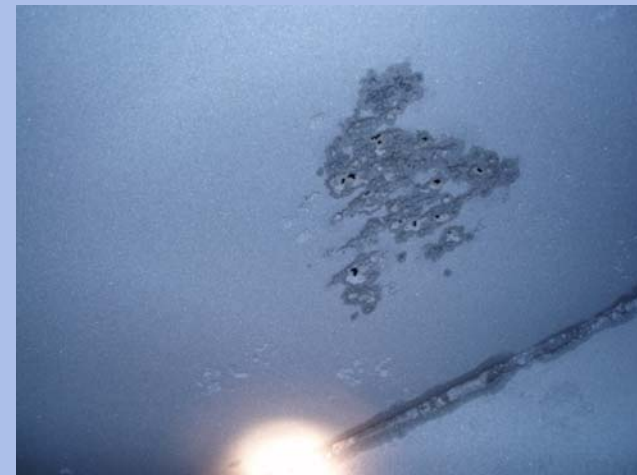
2. **Used high pressured water to remove solids.**

Water entered the area between the 317L liners and the carbon steel. It then permeated the stainless liner at the plug welds and weld seams. This contaminated the welds and the areas adjacent to the welds. In some areas solids precipitated out on the welds.

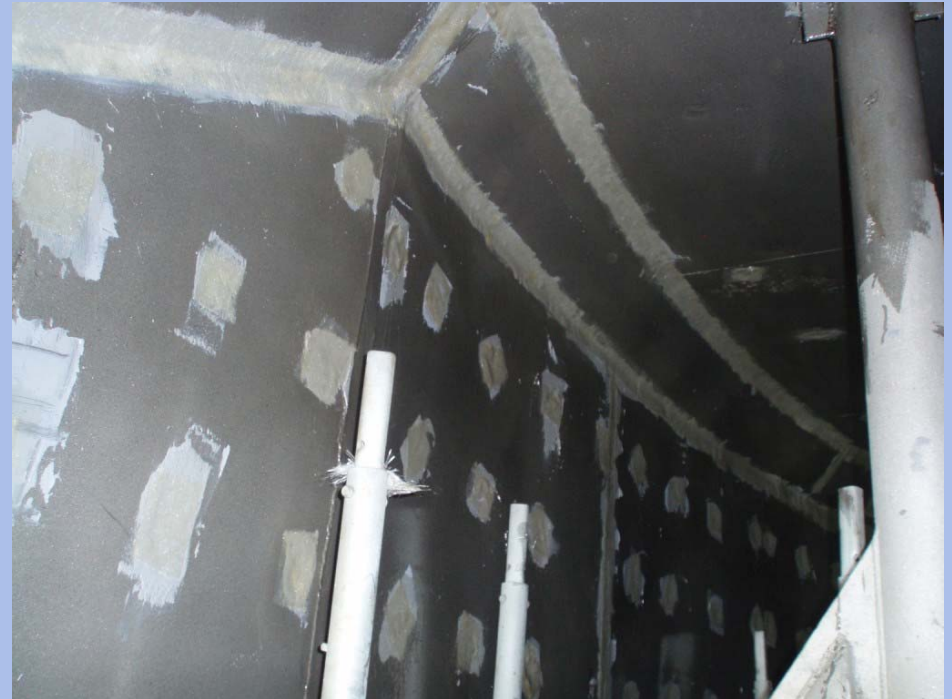
- Had to allow time for the duct to dry out. Drafting through the stack and sandblasting helped assist with drying out.
- Striping the welds was not sufficient to clean the area prior to application and patches were placed over some welds to protect the lining system from the solids.

3. Plug welds and weld seams that attached the 317L to the carbon substrate, were covered with glass mat patches. The patches were placed over the welds for several reasons. The additional patches slowed production and increased costs.
 - 1. Glass mat over holes in 317L liner greater than a certain diameter.
 - 2. Provide additional structural support where needed.
 - 3. Matt over plug welds and weld seams that were precipitating moisture and solids.
 - 4. Ensure applicator passed holiday test.
