## **2016 APC-Wastewater Round Table & Expo Presentation**

July 18 & 19, 2016 in Dearborn, MI / Hosted by DTE Energy

**Case Studies: DSI and ACI System Retrofits for Improved  
Reliability and Performance**

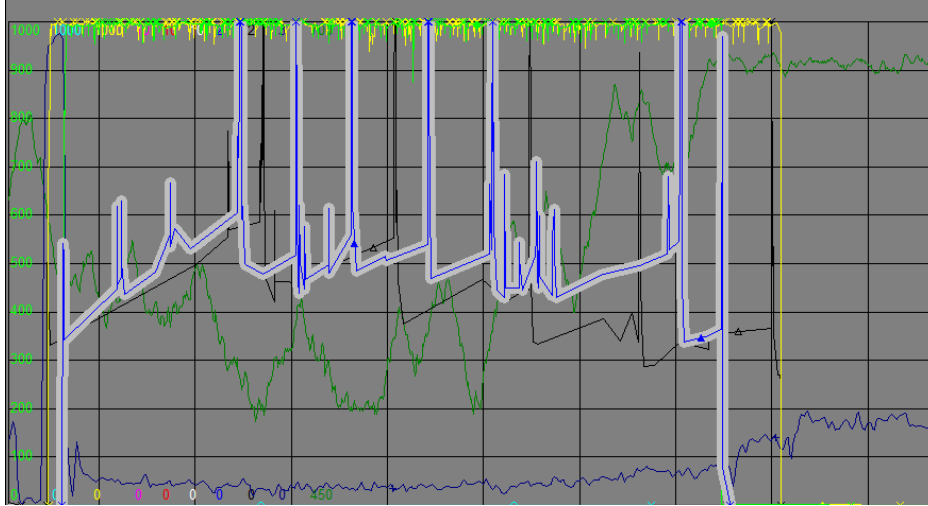
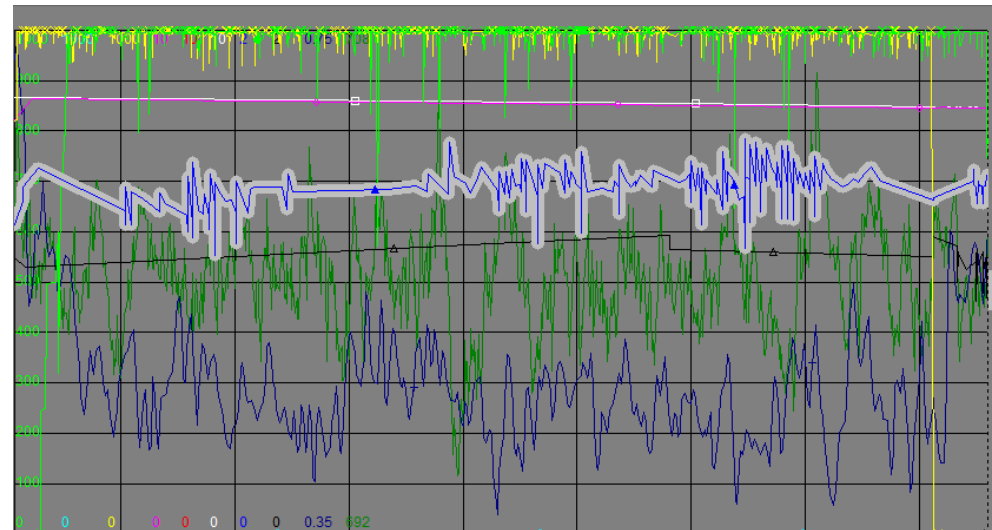
# Pneumatics

- Original
  - 1000 lb/hr
  - Spiking causing shutdown

- New
  - 1000 lb/hr
  - Steady operation
    - 8 hours shown

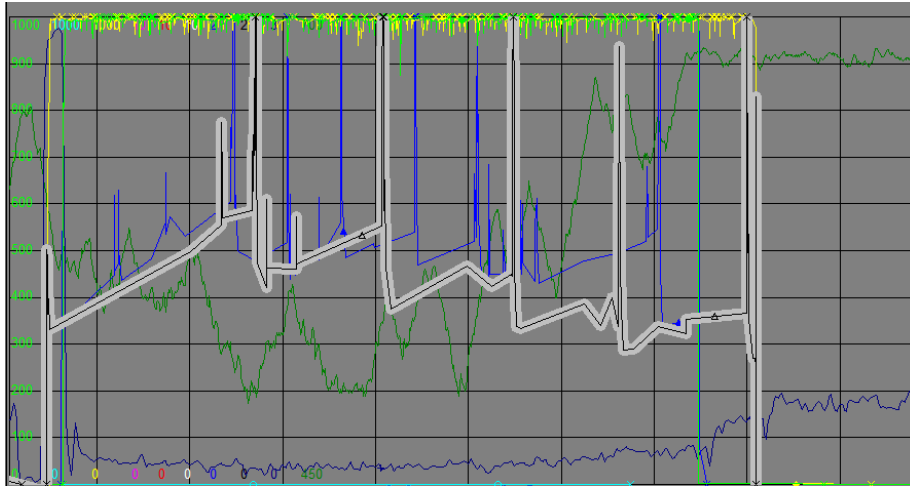
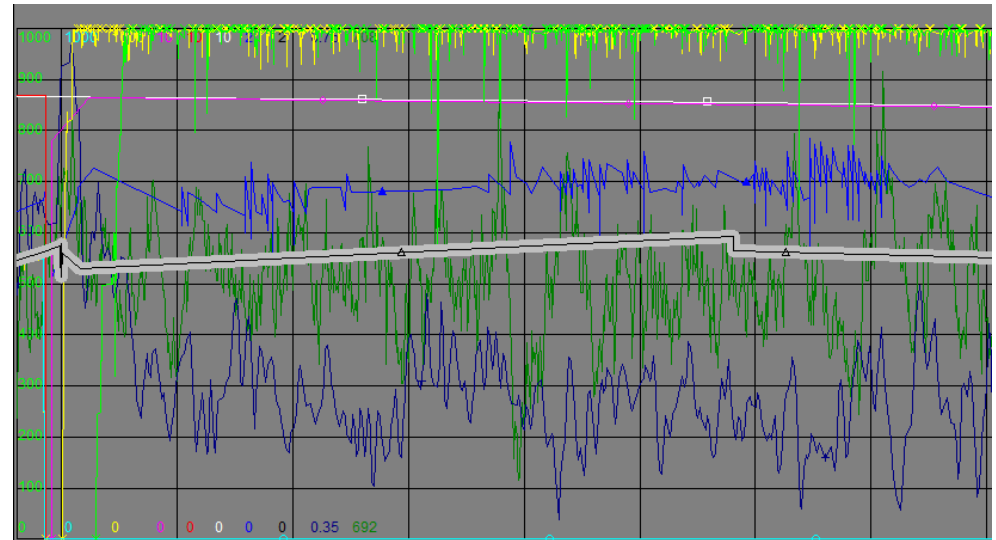
# Pneumatics

- Original
  - 1000 lb/hr
  - Spiking causing shutdown

- New
  - 1000 lb/hr
  - Steady operation
    - 8 hours shown

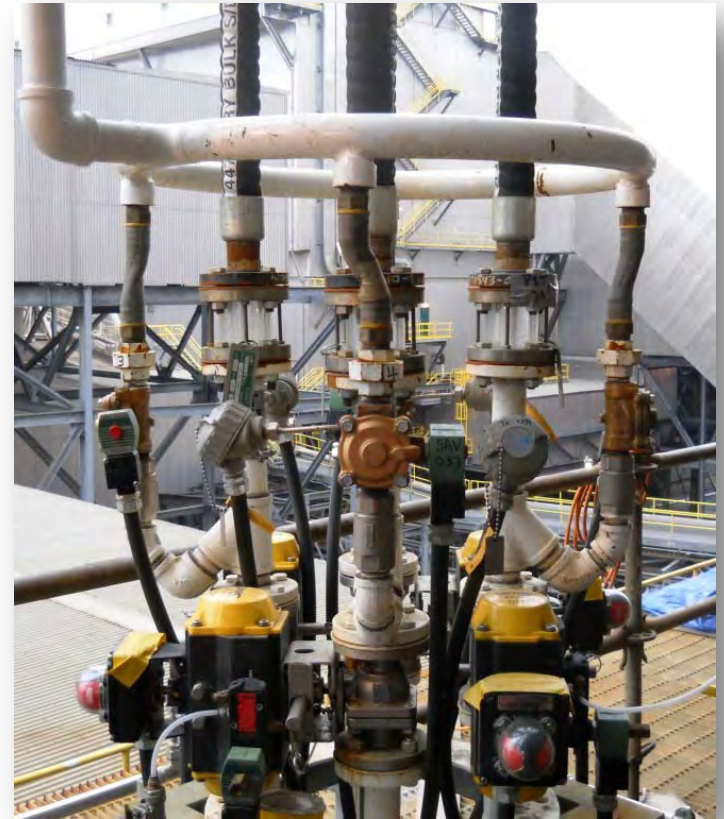
# Splitter with Auto Lance Purge System

- **Splitter Includes Proprietary Insert and Static Mixer**
- **Purge Systems Prevents Soft Plug Formation**
  - Automatically purges lines daily
- **Clears Soft Plugs When Detected**
  - Automated push/pull logic to clear the soft line plug

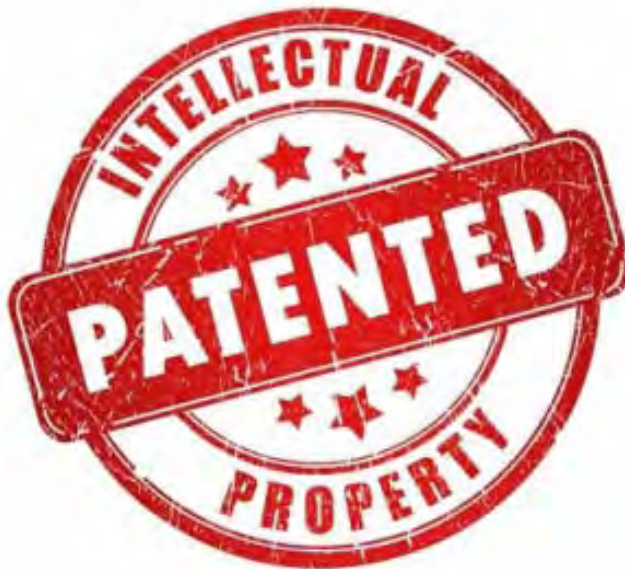
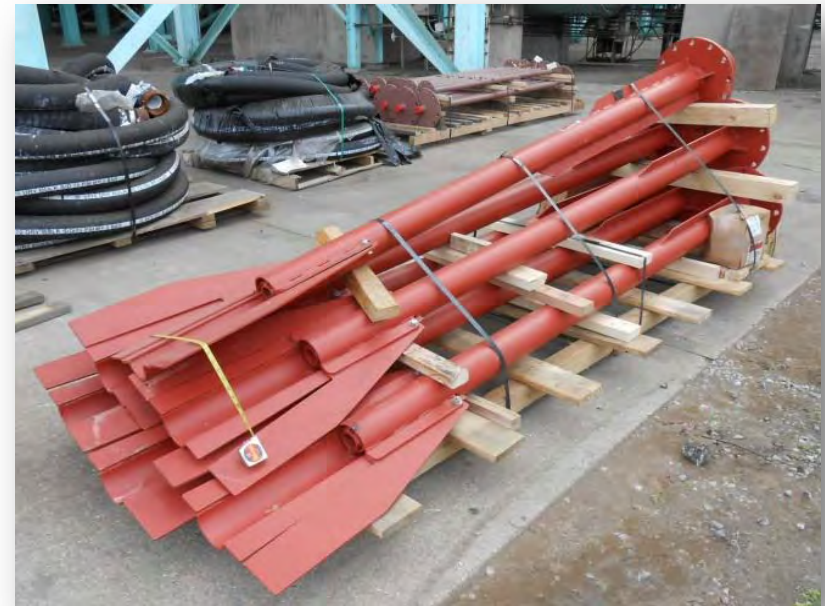
# COBRA™ Lances

- Advantages UCC-patented COBRA Lance
  - Improved sorbent distribution on short residence time and “difficult” flue gas ducts
  - Allows less lances to be used
  - Optimizes sorbent usage

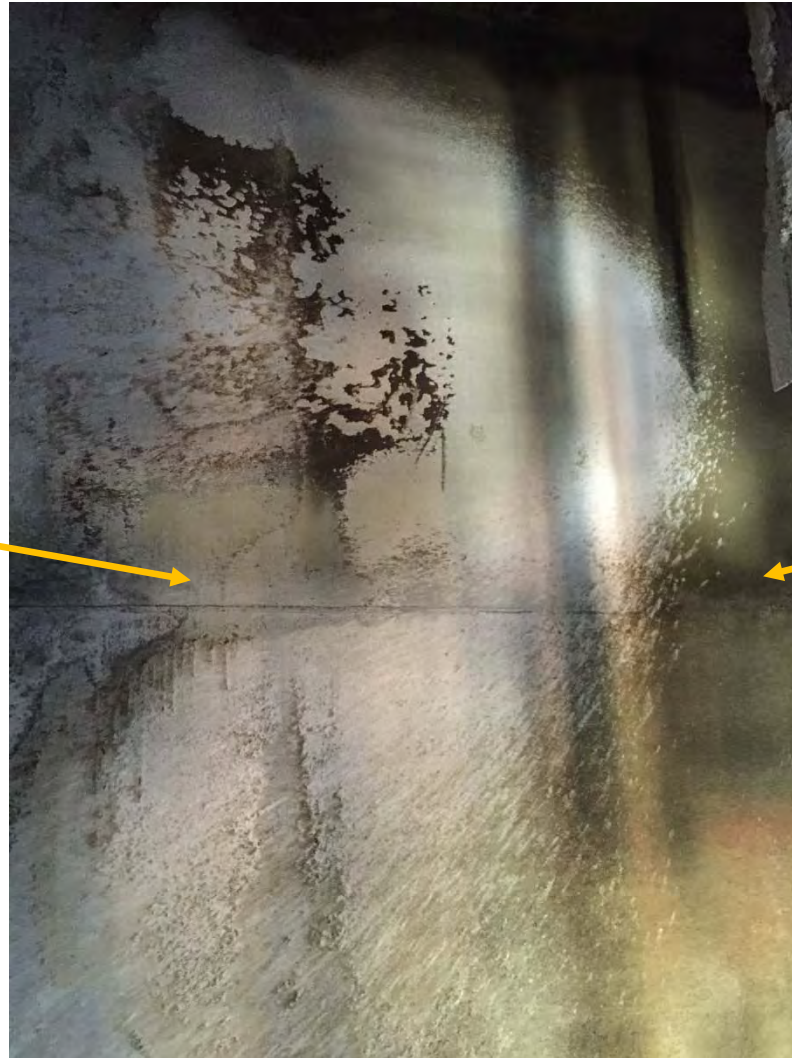
# COBRA Lance Performance

**Clean Duct Wall**

**Sulfur Buildup**

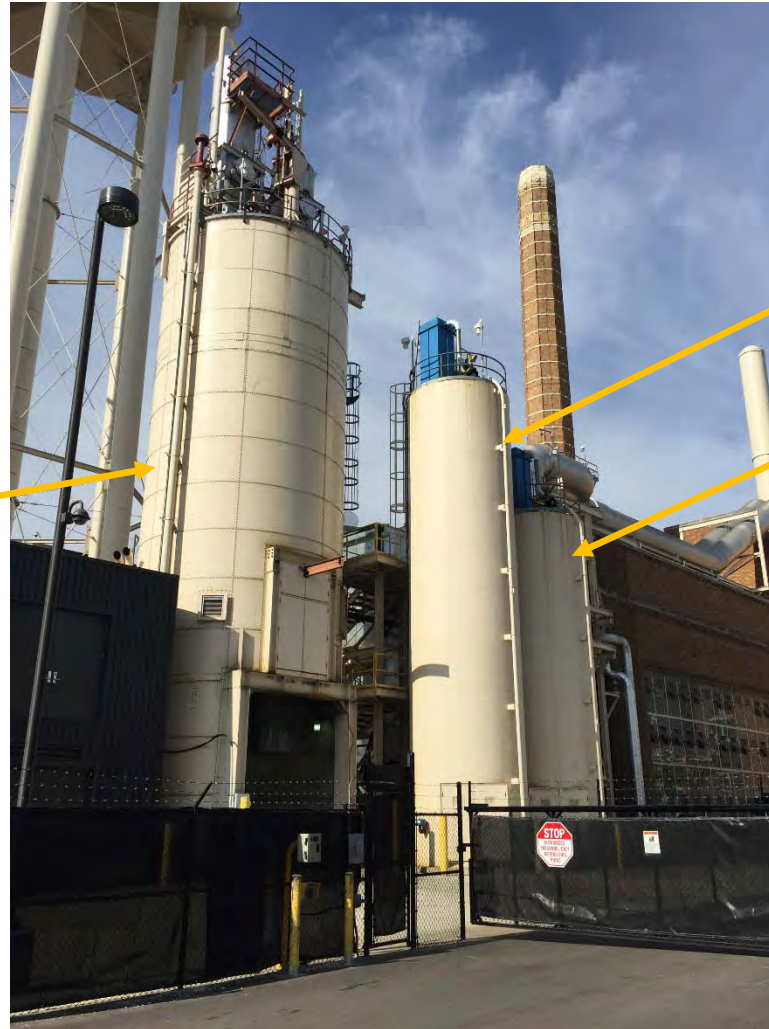
# Site Layout

**Old Ash Silo  
Converted to DSI**

**DSI Silo Reused**

**ACI Silo Reused**

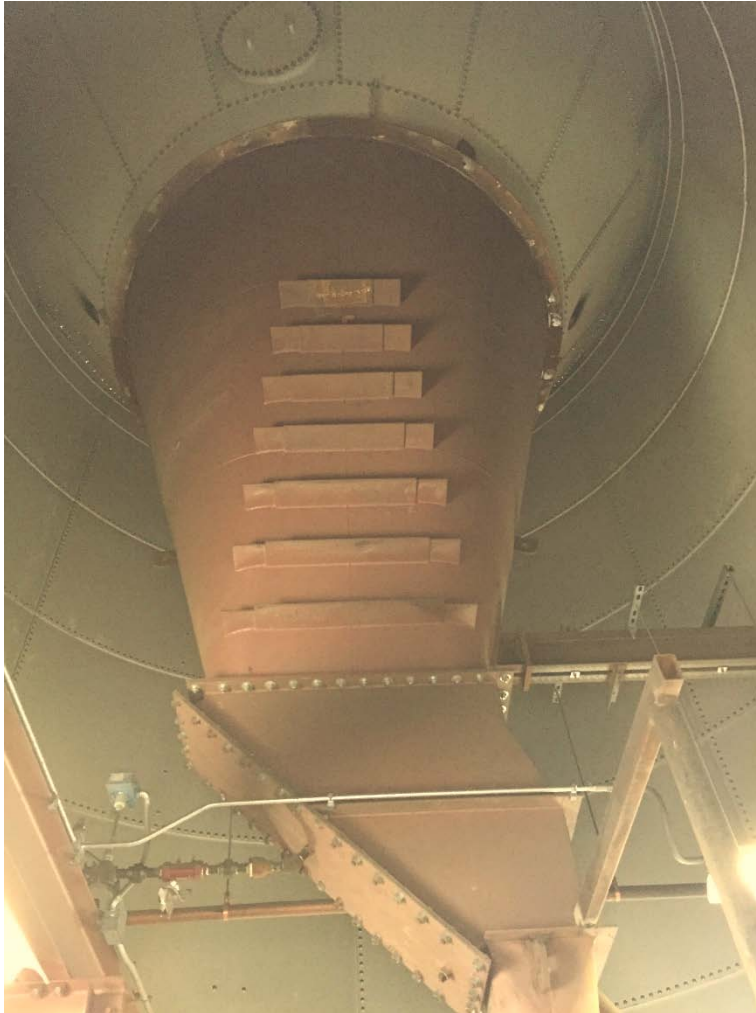
- Silo Modifications
  - Changed to Chisel Bottom Concept
  - Included weigh bins, feeders, blowers, and dehumidifiers in silo skirt (previously unloading level)

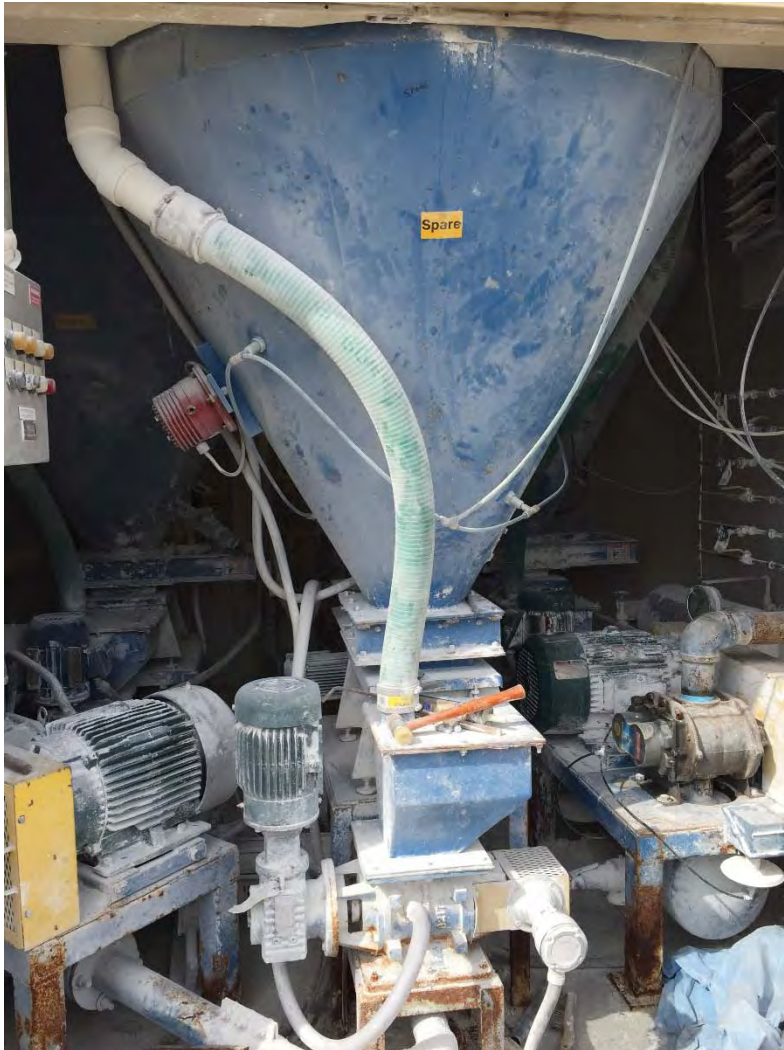
- DSI System Modifications
  - Replaced weigh bins
  - Replaced fluidizing
  - Provided instrumentation and controls
  - Improved dispersion
    - COBRA Lance
  - Improved access

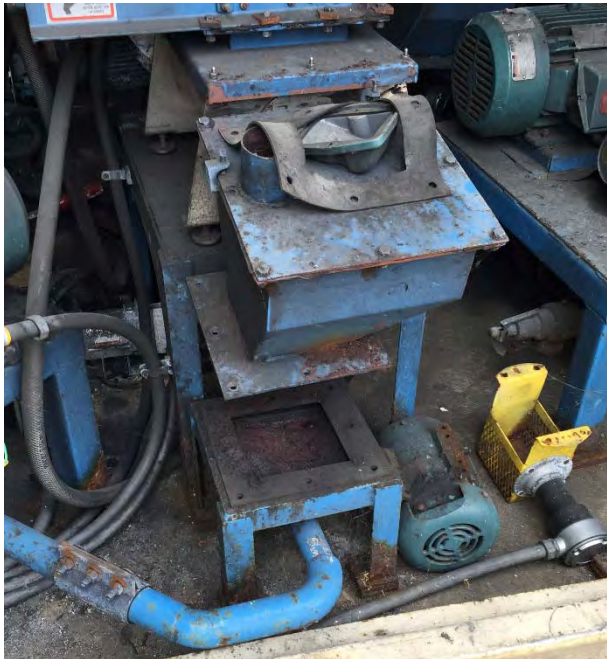
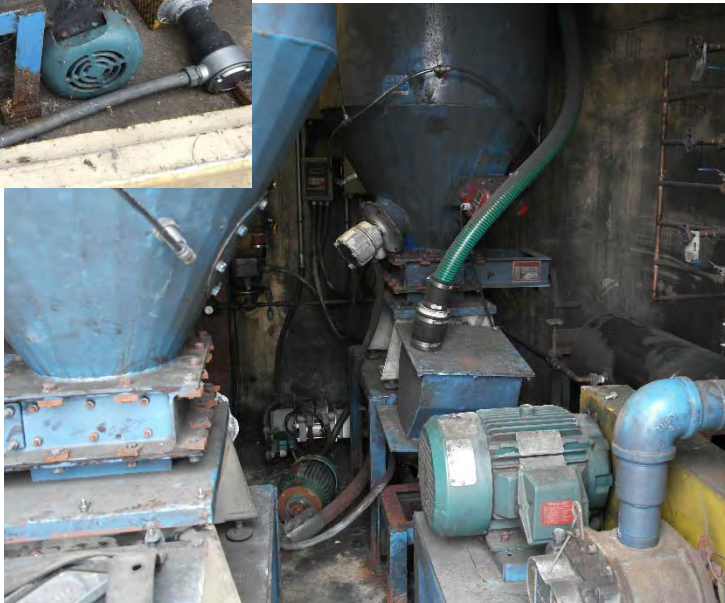
# ACI Modifications

- ACI Modifications
  - Provided Gravimetric Feeders
  - Provided instrumentation and controls
  - Replaced corroded feeders, piping, and components
  - Lined silo in field

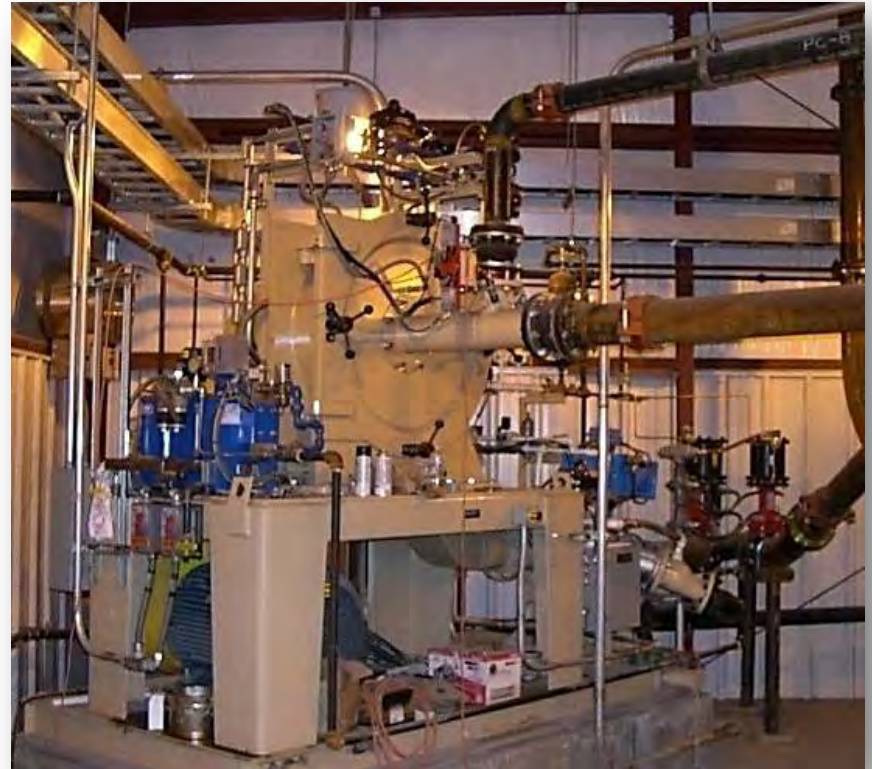
# Case Study 1 – DSI System Description

- UCC VIPER Mills
- Plant since changed to hydrated lime injection, bypass mills

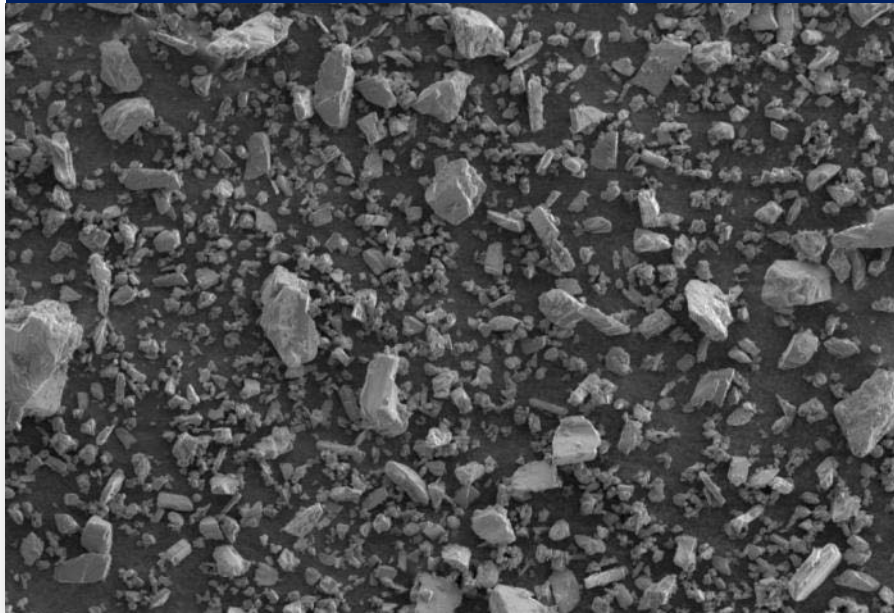
## Unmilled Trona

30-50  $\mu\text{m}$

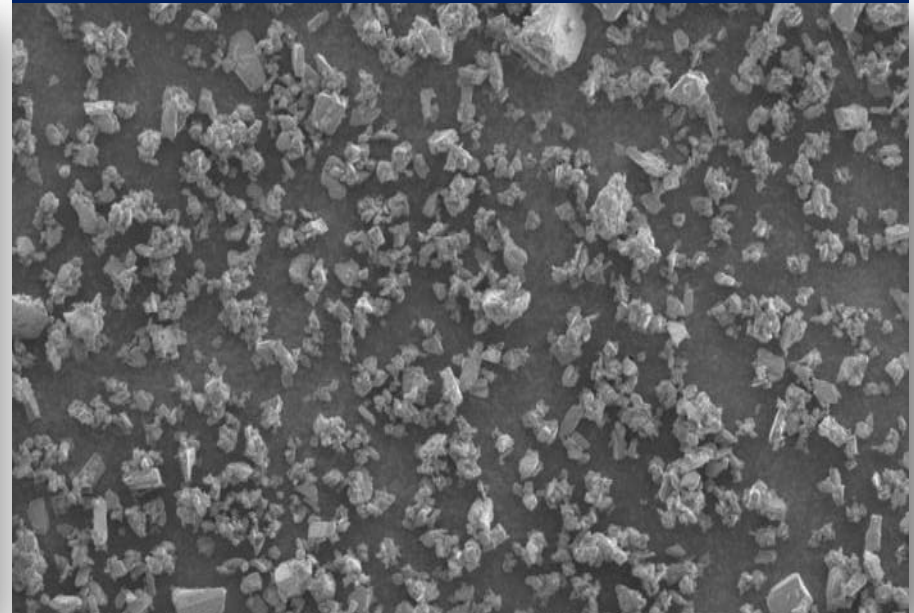
## Milled Trona

9 -15  $\mu\text{m}$
