## **2014 NO<sub>x</sub>-Combustion Round Table & Expo Presentations**

February 10 & 11, 2014, in Charlotte, NC / Hosted by Duke Energy

# SCR Design and Operational Issues

# Nebraska Utility Case Example

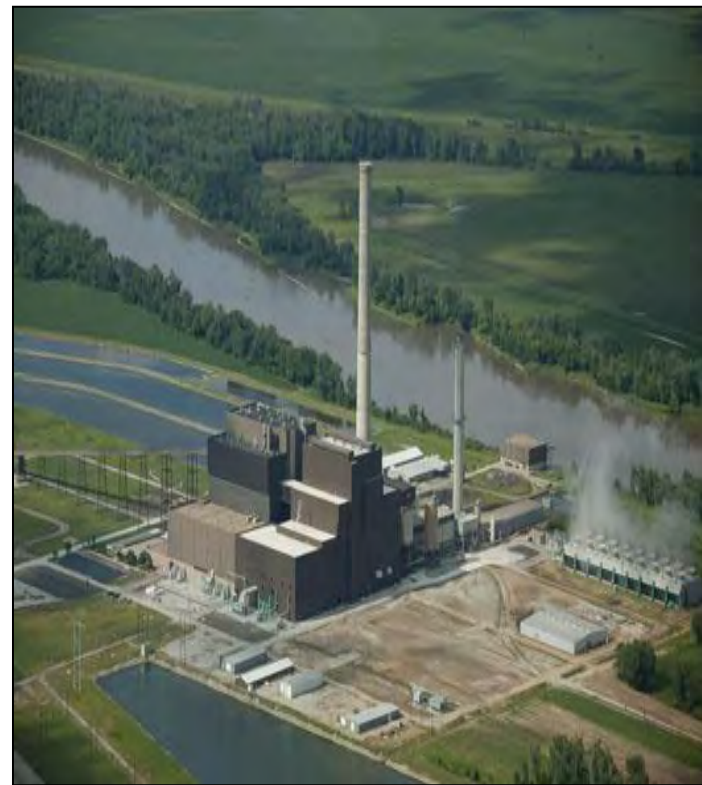
- 740 MW Commercial Operation 2009
- 100% PRB Coal Fired
- PC Boiler
- Low NOx Burners
- SCR
- Spray Dry Absorber/Fabric Filter
- Powder Activated Carbon-Injection

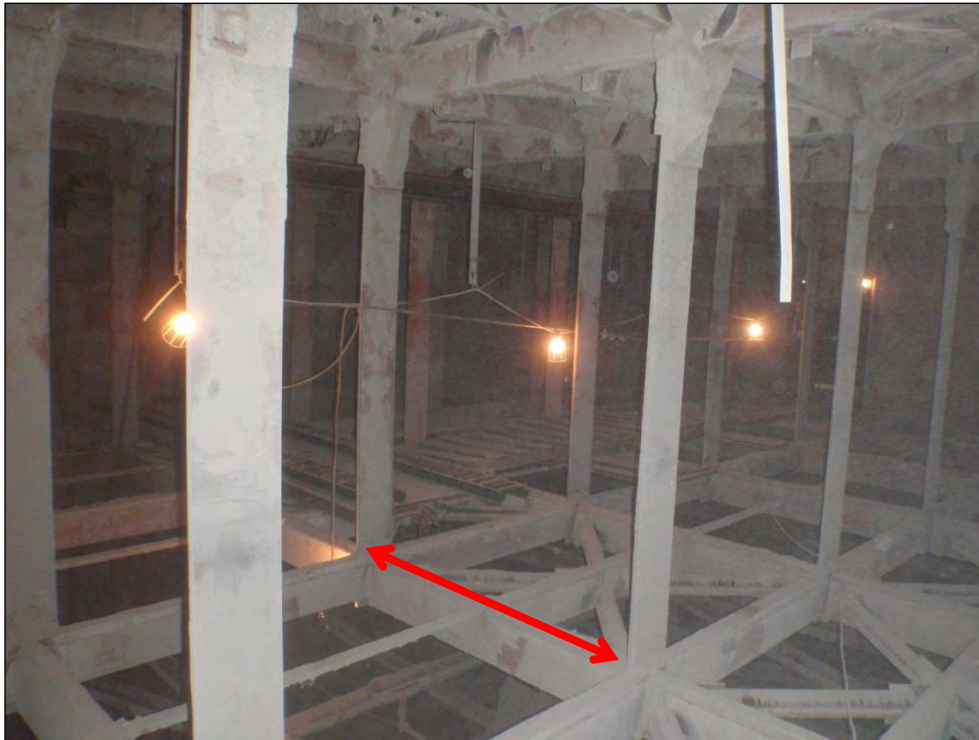
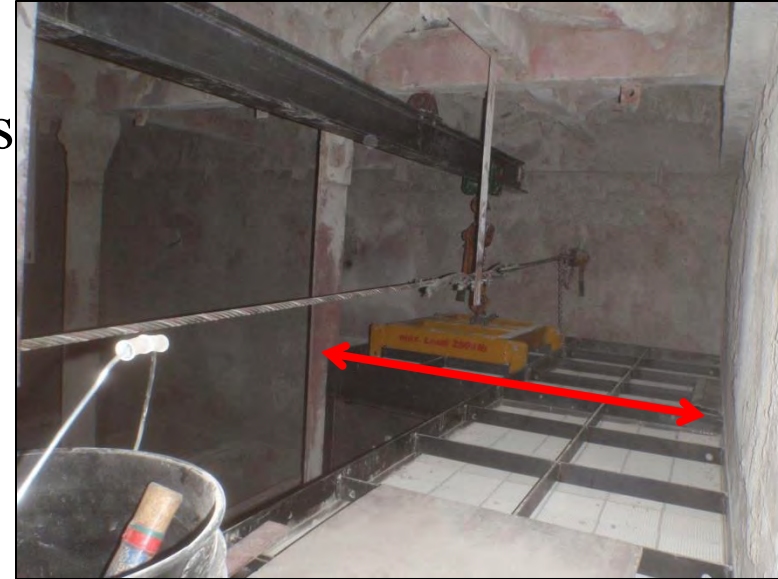
# SCR Plan Arrangement & Module Sizing

- Fixed Catalyst Support Framing Required Smaller Sized Module Frames
- No Module Wall Seals

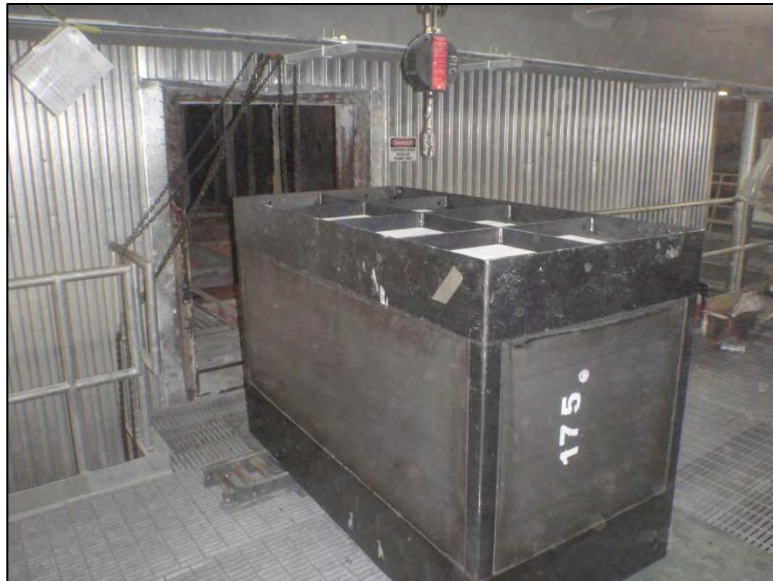
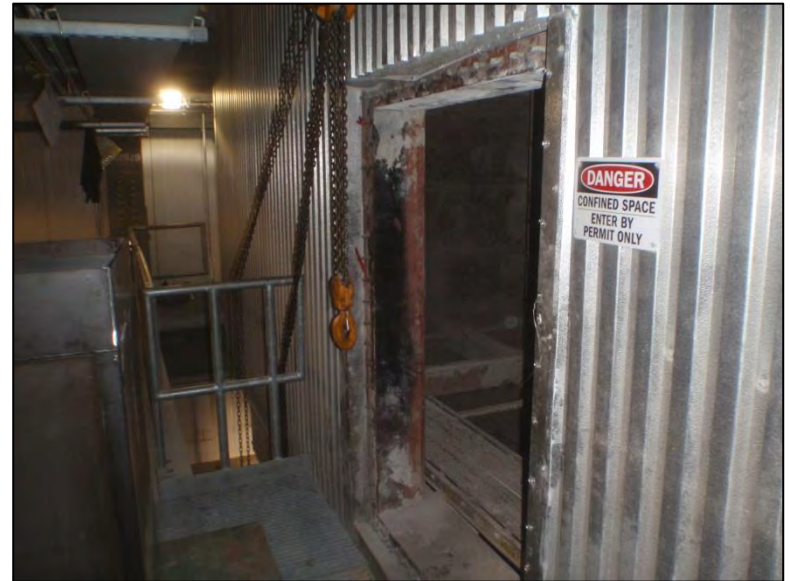
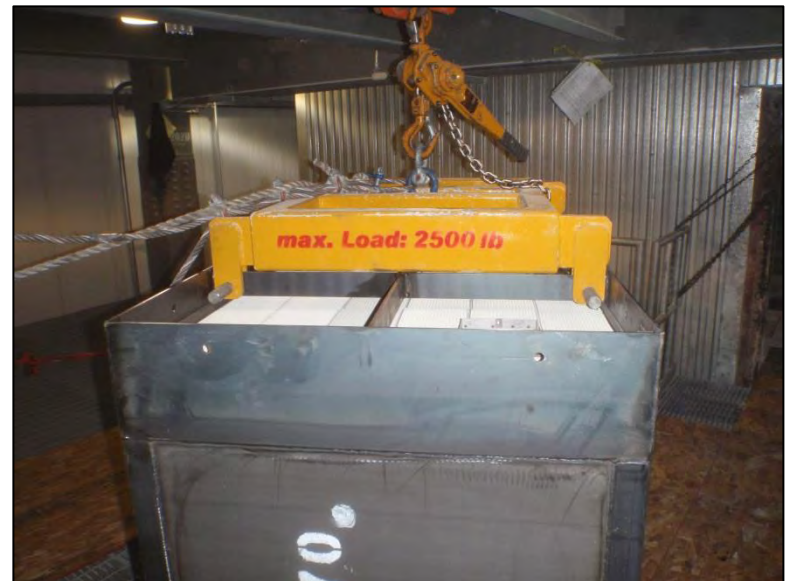
# SCR Module Sizing

- Limited Module Height
  - Loading Door Size

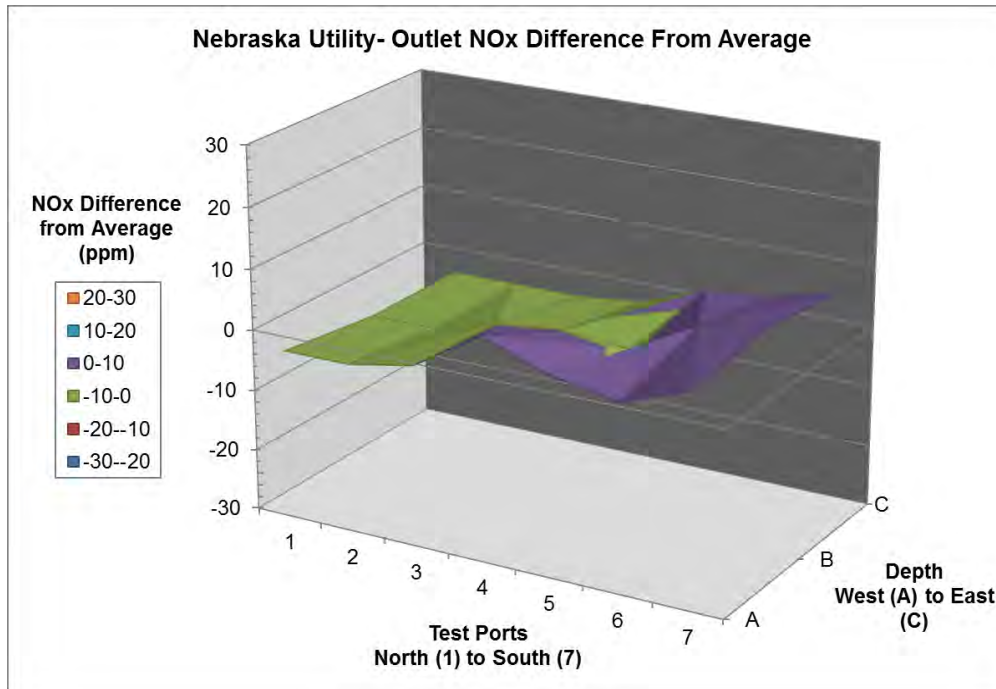
# AIG Tuning 2011

- AIG tuning performed by CERAM
- Ammonia distribution found to be excellent
  - NOx Distribution +/- 10 ppm

Nebraska Utility Baseline AIG Tuning 2011 Summary			
	Units	'A' Side Corrected Outlet NOx	'B' Side Corrected Outlet NOx
Average Outlet NOx	ppm	53	45
Max Outlet NOx	ppm	60	48
Min Outlet NOx	ppm	49	38
Standard Deviation	ppm	4	3
<b>Target Distribution:</b>			
Points within ±10 ppm		21 of 21	21 of 21
Points within ±5 ppm		19 of 21	20 of 21

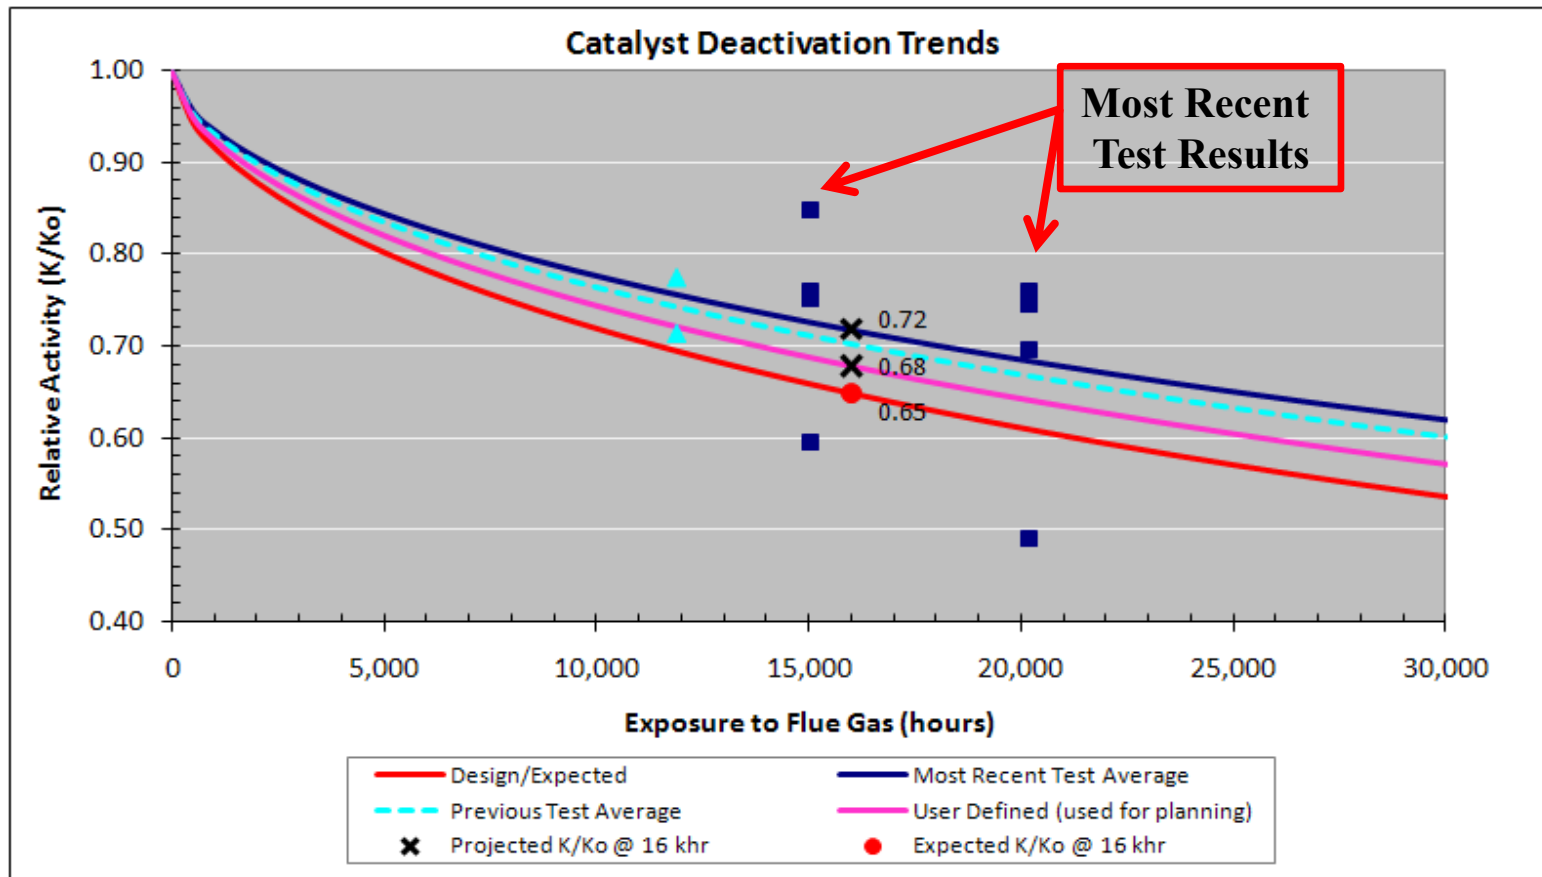
# 2011 Catalyst Testing Results

Test Average K/Ko at 16k hrs of 0.72

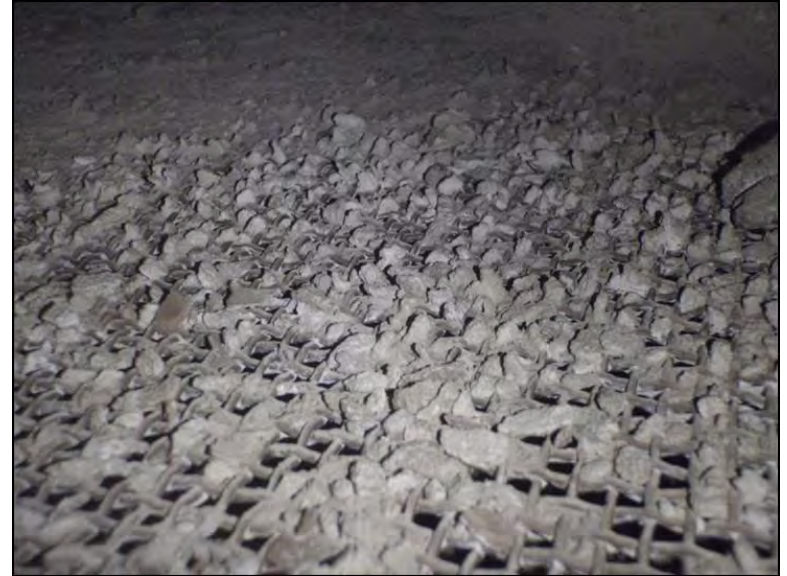
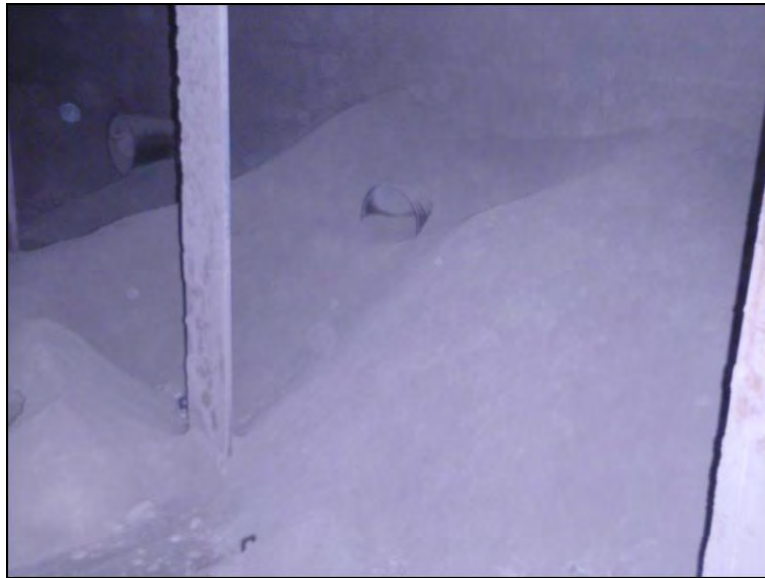
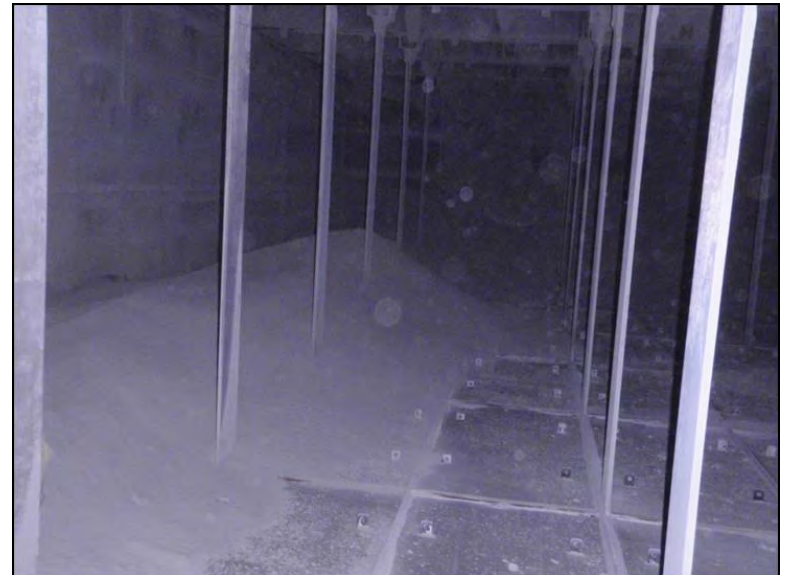
# 2012 Inspection Results

- LPA and Fly Ash Buildup on Covergrates (Small Opening)
- Ash Piles 2 - 5 ft
- Ash Accumulation on Flat Module Seals (Supplied by Others)

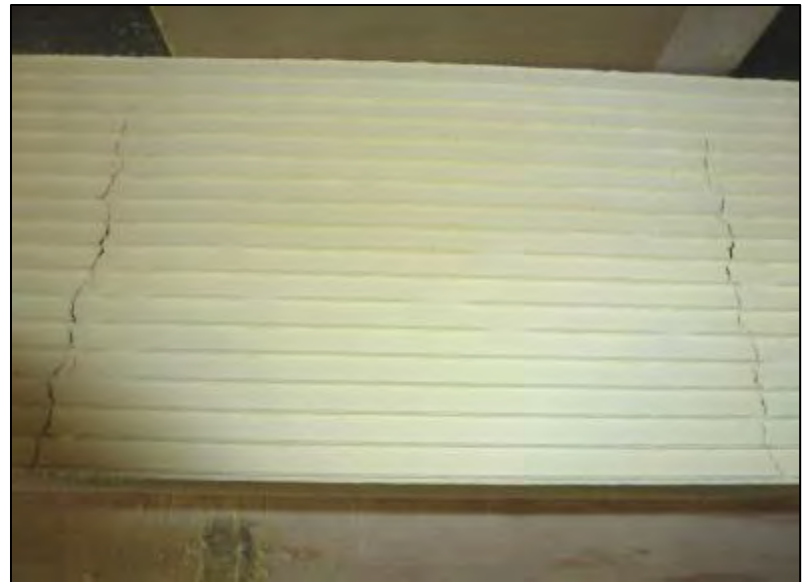
# 2012 Inspection Results

- Severe Catalyst Wall Thinning (Levels 1 & 2)
  - Small Fissures and Cracks at the Inlet Face of the Catalyst
  - Internal Cracks Observed with Test Elements
  - Regeneration was not an Option due to Mechanical Condition and Thin Wall Construction of Original Catalyst

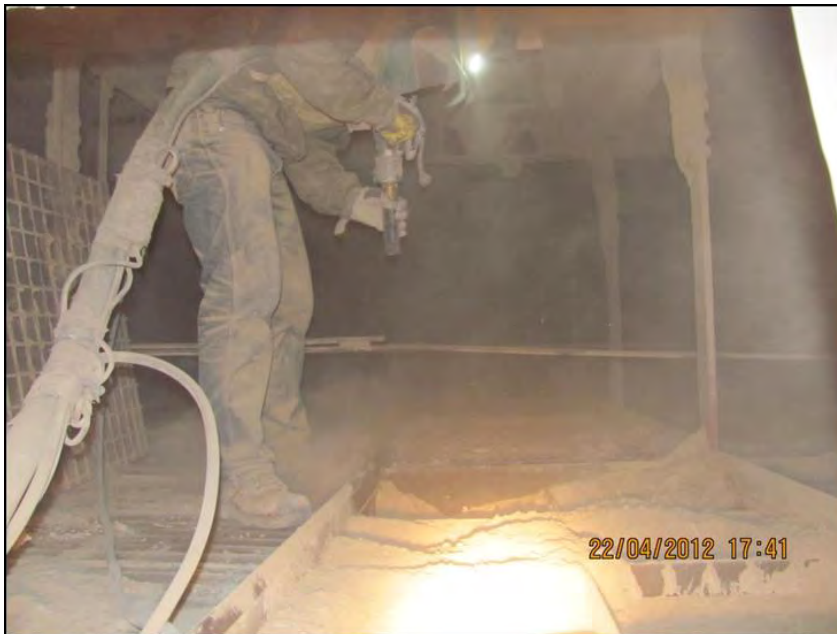
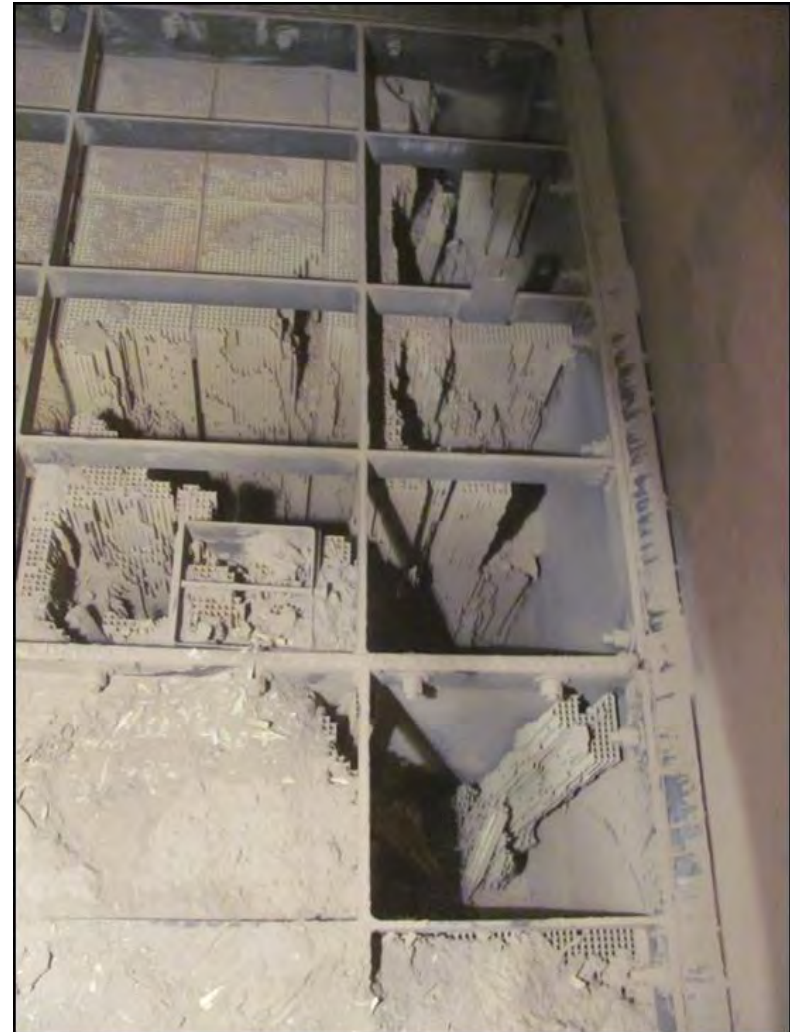
# 2012 Inspection and Cleaning

- Not Possible to Clean Thin Walled Honeycomb Catalyst by Other's
  - Air Lance Cleaning Damaged 4 Modules
    - ◆ Cleaning Halted Due to Damage
  - Affected Modules were Covered with a Steel Plate to Prevent Further Damage

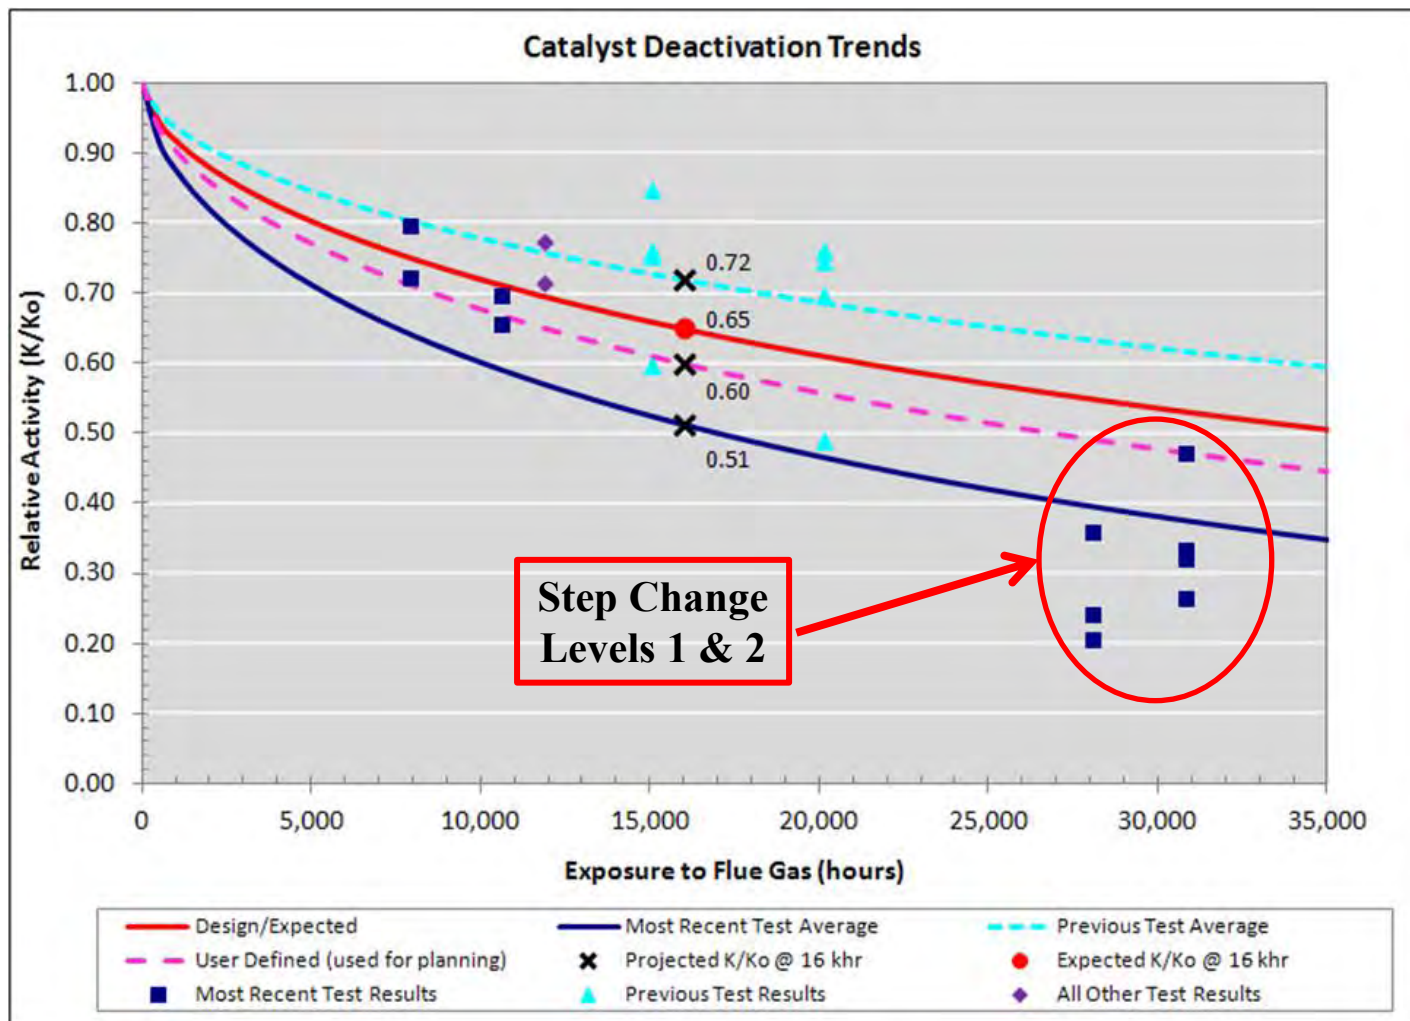
# 2012 Catalyst Testing Results

Test Average K/Ko at 16k hrs of 0.51  
(2011 was K/Ko at 16k hrs 0.72)

- Severe Step Change Deactivation Observed in the 1<sup>st</sup> and 2<sup>nd</sup> Level ( $K/K_o|_{16\text{hr}} = 0.51$ )
  - Calcium Sulfate Fouling and Phosphorus Poisoning
  - Low Tungsten Content in Catalyst
  - Thinning of the Catalyst Walls (Pore Structure)
- Step Change was not Observed in the 3<sup>rd</sup> Level of CERAM Catalyst

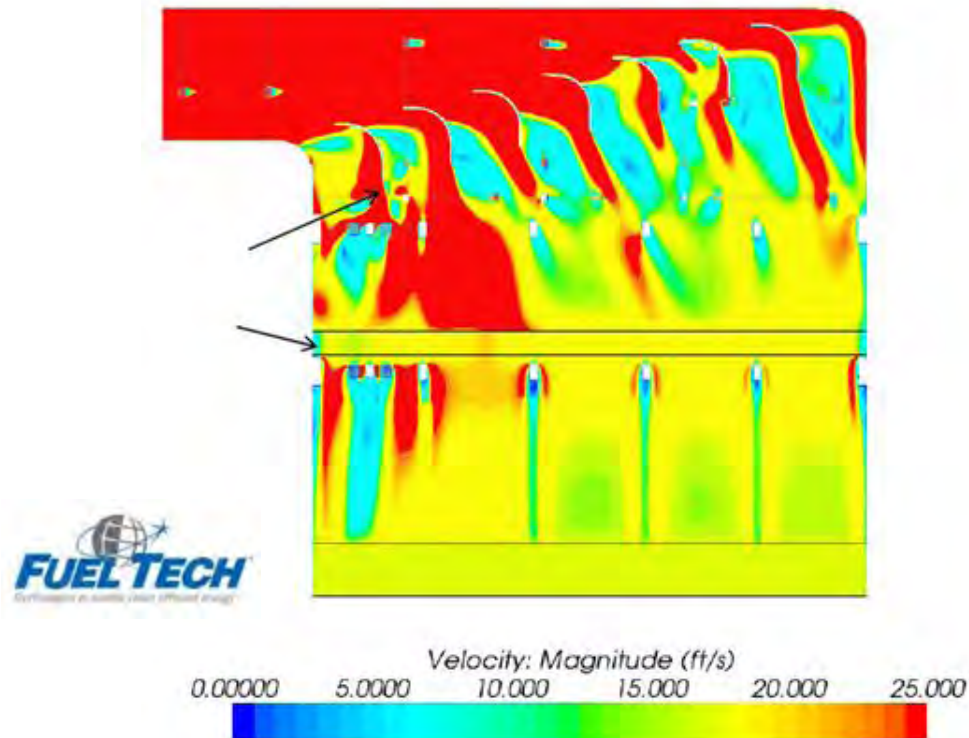
# SCR Improvements & Solutions

- CERAM Recommended Utility Perform Flow Modeling of the SCR
  - Confirm Areas of Poor Flow in the Reactor
  - Identify Possible Solutions to Reduce Pluggage

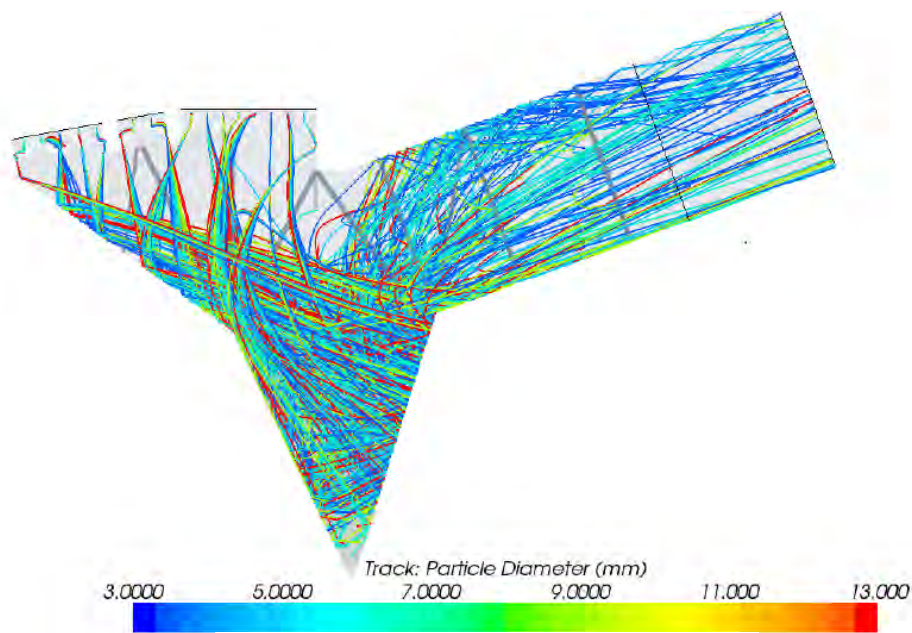
- Particle Modeling Performed
  - Baseline Yielded 54% Particle Removal
  - Baffle Plate Option 5 Yielded 89% Particle Removal

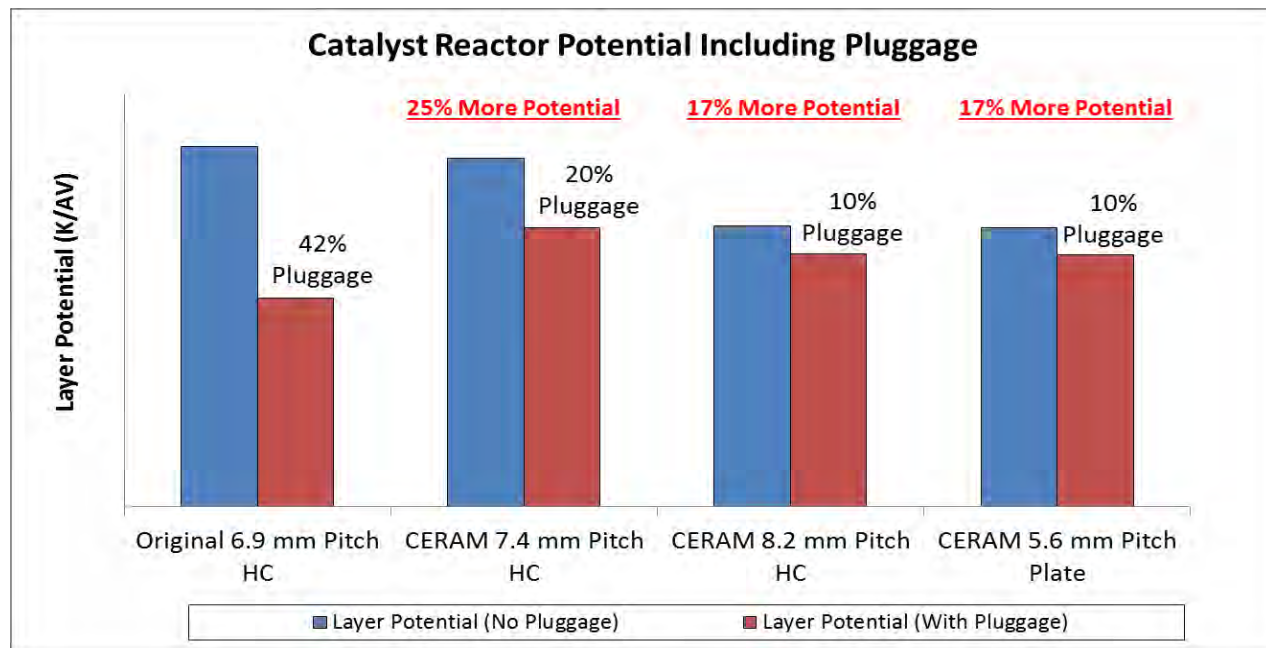
- Catalyst Pitch Evaluation

- Transitioning to Larger Pitch – Reduced Surface Area must be Offset by Reduction in Catalyst Pluggage
- 8.2 mm Pitch Honeycomb has 22% Less Specific Surface Area Compared to 6.9 mm
- 7.4 mm Pitch Honeycomb has 13% Less Specific Surface Area Compared to 6.9 mm
- 5.6 mm Pitch Plate has 36% Less Specific Surface Area Compared to 6.9 mm

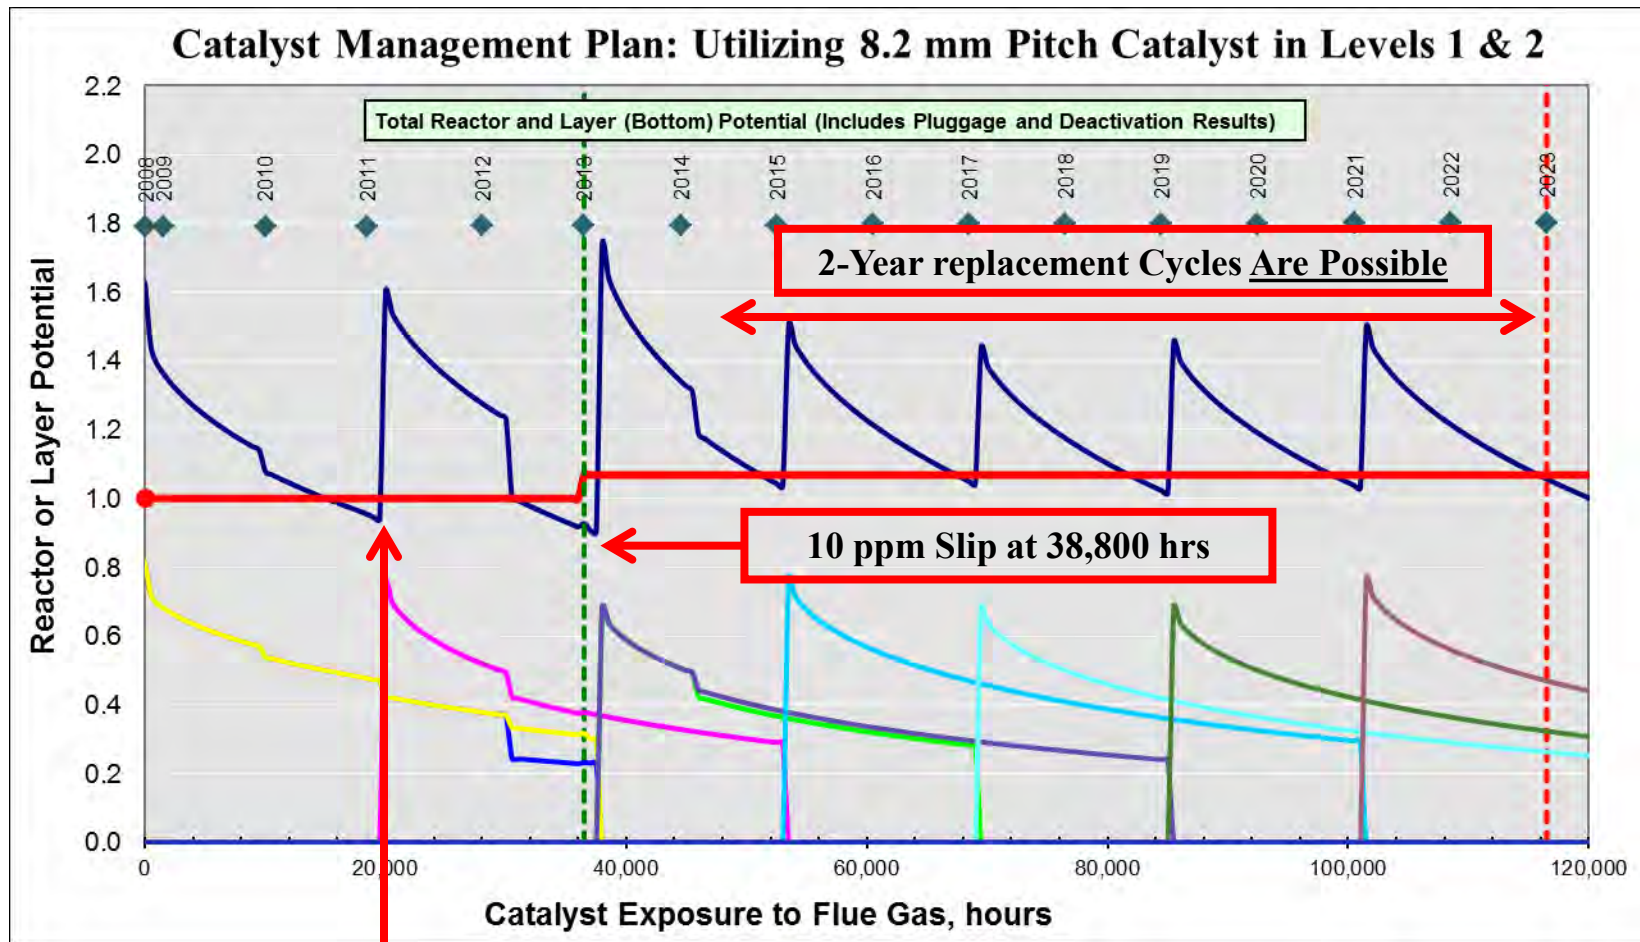
# Optimized CMP – 2 Year Replacement Cycles

4 - 5 ppm Slip at 20,200 hrs

Utilizing 8.2 mm Pitch Catalyst Allows for 2 Year Replacement Cycle

- Goal was to Develop Long Term Catalyst Management Plan to fit Desired Outage Schedule
  - Replace One Layer Every 2 Years
- Transition to Larger Catalyst Pitch
  - 8.2 mm CERAM Replaced Original 6.9 mm First Layer in Spring 2013
  - 8.2 mm CERAM Replaced Original 6.9 mm Second Layer in Spring 2013
  - Replace Third Layer in Spring 2015
- Future 2 Year Replacement Cycle is Achievable
