2008 NOx-Combustion Round  
Table & Expo Presentation

# LPA Removal Alternatives

# Muskingum River Unit 5 LPA Issues

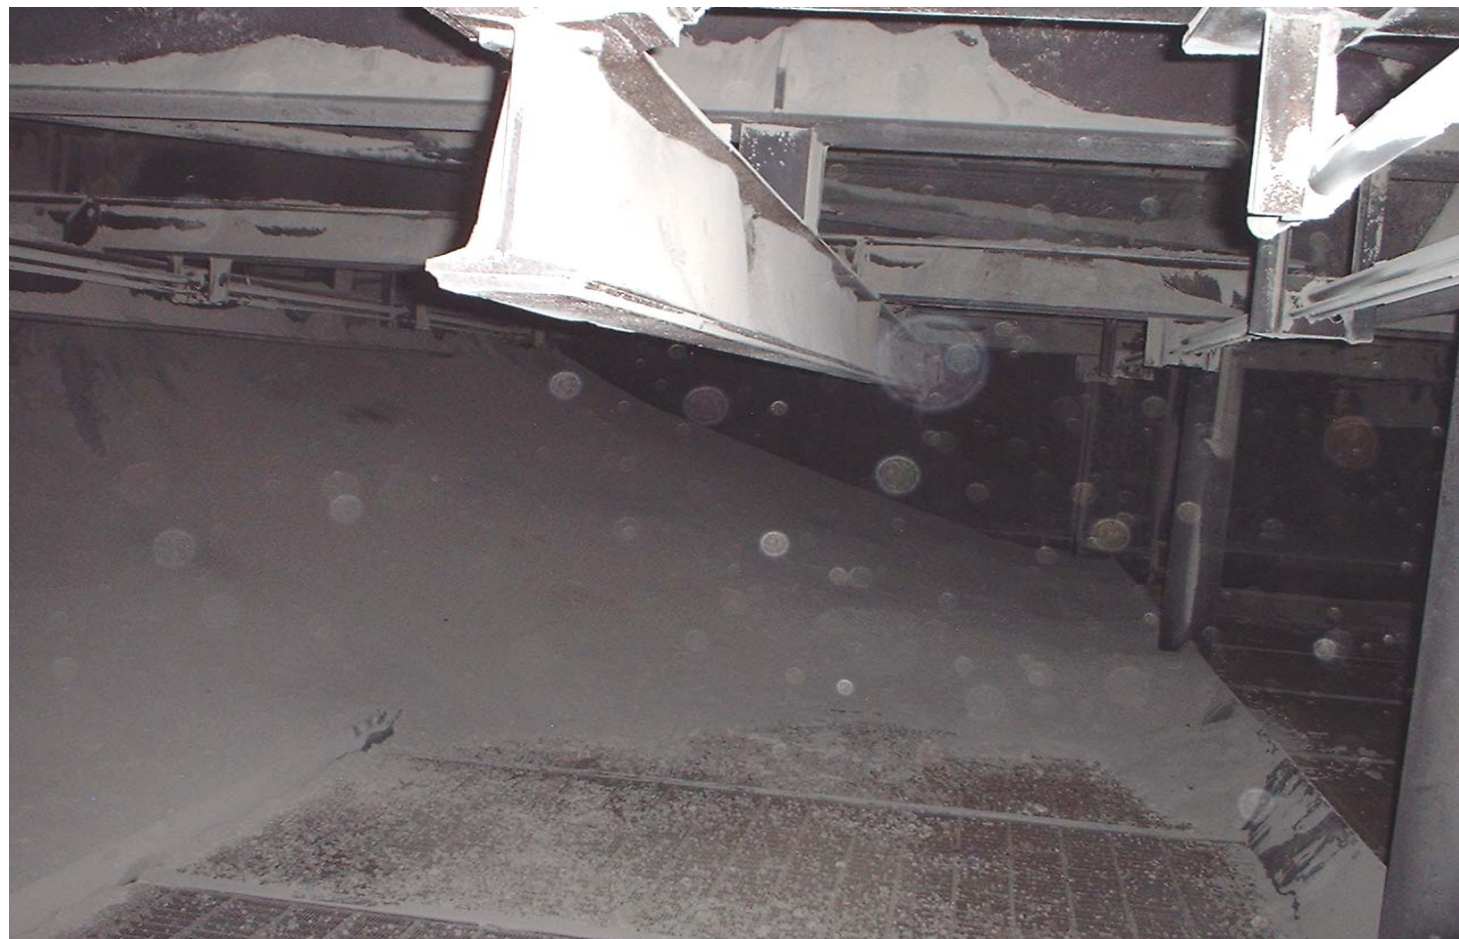
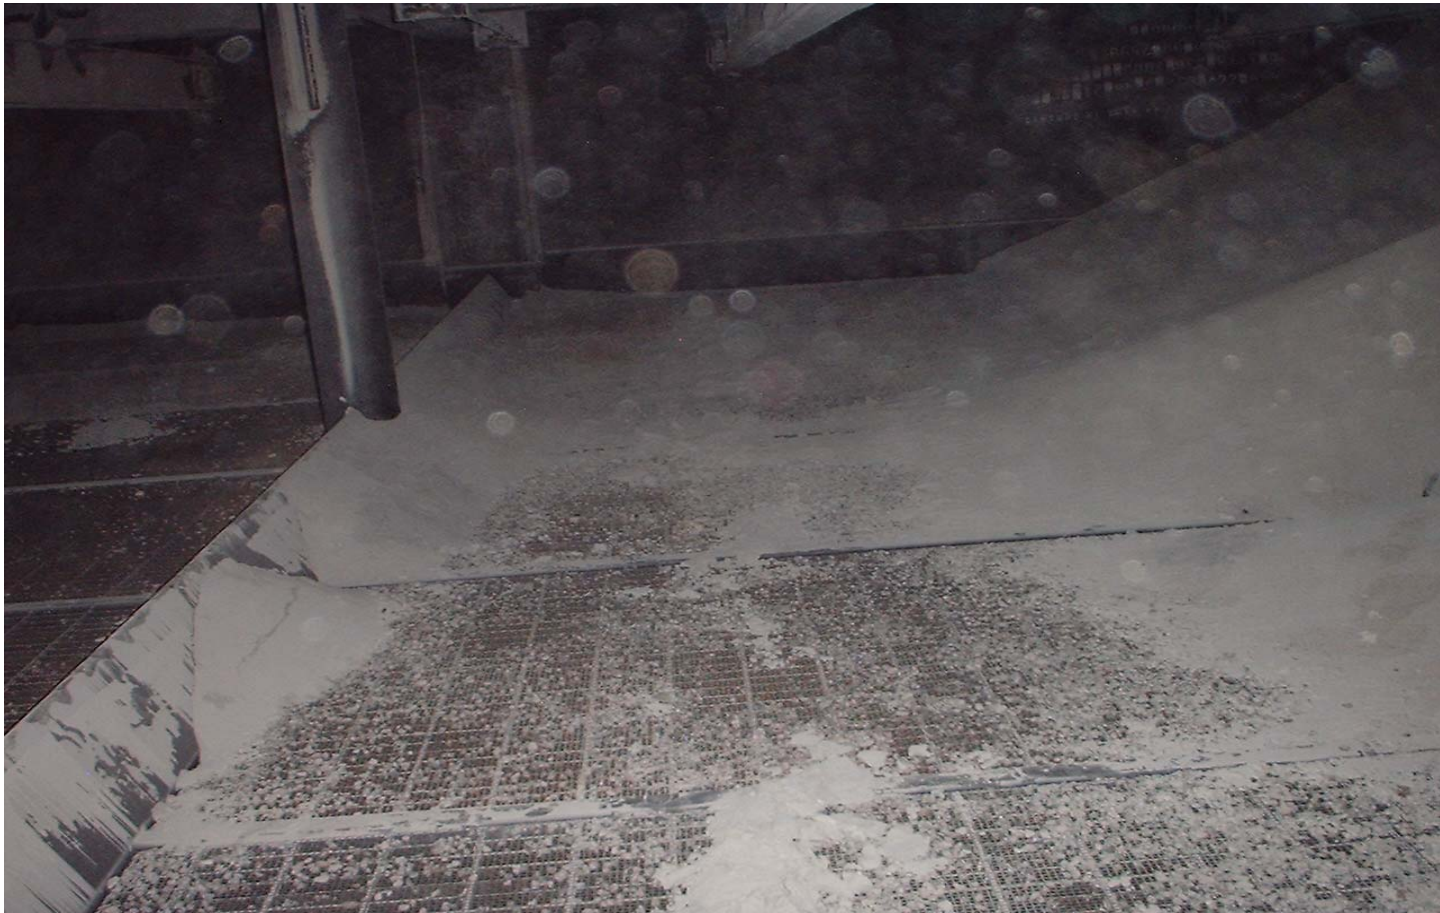
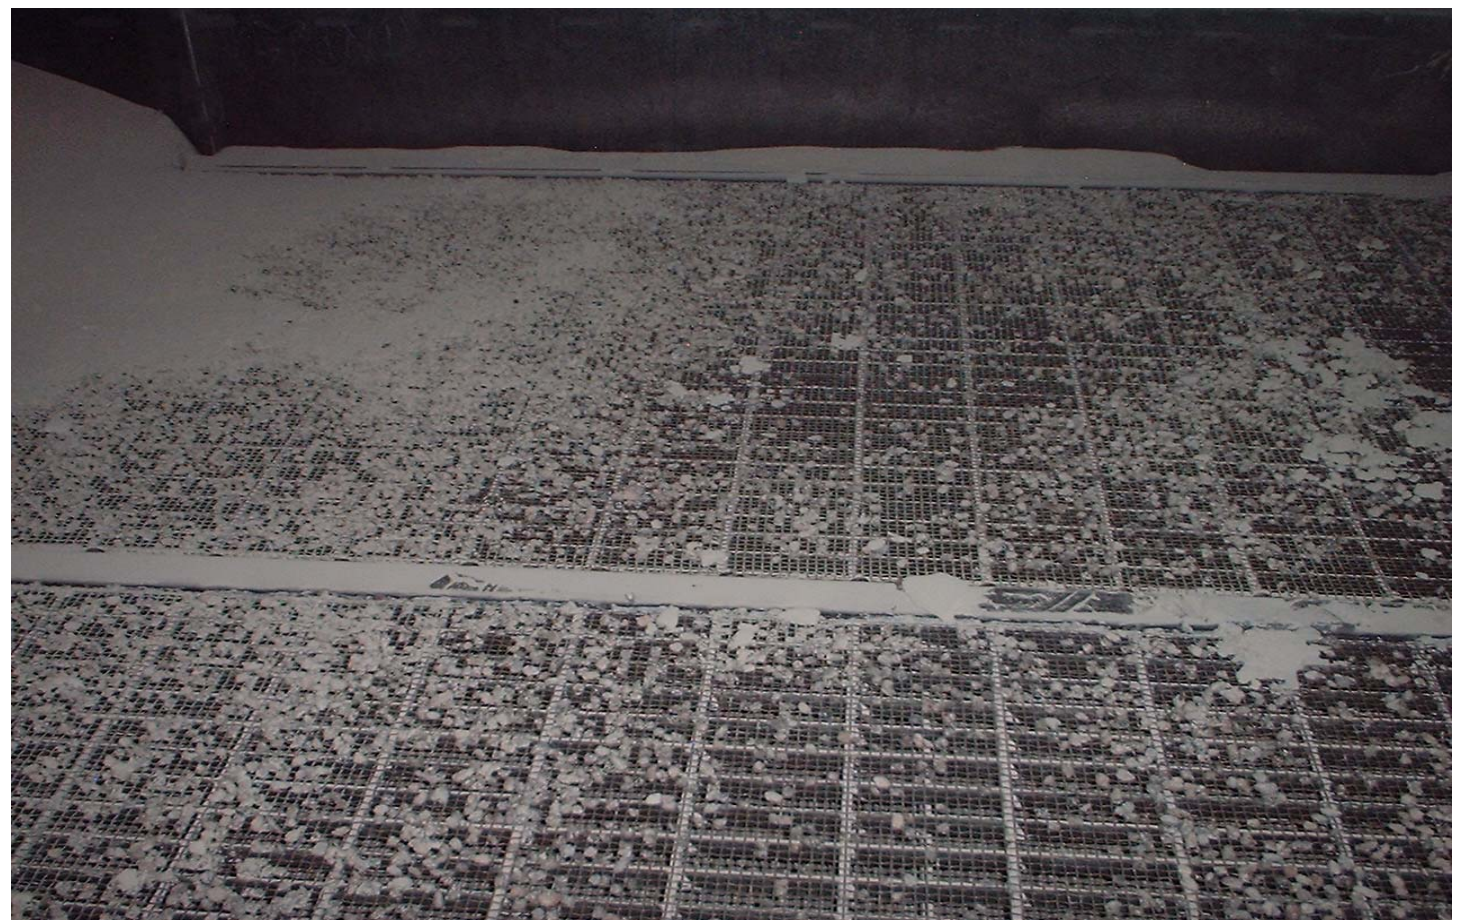
June 2005

- The ash pile covered most of the first two rows of catalyst from inlet duct wall (1/4 of cross sectional area of reactor).
- The height of ash pile on the inlet duct wall is about 4 to 5 ft and is tapered off toward the center of reactor.
- At the bottom of the ash pile and the adjacent areas, significant quantity of large particle ash (LPA) laid on the catalyst protective screens.
- The quantity of LPA on the protective screens decreases considerably away from the ash pile.

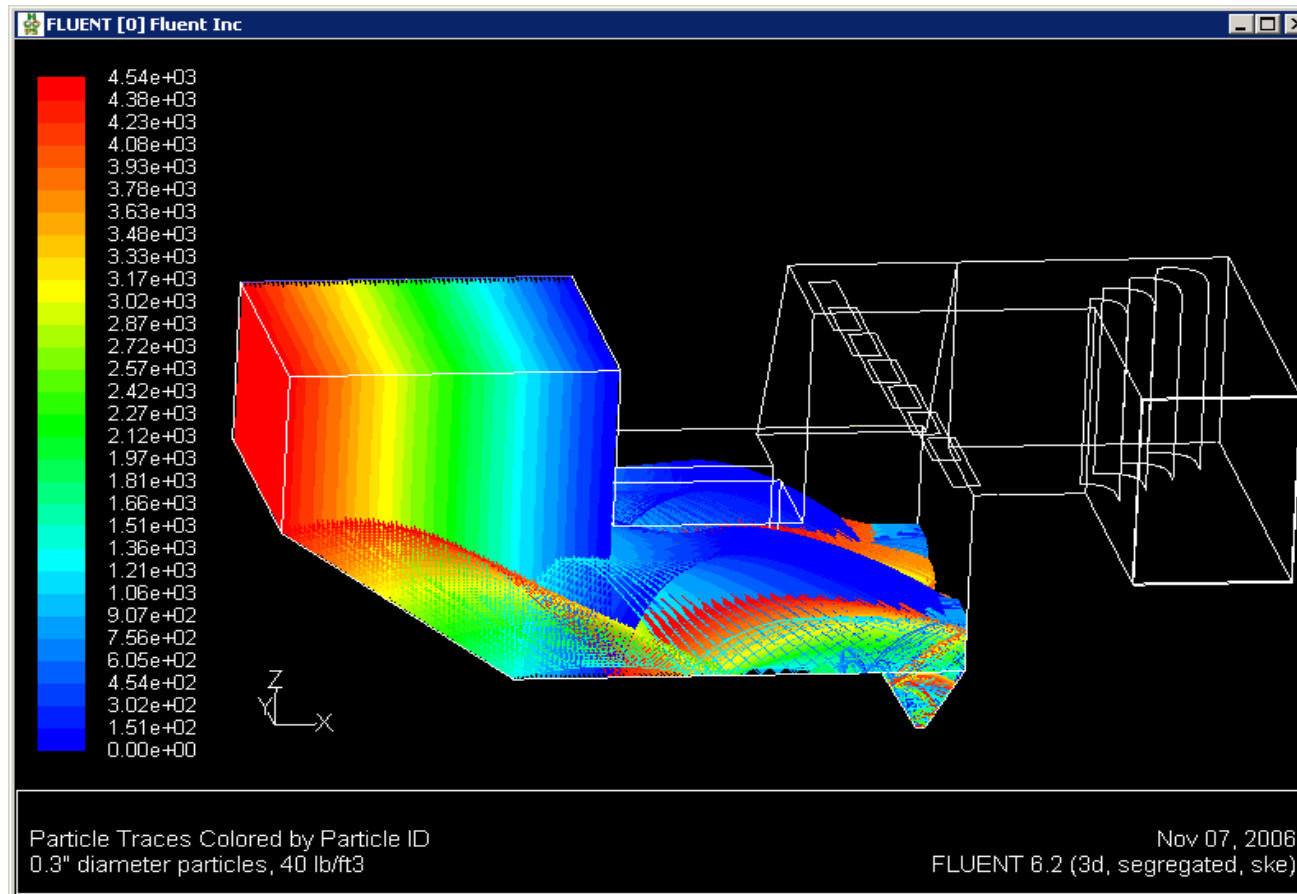
- From economizer exit to the beginning of two separated ducts to SCR reactors
- Because of geometric symmetry, only half of the duct work was modeled.
- Assume uniform flue gas velocity distribution at economizer exit.
- LPA's were modeled using post processor particle tracking.
- Various particle sizes (1 to 13 mm) and densities (10 to 50 lbs/ft<sup>3</sup>)
- Density of LPA at Muskingum River Unit 5 is approximately 40 lbs/ft<sup>3</sup>.
- Reflection coefficient of 1.0 and 0.8

- LPA dropout hoppers at the second 90° elbow downstream of economizer have potential of capturing LPA's of 40 lb/ft<sup>3</sup> with size ranging from 1 to 13 mm.

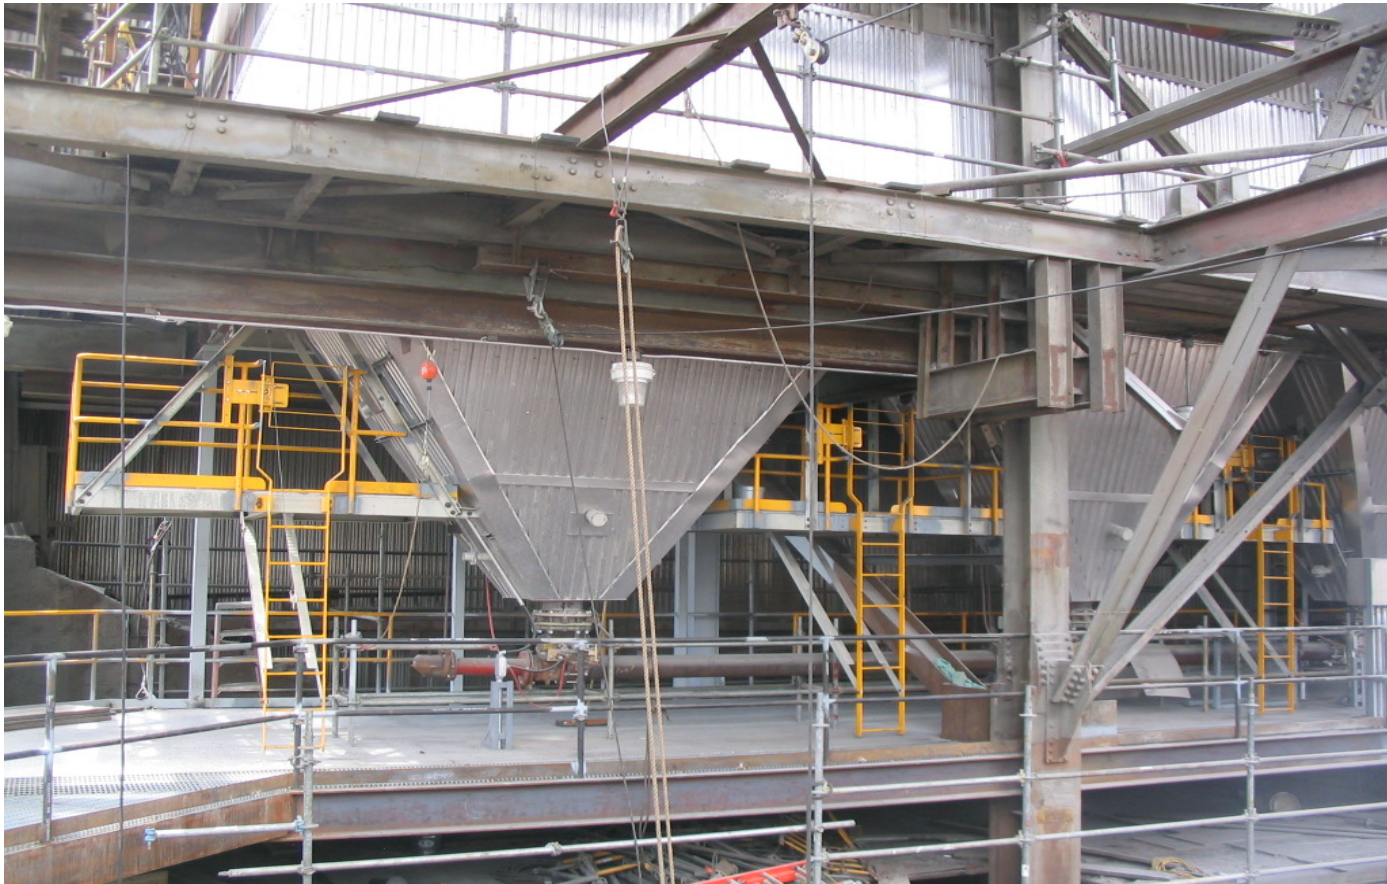
SCR & LPA dropout hopper inspection was performed in July 2007 during a unit outage

- SCR Reactors
  - The ash pile that used to cover the first two rows of catalyst next to the inlet duct wall was not found.
  - LPA's spread on the screens of the first row of catalyst covering approximately 10% of screen area in north SCR reactor and 20% screen area in south SCR reactor.
  - Only few LPA's were found in the remaining area of the top catalyst layer.
- LPA Dropout Hoppers
  - Hoppers and top gratings were clean with no ash pluggage.
  - Ash pile was formed at the front of hopper openings because of the low velocity zone at the elbow.

- Remove guide vanes at the elbow.
- Install four LPA dropout hoppers.
- Install grating at the top openings of hoppers to prevent re-entrainment of LPA's.
- Install hopper access platforms
- Install ash conveying system and integrate operation with existing ash system.
