2016 NO_x-Combustion-CCR Round Table Presentation

February 1 & 2, 2016, in Orlando, FL / Hosted by OUC

Controlling the Cost of MATS Compliance via Air In-Leakage Reduction

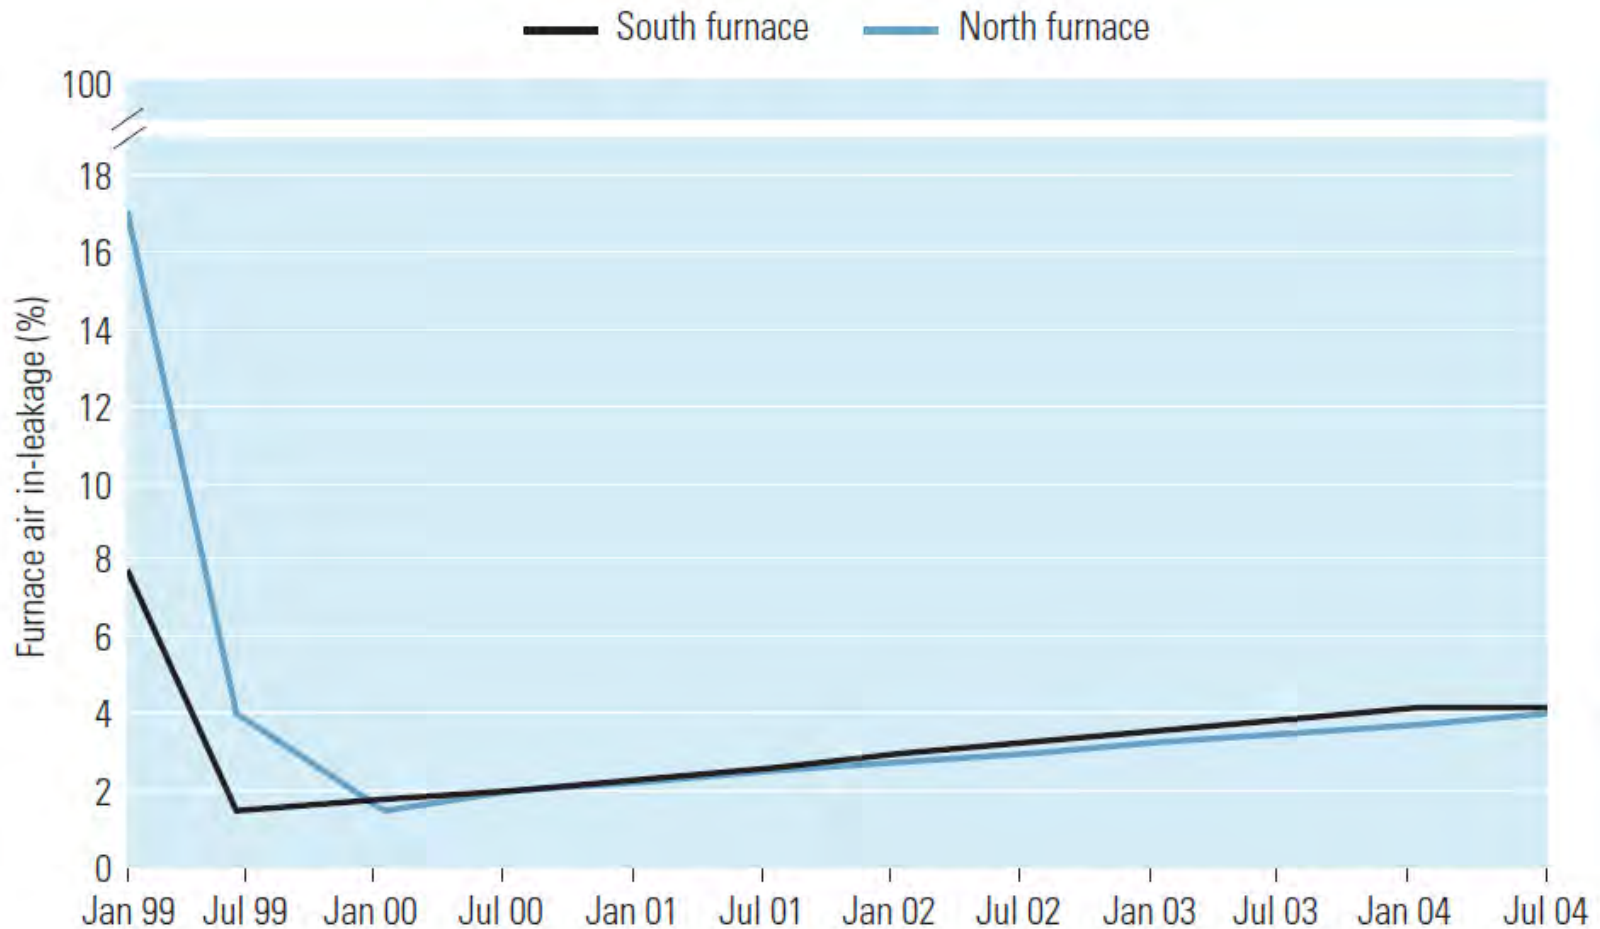
Case Study: Gorgas Electric Generating Plant Air In-Leakage - Excess Oxygen Levels

Graph Courtesy of POWER Magazine & Innovative Combustion Technologies, Inc.

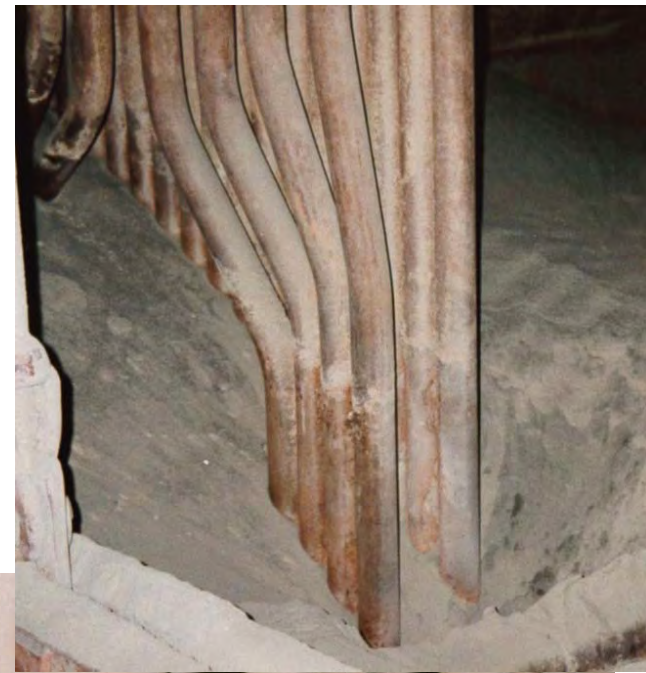
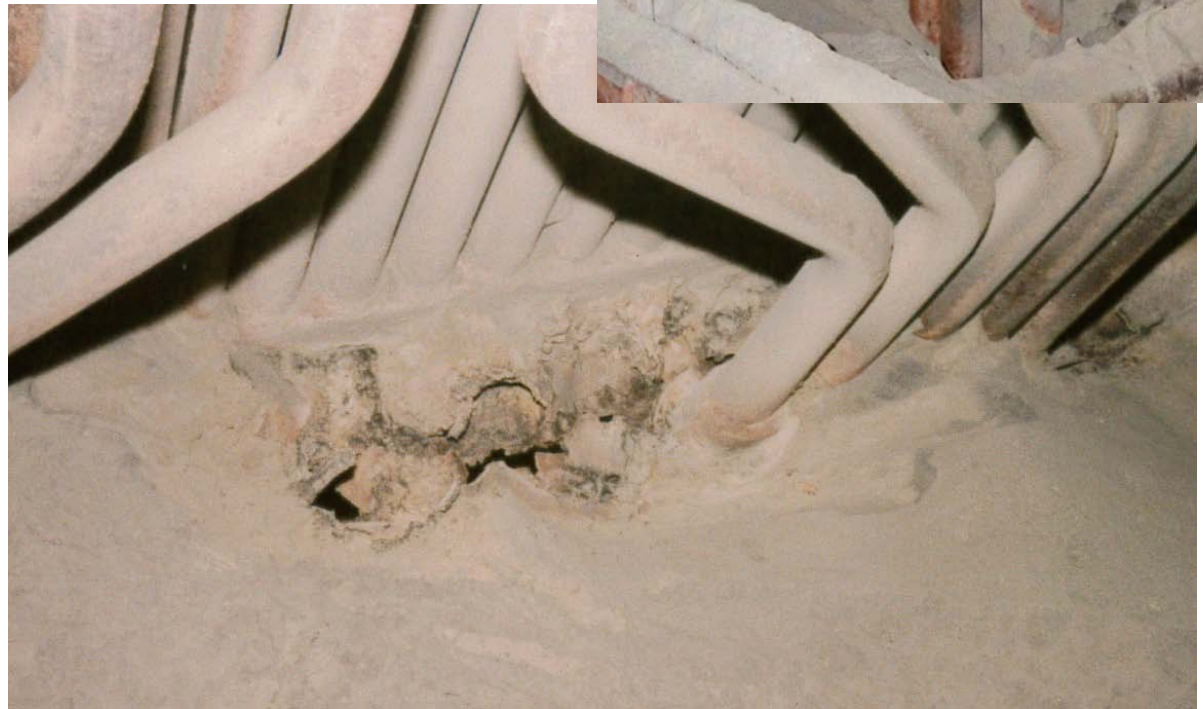
Duke Marshall Penthouse

- Unit 4: 700 MW Supercritical Unit
- 3-5 feet of ash accumulation
 - approximately 100 tons
- Ingress of flyash caused typical problems
 - Safety
 - Reliability
 - Efficiency
 - Housekeeping

***Prior to installation of
ISOMEMBRANE® in 1994***

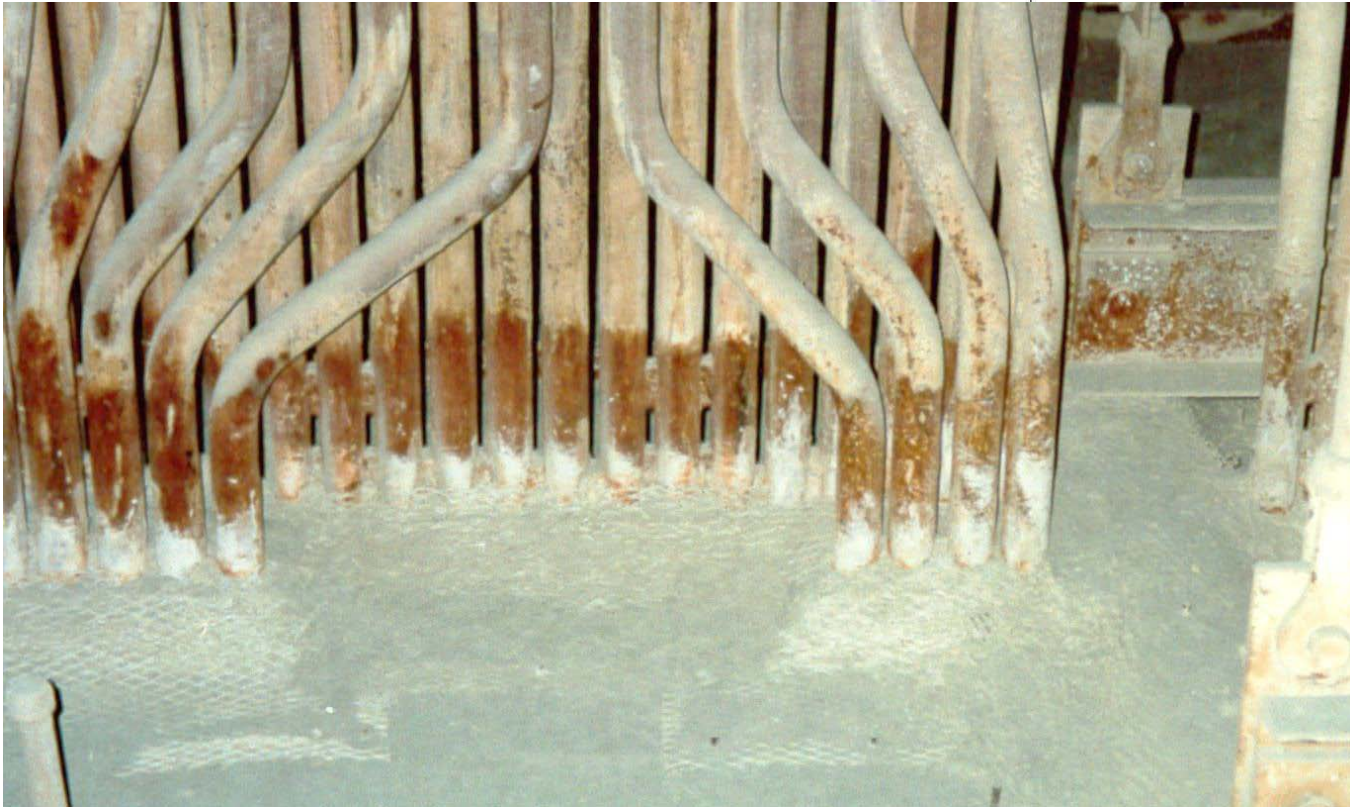
After 1 Year in Service

- No vacuuming required
- Reduced outage requirements
- Reduced costs and labor requirements

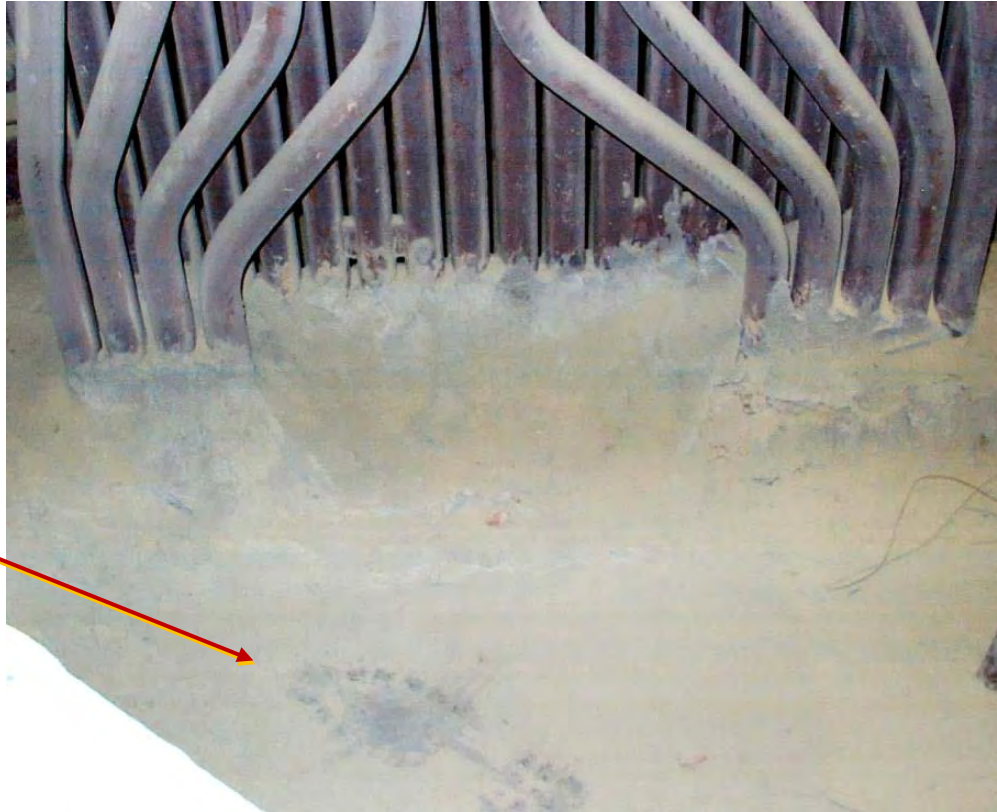
Case Study: Duke Marshall Penthouse *After 10 Years in Service*

- Still no vacuuming required, only minor ash dusting exhibited
- Improved outage costs, budget flexibility, labor and safety
- Significant payback in reduced vacuuming & inspection costs alone

*Minor ash dusting
(note foot print)*

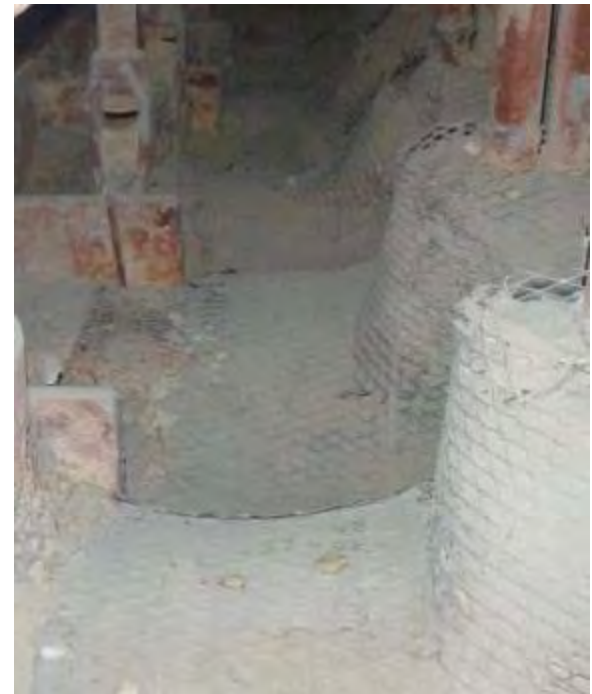
Case Study: Duke Marshall Penthouse *After 19 Years*

- No ISOMEMBRANE® maintenance required
- Improved outage effectiveness, safety, and time & budgetary savings

Original ISOMEMBRANE® Installation in 1994, photos taken May 2013

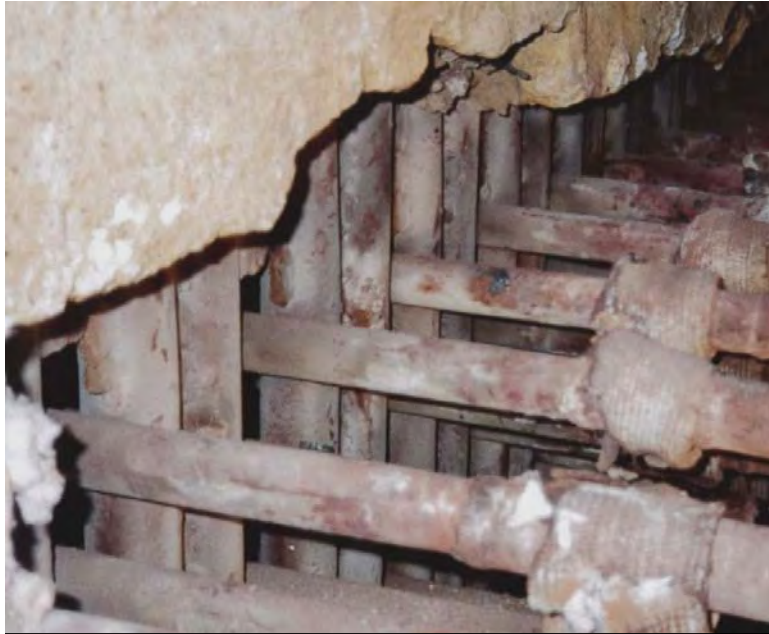
Before

- *Opposing movements cause repetitive failure of traditional repair & sealing tactics, allowing excessive air in-leakage.*
- *This plant was experiencing escaping flames in the rear corners.*

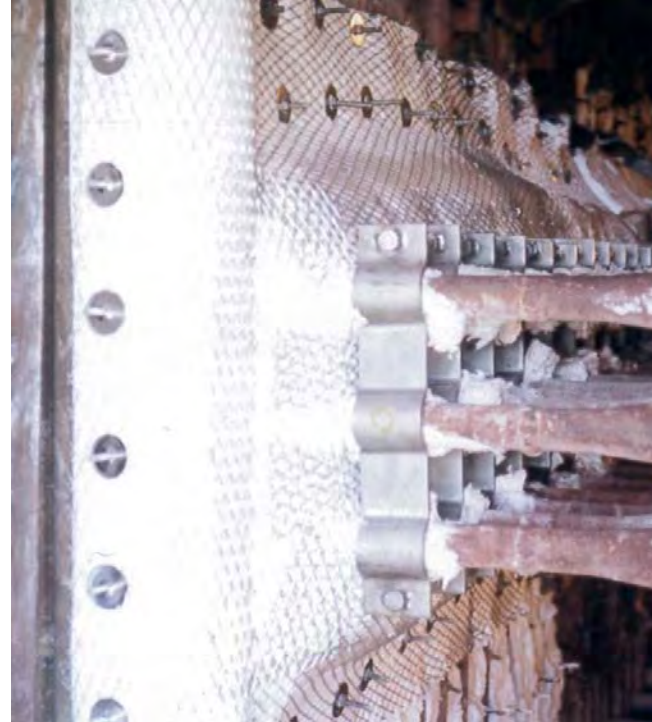
After

- *ISOMEMBRANE® creates a flexible, yet robust “boot,” that allows for the inevitable tube movement, while ensuring a reliable*

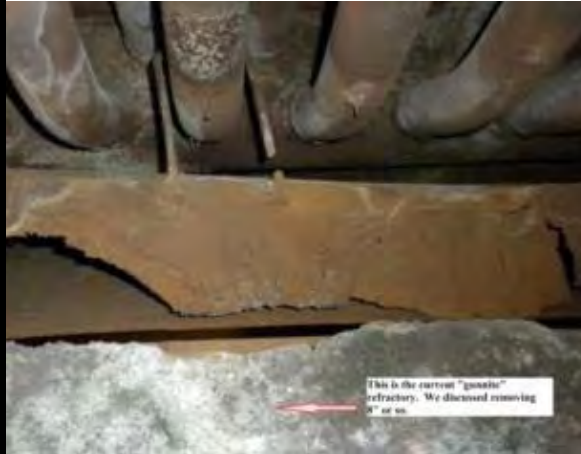
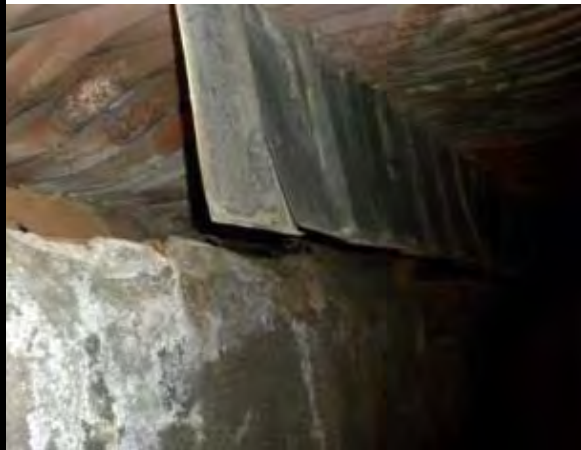
Before

- *Trough seals inherent lack of reliability renders them ineffective.*
- *The failed trough seal allowed excess air, resulting in excess NOx emissions, lower furnace slagging & heat loss out of the bottom of the boiler (impacting safe access to the area).*
- *Plant Reported Results:*
 - *“a significant reduction in the excess air leakage*
 - *NOx emissions are controlled.”*
 - Improved unit efficiency.*
 - *ISOMEMBRANE® “has been very reliable & looks the same as when it was first installed.”*

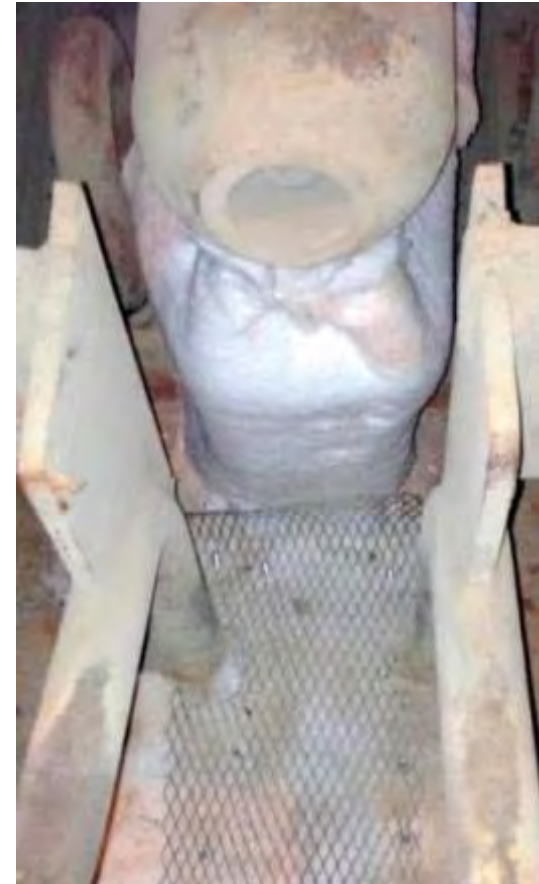
ISOMEMBRANE® in the
4th & 5th stages of installation

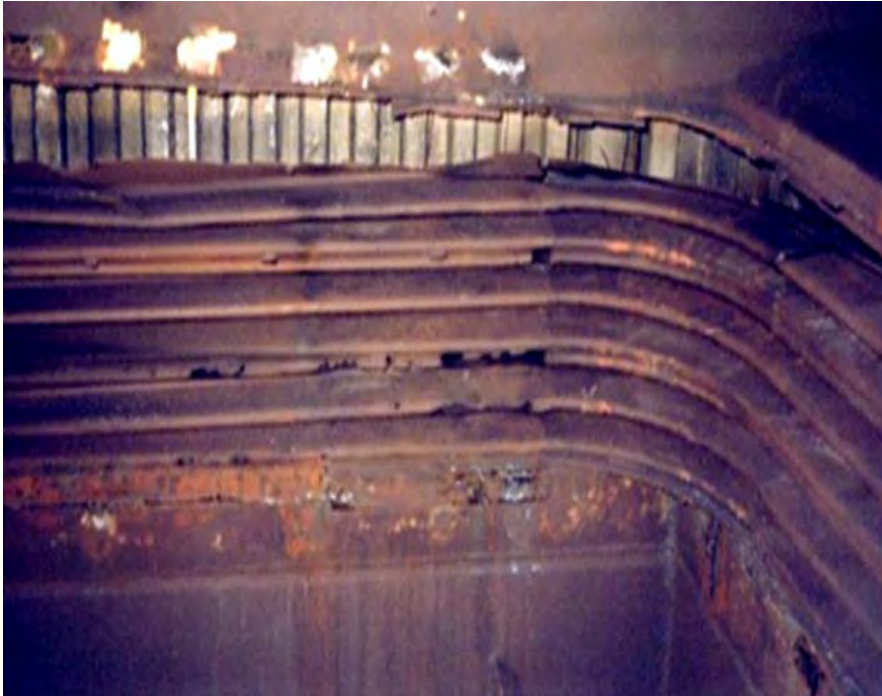
Retire Existing Joint In-place – Capital Budget Item

Expensive & time-consuming to replace.

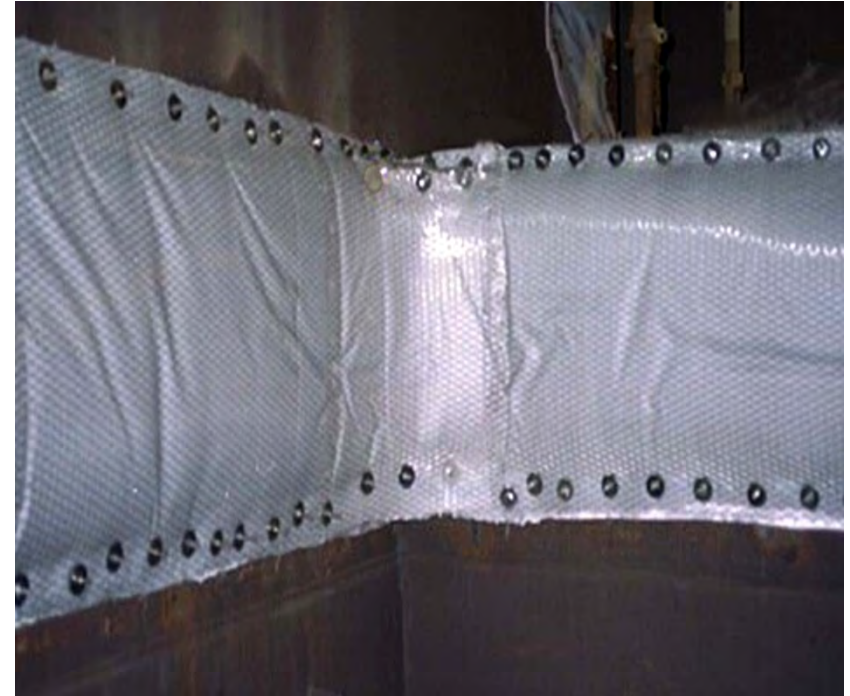
- *ISOMEMBRANE® bridges beyond corroded flanges & ductwork to good metal.*
- *Restored the integrity of the flue gas path*
- *Installed in 2 shifts.*

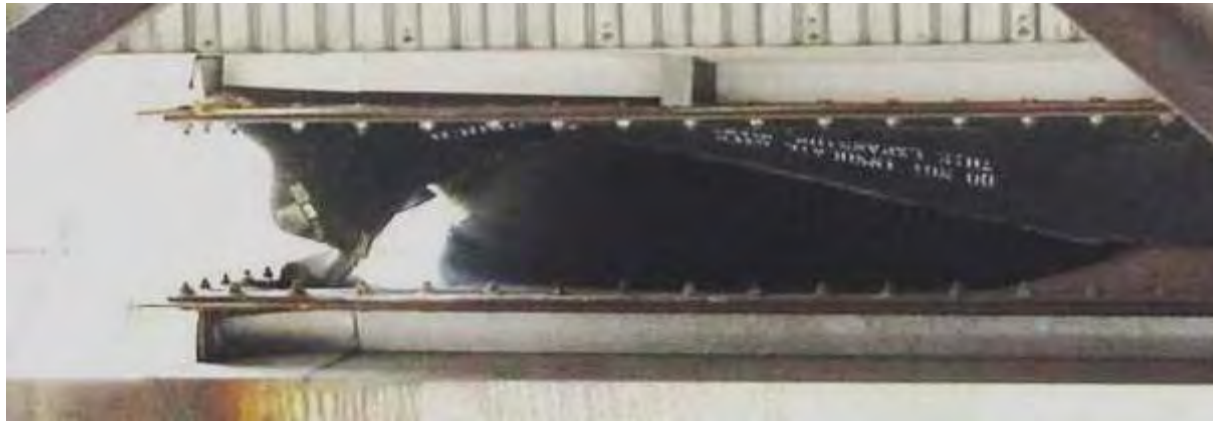
Before

- SCR system installed
- Joint blew when unit came on-line.
- Derate of 20MW
- The operating pressure was negative 20-25" H₂O.
- The plant dialed down the draw to about 6-8" H₂O.
- Installed in 1 ½ shifts, (in 20 degree weather!, which is why it's not the prettiest installation.)
- After 1st layer of ISOMEMBRANE® was installed, the plant returned to full load
- Immediately recovered 20MW
- Project Cost: \$21,000
- Installed in 2003.
- Still in-service

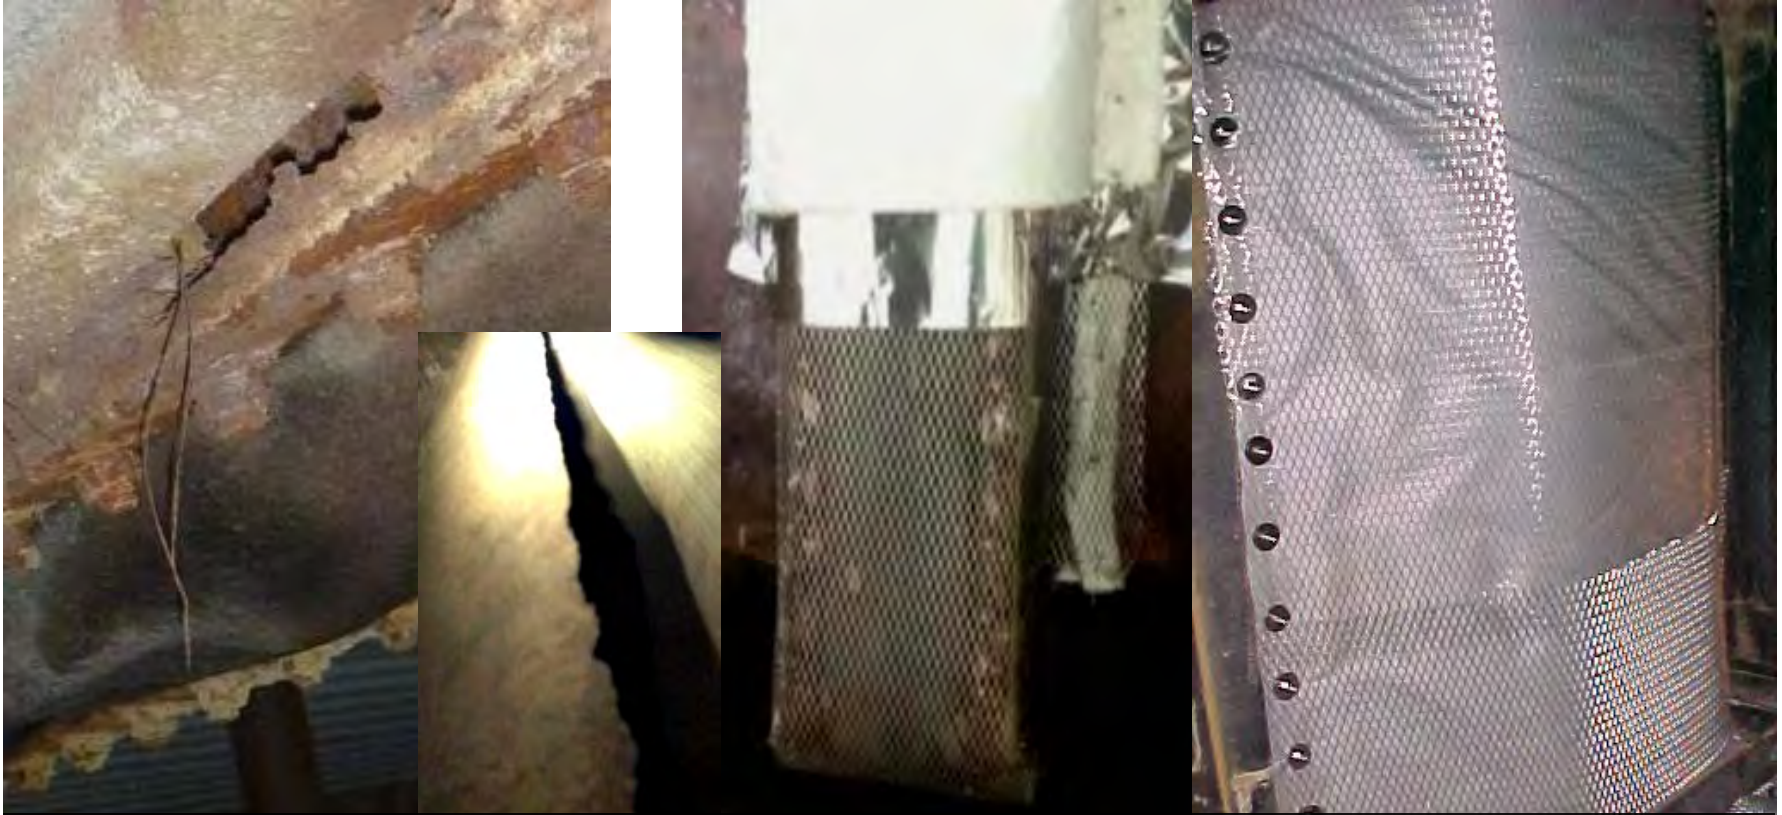
Case Study: Gas Recirculation Fan Joint Over Flange Installation, Bridge Over Corrosion

- *Catastrophic failure of corroded ductwork adjacent to the gas recirculation fan outlet expansion joints shutting the unit down during peak summer demand.*
- *HTT installed the ISOMEMBRANE® sealing the joint and beyond ductwork breach.*
- *After the ISOMEMBRANE® was installed, along with other repairs, the station successfully passed their capacity test for the first time in 3 years, restoring capacity payments.*

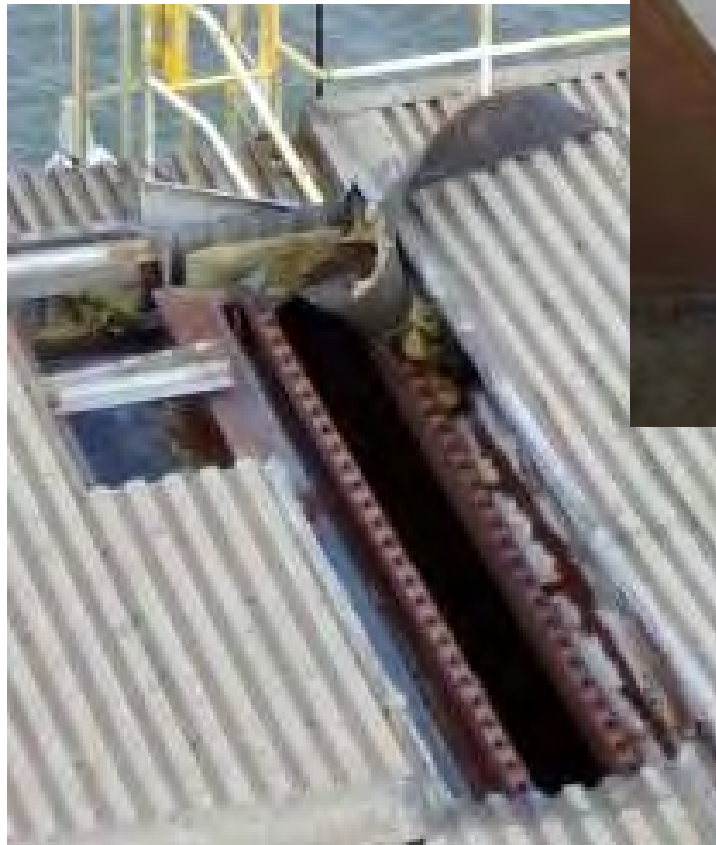
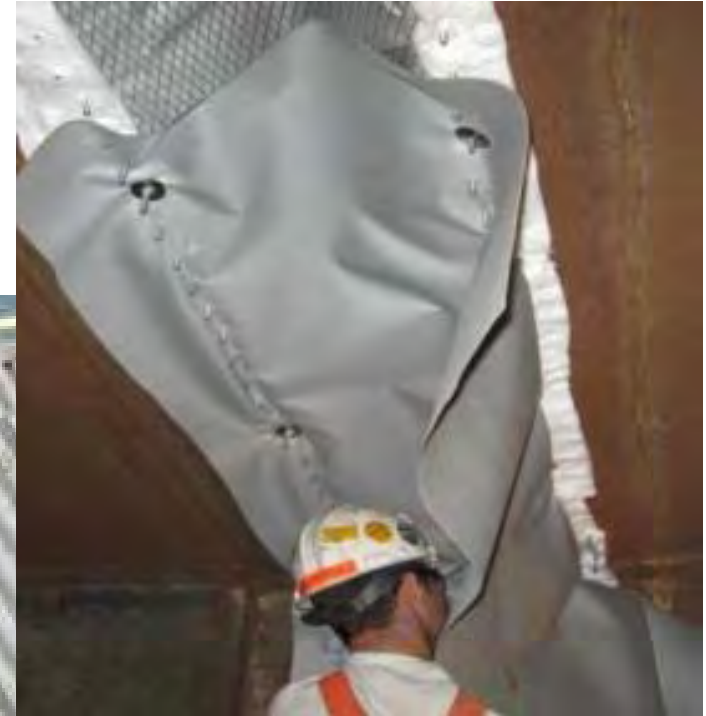
Case Study: FD Fan Expansion Joint

- Sudden Joint Failure
 - Decreased output from 198 MW to 130 MW
 - Decreased duct pressure from 54" H₂O to 30" H₂O
- Installed 1 ½ shifts
- Project Cost: \$25,000

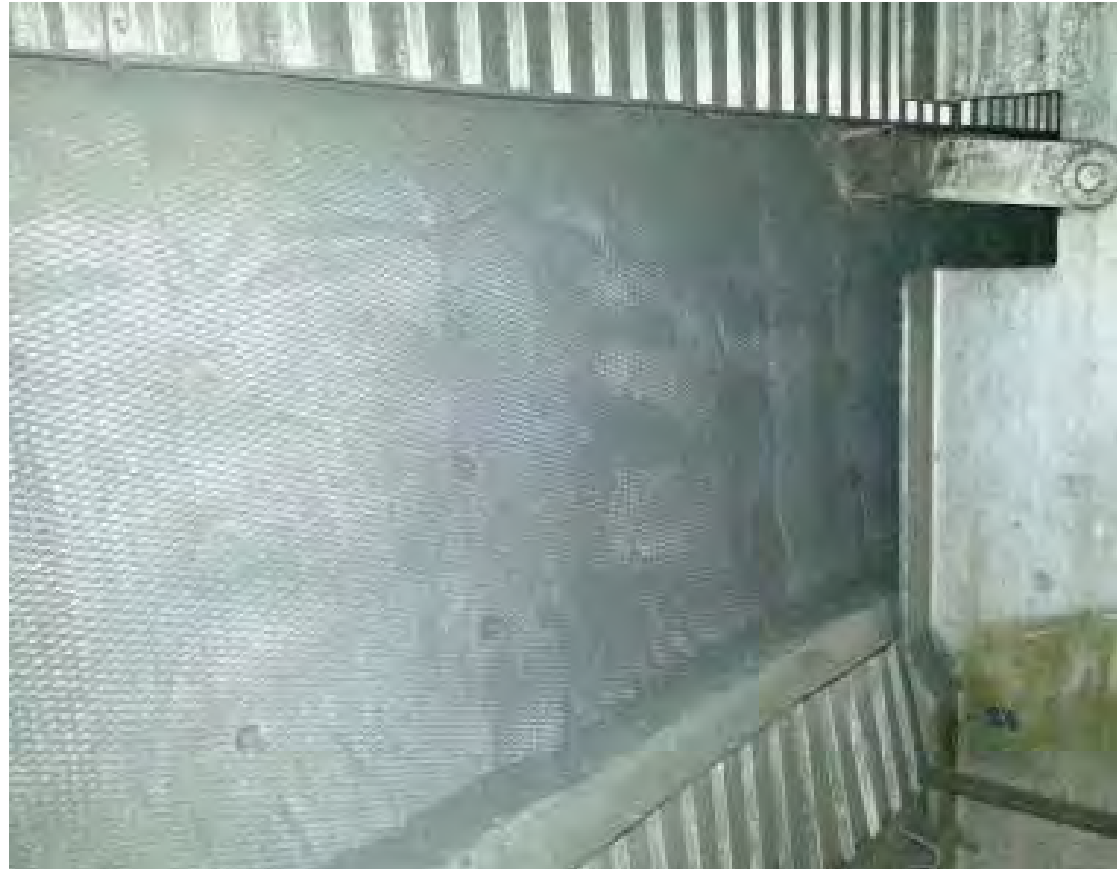
Case Study: Economizer Outlet Joint

- LOI decreased on “A” side from 8% to 6% for a heat rate improvement of 0.1%
- MS & RH temperatures improved by 5°F for a heat rate improvement of 0.12%
- Electrical auxiliaries decreased for a heat rate improvement of 0.05%
- Decreased average coal feeder speed from 8.2 to 7.8 rpm
- Total 0.27% effect on heat rate: \$50,000/year at 60% capacity factor
- Project Cost: \$30,000

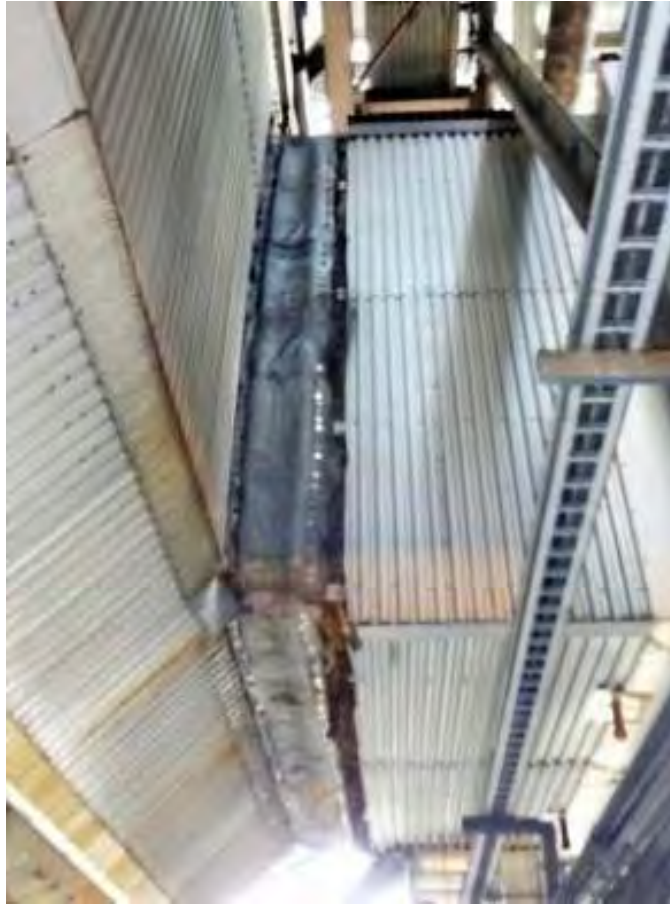
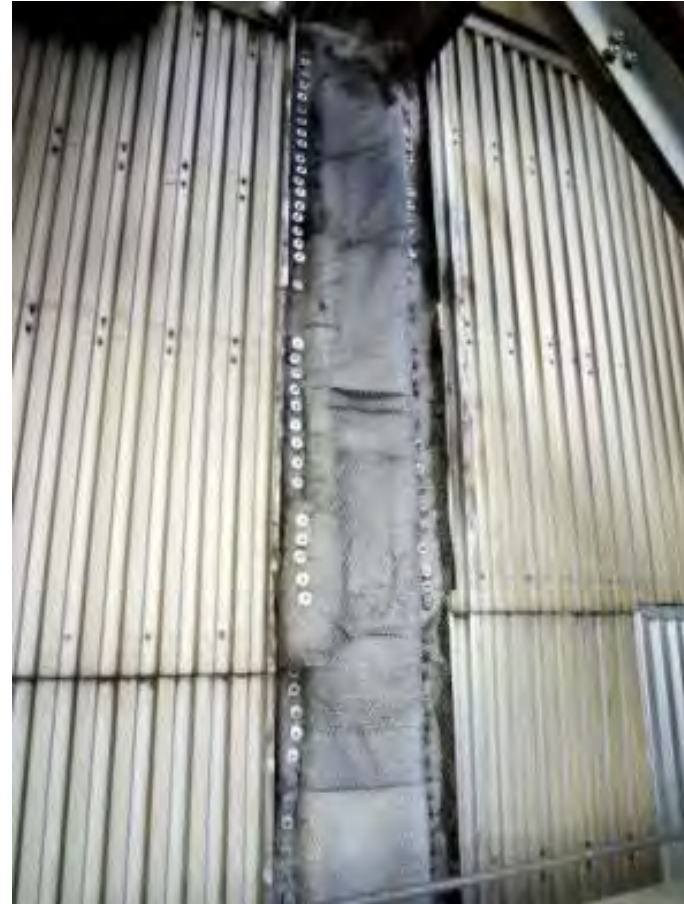
CASE STUDY: Air Heater Expansion Joint *After 18 Years*

Original ISOMEMBRANE® Installation in 1996, photos taken Jan 2013
