**2015 APC Round Table  
& Expo Presentation**

July 13 & 14, 2015, in Atlanta, GA / Hosted by Southern Company

**Case Studies: Using Trona, SBC, and Hydrated Lime for High  
Level SO<sub>2</sub> Removal  
Reinhold APC Conference  
July 14, 2015**

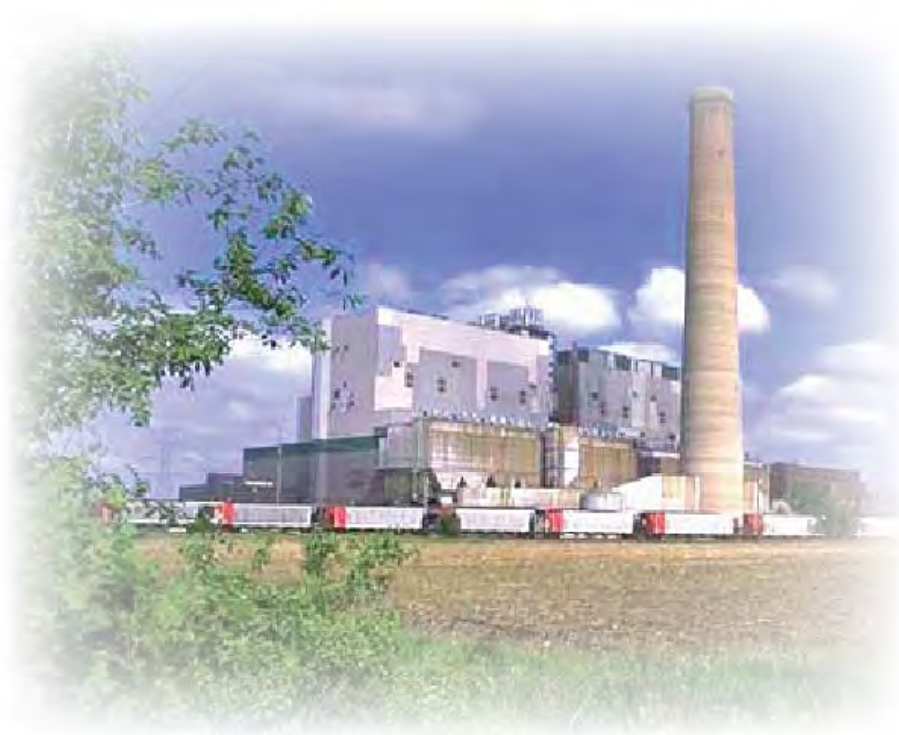
- 600 MW Unit
- PRB Coal
- SCR, Cold Side ESP
- ACI System
- Ash Landfilled On-site

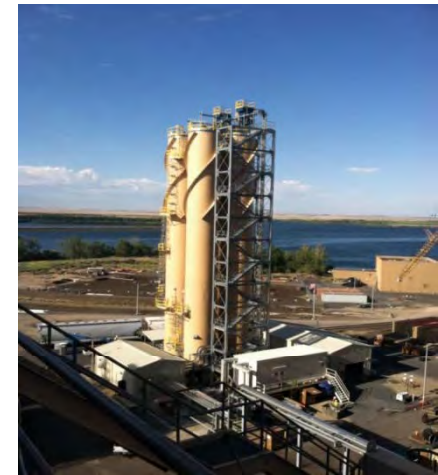
- In-line milled trona injection
- Injection at air heater inlet
- Four silos, over 120 feet tall, with common stair tower
- Rail unloading
- Screw feeder/rotary air lock design
- Conditioned rail unloading and conveying air
- Two VIPER® Mills
- Blower building
- Electrical building
- Mill building

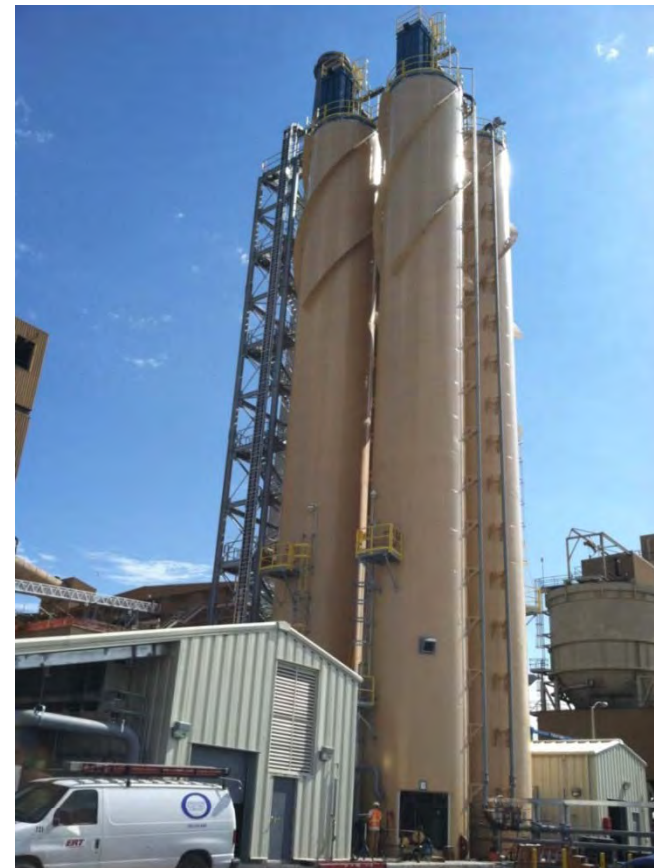
- Silos
  - Two piece design
    - Welded on site
  - Bin Activators
  - All equipment Installed on site

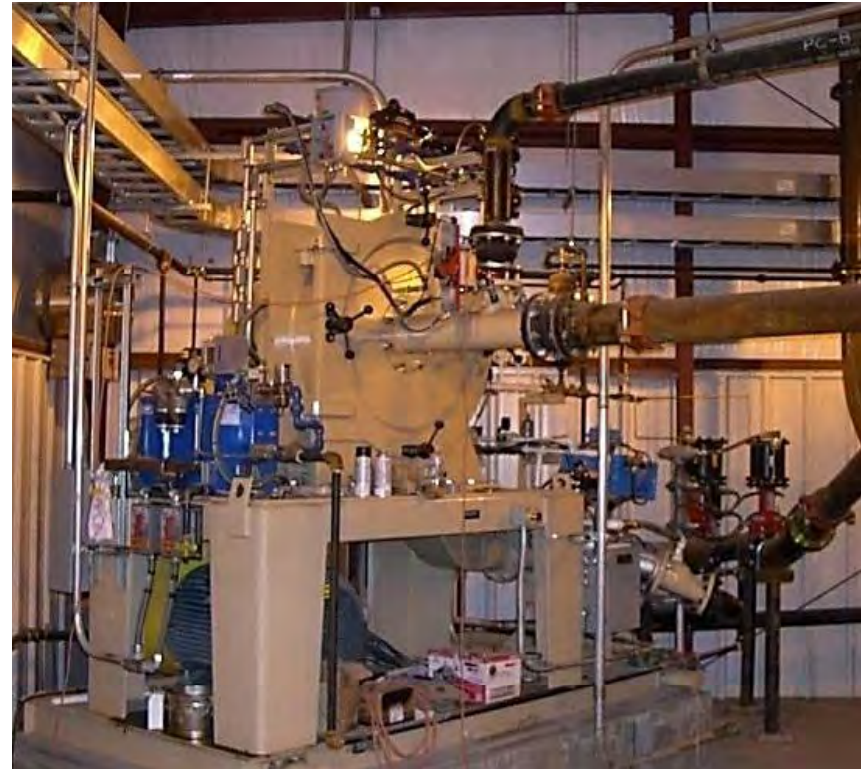
- UCC VIPER Mills
  - Two mills with approximately 1 ½ years of run time
  - No wear issues observed and no downtime

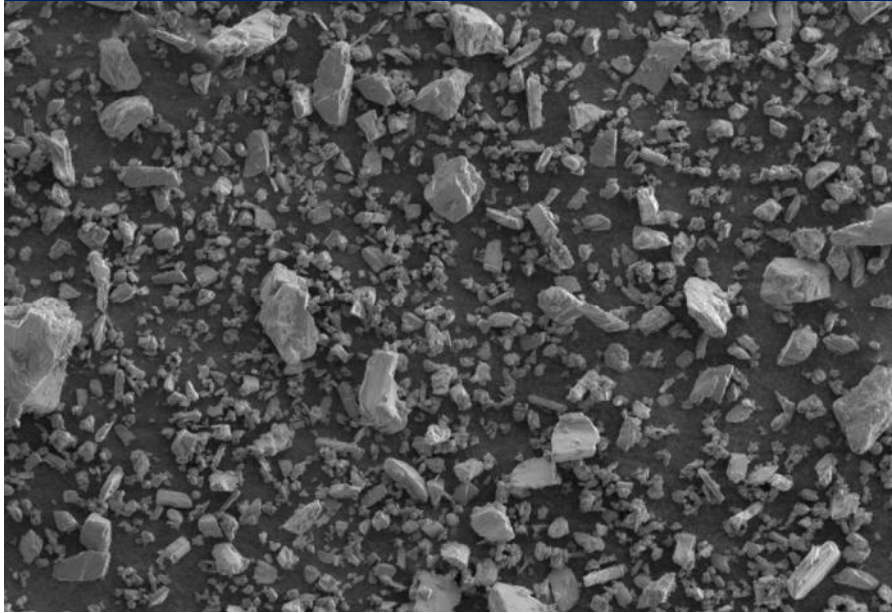
## Unmilled Trona

30-50  $\mu\text{m}$

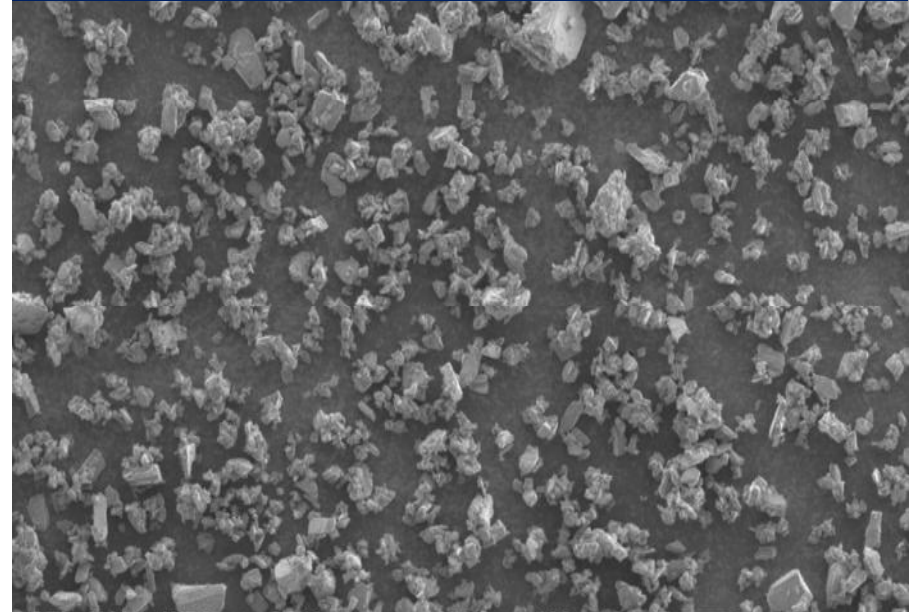
## Milled Trona

9 -15  $\mu\text{m}$

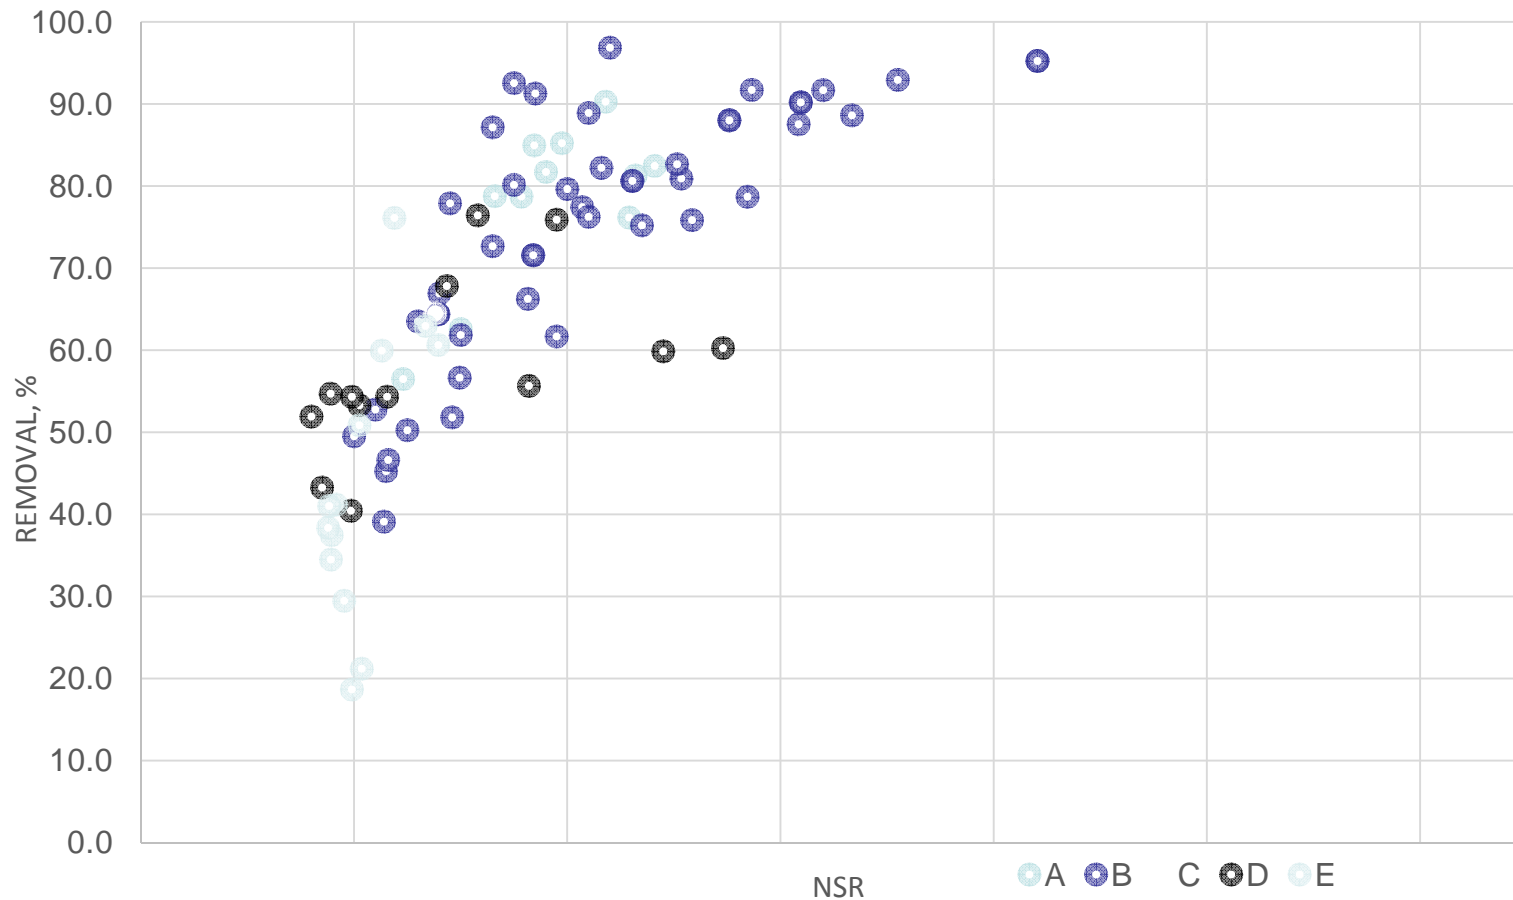
SO<sub>2</sub> removal (PRB Coal) with milled Trona at Air Heater inlet

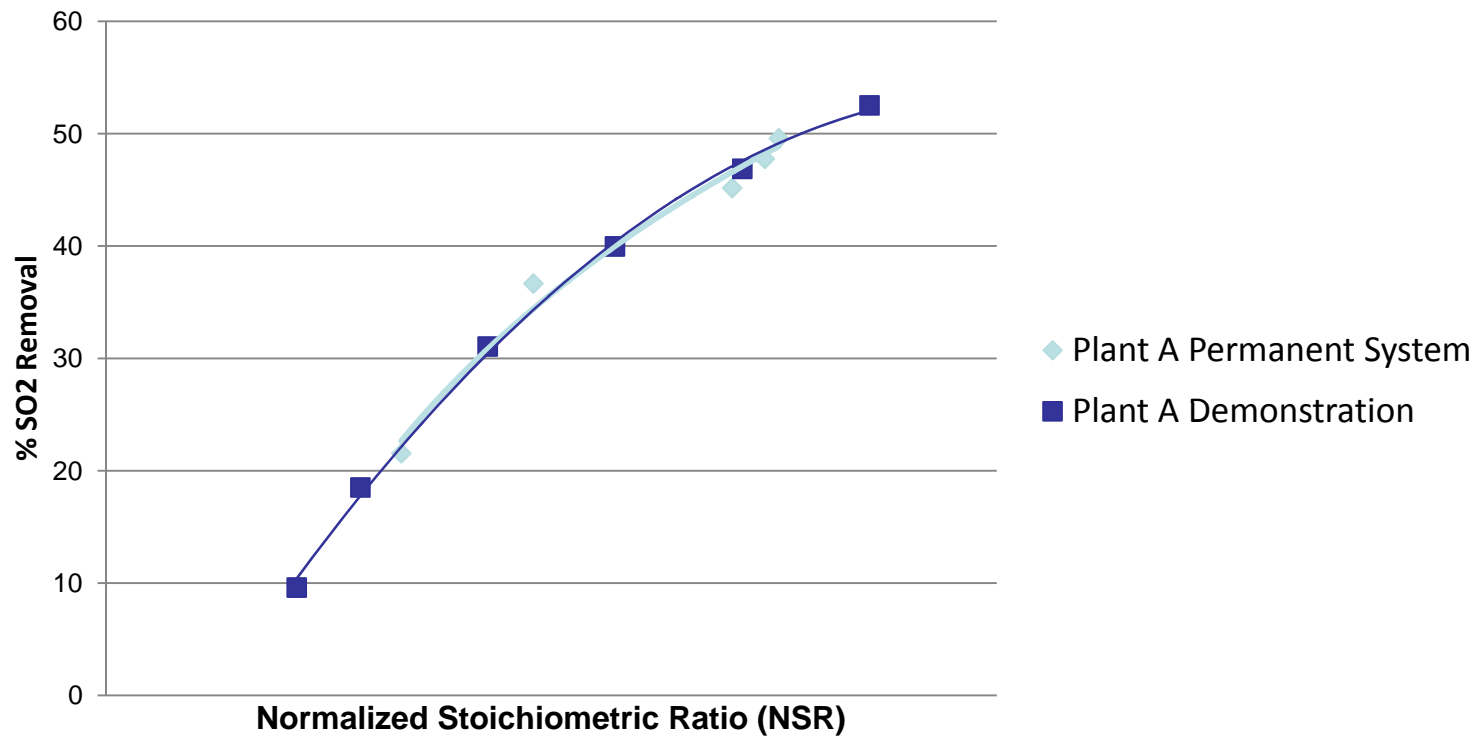
## % SO<sub>2</sub> Removal vs. NSR

- CFD modeling was completed prior to demonstration to optimize results of test

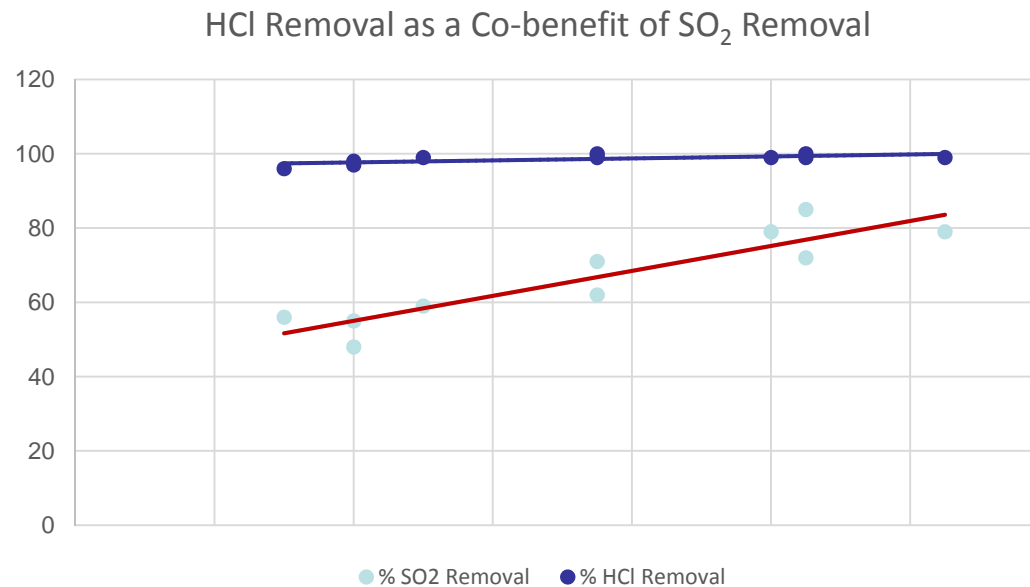
- Mercury Removal
  - Initially required up to 3X more PAC when trona used
  - Were able to nearly eliminate effects by separating trona and ACI
- HCl Removal as a Co-benefit

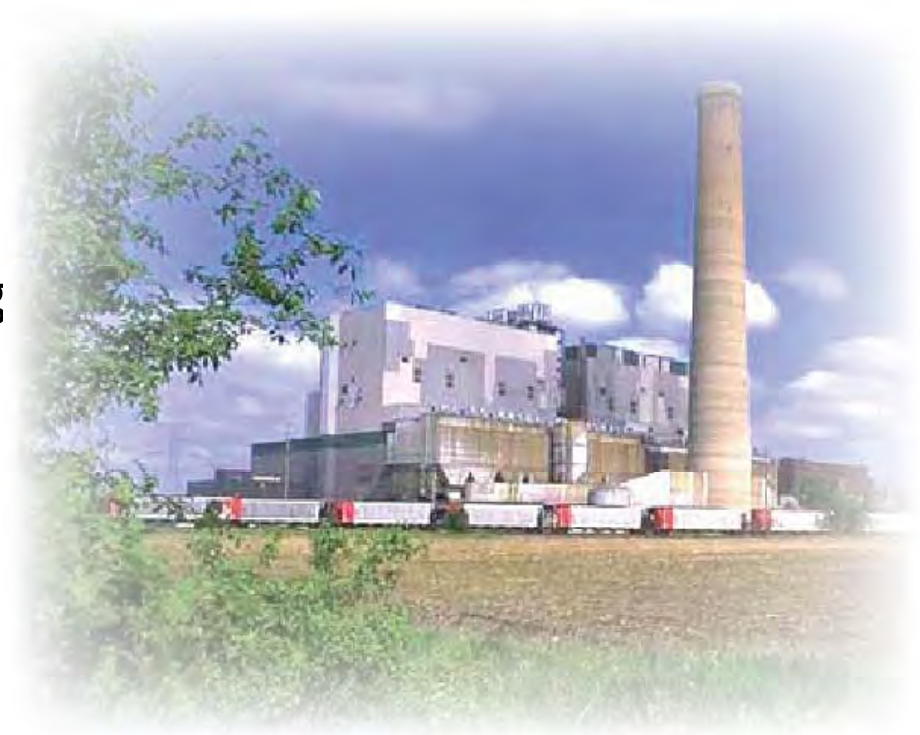
- 400 MW Unit
- PRB Coal
- Hot Side ESP
- Fabric Filter
- ACI System
- Ash Landfilled after mixing with SBC byproduct

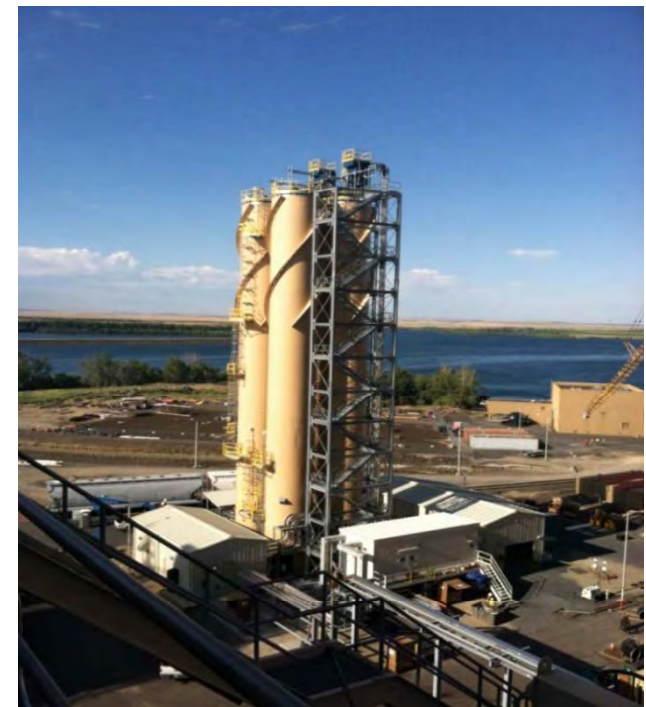
- In-line milled sodium bicarbonate injection
- Injection at air heater outlet
- Four silos, 100 feet tall, with common stair tower
- Truck unloading
- Screw feeder/rotary air lock design
- VIPER<sup>®</sup> Mills
- Blower/electrical building
- Mill building
- Conditioned truck unload and conveying air

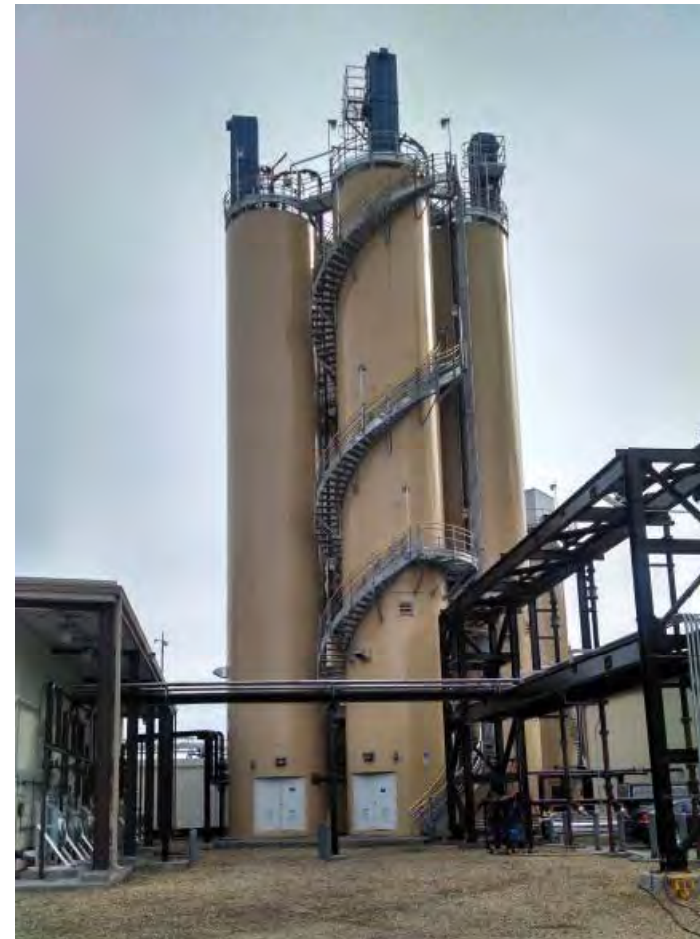
- Silos
  - One piece design
  - Chisel bottom
  - All equipment installed on site

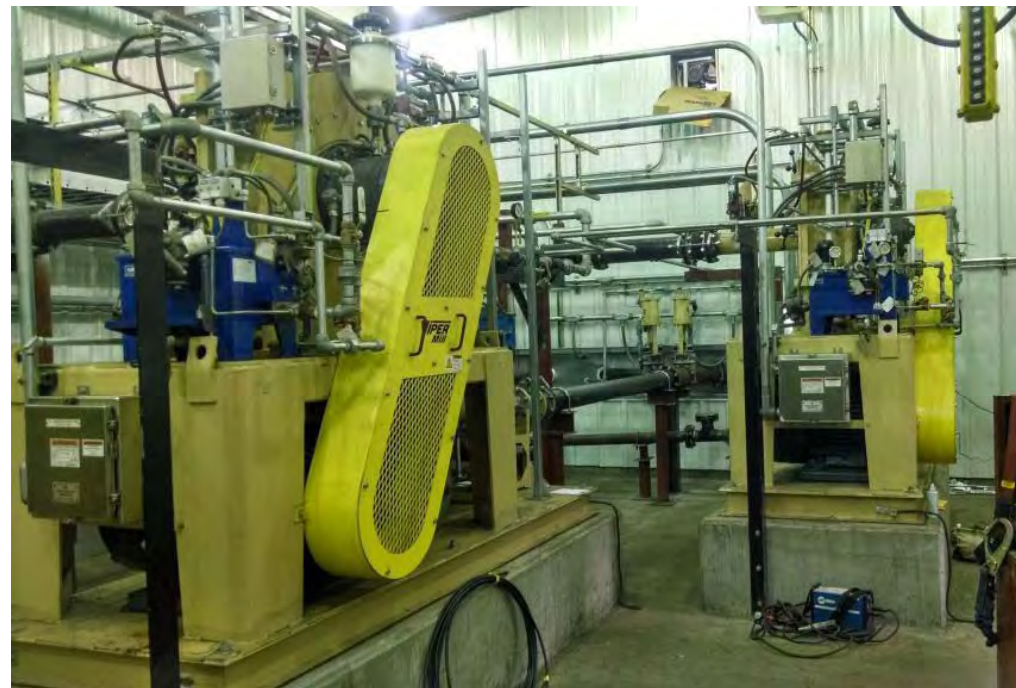
- UCC VIPER Mills
  - Three mills
  - Approx. 1-year run time to date

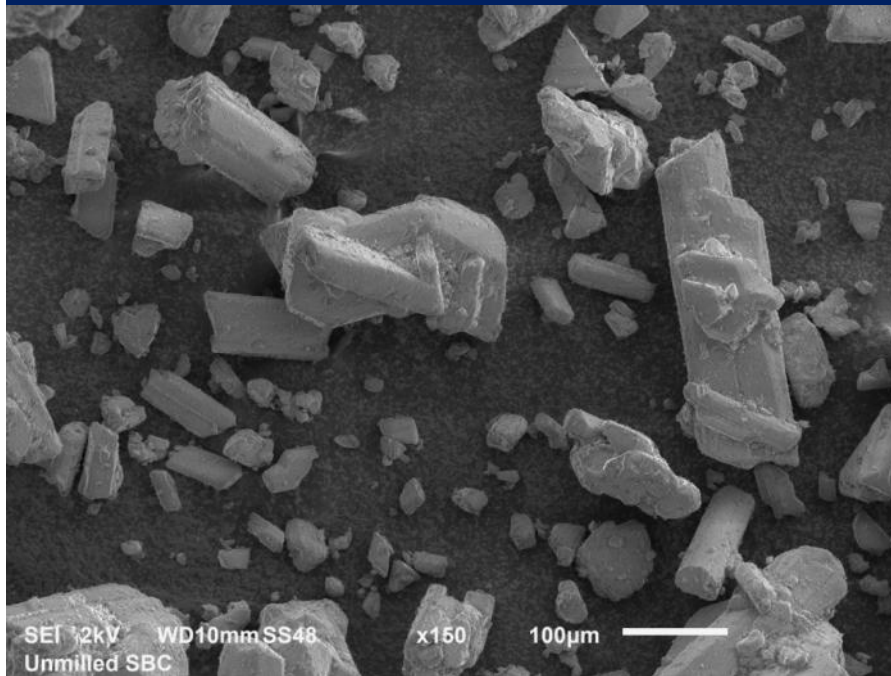
## Unmilled SBC

180-250  $\mu\text{m}$

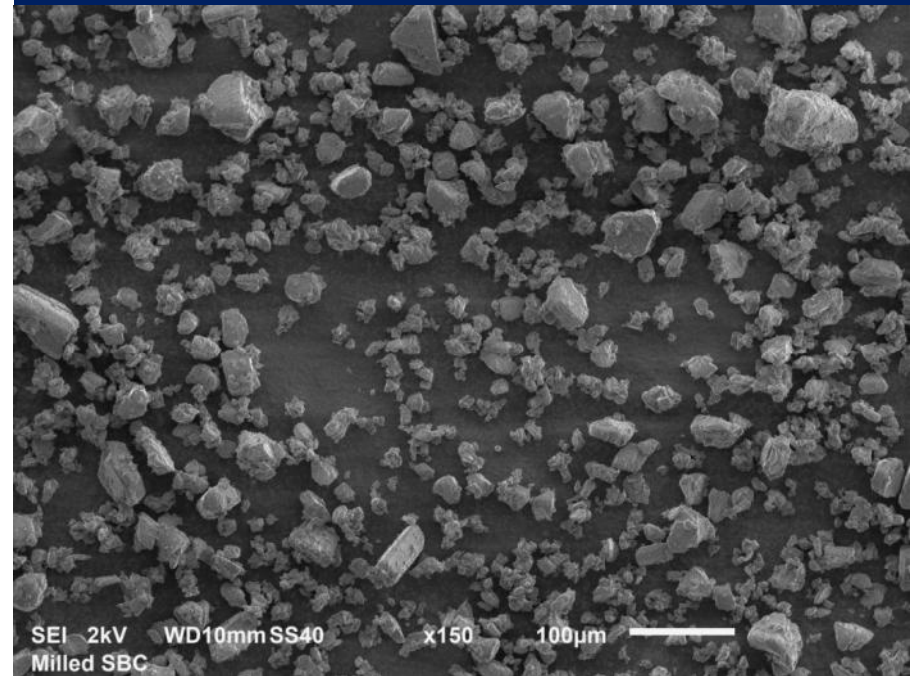
## Milled SBC

12-15  $\mu\text{m}$

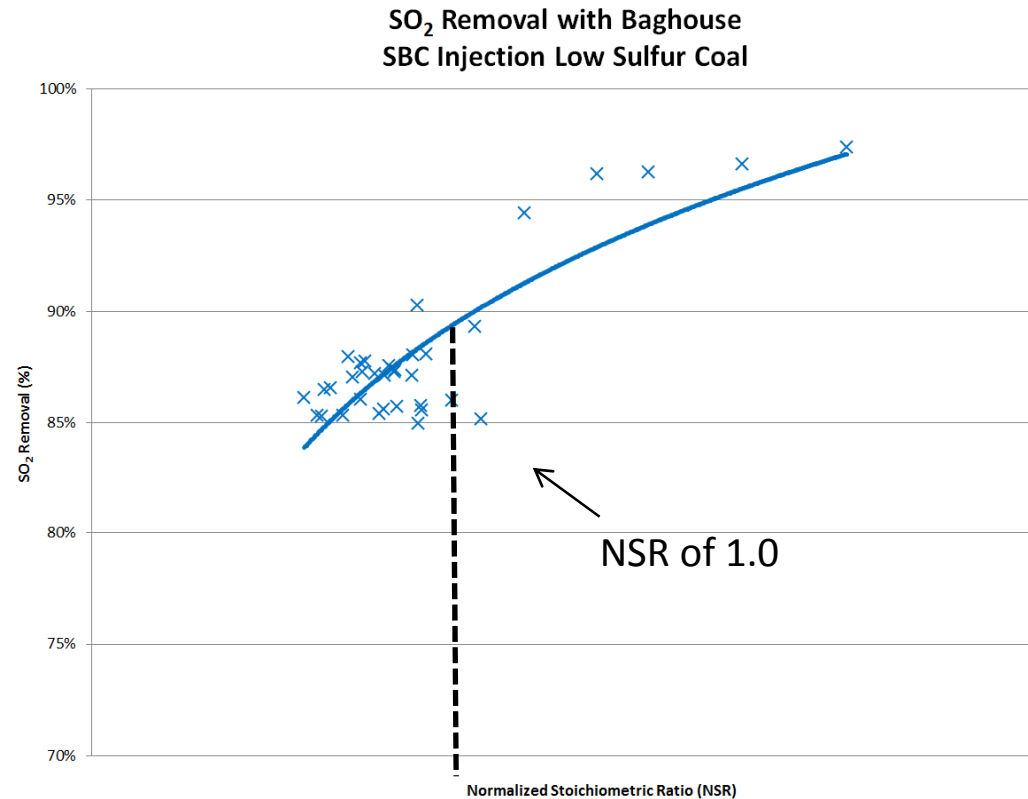
- Efficiencies compete with scrubbers on a 20-year life cycle
- In-line milled SBC <15 microns (from coarse SBC)

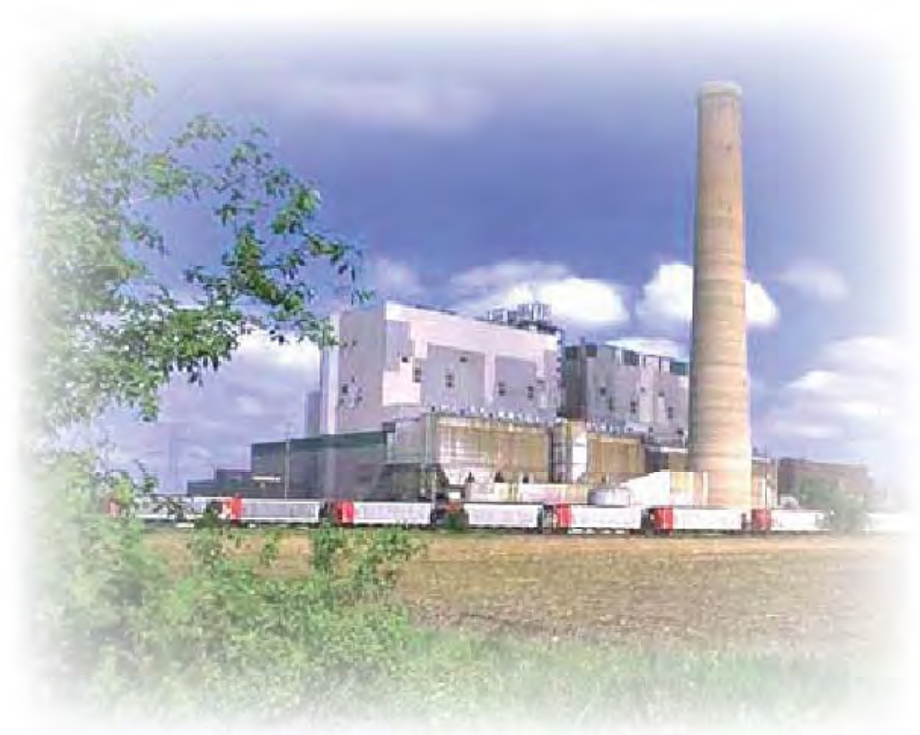
- 350 MW Unit
- PRB Coal
- Fabric Filter
- ACI System
- Ash Landfilled

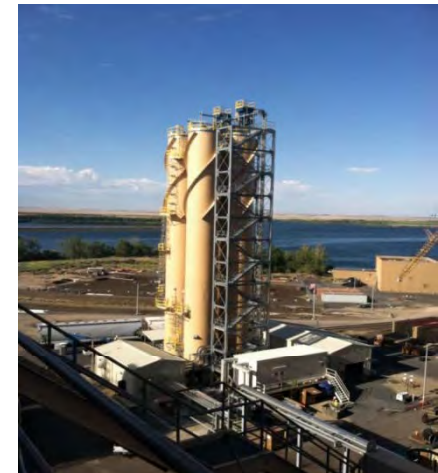
- Hydrated Lime Injection at air heater inlet
- Two silos, with common stair tower
- Truck unloading
- Screw feeder/rotary air lock design
- Conditioned truck unloading and conveying air
- Space reserved for future VIPER Mills
- Blower building and Electrical building
- Designed for high reactivity hydrated lime
  - Not a specific hydrated lime manufacturer

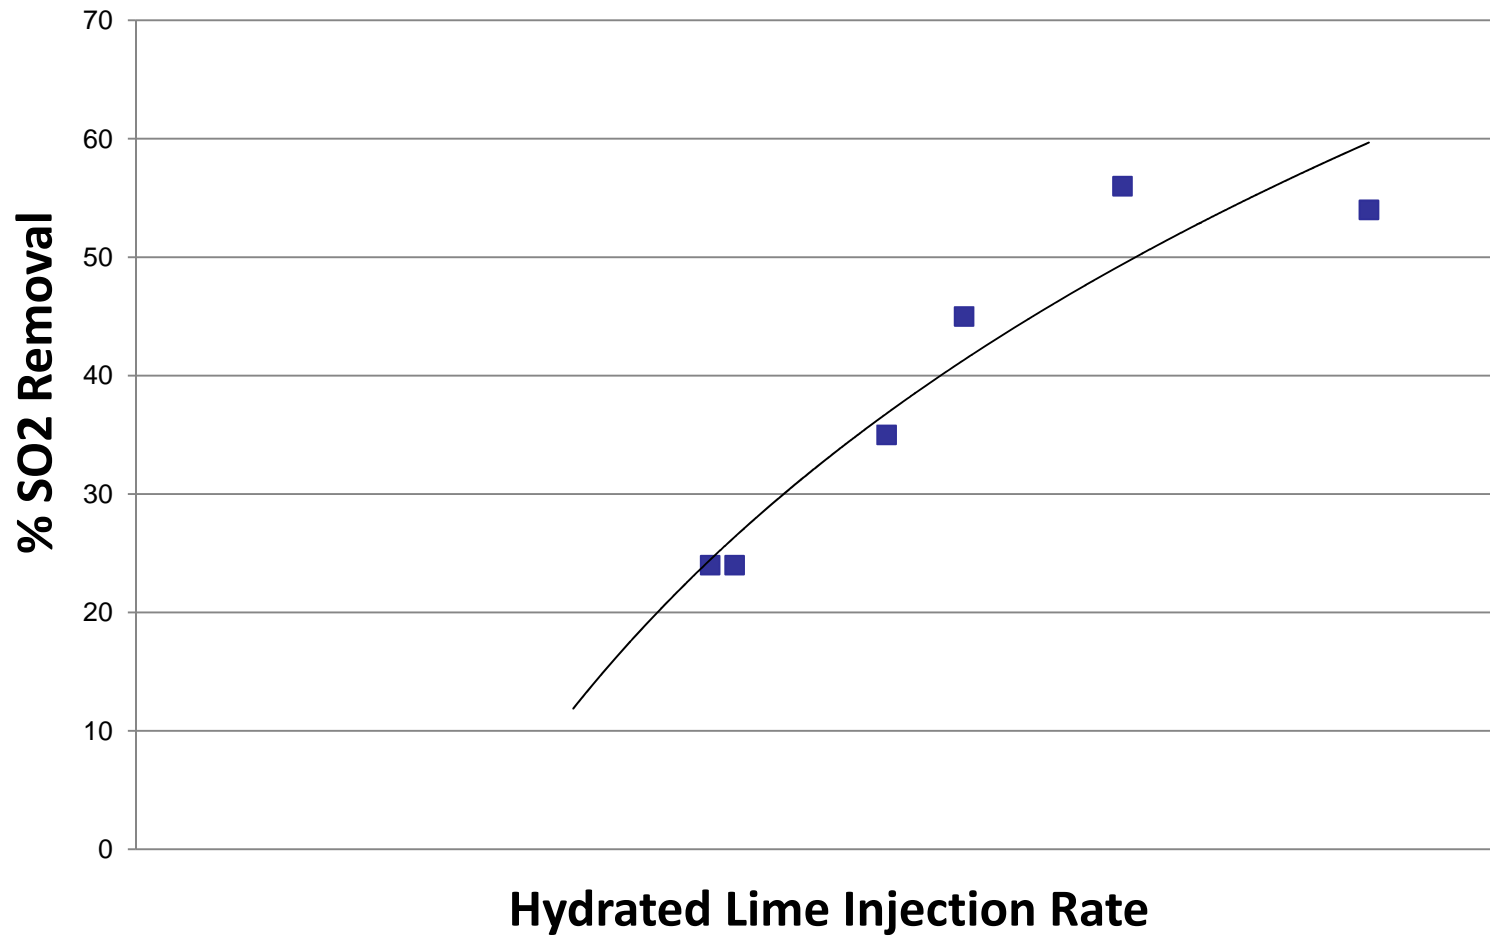
# Case Study 3 - SO<sub>2</sub> Reduction Performance

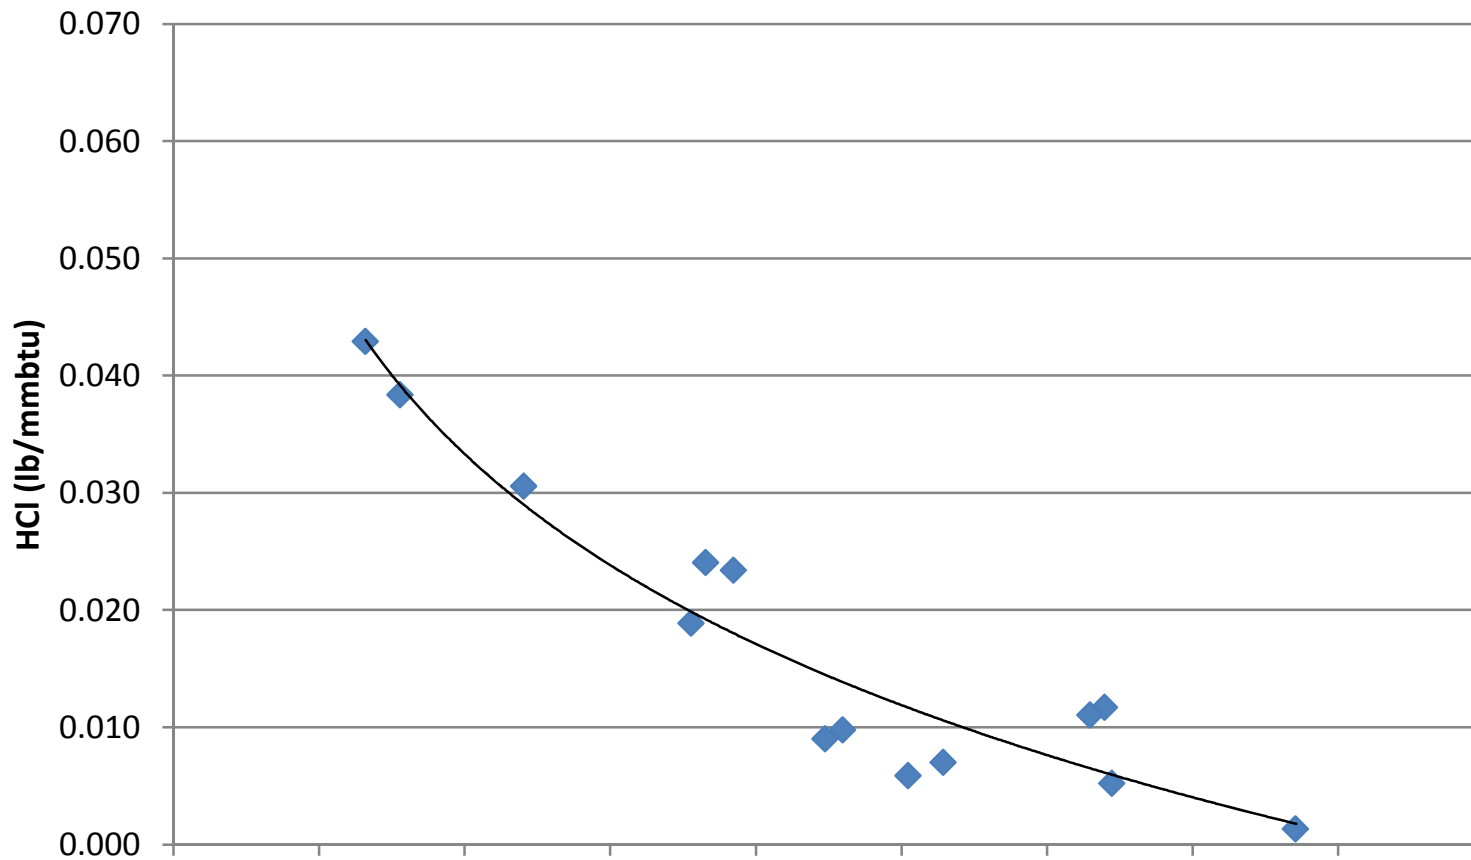
# Case Study 3 – HCl Removal with Hydrated Lime
