**2017 APC & Wastewater Round Table
& Expo Presentation**

Review of Corrosion Findings from EPRI's 2016 Bromine Balance of Plant Survey

AECOM: Katherine Dombrowski

EPRI: Nanda Srinivasan

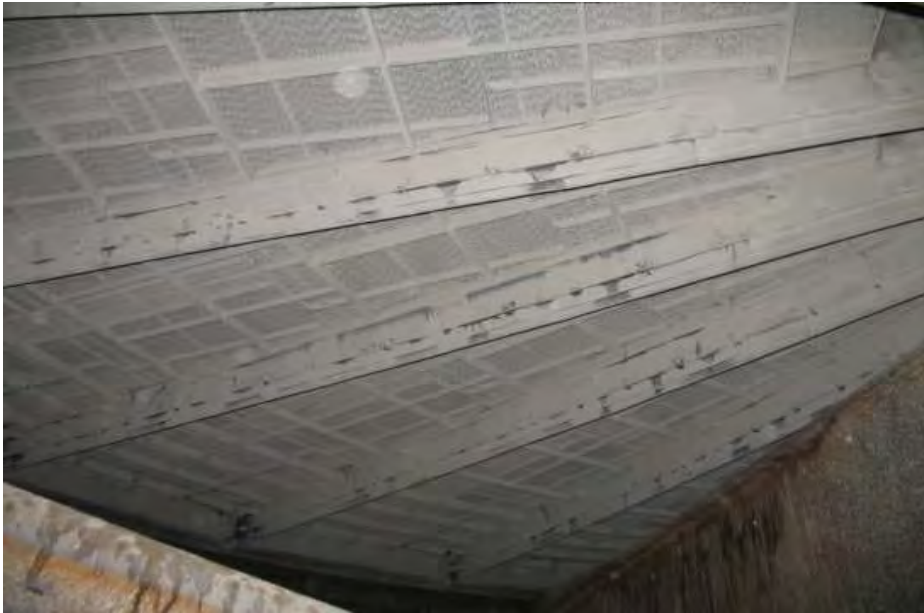
Severe air heater corrosion can occur within 12 months of Br addition

Cold-end baskets with 15 years operation

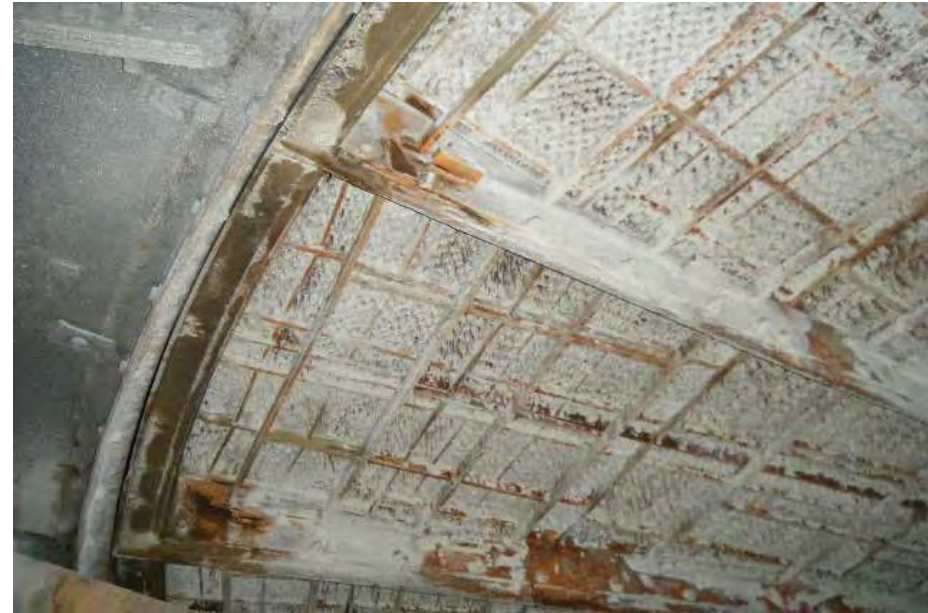
**Cold-end baskets with 15 years operation
+ 1 year of Br addition**

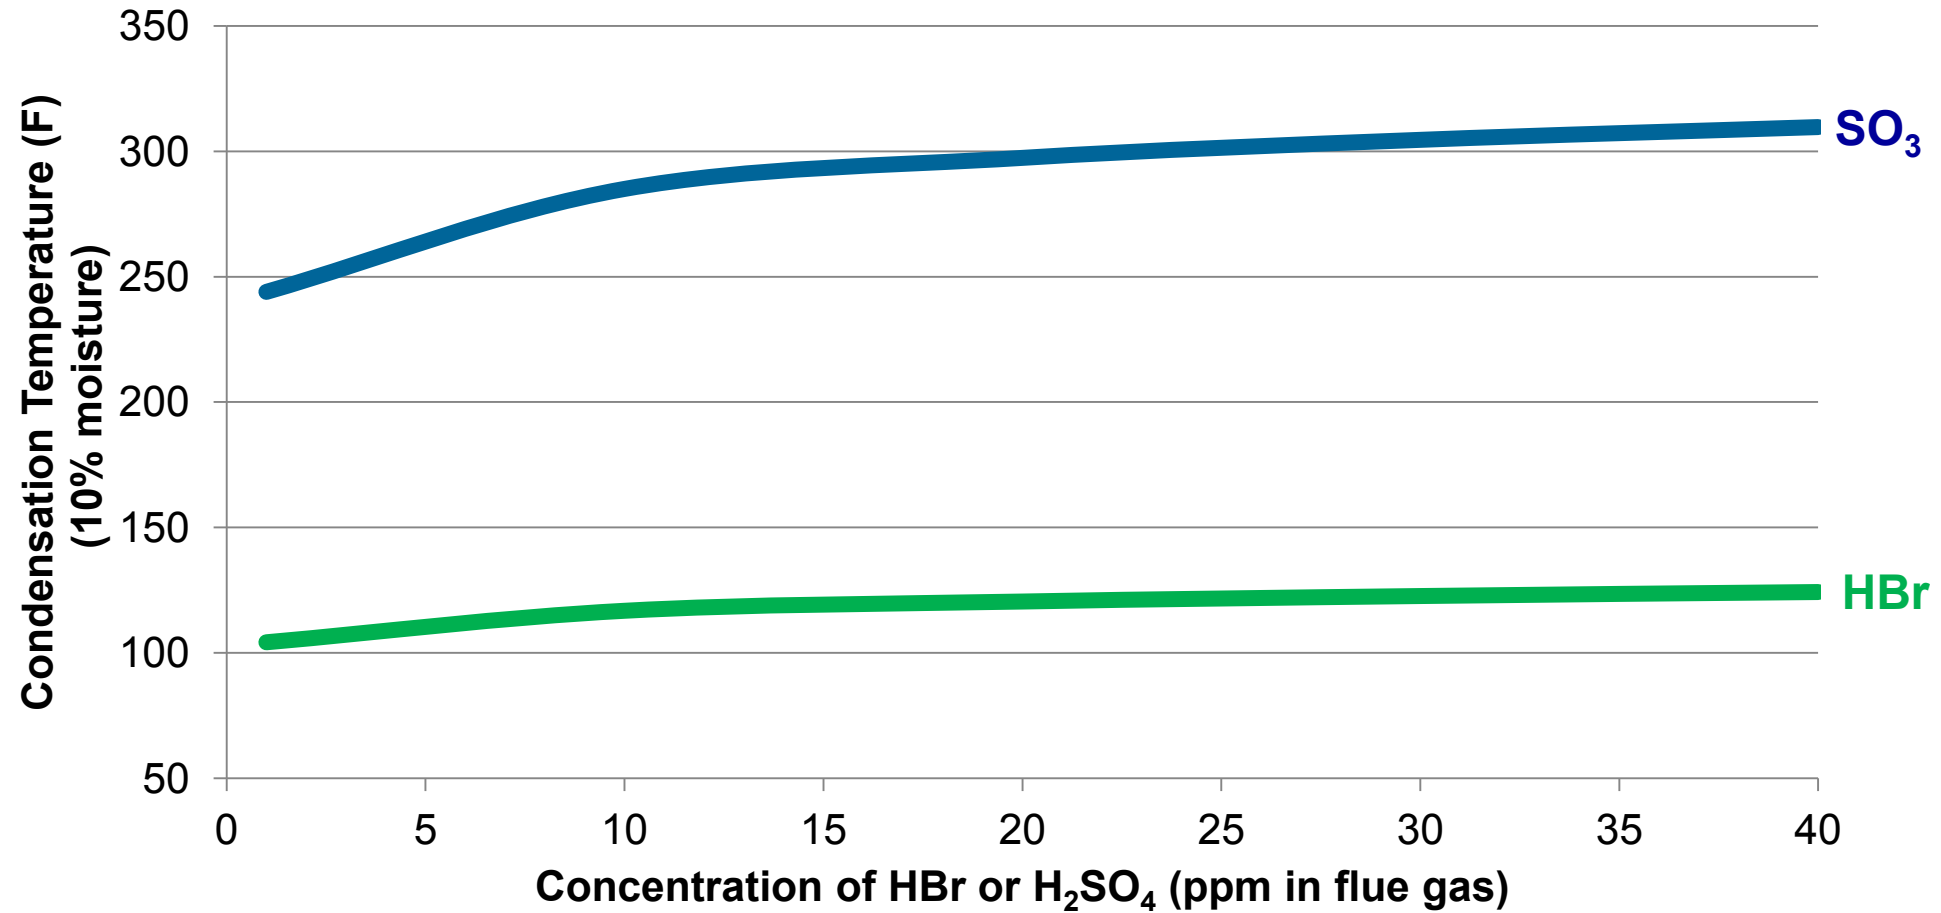
HBr condenses at a much lower temperature than SO₃

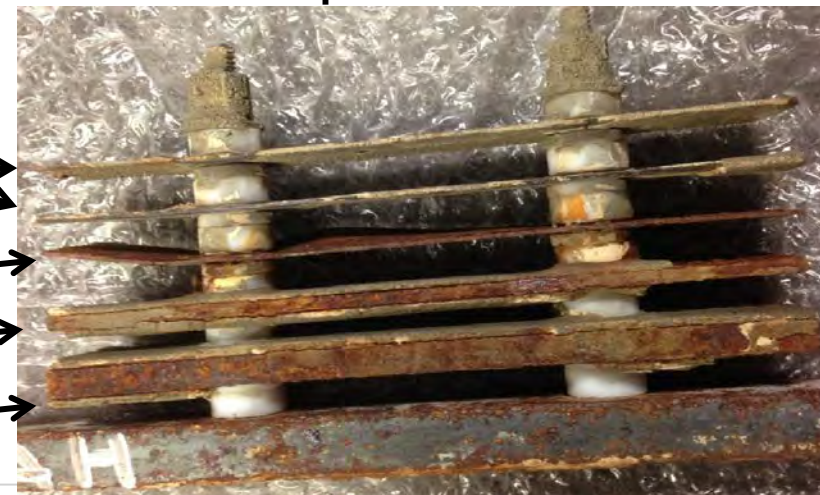
Field: AH corrosion on all coupons except enameled coupons; thin elements experienced severe corrosion

AH coupon after removal

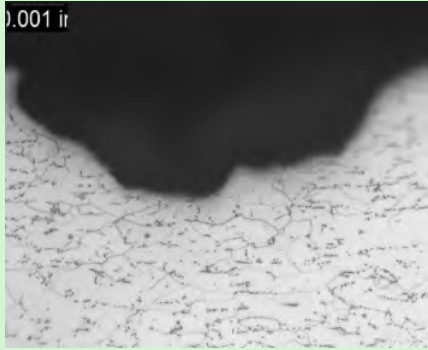
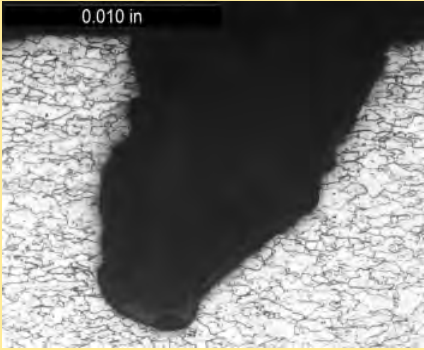
Lab: Higher moisture coals more vulnerable to AH corrosion, even at lower Br rates

Test temperature (°F)	170°F	
	<i>Above HBr Dew Point, Below SO₃ Dew Point</i>	
Coal flue gas simulated	Low Moisture	High Moisture
Gas moisture (%)	5	12
HBr (ppm)	8	2
SO ₃ (ppm)	8	2
SO ₂ (ppm)	1500	200
Maximum Pit Depth (in)	0.002	0.013
Visual

Metallography

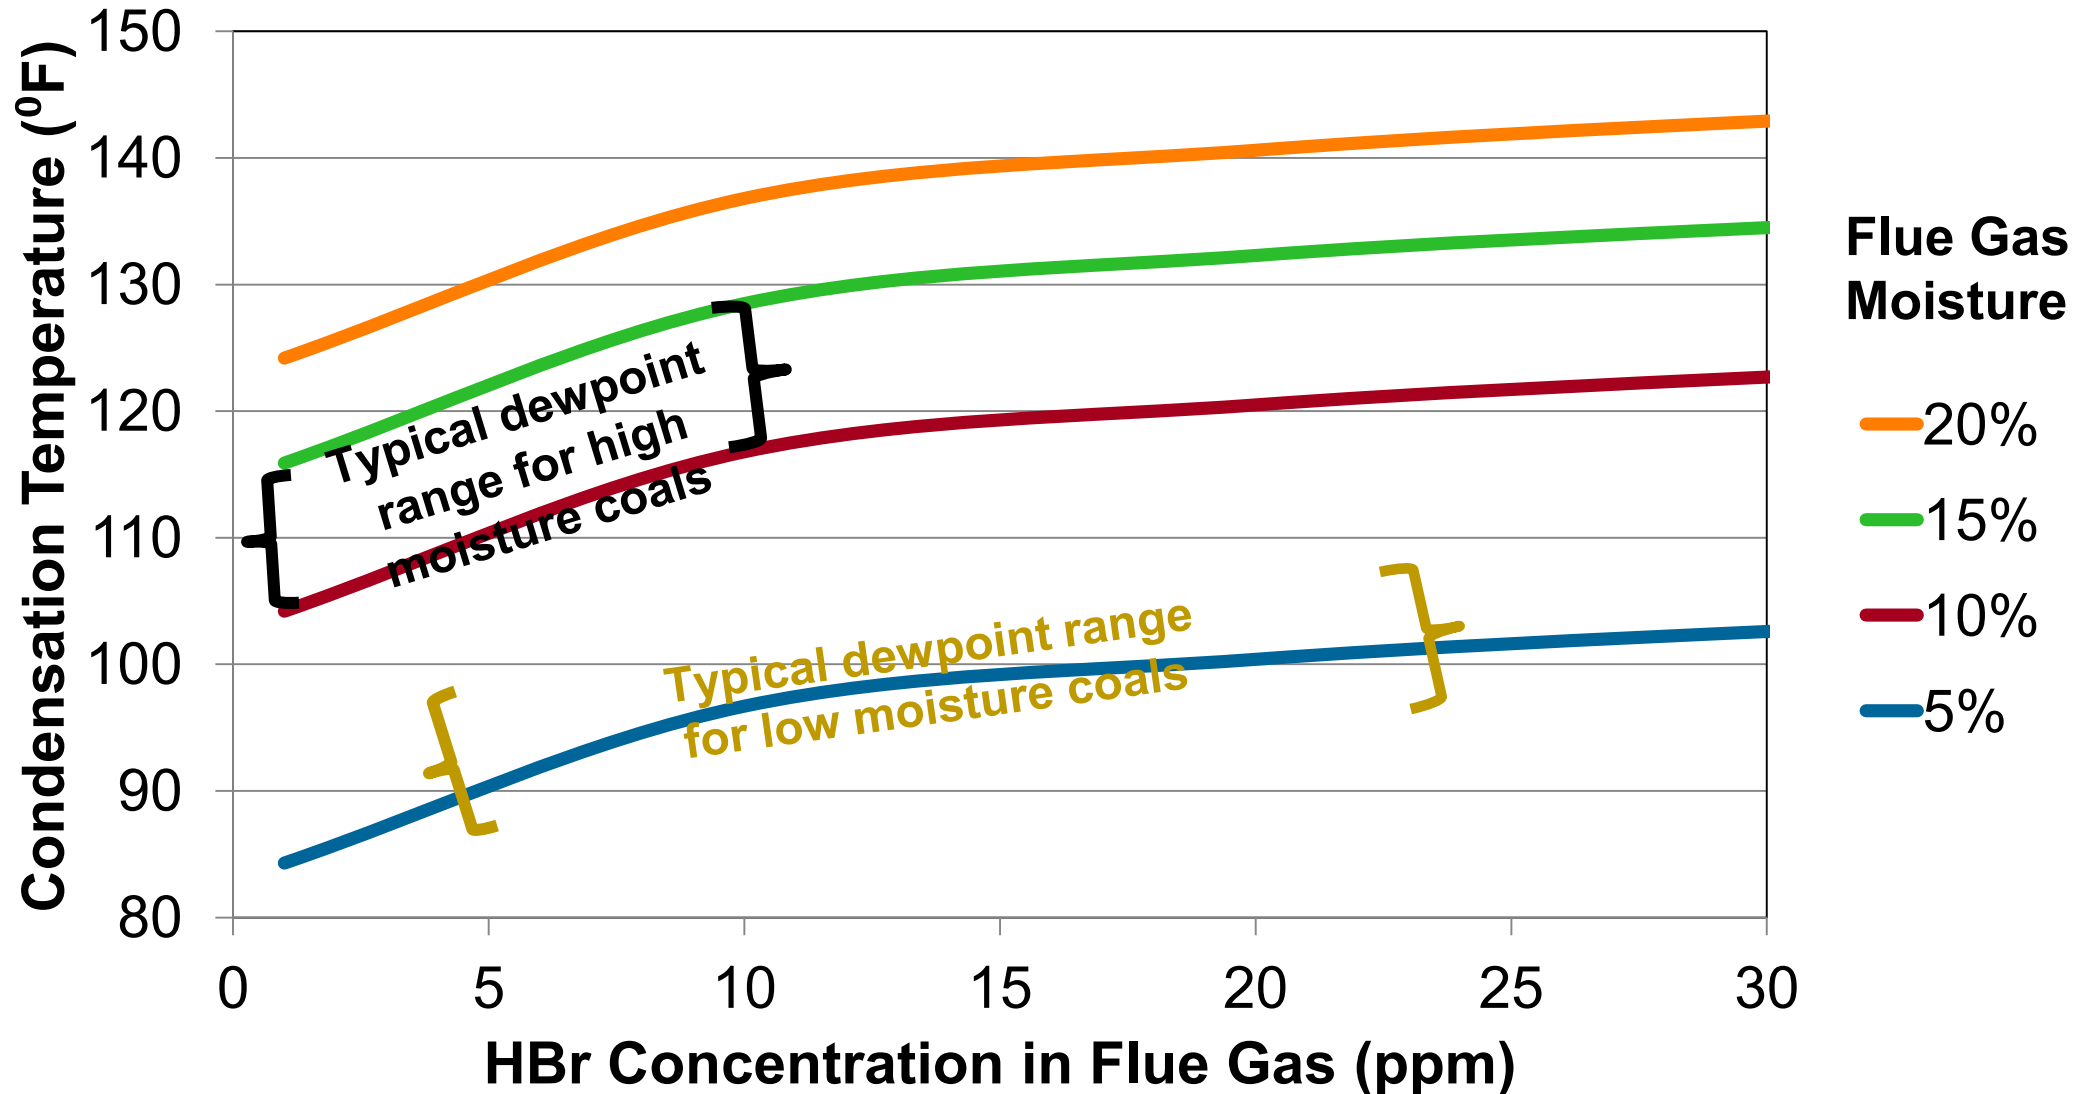
High moisture coals may be more vulnerable to corrosion due to higher HBr condensation temperatures

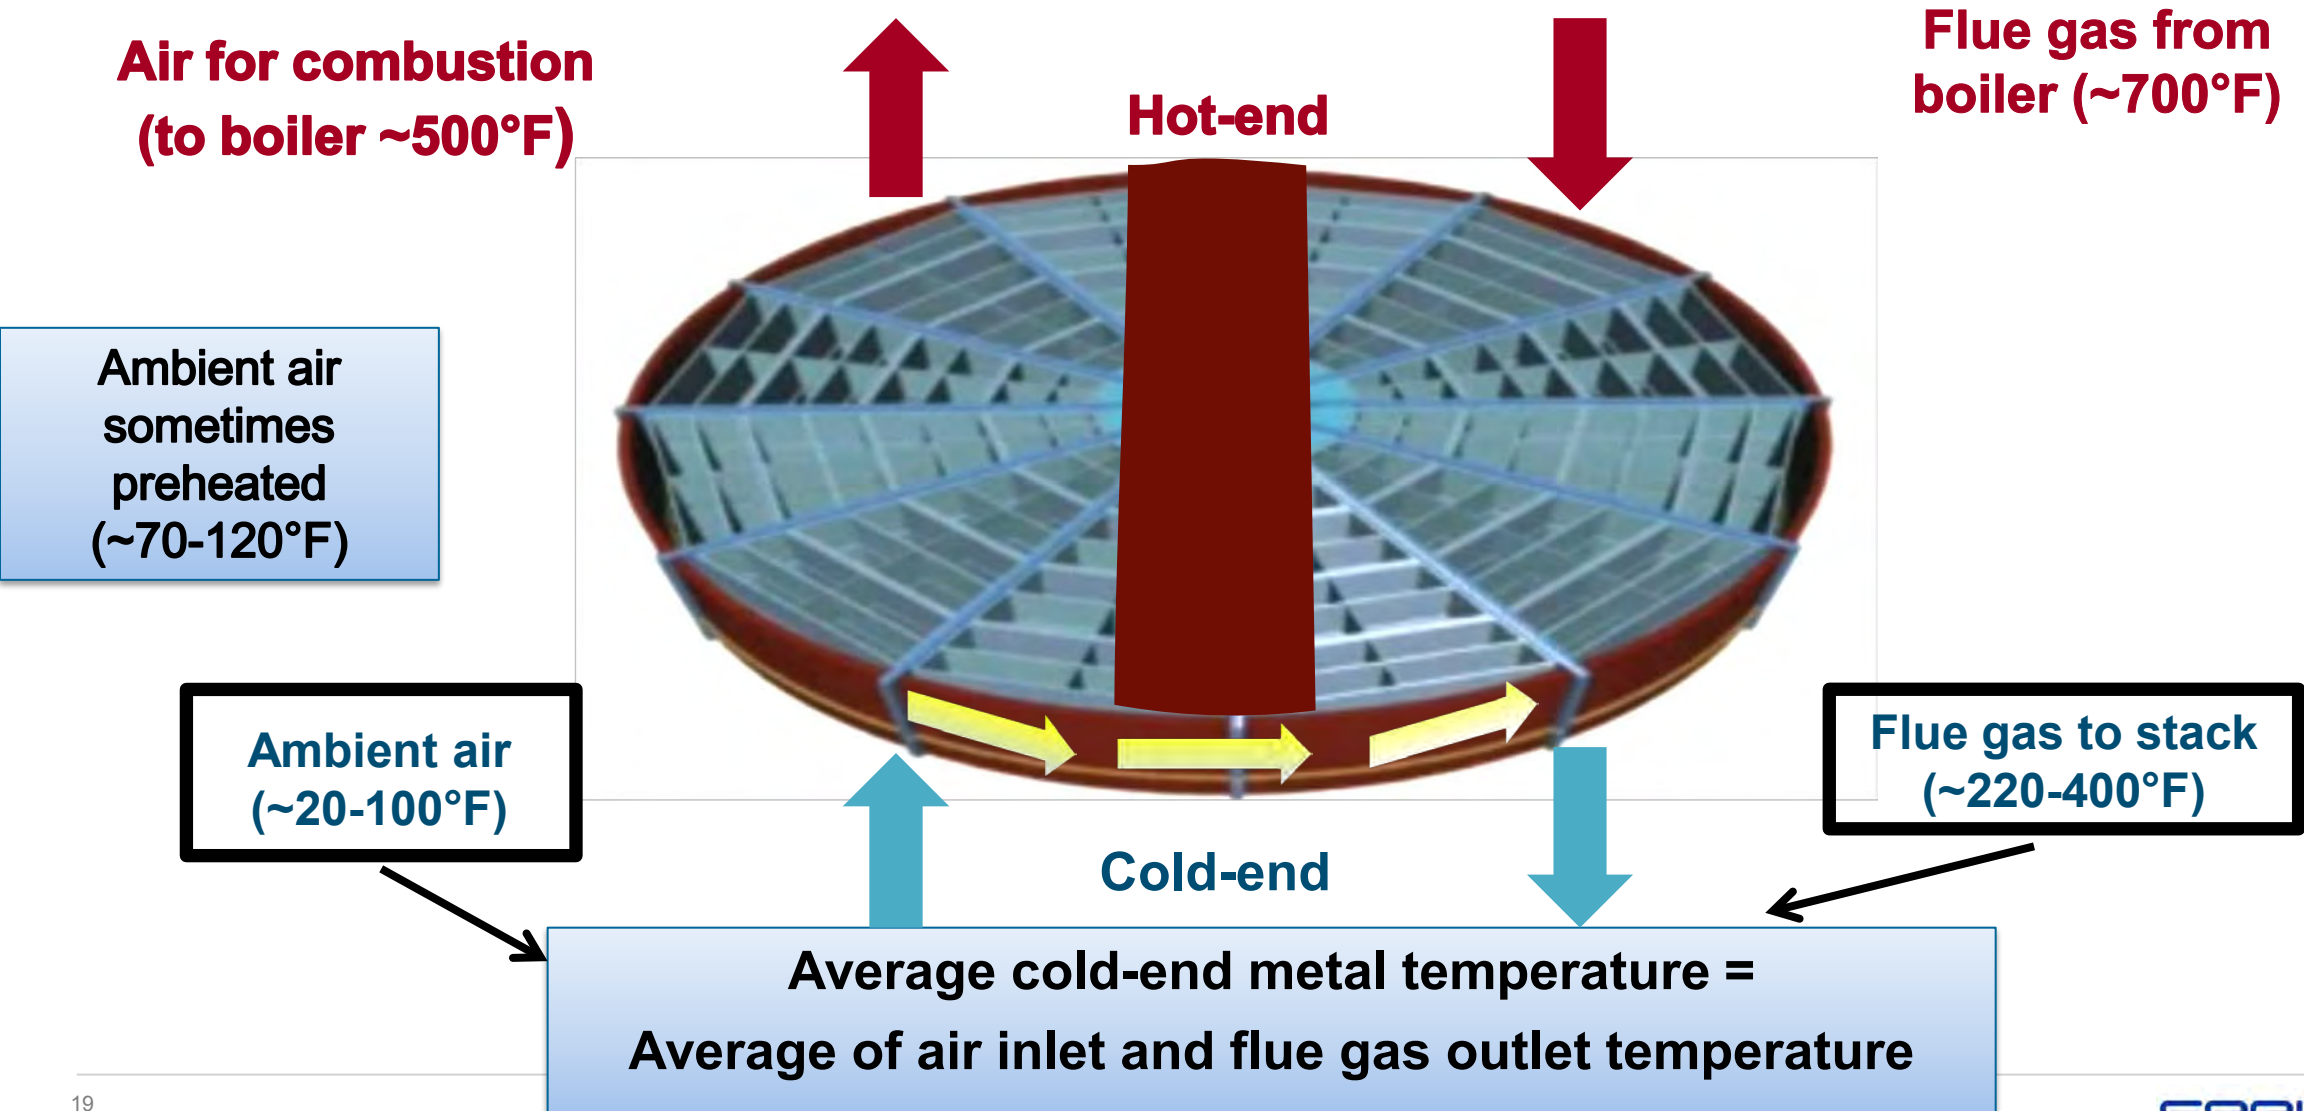
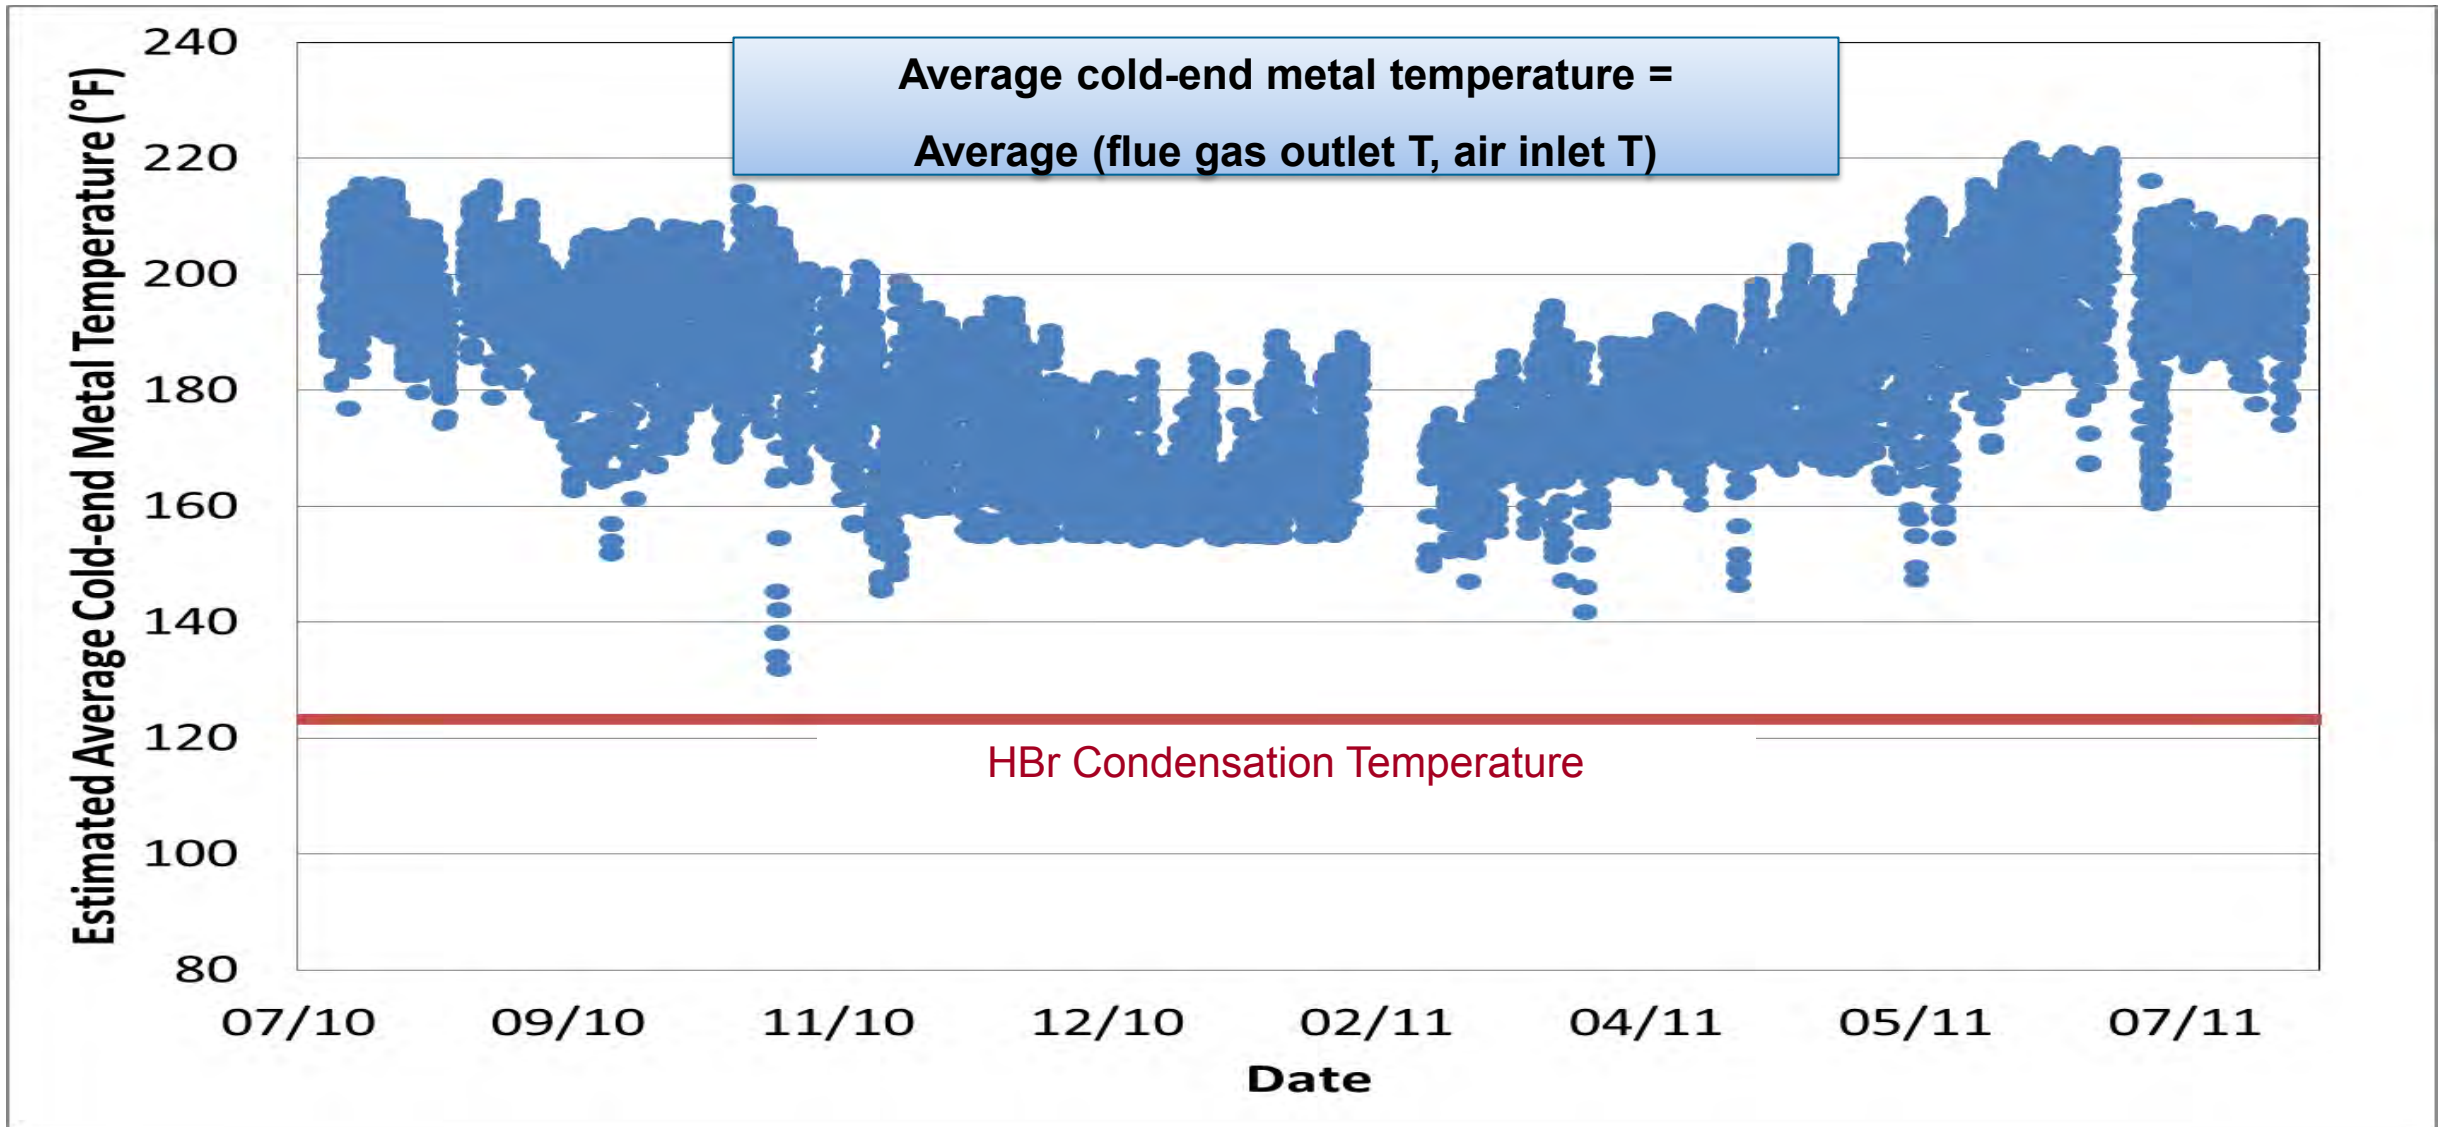
Plants control average cold-end metal temperature of air heater

Average AH cold-end metal temperature

Br addition rate of 250 ppm to coal, coal moisture 30%

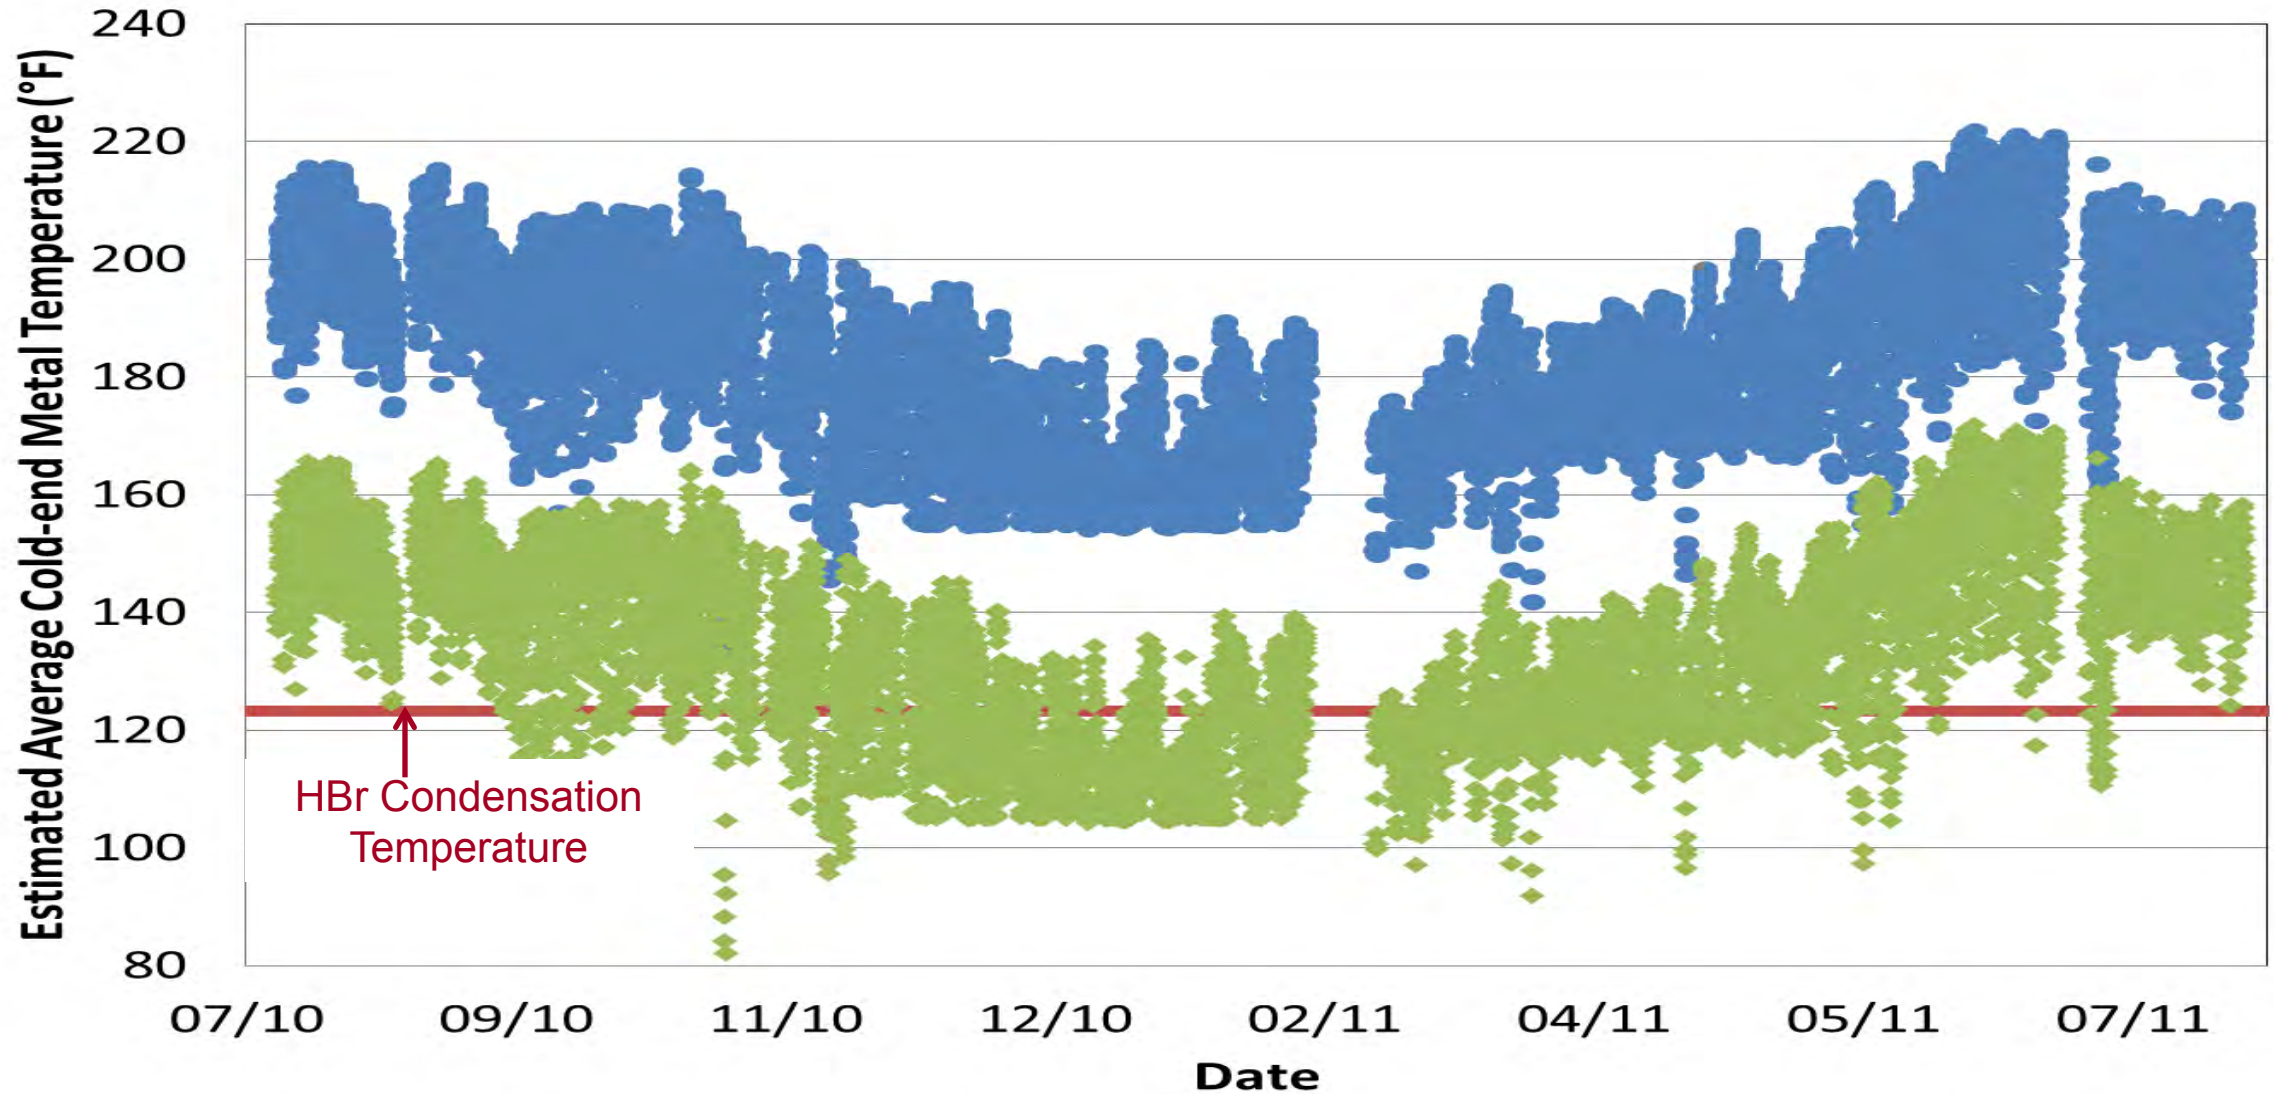
Minimum metal temperatures can be 50°F lower than average → closer to HBr condensation temperature

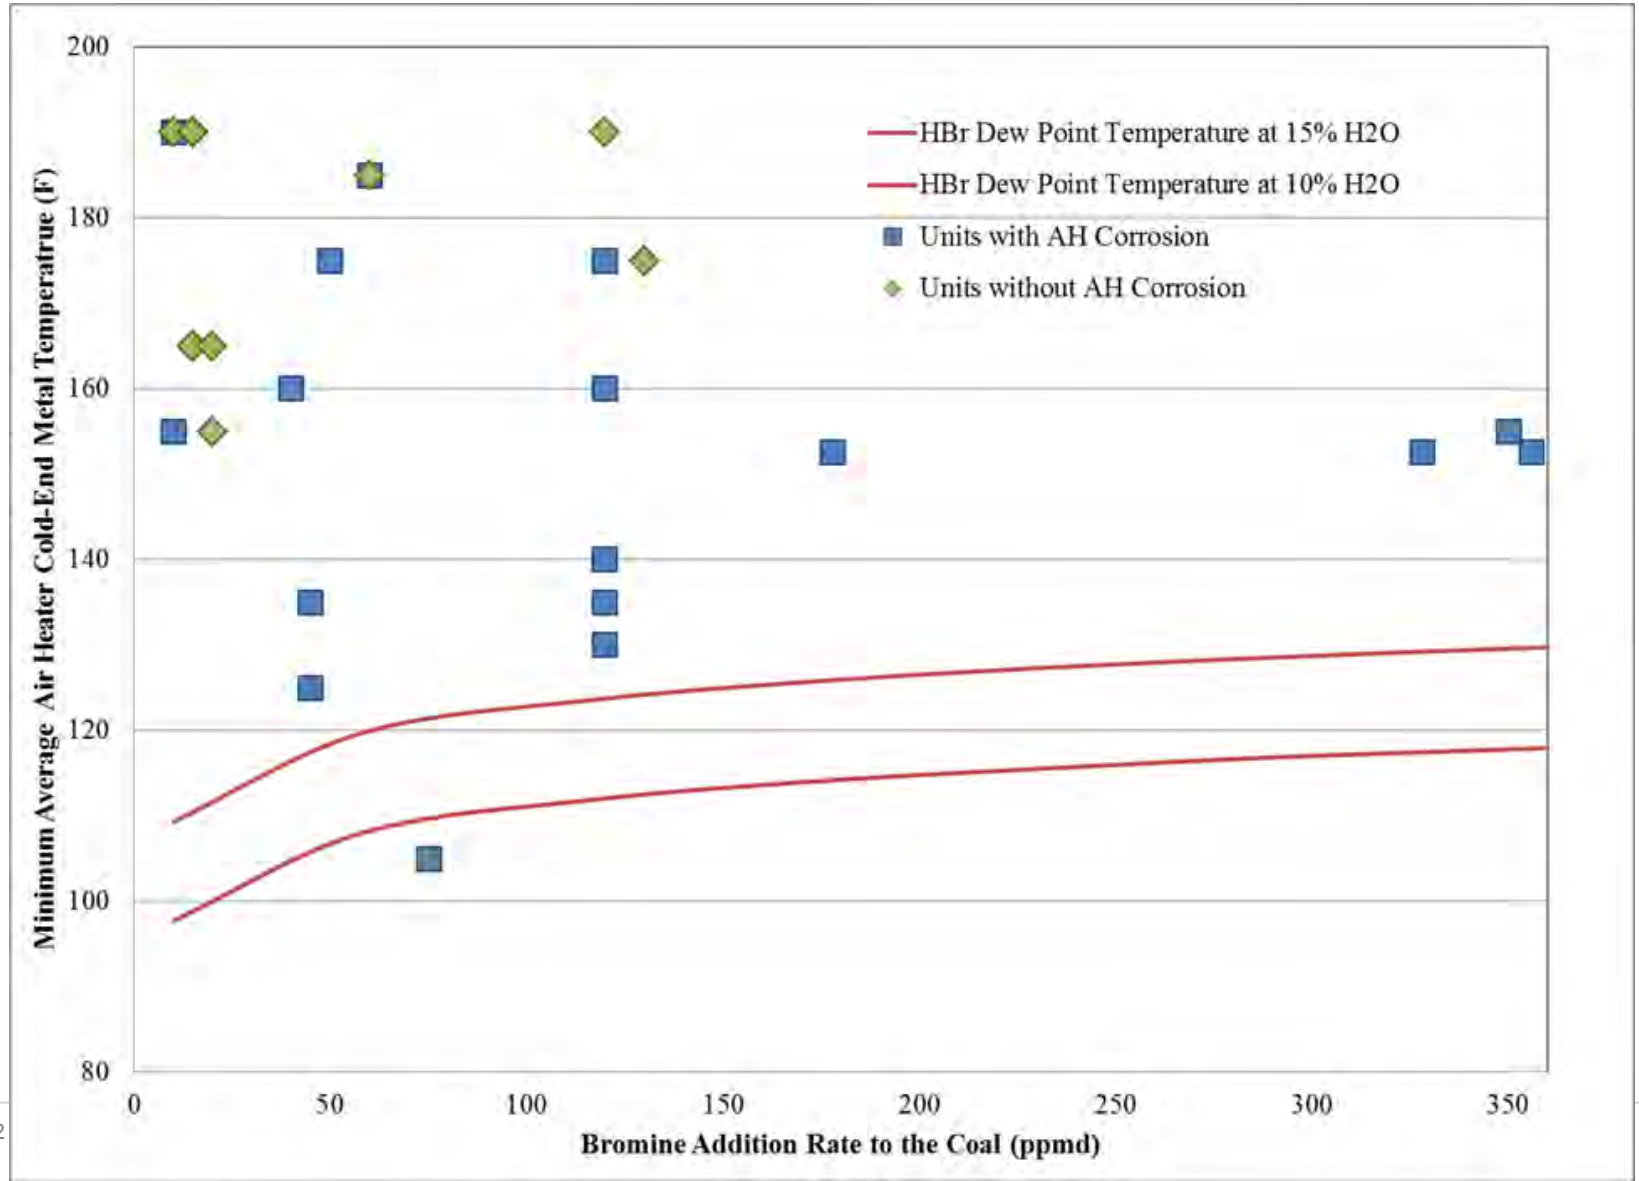
Average cold end metal temperature was not a good predictor of observed air heater corrosion

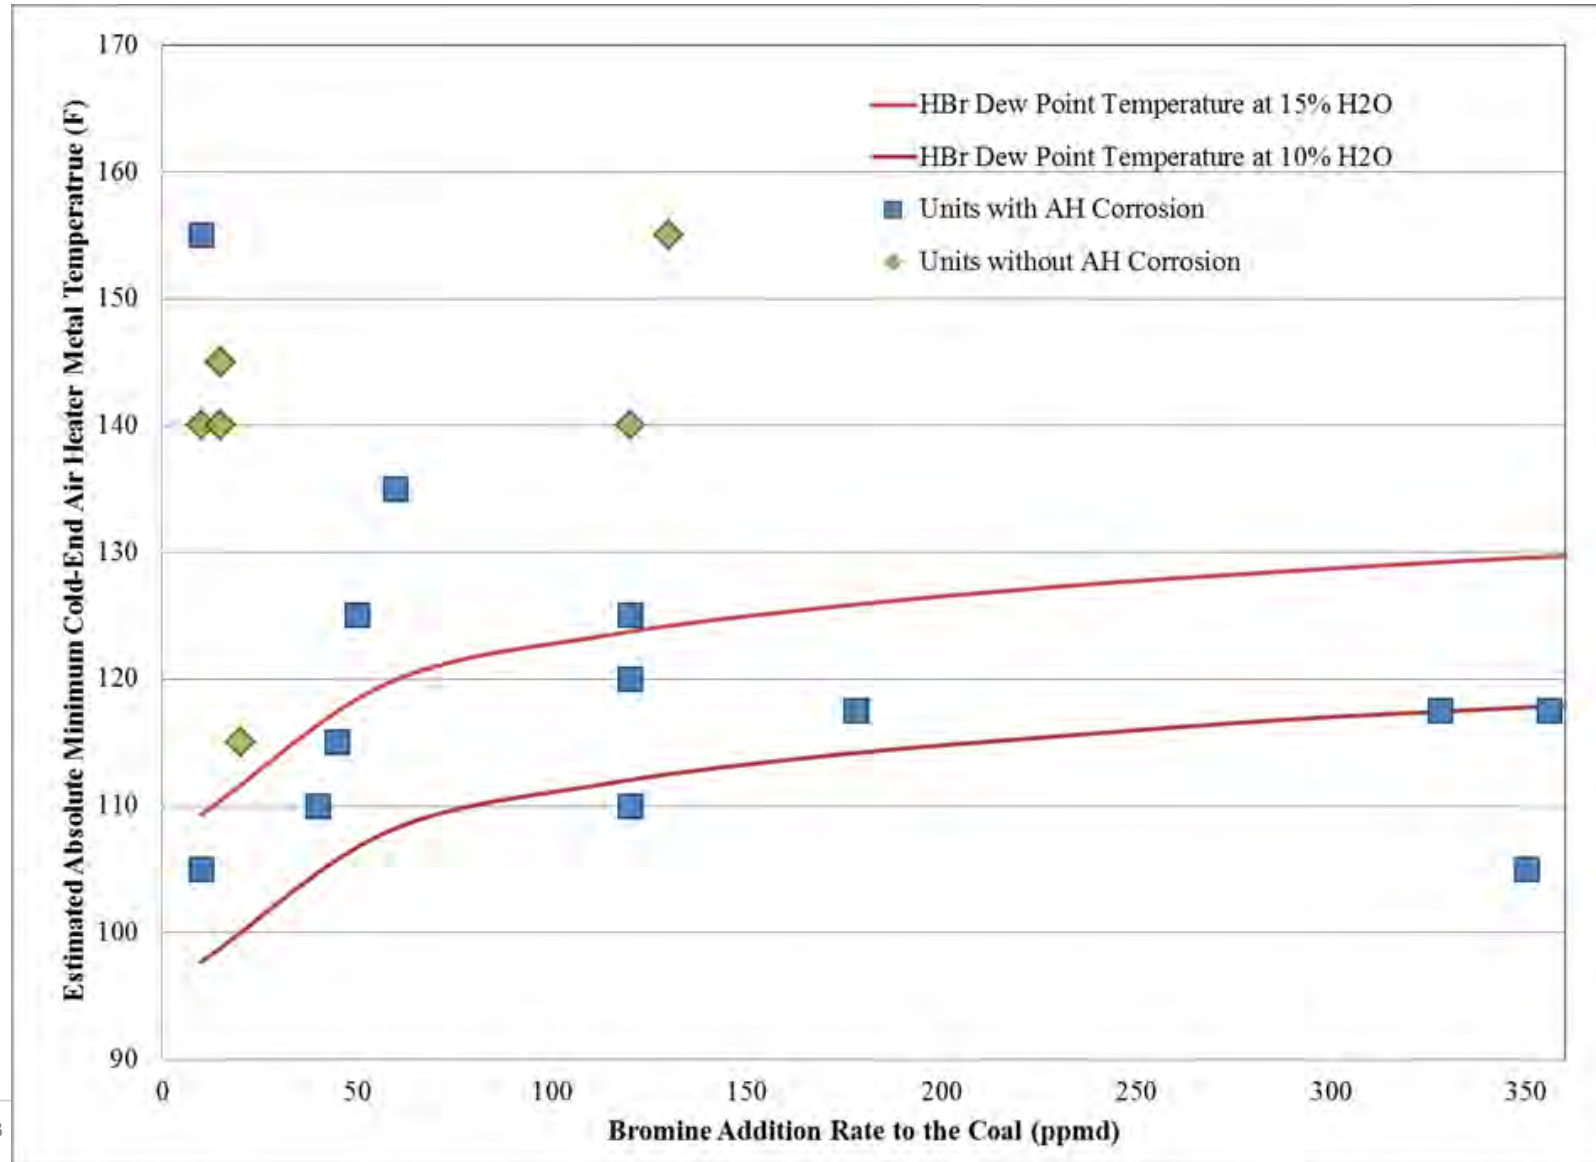
Absolute minimum metal temperature was a better predictor of air heater corrosion
