2019 NO_x-Combustion-CCR Round Table Presentation

SCR LESSONS LEARNED BY APS.

Bruce Salisbury
February 10th, 2019

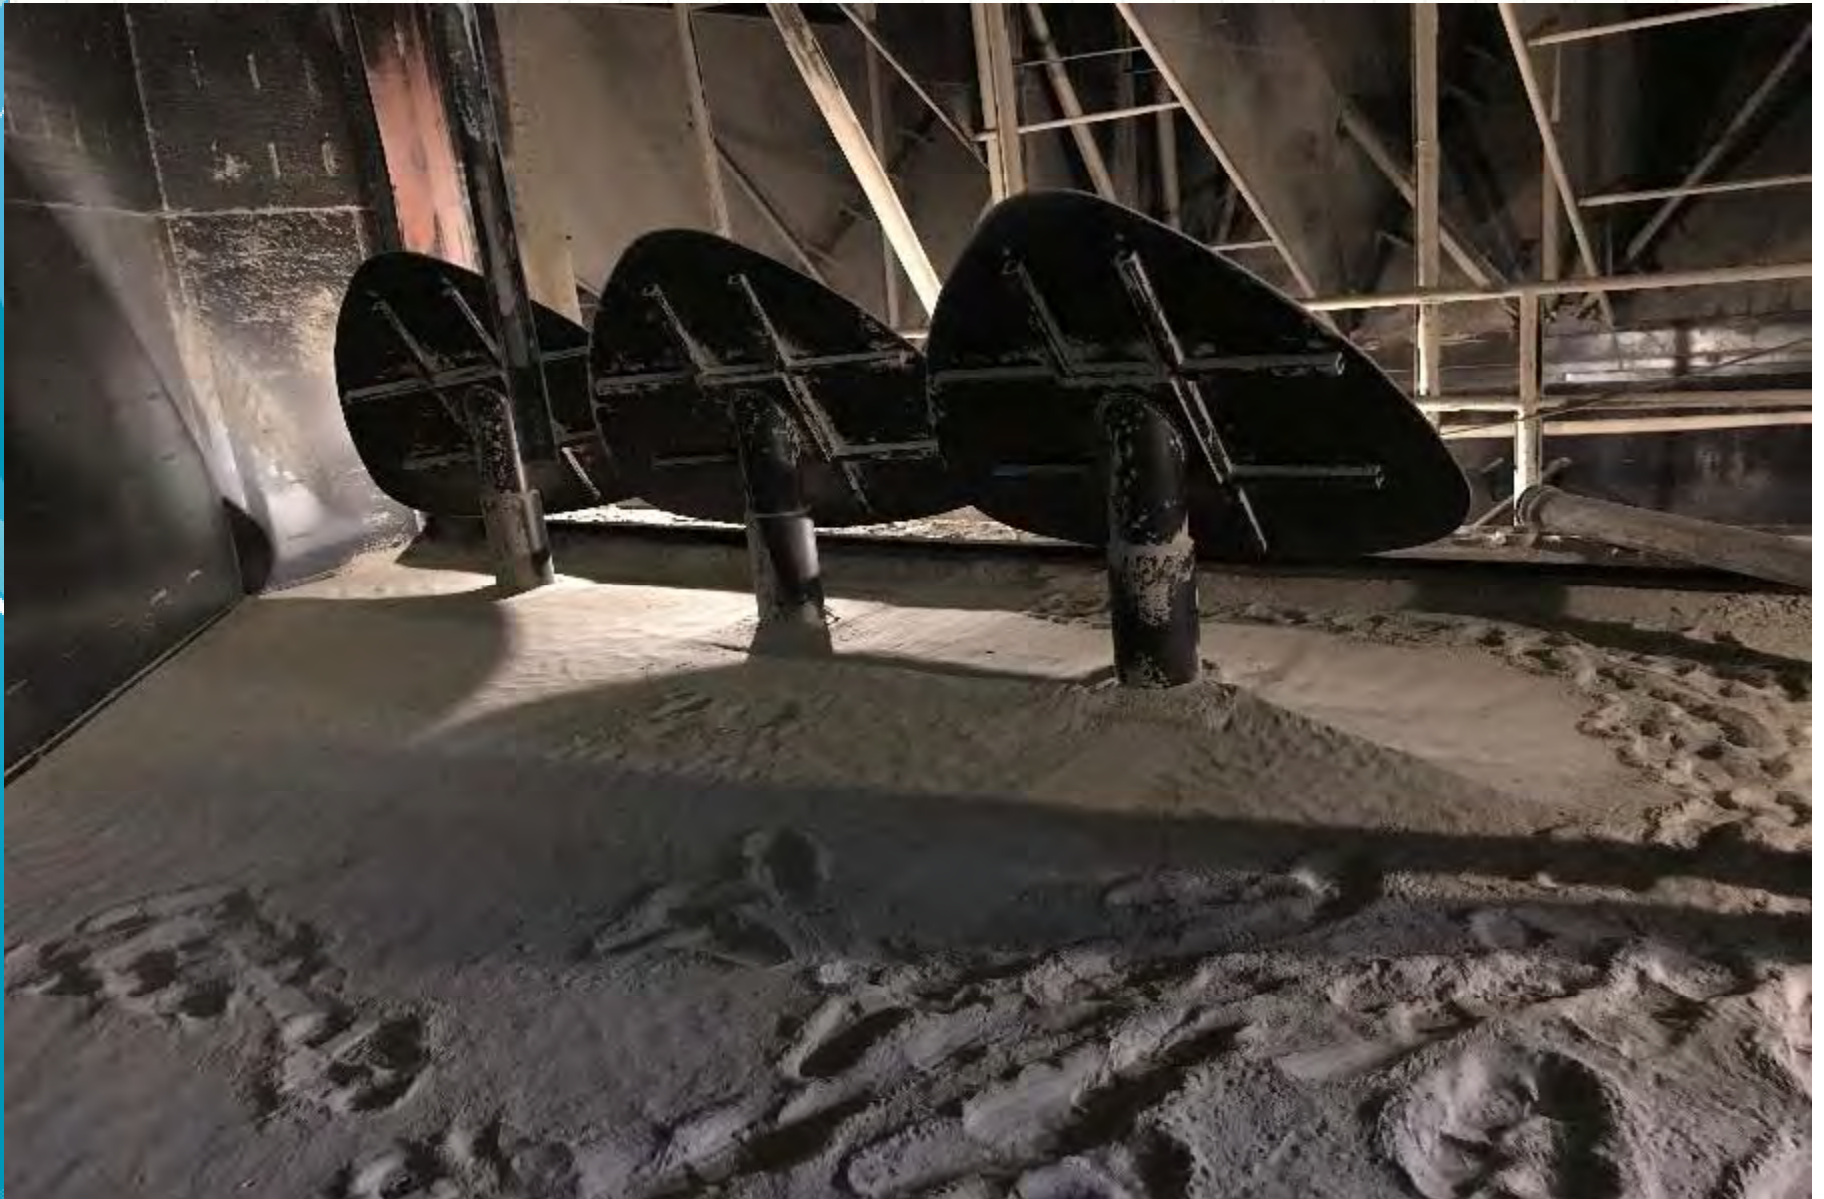
Pressure Drop Solutions

- During the design process, internal ductwork was designed to have minimal drag.
- Existing inlet ductwork was redesigned to remove internal trussing for pressure drop relief.
- All of this was modeled mechanically. As an unintended consequence, it was discovered that roped flow conditions existed in the original inlet ductwork, explaining a long-term issue the plant had with erosion in the inlet ductwork.
- Delta wings were added in the existing ductwork outside of the scope of the build to rectify a long-term plant issue

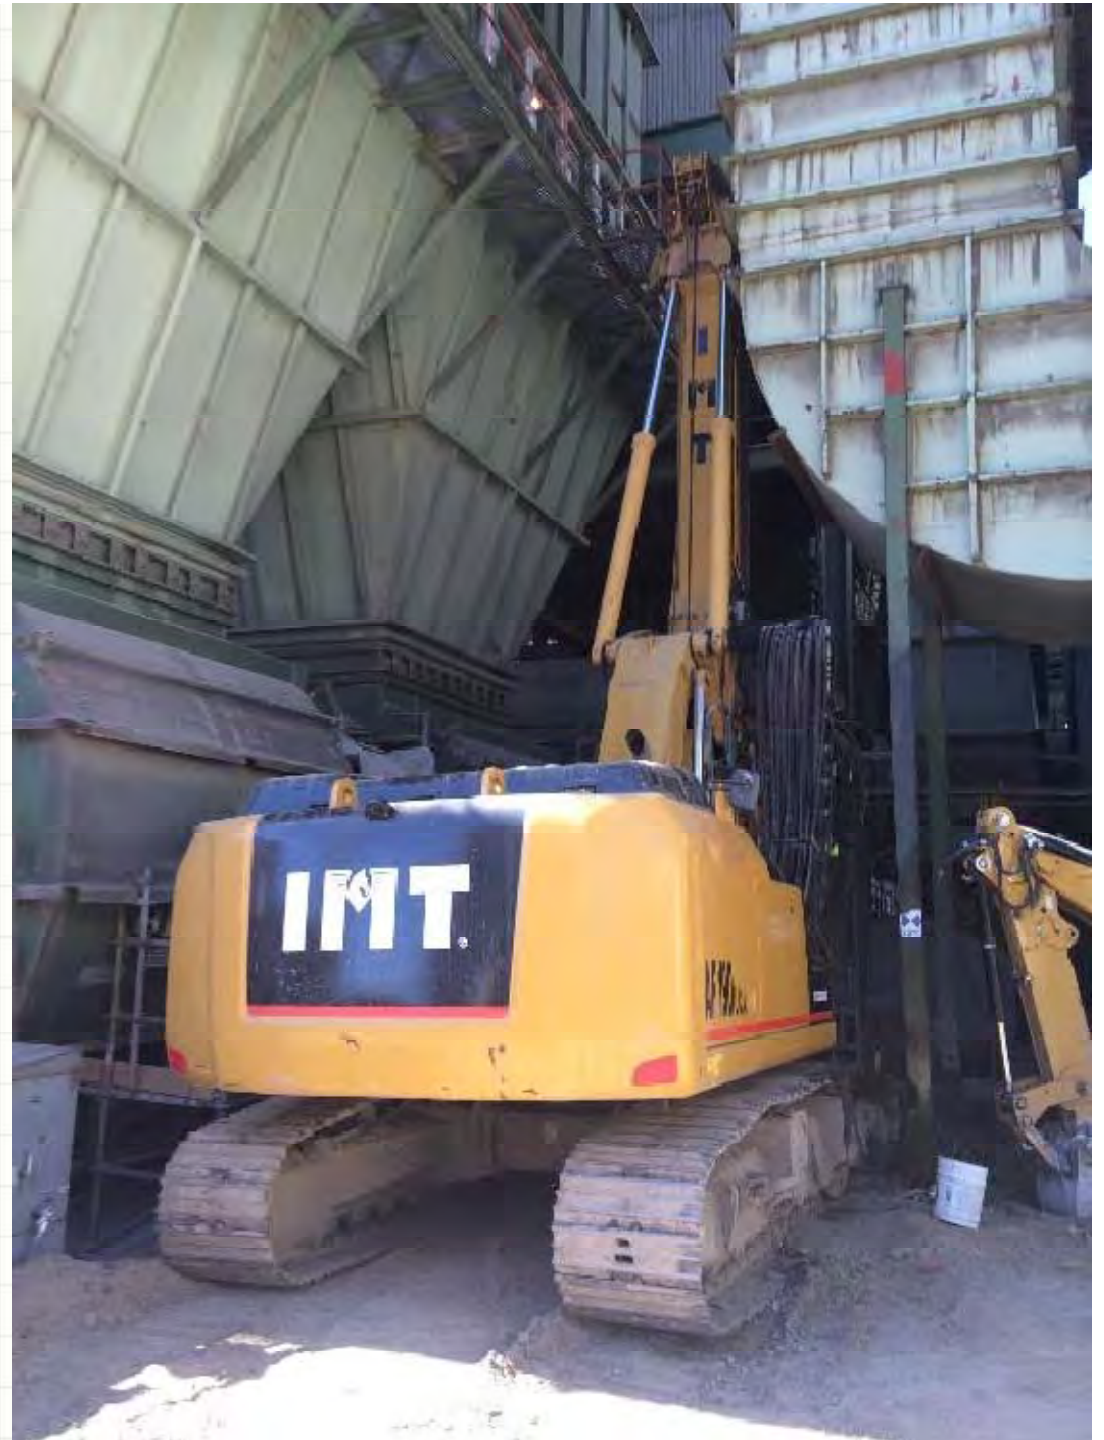
Like almost all SCR builds, sometimes you are working in a phone booth. Low clearance drilling rig drilling caissons between existing unit fans,

- A Test Caisson was cast and broken. It indicated that the finished caissons could be substantially shallower and smaller than originally thought. This led to a redesign of a smaller, less expensive foundation.

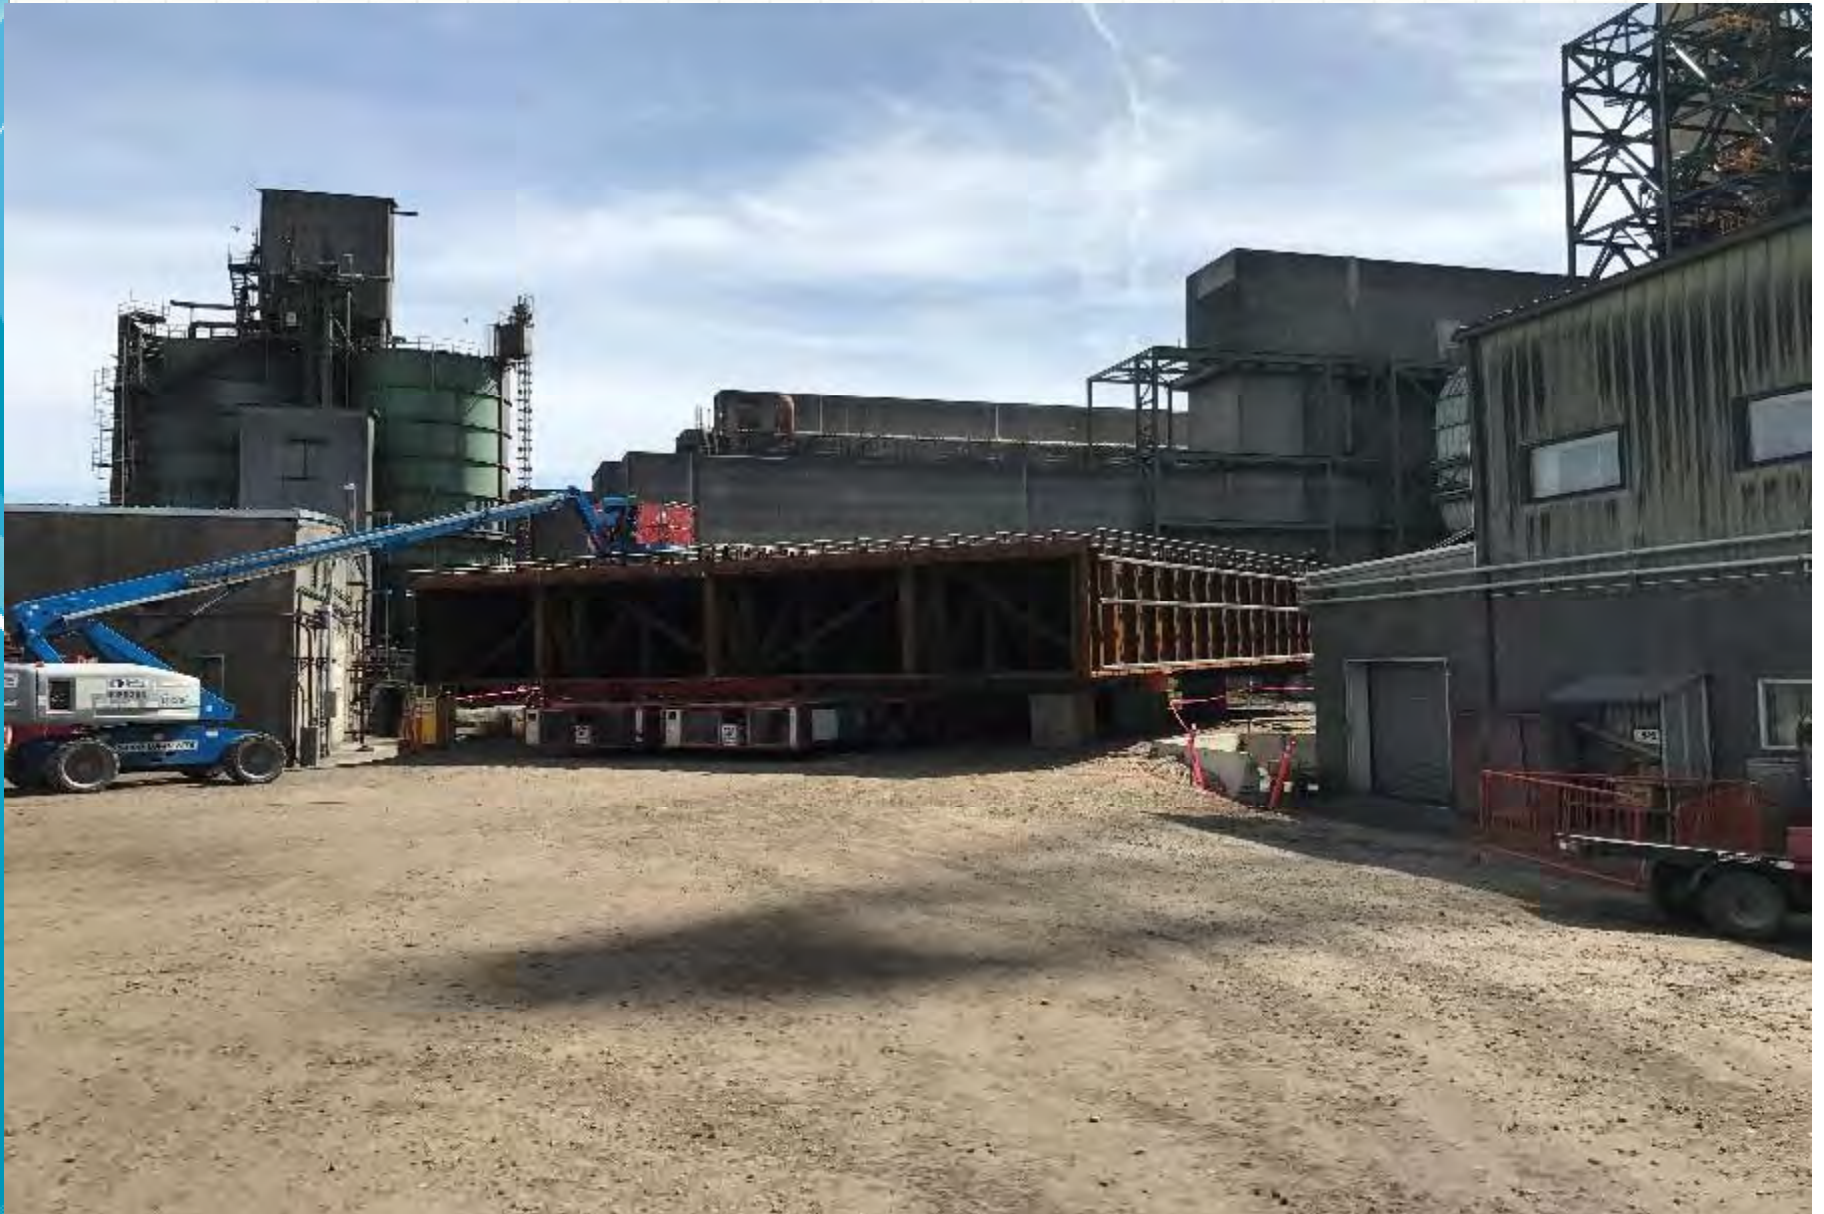
Optimizing Construction: the end of the assembly line

- Taking a page from the assembly line, ductwork pieces were laid out in the fabrication area, in the order that they were going to be installed.

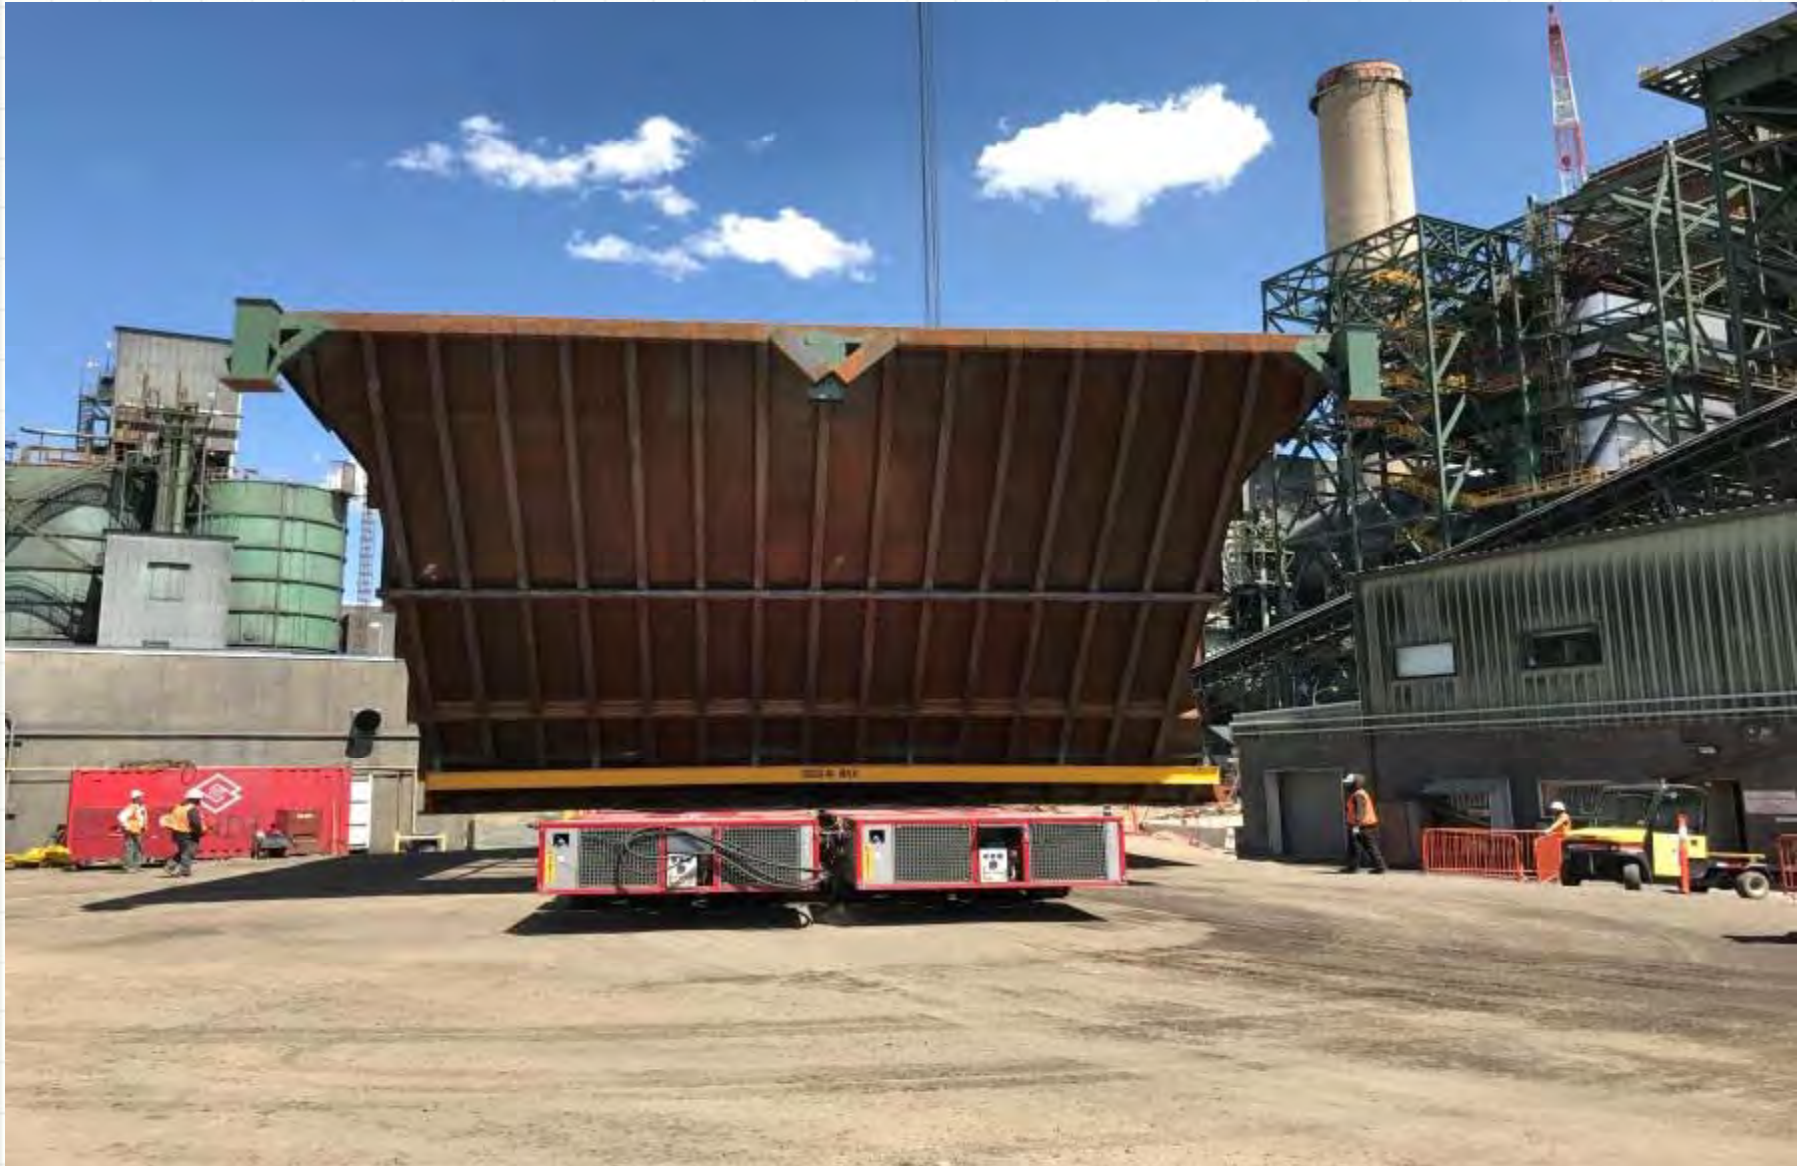
Build as big as possible on the ground.

- Building as big as possible, on the ground
 - Productivity drops as you elevate works off the ground, and reduce their footprint of movement.
- This requires a lot of thought on crane size and placement.

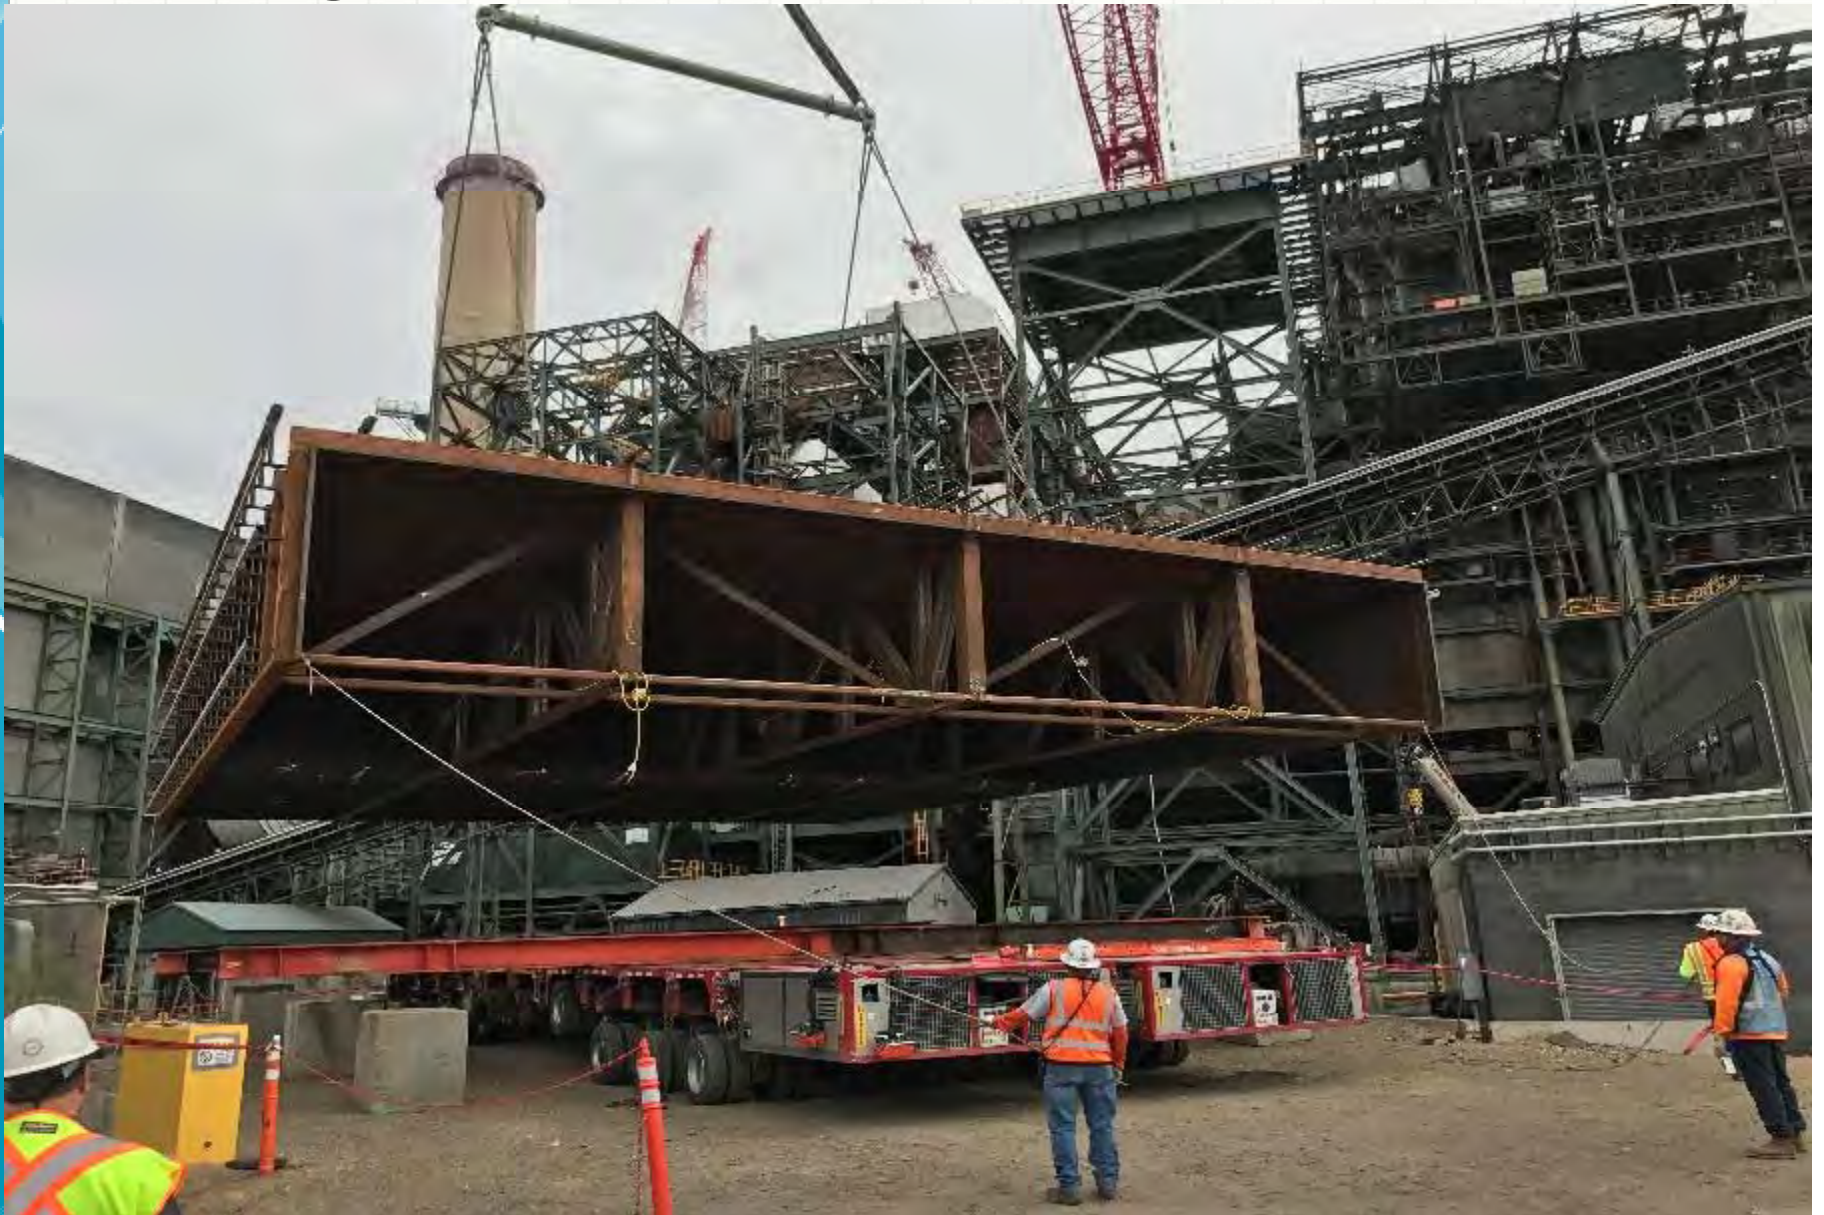
888 ringer on 170 foot tall tower, for Unit 4

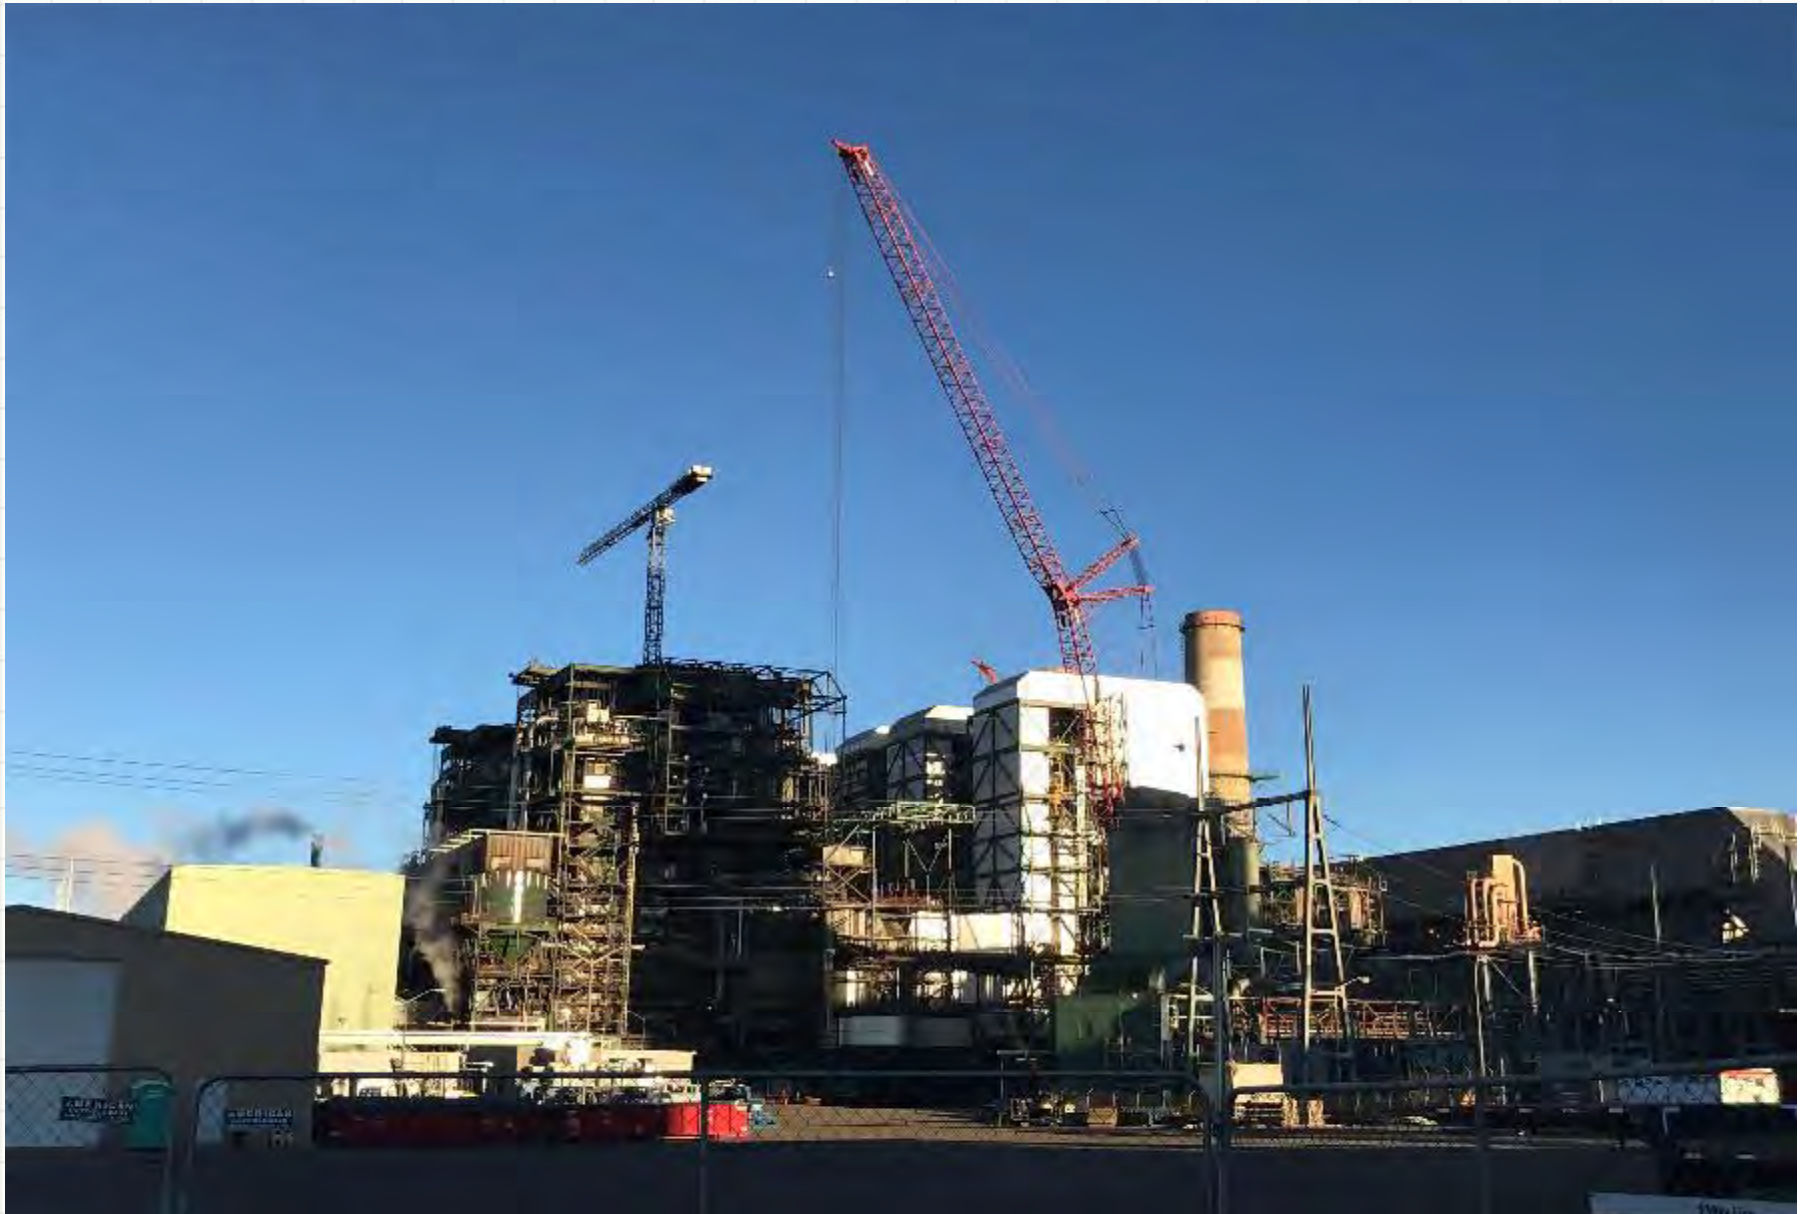
Manitowok 18000 for the Unit 5 side of the build.

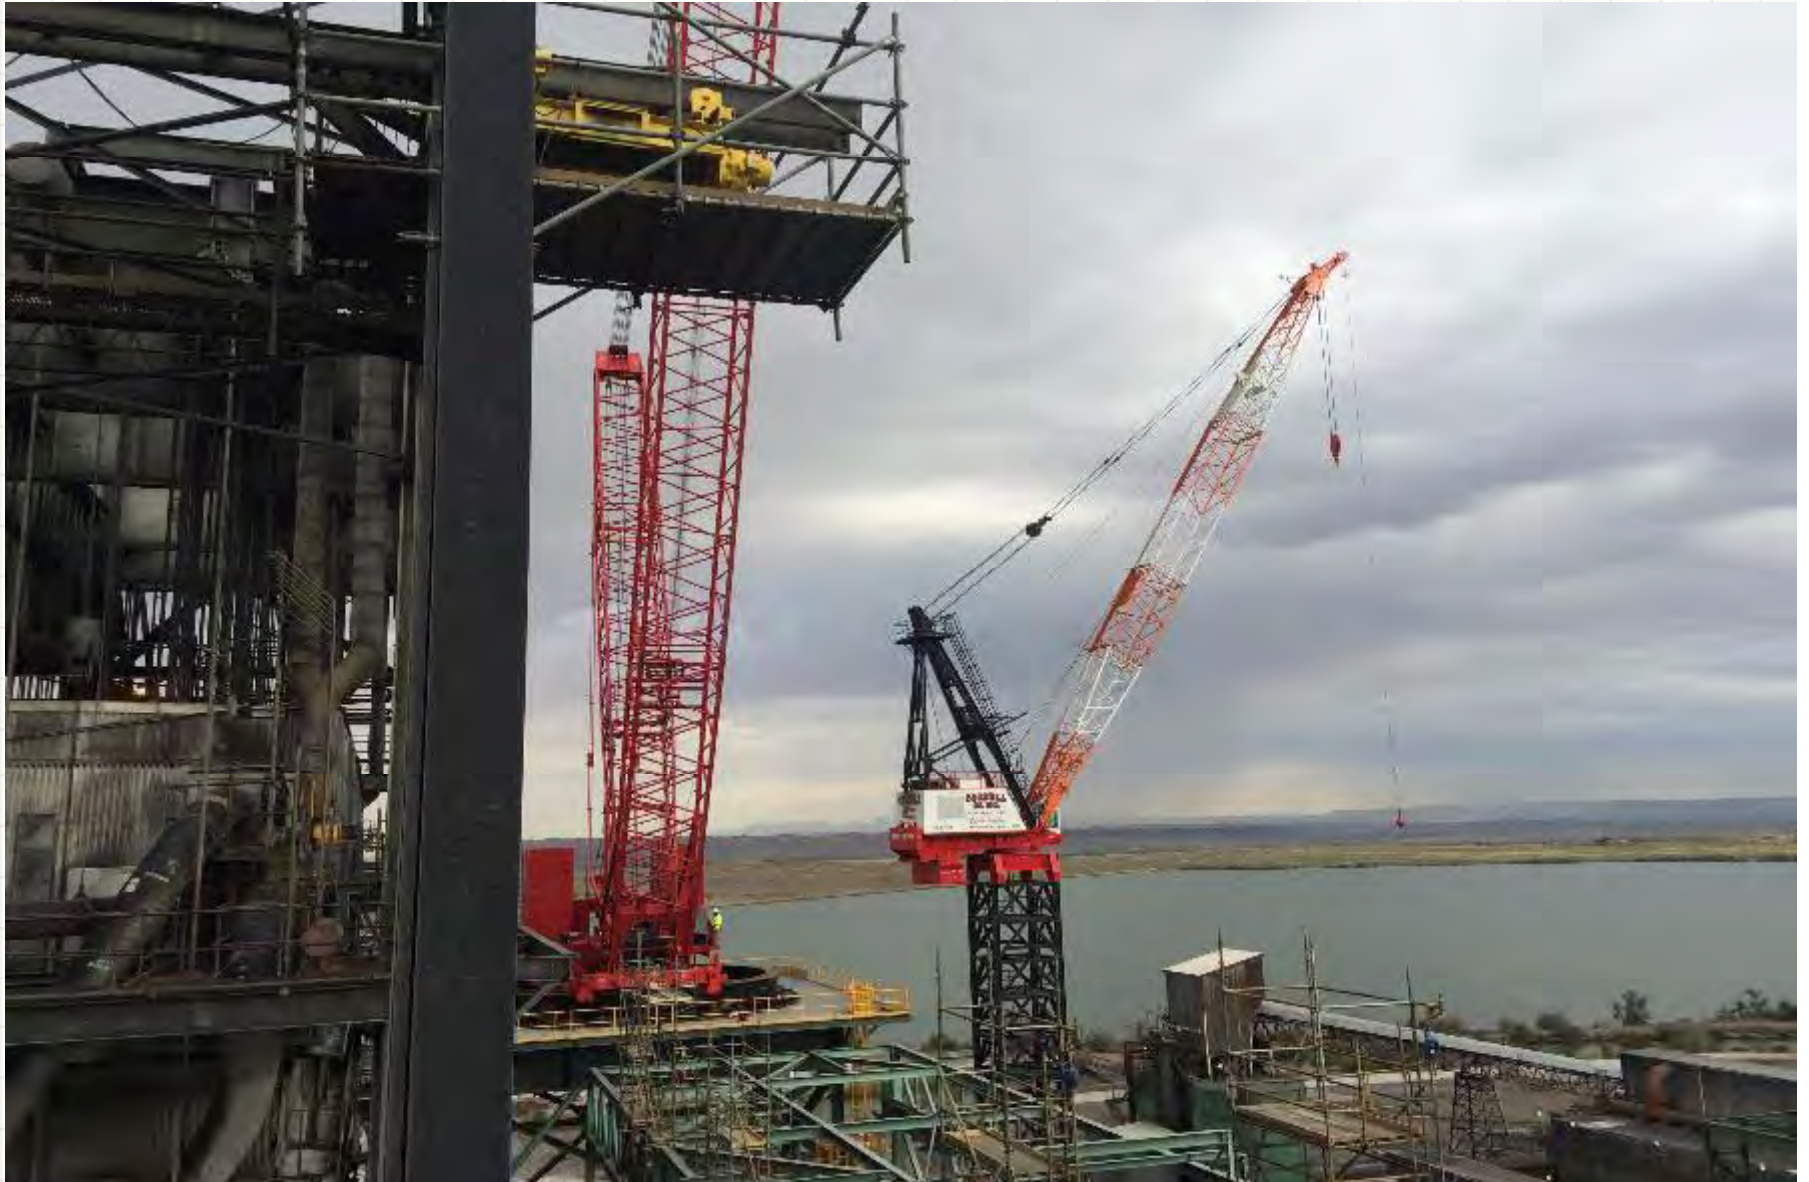
Elevation view of the Unit4 tower crane and the small tower crane between unit 4&5
