Recent Industry Experience with Corrosion in Wet Flue Gas Desulfurization (FGD) Systems

J. Shingledecker

2011 APC Round Table

July 12, 2011 Cleveland, OH

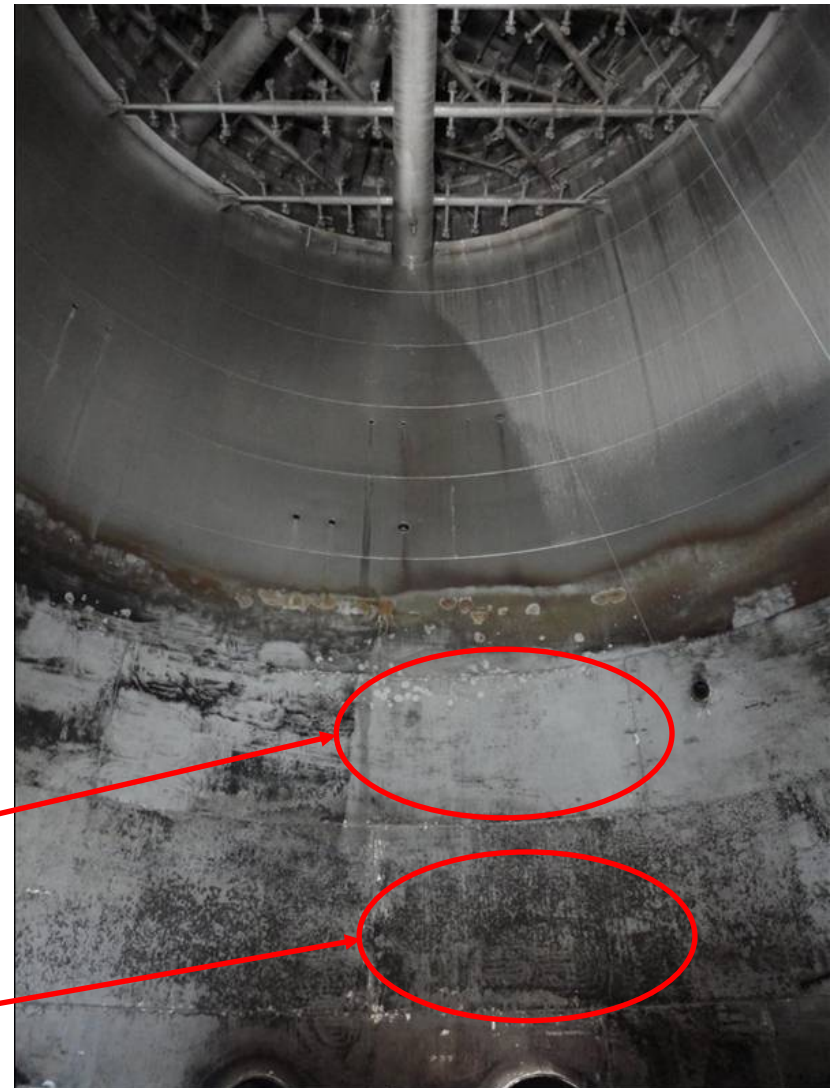
Scale removal is not enough

- Comparison of the same surface (grit blasted) under direct and indirect lighting
- Standard walkthrough could miss the corrosion

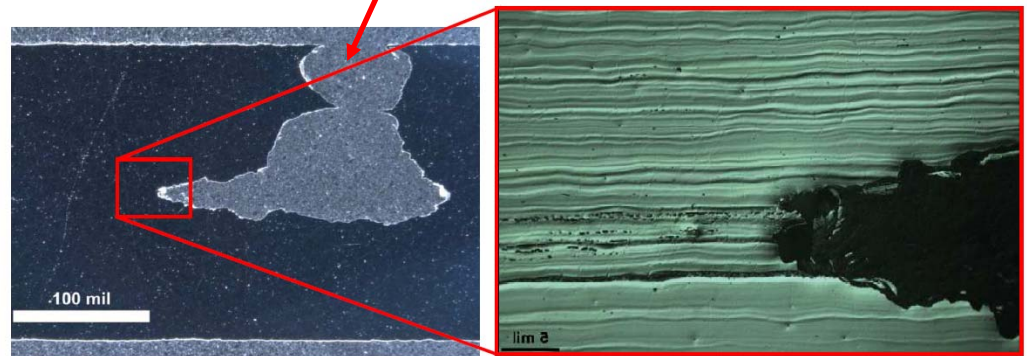
Significant corrosion in a
317LMN absorber vessel
after <1yr. of service

• Industry reports:

- Duplex: 2205, 255
- Austenitics: 317LMN
- Others: 6Mo alloys

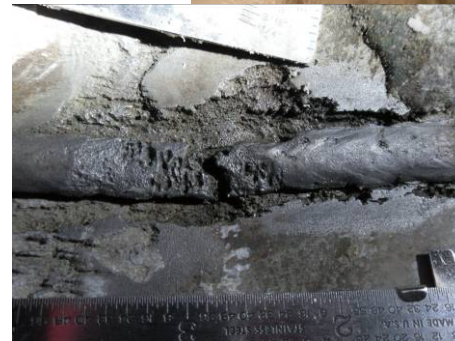
Spray header corrosion

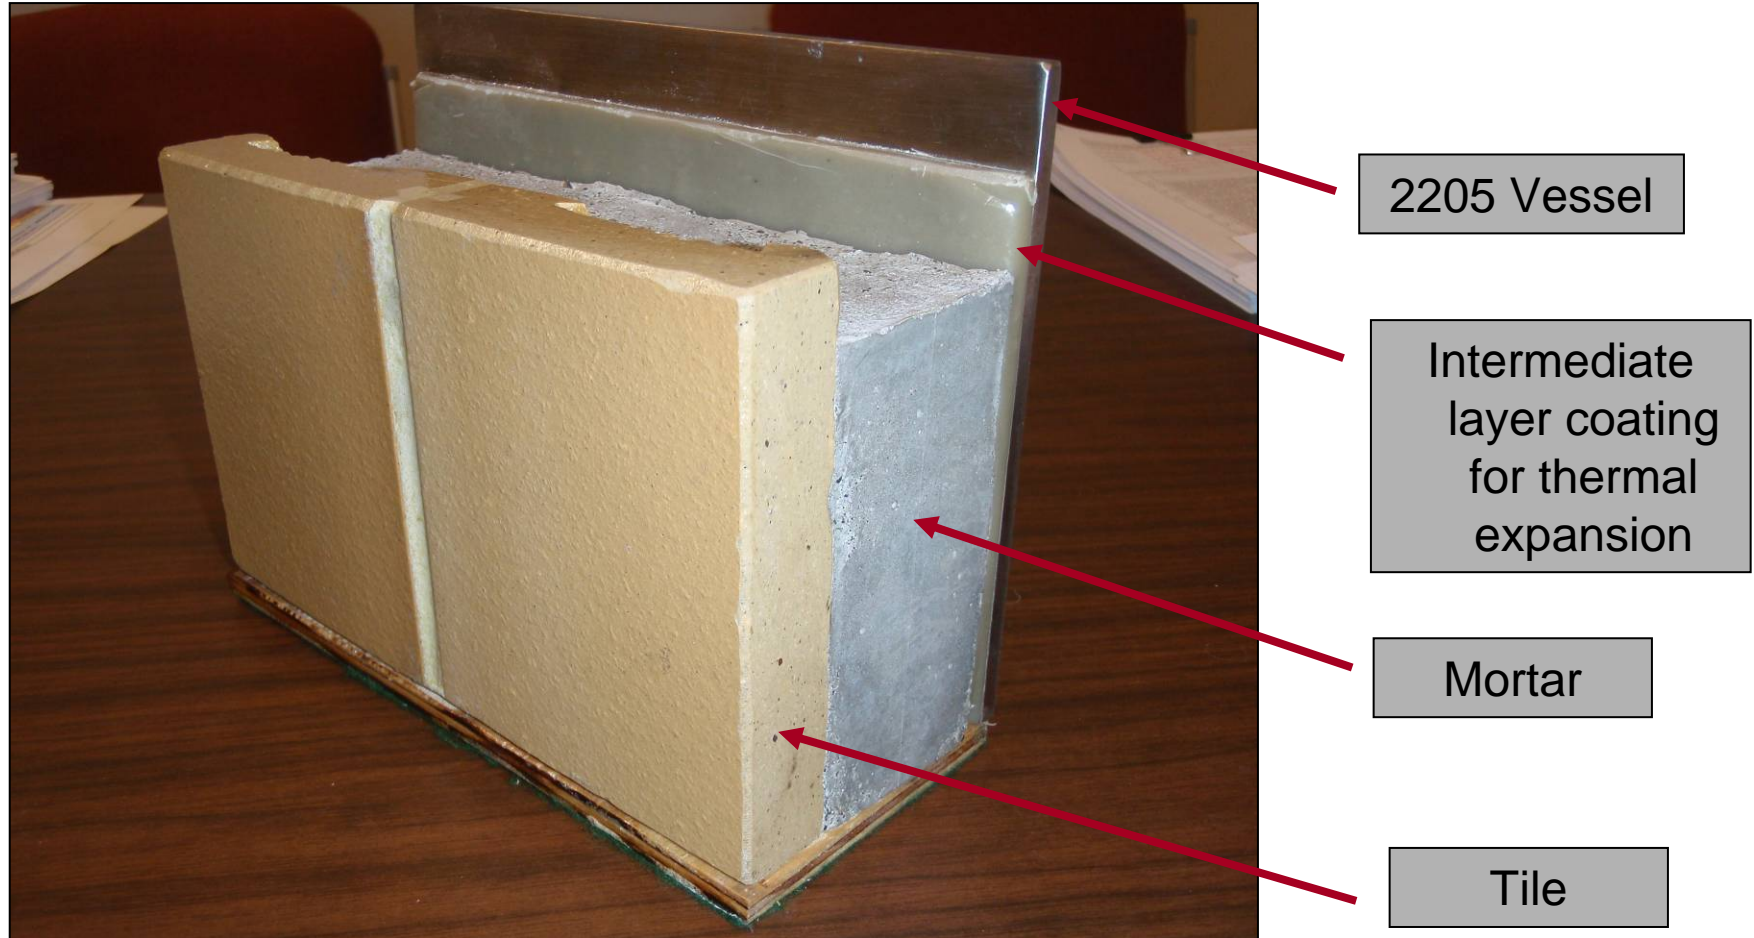
Stebbins Tile Mock-up for 2205 Jet Bubble Reactor Vessel

Currently considered a 'permanent' fix

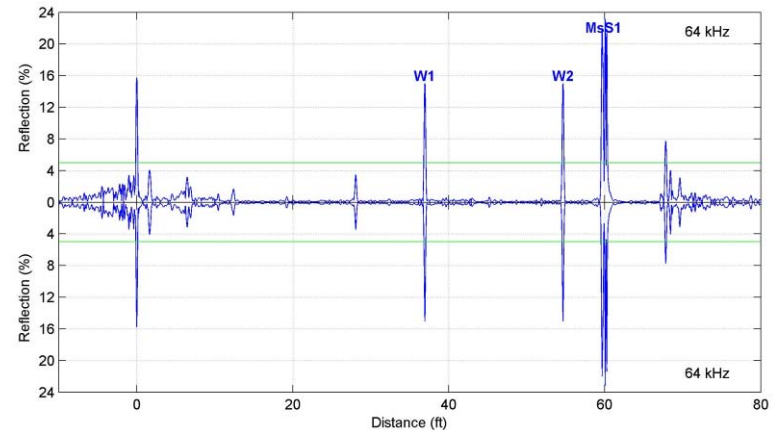
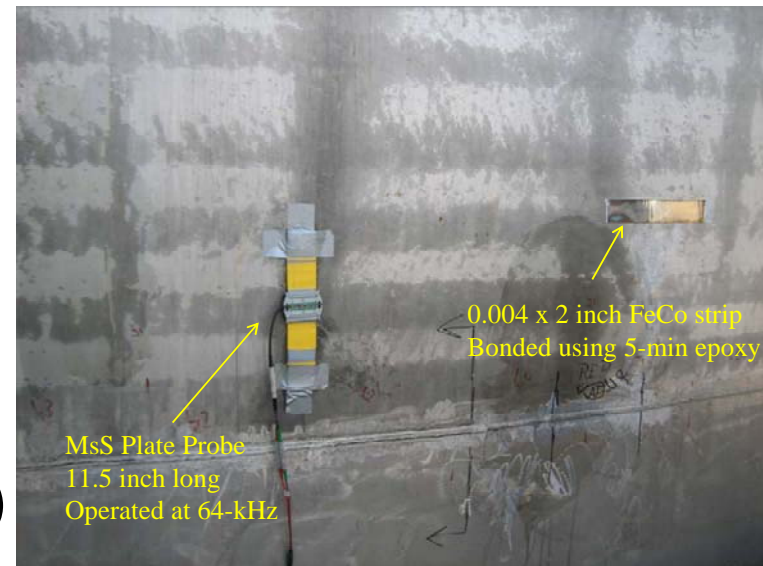
EPRI Studies: NDE – Guided Wave for Vessel Integrity Monitoring

- Proof-of-concept field trial
- Findings:
 - Guided waves propagate well in a 2205 FGD Vessel
 - Over 60 ft can be inspected in less than 1 minute
 - Research shows:
 - w/additional sensors
 - monitoring mode
 - a full vessel integrity inspection could be conducted in ~2.5hrs (once baseline is established)
