**2018 NO<sub>x</sub>-Combustion Round Table  
& Expo Presentation**

# Reinhold Environmental NOx Round Table February 19, 2018

Prepared by  
Greg Holscher and Stacy Steinhauer  
IBIDEN CERAM Environmental, Inc.

## “Midwest Utility” Reactor Inspection Review

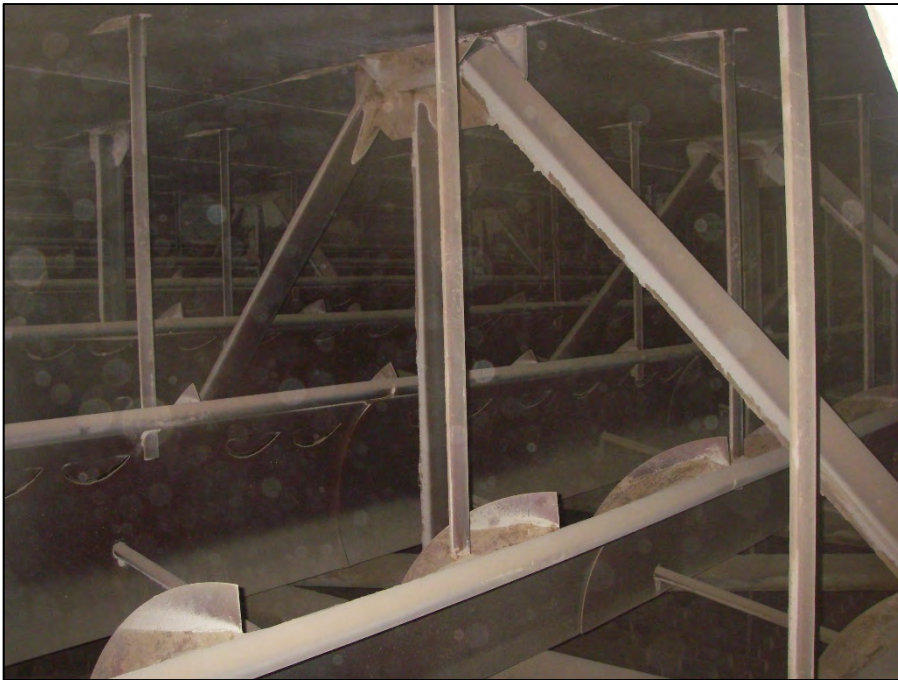
7 Reactor Hood Vanes “Clean” Condition

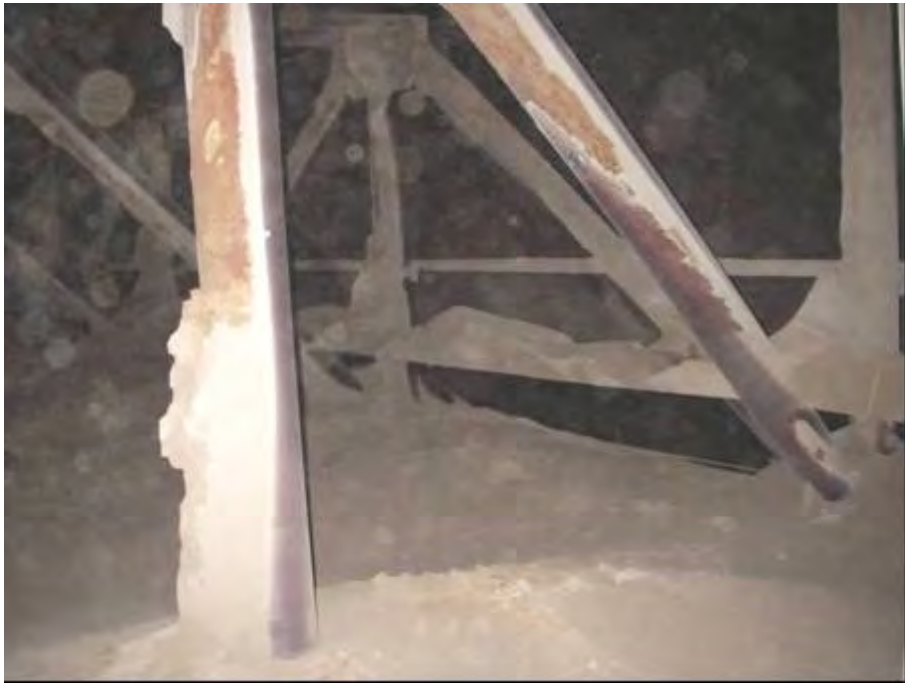
Ash buildup in crossover duct

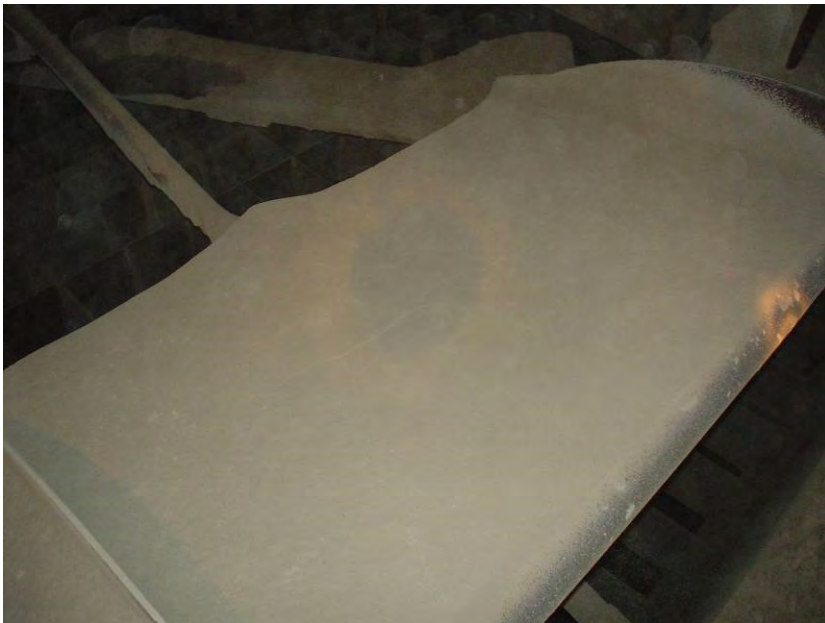
Ash Buildup on Vanes

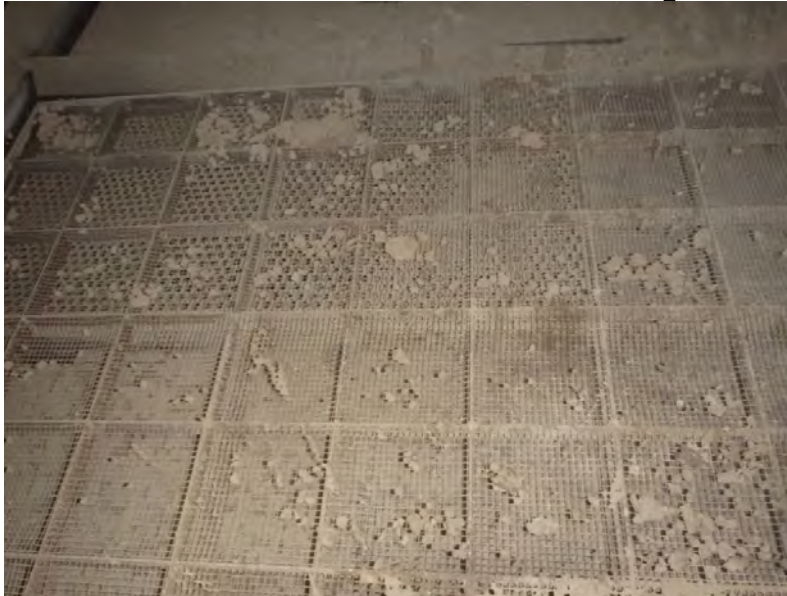
Severe Erosion in L1 after 56,000 hrs

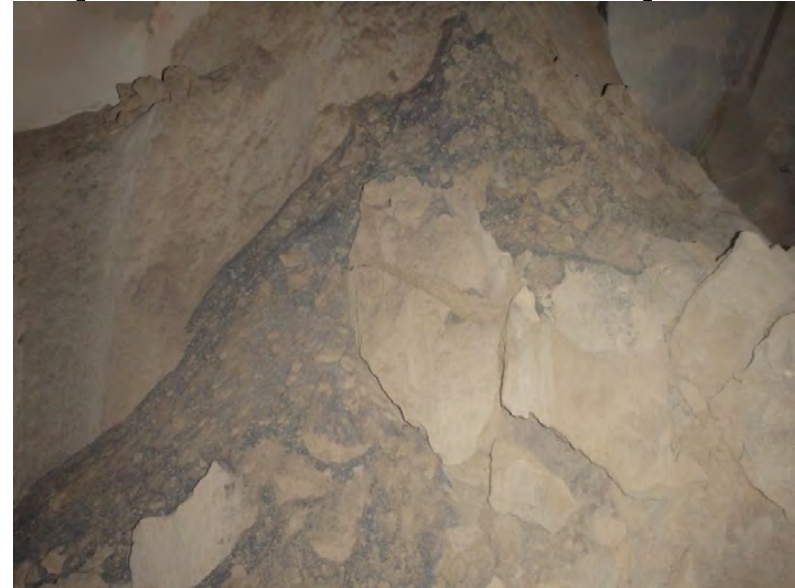
Unburned Carbon in Ash Piles

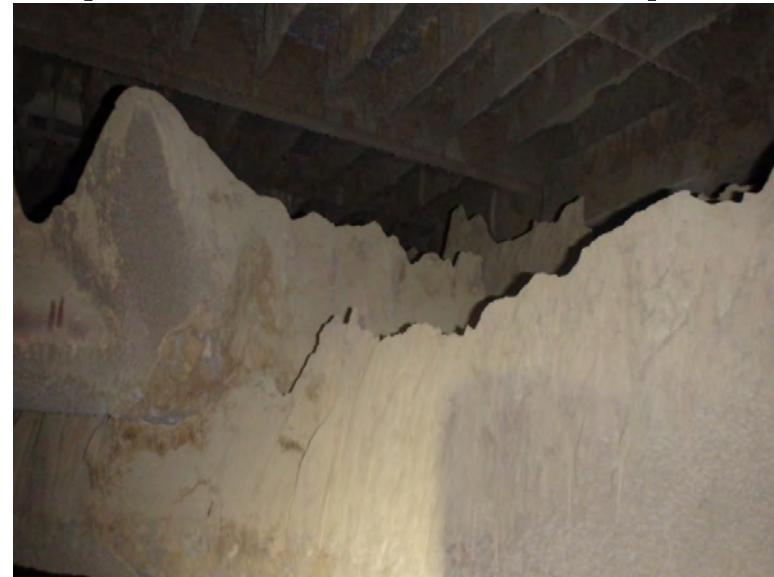
Large Accumulations on Trusses/Beams

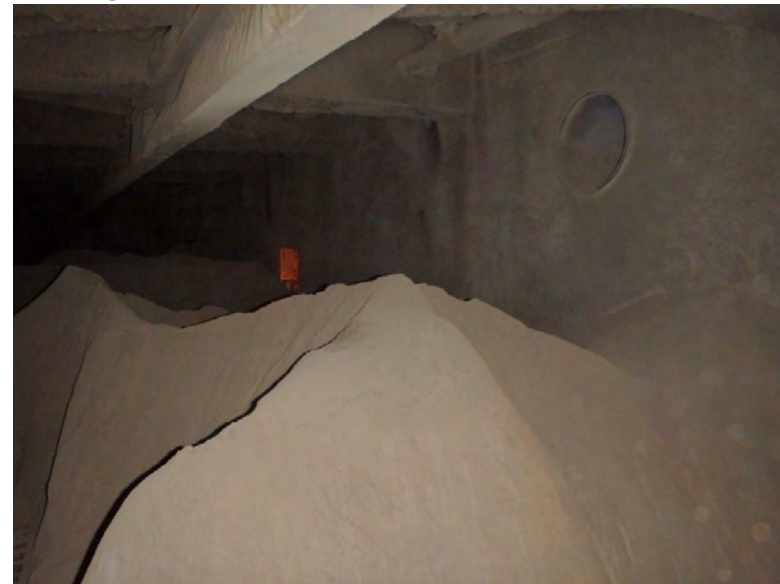
Ash Piles in L2

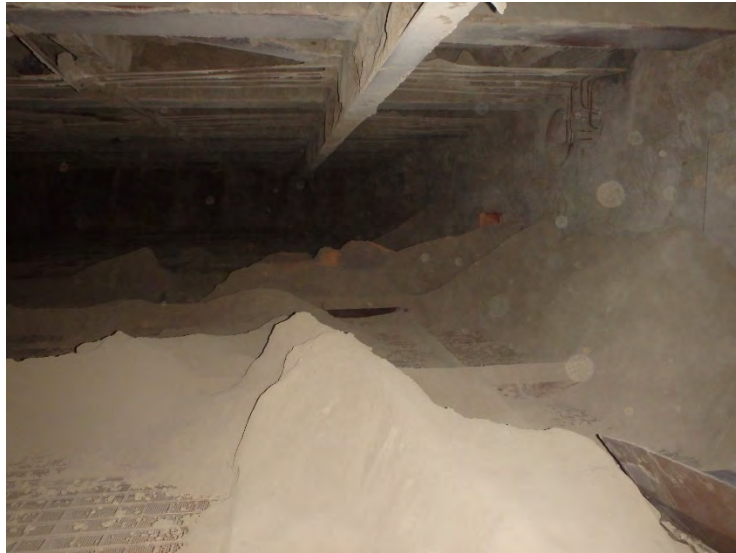
Ash Piles in L3

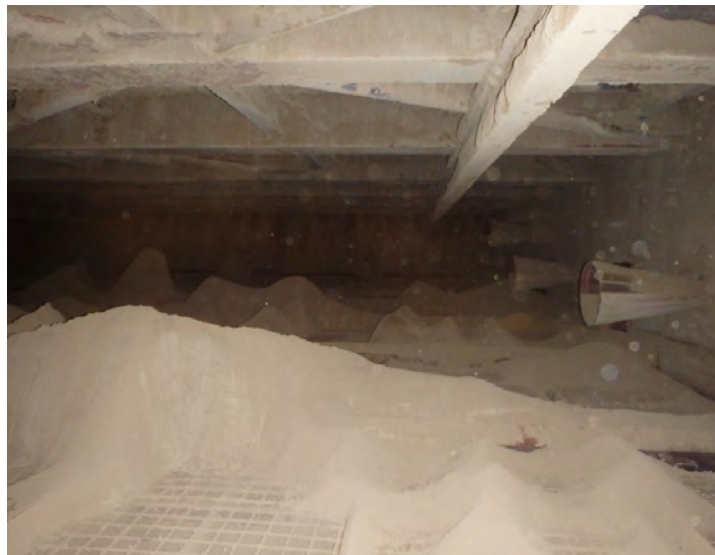
Ash Piles in L4

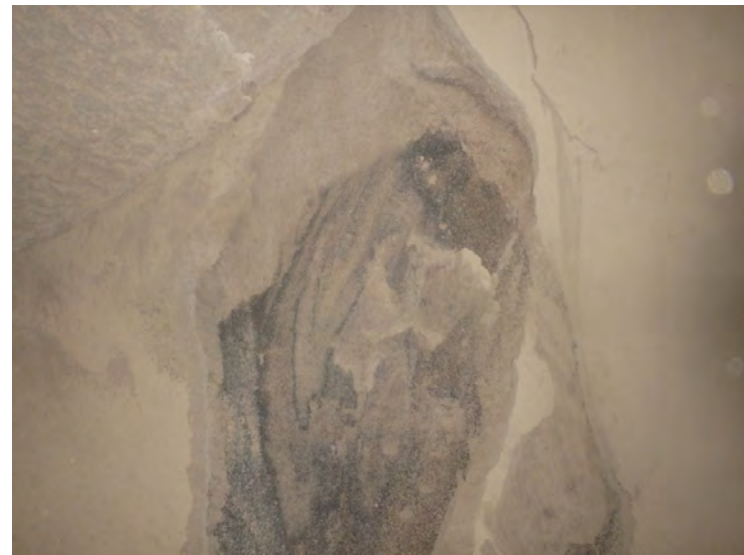
Unburned Carbon in Ash Piles
