2025 Reinhold/PCUG Round Table Presentation

SCR & LPA Screen Efficiency

APS Four Corners Case Study

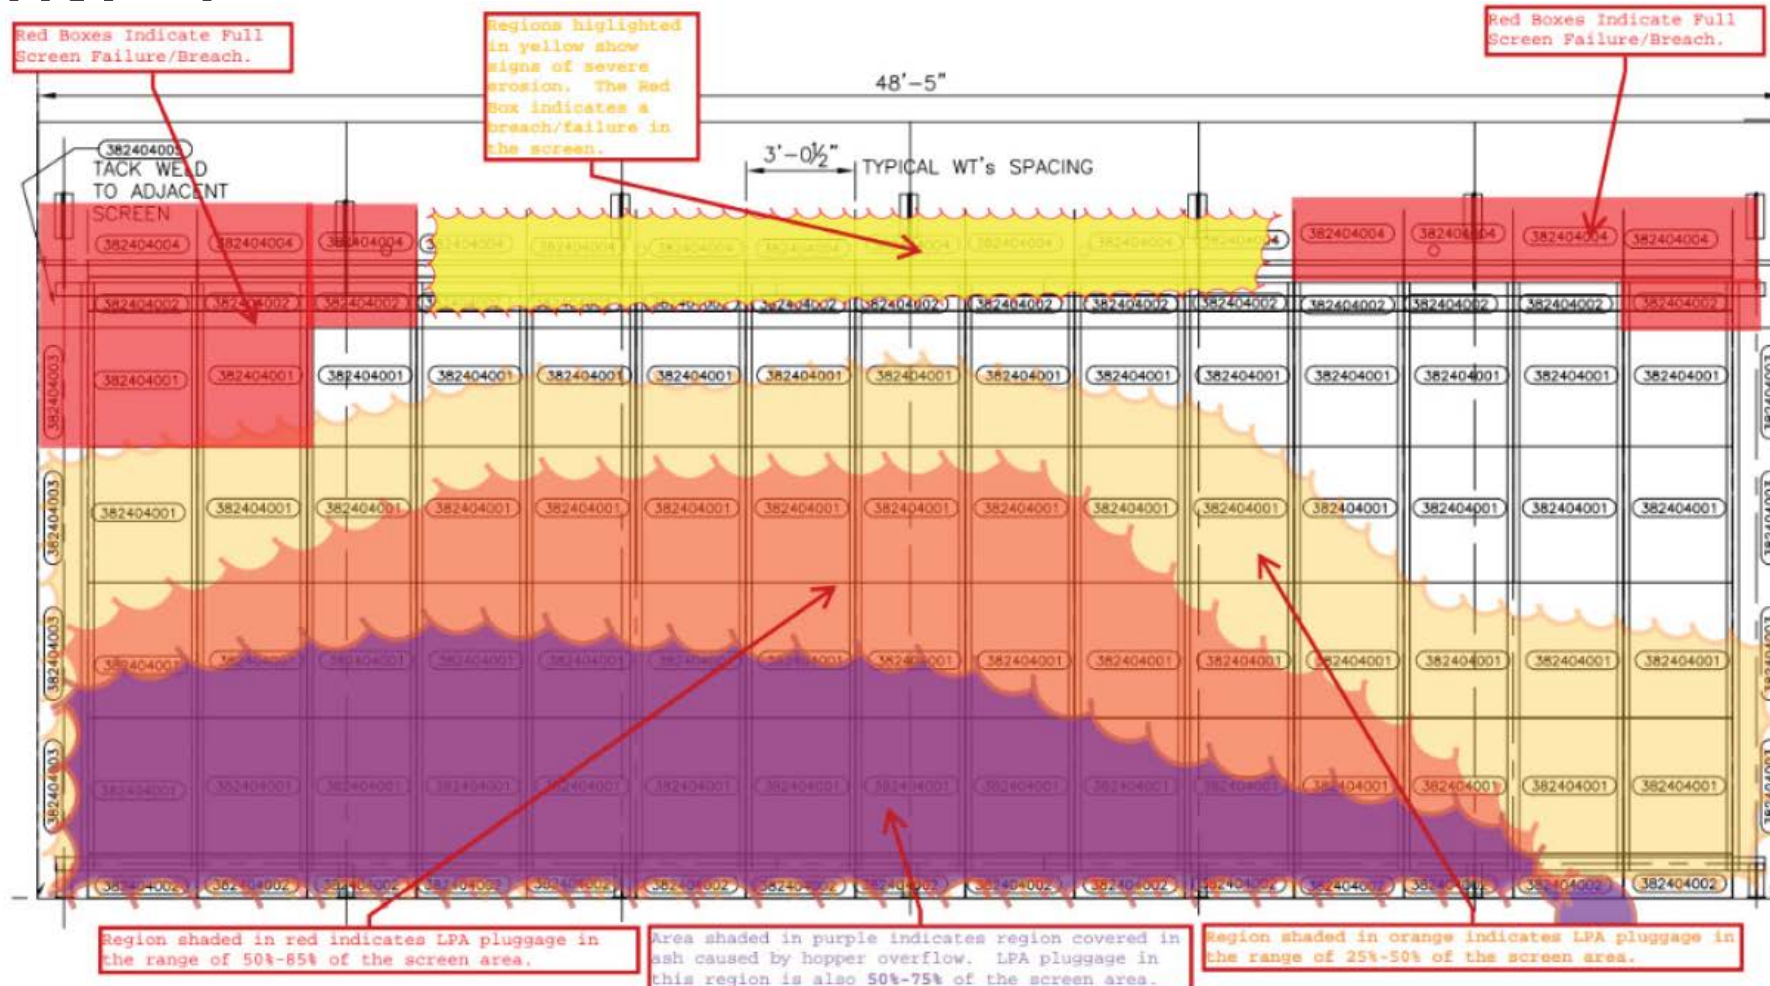
LPA Screen Operational Issues

- Screw Conveyor was inoperable due to continued maintenance issues
- Ash Piled at Screw Conveyor Blocking >50% of the screen
- LPA at Four Corners exhibited characteristics of slag and ash LPA types with a porous, sintered matrix surrounded by fly ash agglomerates.
 - I.E Very Erosive
- Reduced LPA Screen surface area due to plugging

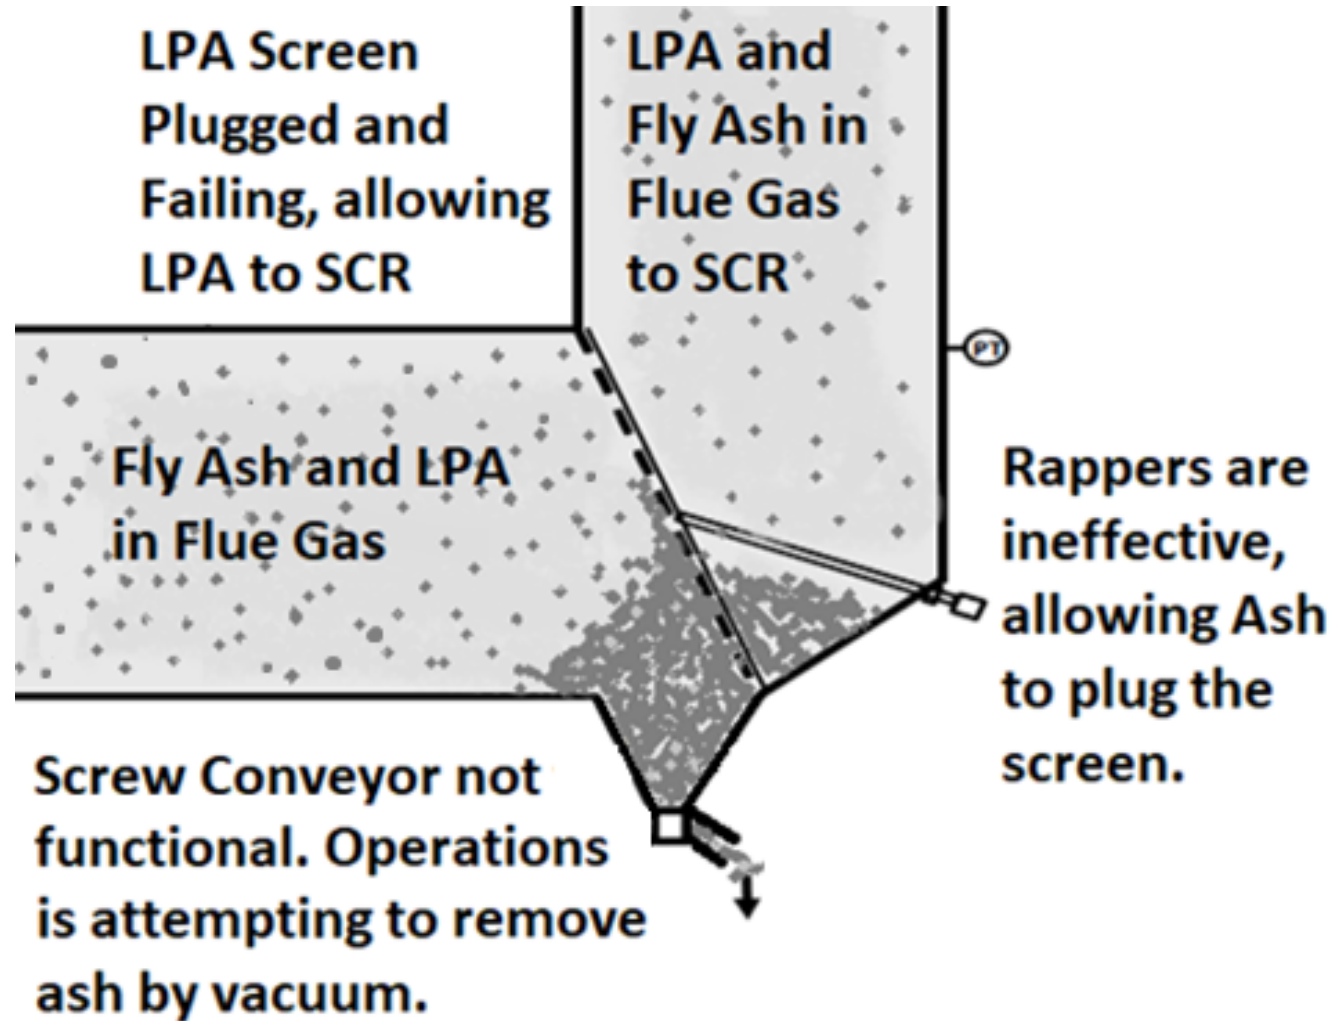
LPA Screen Operational Issues

- Ash Piling Increased velocities through the screen, significantly decreasing screen life
 - Holes developed – they were incorrectly repaired or not repaired
 - LPA broke through to SCR, Preheater, Baghouse, etc.
- Rappers were ineffective in clearing screen due to flow disruptions

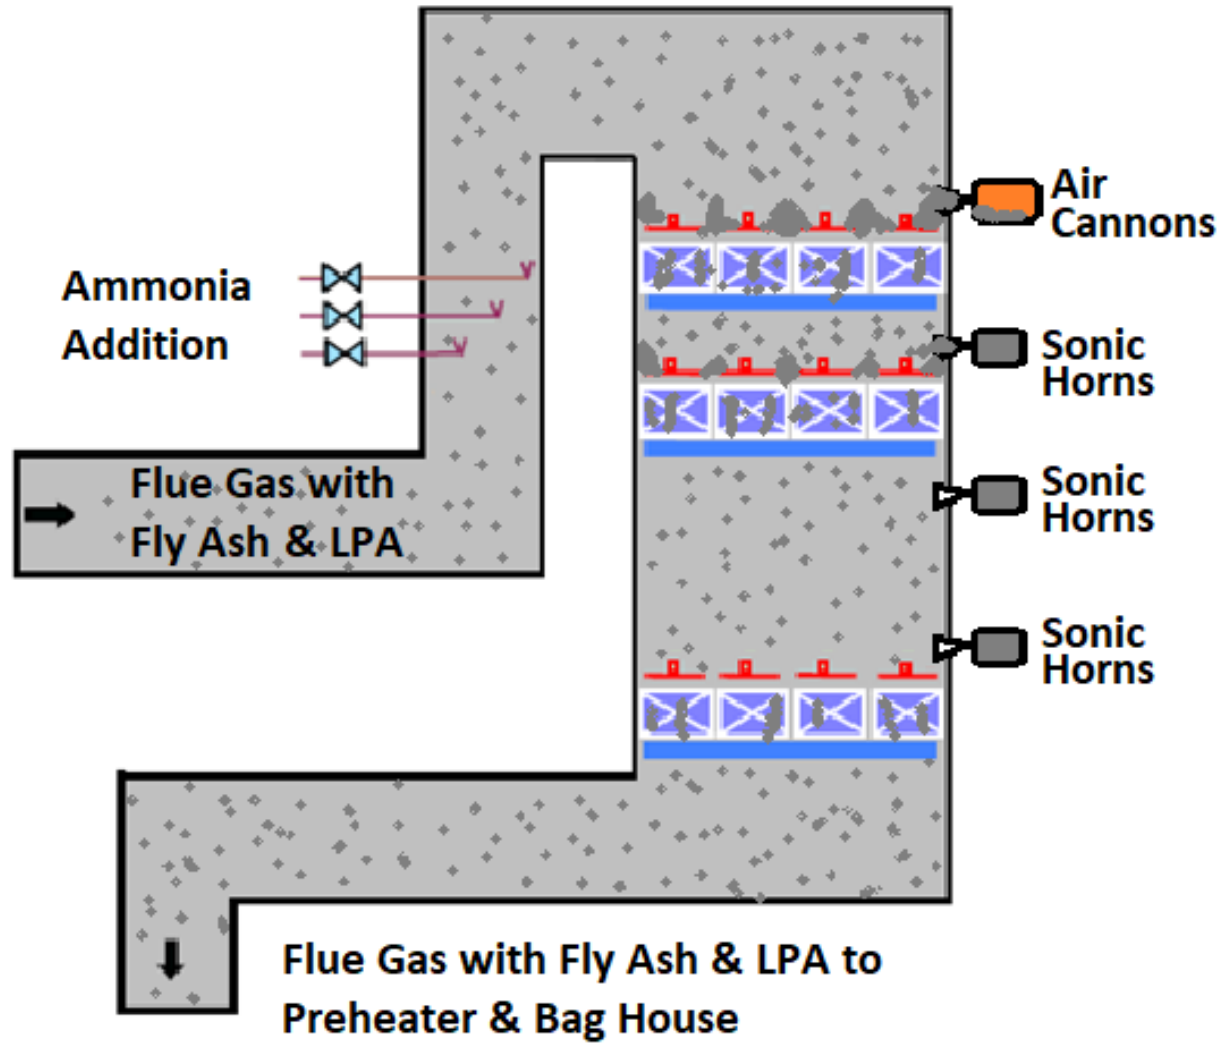
SCR Performance Issues

- Ash Piles on all layers of the catalyst
 - Unit 5 had a maintenance event where steam penetrated the SCR causing significant issues. Unit 4 is not as severe.
- Air Cannons and Sonic Horns were plugged and not operating
- SCR Catalyst Screens damaged from narrowed Air Cannon shots.
- LPA breakthrough visible on all layers. Reducing the life of the SCR from 5-7 years per layer to 3-5 years.

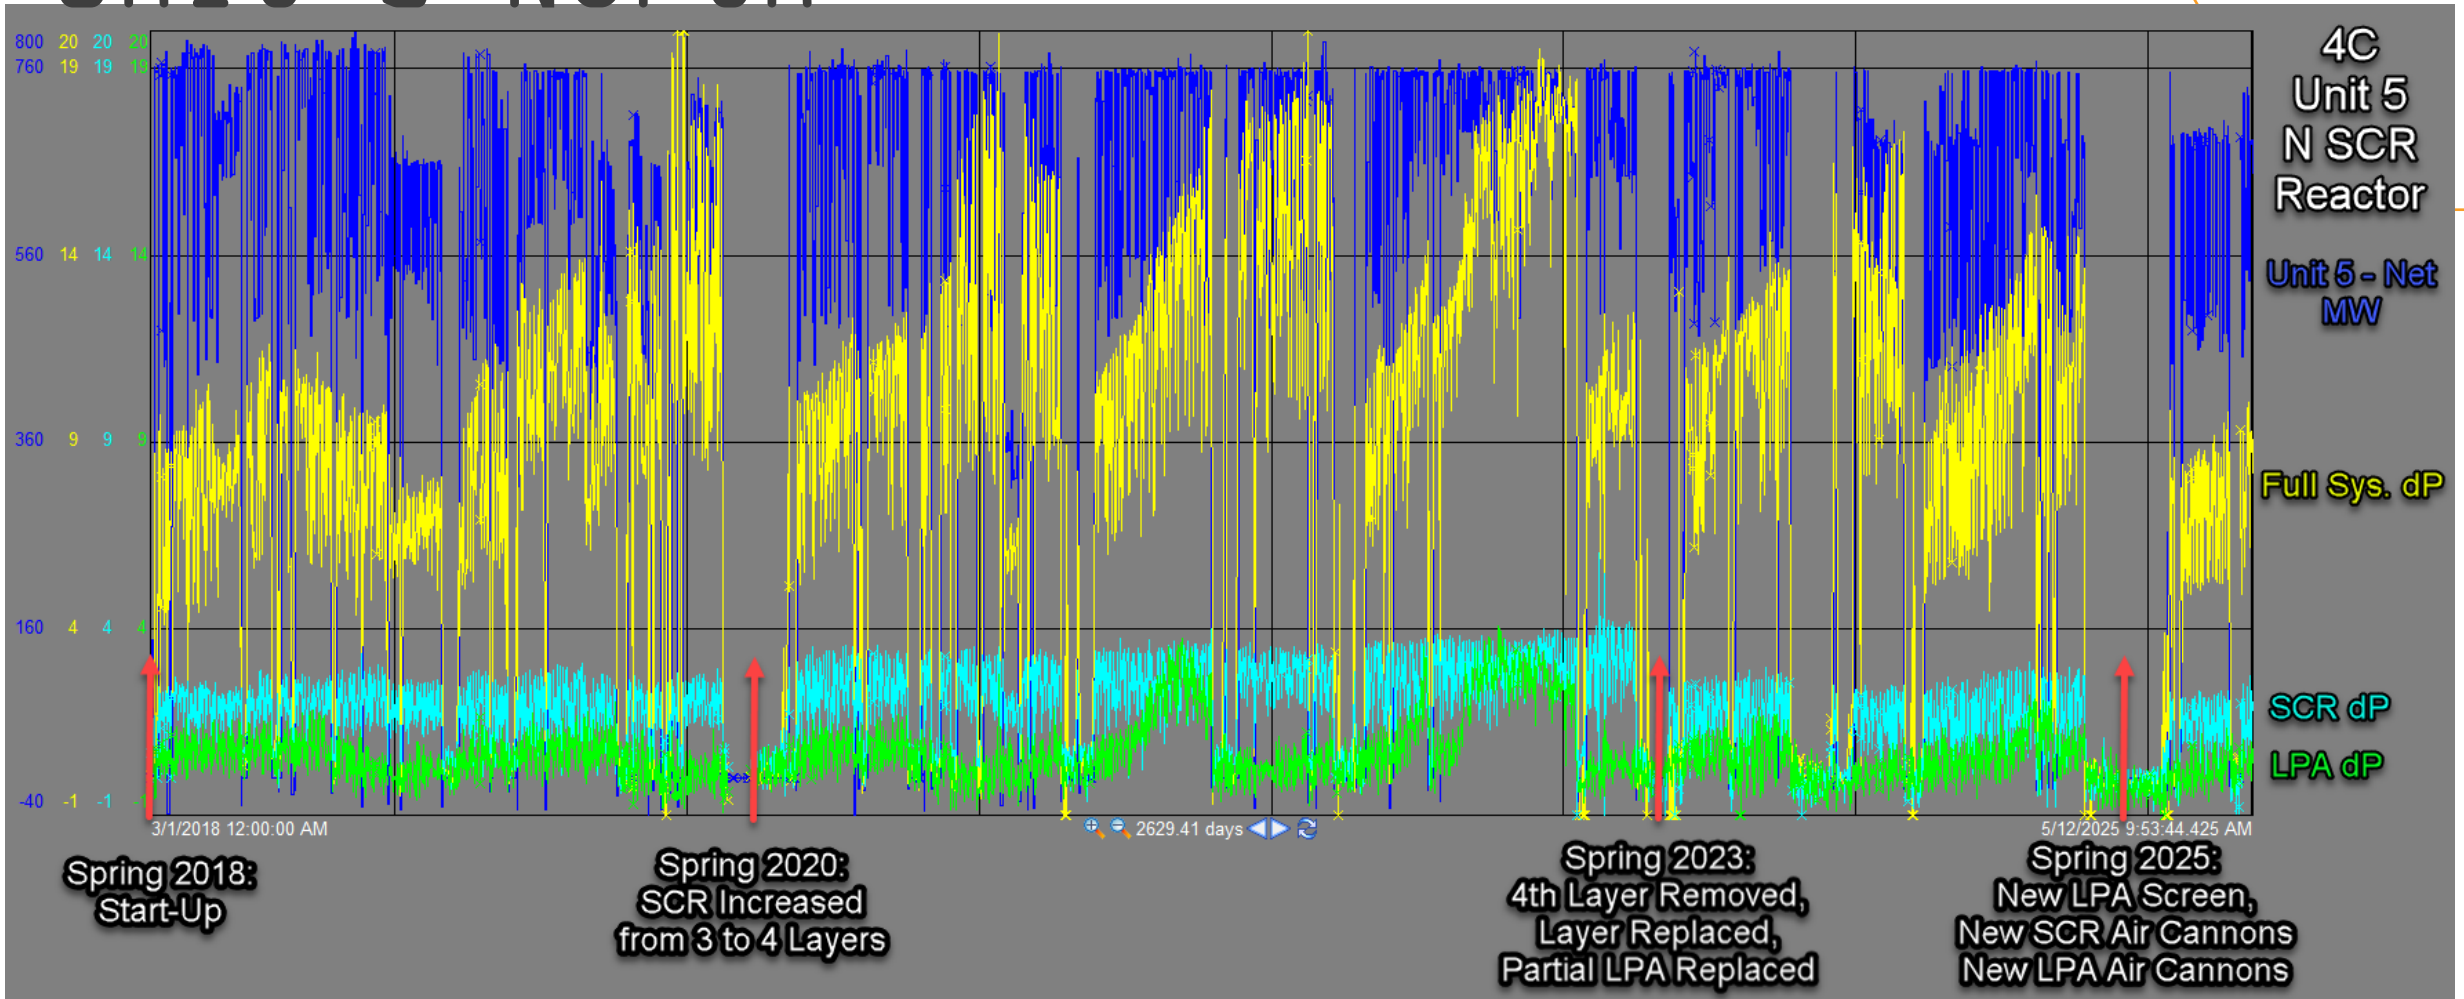
Unit 5 North

- Inspections have not been conducted post LPA System upgrade
- Inspections of the SCR show less Ash Piling
- After 140 days of Operation on Unit 5 and 90 days on Unit 4:
 - **30-60% less Pressure Drop through out the full system**
 - Projected to reach 14 in H₂O at most, reduction of 6 in H₂O
