2025 Reinhold/PCUG Round Table Presentation

PJFF Troubleshooting and Lessons Learned

Emily Yadon, LG&E Mill Creek Station

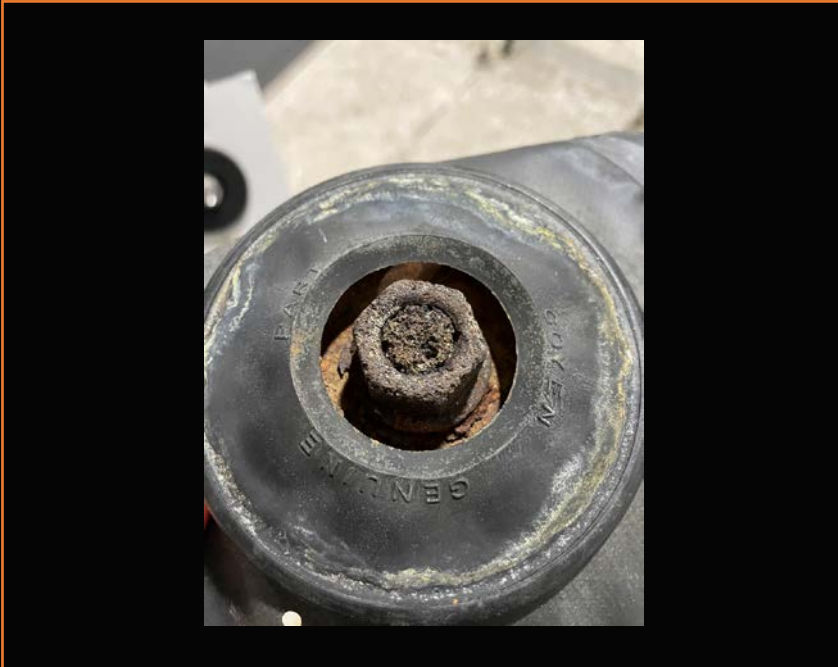
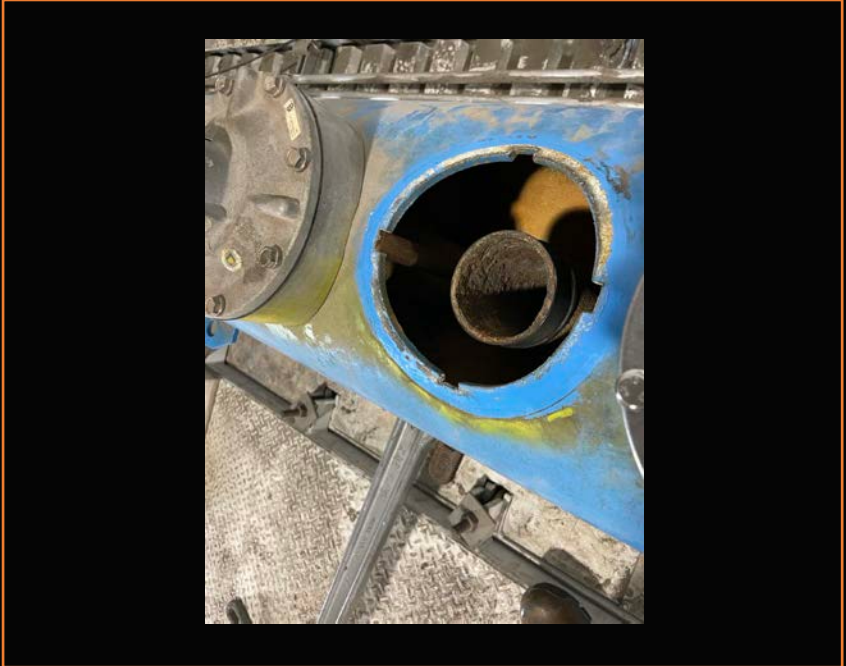
Pulse Air Headers

- Multiple actions taken:
 - Installing an insert- unsuccessful
 - Replacing valves one at a time
 - Added actuators to tanks
 - Replaced valve seats
 - Replaced check valves
 - Added insulation
- Entire header replacement from OEM is costly (new valves and header): \$36k per header

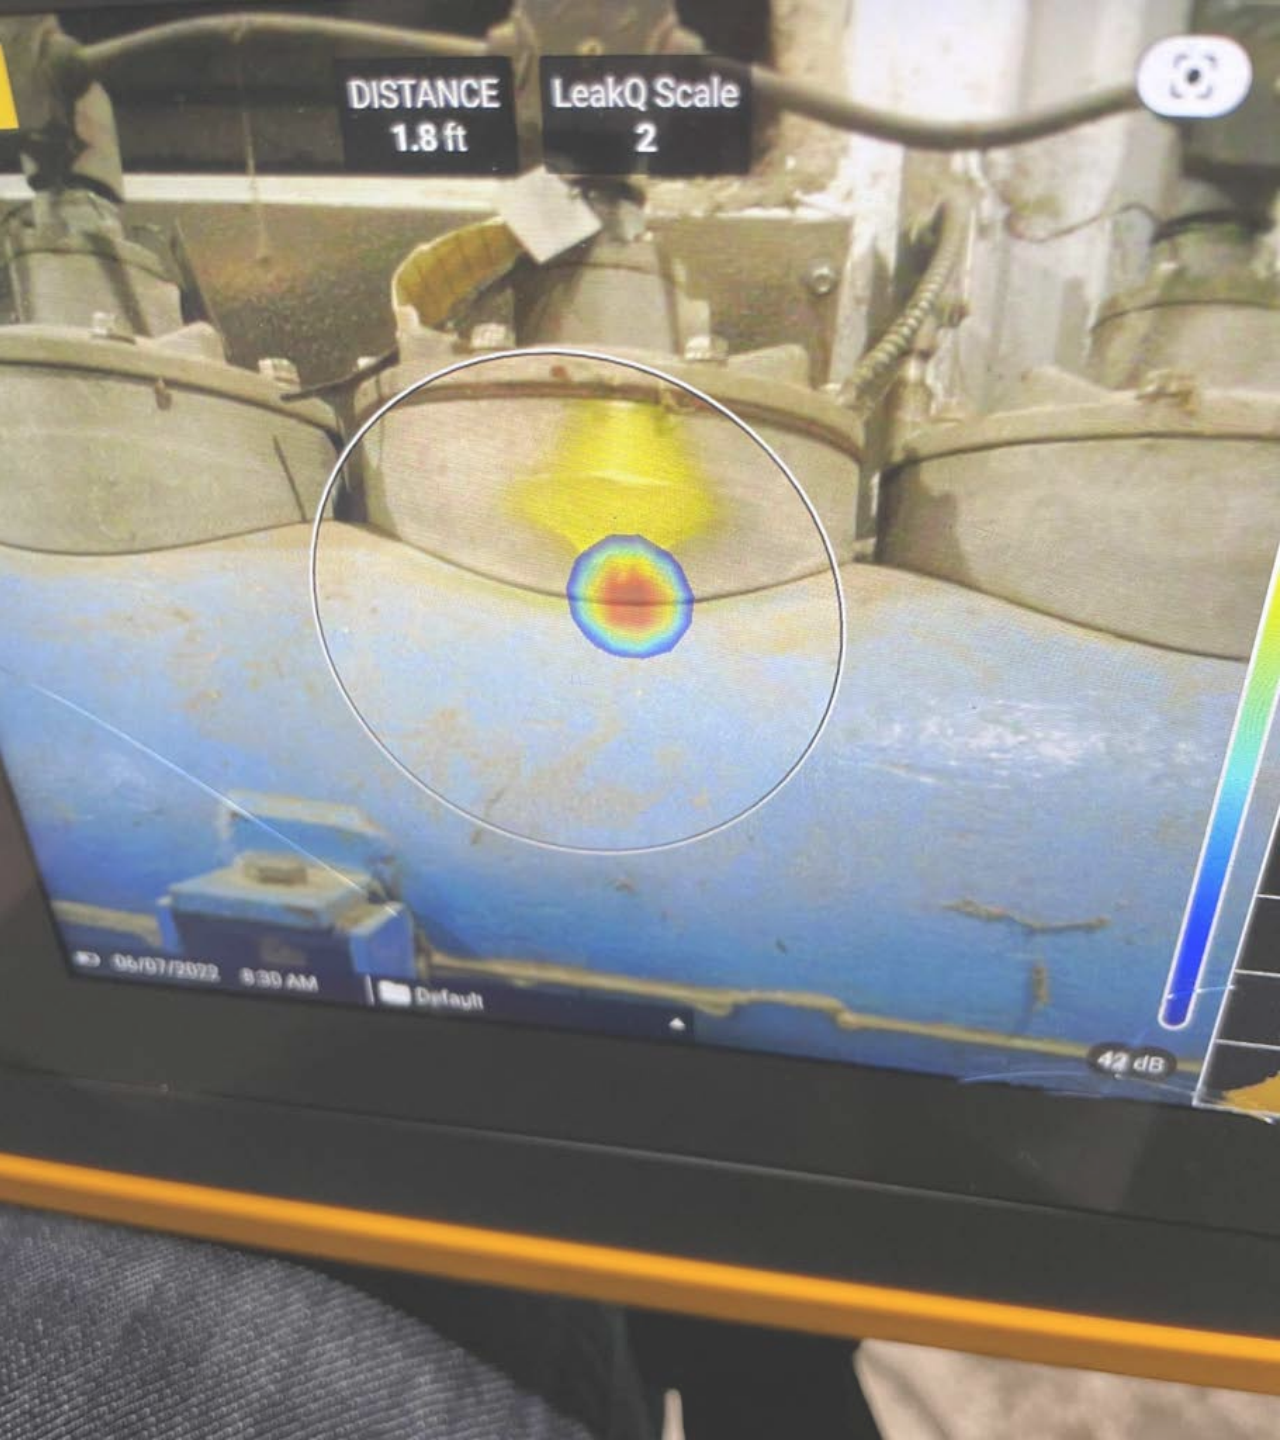
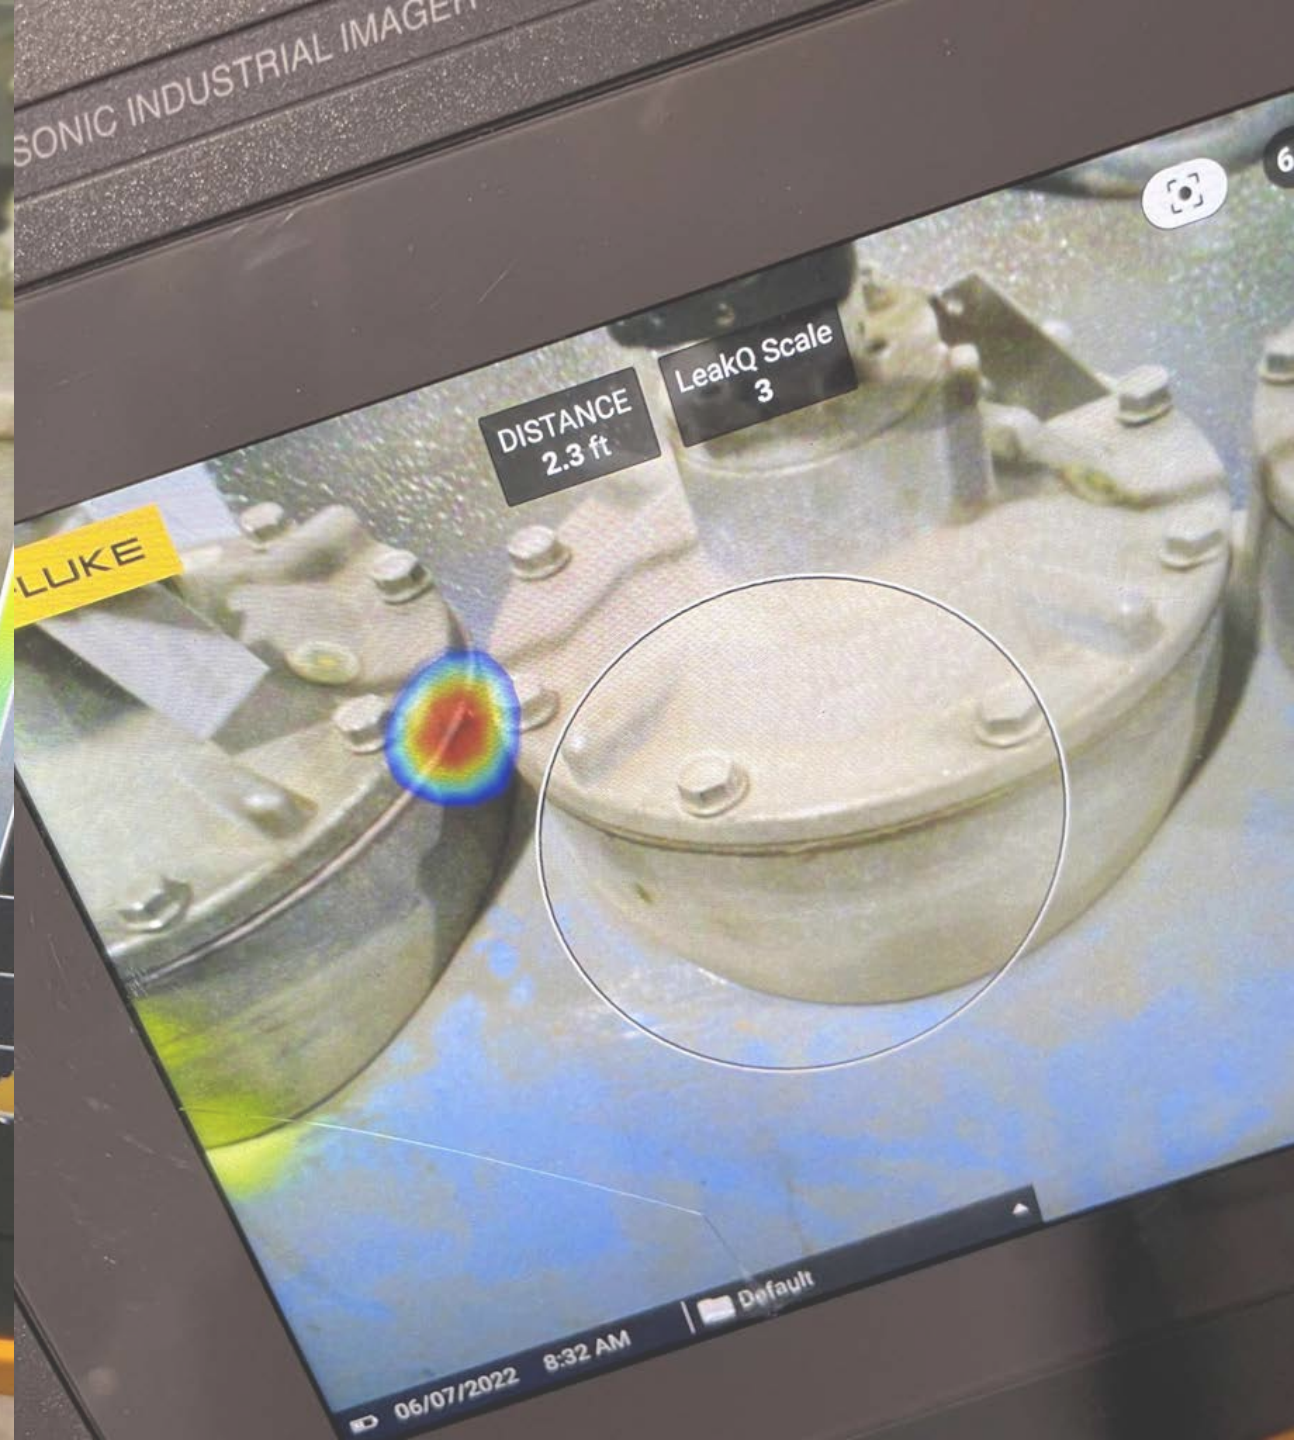
Replaced check valves with 0.062" pressure washer nozzle orifices

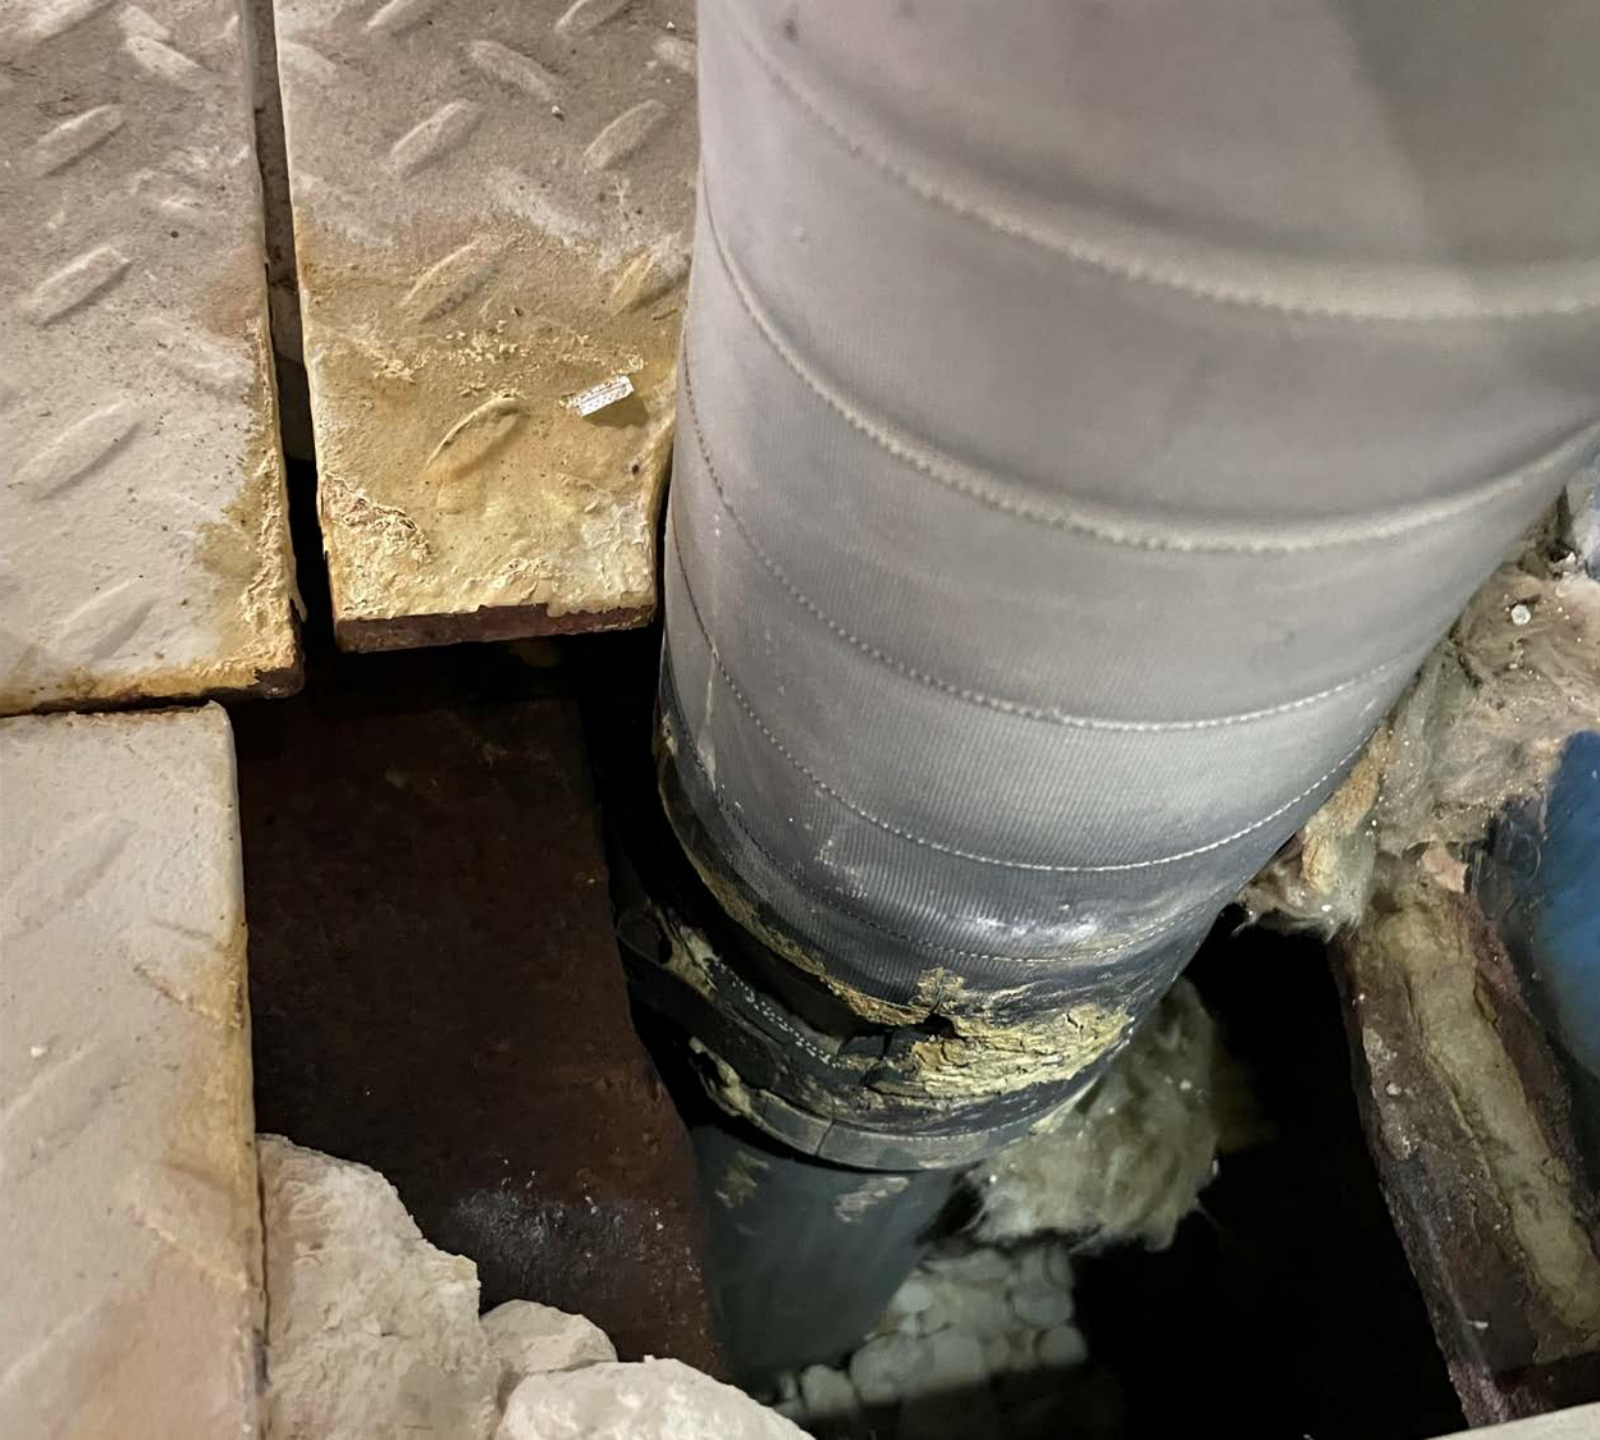
Pulse Air Headers

- Hoses have collapsed and failed due to vacuum
-

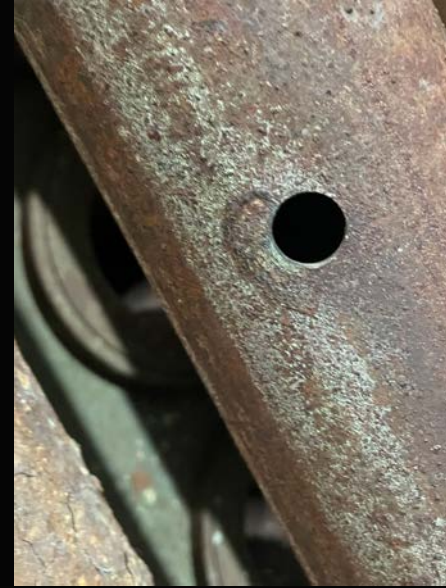
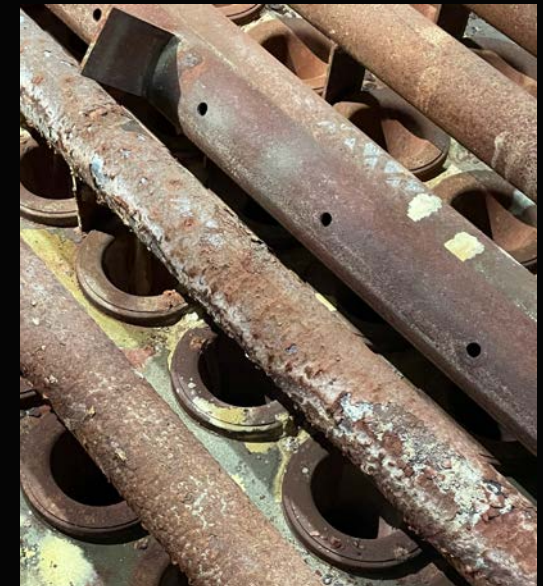
Pulse Pipe Holes

- Ensure holes have not elongated
- Circular hole pattern

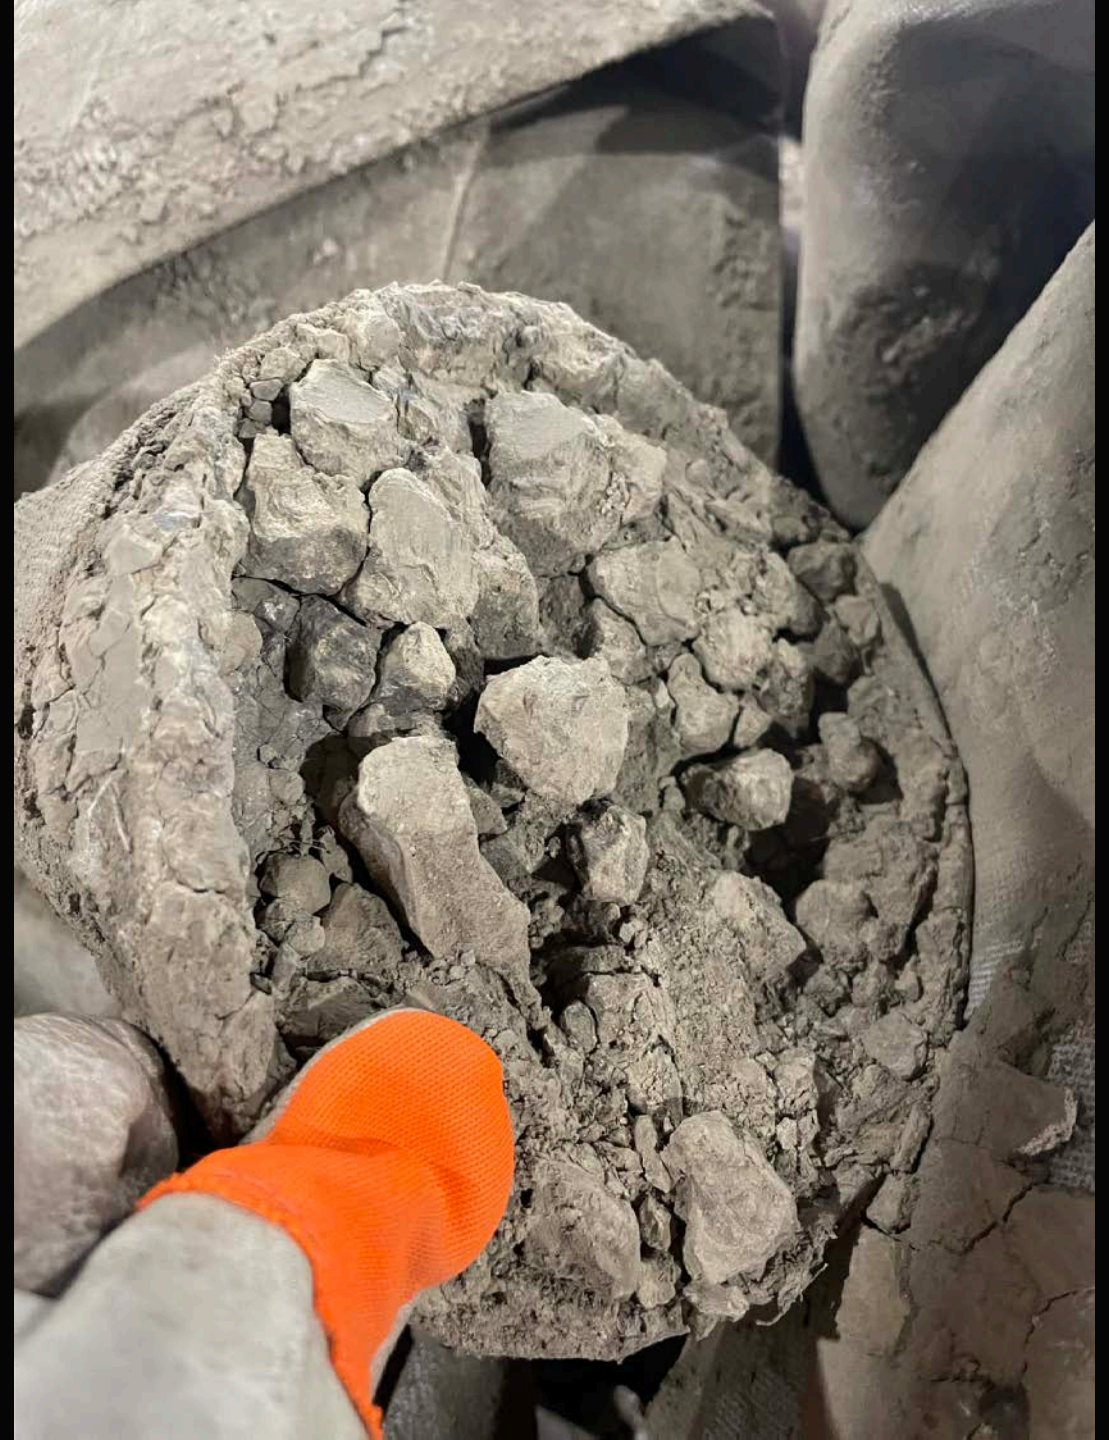
Moisture Issues

- Holes in ductwork or other process areas lead to moisture issues
 - Will also cause increased air flow to PJFF
 - Process upsets can cause issues
 - Operating temps above 300 deg F
-

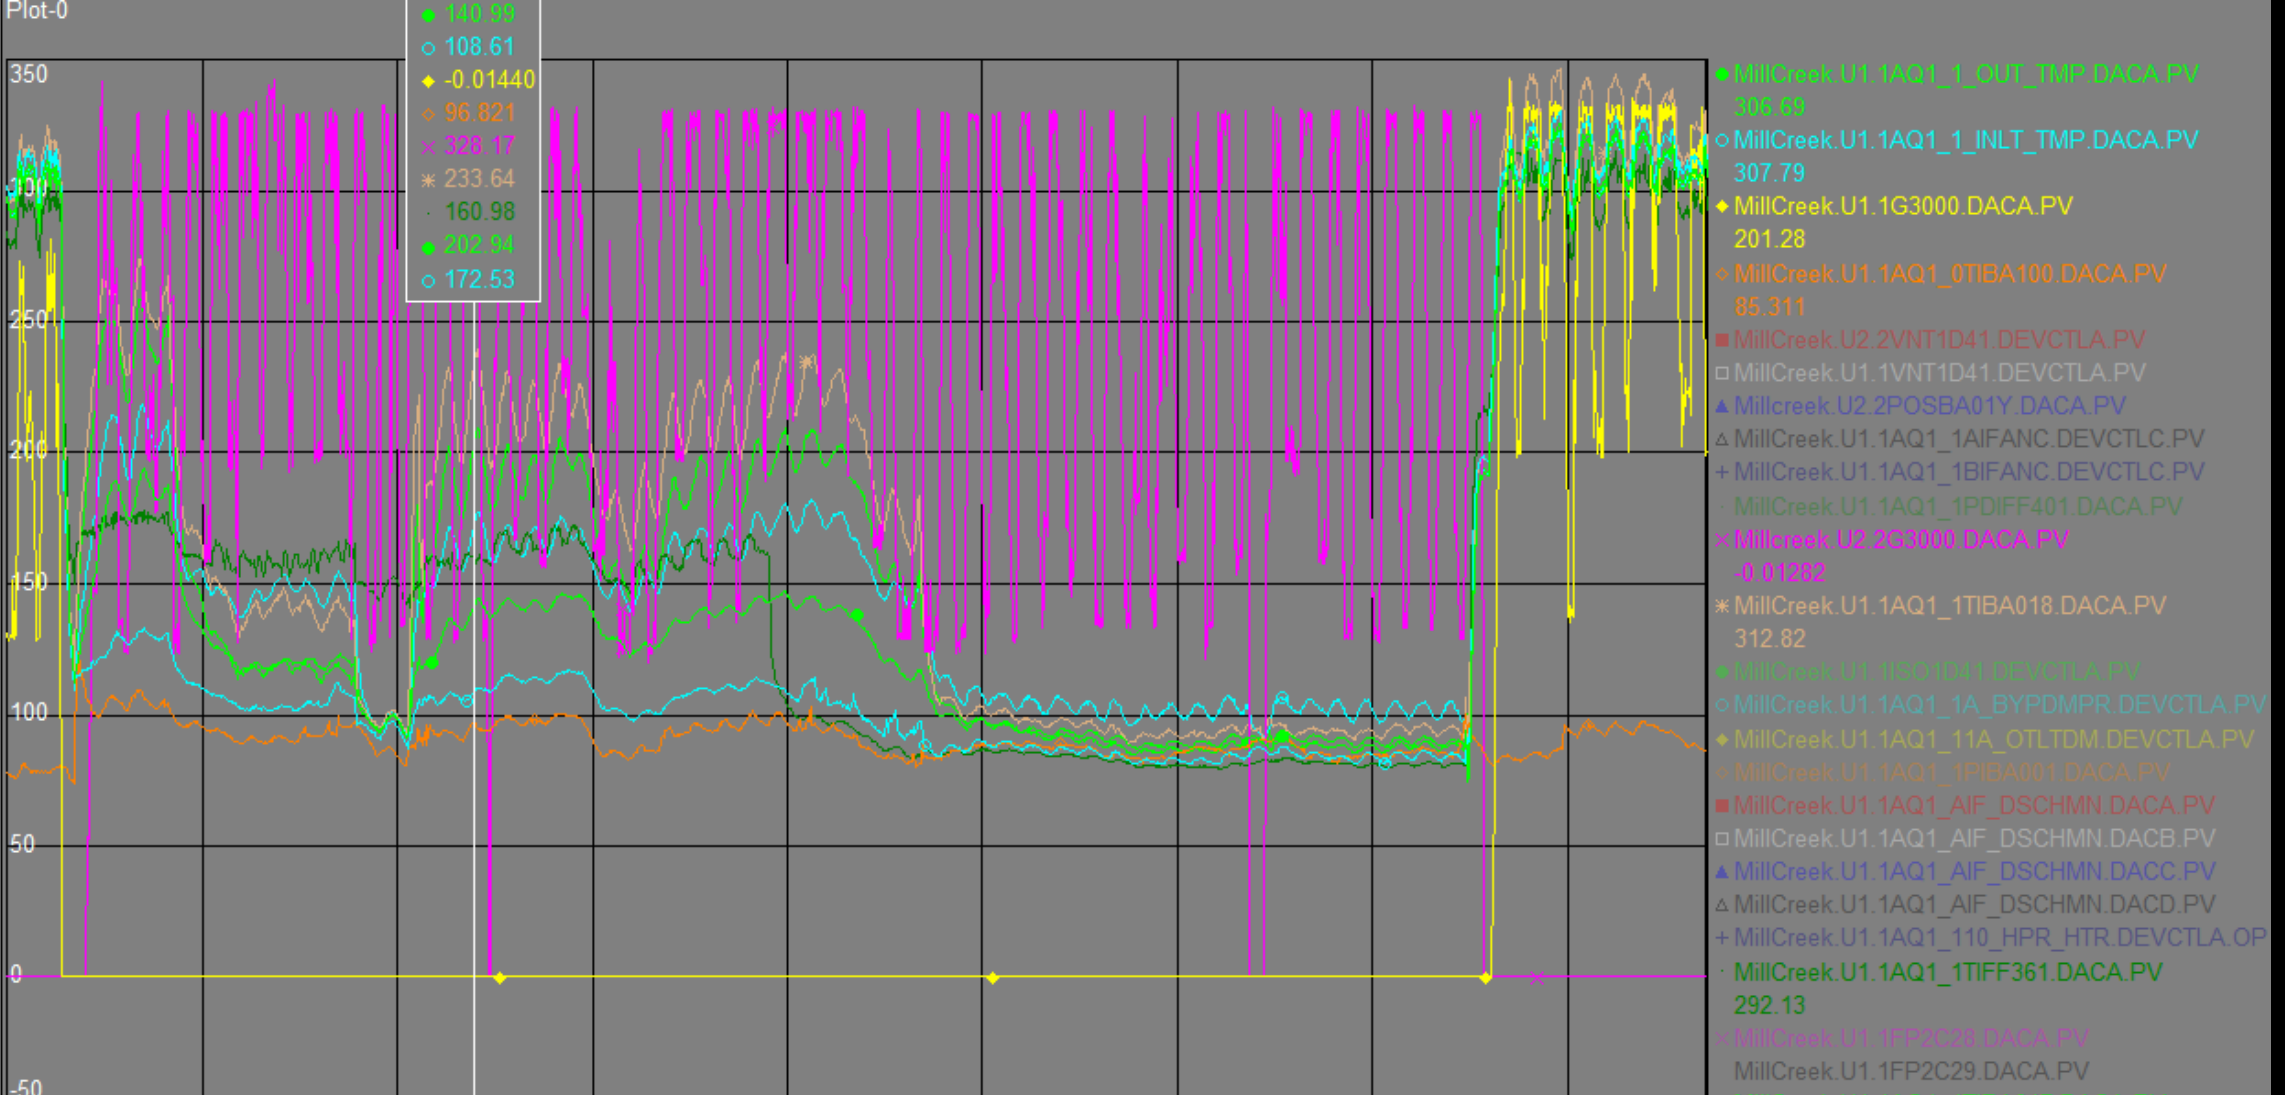
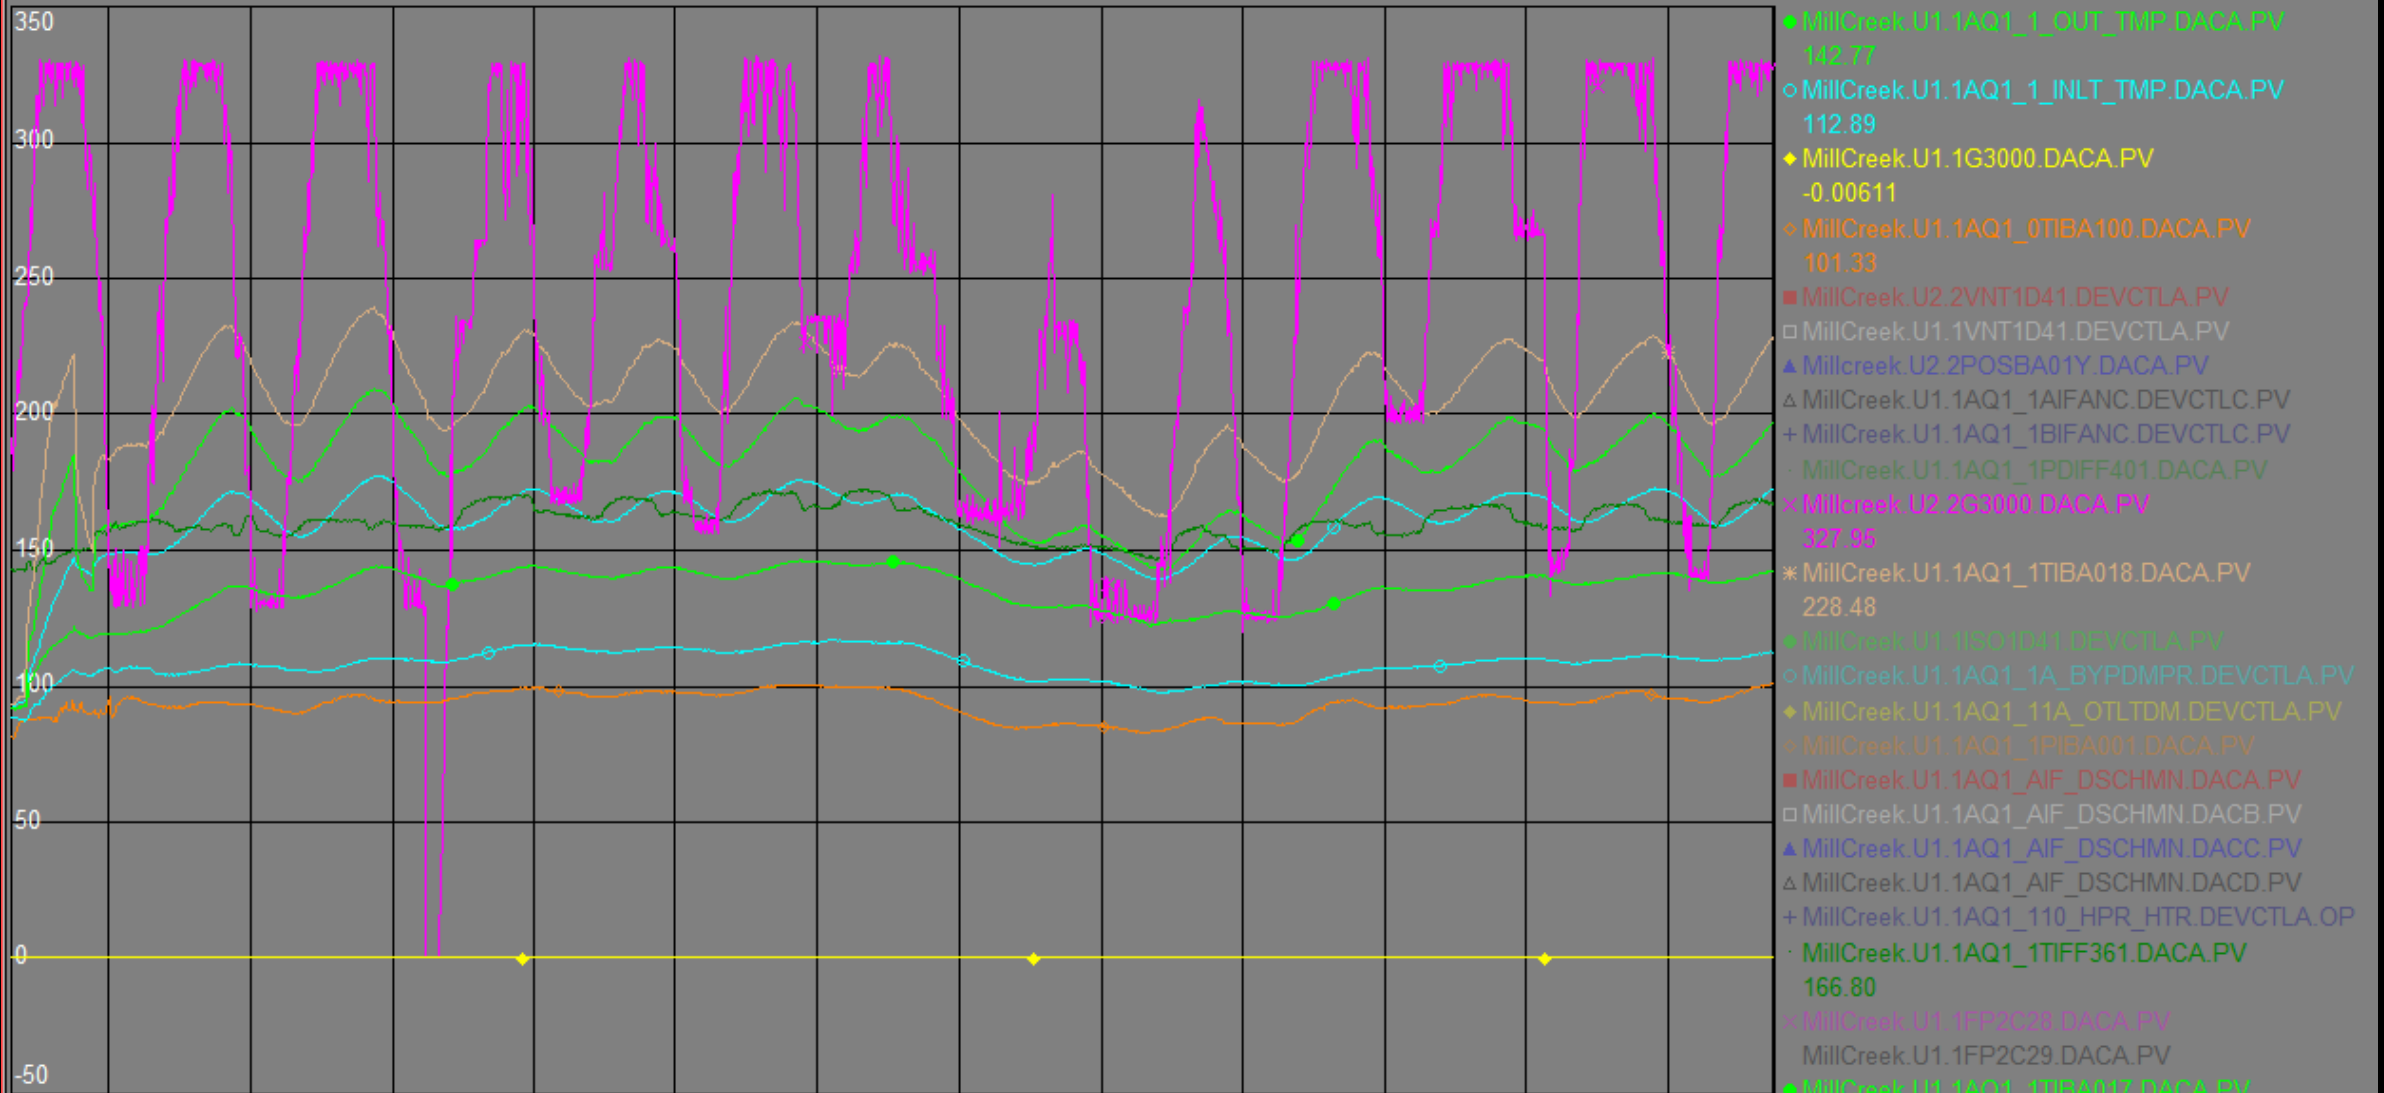
MC1 PJFF 2021

Root cause: leaking FGD isolation damper

- Flue gas leakage
- Permeability and bag performance impacts

- Ensure PJFF dampers were all shut on outages
- Monitor seal air system closely on FGD isolation damper
- Alarm if PJFF temperatures exceed 100 deg F while unit is offline

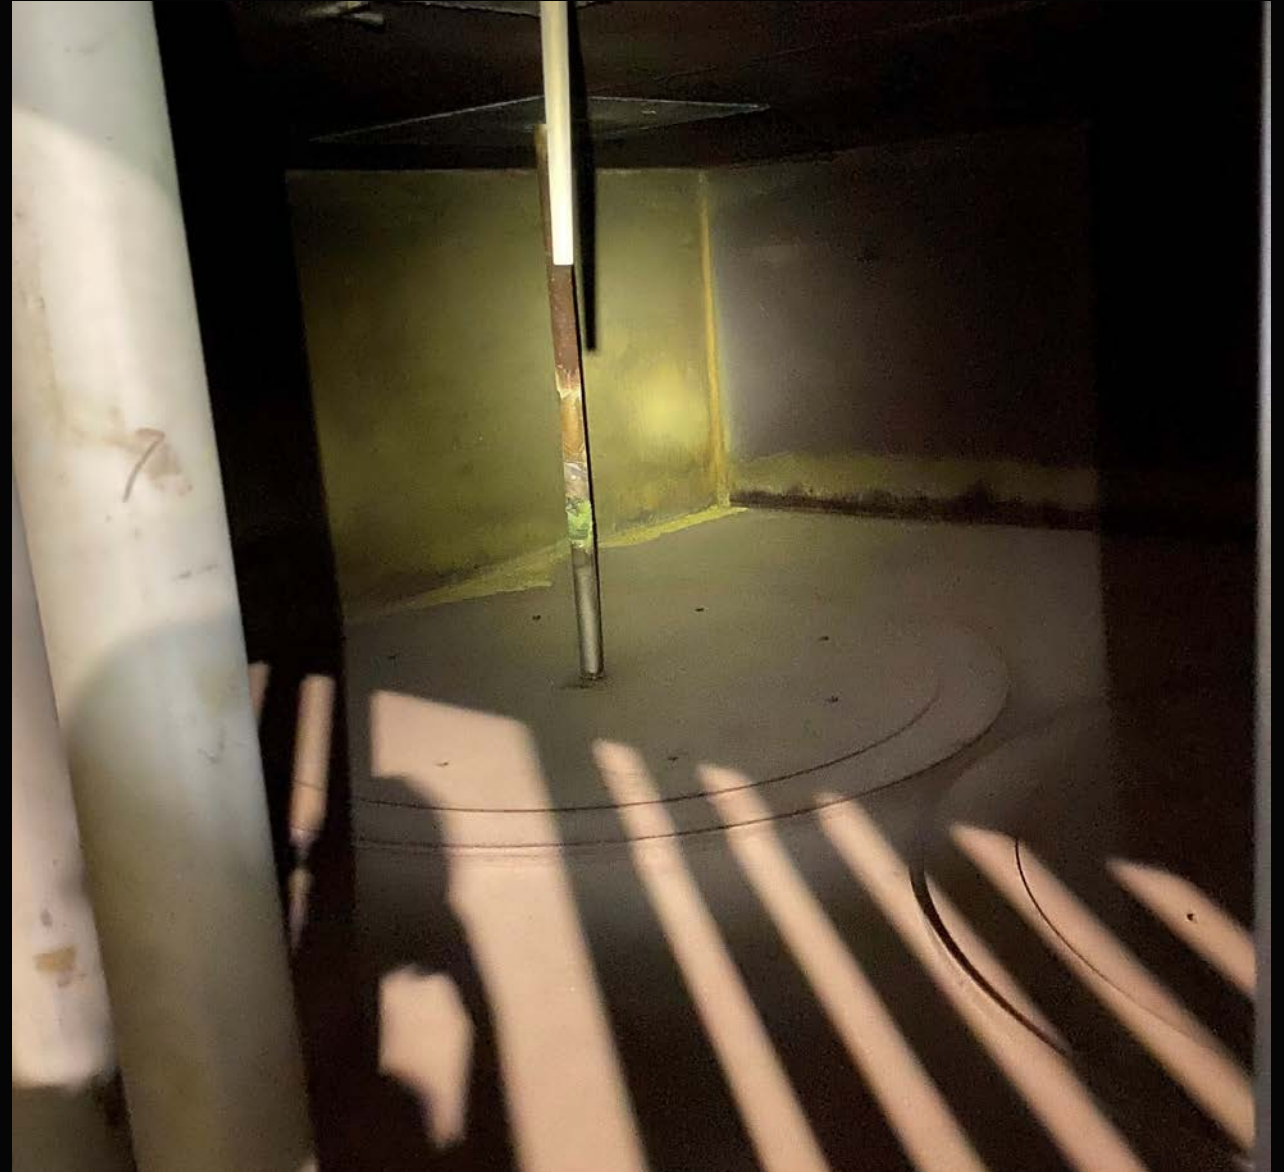
Outlet Poppets

- Ensure proper opening and closing of poppets from the compartments
 - Failures would result in higher DPs
