2012 APC Round Table & Expo Presentation

Southern Company Generation

Lessons Learned with Non-Metallic Materials in FGD Service

Gerald A. Van Beek

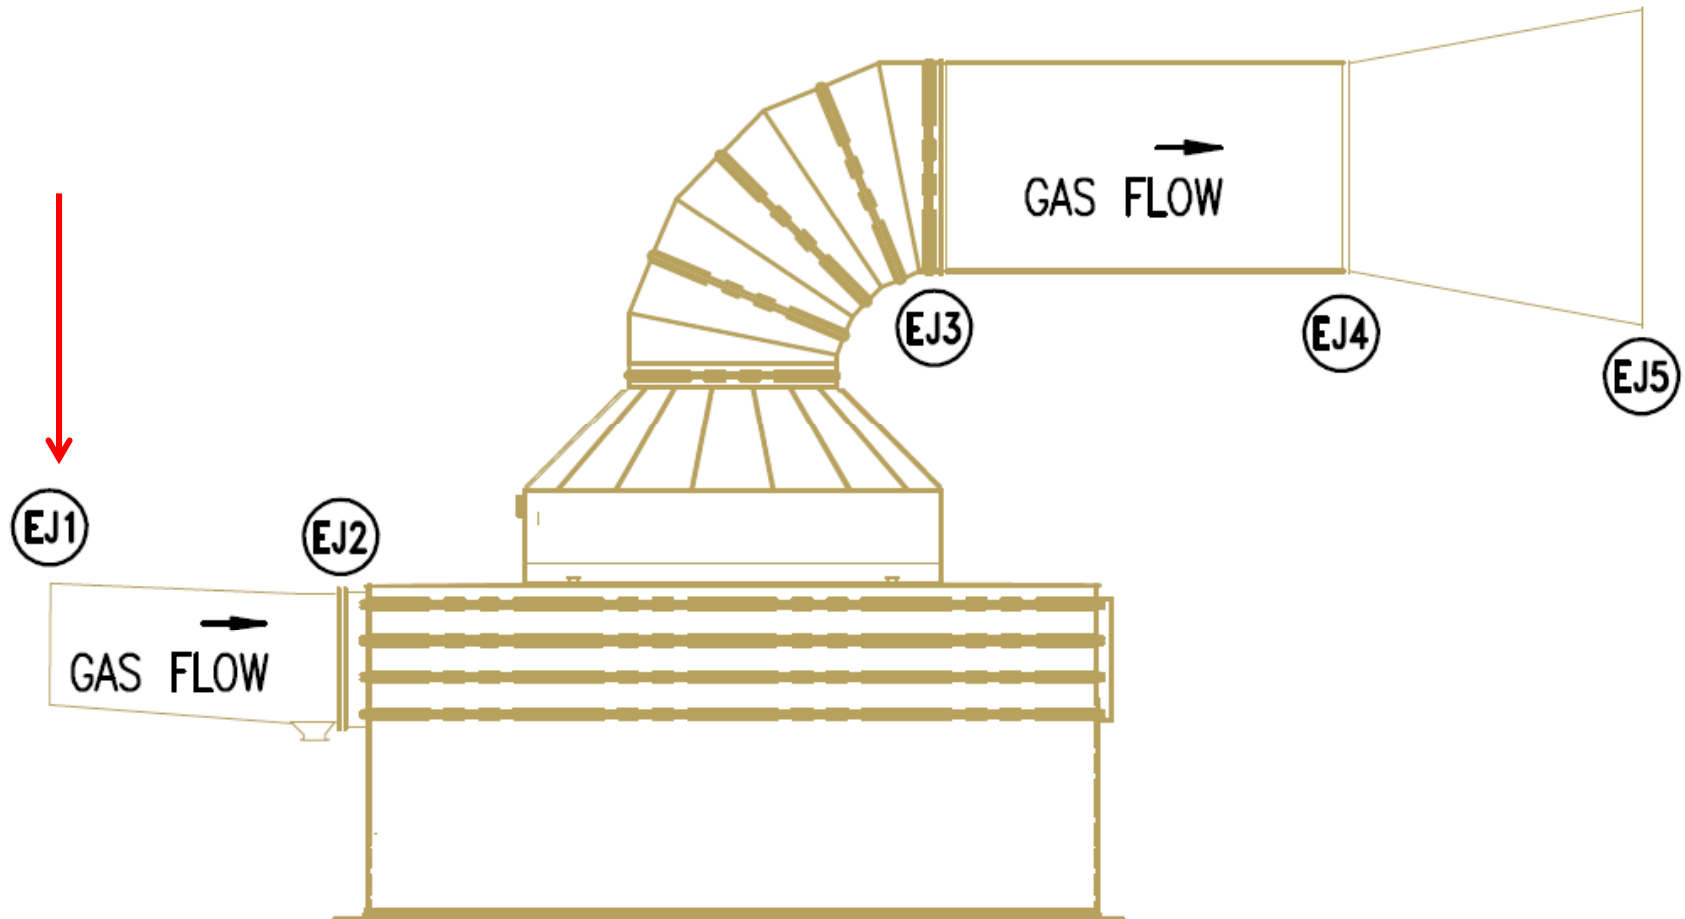
Lesson Learned EJ1 Expansion Joints

- Expansion Joint at the Inlet to scrubber which experiences alternating wet and dry is the most severe FGD joint.
- Industry standard expansion joint not sufficient to handle the service due to the higher operating pressure (25 inH₂O).

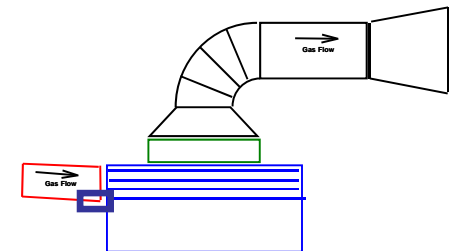
Erosion in surfaces parallel to flow will erode, but at a slower rate.
