2012 APC Round Table & Expo Presentation

July 16-17, 2012, in Baltimore, MD / Hosted by Duke Energy, Entergy,
FirstEnergy, Southern Company & TVA

POLYMER LINING PROTECTION FOR DUPLEX 2205 ALLOY ABSORBER MODULES

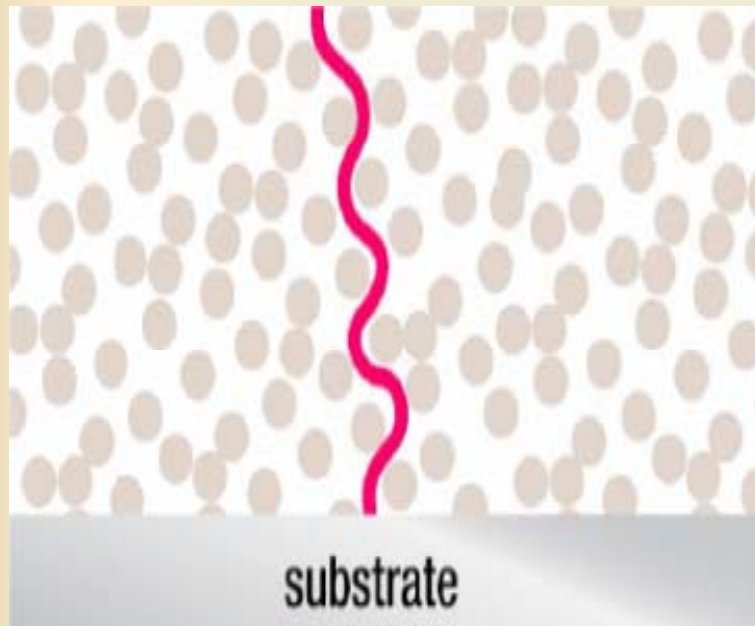
Typical Coating

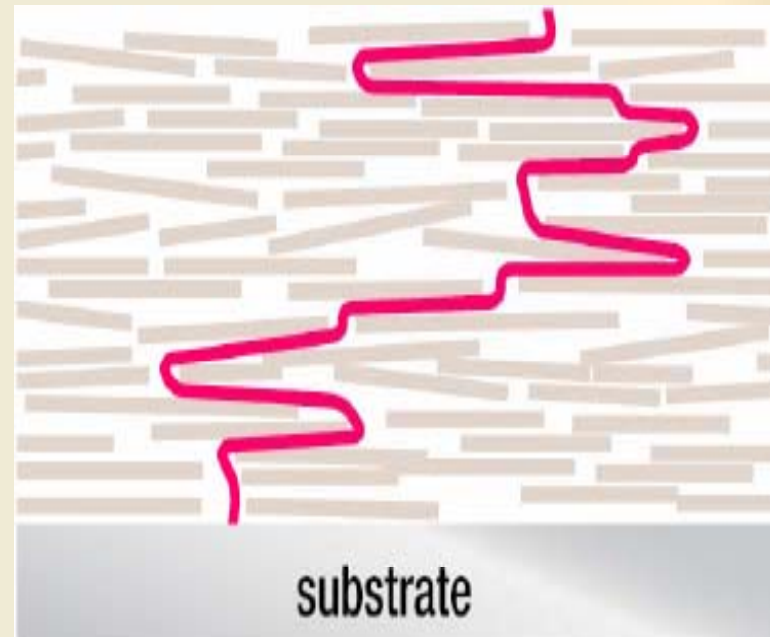
- ❖ Lining system foundation is glass flake filled Epoxy Vinyl Ester.
- ❖ Specifier should select:
 - ❑ Product utilizing chemically treated, large diameter glass flake as part of the formulation.

- ✦ Proper flake selection and chemical treatment will:
 - ▣ Result in maximum integration into the resin mix.
 - ▣ Result in flakes aligning themselves like fish scales.
 - ▣ Provides dense film resistant to moisture vapor transmission.

Properly Formulated Glass Flake Filled Coating
