Worldwide Pollution Control Association

Coal & Gas Seminar

August 24, 2016

WPCA-TVA Coal & Gas Seminar August 2016-Tim Stark

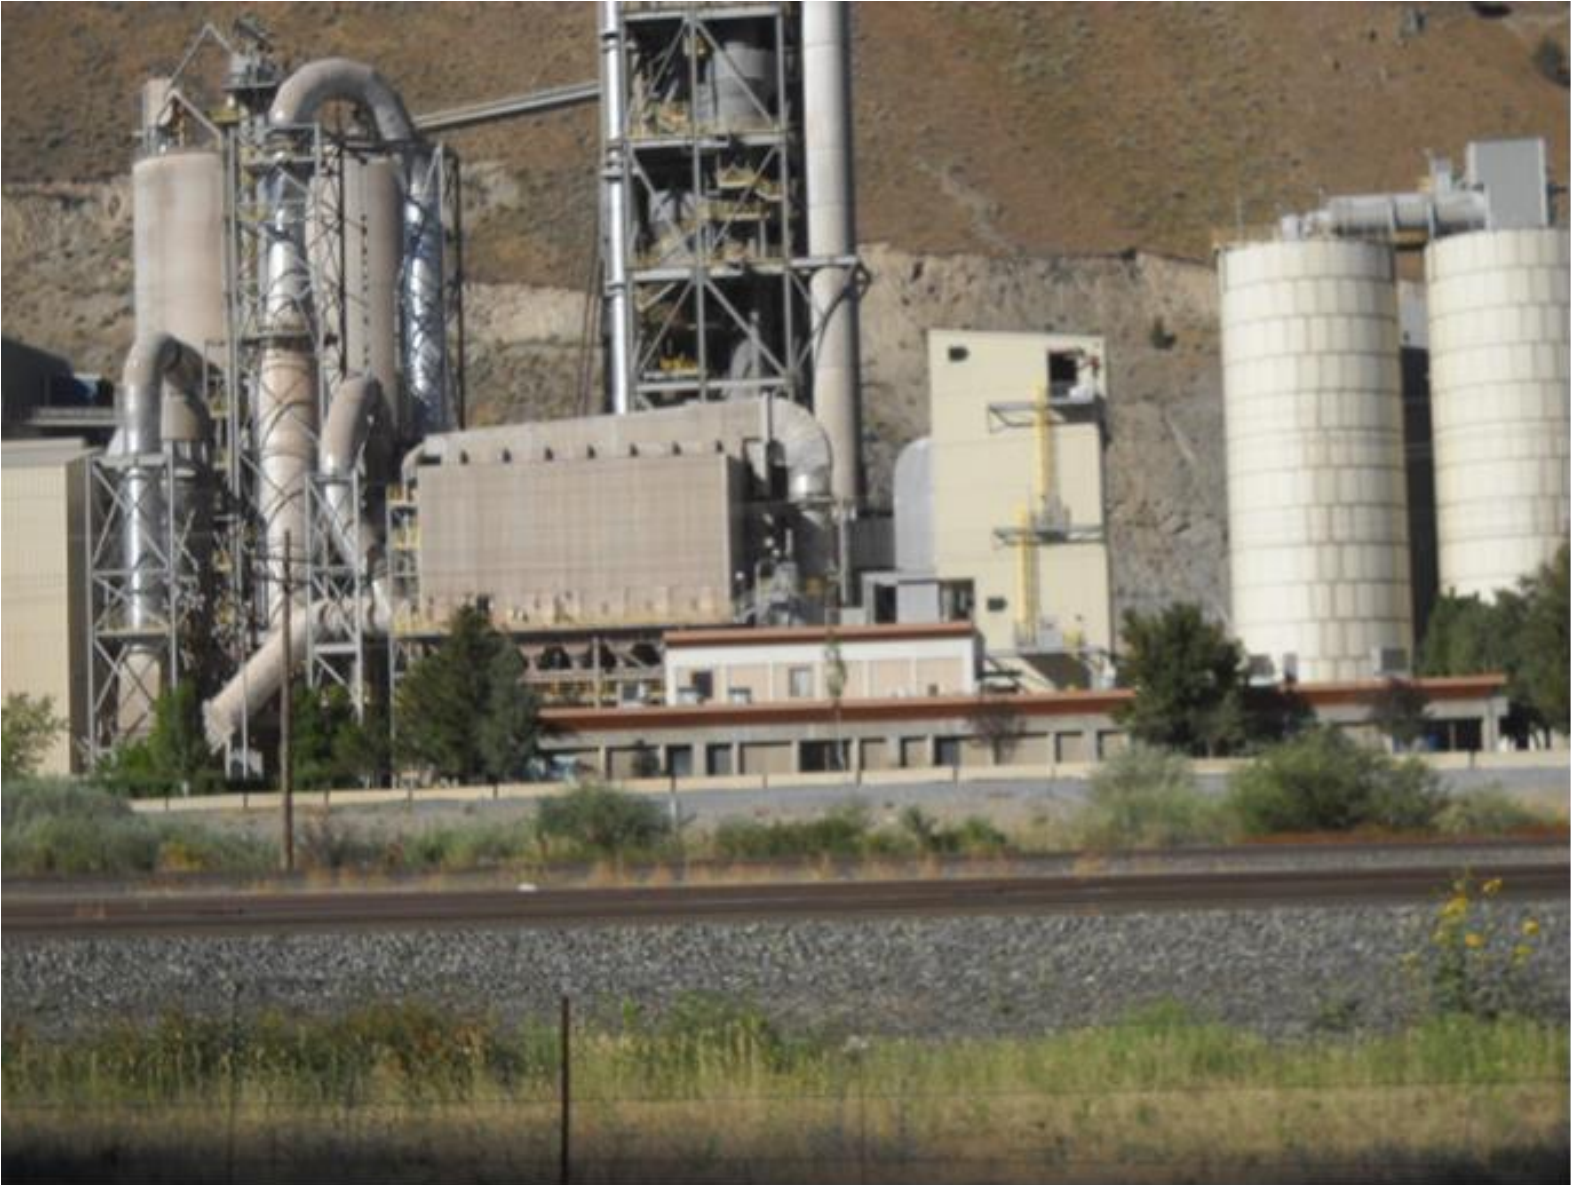
Baghouse Refurbishment

Estimated price off-line 500 MW boiler bag change out:

Pulse Jet: \$1.2 to \$1.8 million installed

Reverse air: \$1.0 to \$1.25 million installed

Filter bag replacement is the highest bag house maintenance cost
