Process Problems – Identify and Correct

Gordon Maller – URS Corporation

Special FGD Operating Problems

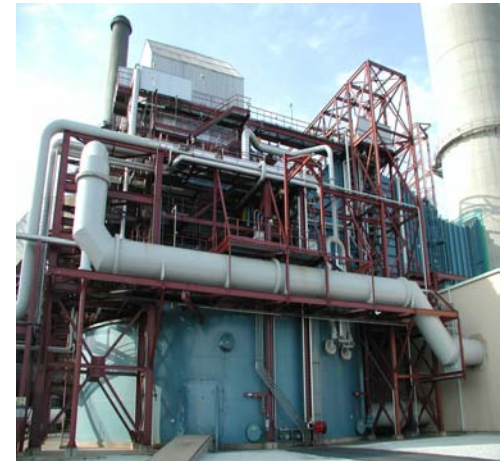
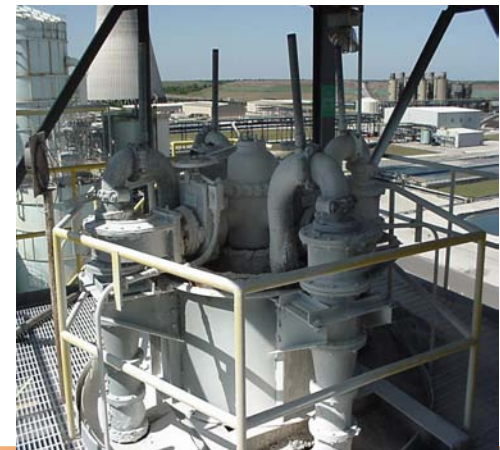
Scaling and Solids Buildup

Common areas where can occur

- Scrubber inlet
- Absorber internal walls and support structure
- Absorber spray headers
- Inside spray piping
- Trays
- Reaction tank walls

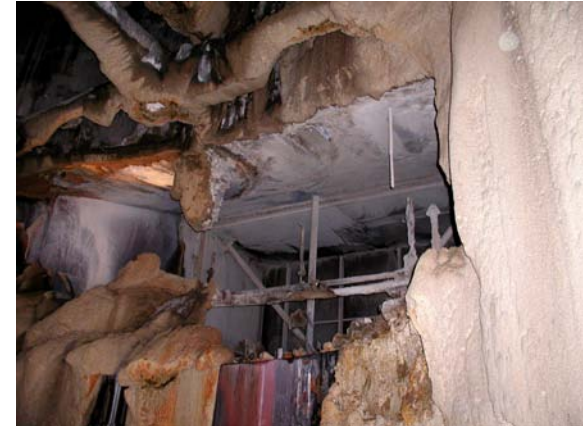
Scaling and Solids Buildup (cont.)

Causes:

- Chemical (high gypsum relative saturation)
 - Oxidation
 - Insufficient seed solids
 - Solid residence time that is too short
 - Poor wash water quality
- Wet-dry interface and recirculation of slurry
- Poor reagent utilization

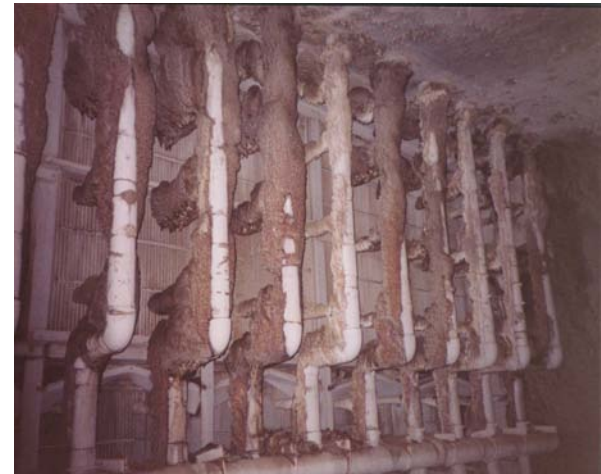
Mist Eliminator Pluggage

- Chemical causes
 - Poor reagent utilization
 - Poor quality wash water
- Mechanical causes
 - Poor design of wash system
 - Broken or plugged wash system
 - Non-uniform gas flow and liquid loading distribution

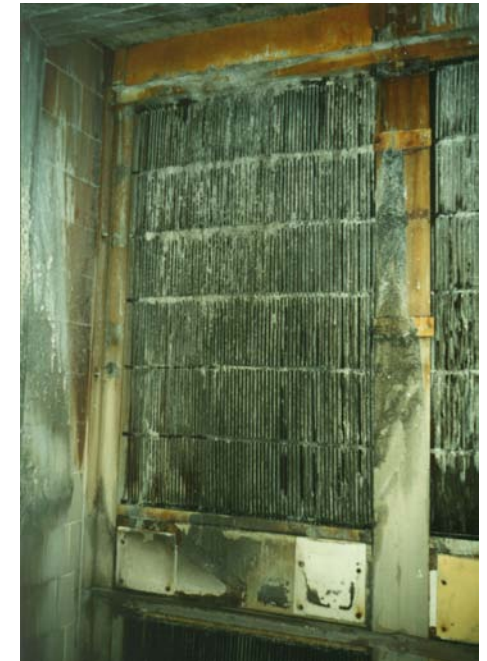
Mist Eliminator Pluggage

- Indication
 - Increase in pressure drop
 - Visual observation during inspection
- ME pluggage can:
 - Result in increased gas velocity through ME and liquid carryover into outlet duct
 - Cause stack rainout and particulate emissions
 - Damage ME due to weight of solids
