**2018 NO<sub>x</sub>-Combustion Round Table  
& Expo Presentation**

# Reinhold Environmental NOx Round Table February 19, 2018

Prepared by  
Greg Holscher and Stacy Steinhauer  
IBIDEN CERAM Environmental, Inc.

## “Midwest Utility” Reactor Inspection Review

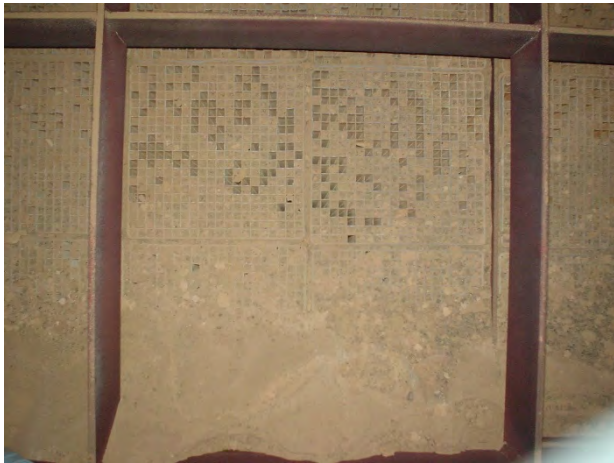
Sintered Catalyst from Ash Pile

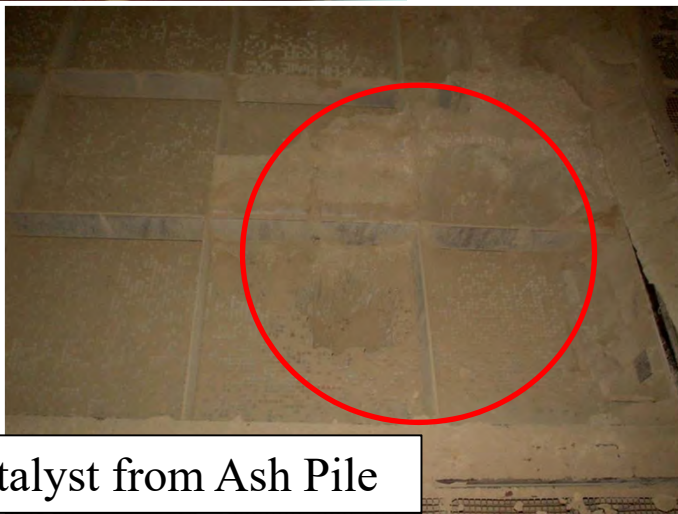
Pile disturbed revealing unburned carbon

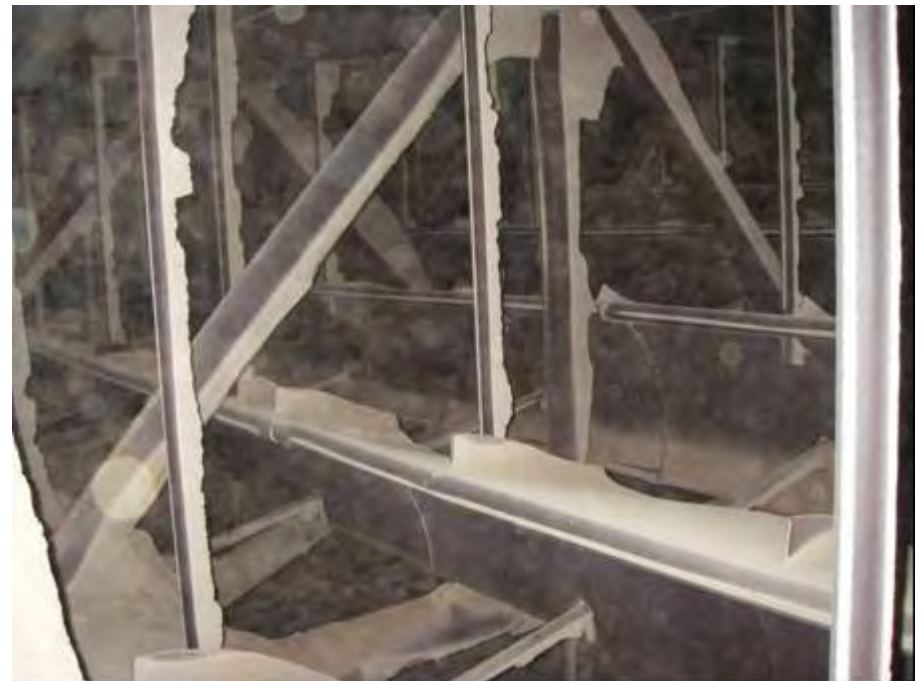
Are these vanes clean?  
“Nature of PRB ash”

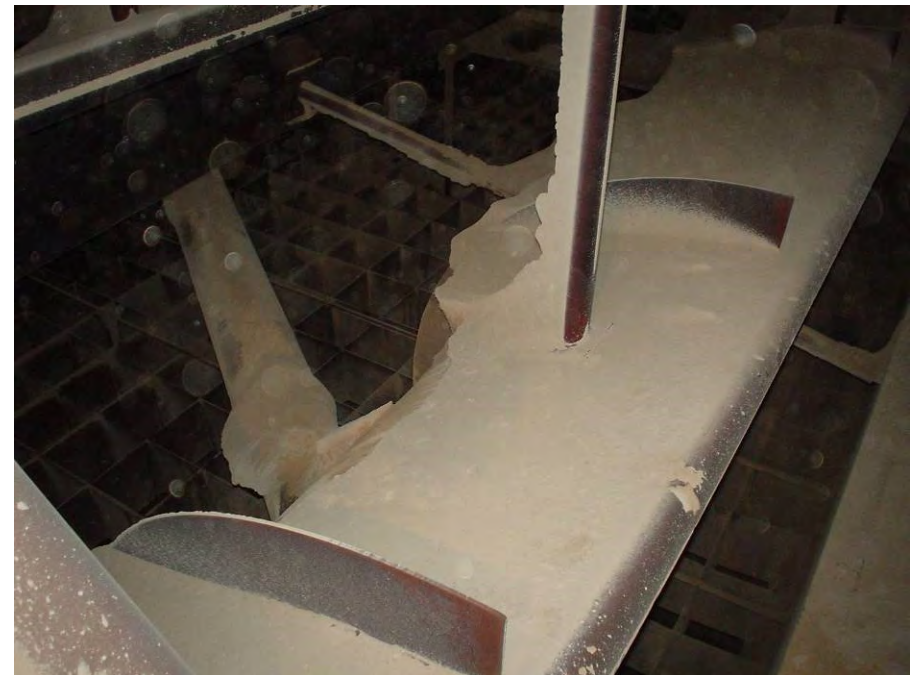
Affects of Ash Shear

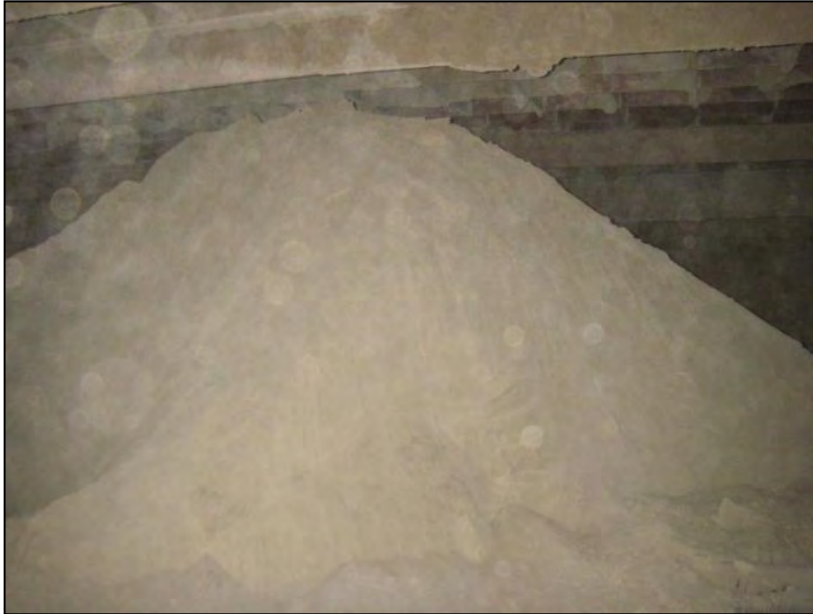
Ash Piles Eventually in L1

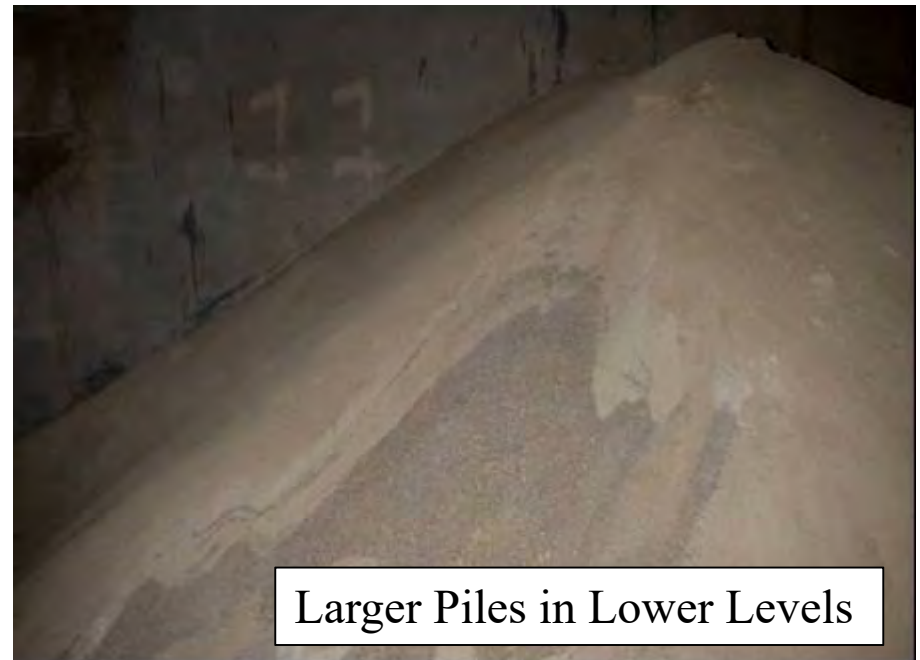
Larger Piles in Lower Levels

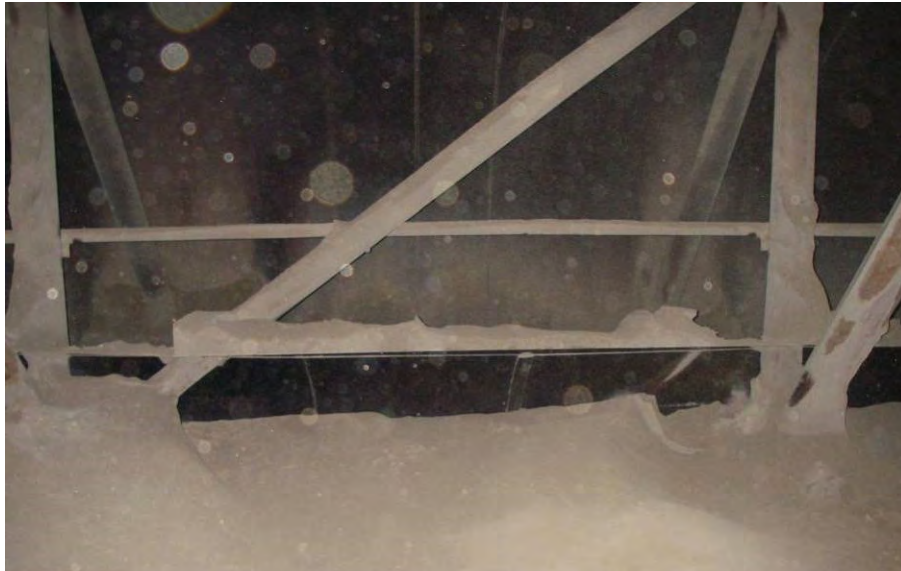
Still Have Ash Dropout in Crossover Duct

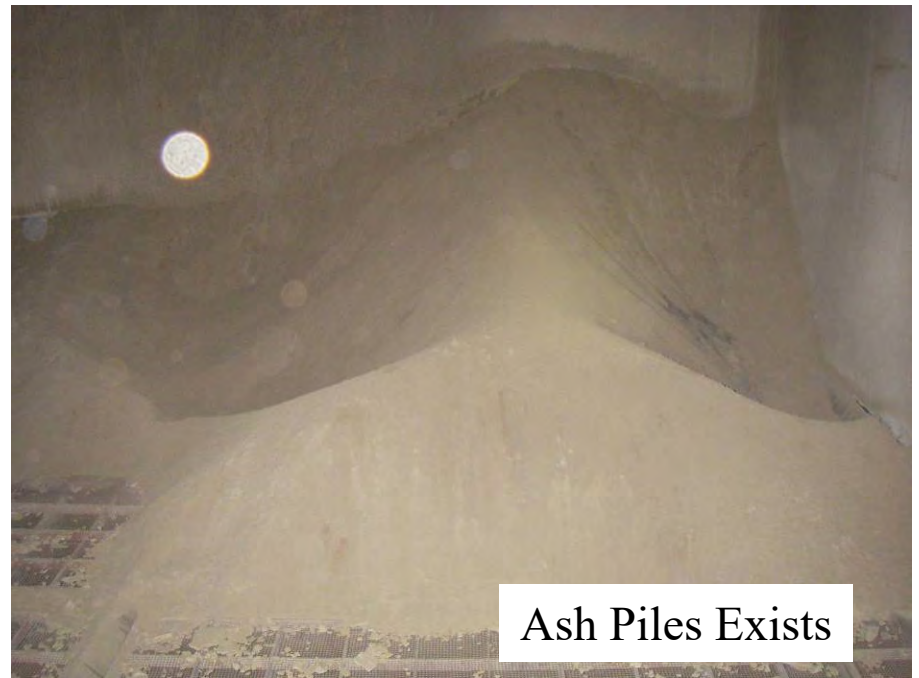
Ash Piles Exists

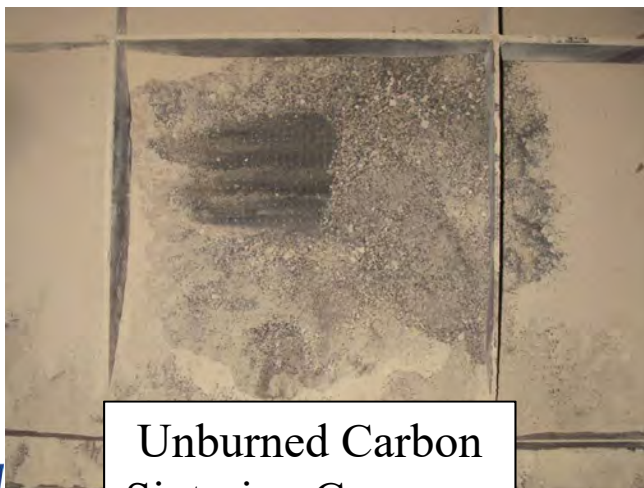
Unburned Carbon  
Sintering Concerns

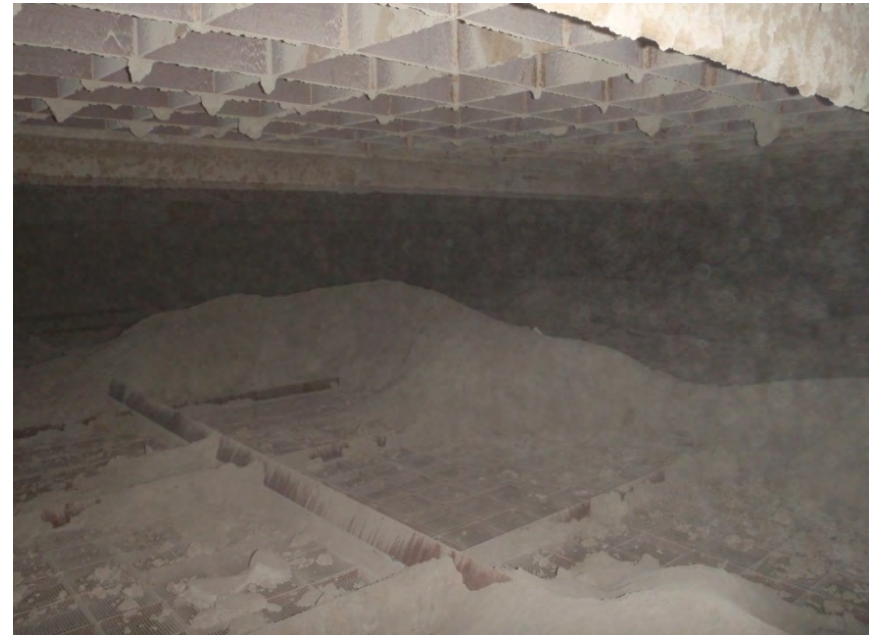
Smaller Ash Piles in L1-L3

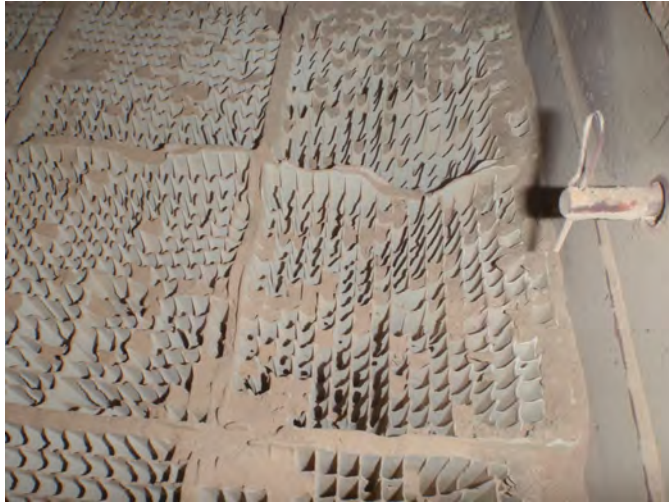
Moderate Erosion in L1 after 18,500 hrs

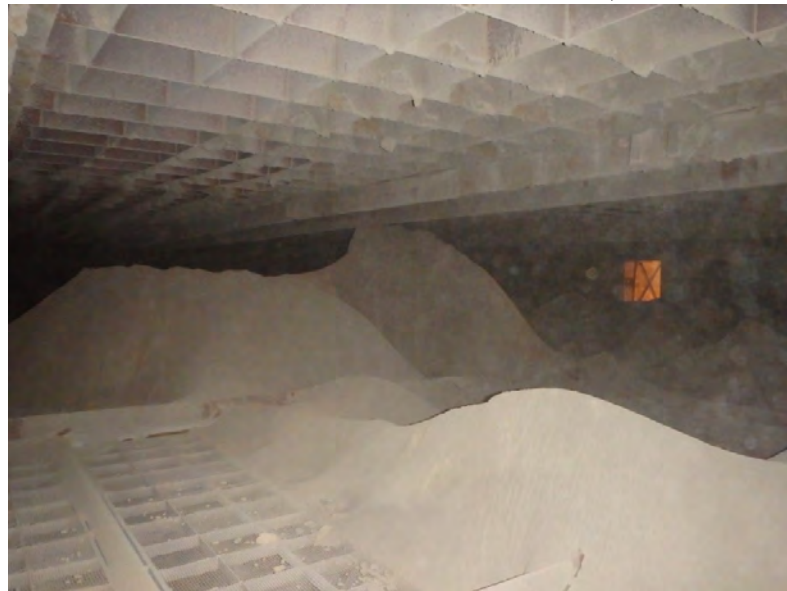
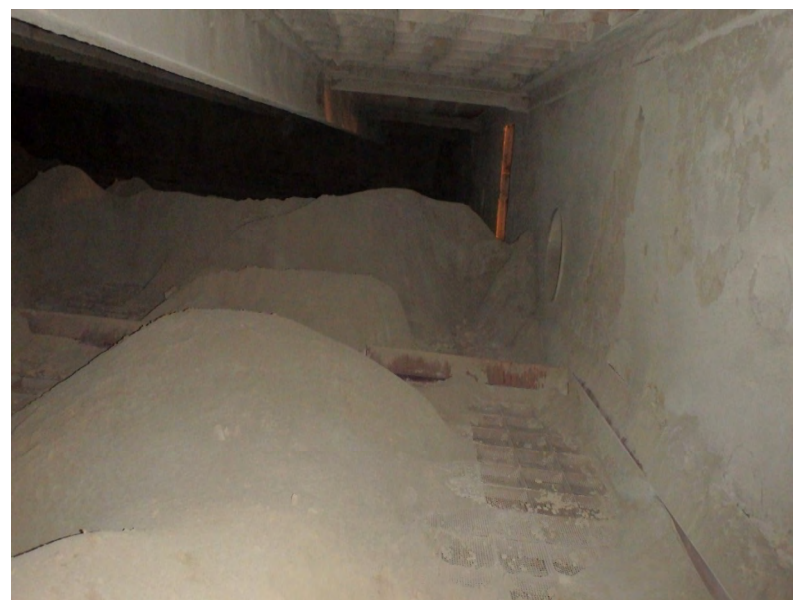
Larger Ash Piles From AIG to Far Side Through Center of Reactor

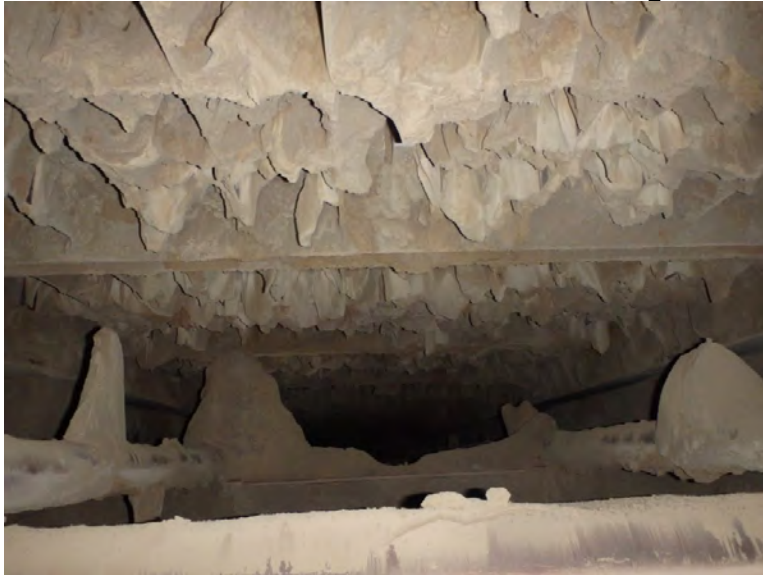
“Mud Daubers” on Outlet in L1

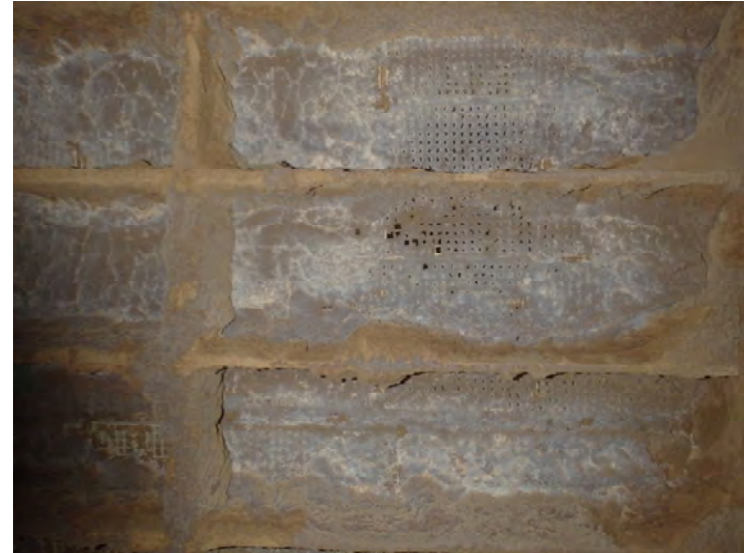
Pluggage on L3 Outlet (Hard & Compact)

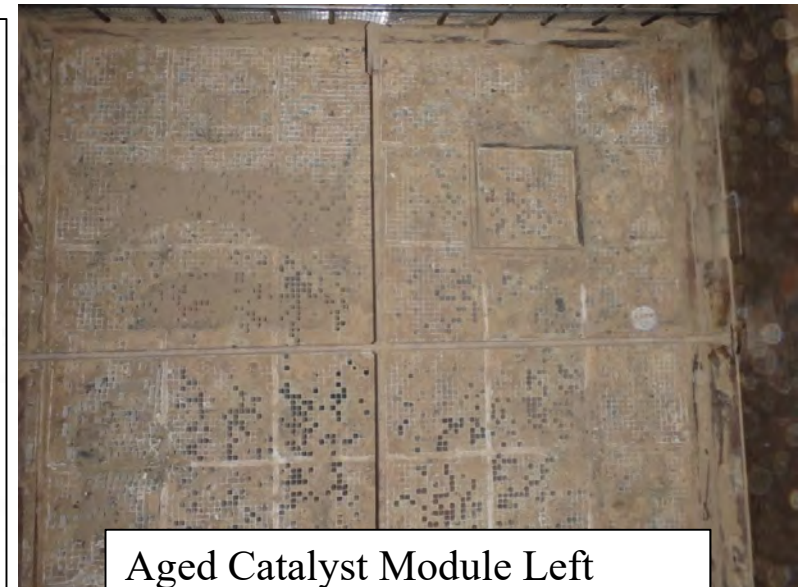
Aged Catalyst Module Left  
Installed in Unit (2-A12)

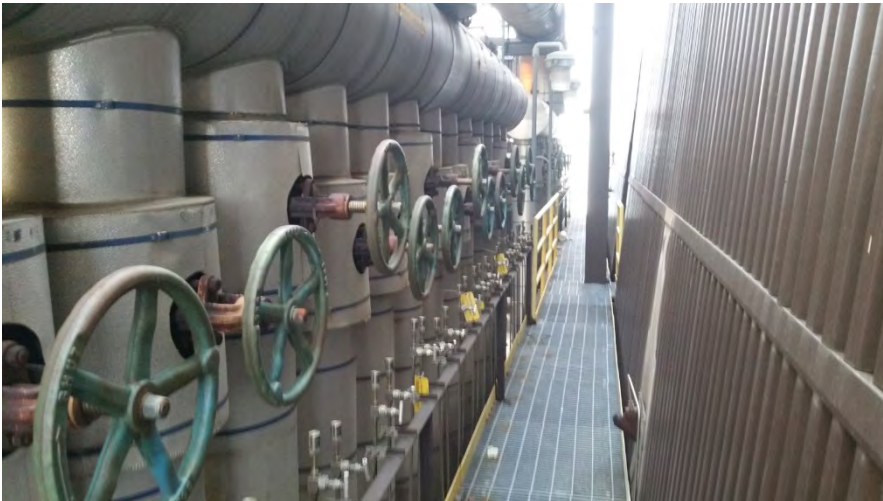
- Pressure Drop Measurements
- Historically Pressure Taps and Lines Are Plugged.
- Urea Salt's Out and Plugs Taps and Lines. Maintaining Clean Lines Extremely Difficult
- Recorded Number of Threads Exposed for All 30 Valves
